**REPORT NUMBER: TR-P32096-09-NC**

**RESEARCH AND DEVELOPMENT  
80 KM/H 70% OVERLAP REAR IMPACT**

**FORD MOTOR CO.  
1999 FORD F-150 2-DOOR TRUCK**

**FINAL REPORT**

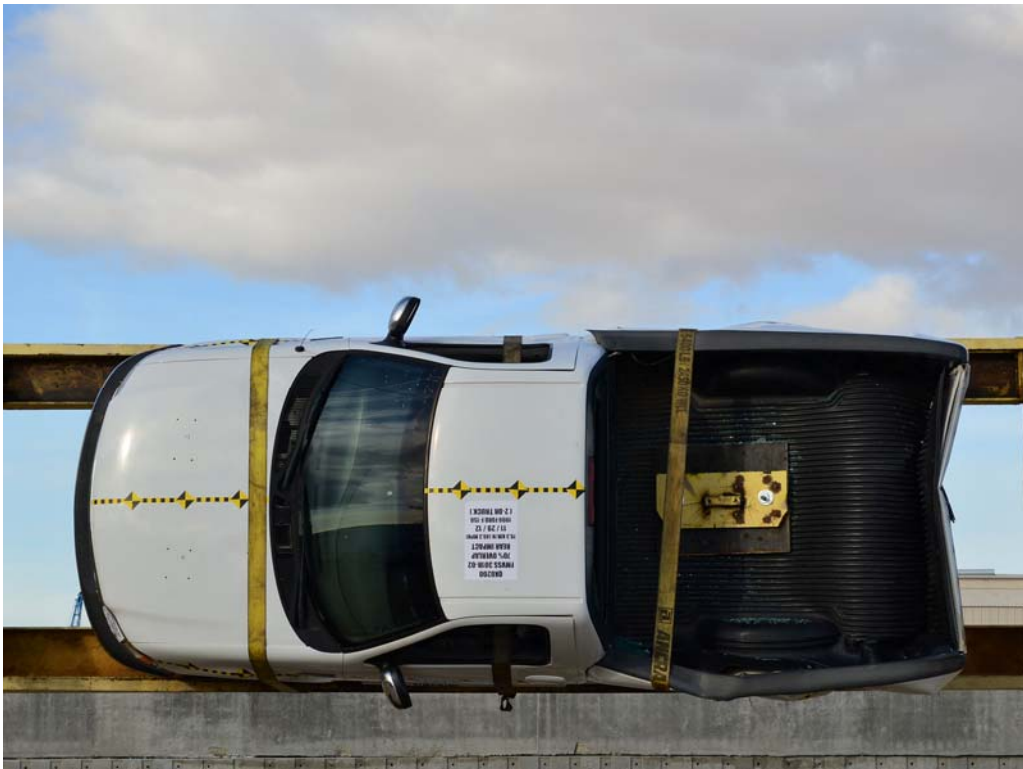
FIGURE 26. Vehicle at 90° on Static Rollover Device

Details of Stoddard solvent spillage: Stoddard solvent leaked from the fuel filler door between the 0° to 90° and 90° to 180° intervals. The vehicle also leaked from the area above the gas tank at the static 270°.

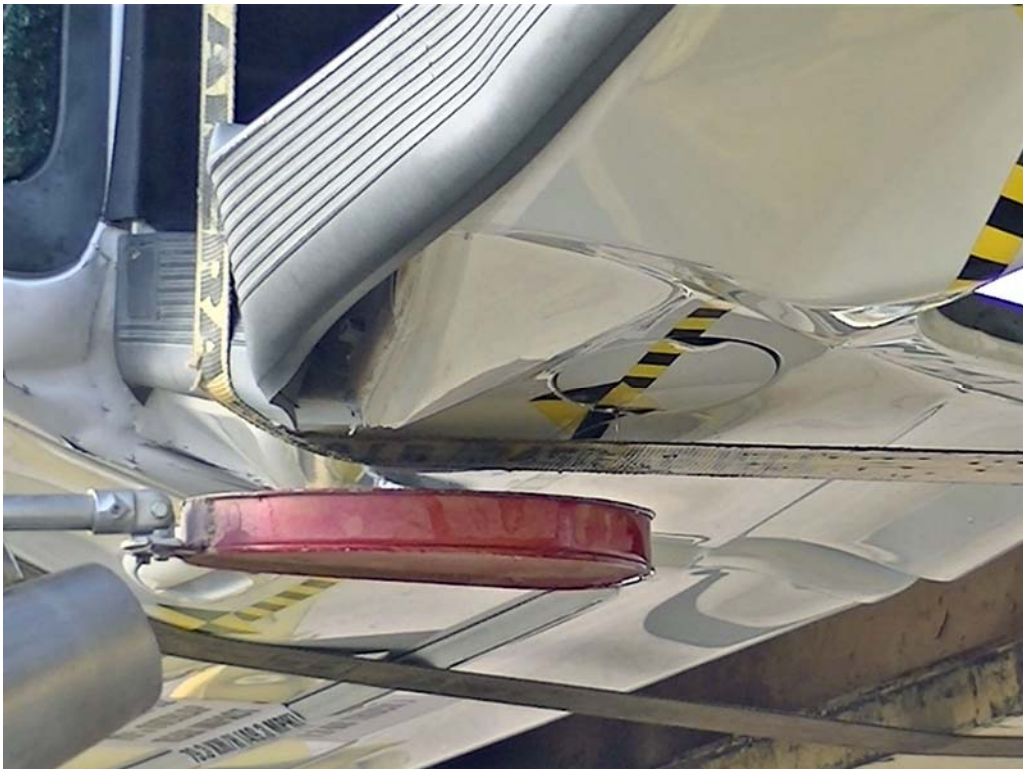
FIGURE 30. Post-Test Stoddard Solvent Spillage Location View

Test Phase	Spillage Location
0° To 90°	Area Around Fuel Filler Door
90° To 180°	Area Around Fuel Filler Door
180° To 270°	Area Above Gas Tank
270° To 360°	No Spillage
