REPORT NUMBER: TR-P35090-05-NC
SAFETY COMPLIANCE TESTING FOR FMVSS 301R
FUEL SYSTEM INTEGRITY – REAR IMPACT
79.3 KM/H 70% OVERLAP REAR IMPACT

MITSUBISHI MOTORS CORPORATION
2015 MITSUBISHI OUTLANDER ES 5-DOOR MPV

NHTSA NUMBER: C20155600

PREPARED BY:
KARCO ENGINEERING, LLC.
9270 HOLLY ROAD
ADELANTO, CA 92301

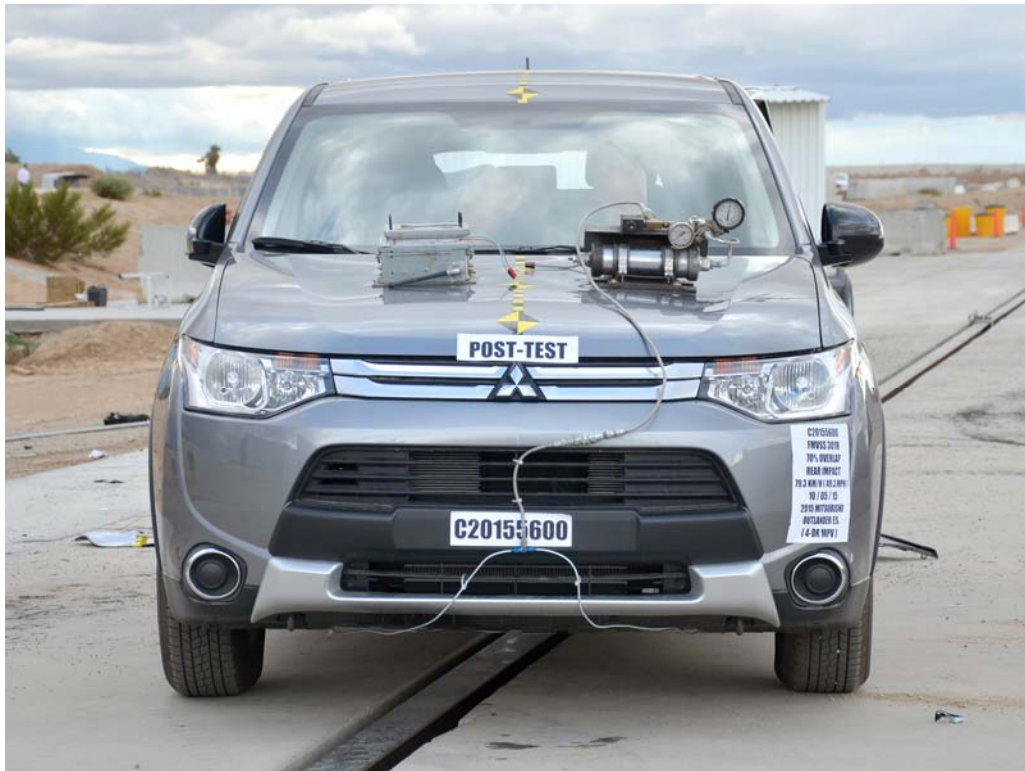
FIGURE 6. Post-Test Front View of Test Vehicle

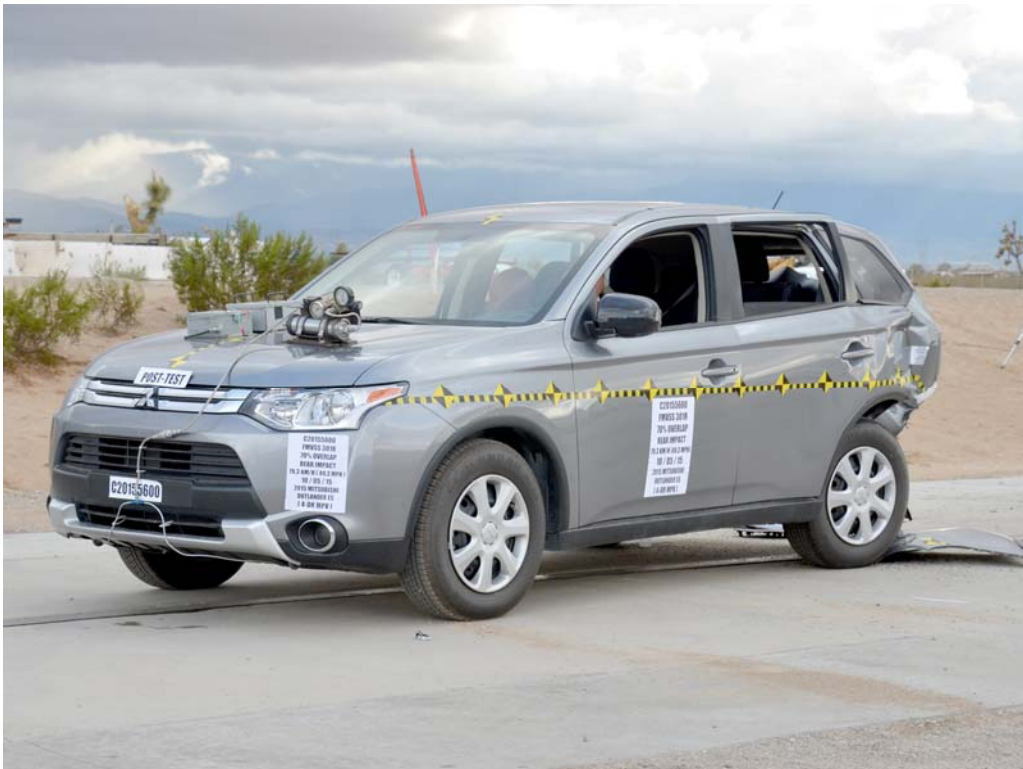
FIGURE 8. Post-Test Left Front $\frac{3}{4}$ View of Test Vehicle

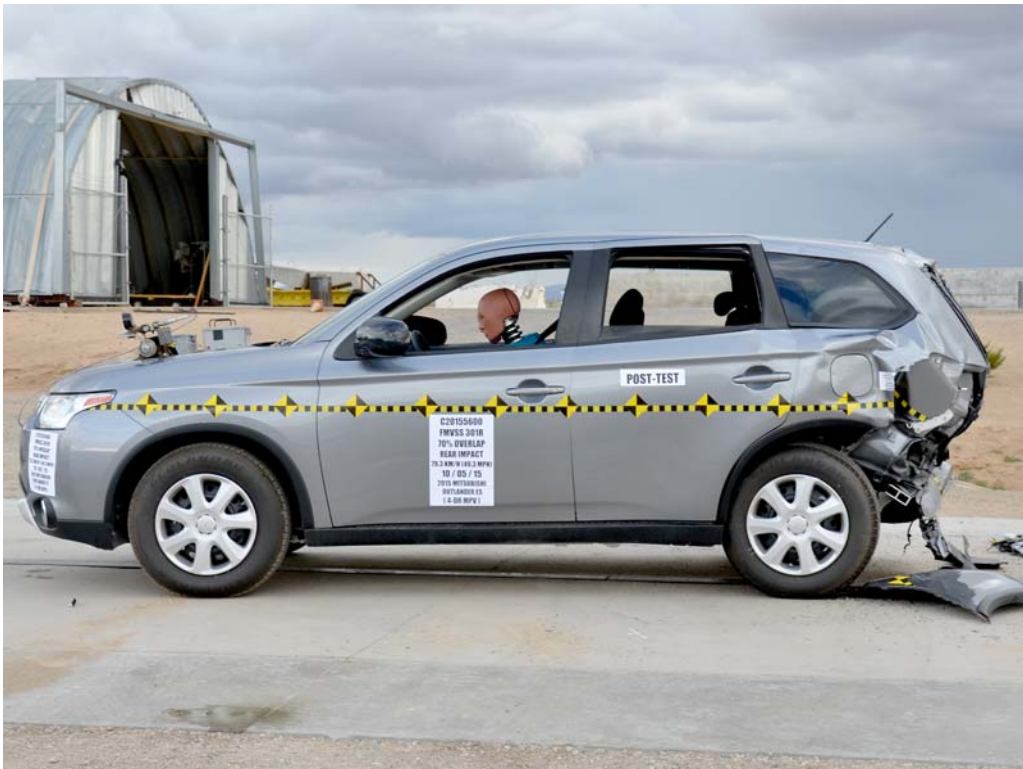
FIGURE 10. Post-Test Left Side View of Test Vehicle

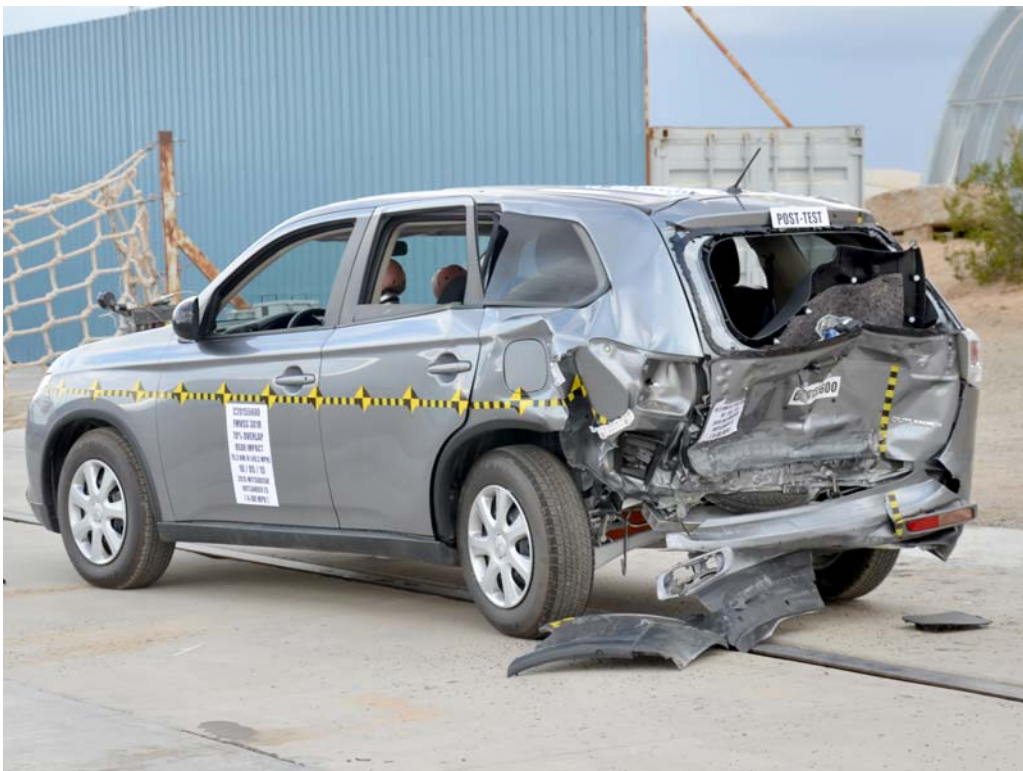
FIGURE 12. Post-Test Left Rear $\frac{3}{4}$ View of Test Vehicle

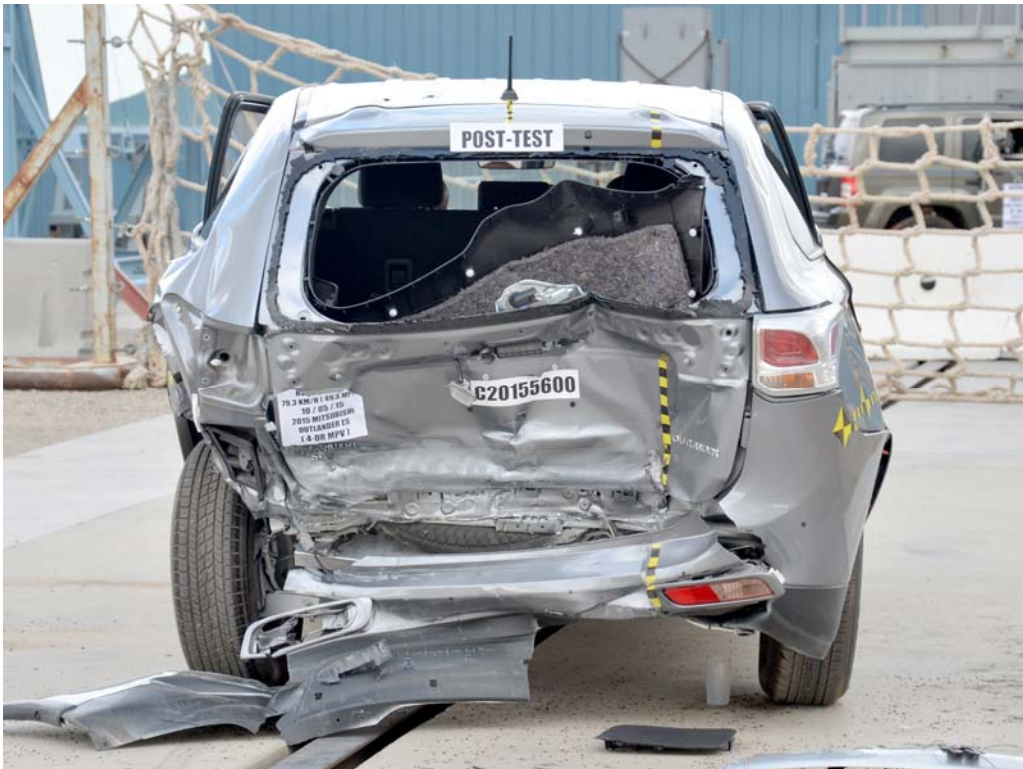
| Description | Driver | Passenger |
|---|---|---|
| Hatch and other doors | Rear Hatch Jammed Shut | |

FIGURE 14. Post-Test Rear View of Test Vehicle

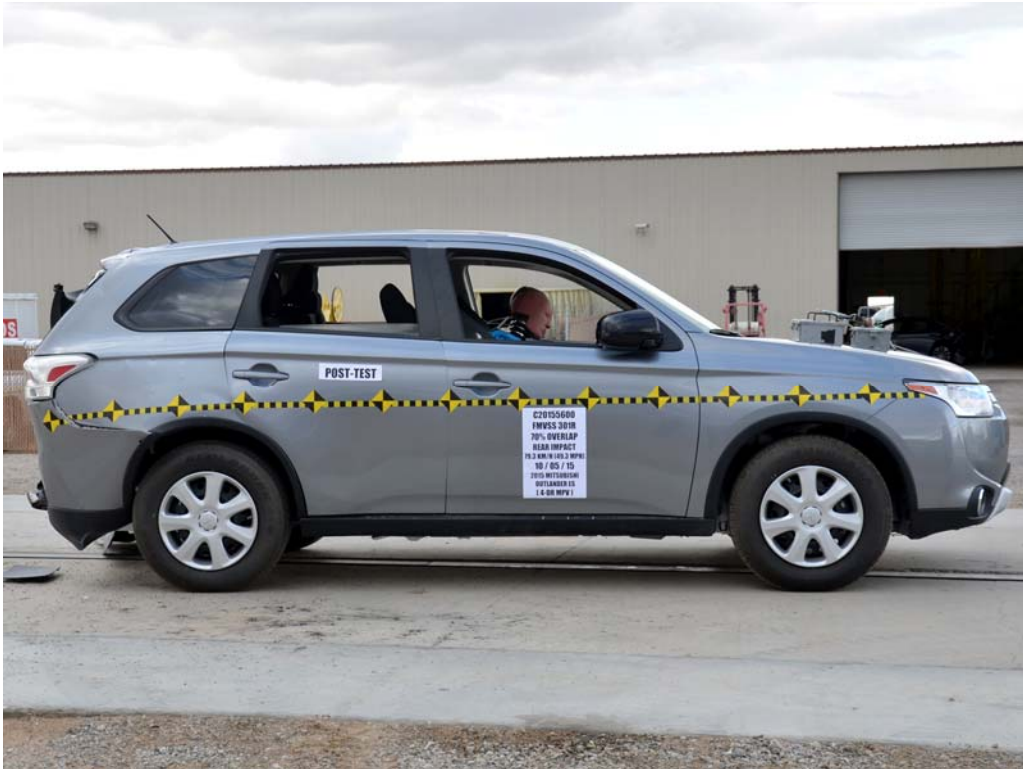
FIGURE 18. Post-Test Right Side View of Test Vehicle

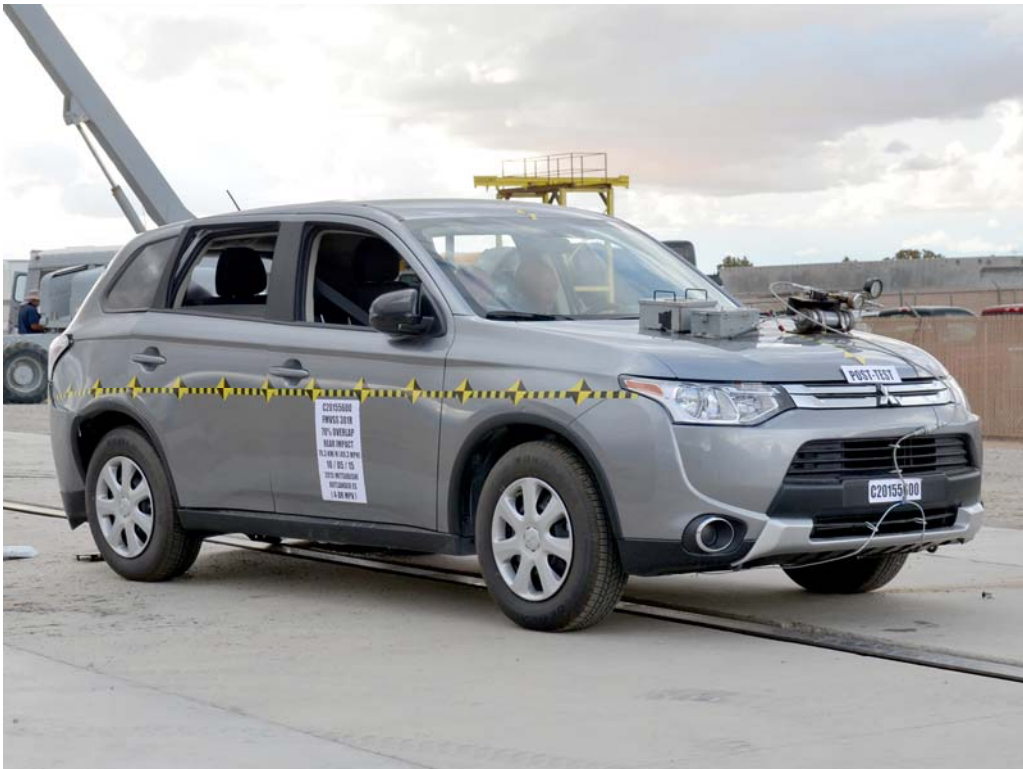
| Description | Driver | Passenger |
|---|---|---|
| Front Door Opening | Remained closed and latched | Jammed Shut |

FIGURE 20. Post-Test Right Front $\frac{3}{4}$ View of Test Vehicle

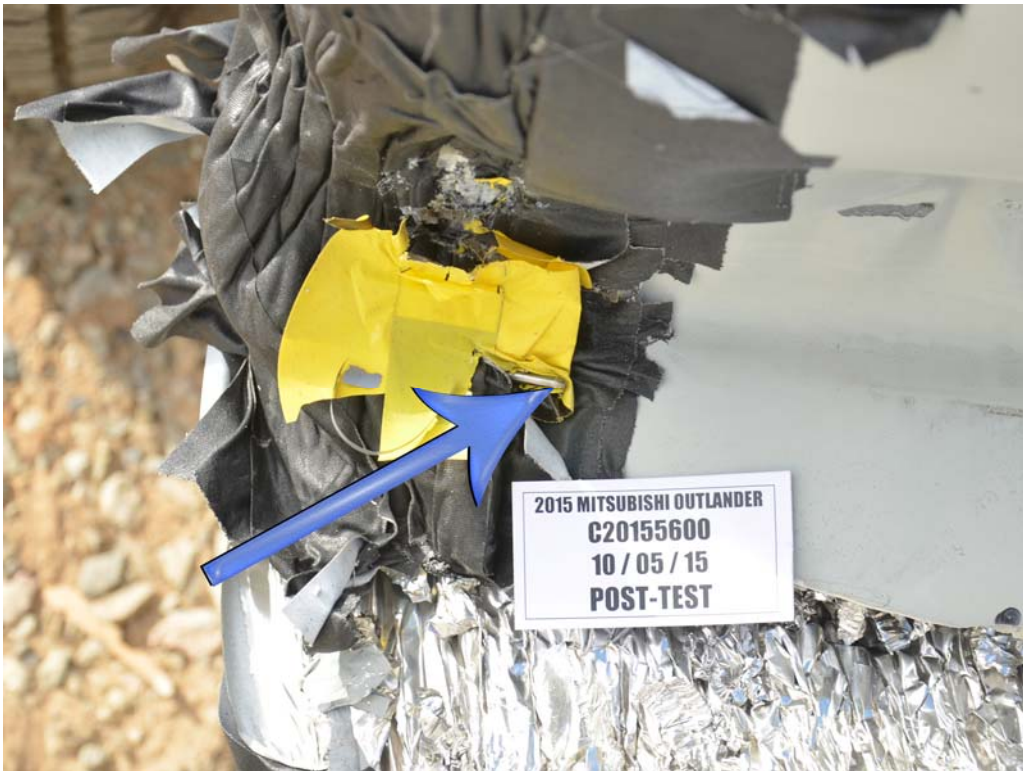
FIGURE 22. Post-Test Close-Up View of Impact Point Target

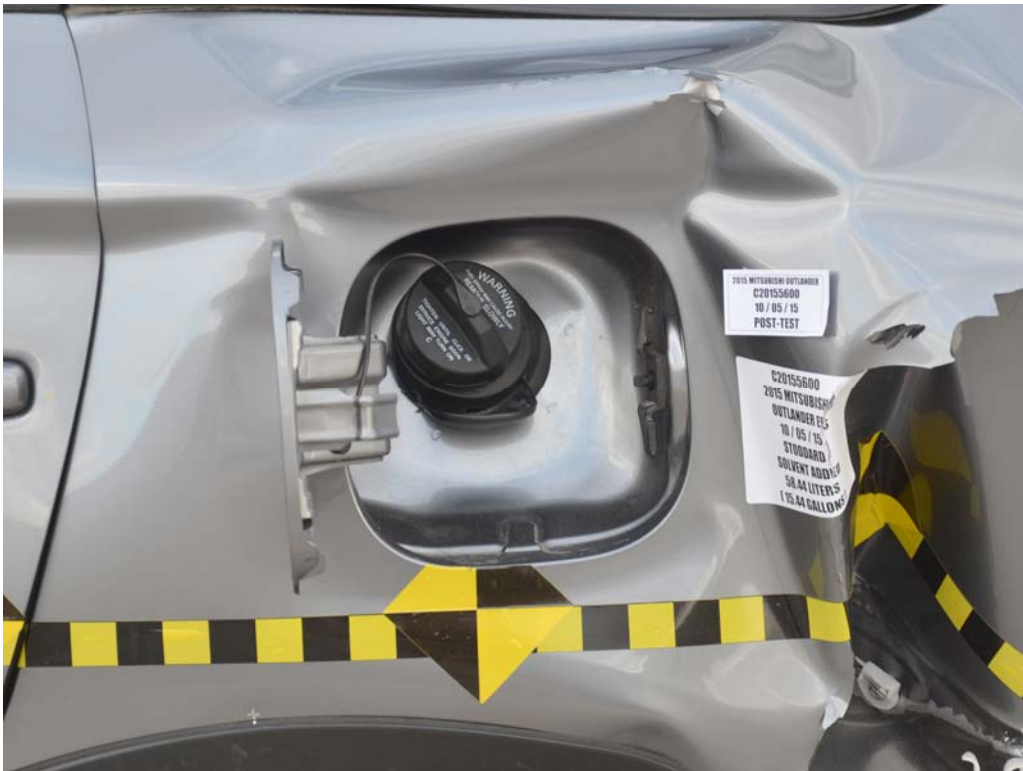
FIGURE 24. Post-Test View of Fuel Filler Cap

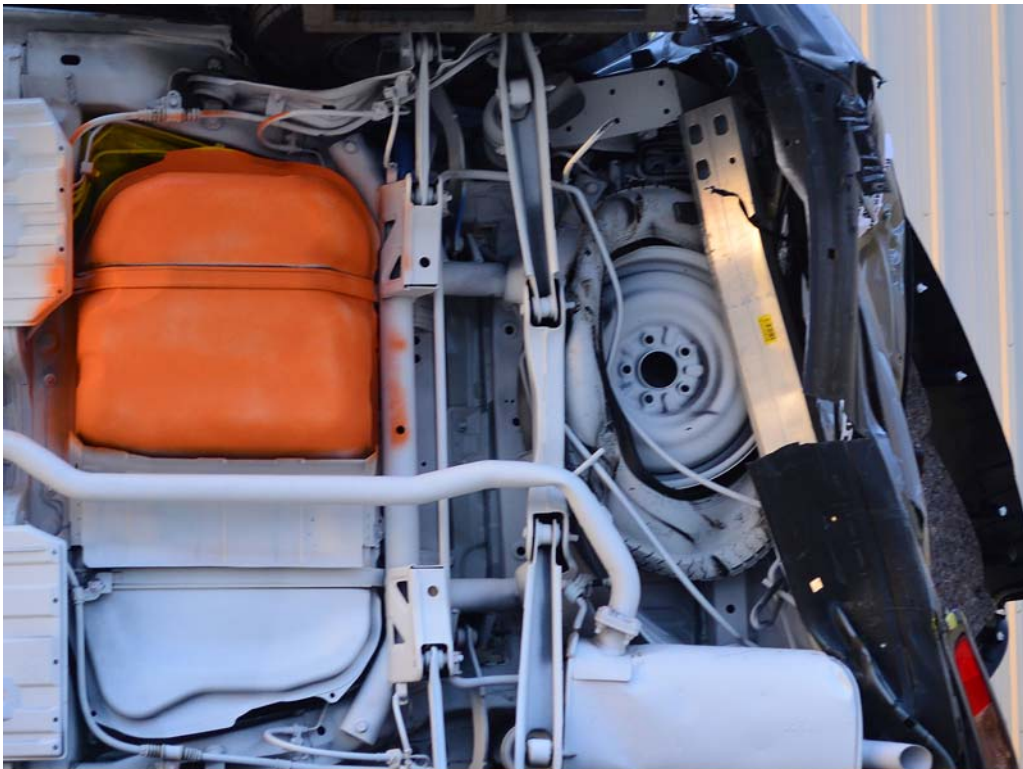
FIGURE 26. Post-Test Rear Underbody View of Test Vehicle

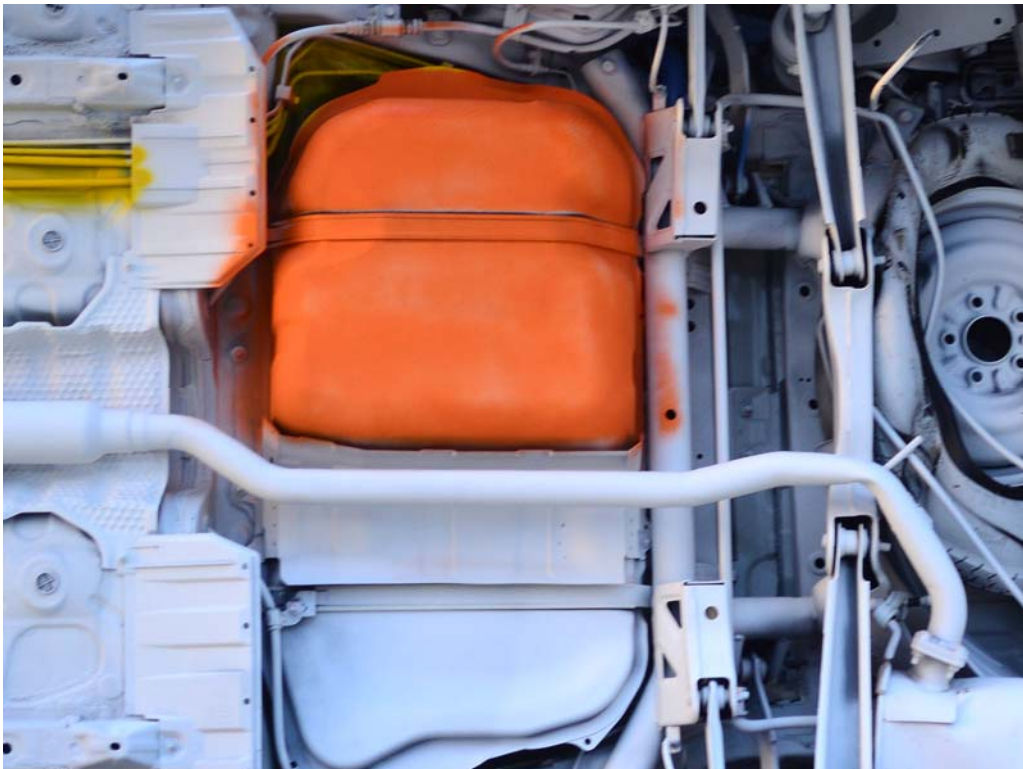
Stoddard solvent was observed immediately post impact, but not during any phase of the static rollover. After the test, a tear down and inspection was conducted on the vehicle's fuel system. The source of the leak was not found and the charcoal canister was found to be crushed by the impact. The charcoal canister may have been the source of the leak if the tank was overfilled at any point prior to testing. The test vehicle appeared to comply with all requirements of FMVSS 301R "Fuel System Integrity – Rear Impact". FMVSS 301 data is summarized in Data Sheets 6 and 7.

FIGURE 28. Post-Test Underbody View of Fuel Tank

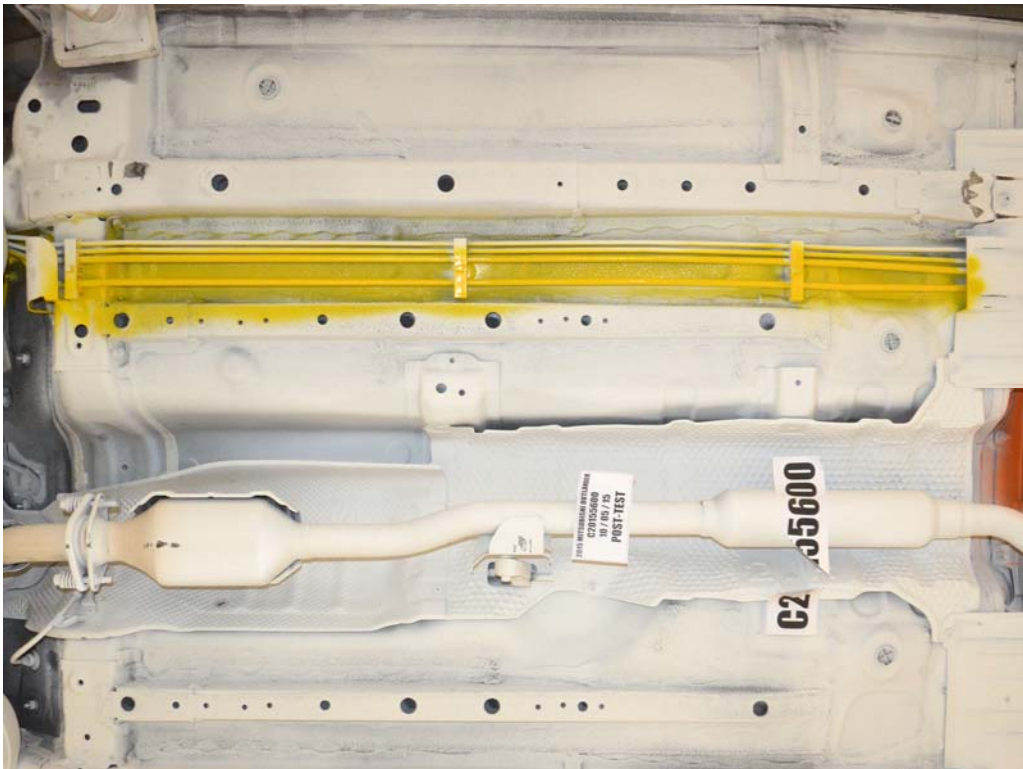
FIGURE 30. Post-Test Underbody View of Fuel Lines

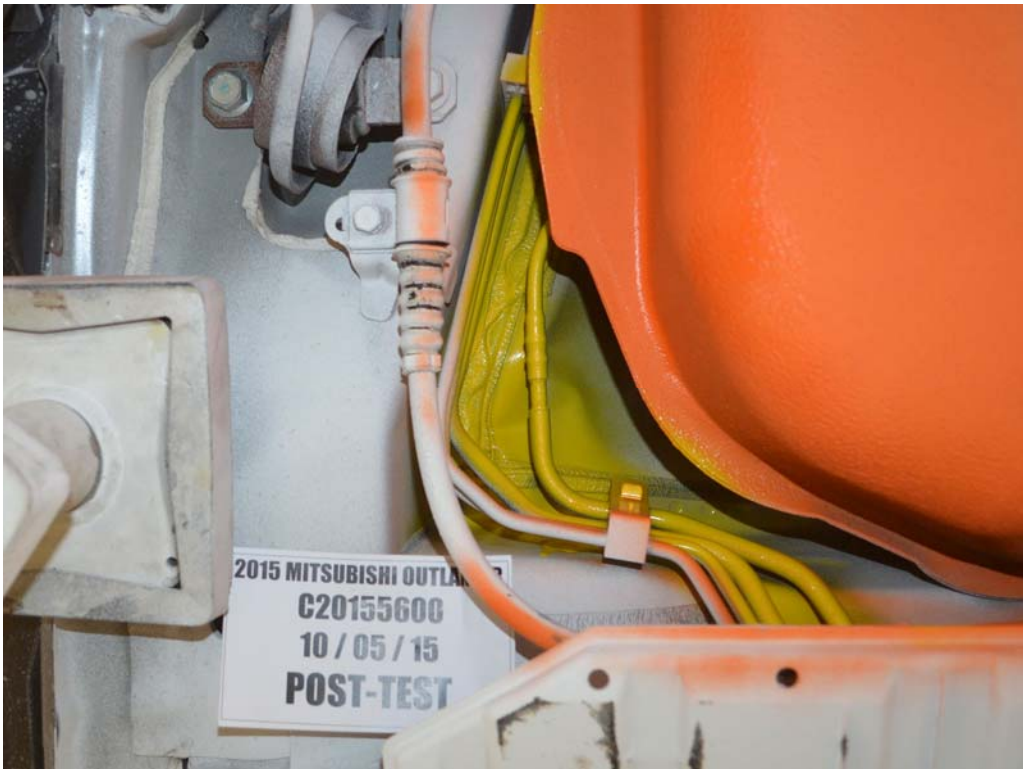
FIGURE 32. Post-Test Underbody View of Fuel Lines
