REPORT NUMBER: NCAP305I-MGA-2016-005

**NEW CAR ASSESSMENT PROGRAM (NCAP)
FMVSS No. 305 Indicant Test**

**VOLVO CAR CORPORATION
2016 Volvo XC90 T8 Inscription 5-Door SUV
NHTSA No.: O20165903**

FINAL REPORT

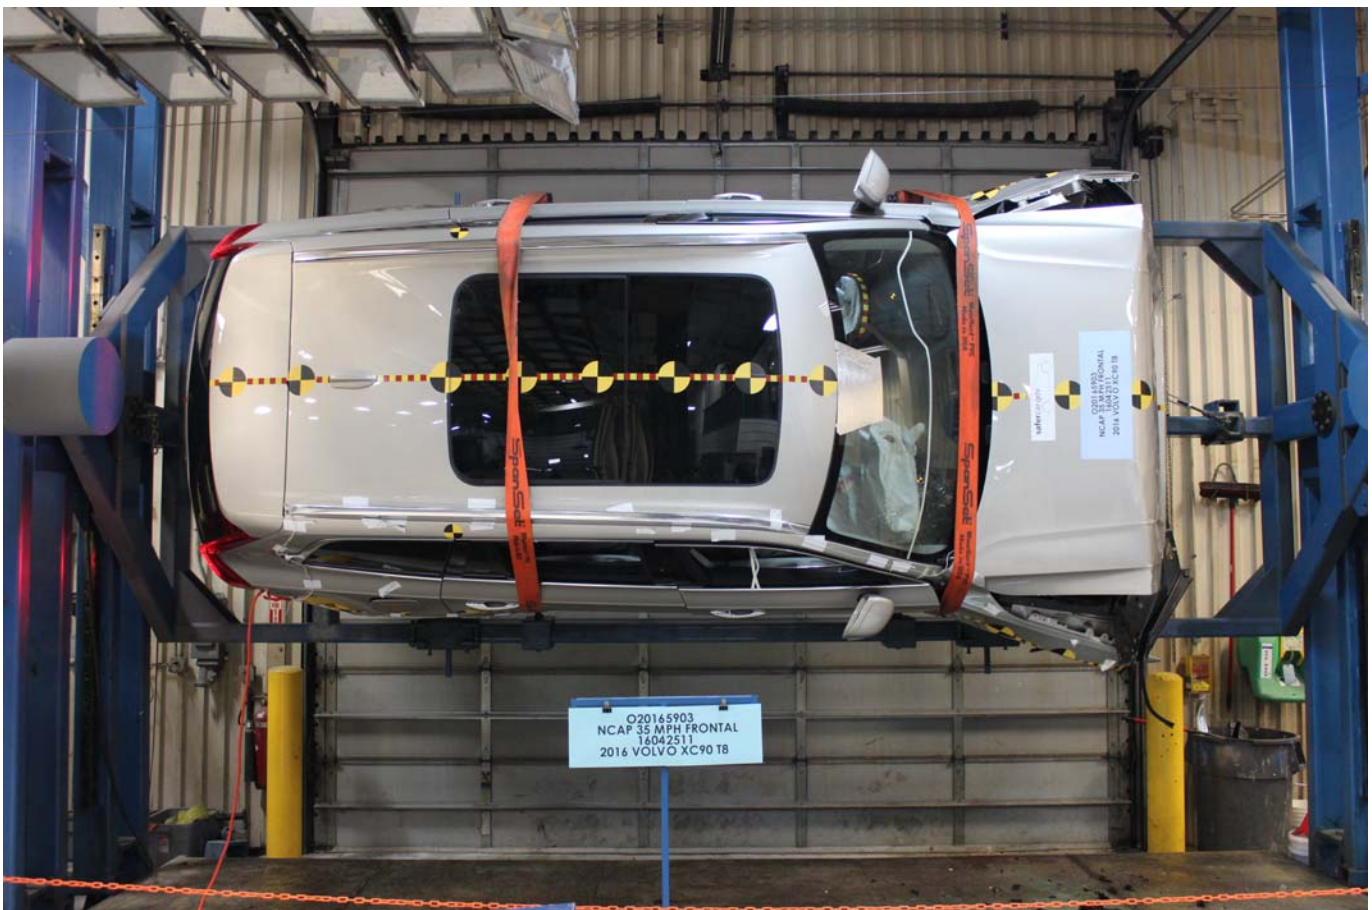
Photo No. 027 - FMVSS No. 305 Static Rollover at 90°

| Rollover Stage | Electric Energy Storage/Conversion Device Electrolyte Spillage (L) | Spillage Location |
|---|--|---|
| 90° to 180° | 0 | Not Applicable |

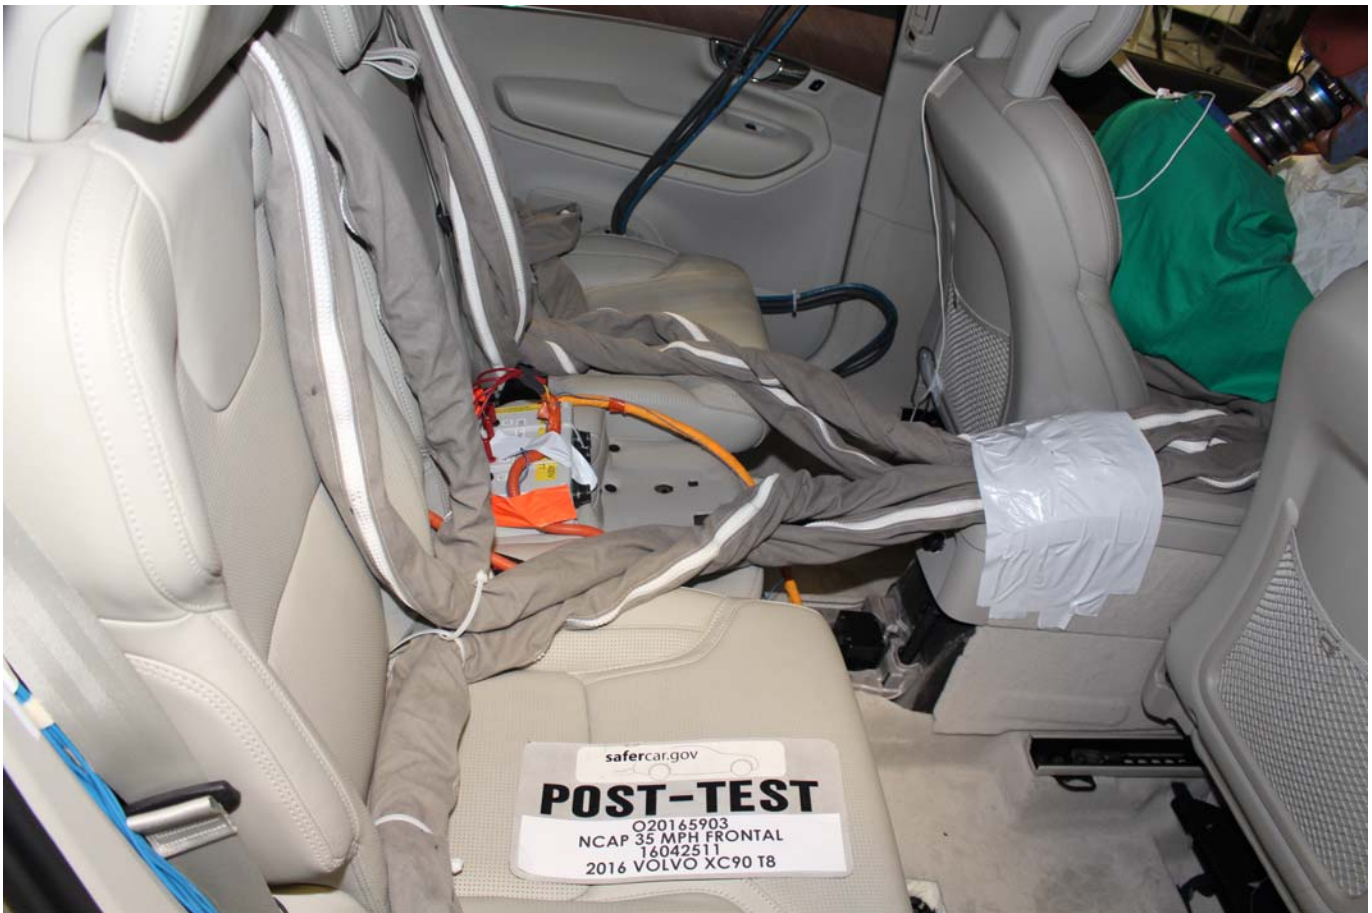
Photo No. 032 - Post-Impact View of the Vehicle Passenger Compartment Adjacent to Propulsion Battery

| Describe intrusion of an outside Electric Energy Storage/Conversion Device into the passenger compartment [Supply photographs as appropriate]: |
|--|
| No Intrusion |

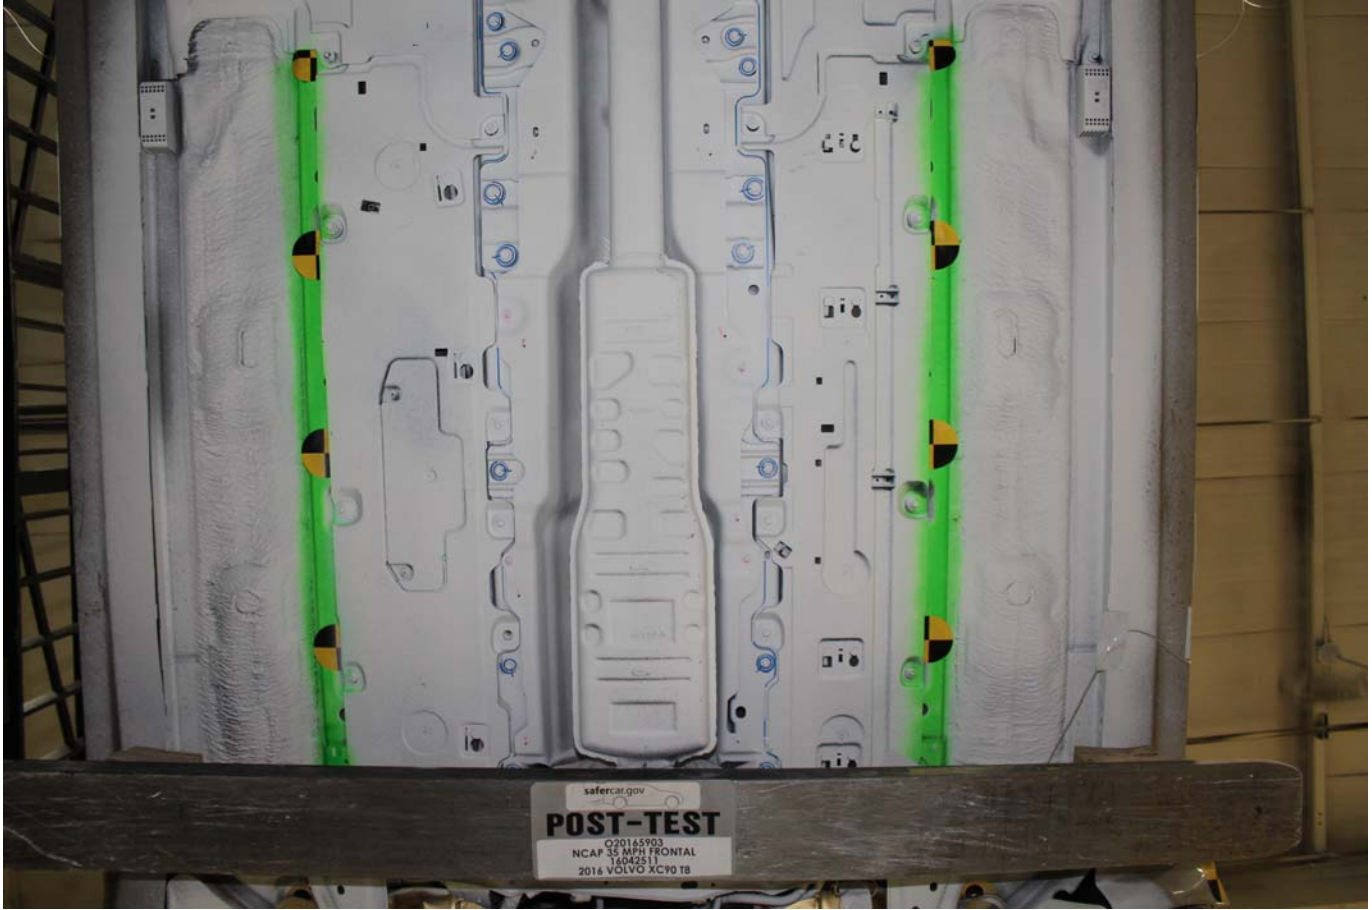
Photo No. 033 - Post-Impact Propulsion Battery System Mounting and-or Intrusion Failure(s)

| | Yes, Pass | No, Fail |
|---|---|---|
| All Components of Electrical Energy Storage/Conversion Device remained attached to the vehicle with at least one mounting location. | X | |
