REPORT NUMBER: NCAP305I-MGA-2016-007

**NEW CAR ASSESSMENT PROGRAM (NCAP)
FMVSS No. 305 Indicant Test**

**VOLVO CAR CORPORATION
2016 Volvo XC90 T8 Inscription 5-Door SUV
NHTSA NUMBER: O20165905**

FINAL REPORT

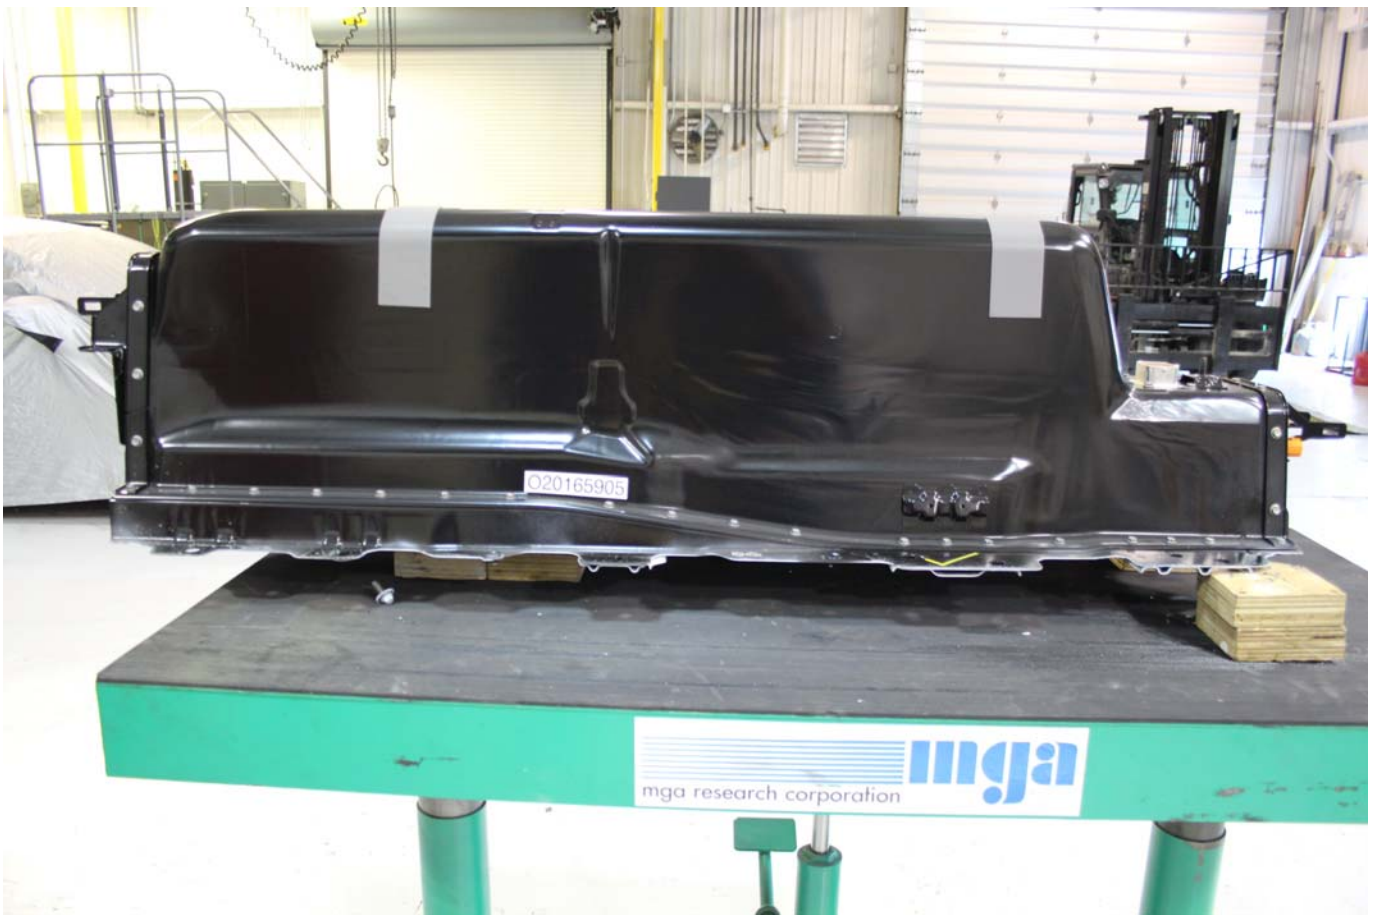
Photo No. 012 - Post-Impact View of Battery Box(s) or Container(s) Which Holds Individual Battery Modules

| | Yes, Pass | No, Fail |
|---|---|---|
| All Components of Electrical Energy Storage/Conversion Device remained attached to the vehicle with at least one mounting location. | X | |

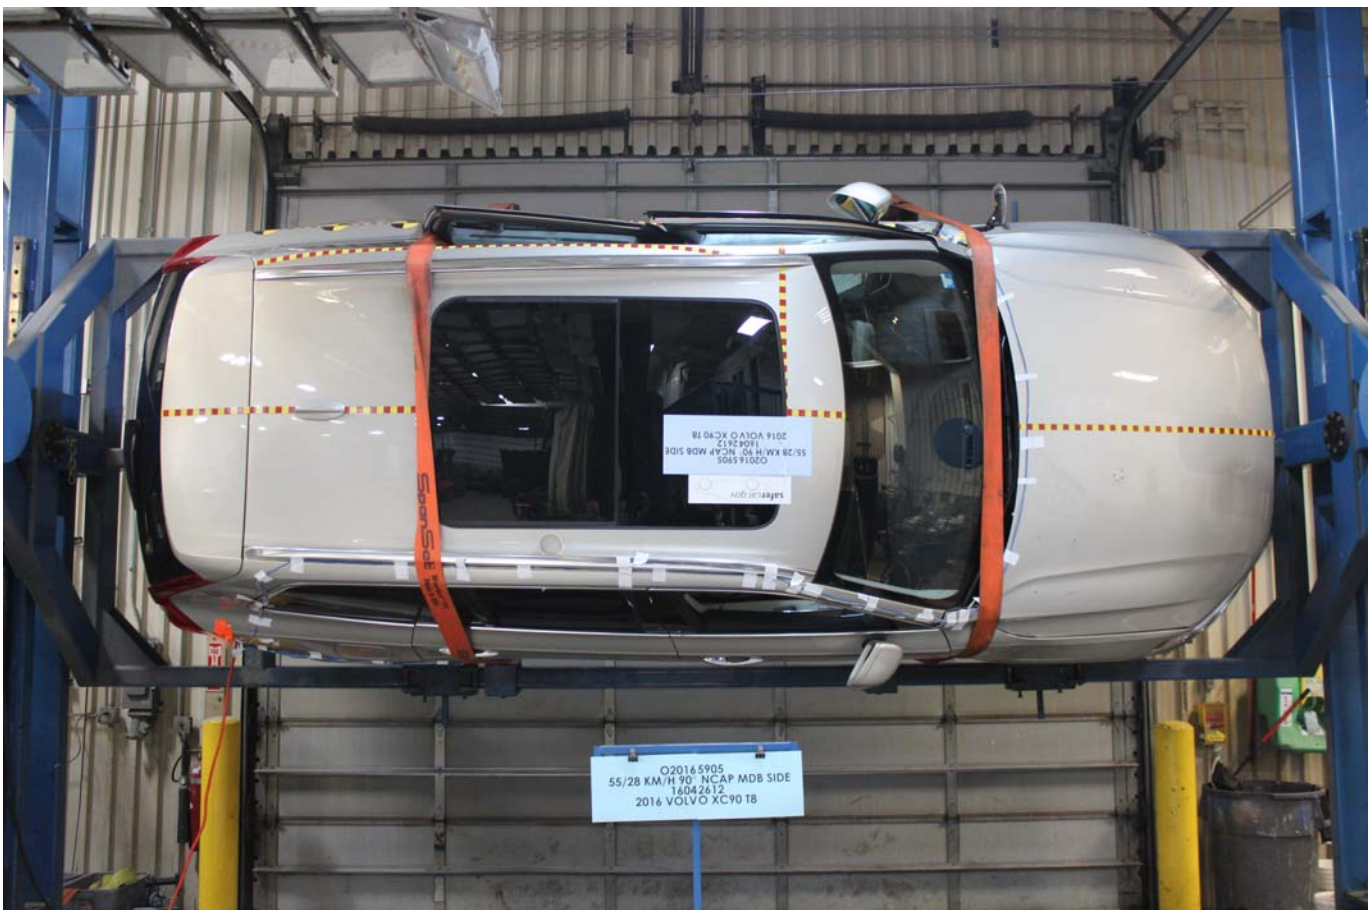
Photo No. 027 - FMVSS No. 305 Static Rollover at 90°

| Rollover Stage | Electric Energy Storage/Conversion Device Electrolyte Spillage (L) | Spillage Location |
|---|--|---|
| 0° to 90° | 0 | Not Applicable |

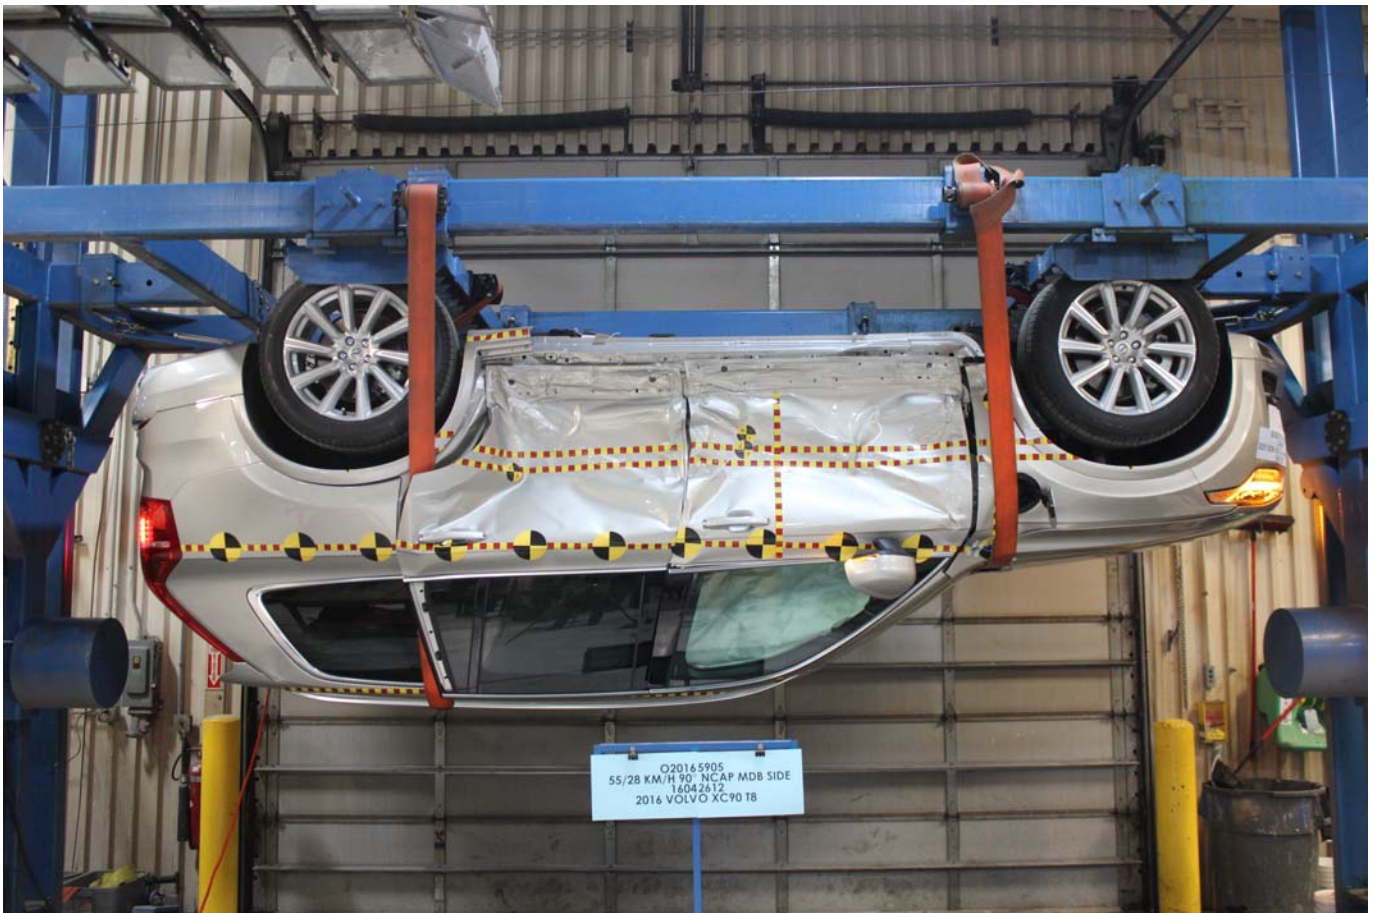
Photo No. 028 - FMVSS No. 305 Static Rollover at 180°

| Rollover Stage | Electric Energy Storage/Conversion Device Electrolyte Spillage (L) | Spillage Location |
|---|--|---|
| 90° to 180° | 0 | Not Applicable |

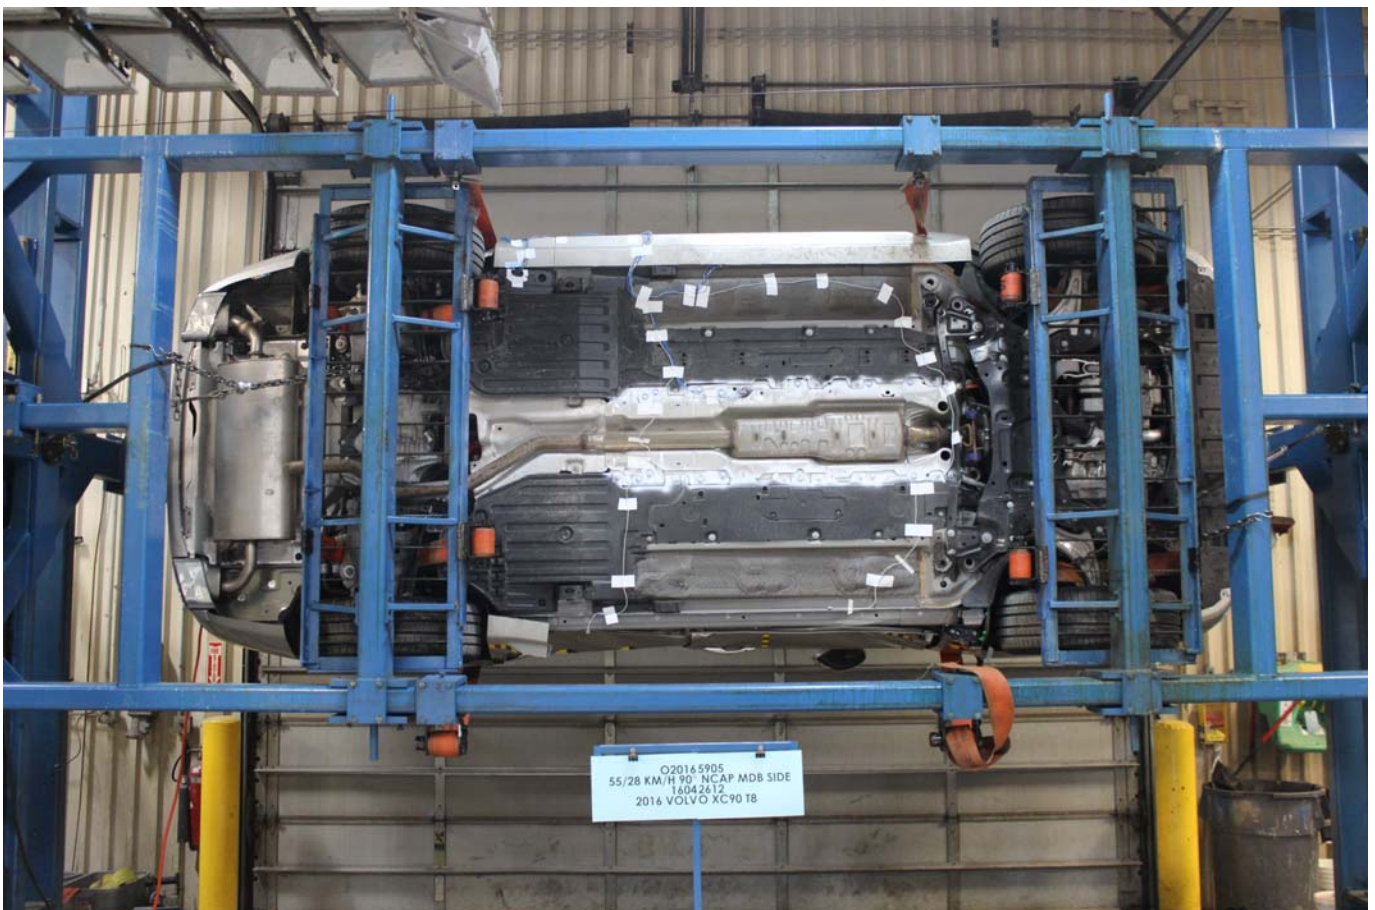
Photo No. 029 - FMVSS No. 305 Static Rollover at 270°

| Rollover Stage | Electric Energy Storage/Conversion Device Electrolyte Spillage (L) | Spillage Location |
|---|--|---|
| 180° to 270° | 0 | Not Applicable |

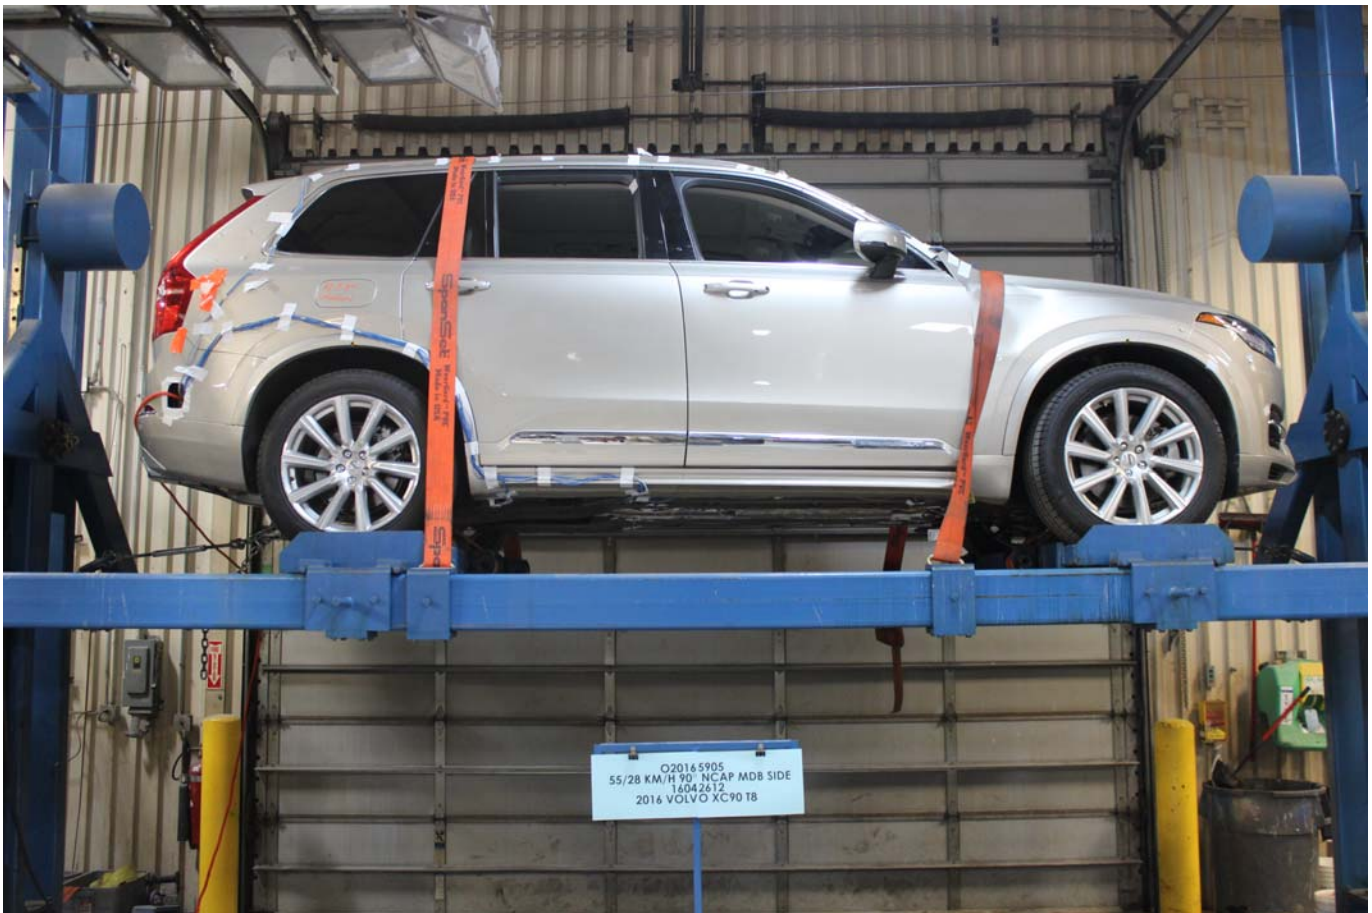
Photo No. 030 - FMVSS No. 305 Static Rollover at 360°

| Rollover Stage | Electric Energy Storage/Conversion Device Electrolyte Spillage (L) | Spillage Location |
|---|--|---|
| 270° to 360° | 0 | Not Applicable |

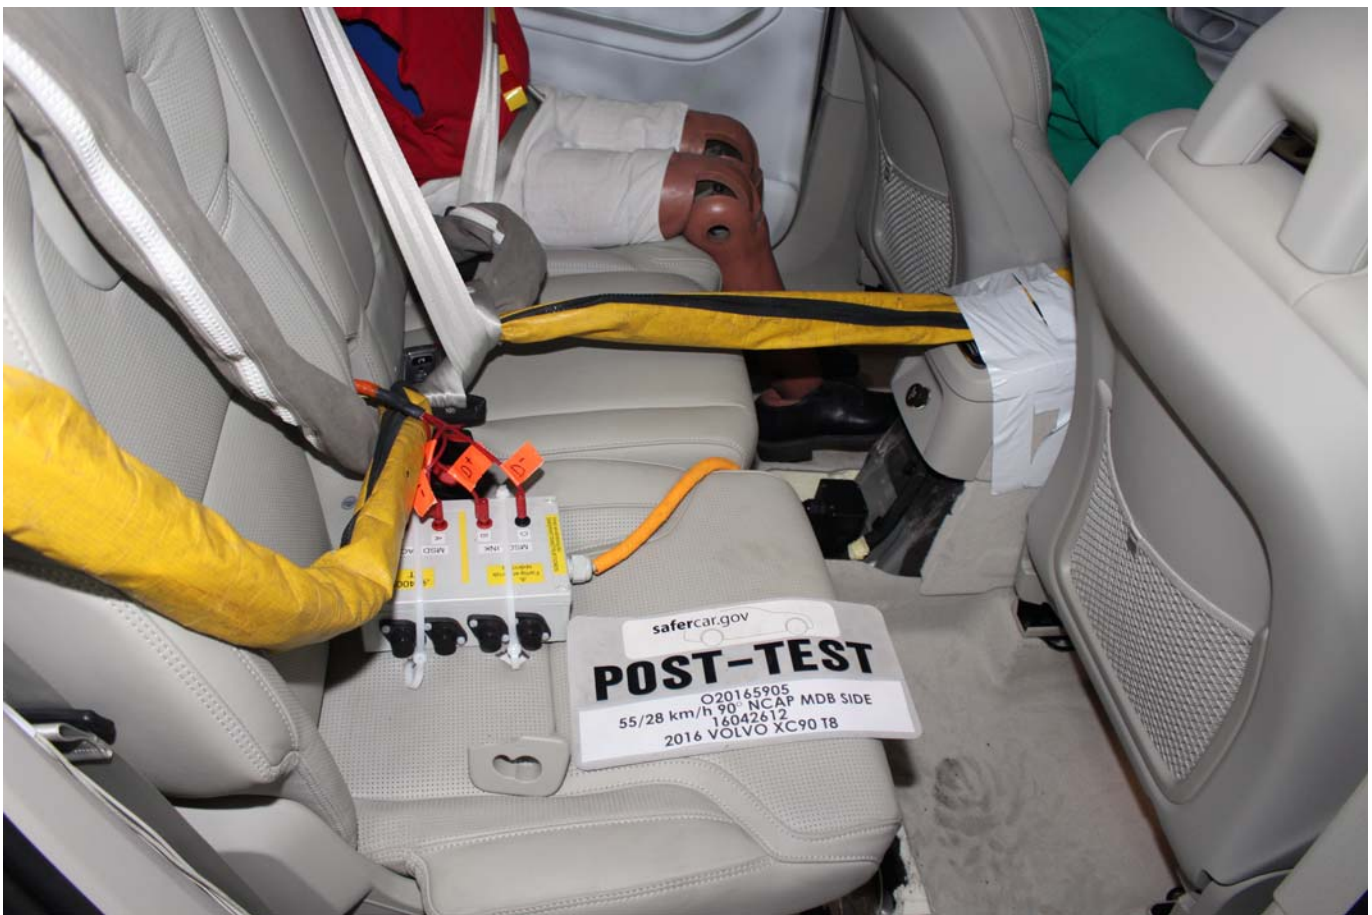
Photo No. 032 - Post-Impact View of the Vehicle Passenger Compartment Adjacent to Propulsion Battery

| Describe intrusion of an outside Electric Energy Storage/Conversion Device into the passenger compartment [Supply photographs as appropriate]: |
|--|
| No Intrusion |

| | Yes, Fail | No, Pass |
|---|---|---|
| Is Electric Energy Storage/Conversion Device electrolyte spillage visible in the passenger compartment? | | X |
