REPORT NUMBER: 301-MGA-2009-001

**SAFETY COMPLIANCE TESTING FOR FMVSS 301R
FUEL SYSTEM INTEGRITY – REAR IMPACT**

**DAIMLER CHRYSLER AG
2008 DODGE SPRINTER 2500 CARGO VAN
NHTSA NUMBER: C80306**

**PREPARED BY:
MGA RESEARCH CORPORATION
5000 WARREN ROAD
BURLINGTON, WI 53105**

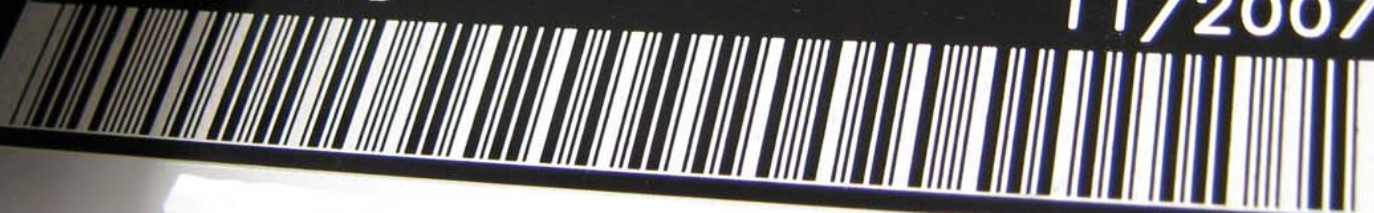
A-1.

Vehicle's Certification Label

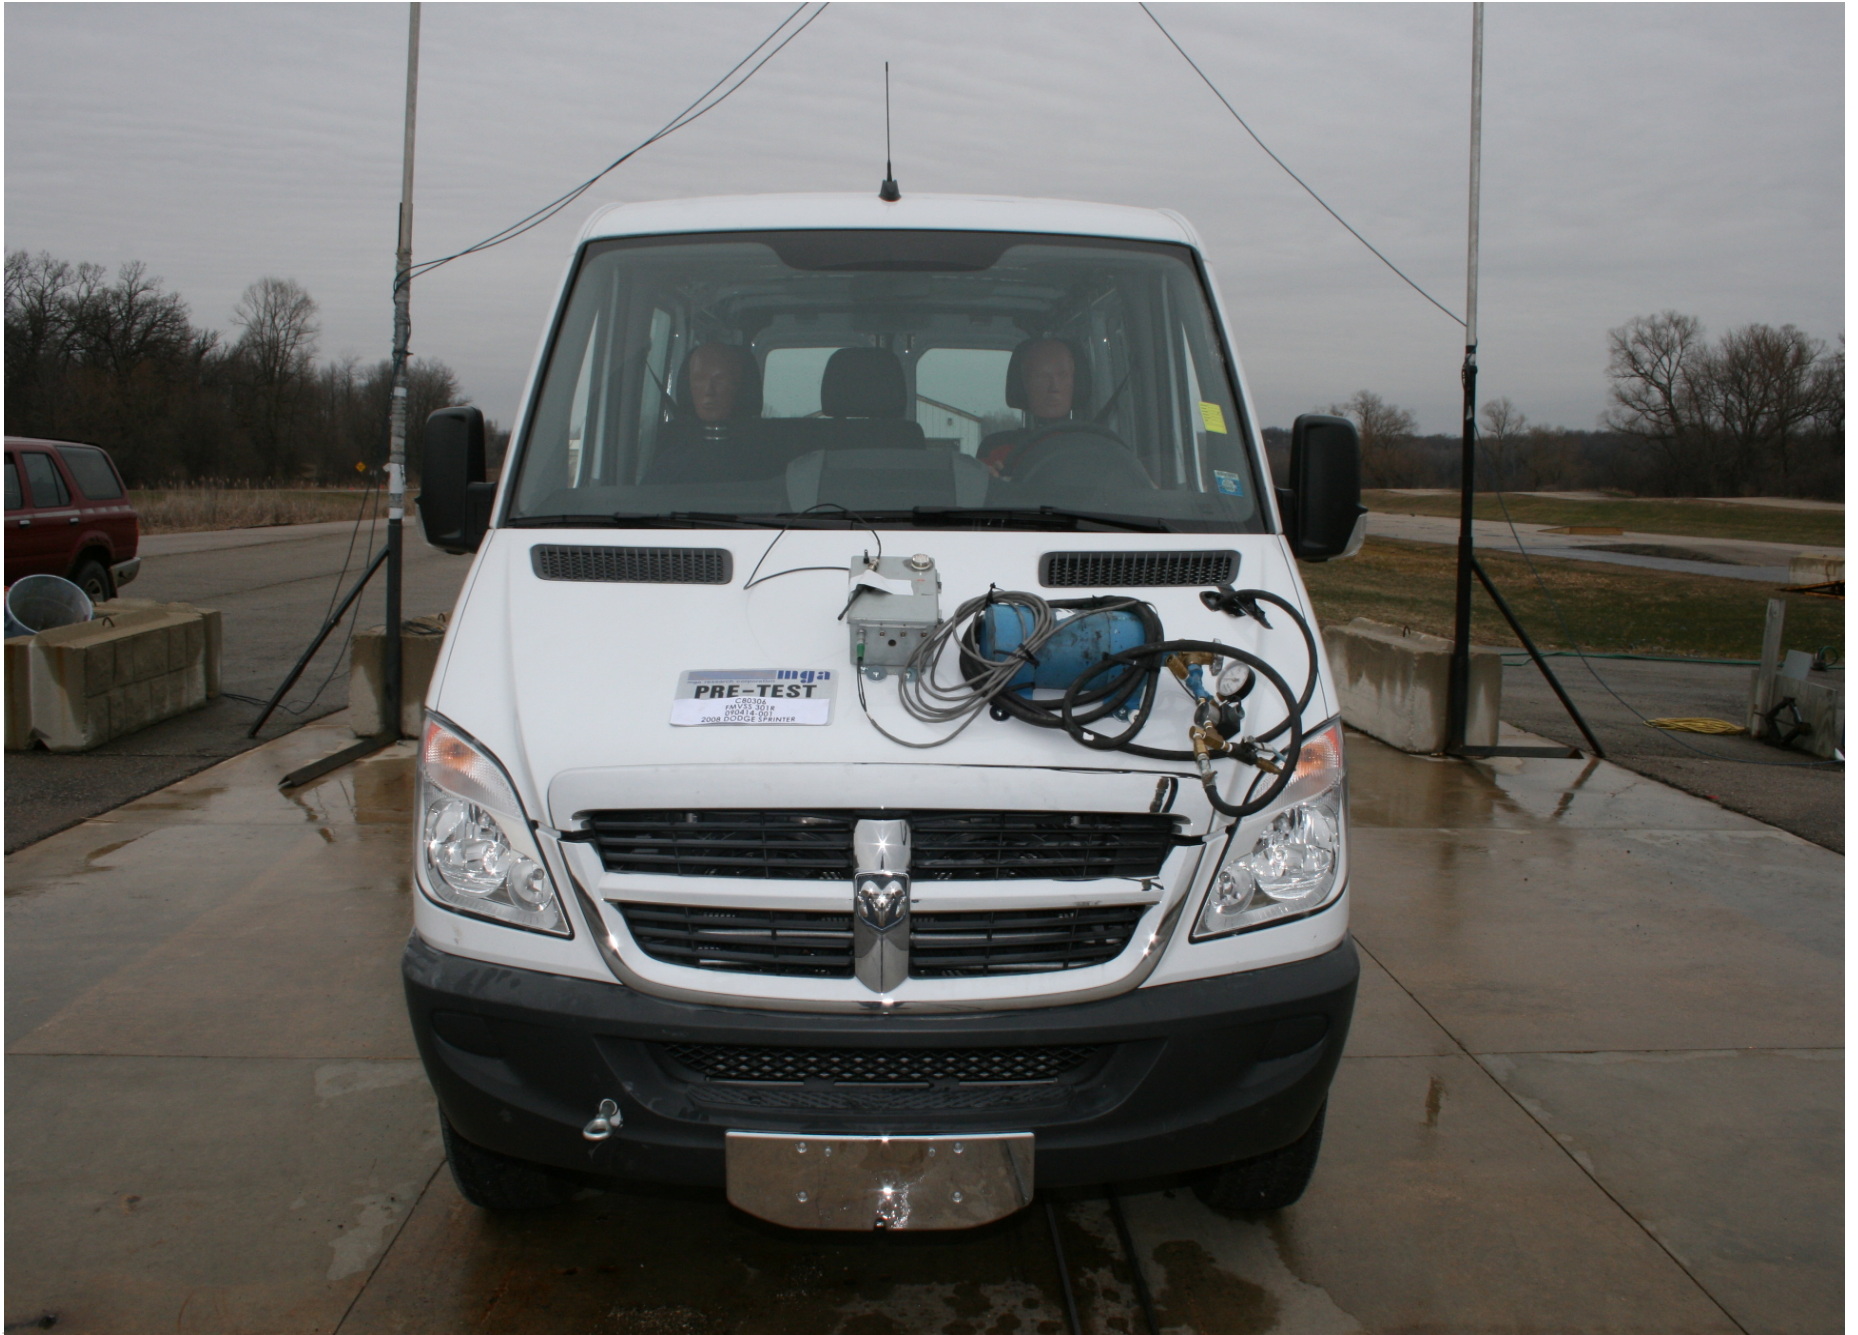
Pre-Test Front View of Vehicle

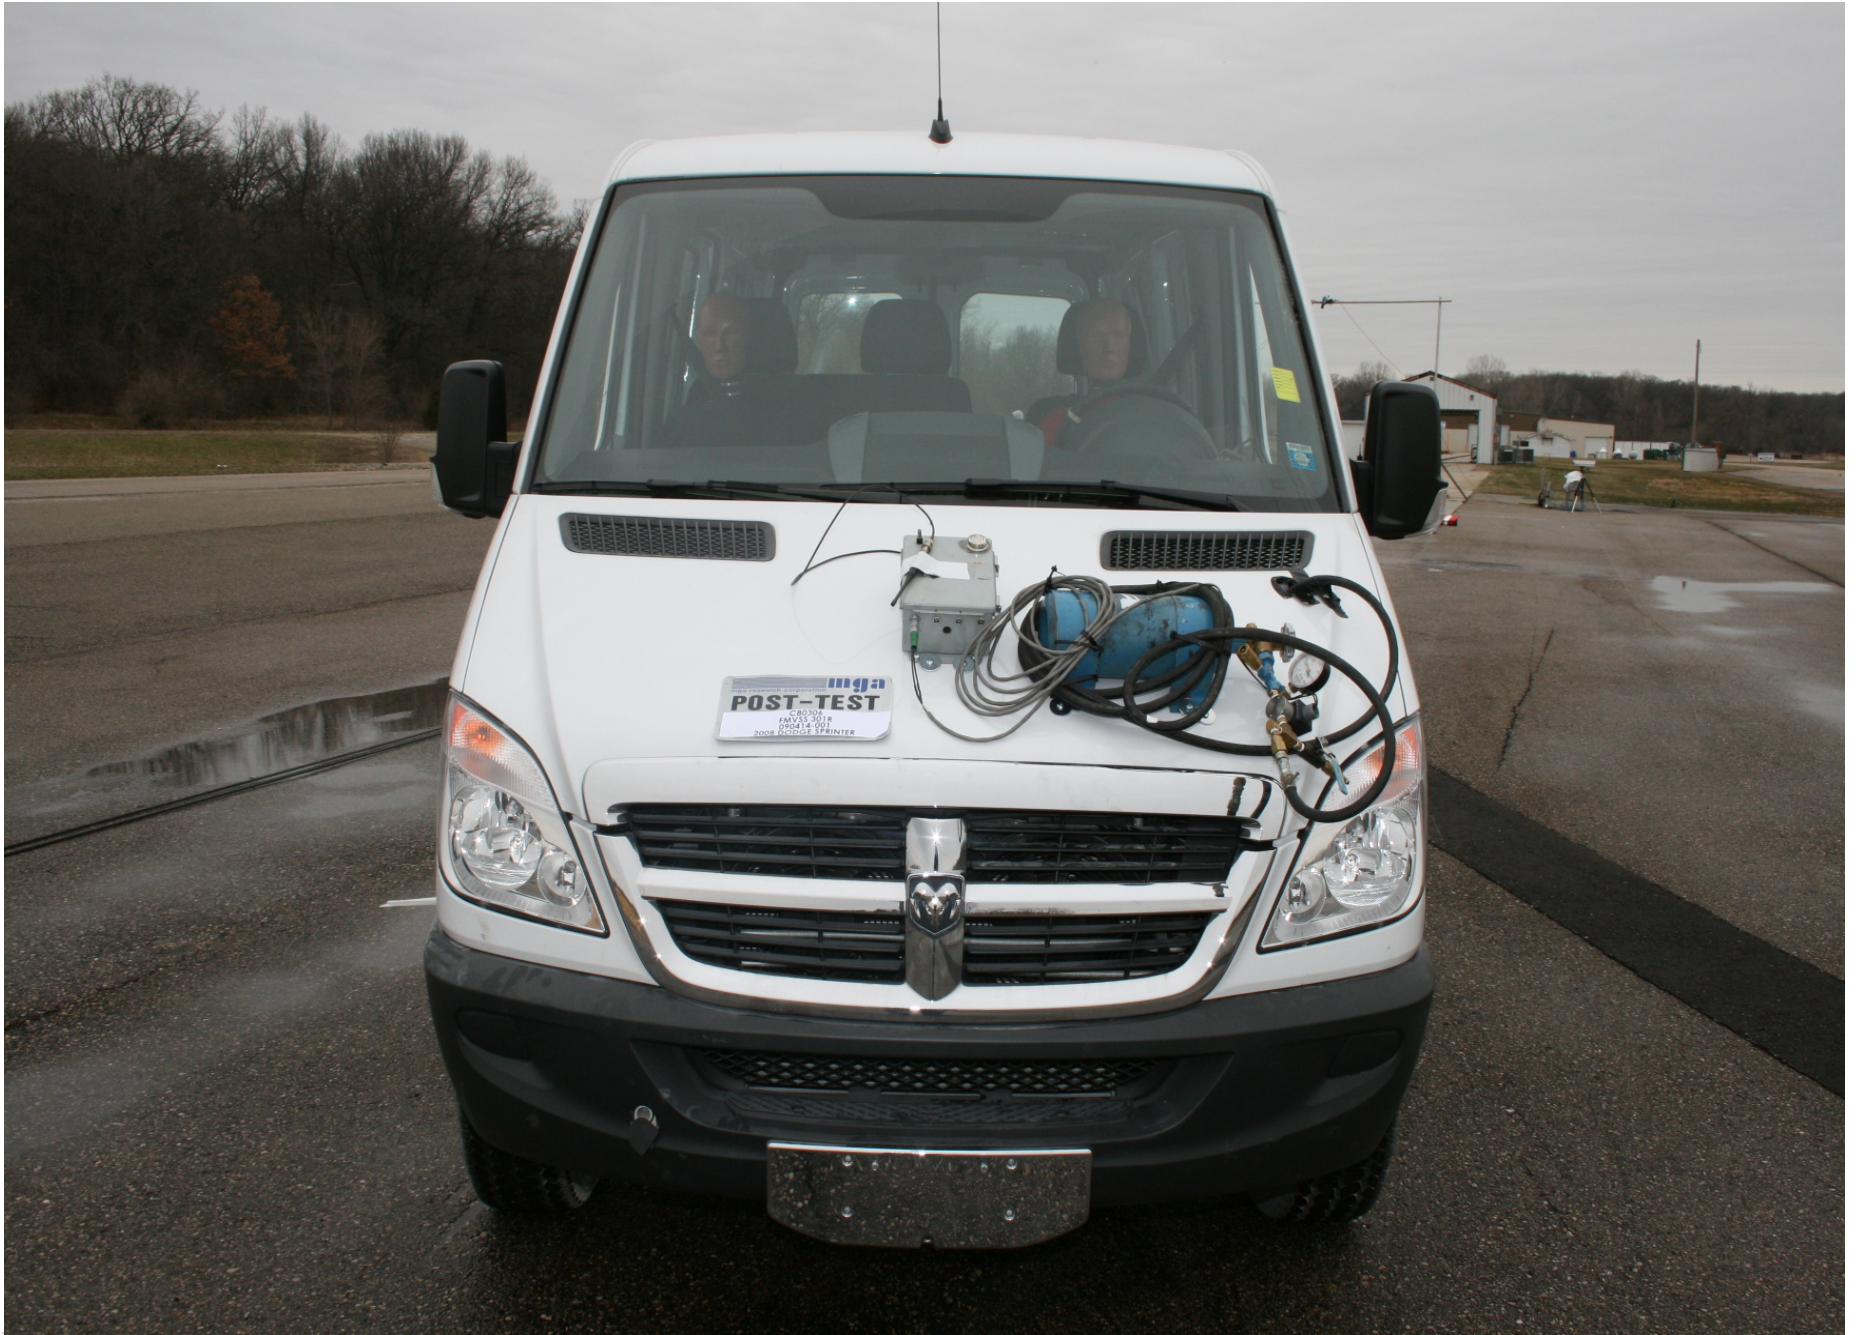
A-4.

Post-Test Front View of Vehicle

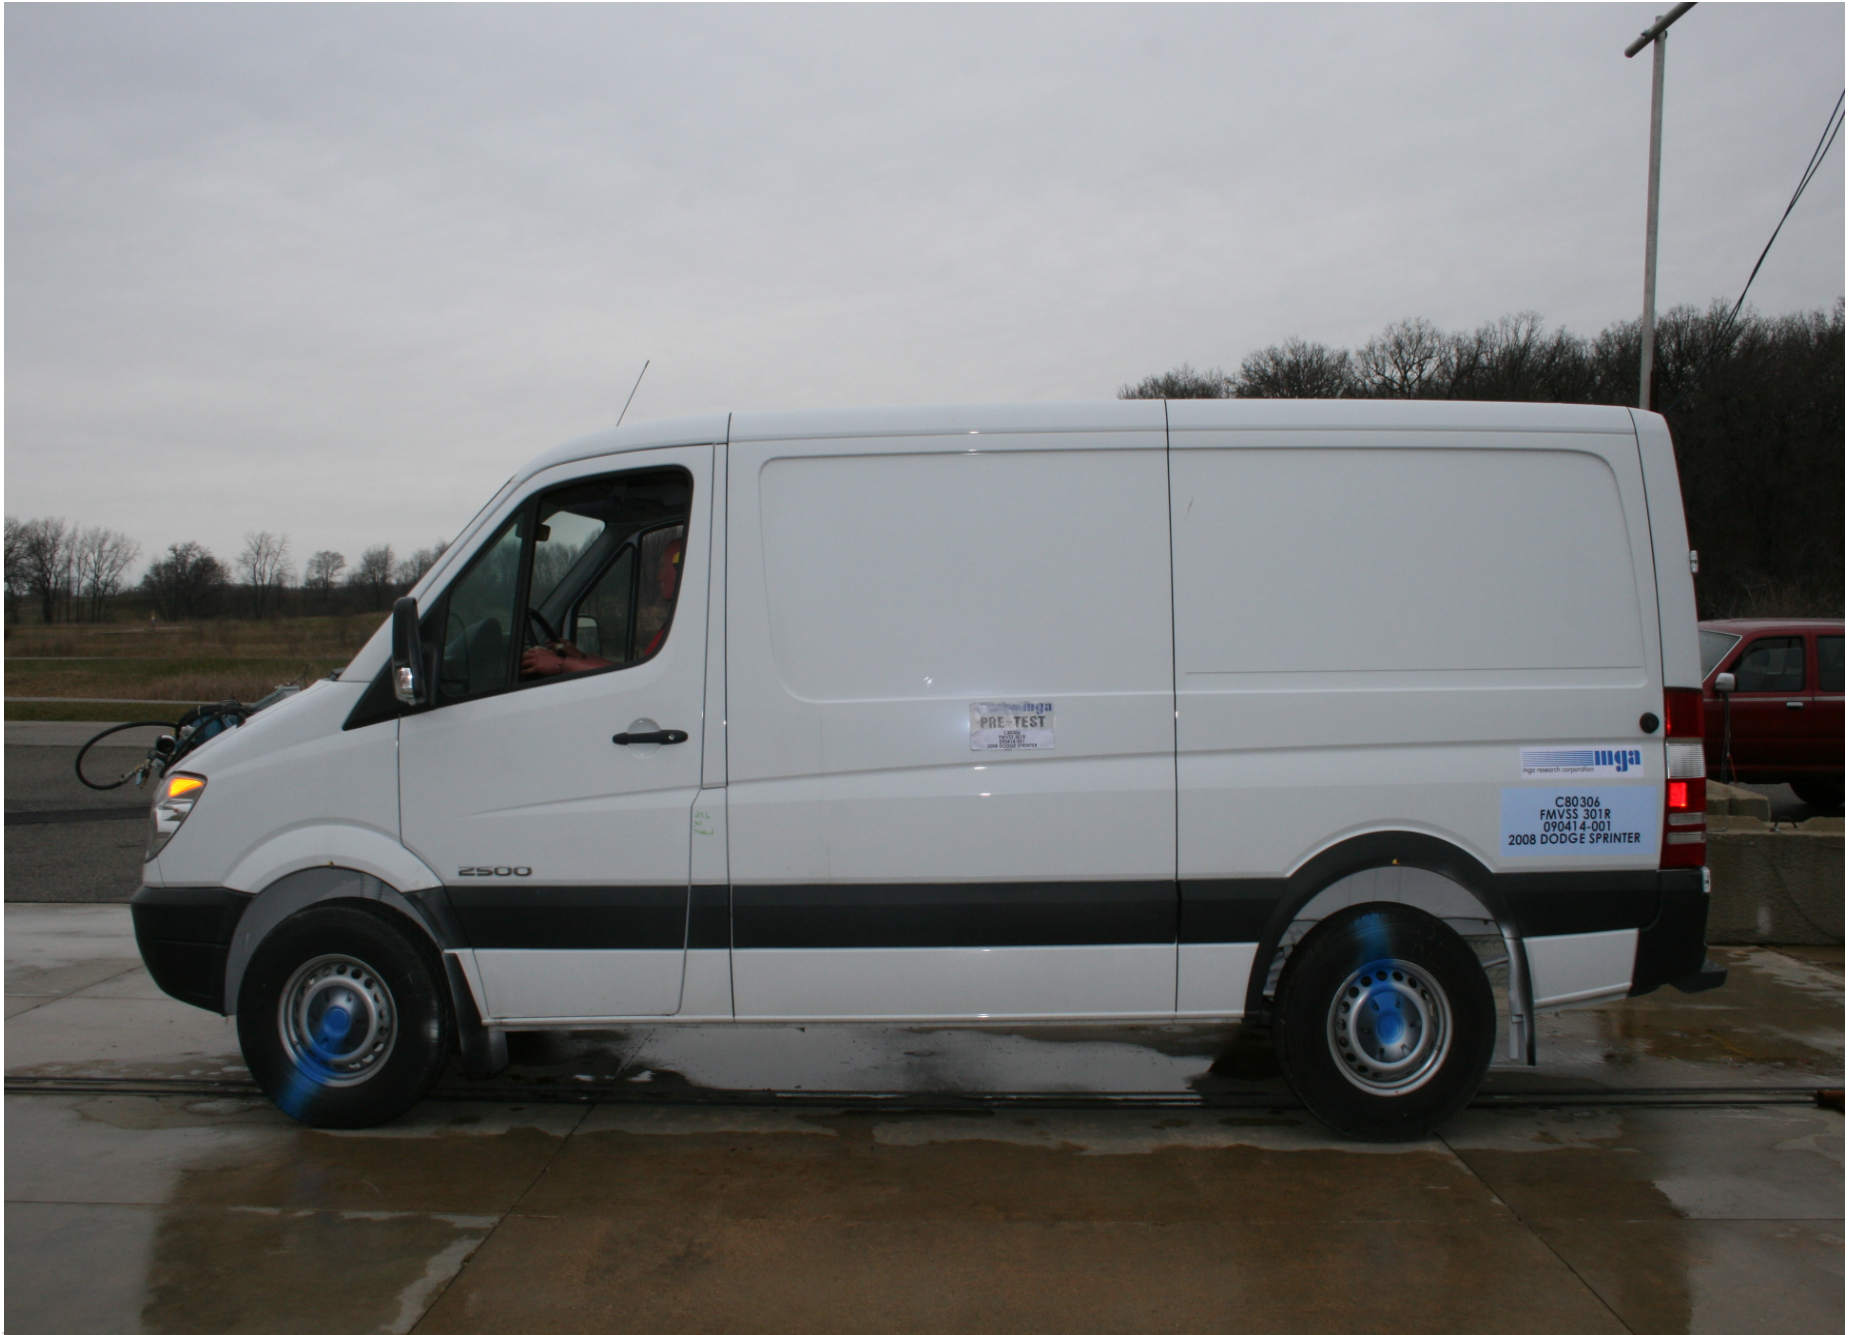
A-5.

Pre-Test Left Side View of Vehicle

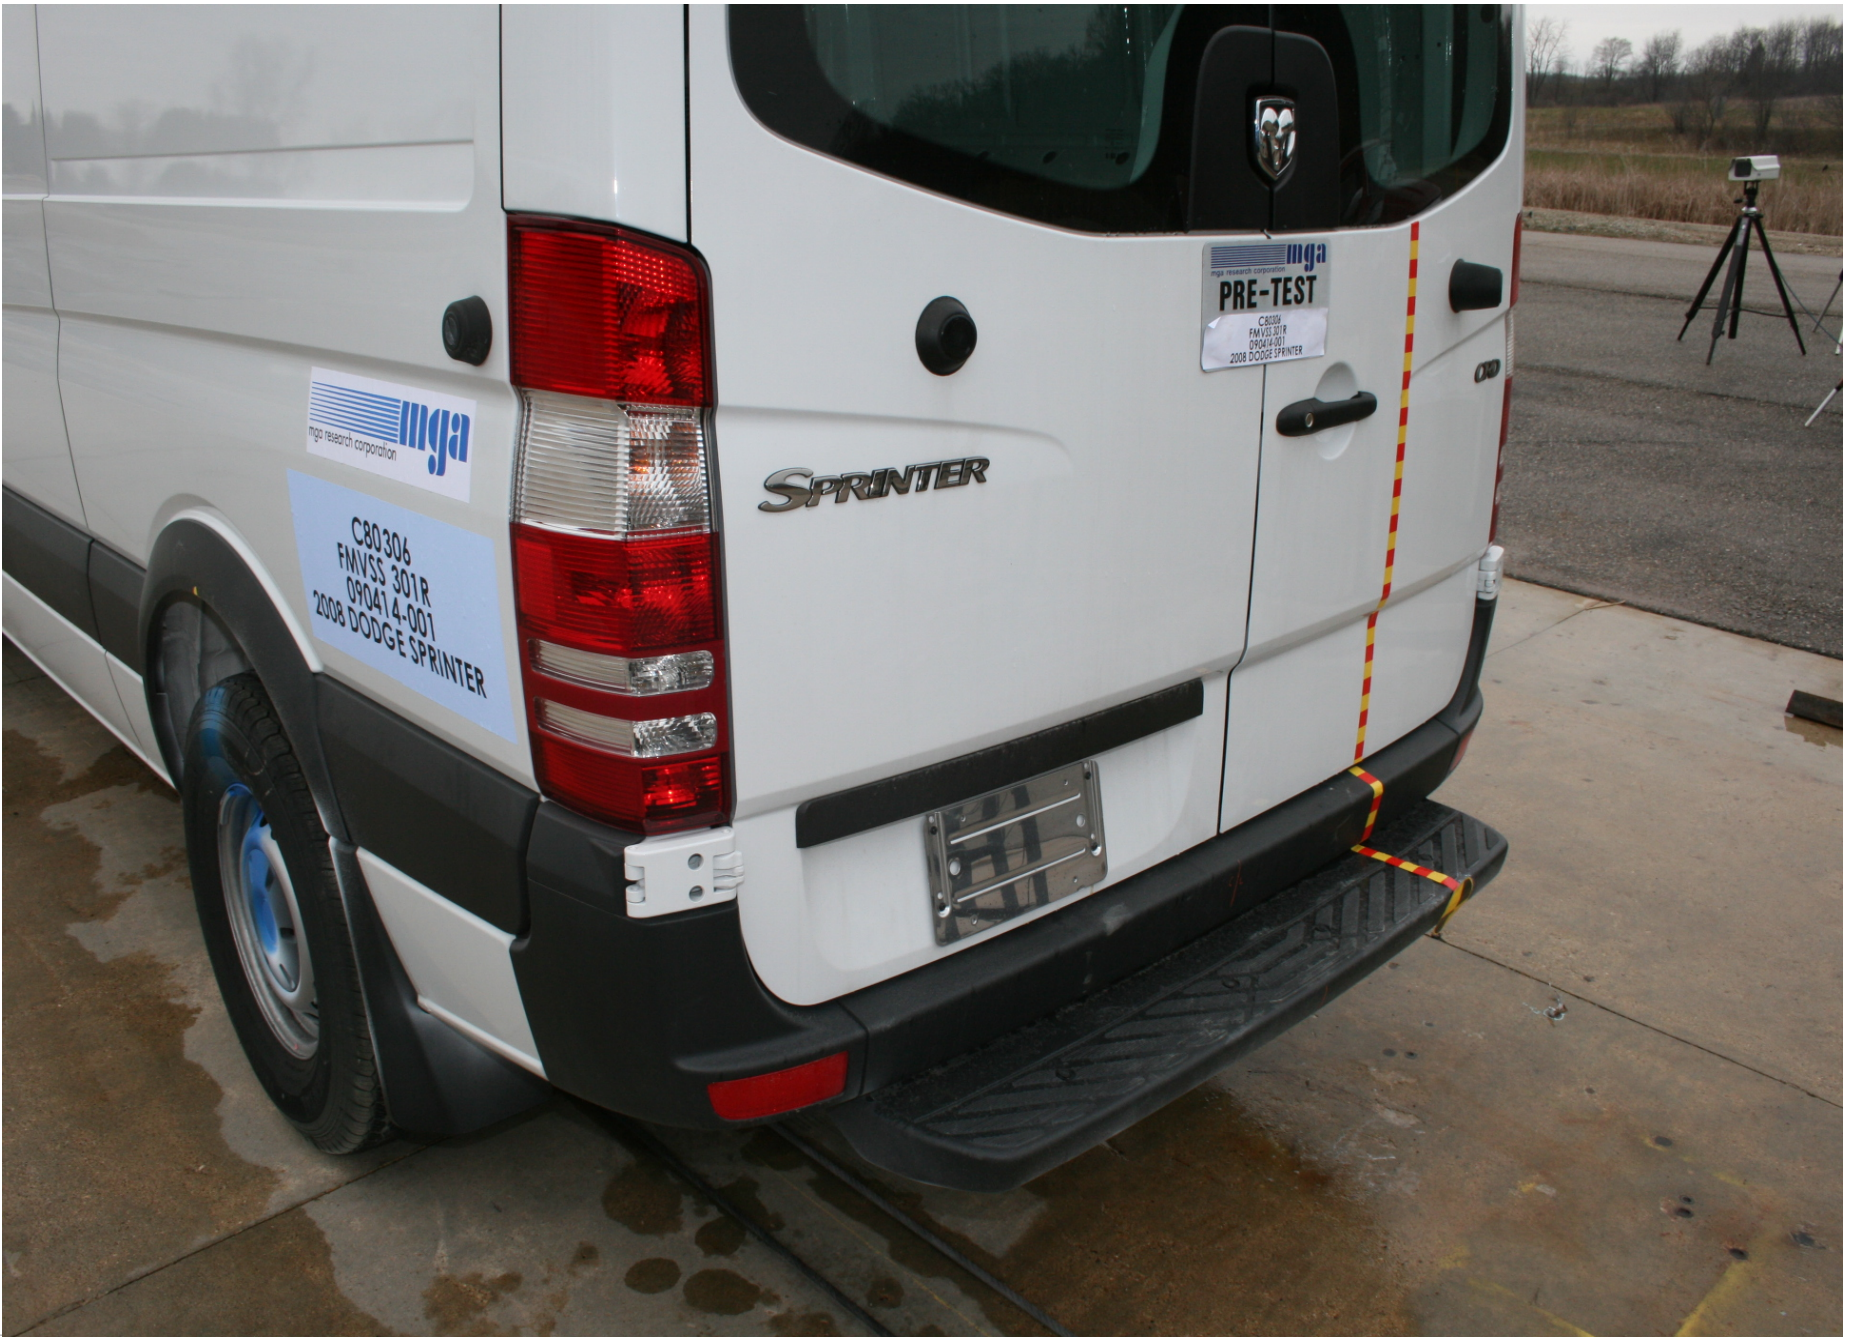
A-6.

Pre-Test Left Rear Close-up View of Vehicle

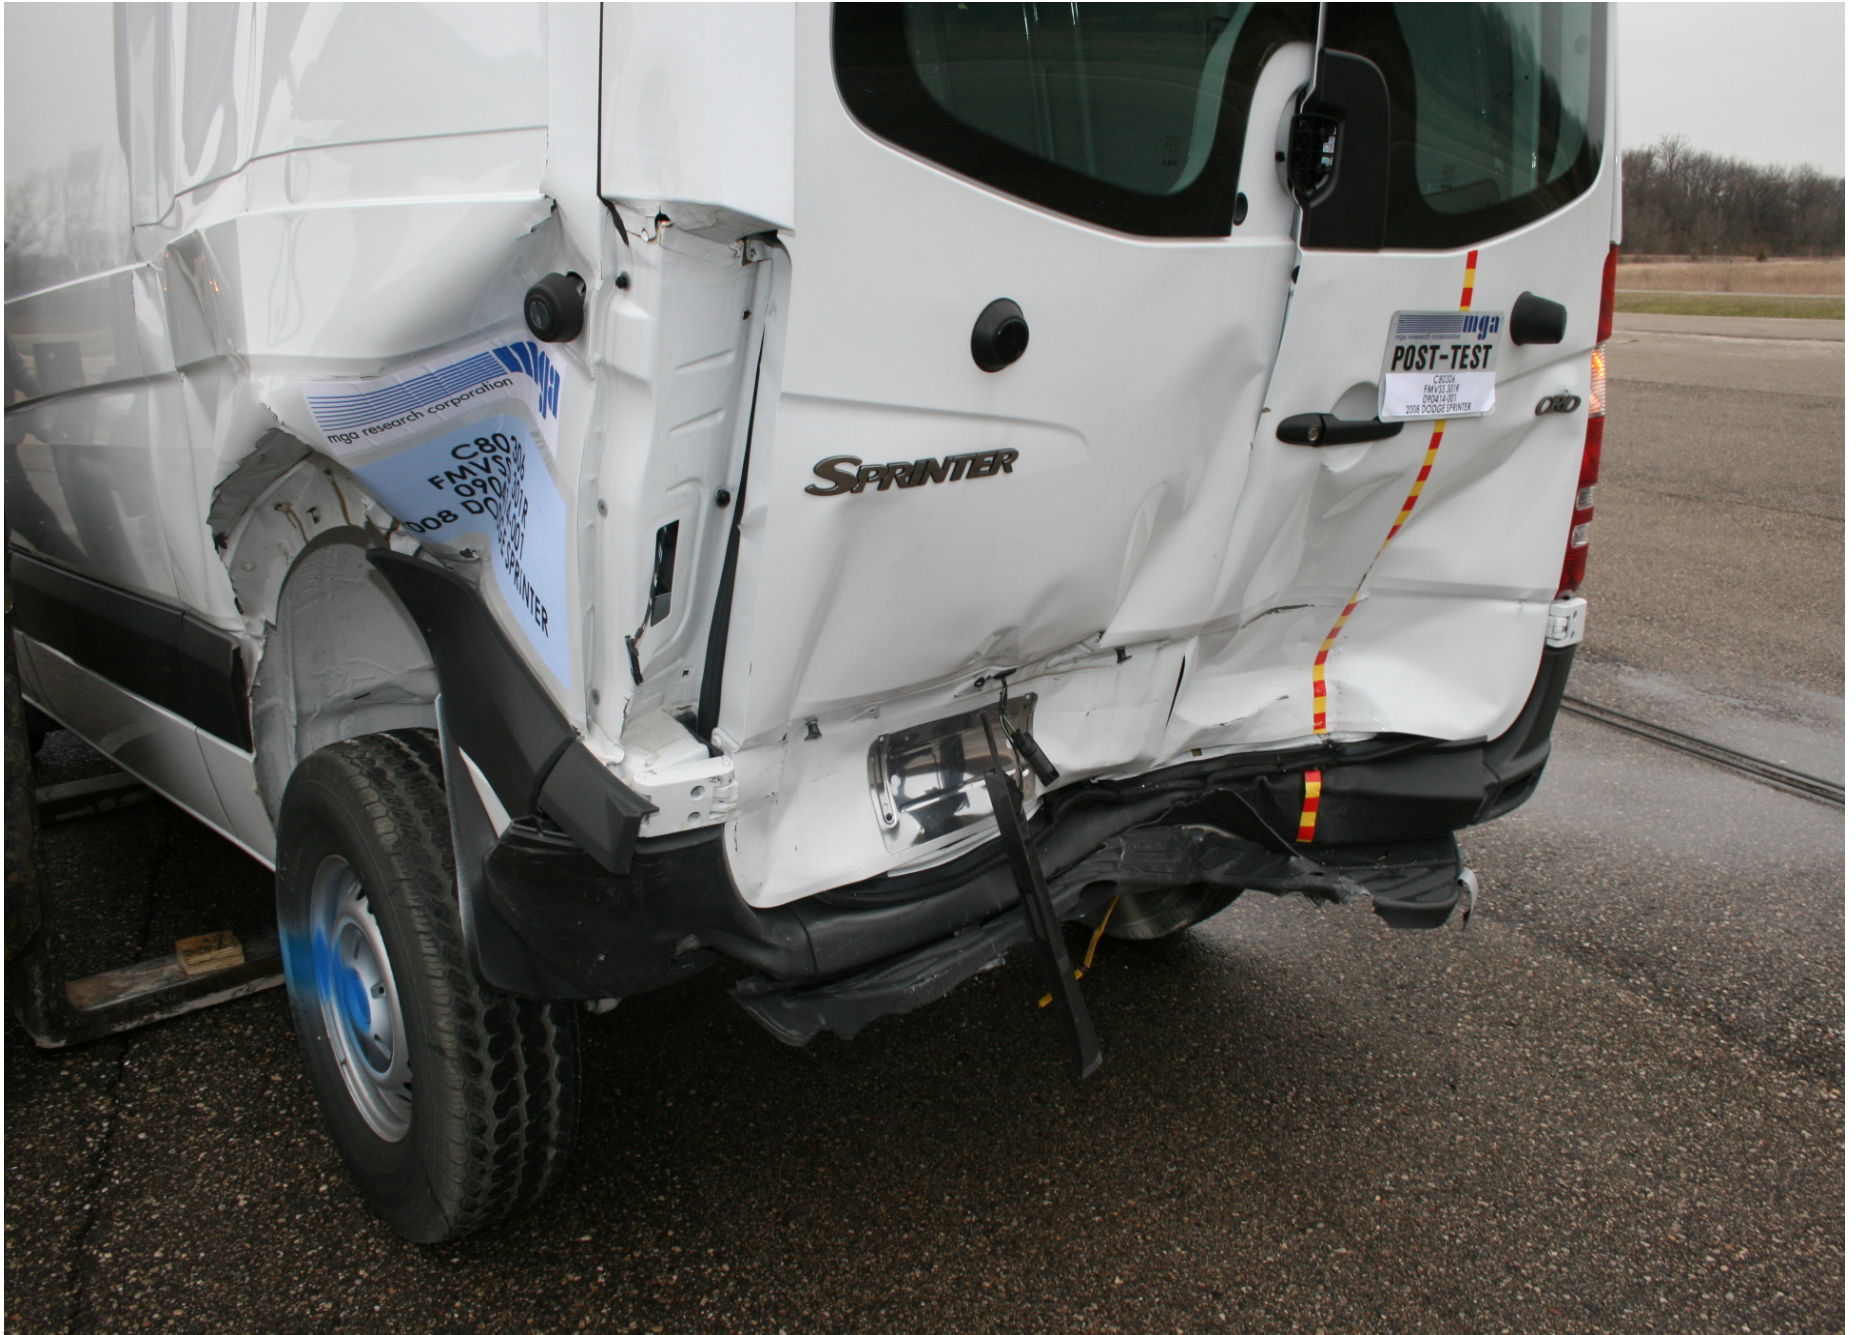
A-7.

Post-Test Left Rear Close-up View of Vehicle

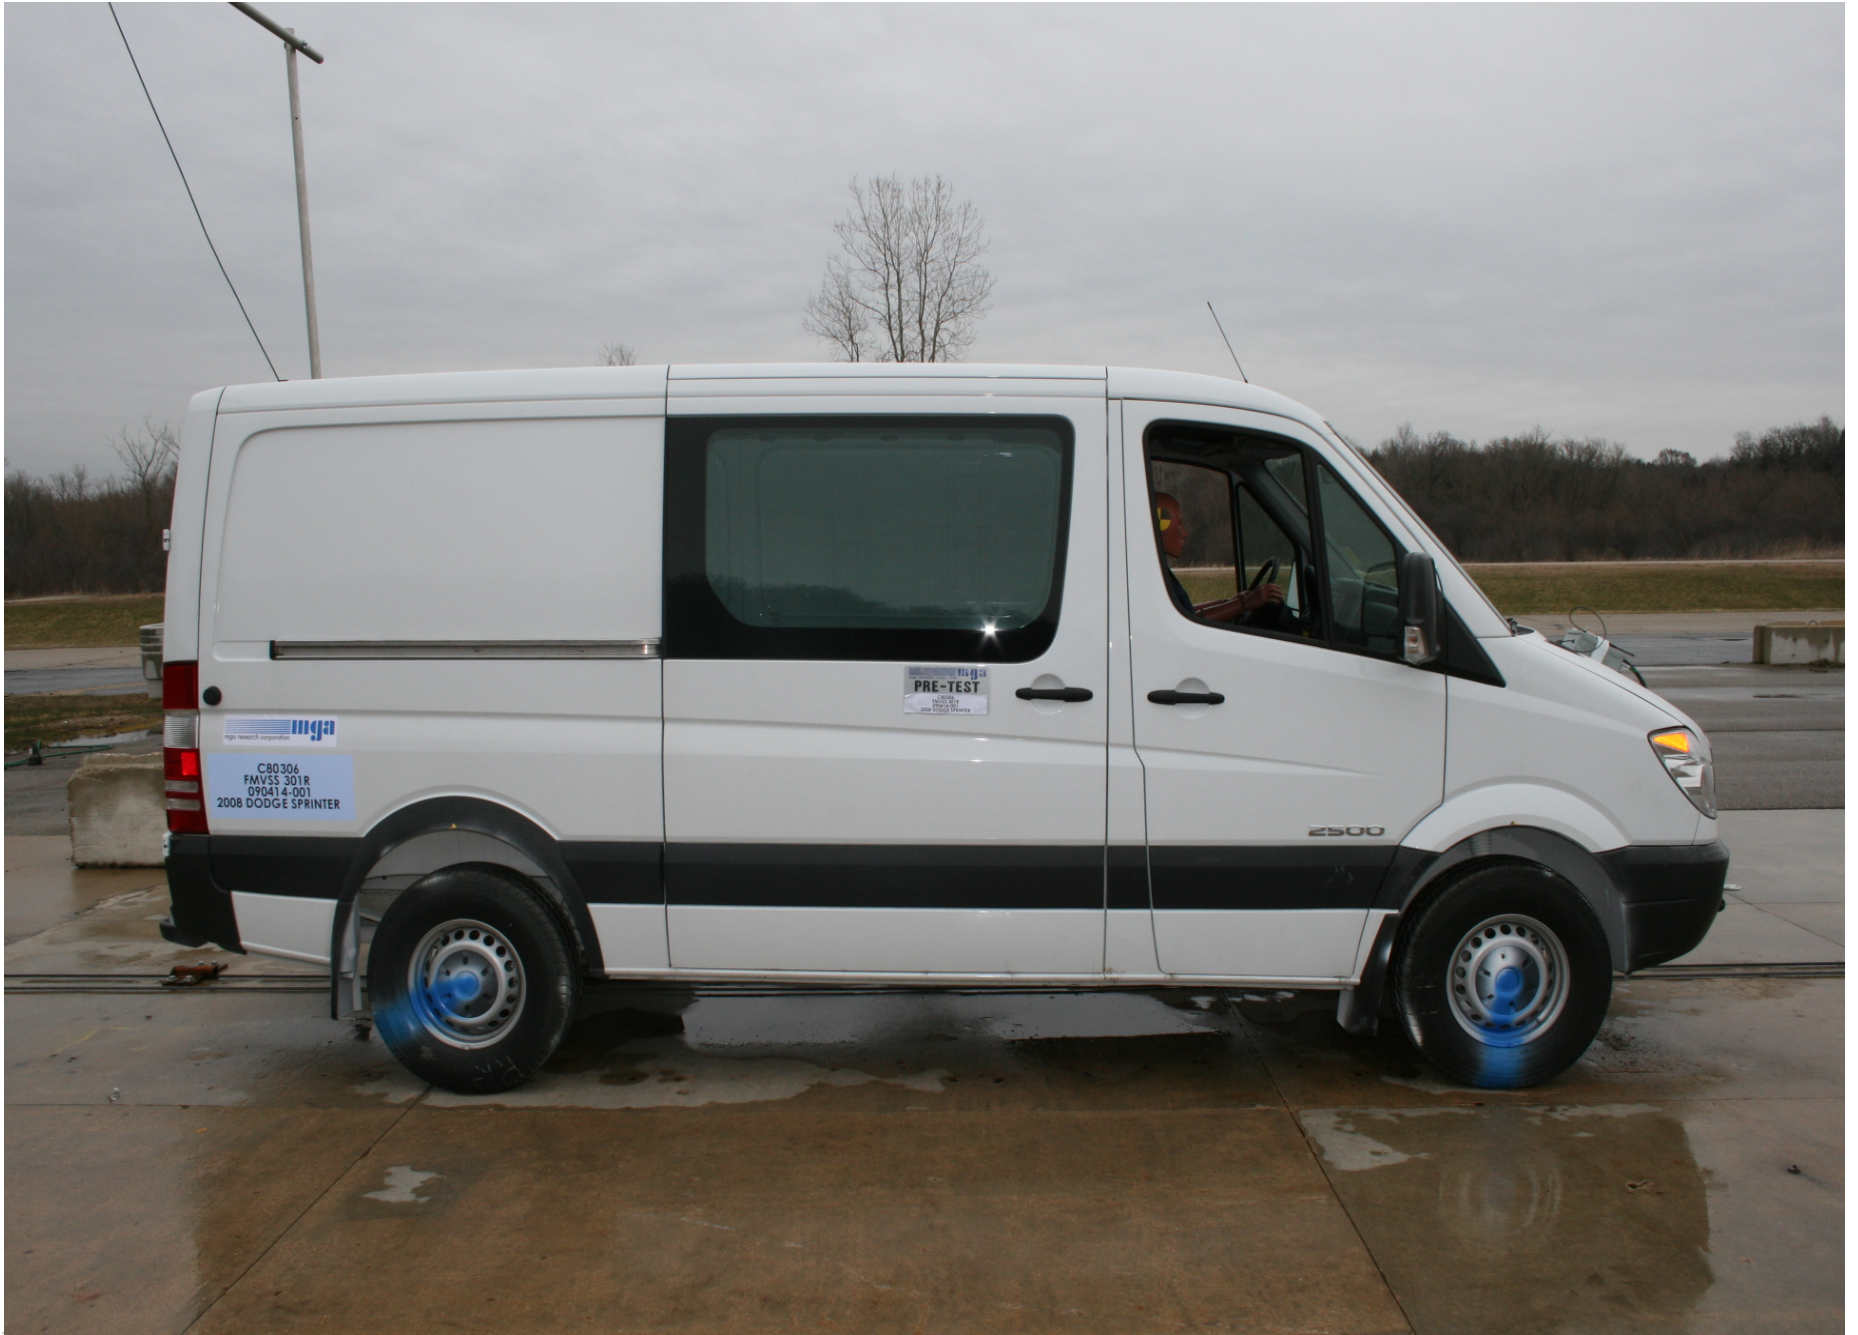
A-8.

Pre-Test Right Side View of Vehicle

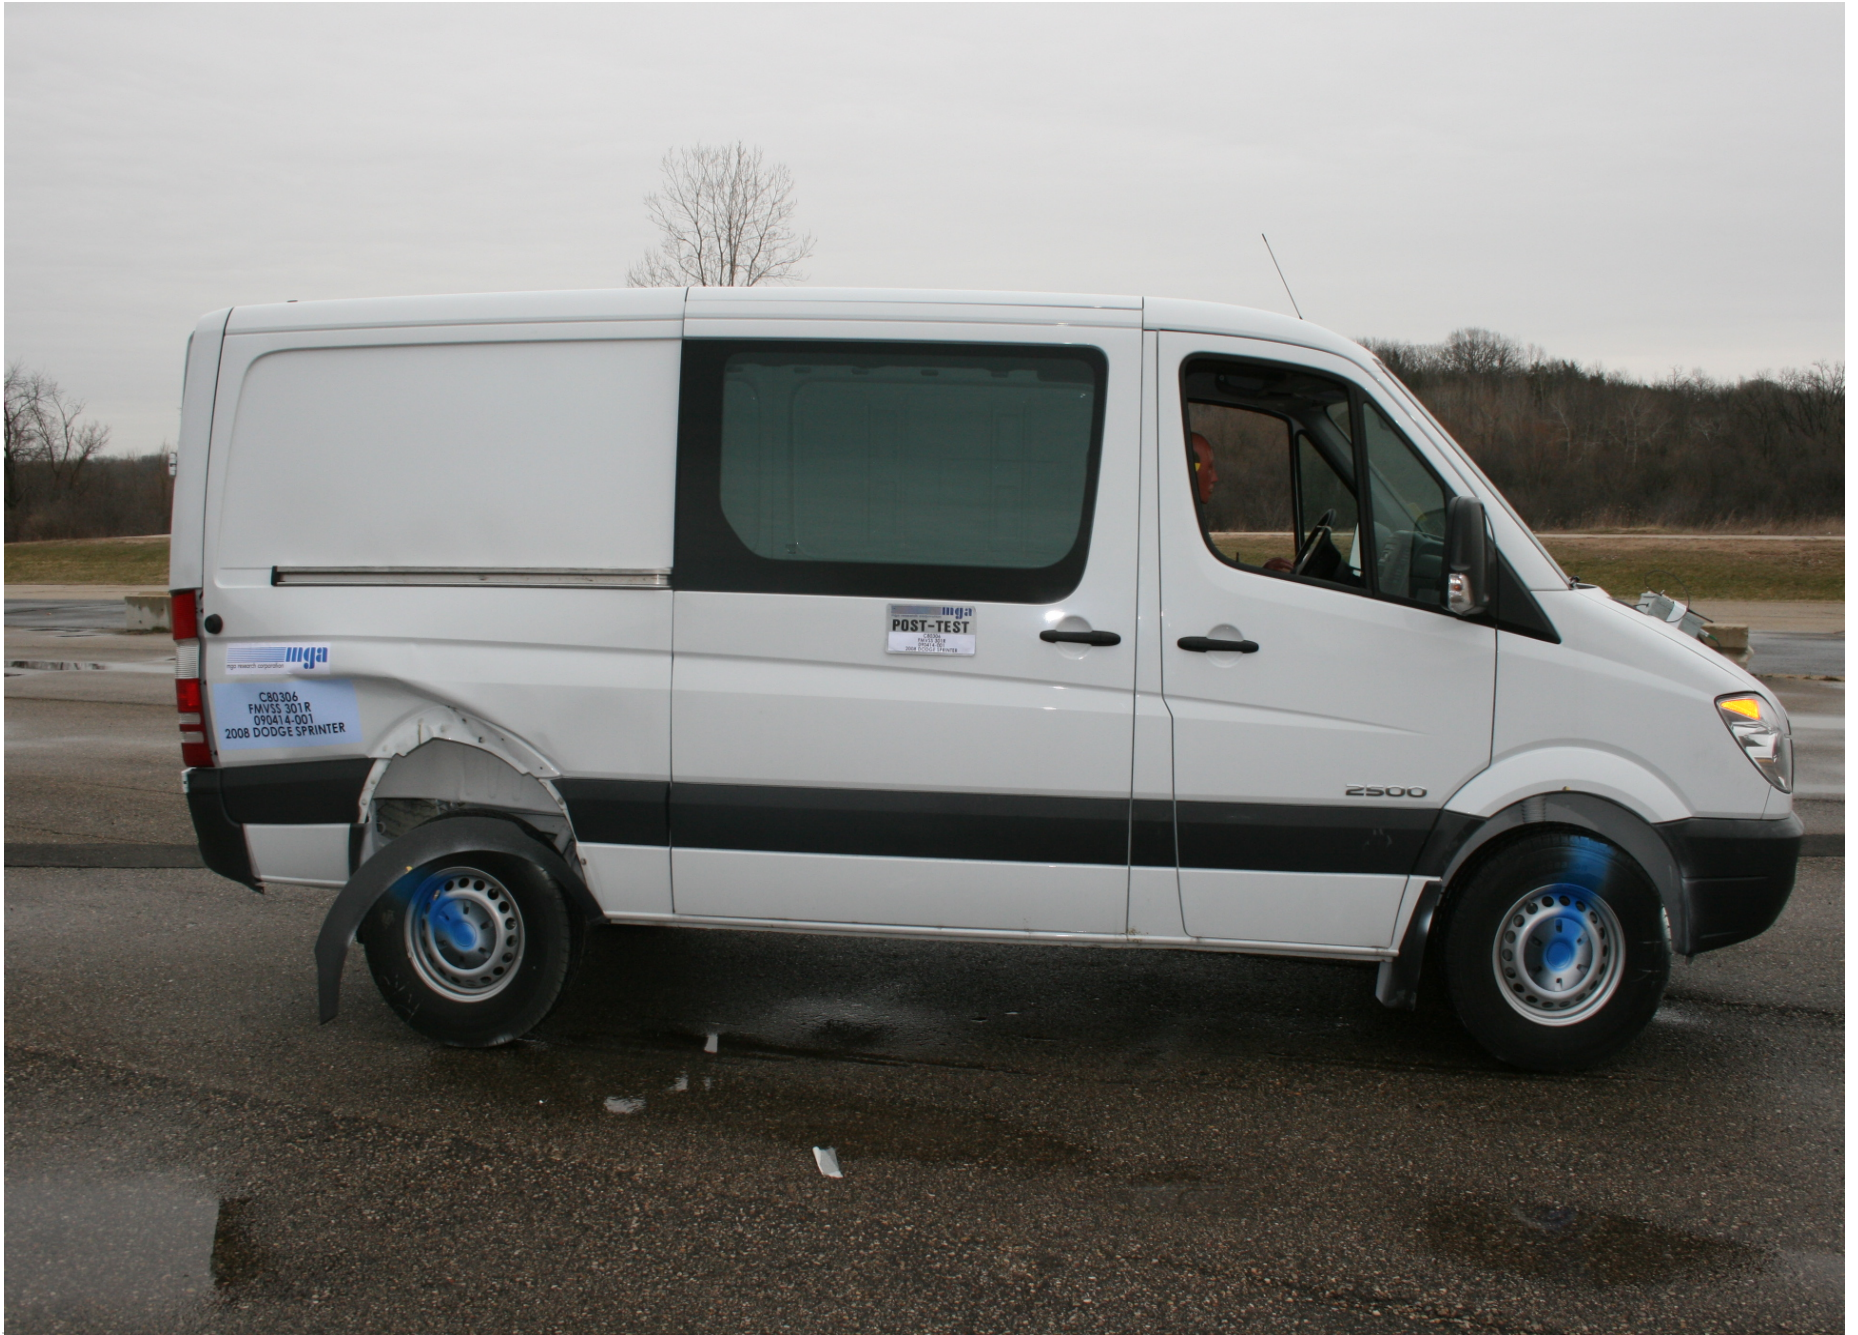
A-9.

Post-Test Right Side View of Vehicle

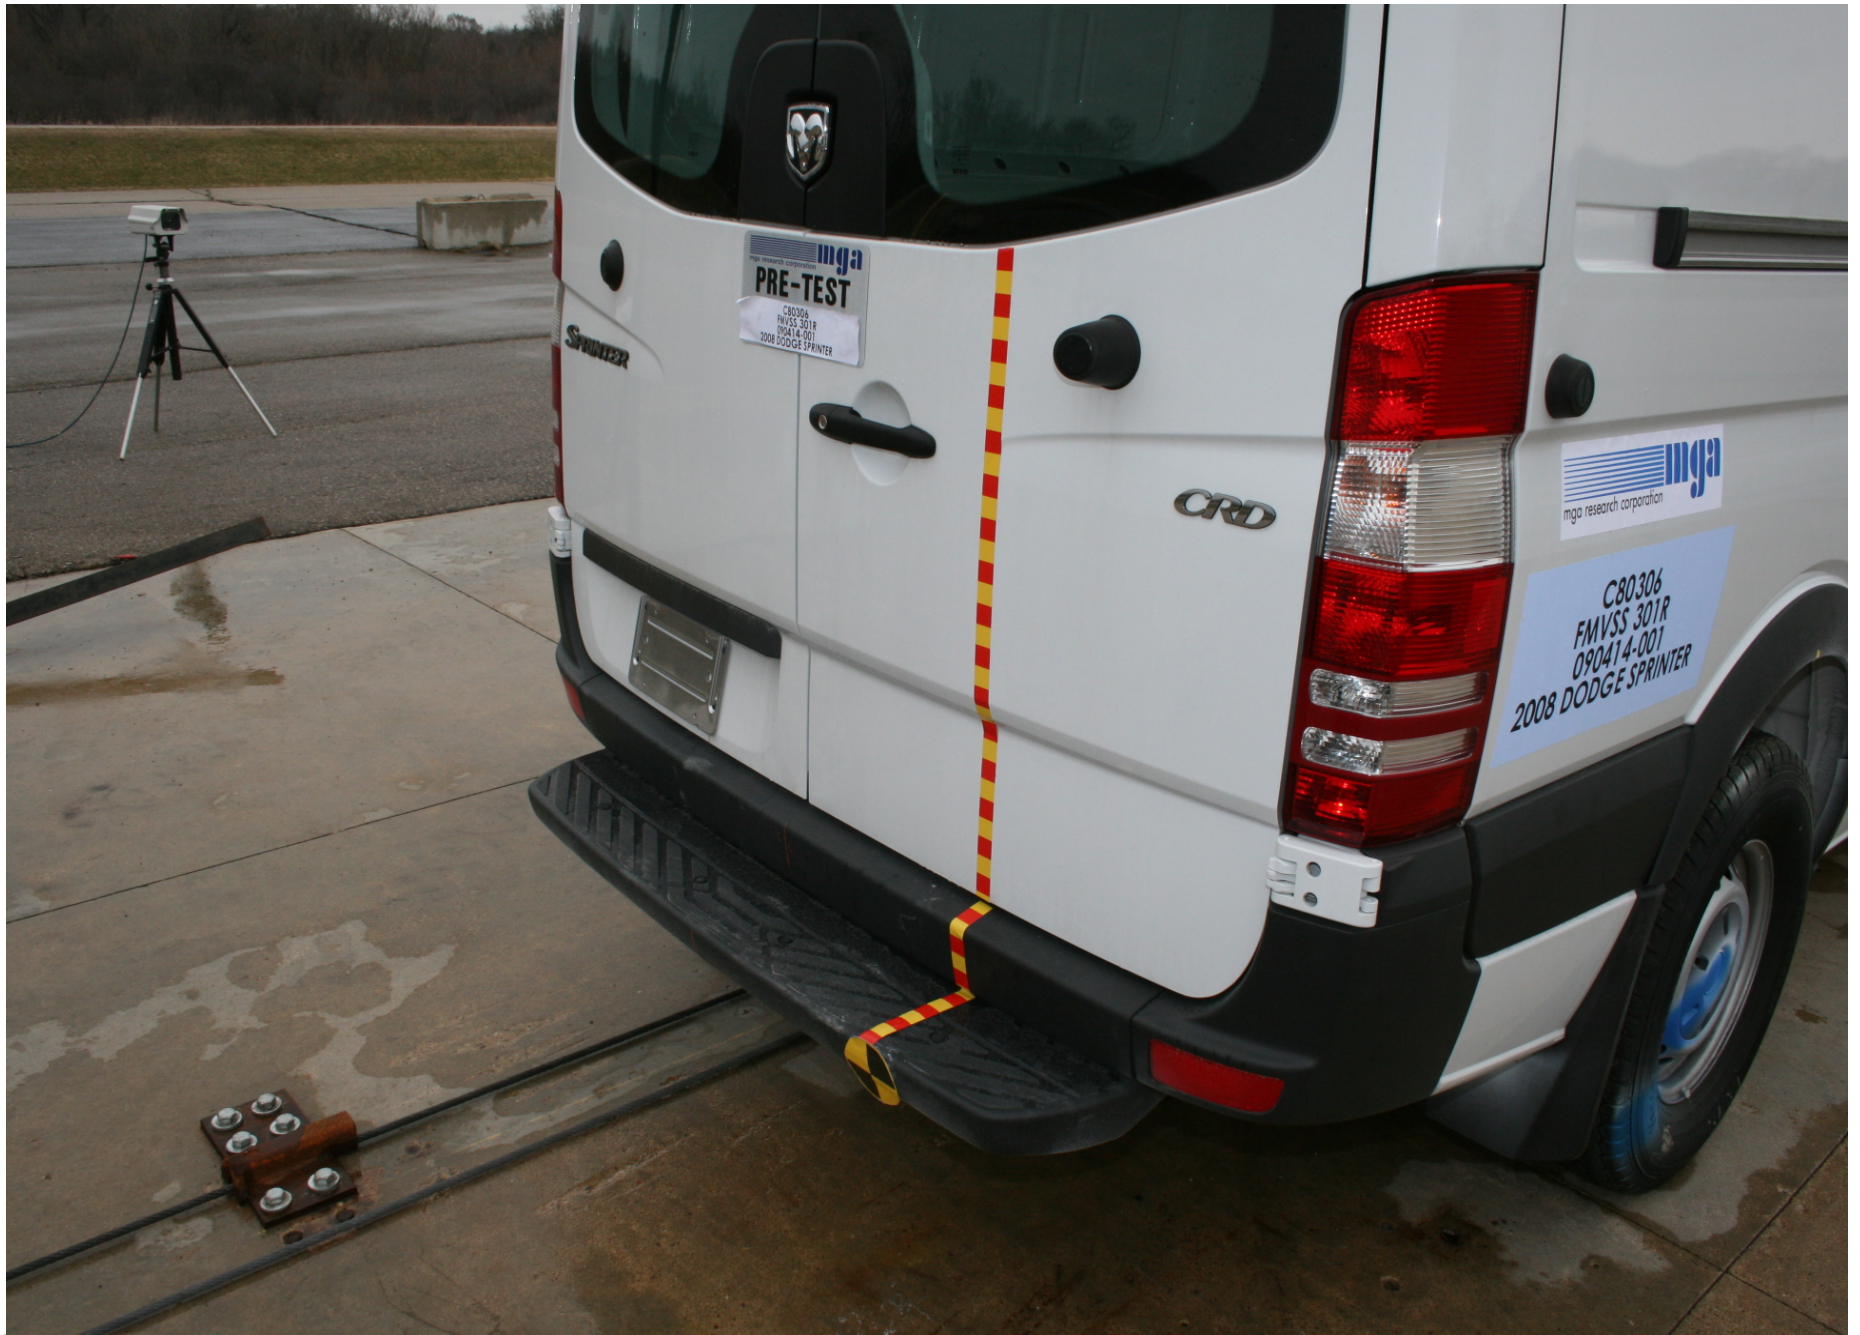
A-10.

Pre-Test Right Rear Close-up View of Vehicle

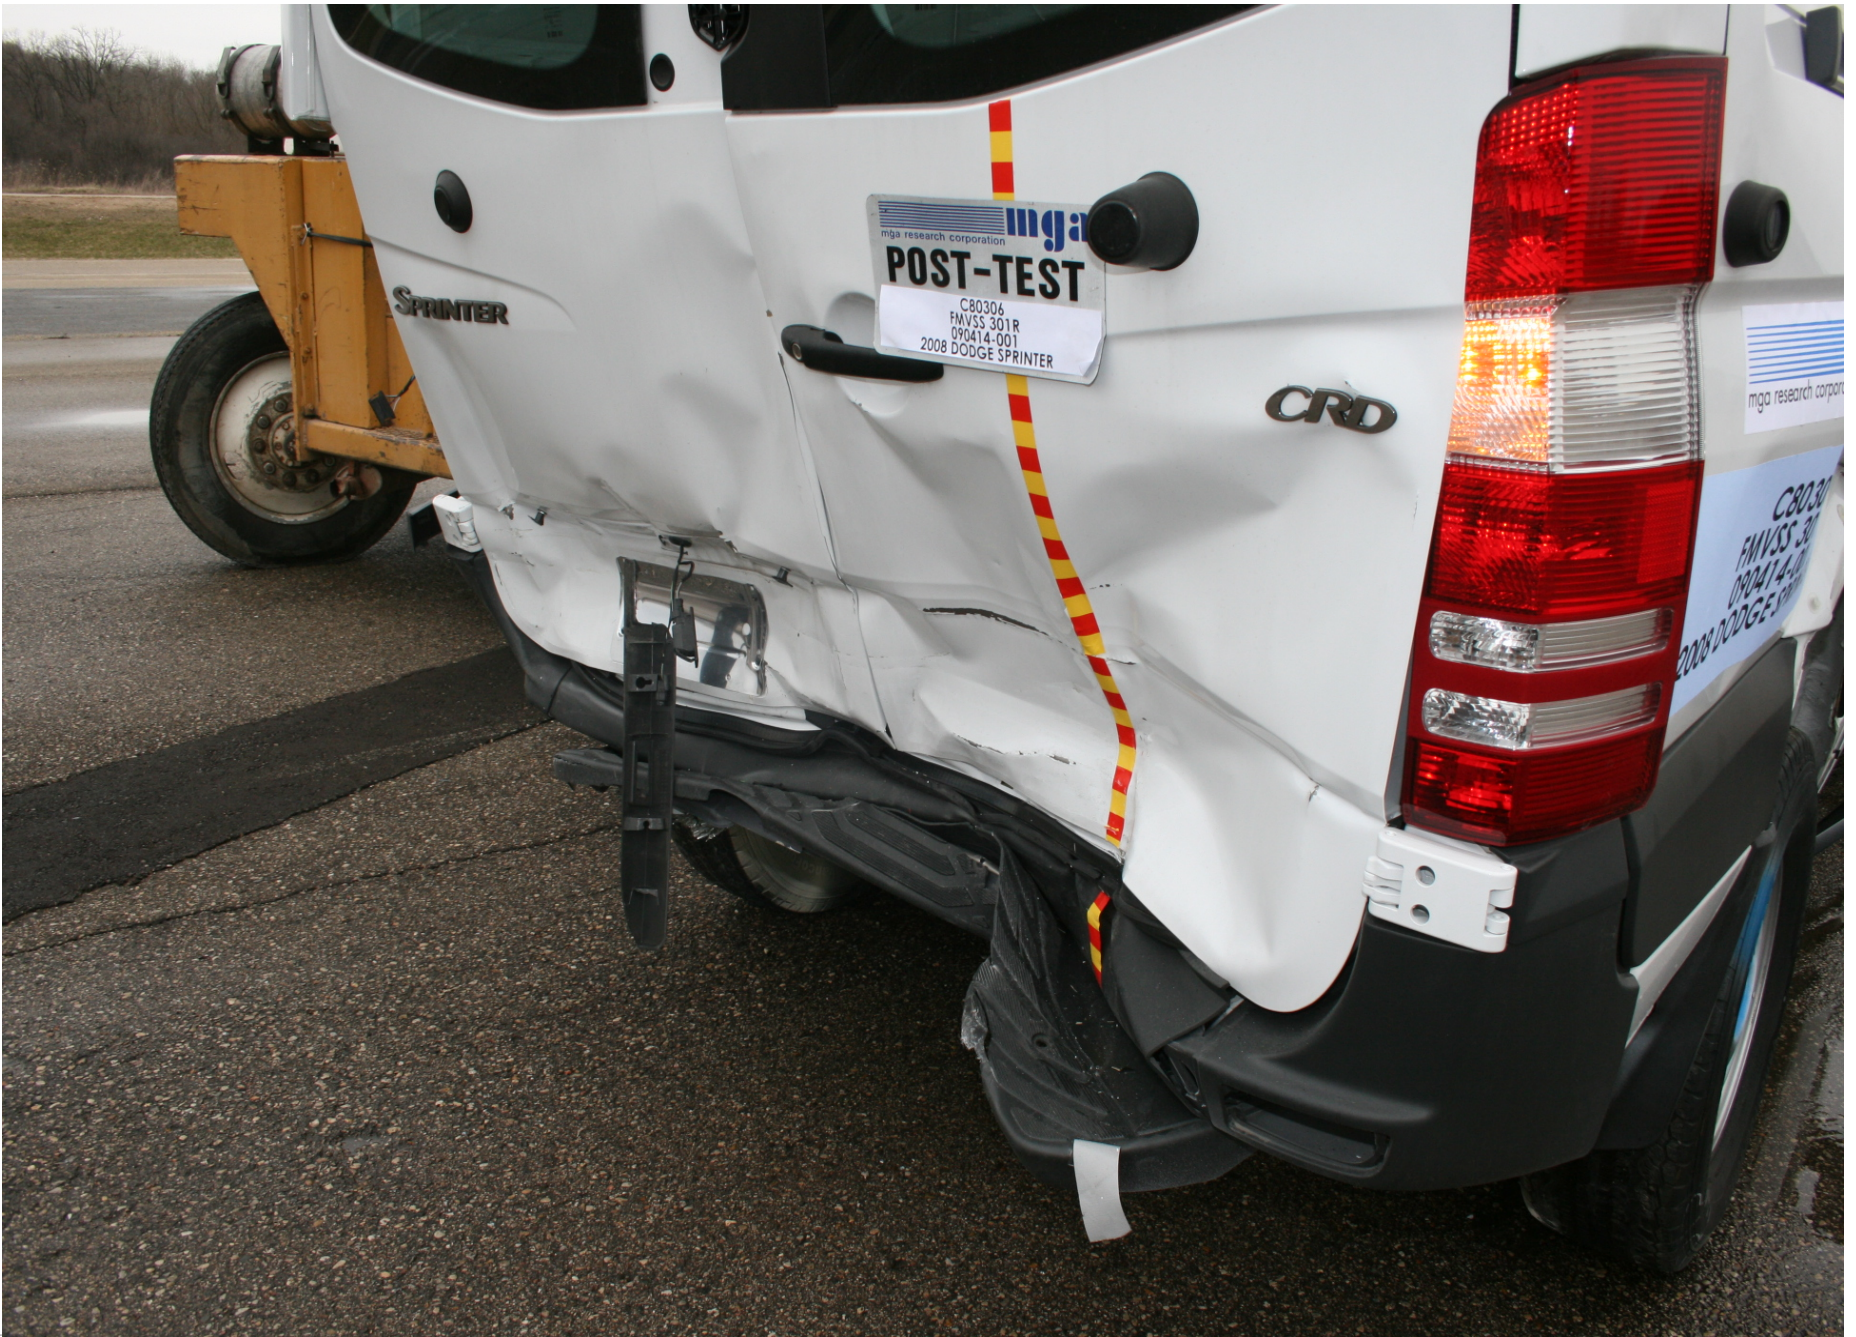
Post-Test Right Rear Close-up View of Vehicle
