REPORT NUMBER: 301-MGA-2009-001

**SAFETY COMPLIANCE TESTING FOR FMVSS 301R
FUEL SYSTEM INTEGRITY – REAR IMPACT**

**DAIMLER CHRYSLER AG
2008 DODGE SPRINTER 2500 CARGO VAN
NHTSA NUMBER: C80306**

**PREPARED BY:
MGA RESEARCH CORPORATION
5000 WARREN ROAD
BURLINGTON, WI 53105**

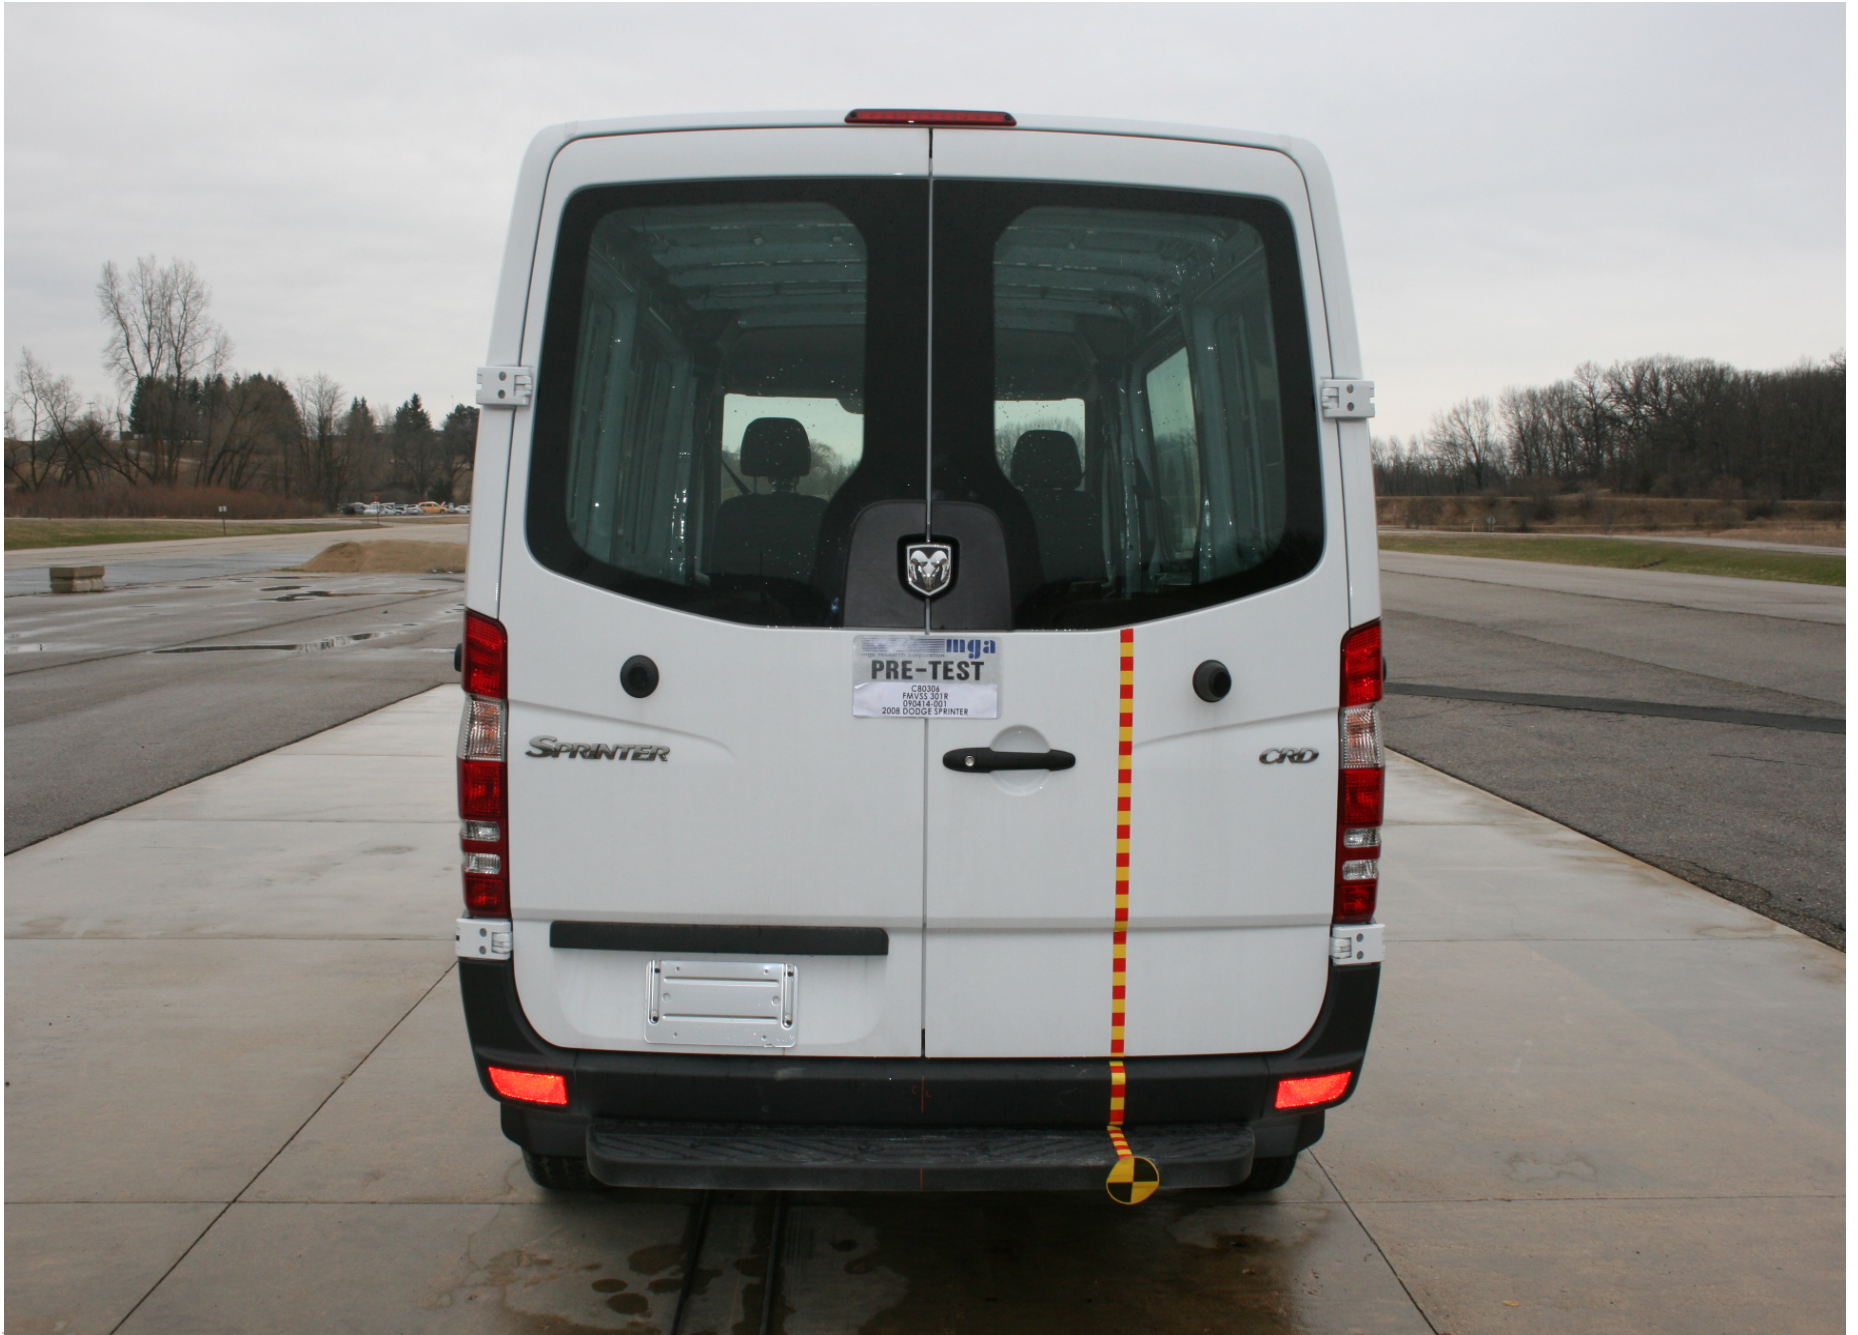
A-12.

Pre-Test Rear View of Vehicle

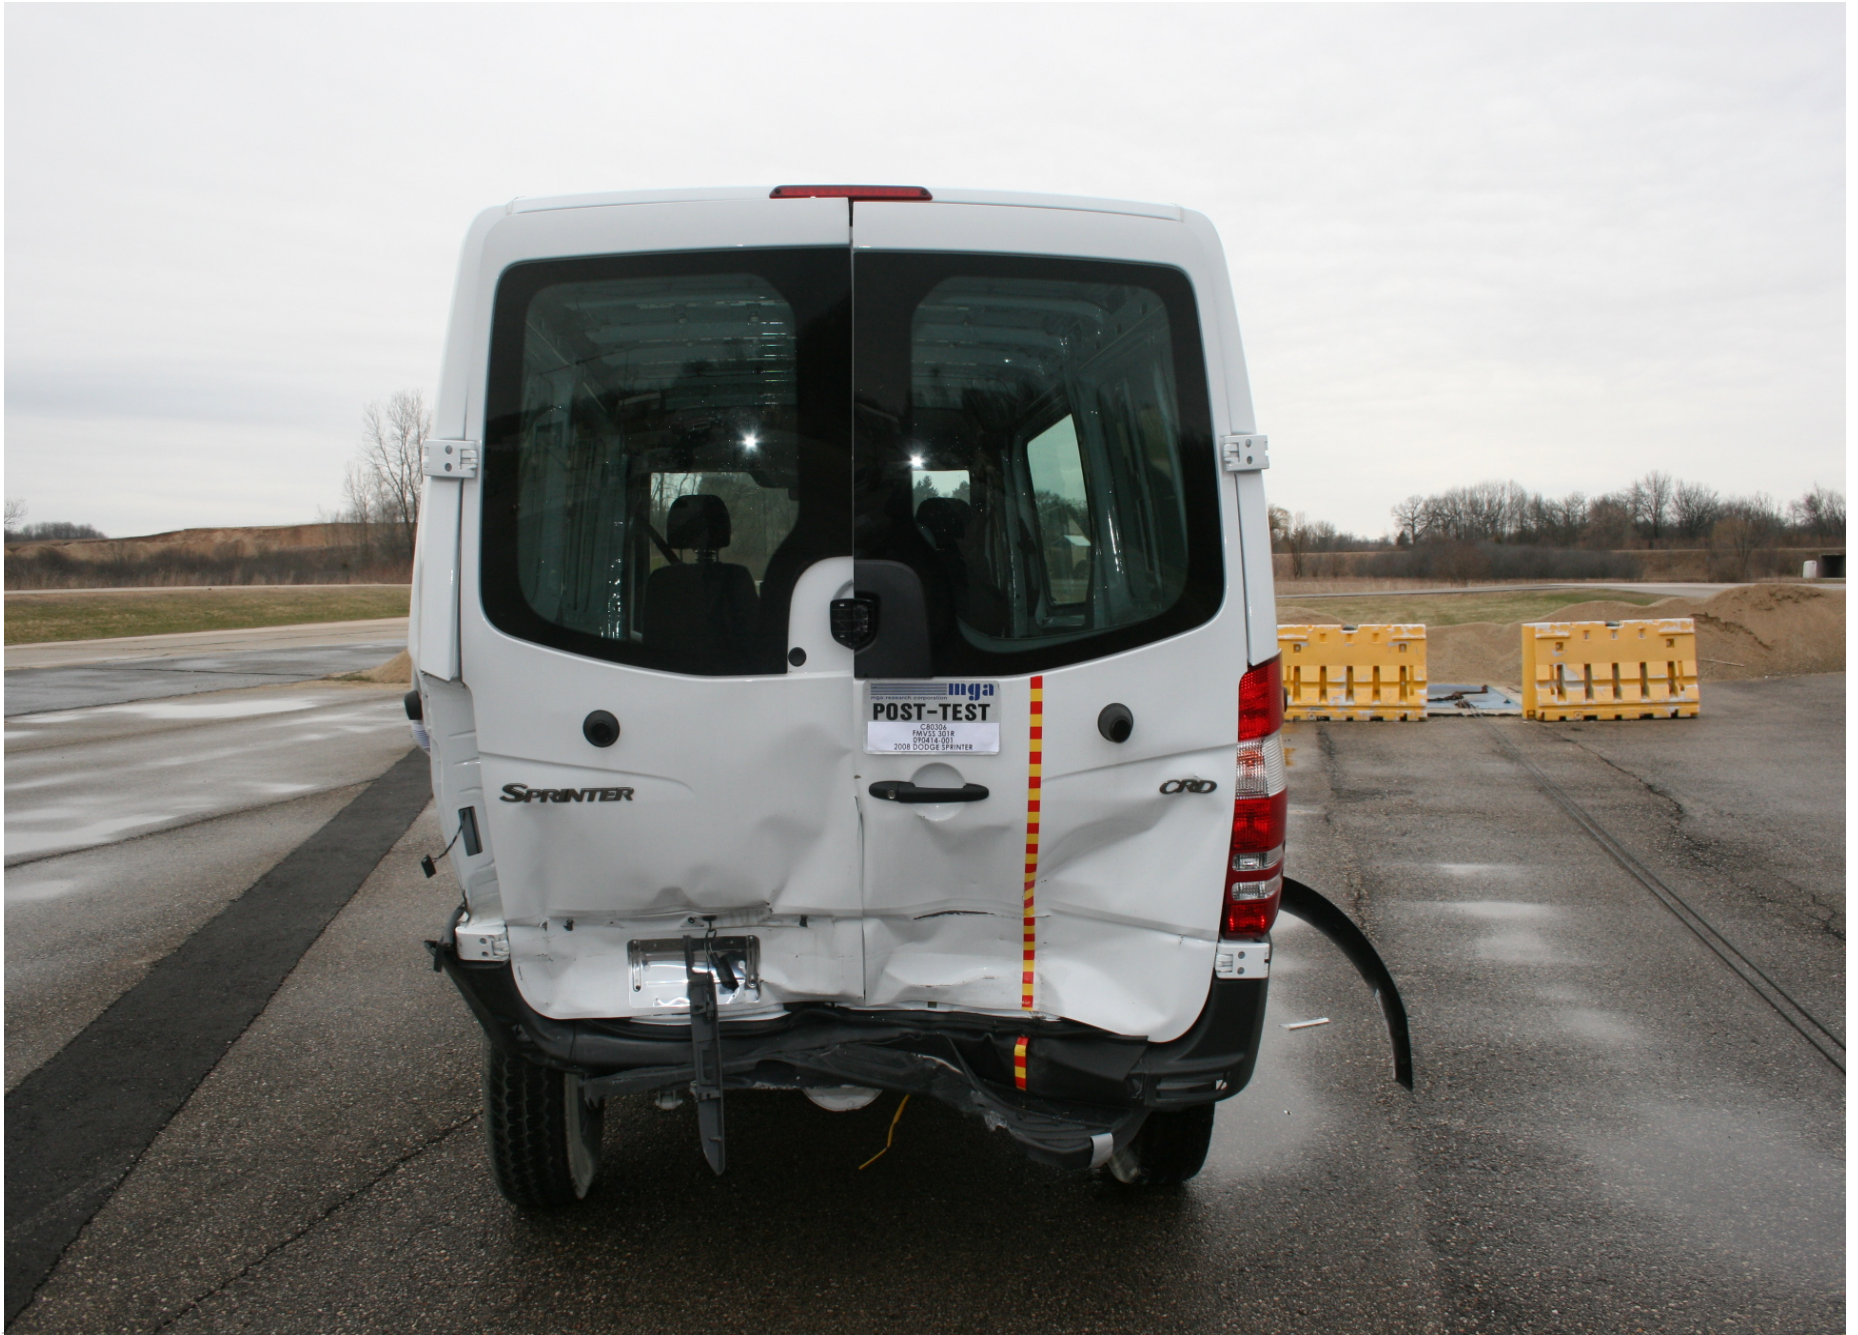
A-13.

Post-Test Rear View of Vehicle

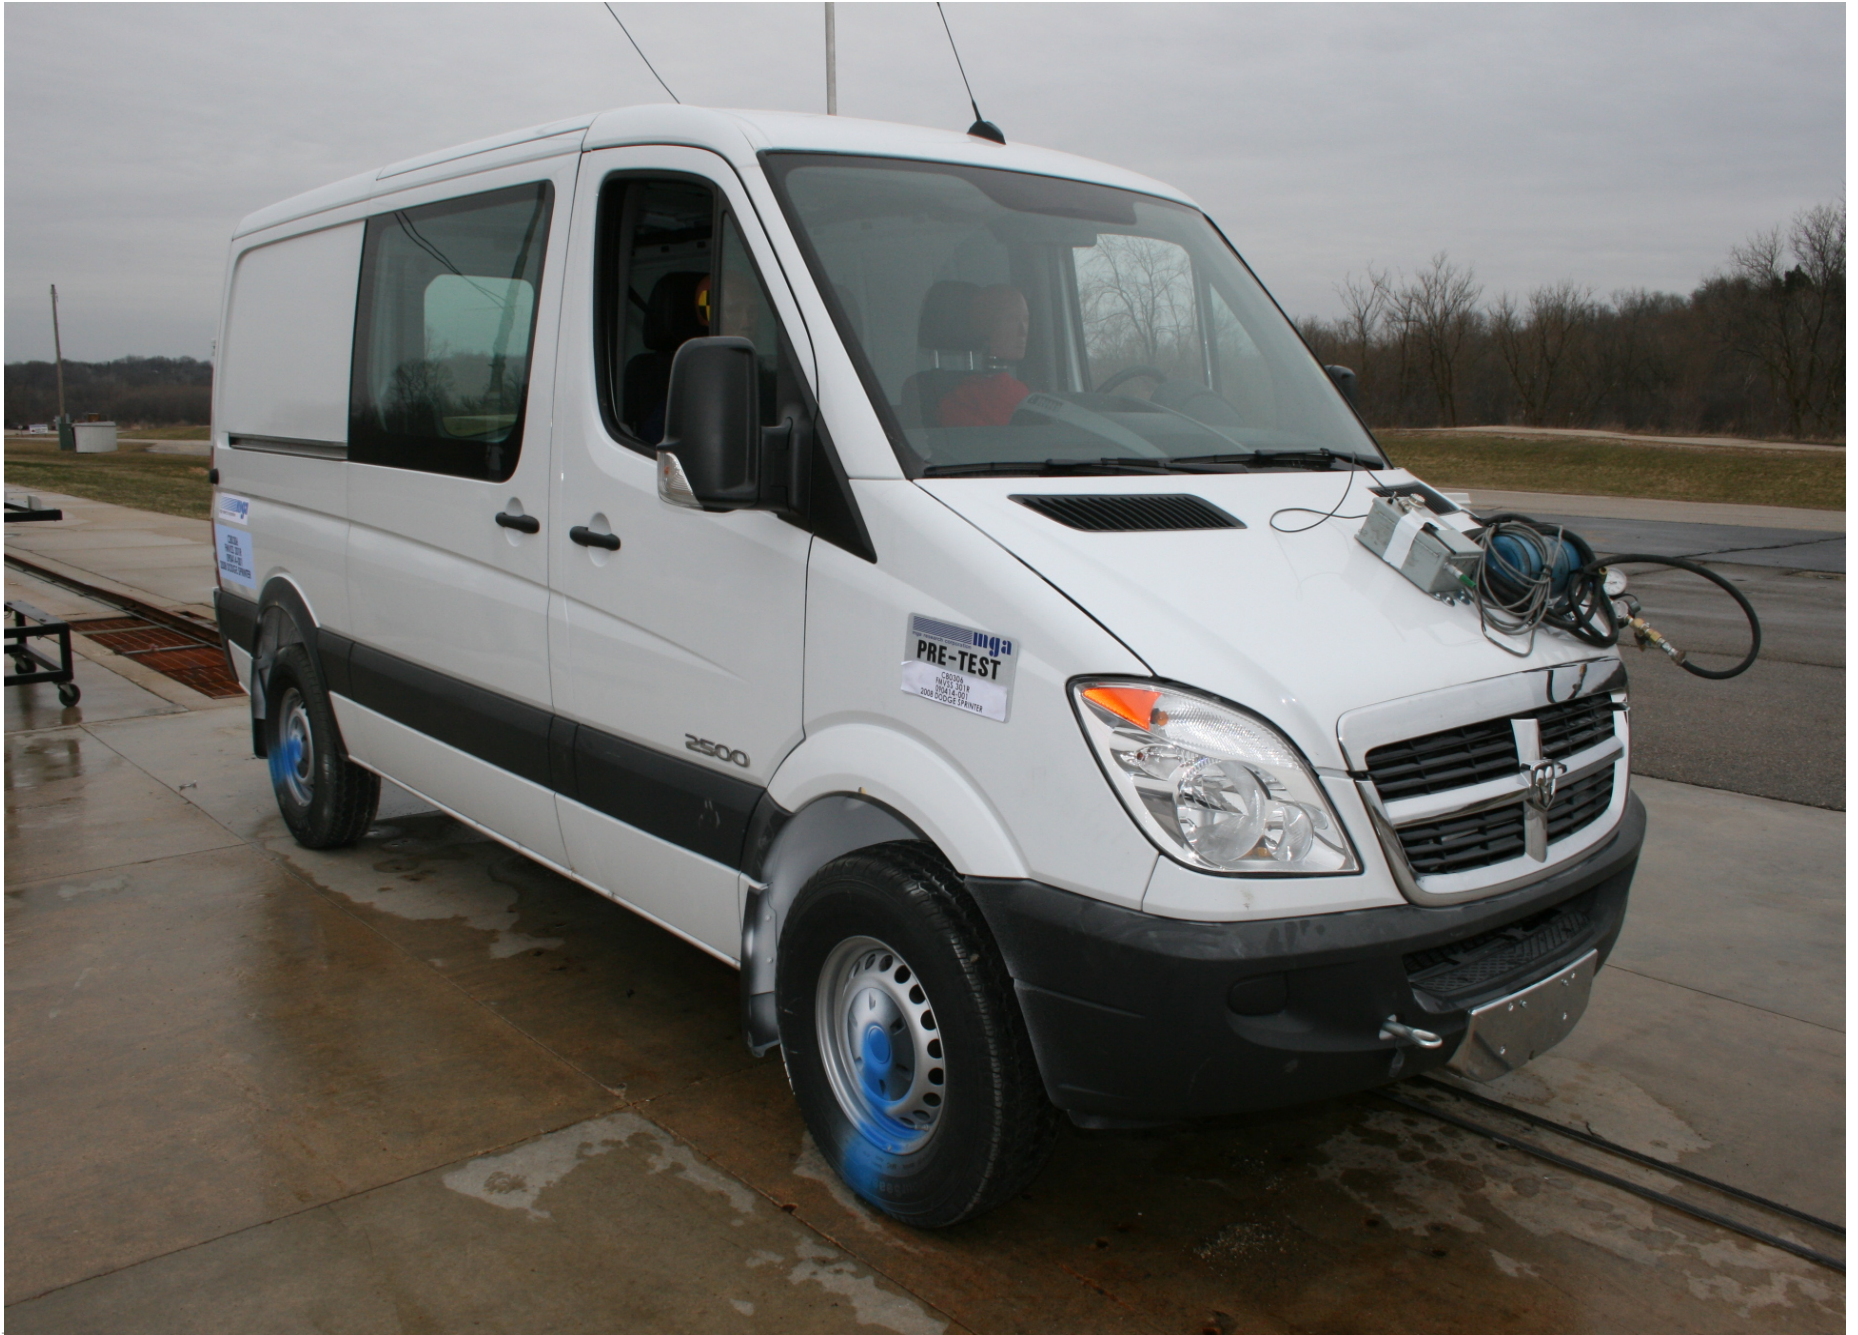
A-14.

Pre-Test ¾ Frontal View From Right Side of Vehicle

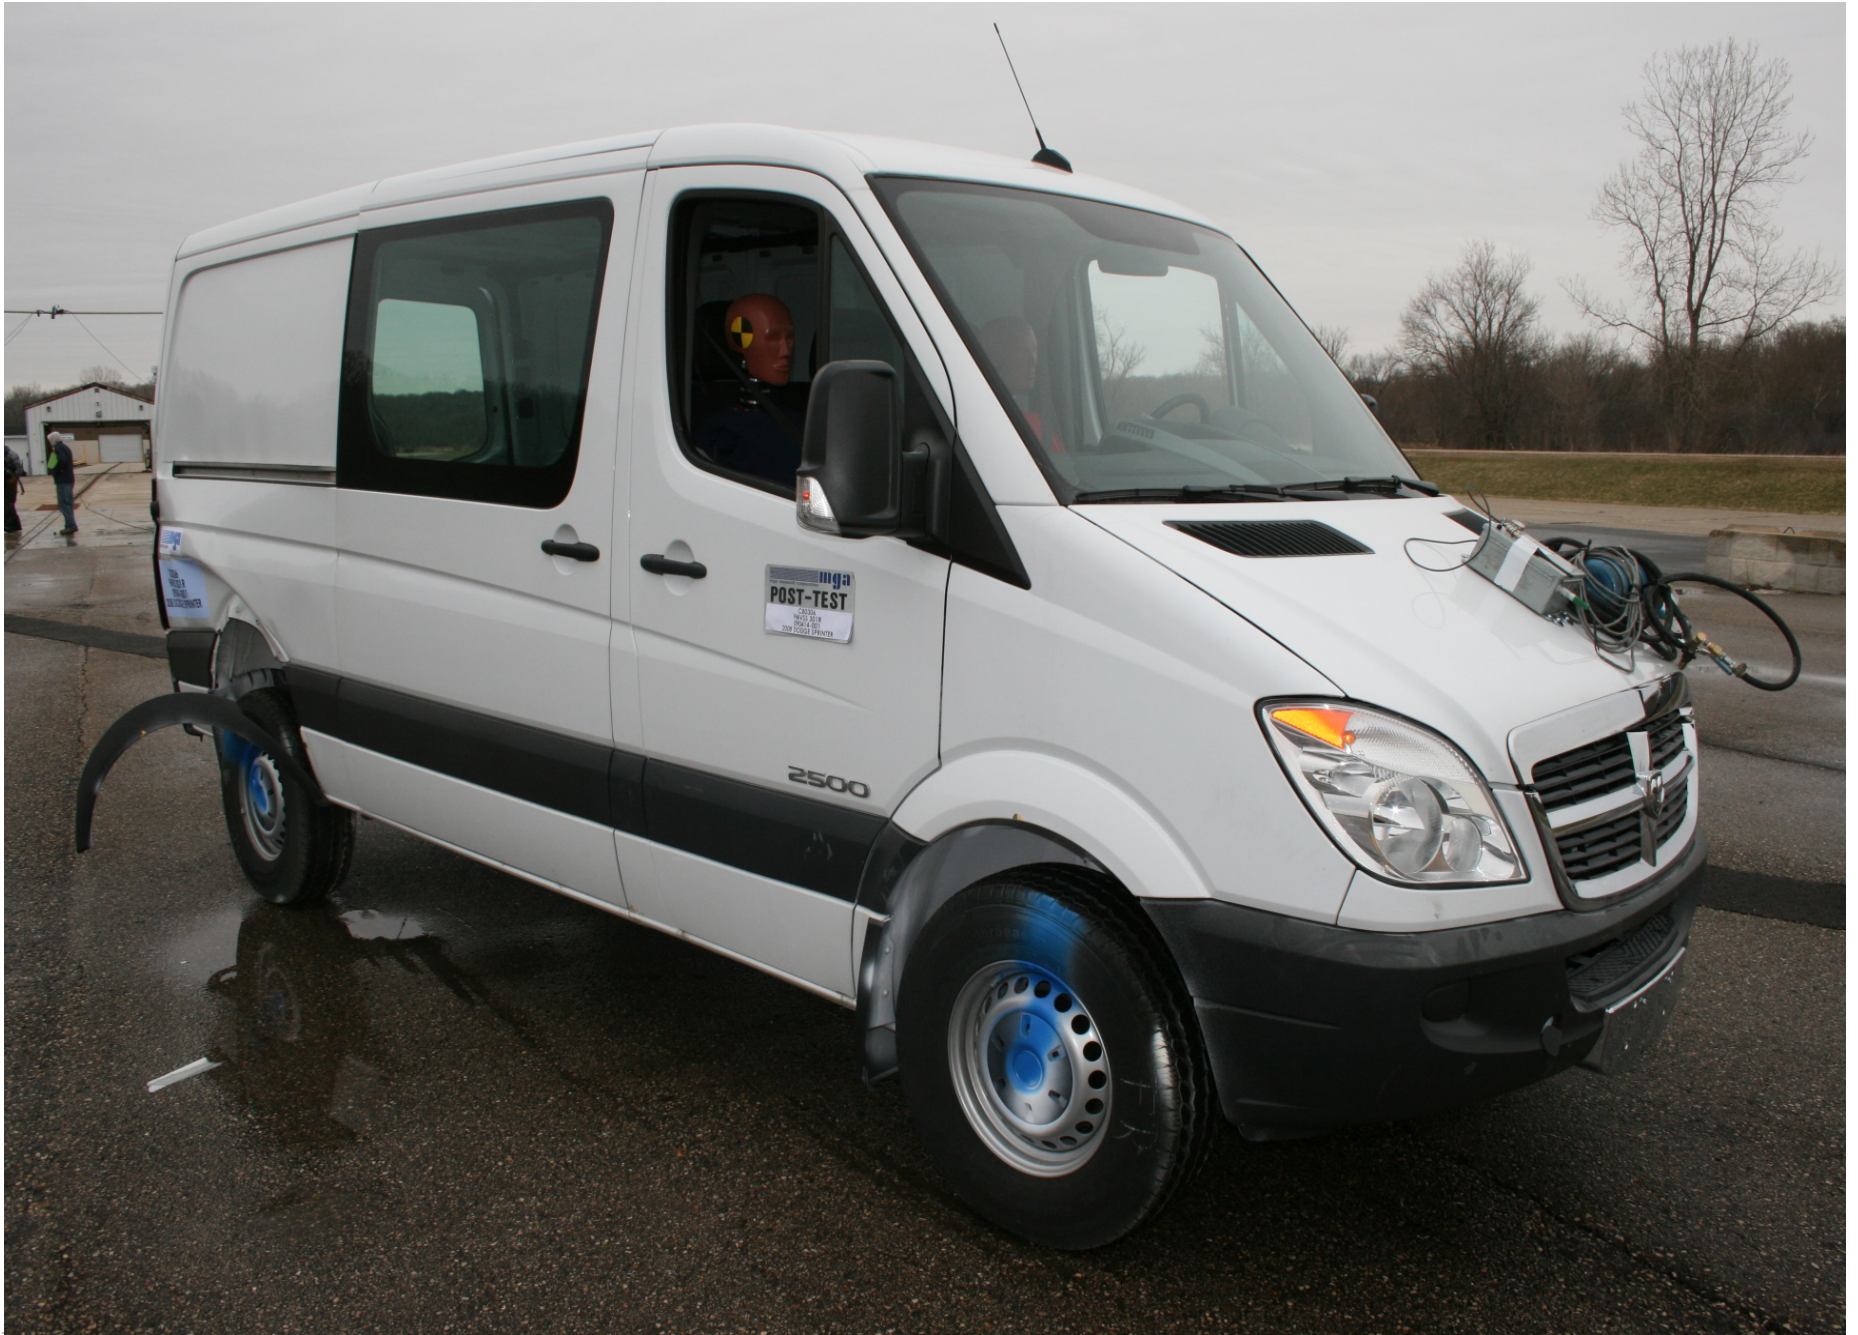
A-15.

Post-Test $\frac{3}{4}$ Frontal View From Right Side of Vehicle

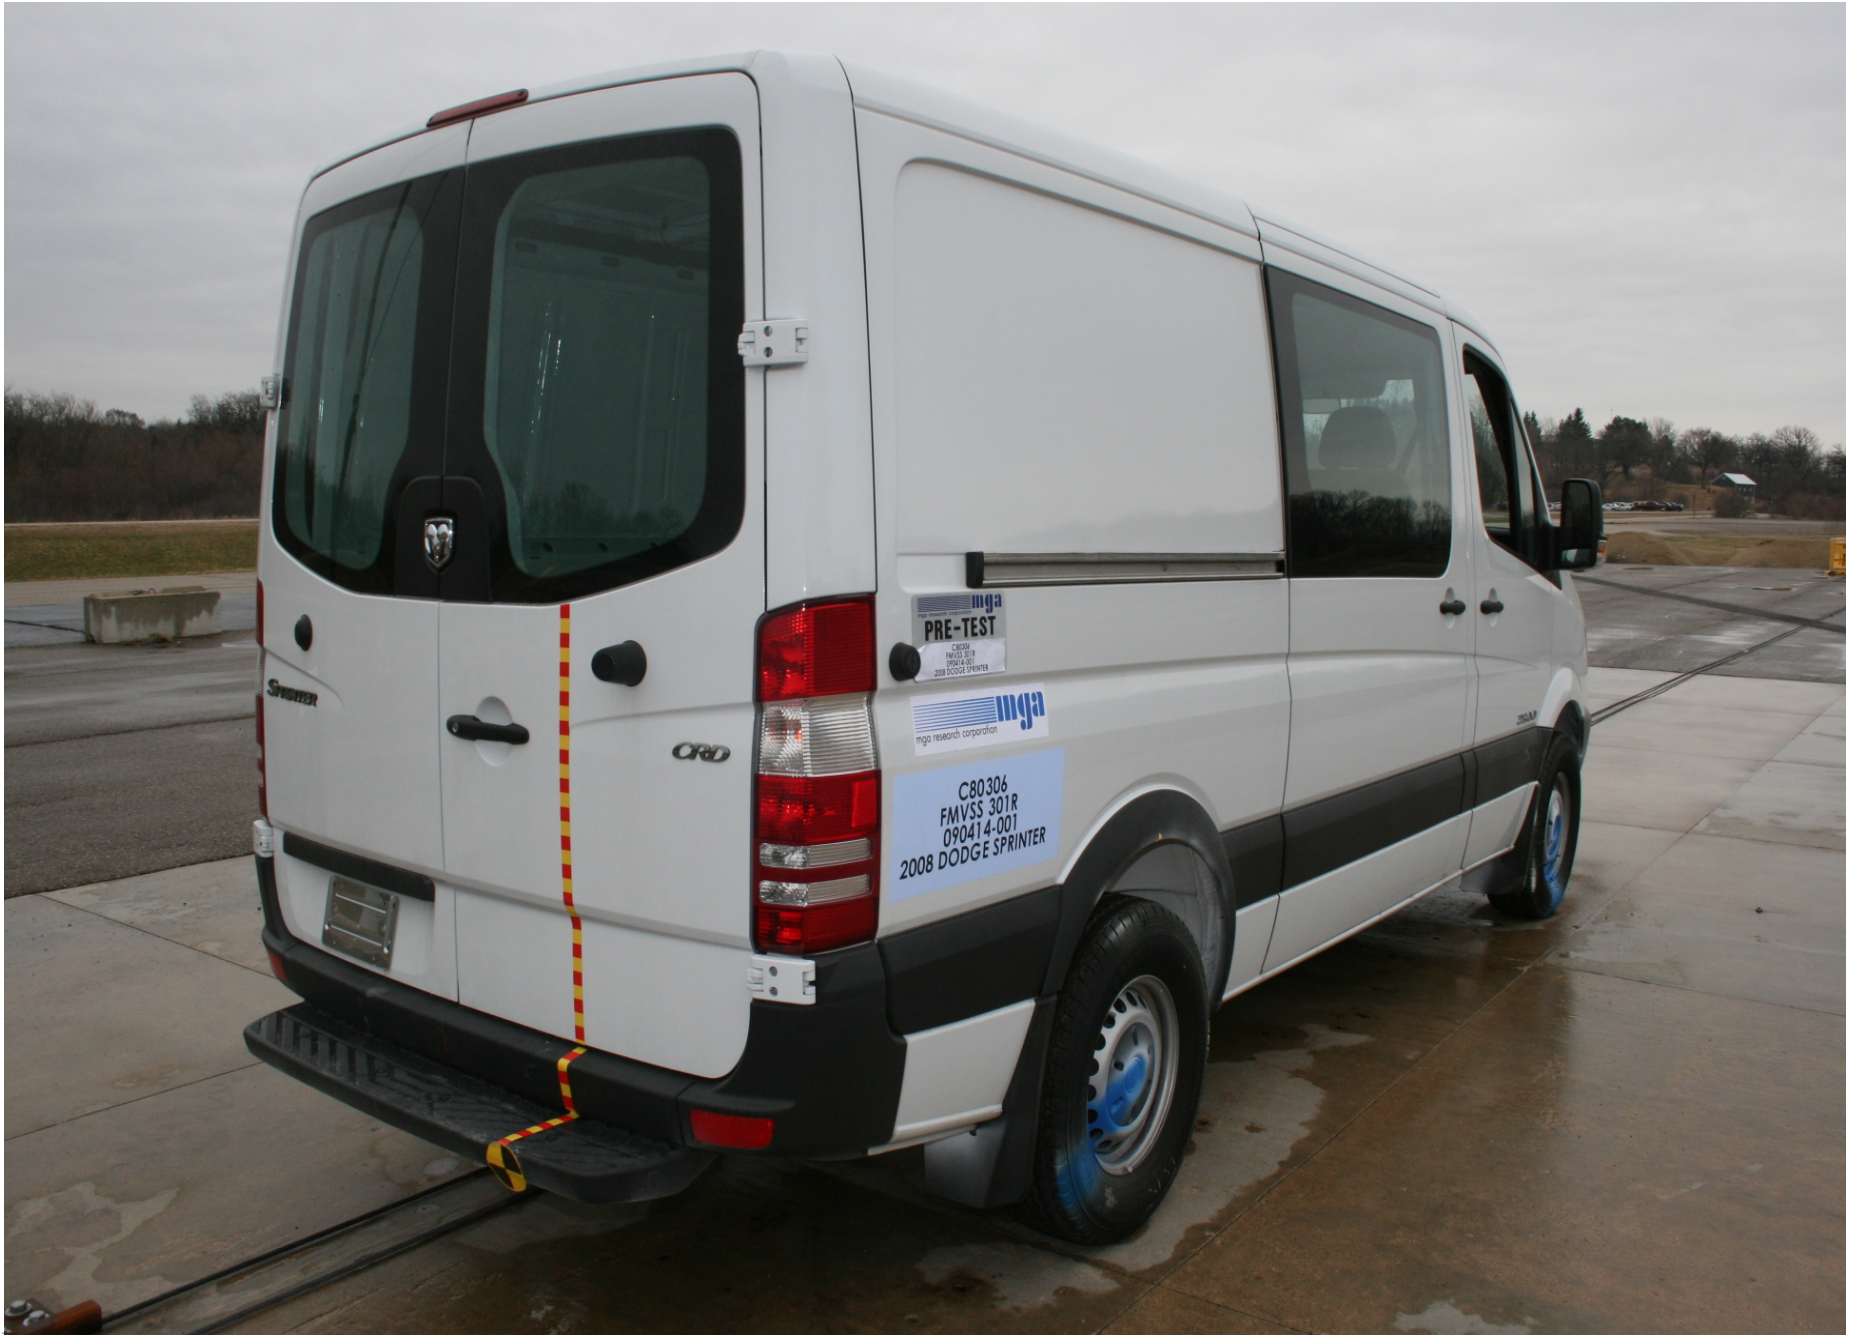
Pre-Test ¾ Rear View From Right Side of Vehicle

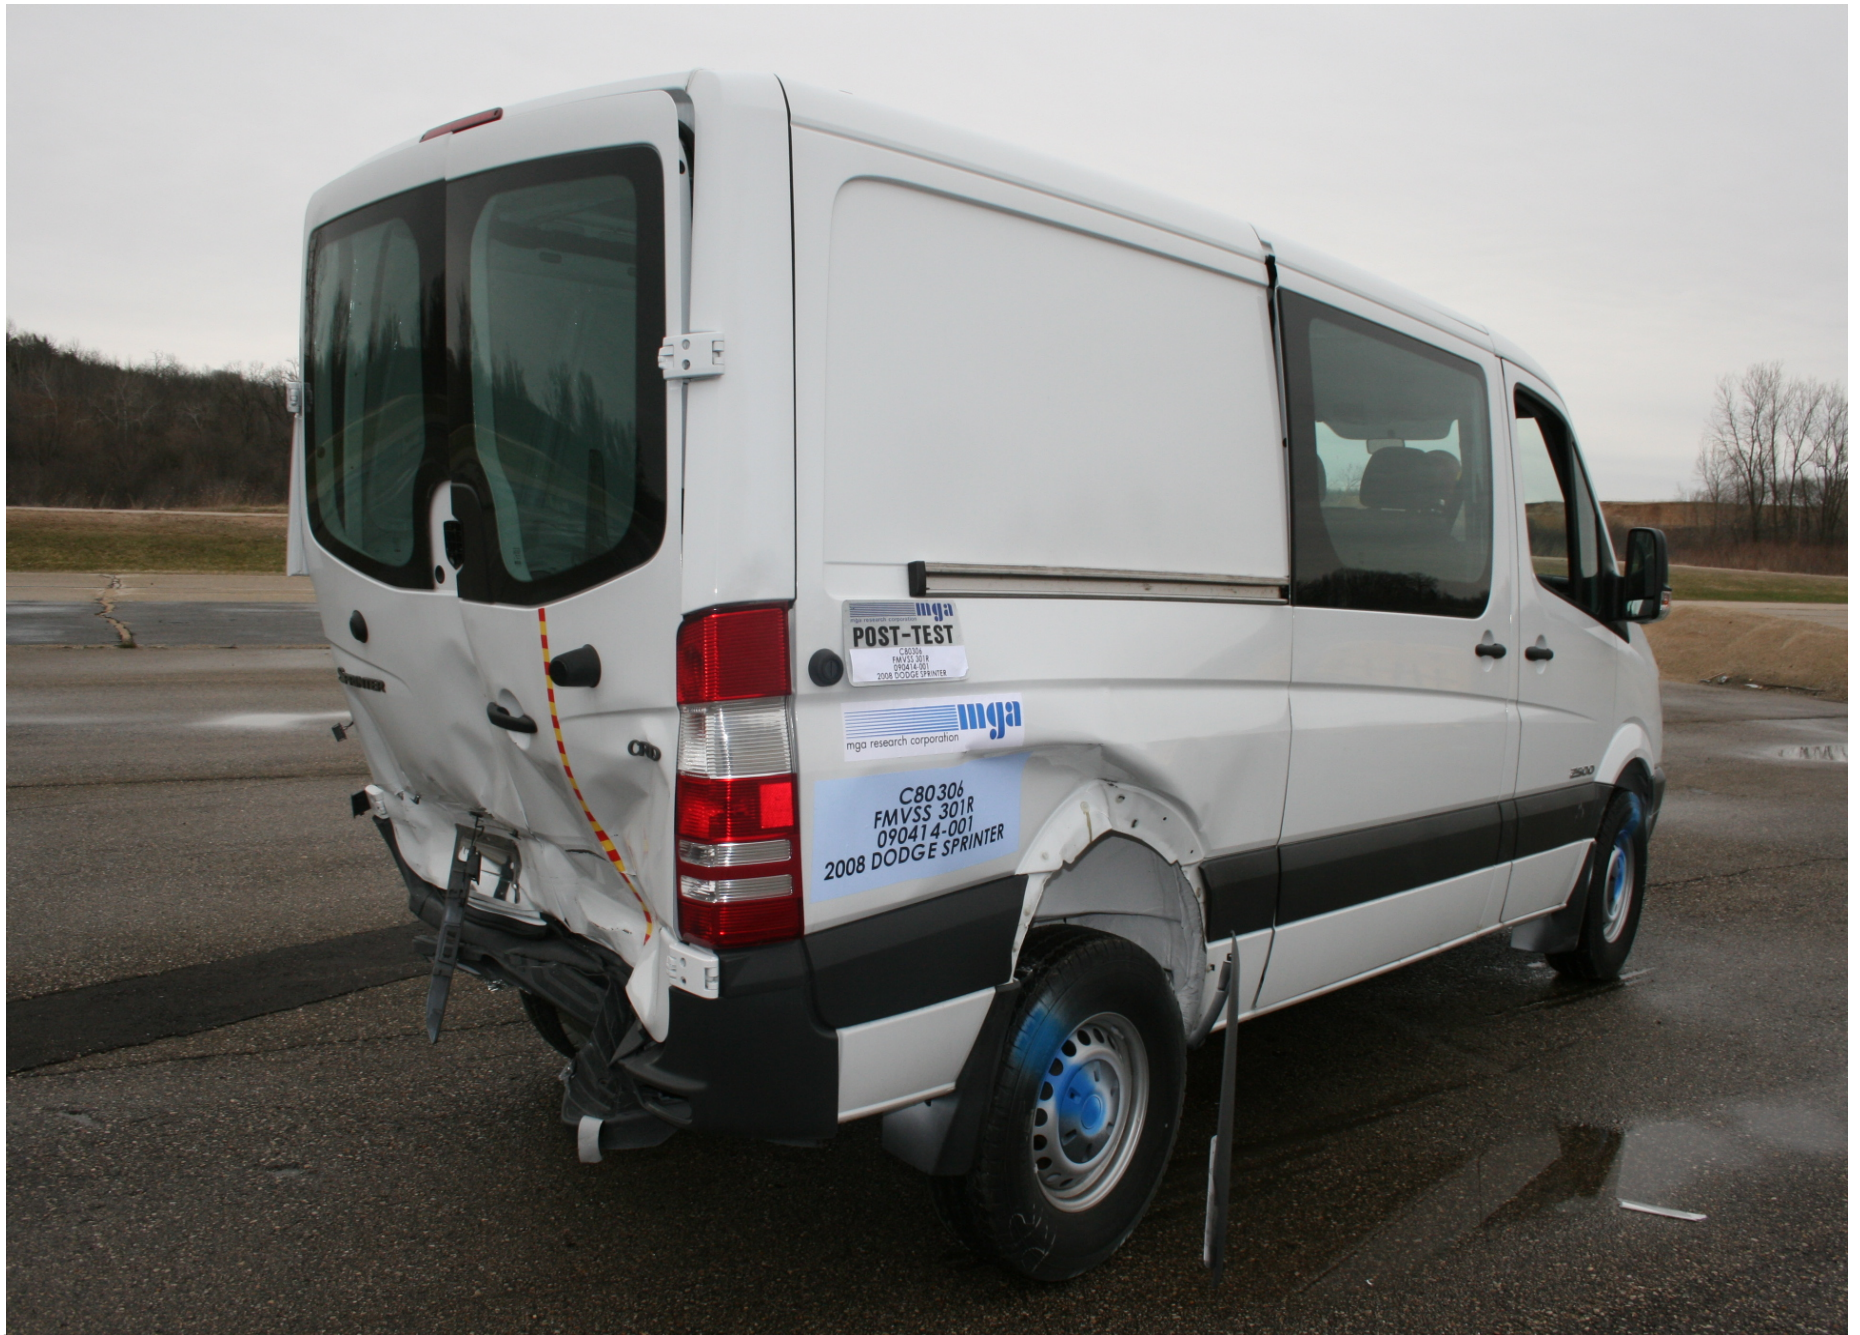
Post-Test $\frac{3}{4}$ Rear View From Right Side of Vehicle

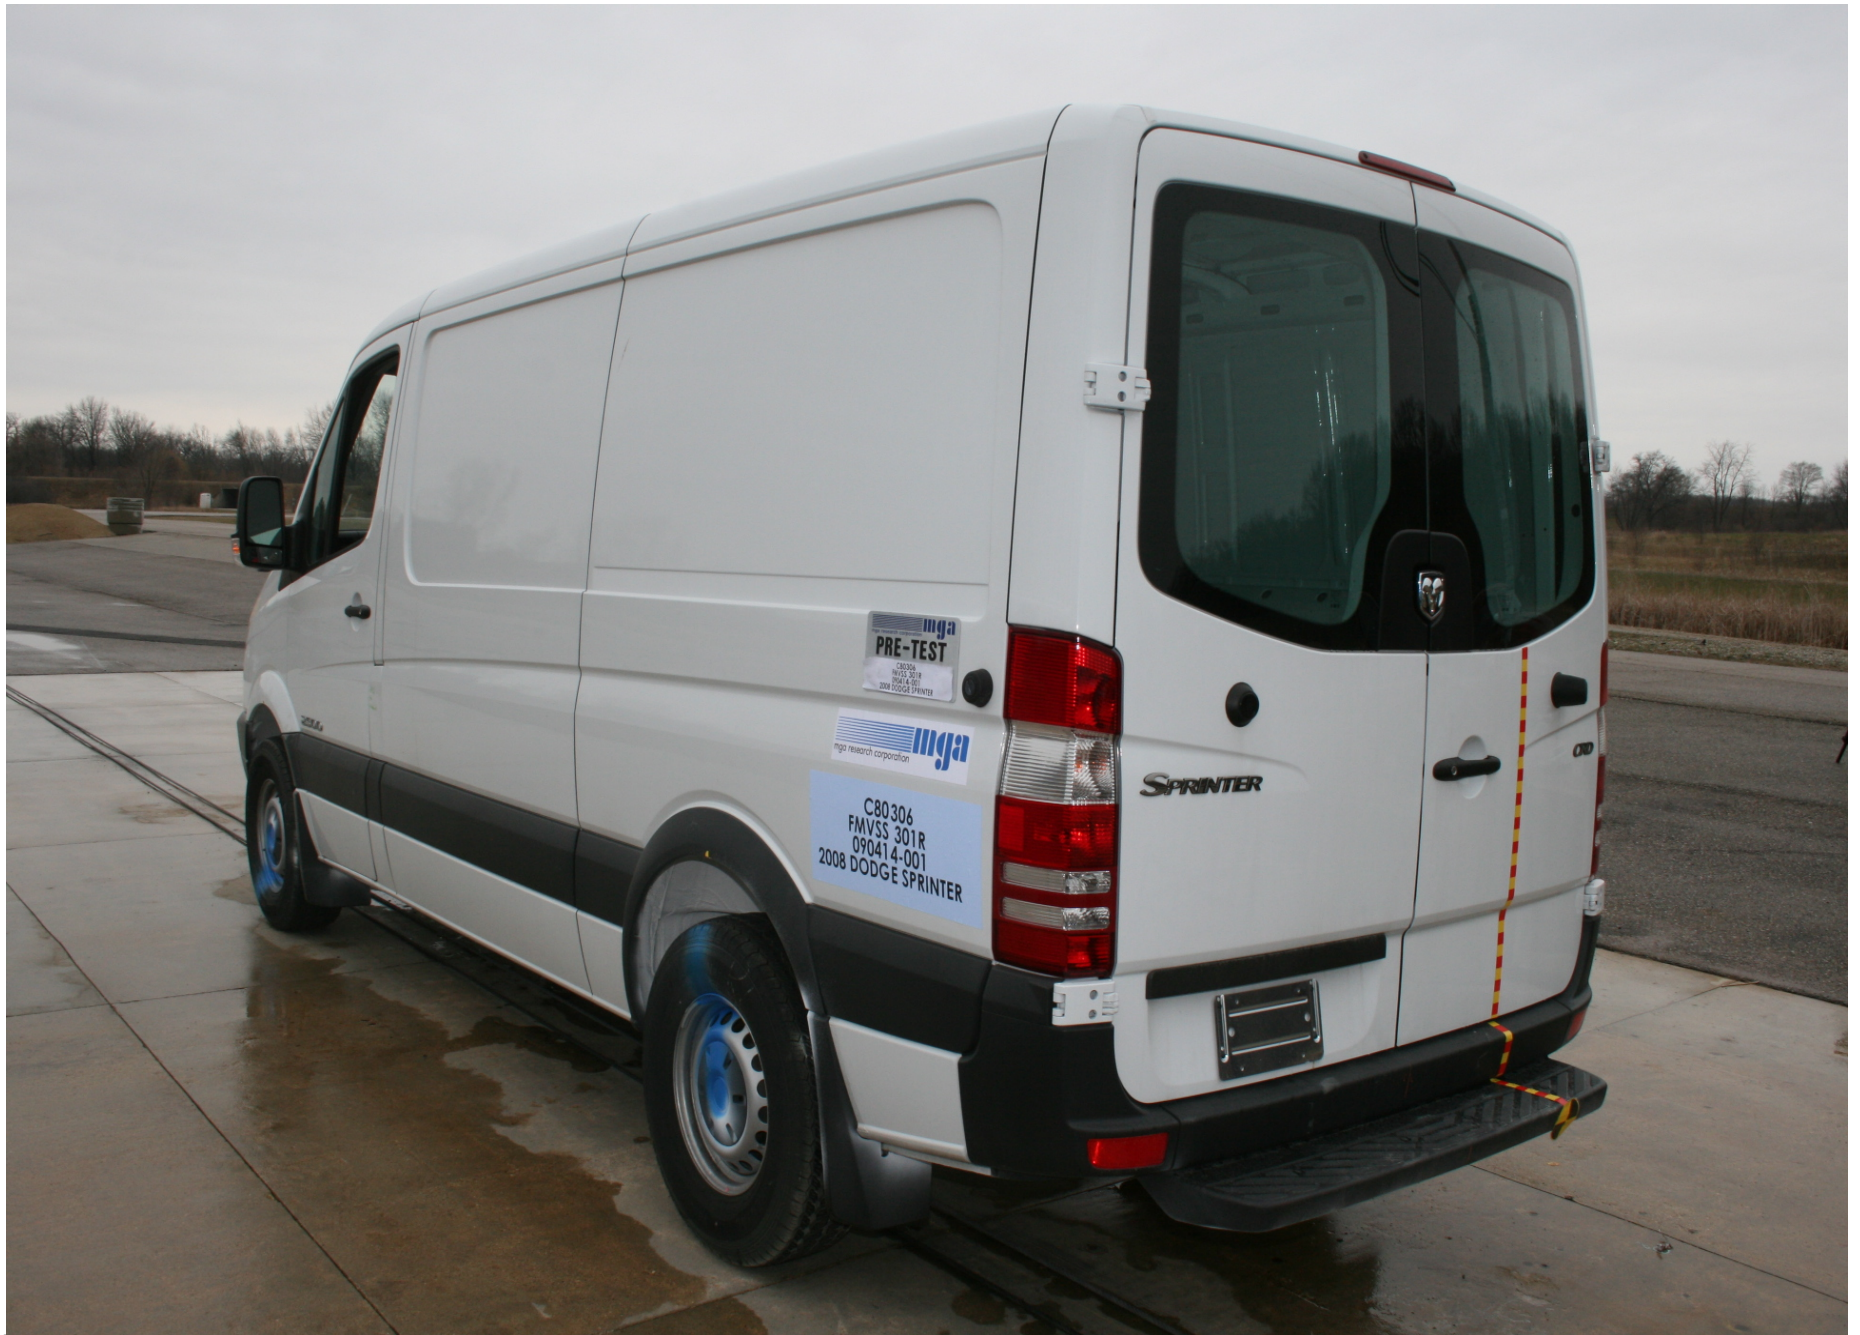
Pre-Test $\frac{3}{4}$ Rear View From Left Side of Vehicle

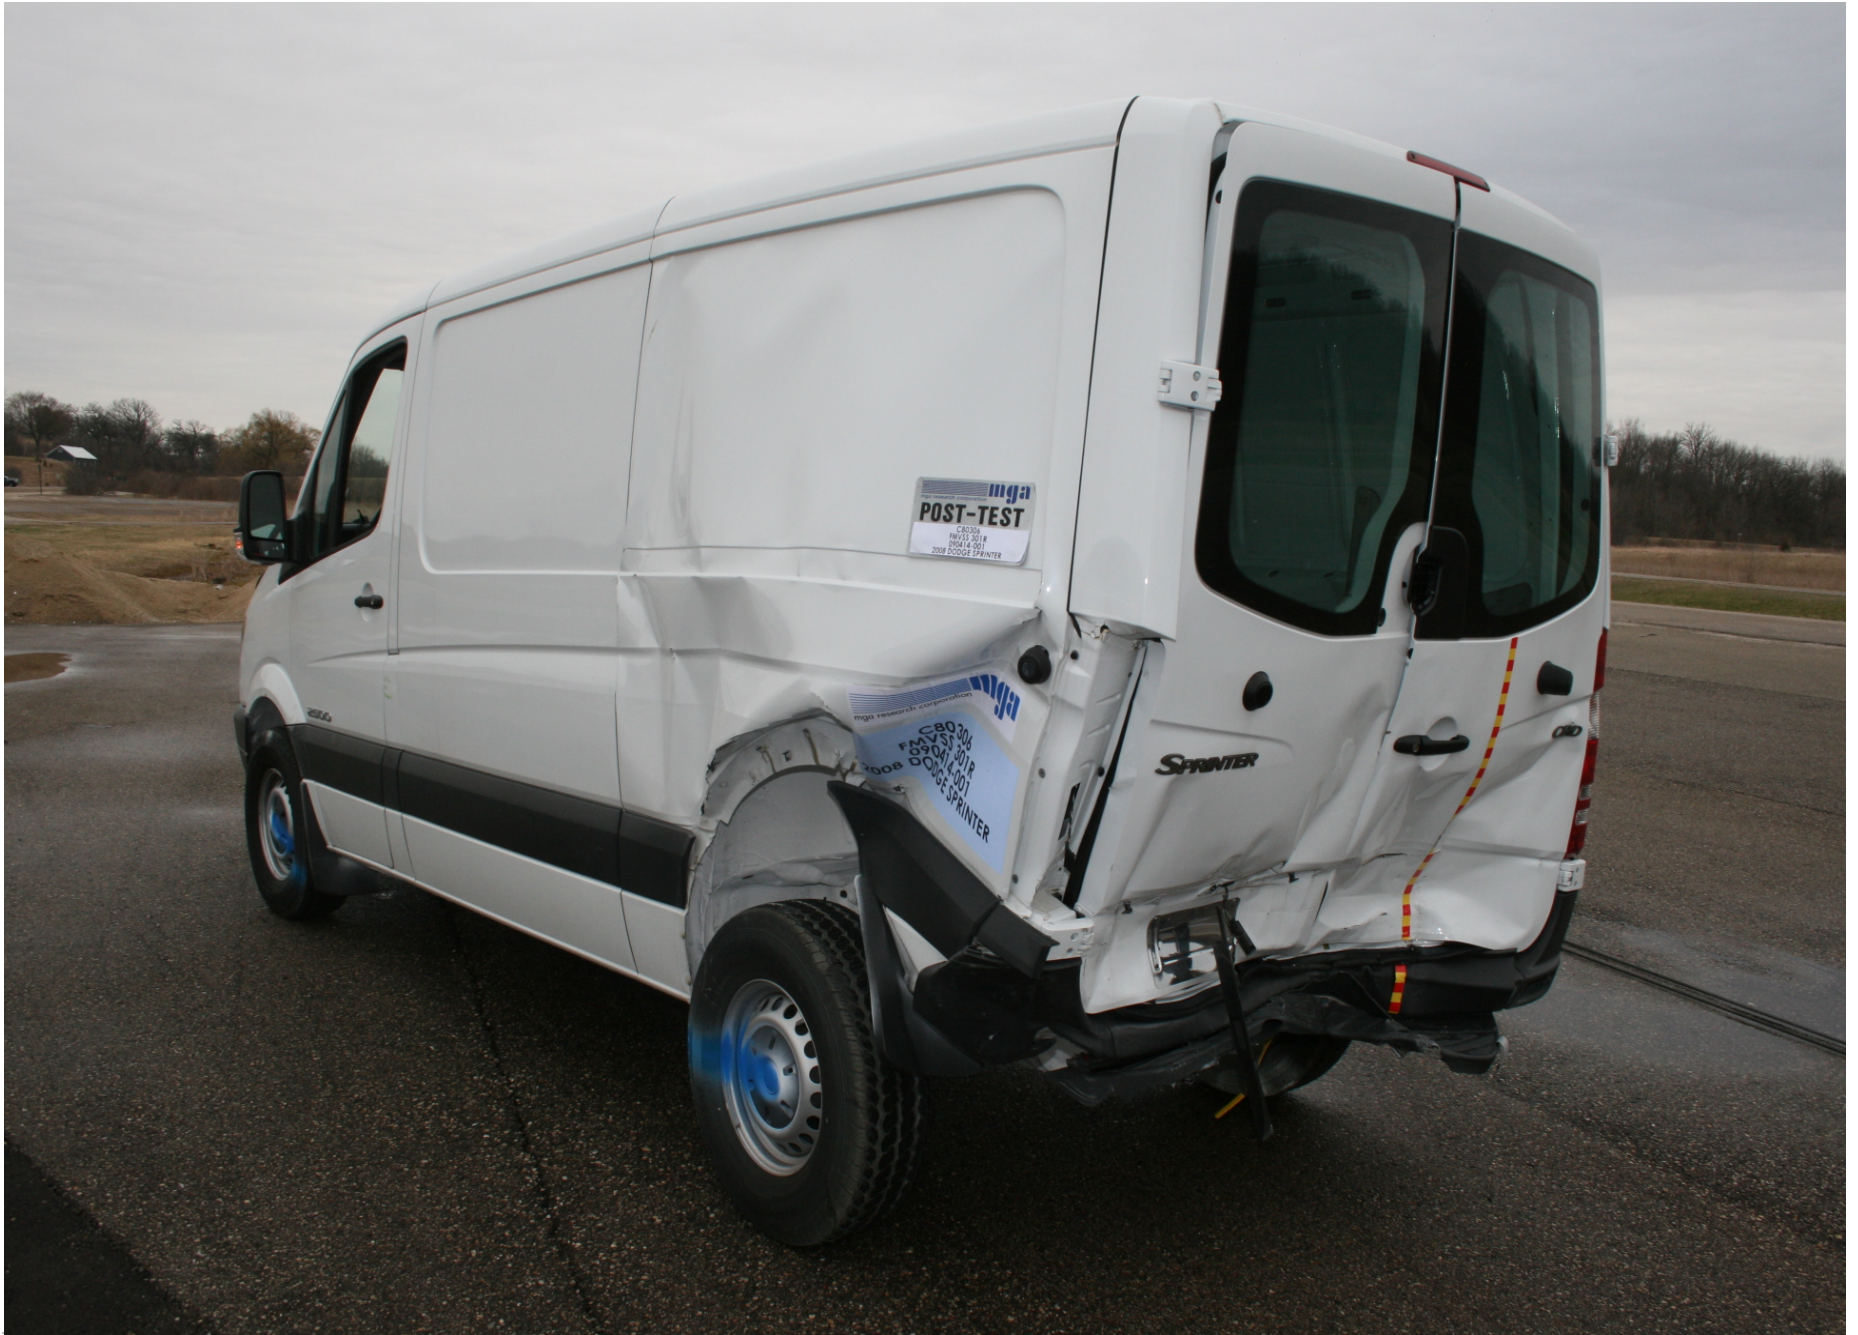
Post-Test ¾ Rear View From Left Side of Vehicle

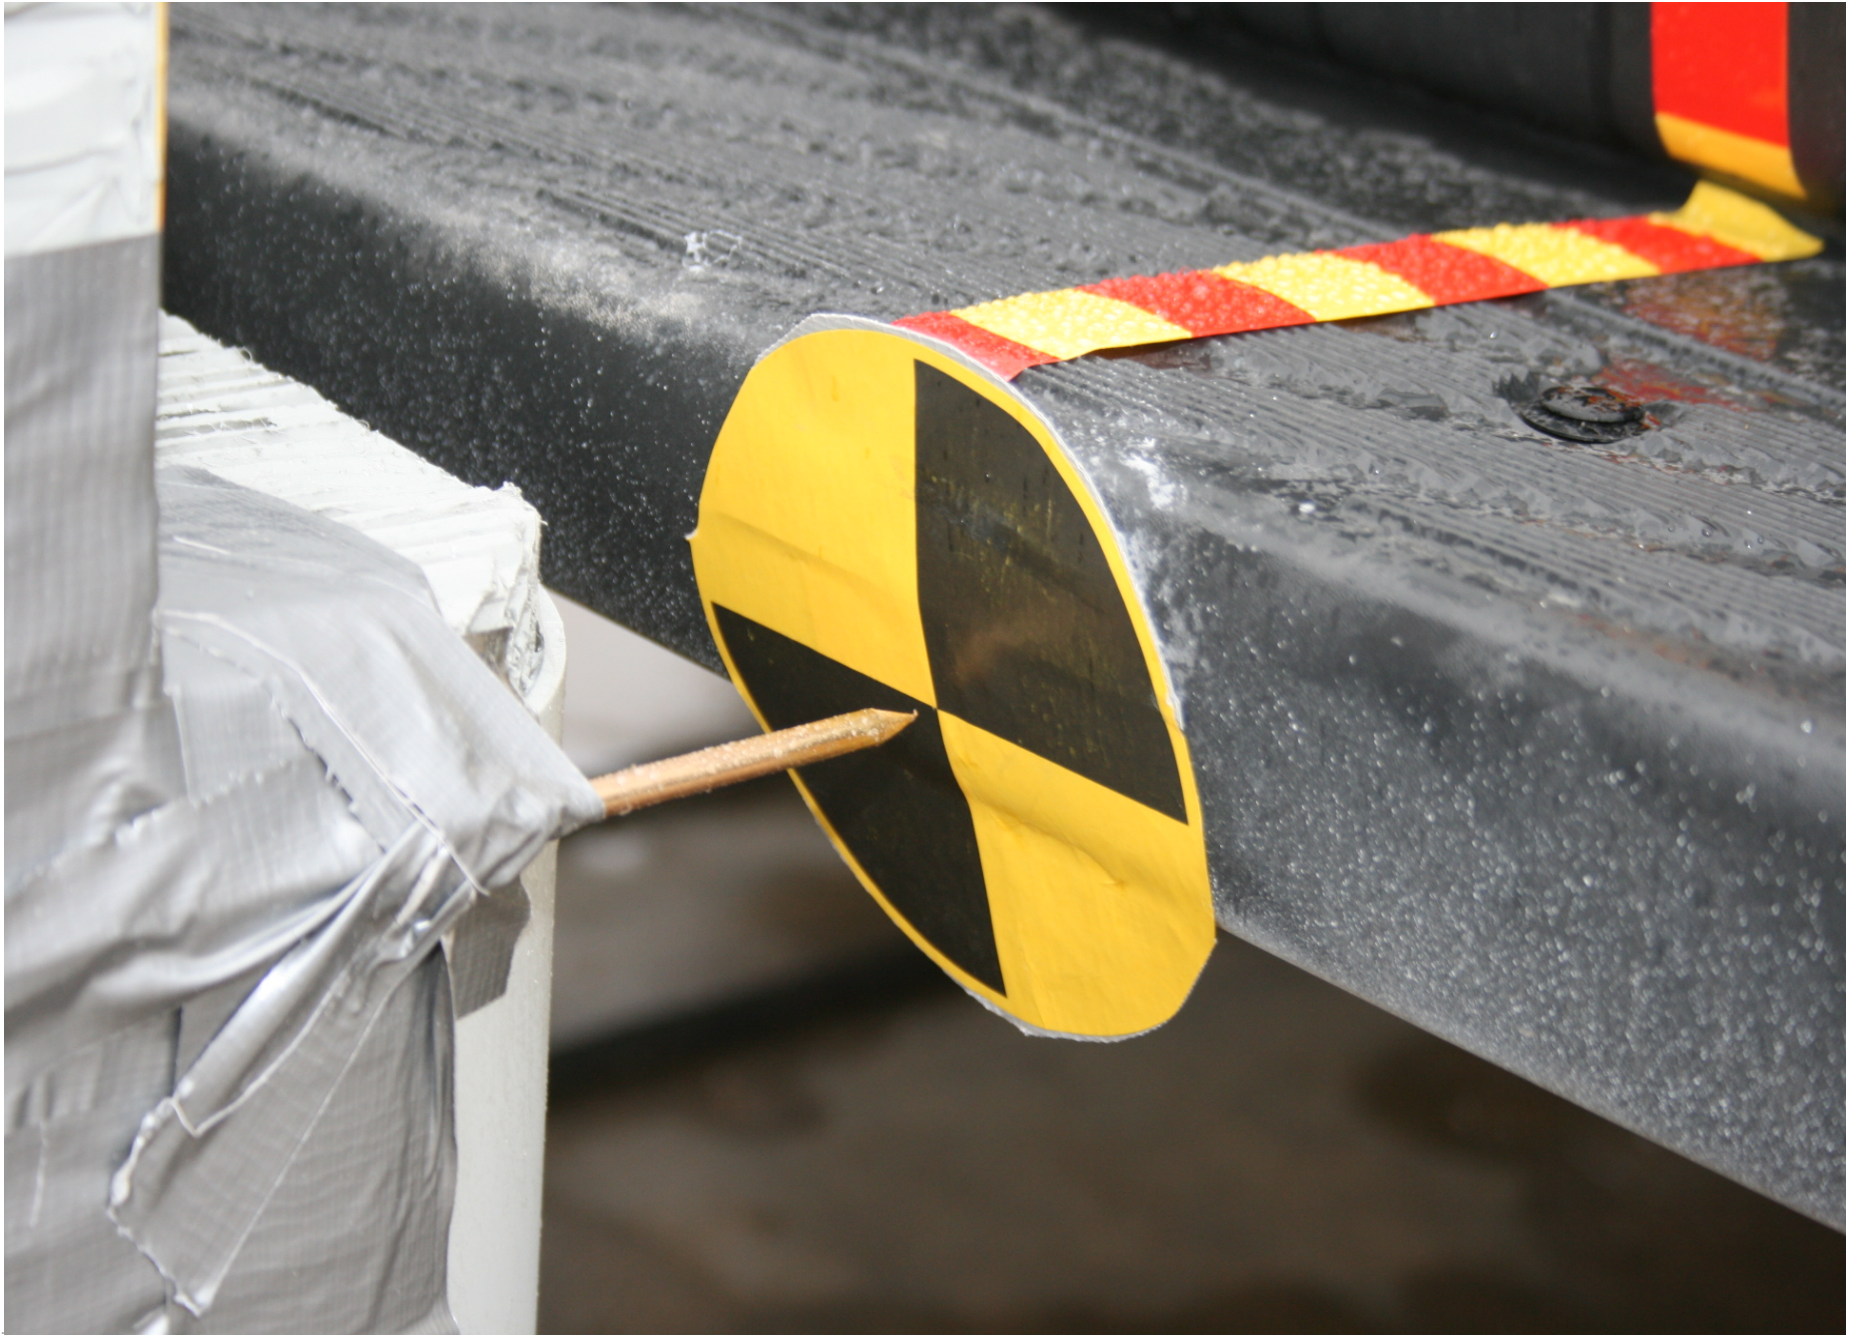
A-20.

Pre-Test Impact Point
