REPORT NUMBER: 301-MGA-2009-001

**SAFETY COMPLIANCE TESTING FOR FMVSS 301R
FUEL SYSTEM INTEGRITY – REAR IMPACT**

**DAIMLER CHRYSLER AG
2008 DODGE SPRINTER 2500 CARGO VAN
NHTSA NUMBER: C80306**

**PREPARED BY:
MGA RESEARCH CORPORATION
5000 WARREN ROAD
BURLINGTON, WI 53105**

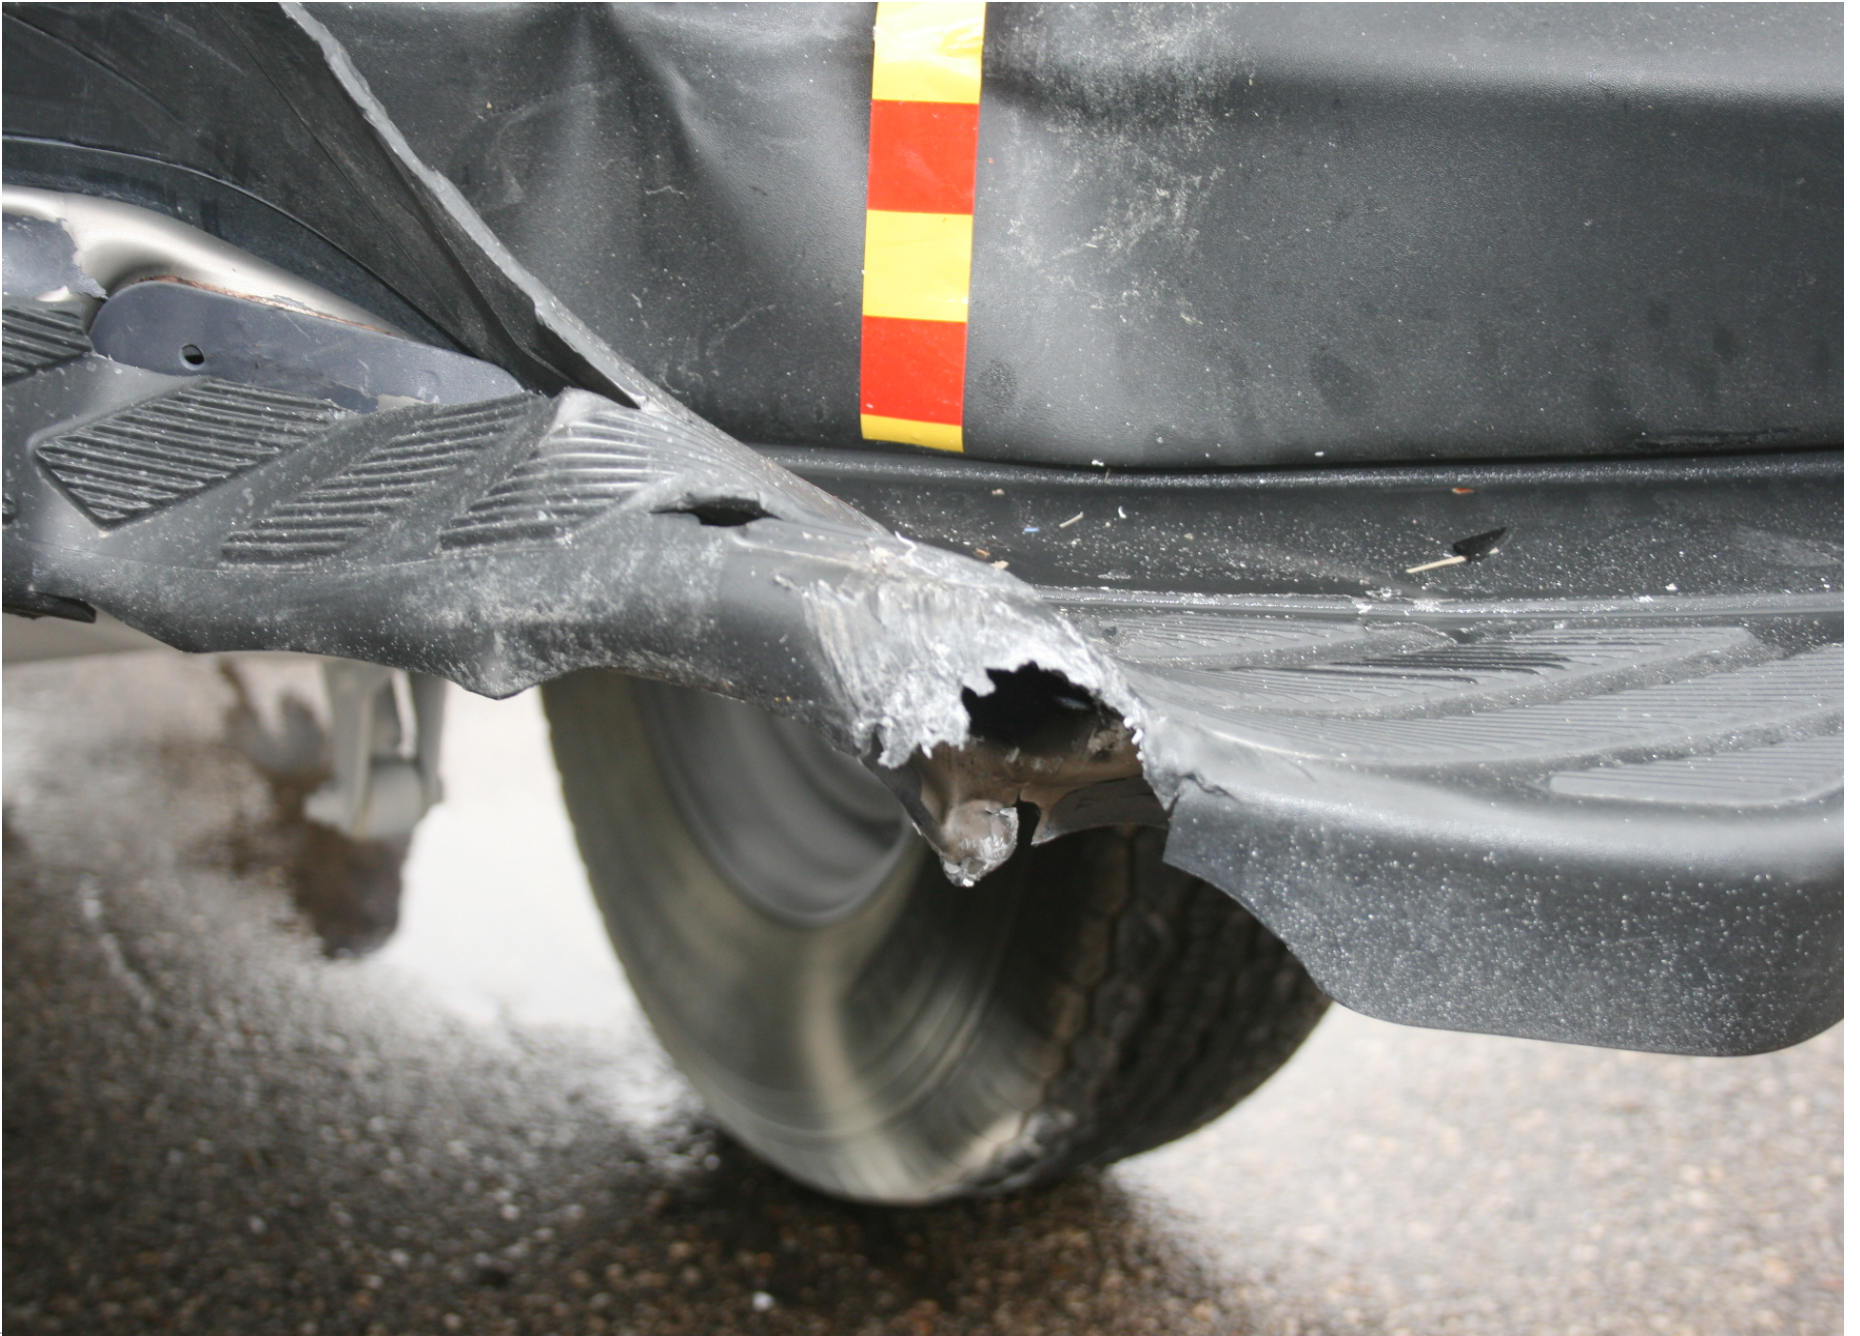
A-21.

Post-Test Impact Point

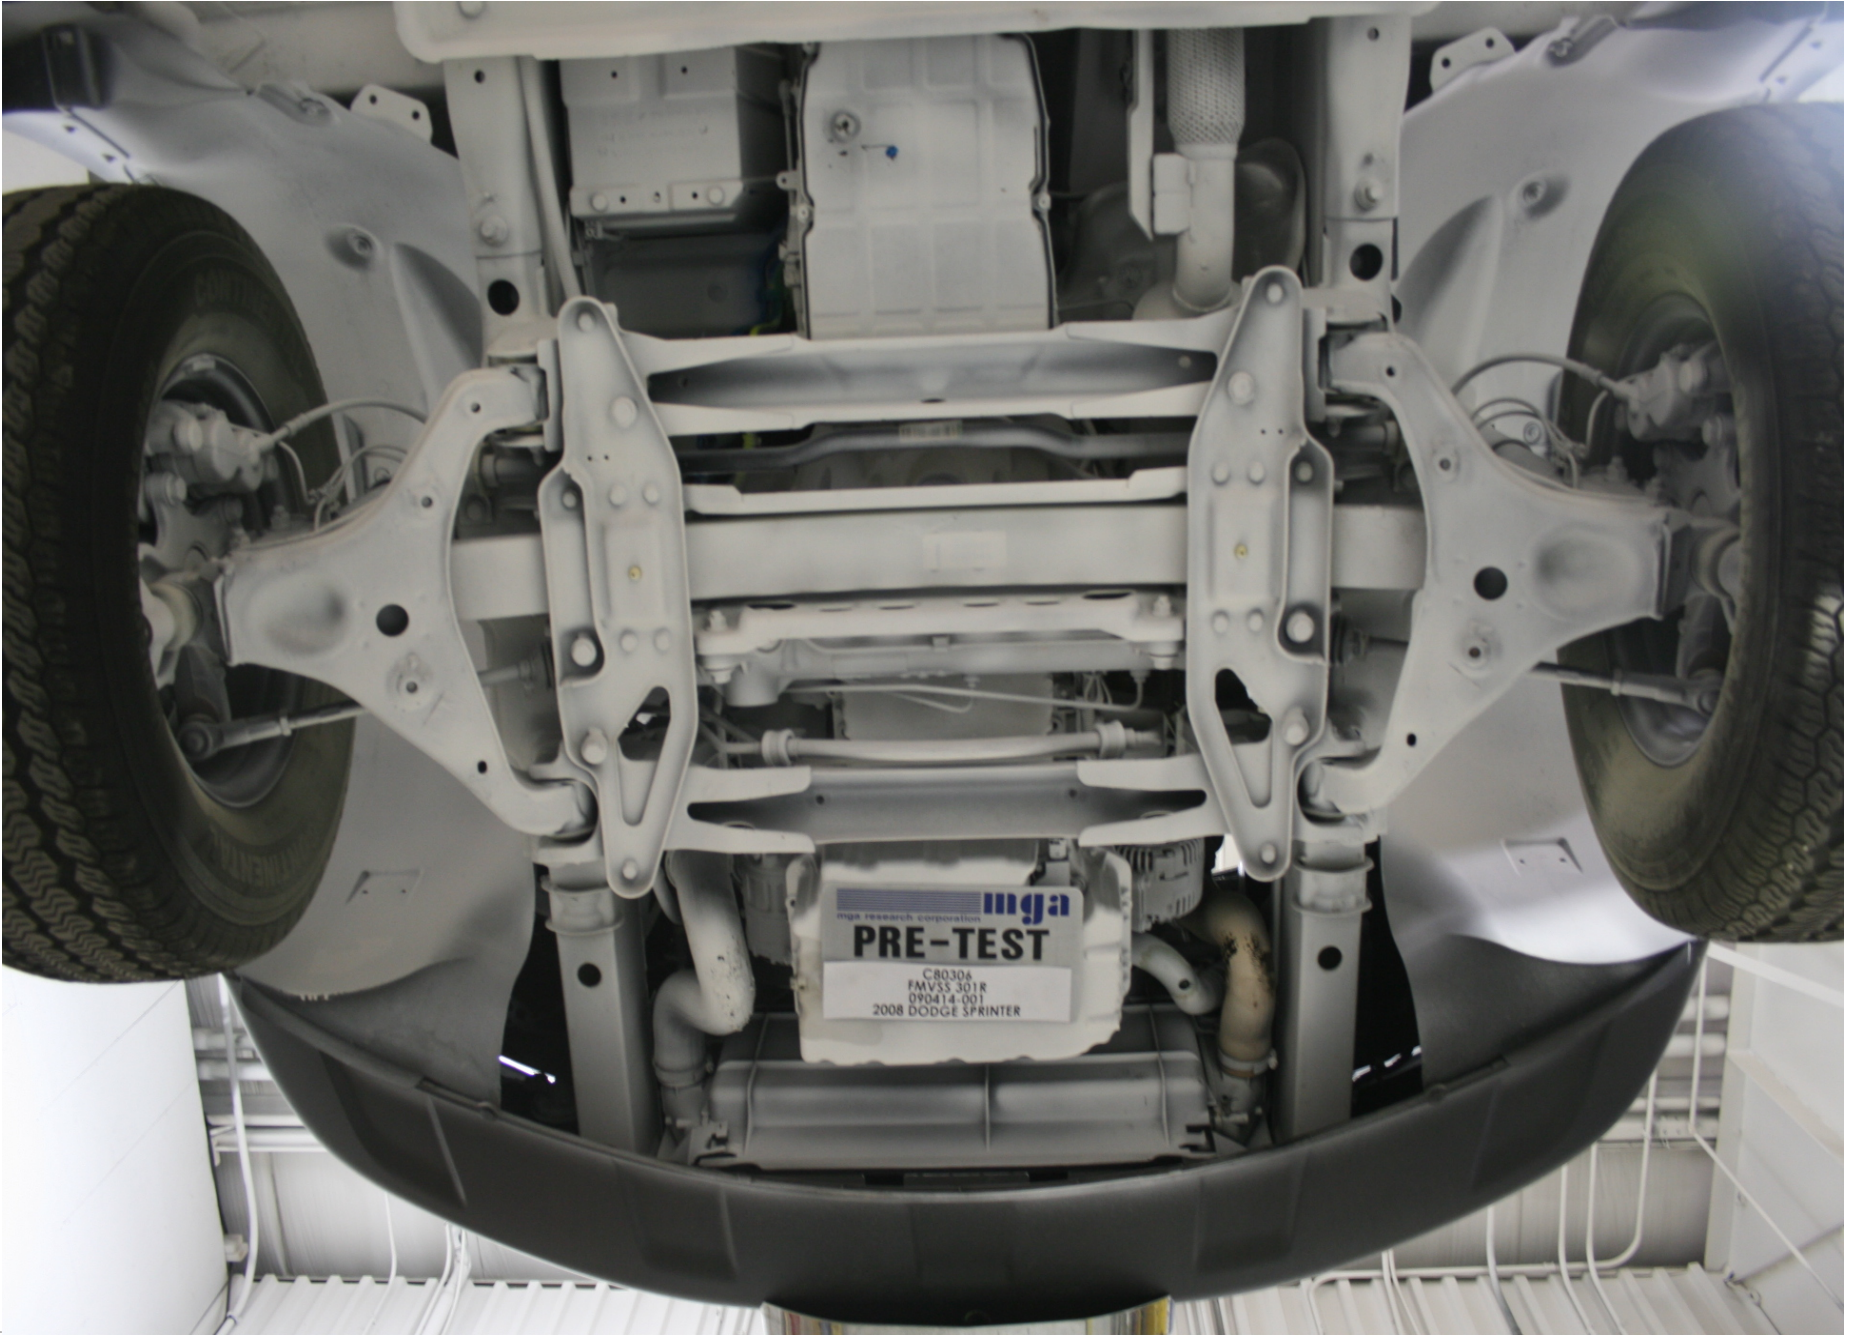
A-22.

Pre-Test Underbody View 1

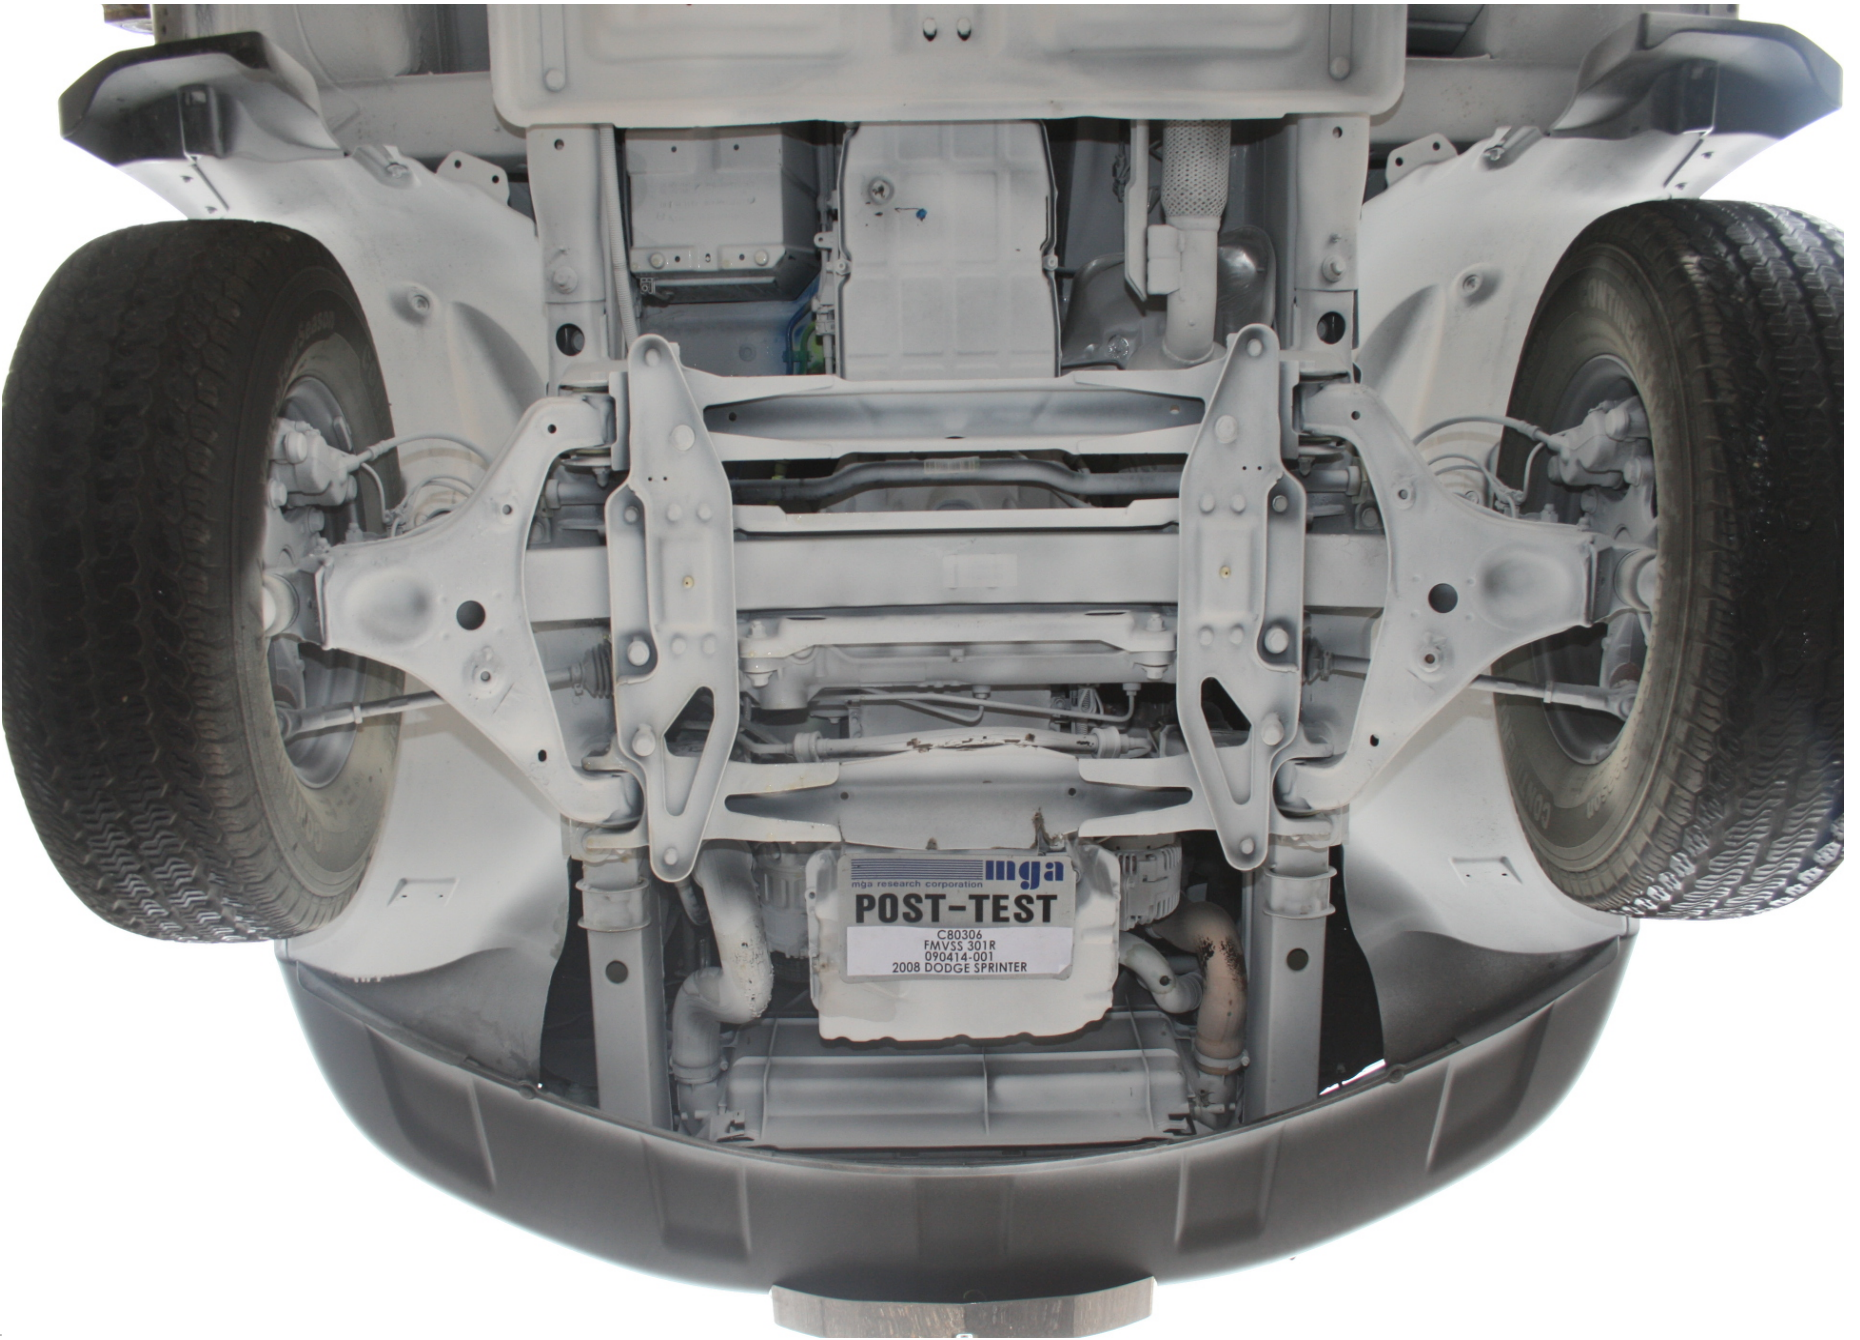
A-23.

Post-Test Underbody View 1

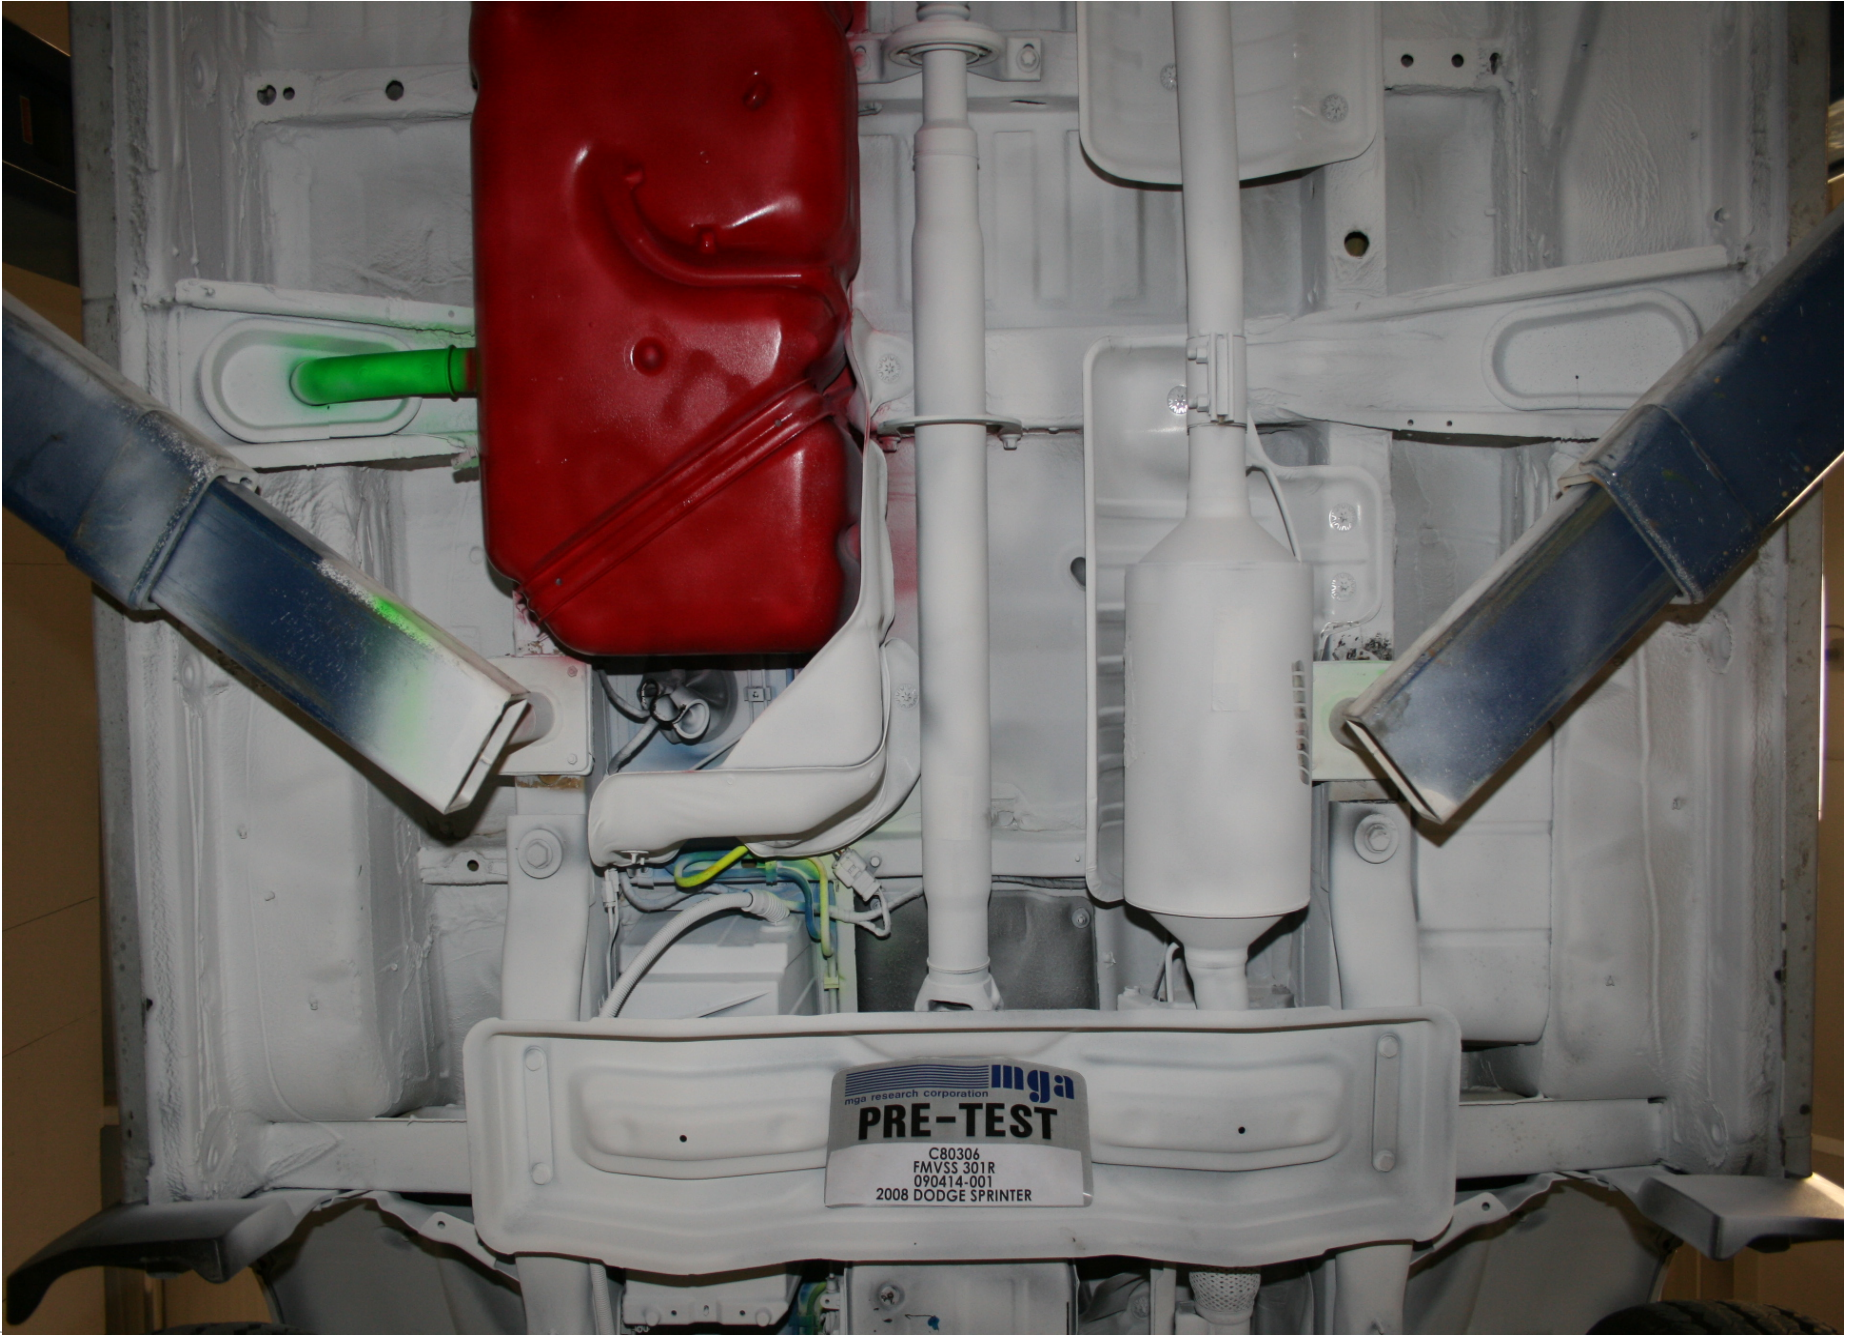
A-24.

Pre-Test Underbody View 2

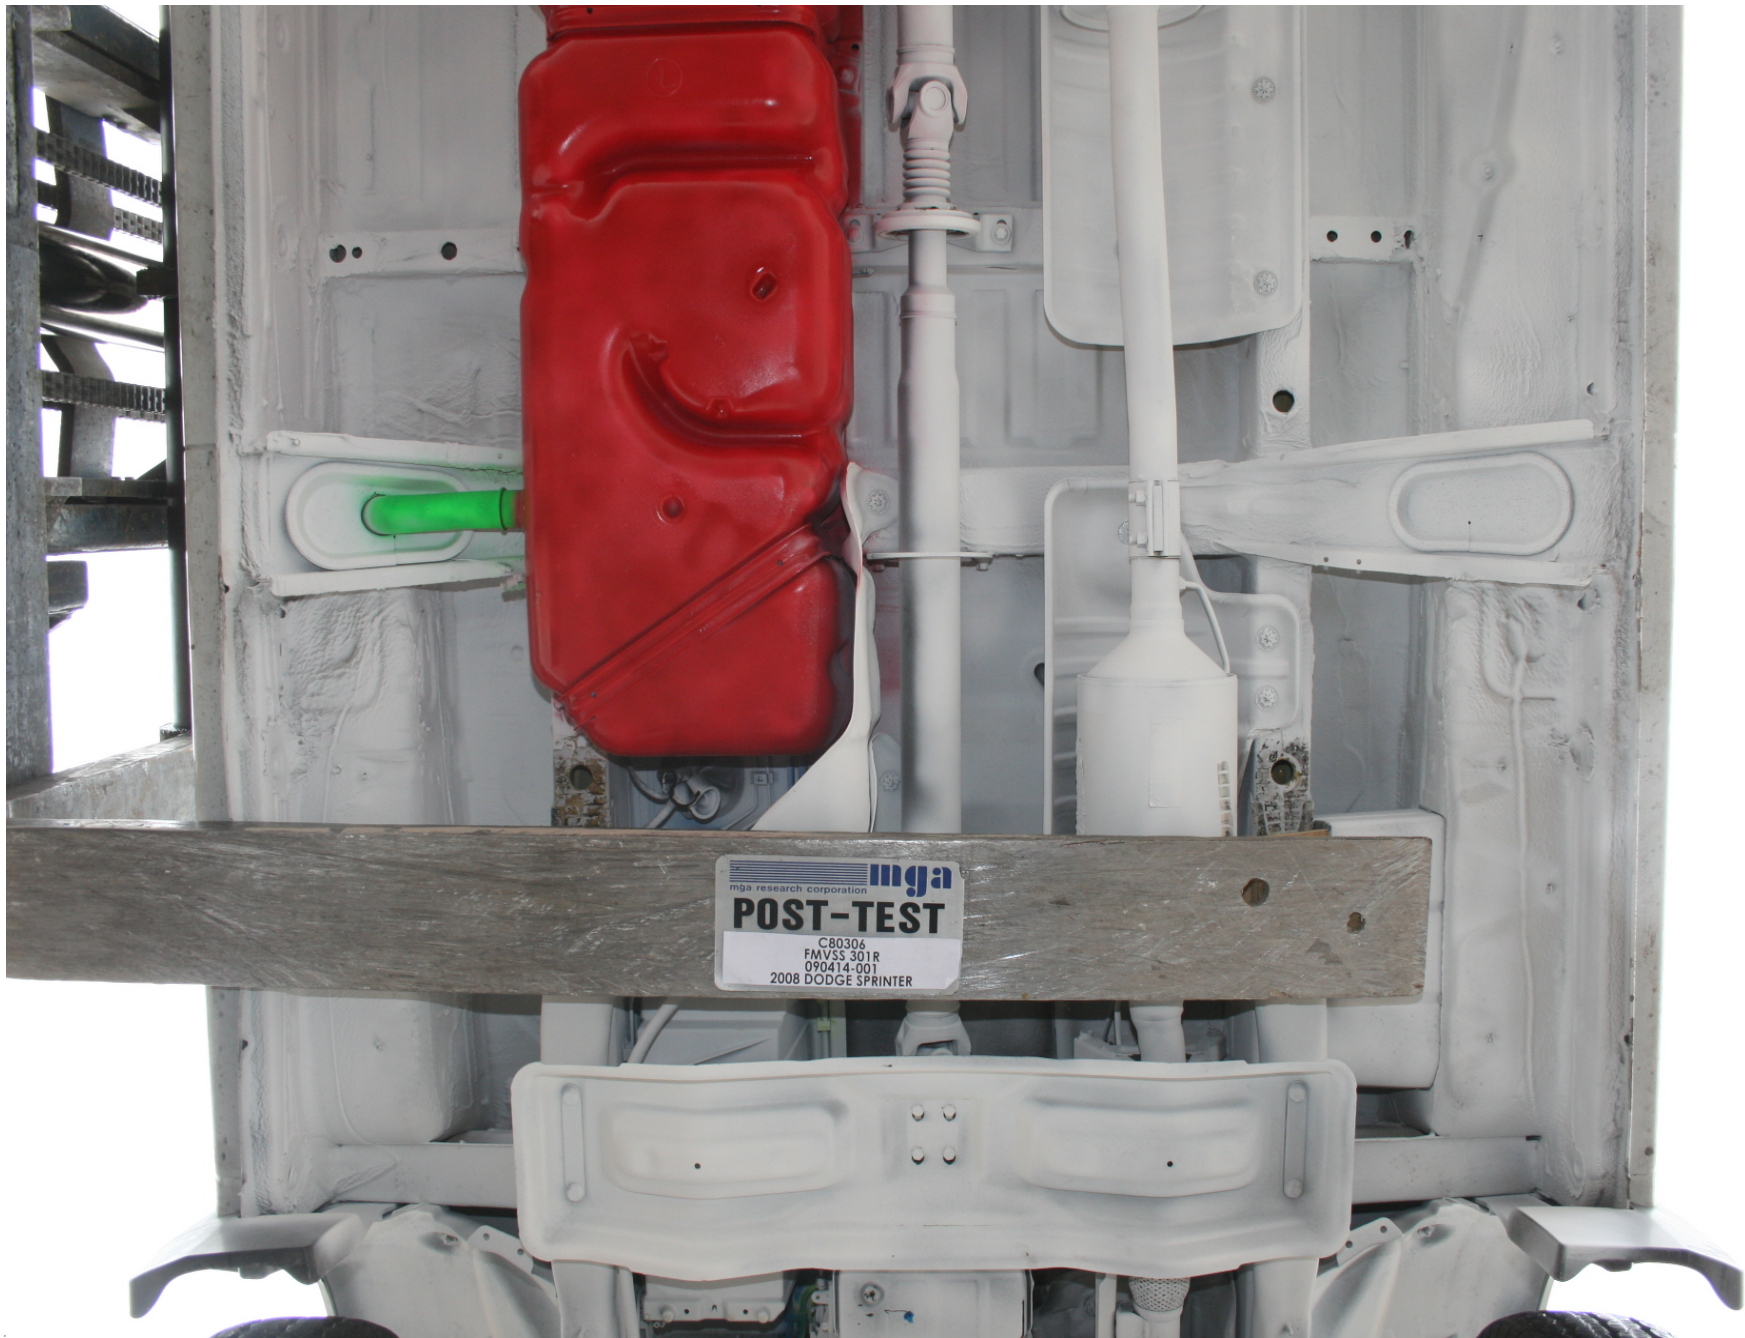
A-25.

Post-Test Underbody View 2

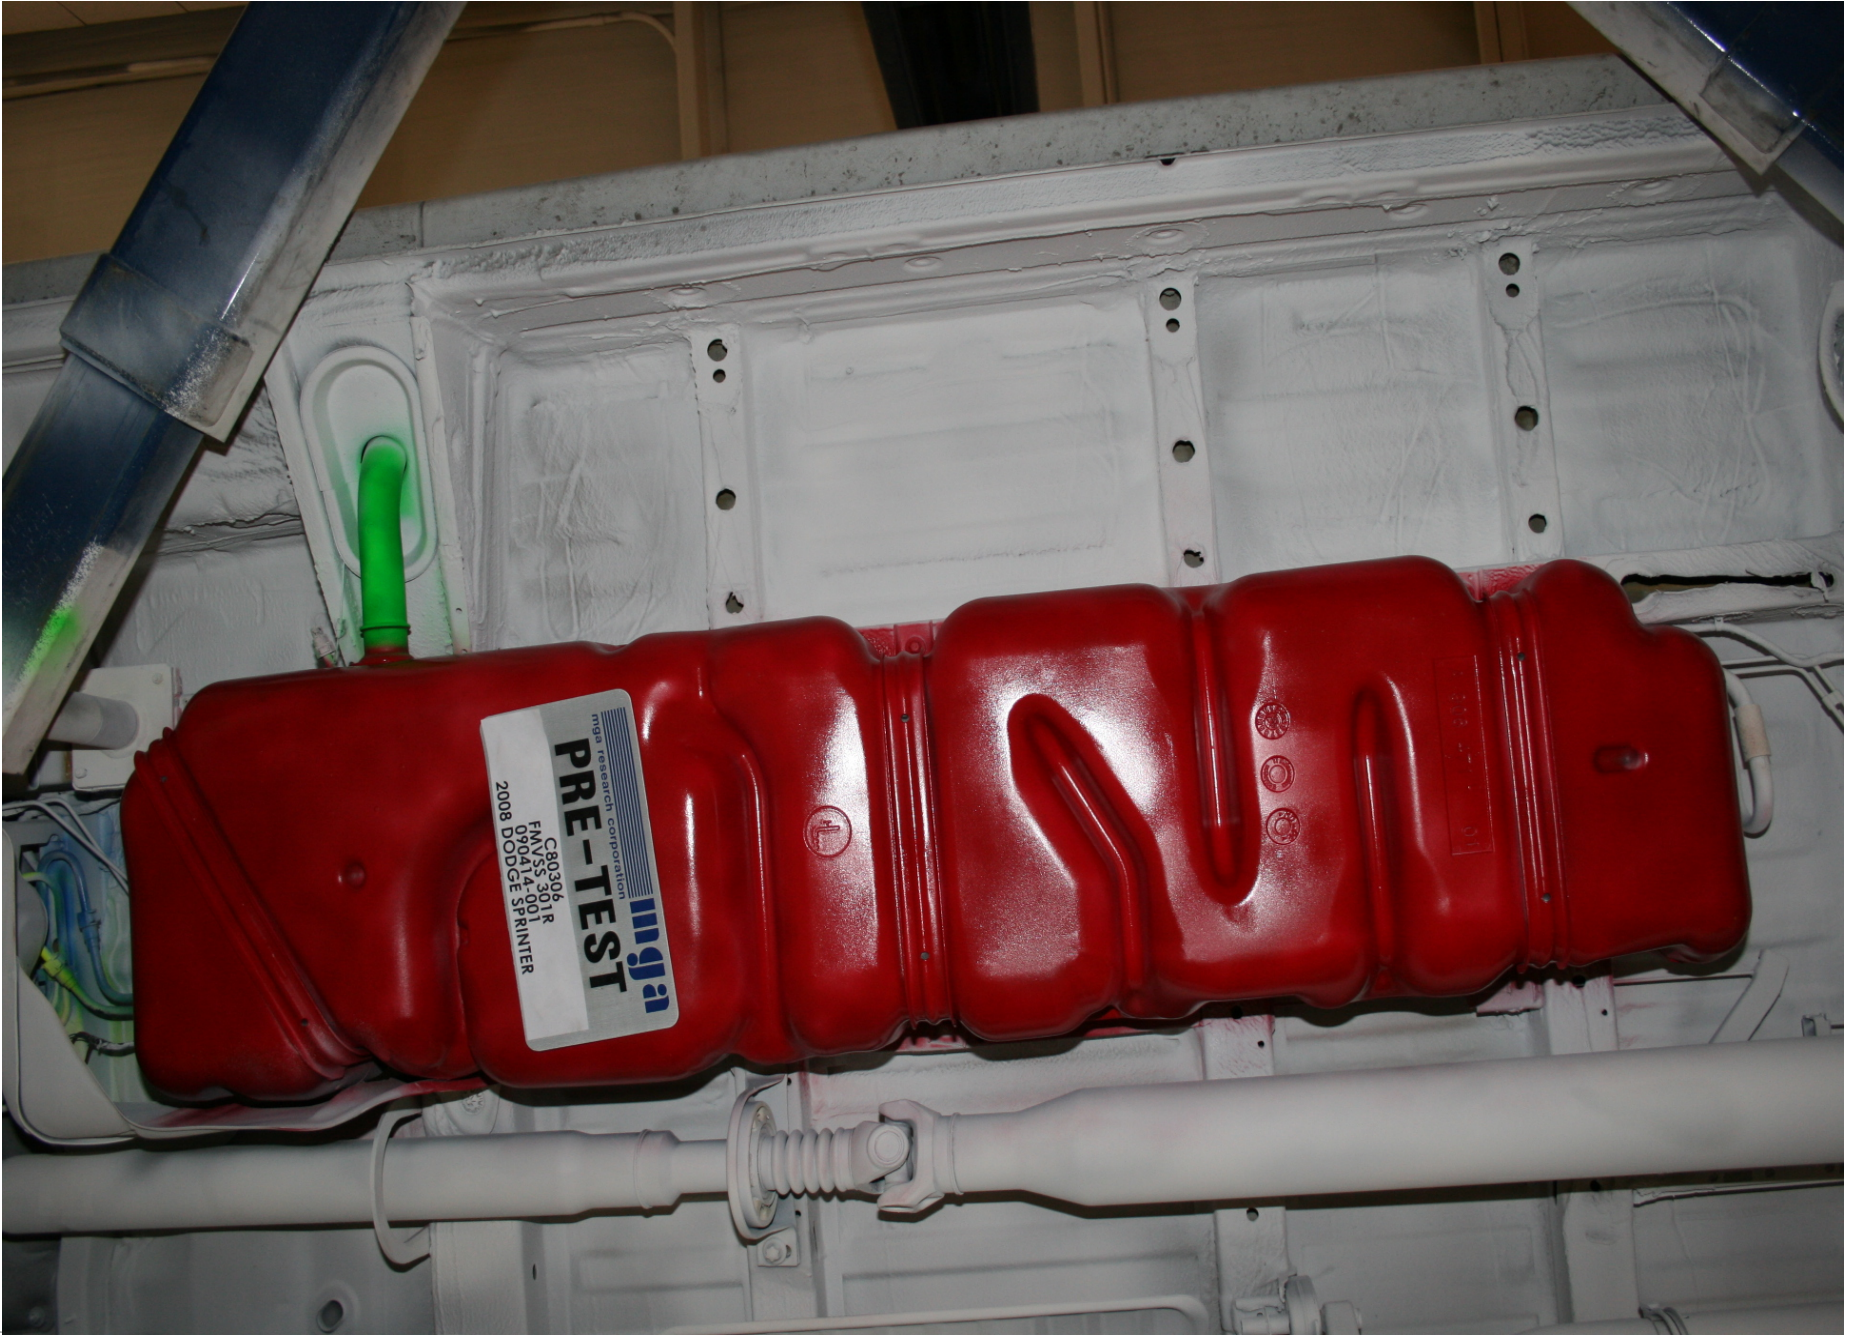
Pre-Test Underbody View 3

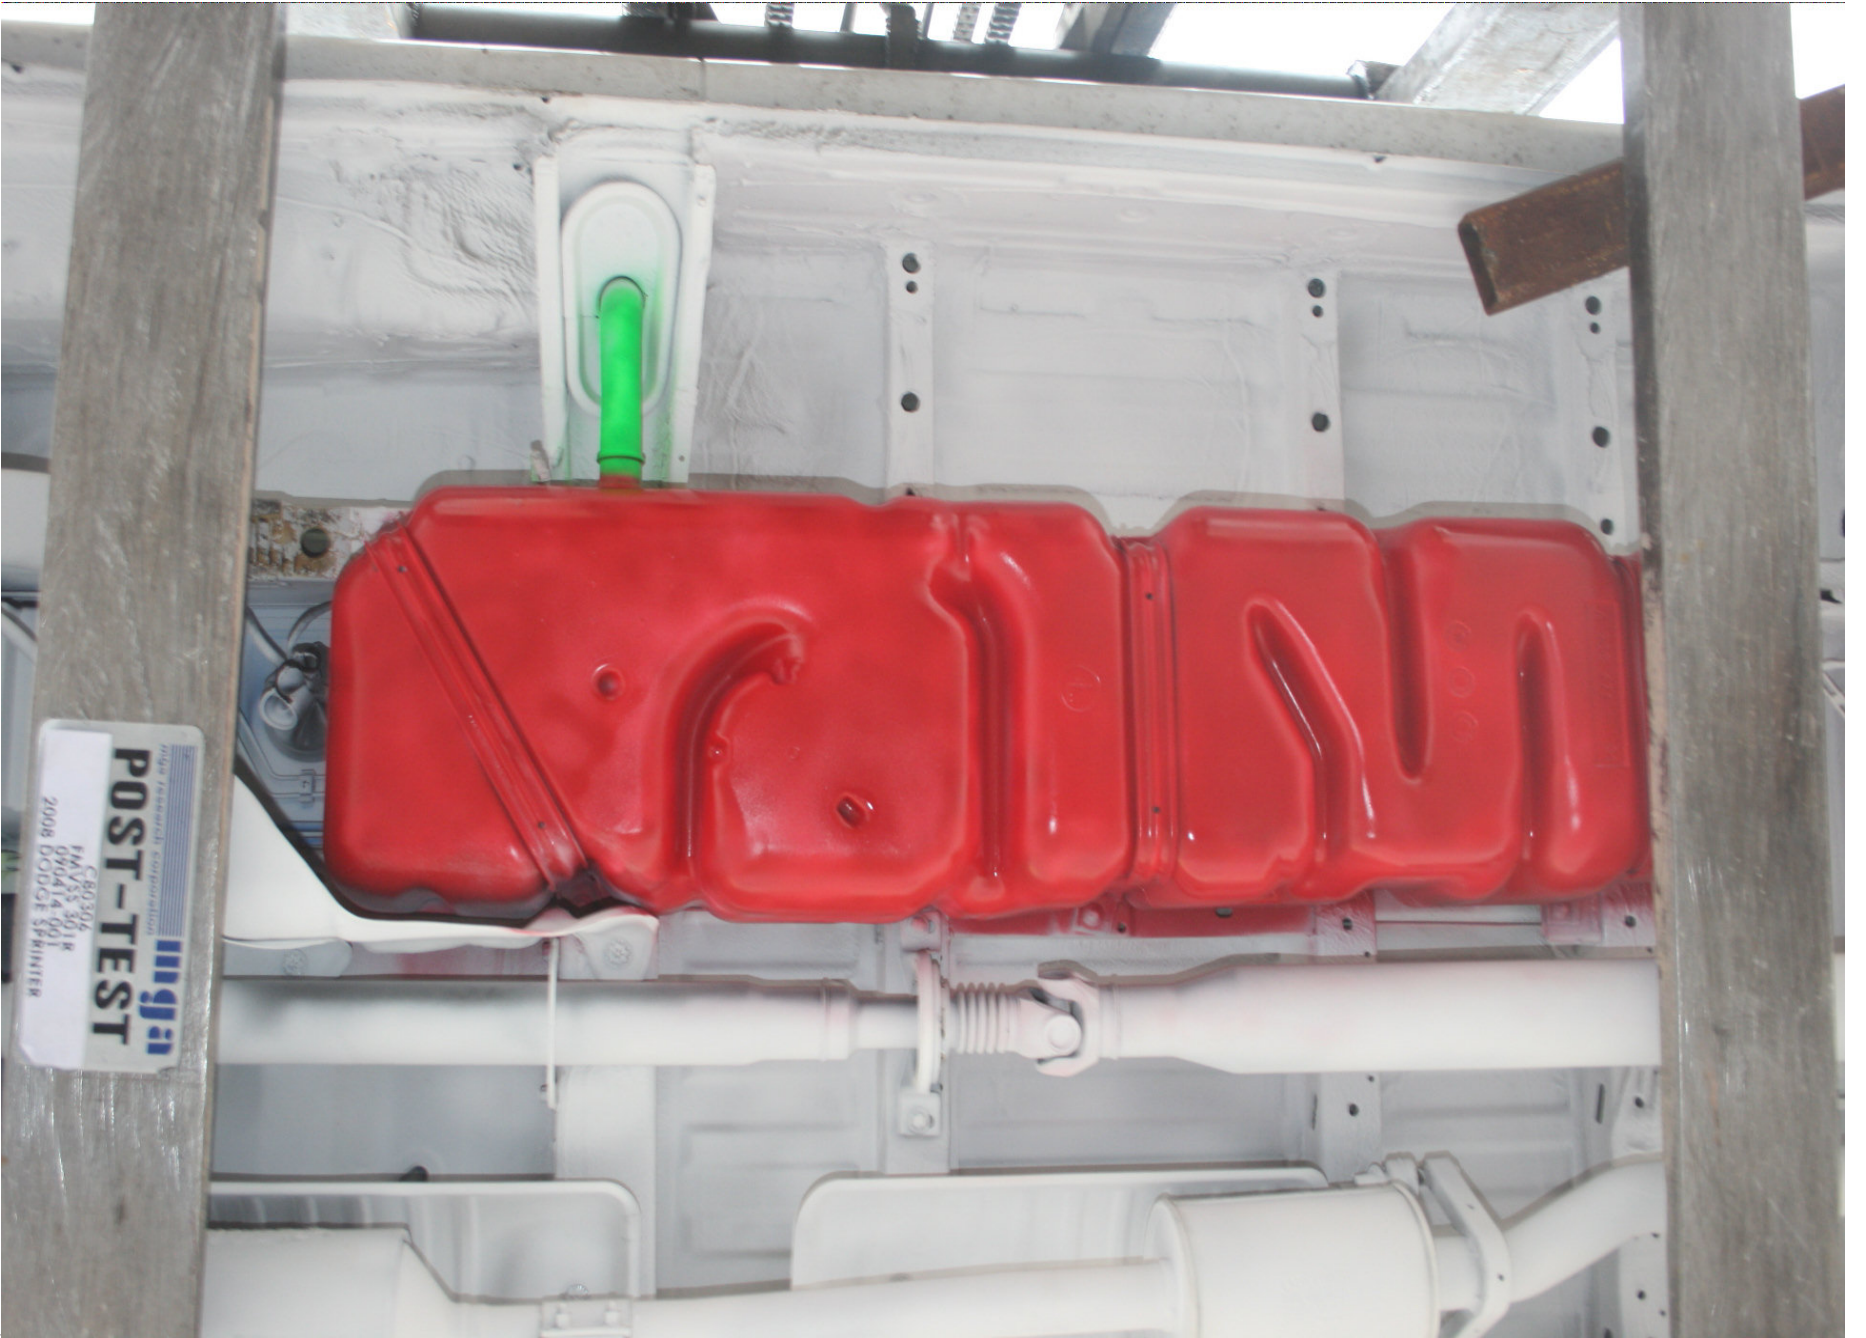
A-27.

Post-Test Underbody View 3

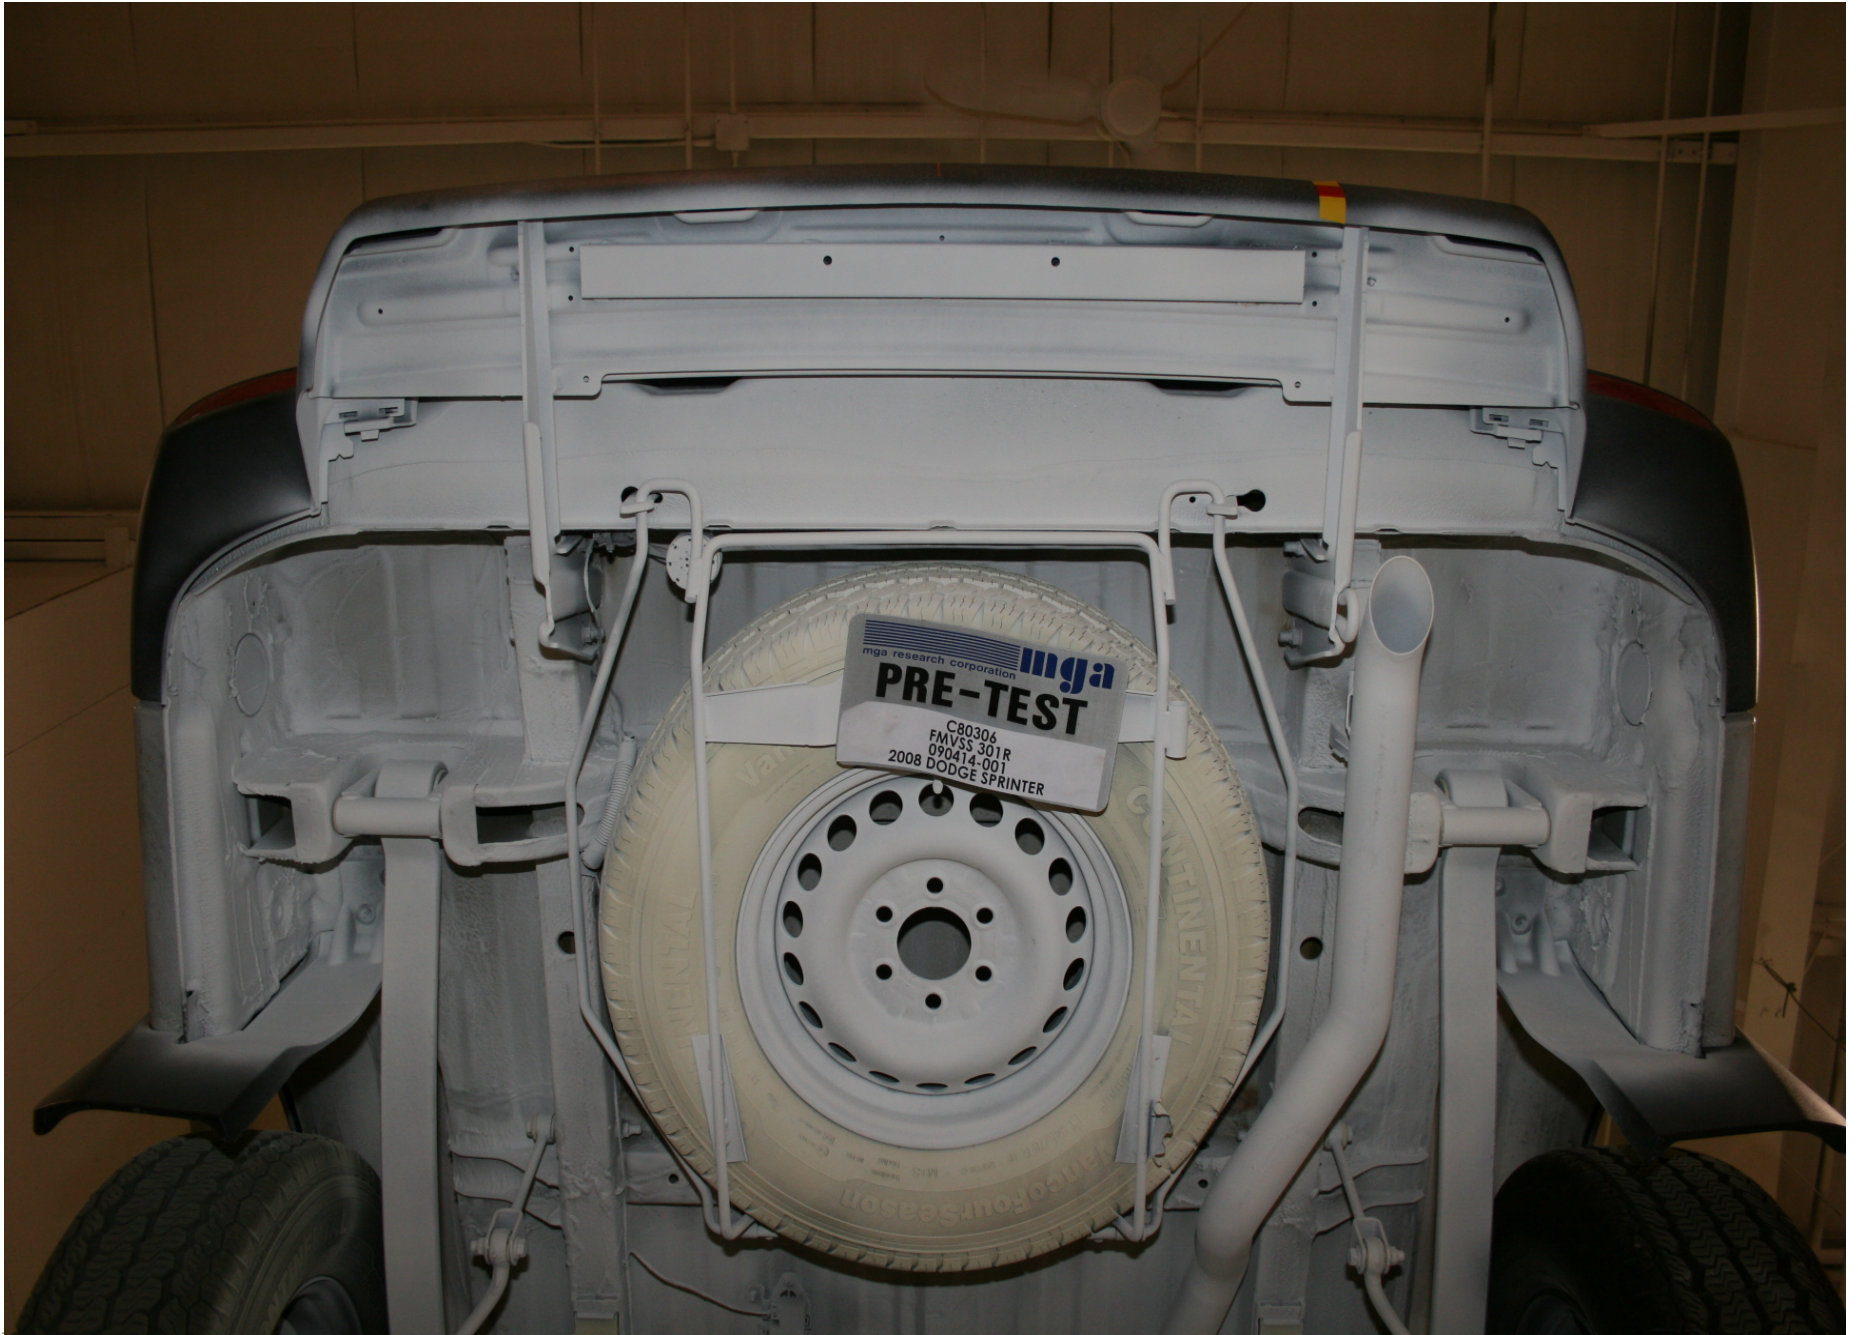
Pre-Test Underbody View 4

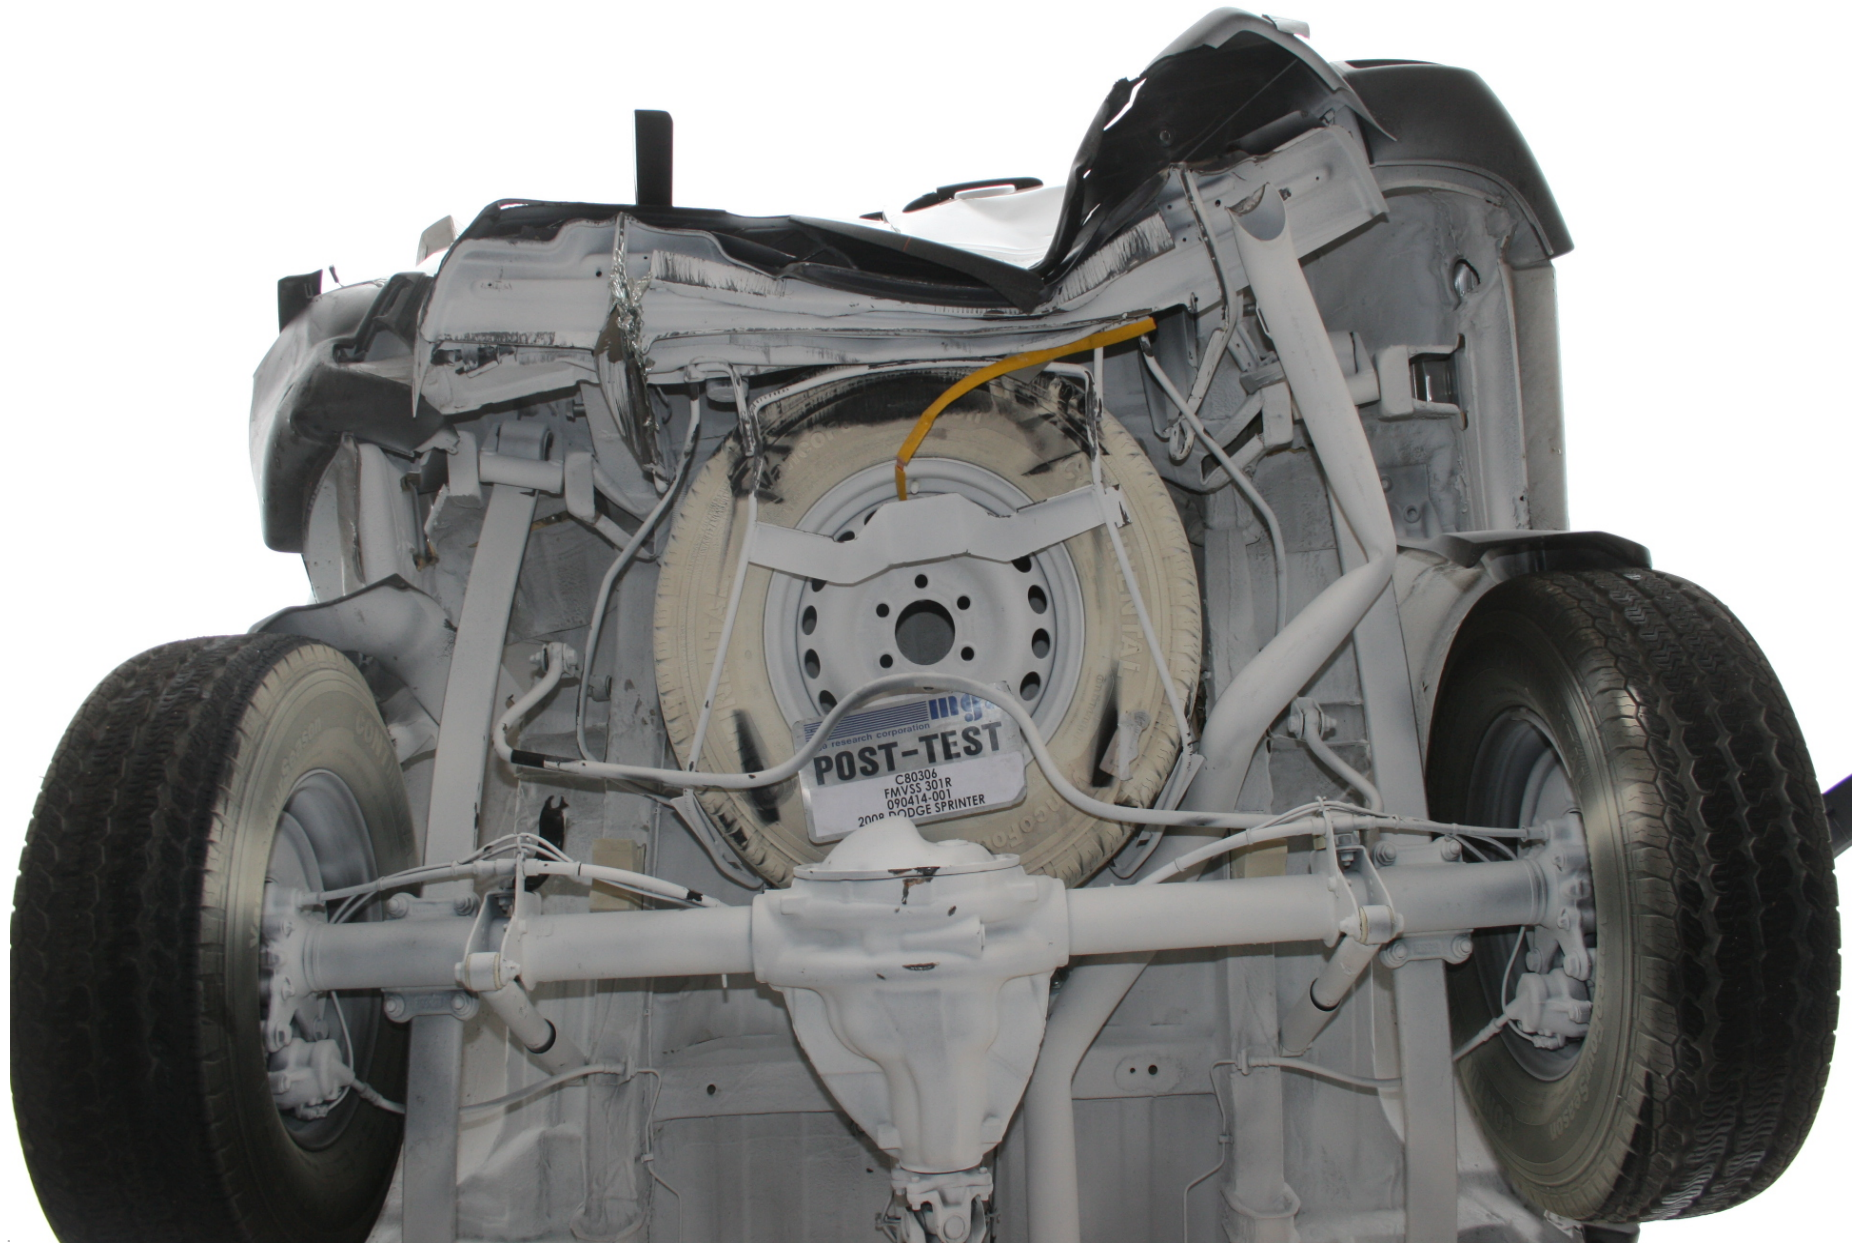
A-29.

Post-Test Underbody View 4
