REPORT NUMBER: 301-MGA-2009-001

**SAFETY COMPLIANCE TESTING FOR FMVSS 301R
FUEL SYSTEM INTEGRITY – REAR IMPACT**

**DAIMLER CHRYSLER AG
2008 DODGE SPRINTER 2500 CARGO VAN
NHTSA NUMBER: C80306**

**PREPARED BY:
MGA RESEARCH CORPORATION
5000 WARREN ROAD
BURLINGTON, WI 53105**

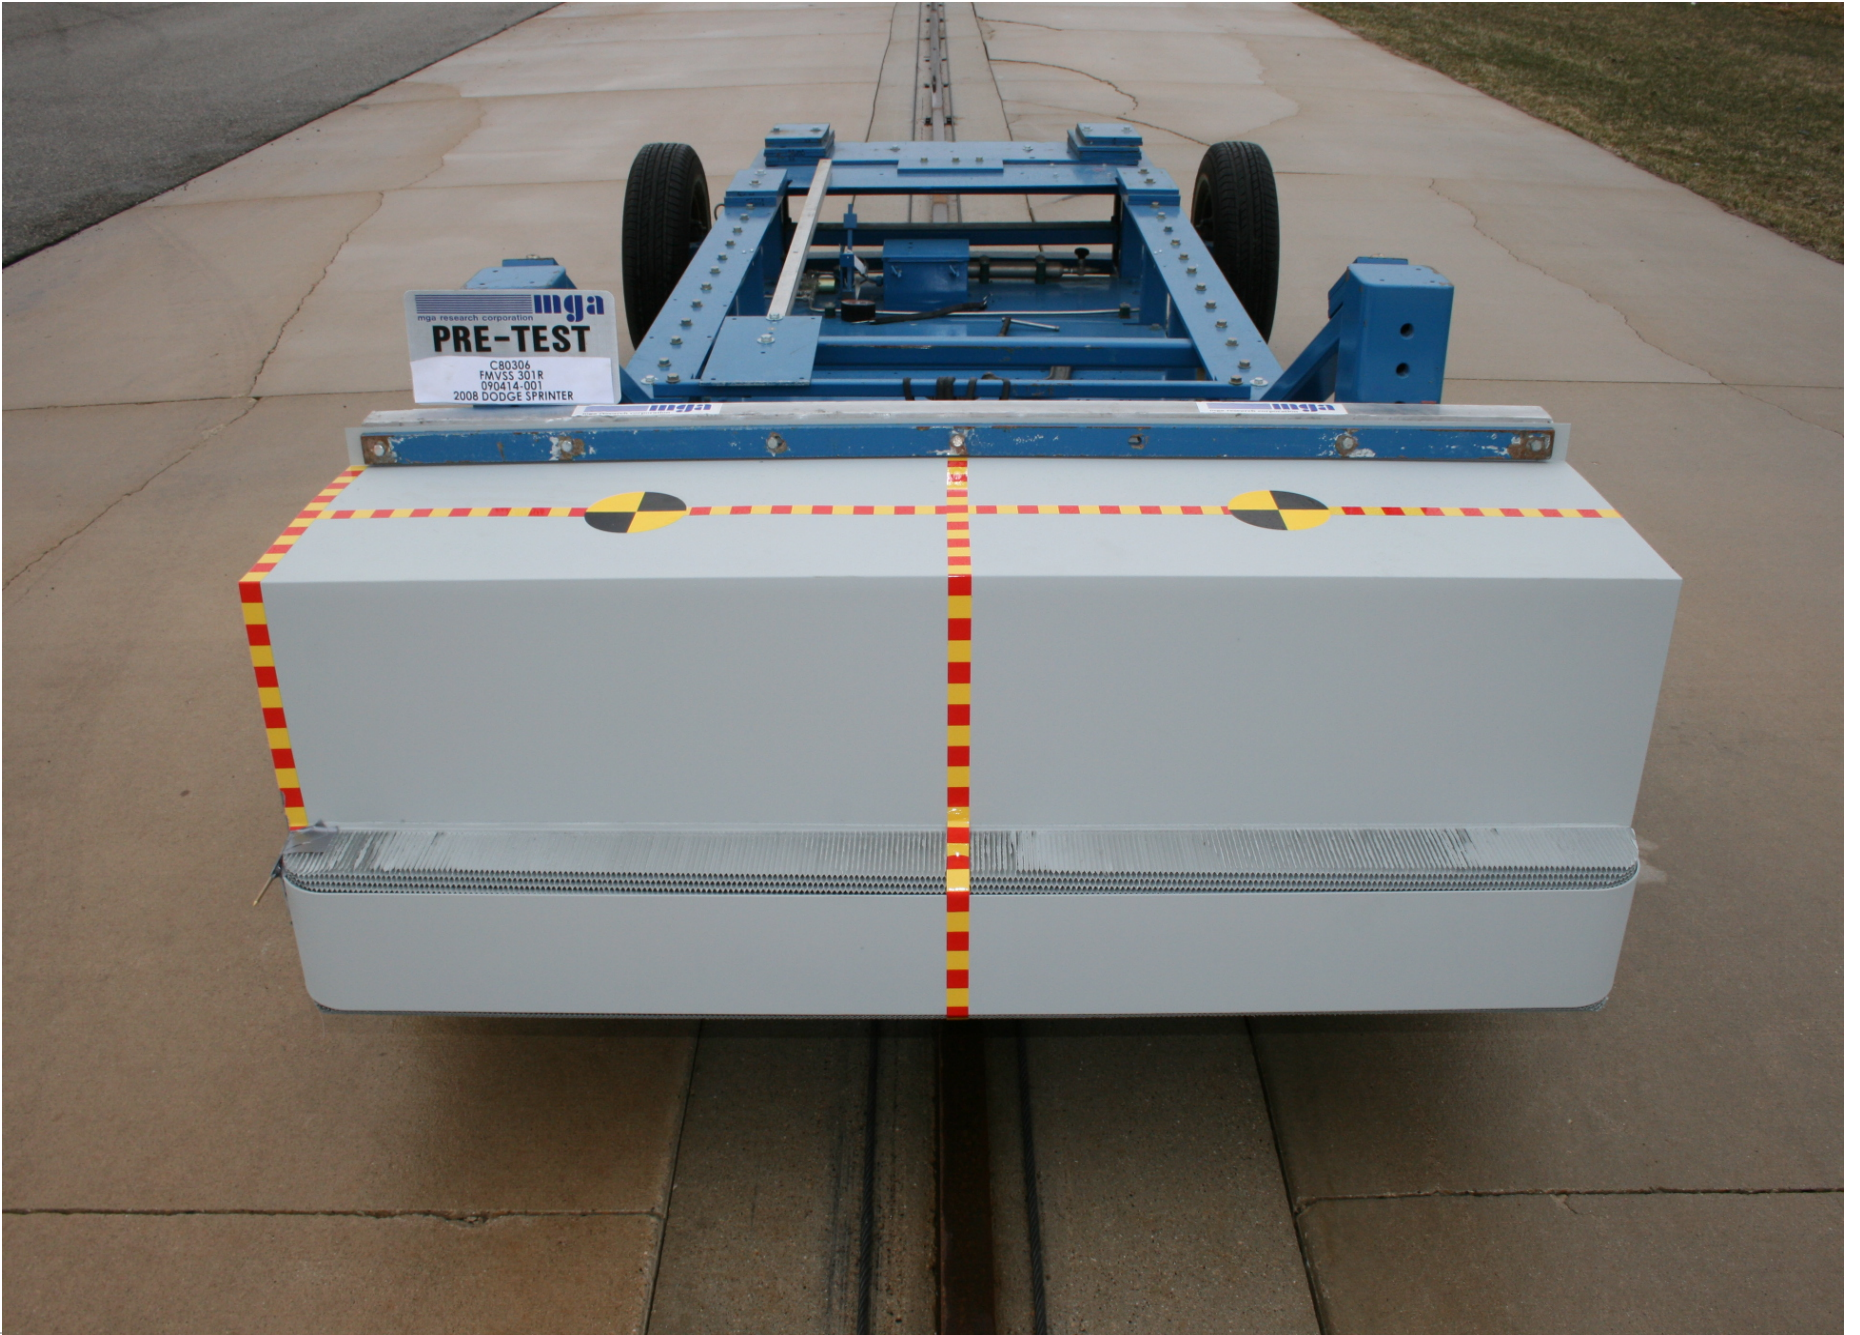
A-30.

Pre-Test Front View of MDB

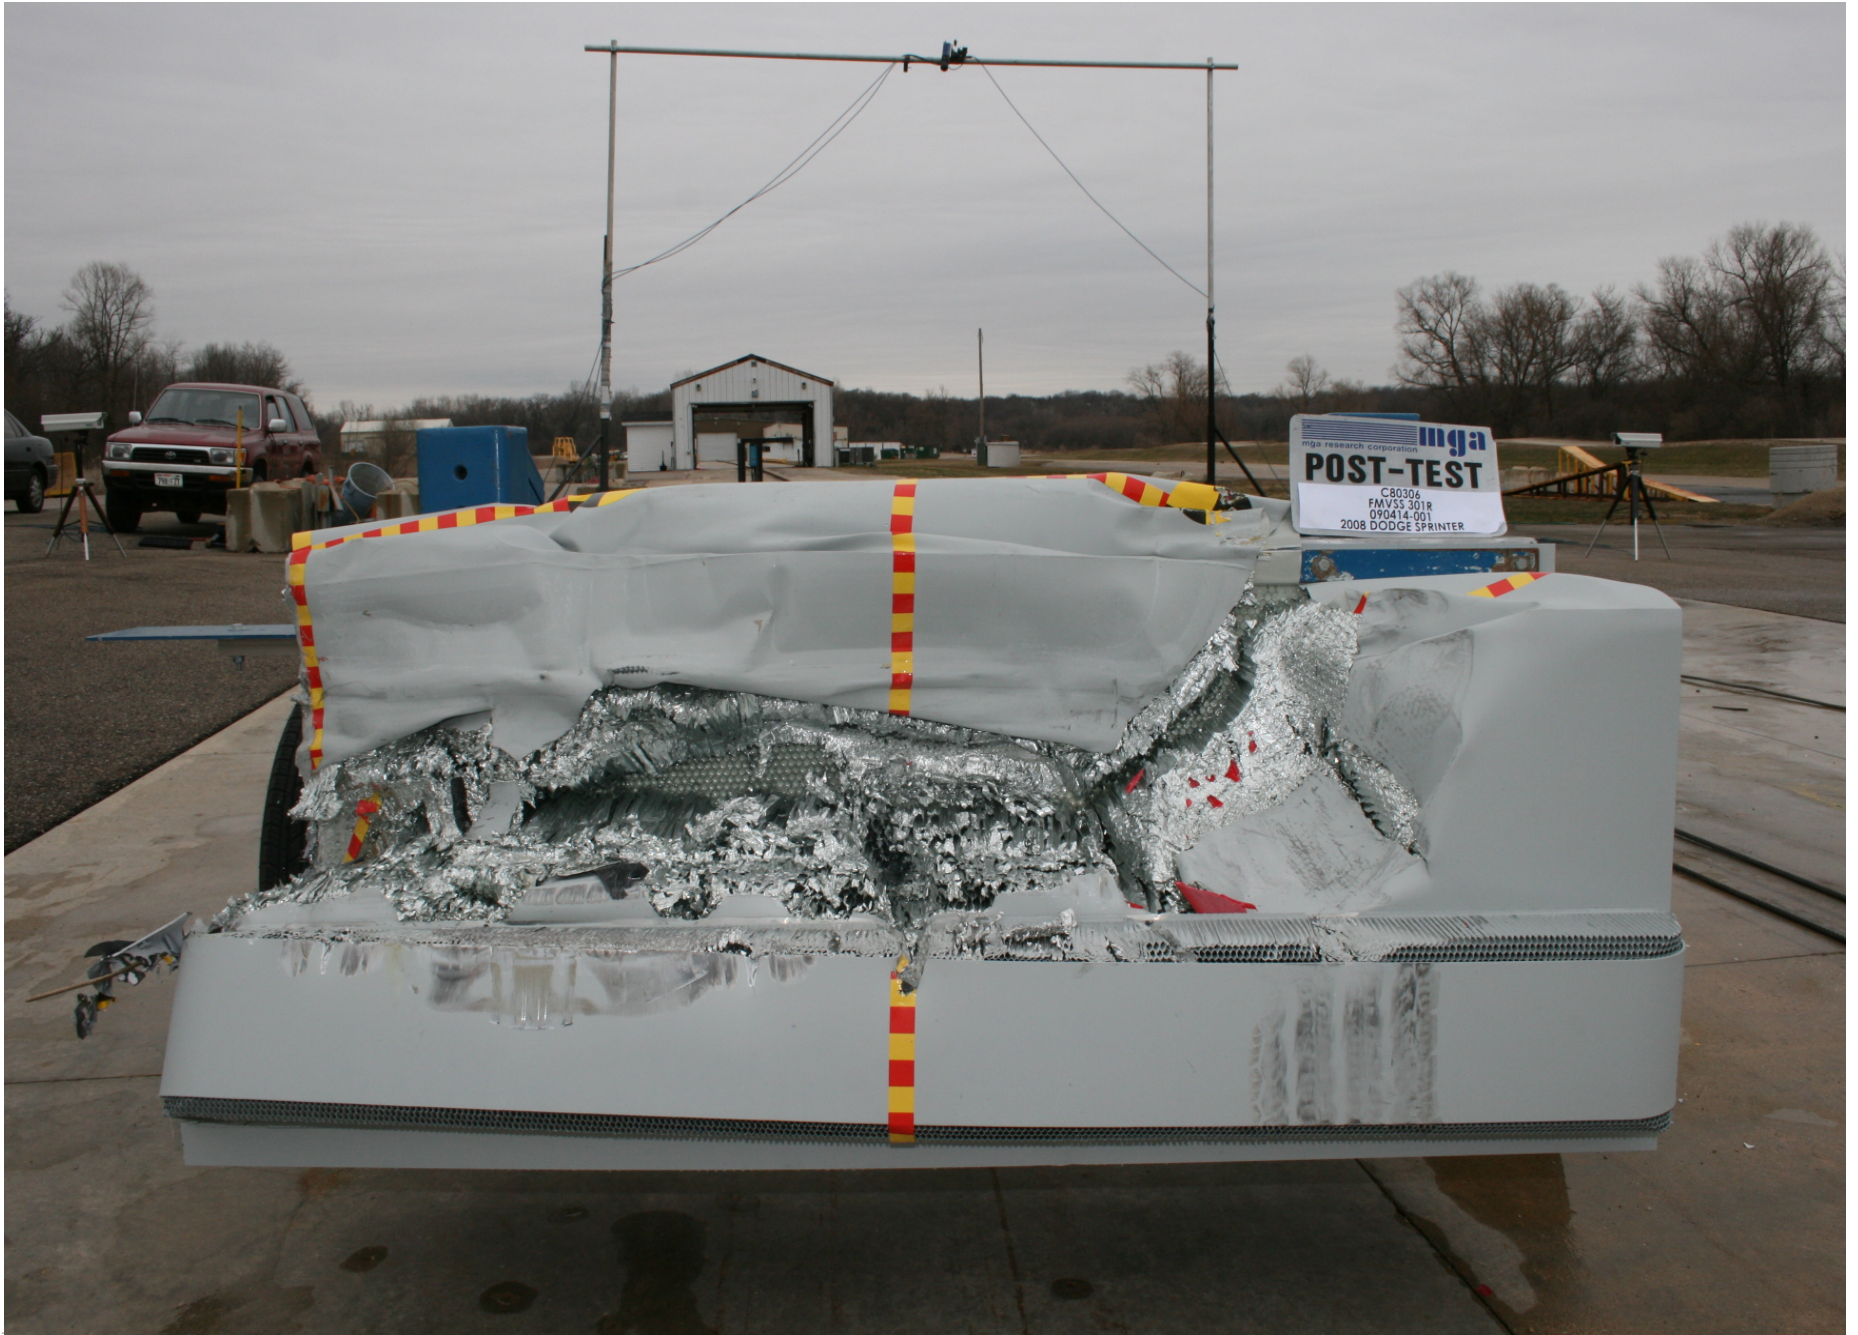
A-31.

Post-Test Front View of MDB

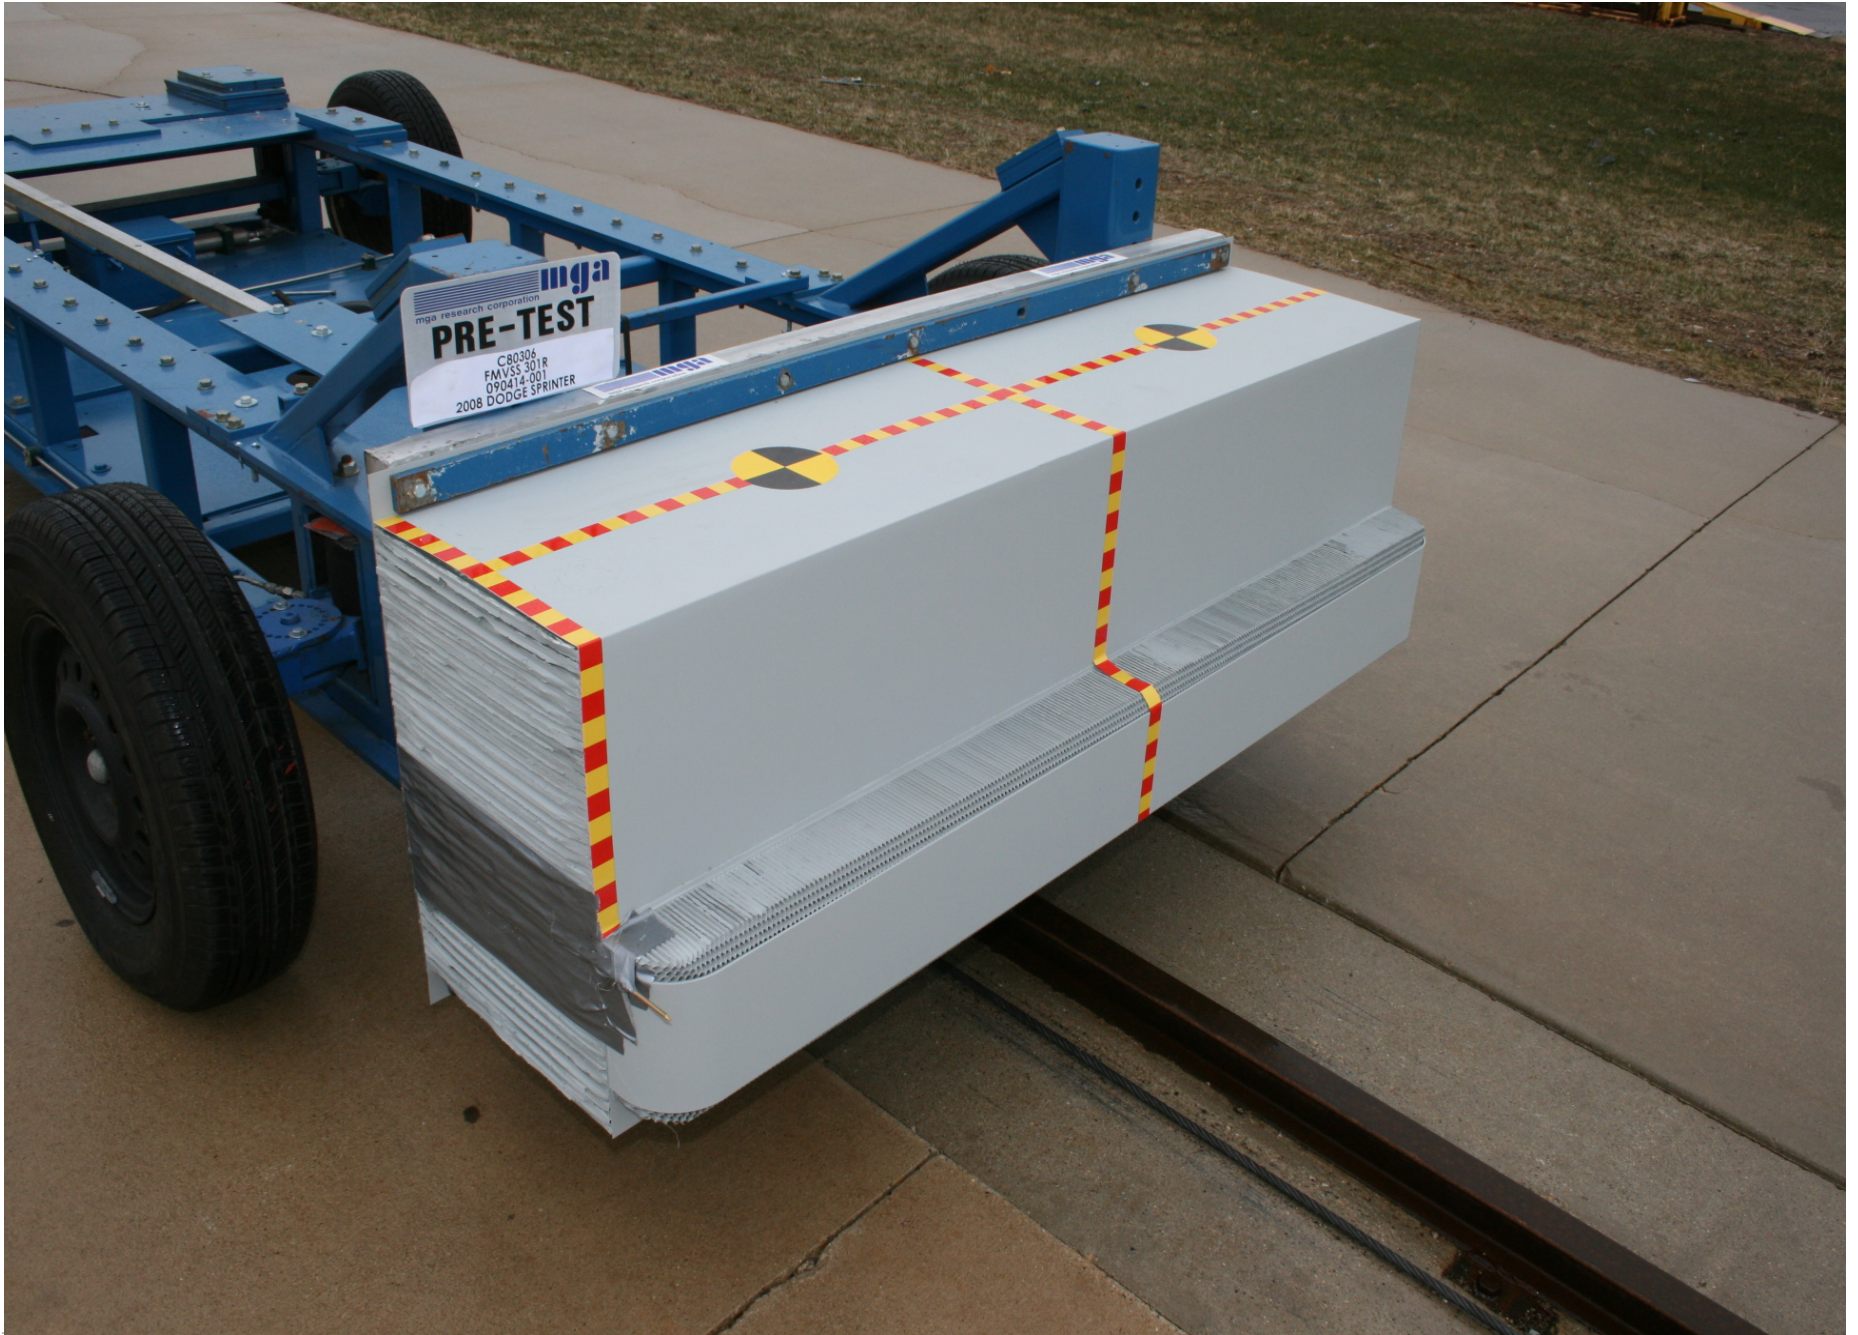
A-32.

Pre-Test $\frac{3}{4}$ Right Side View of MDB

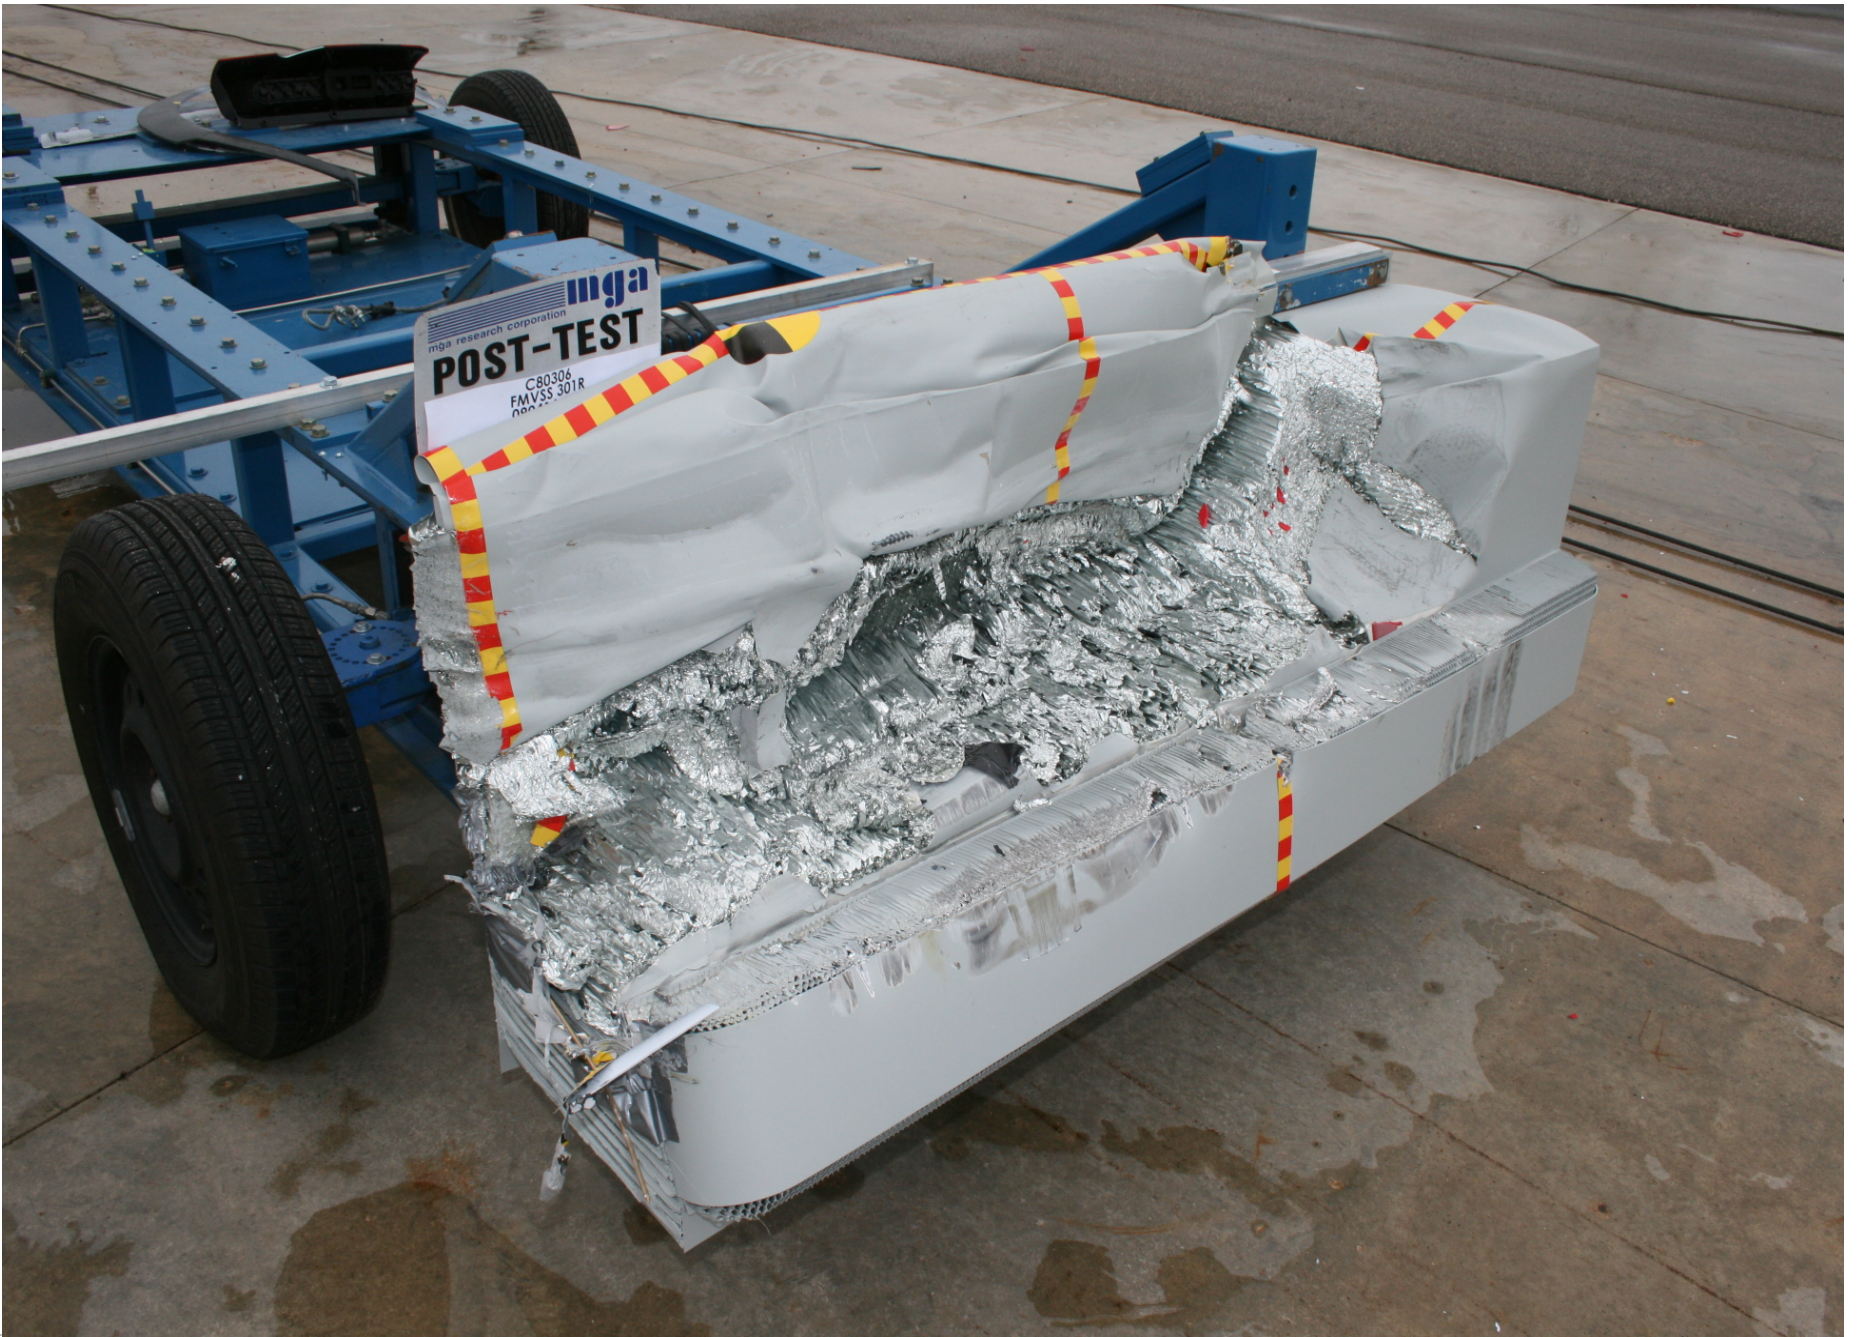
A-33.

Post-Test ¾ Right Side View of MDB

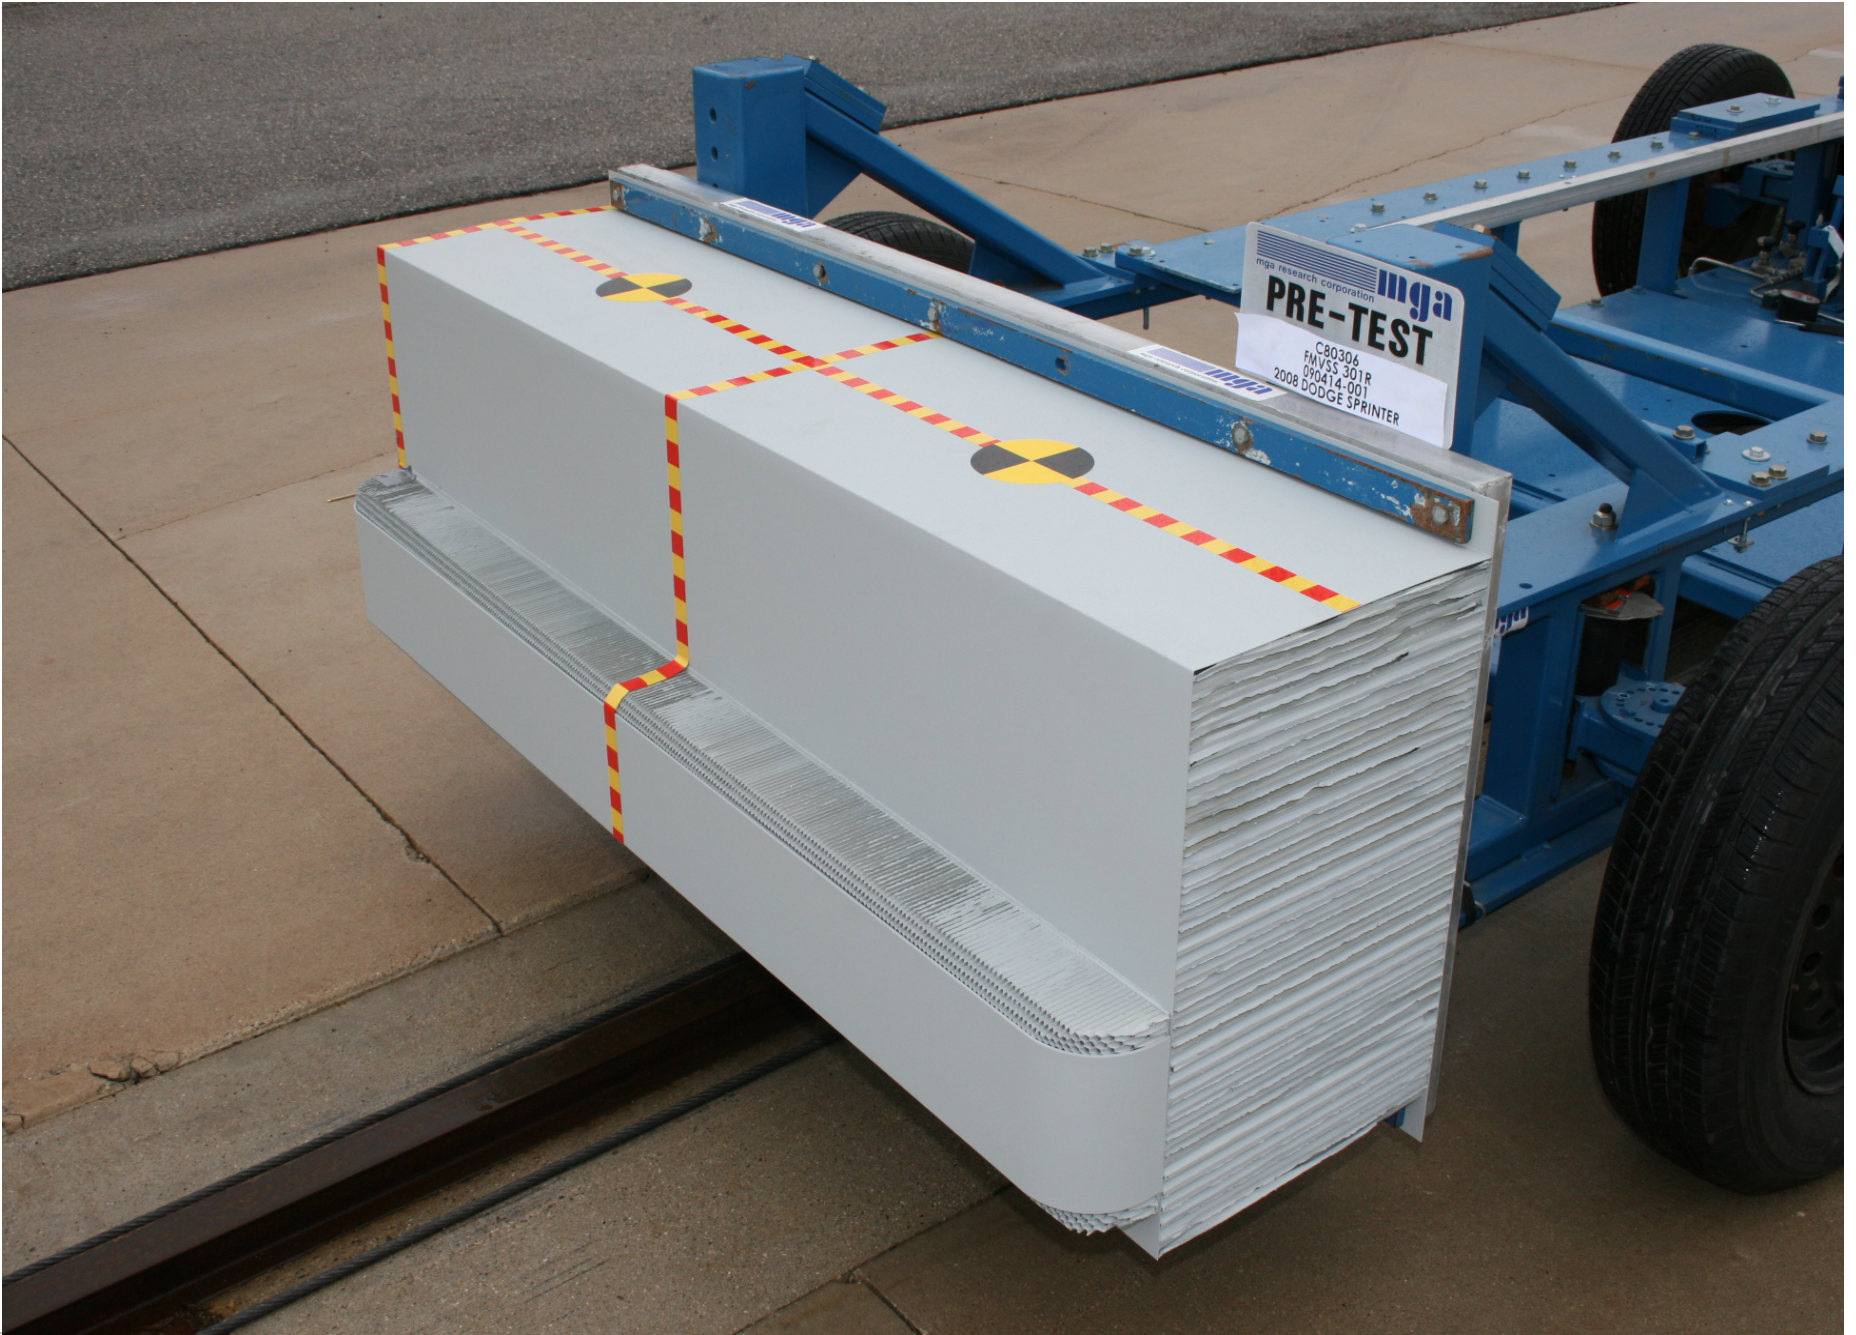
A-34.

Pre-Test ¾ Left Side View of MDB

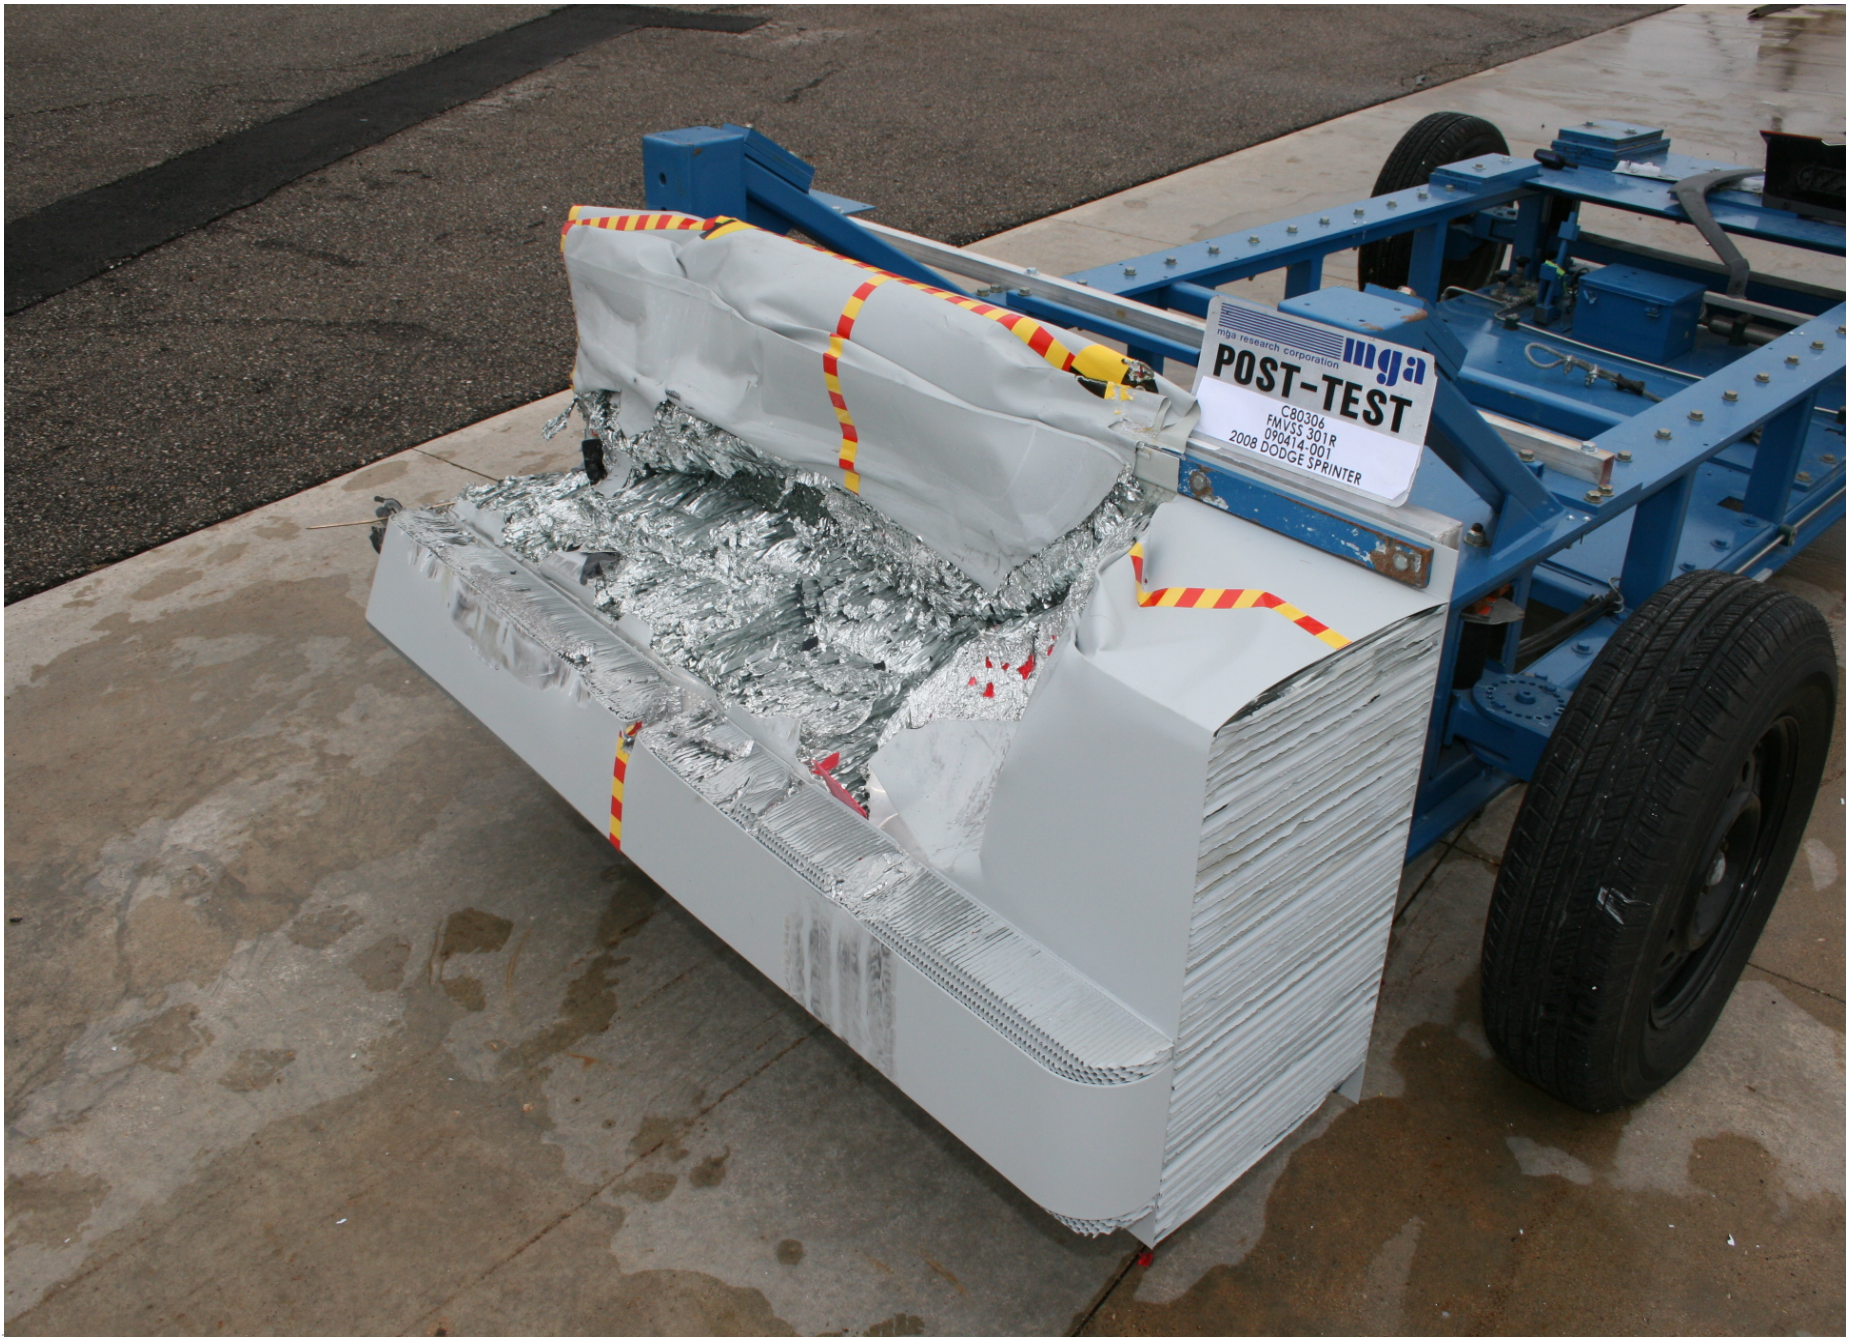
A-35.

Post-Test $\frac{3}{4}$ Left Side View of MDB

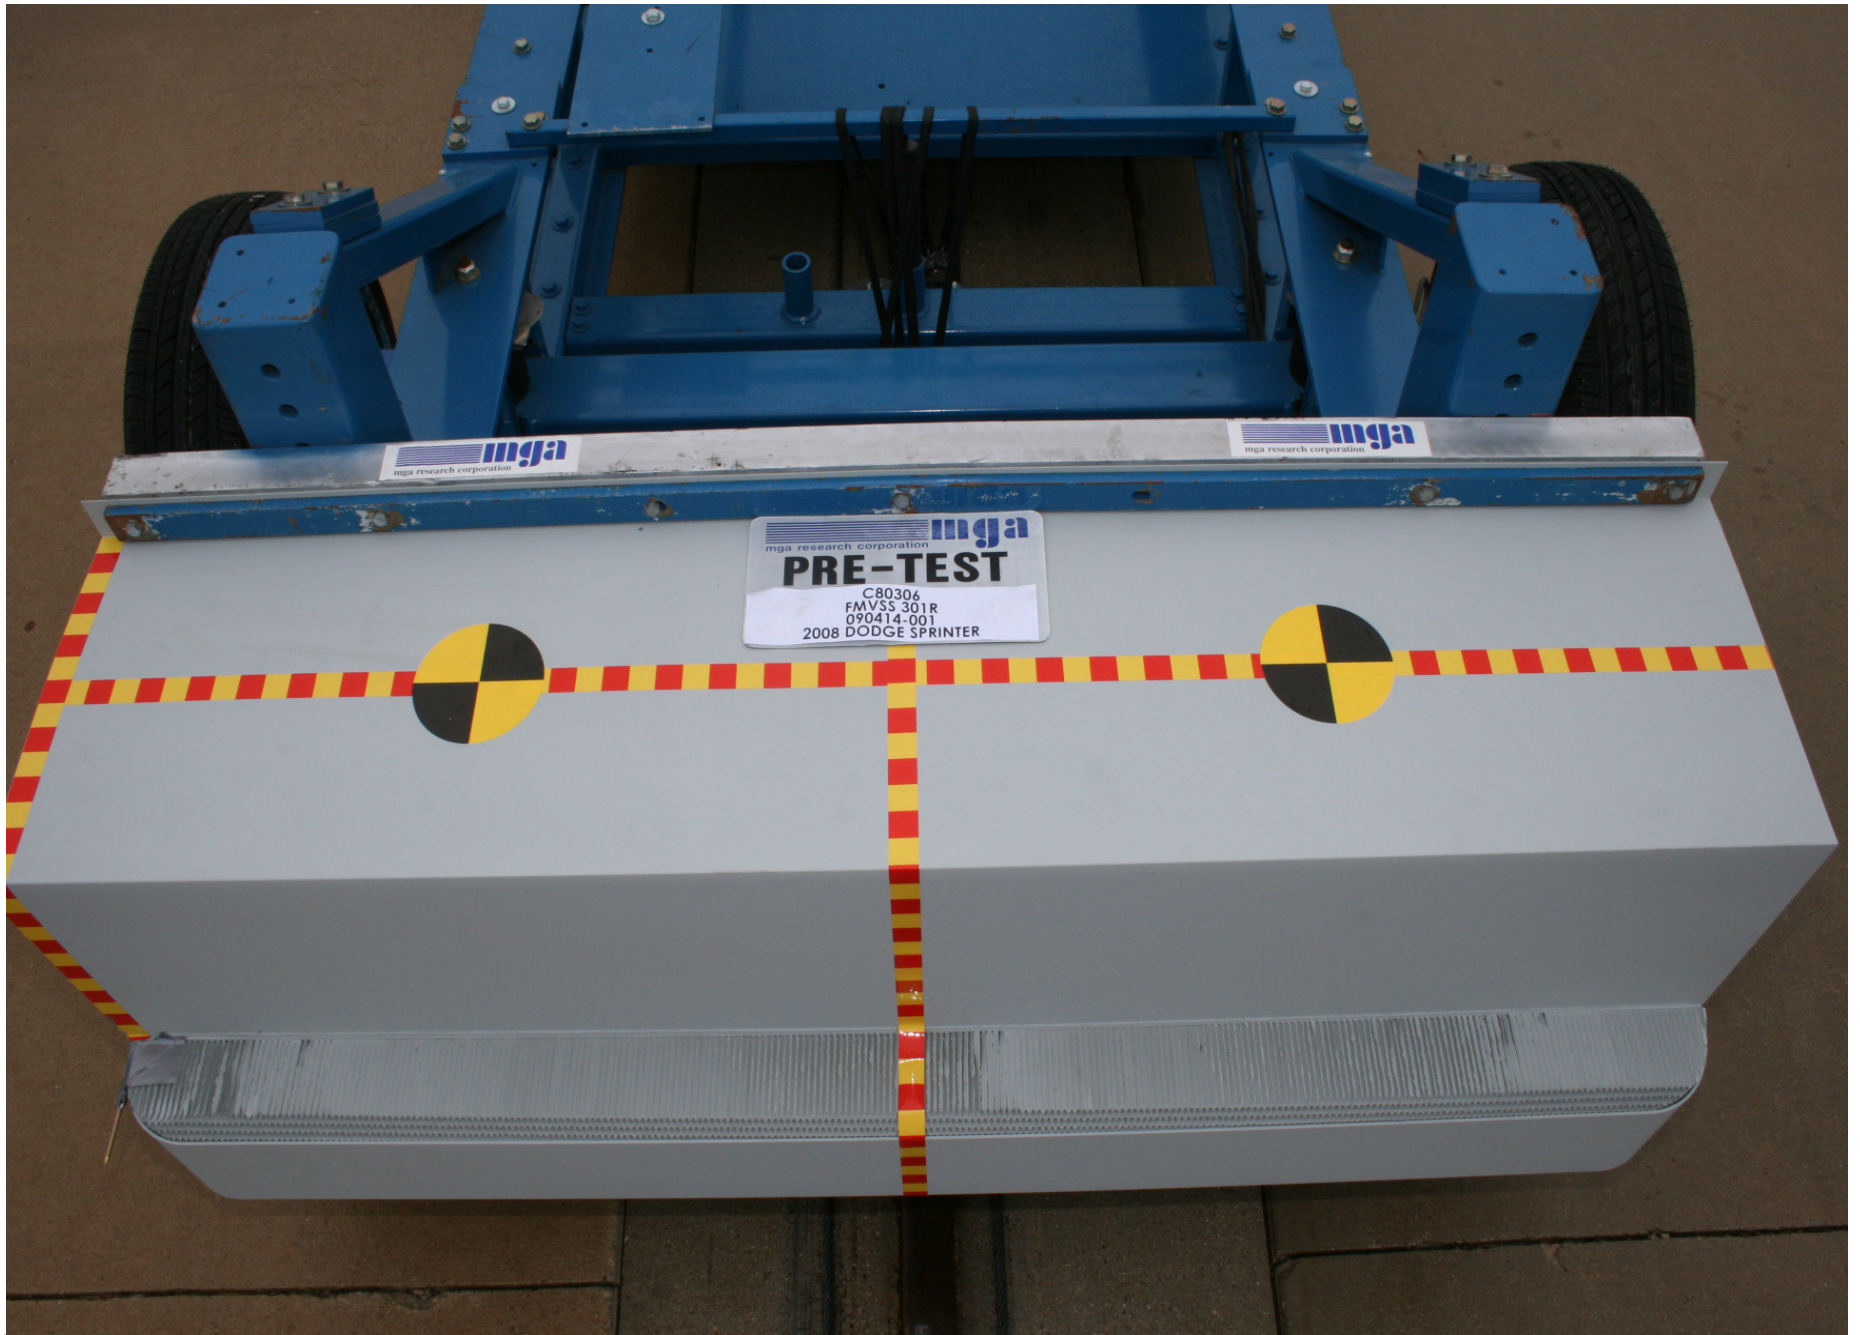
A-36.

Pre-Test Top View of MDB

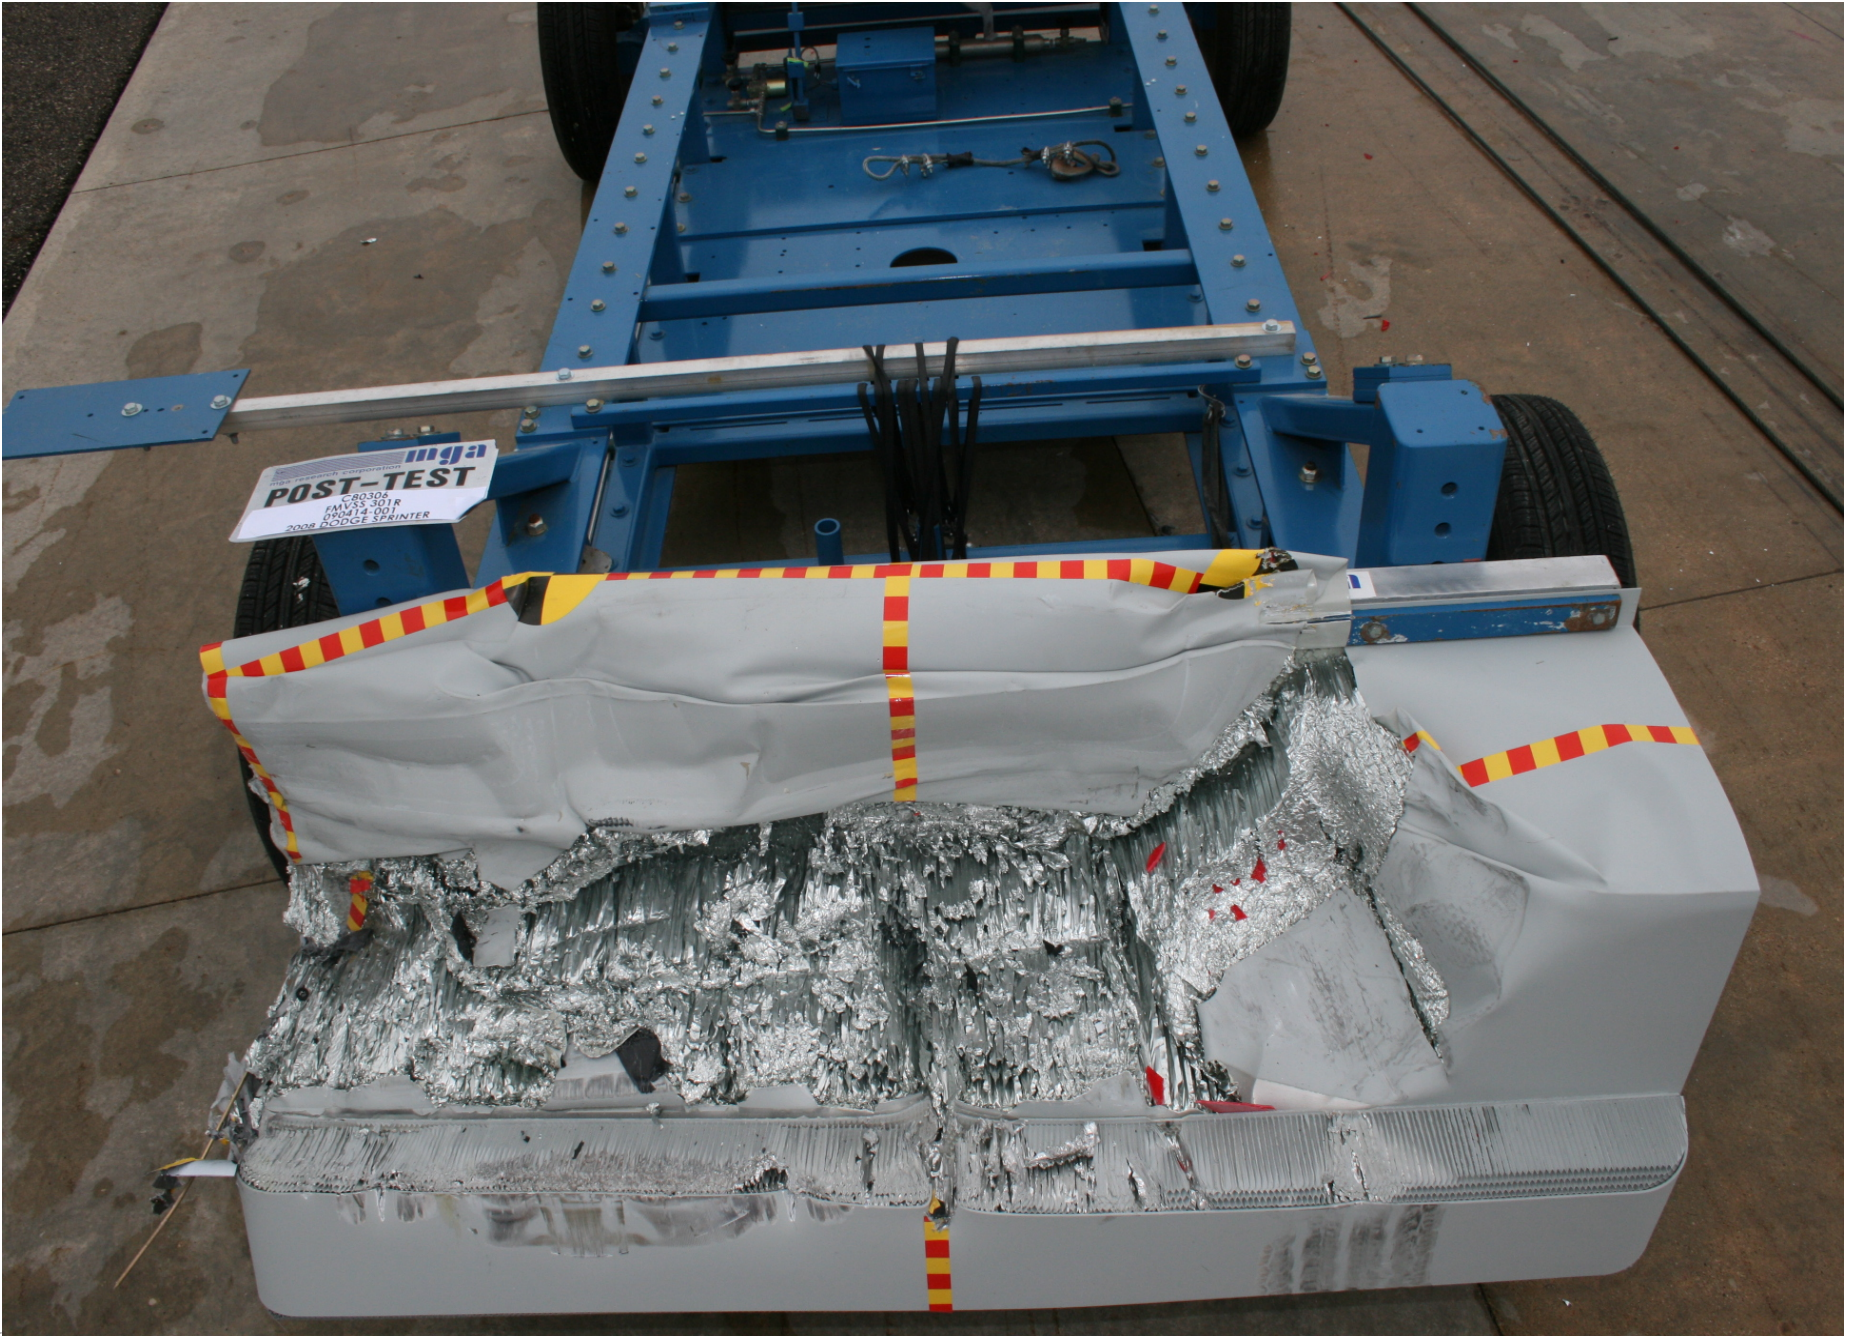
A-37.

Post-Test Top View of MDB

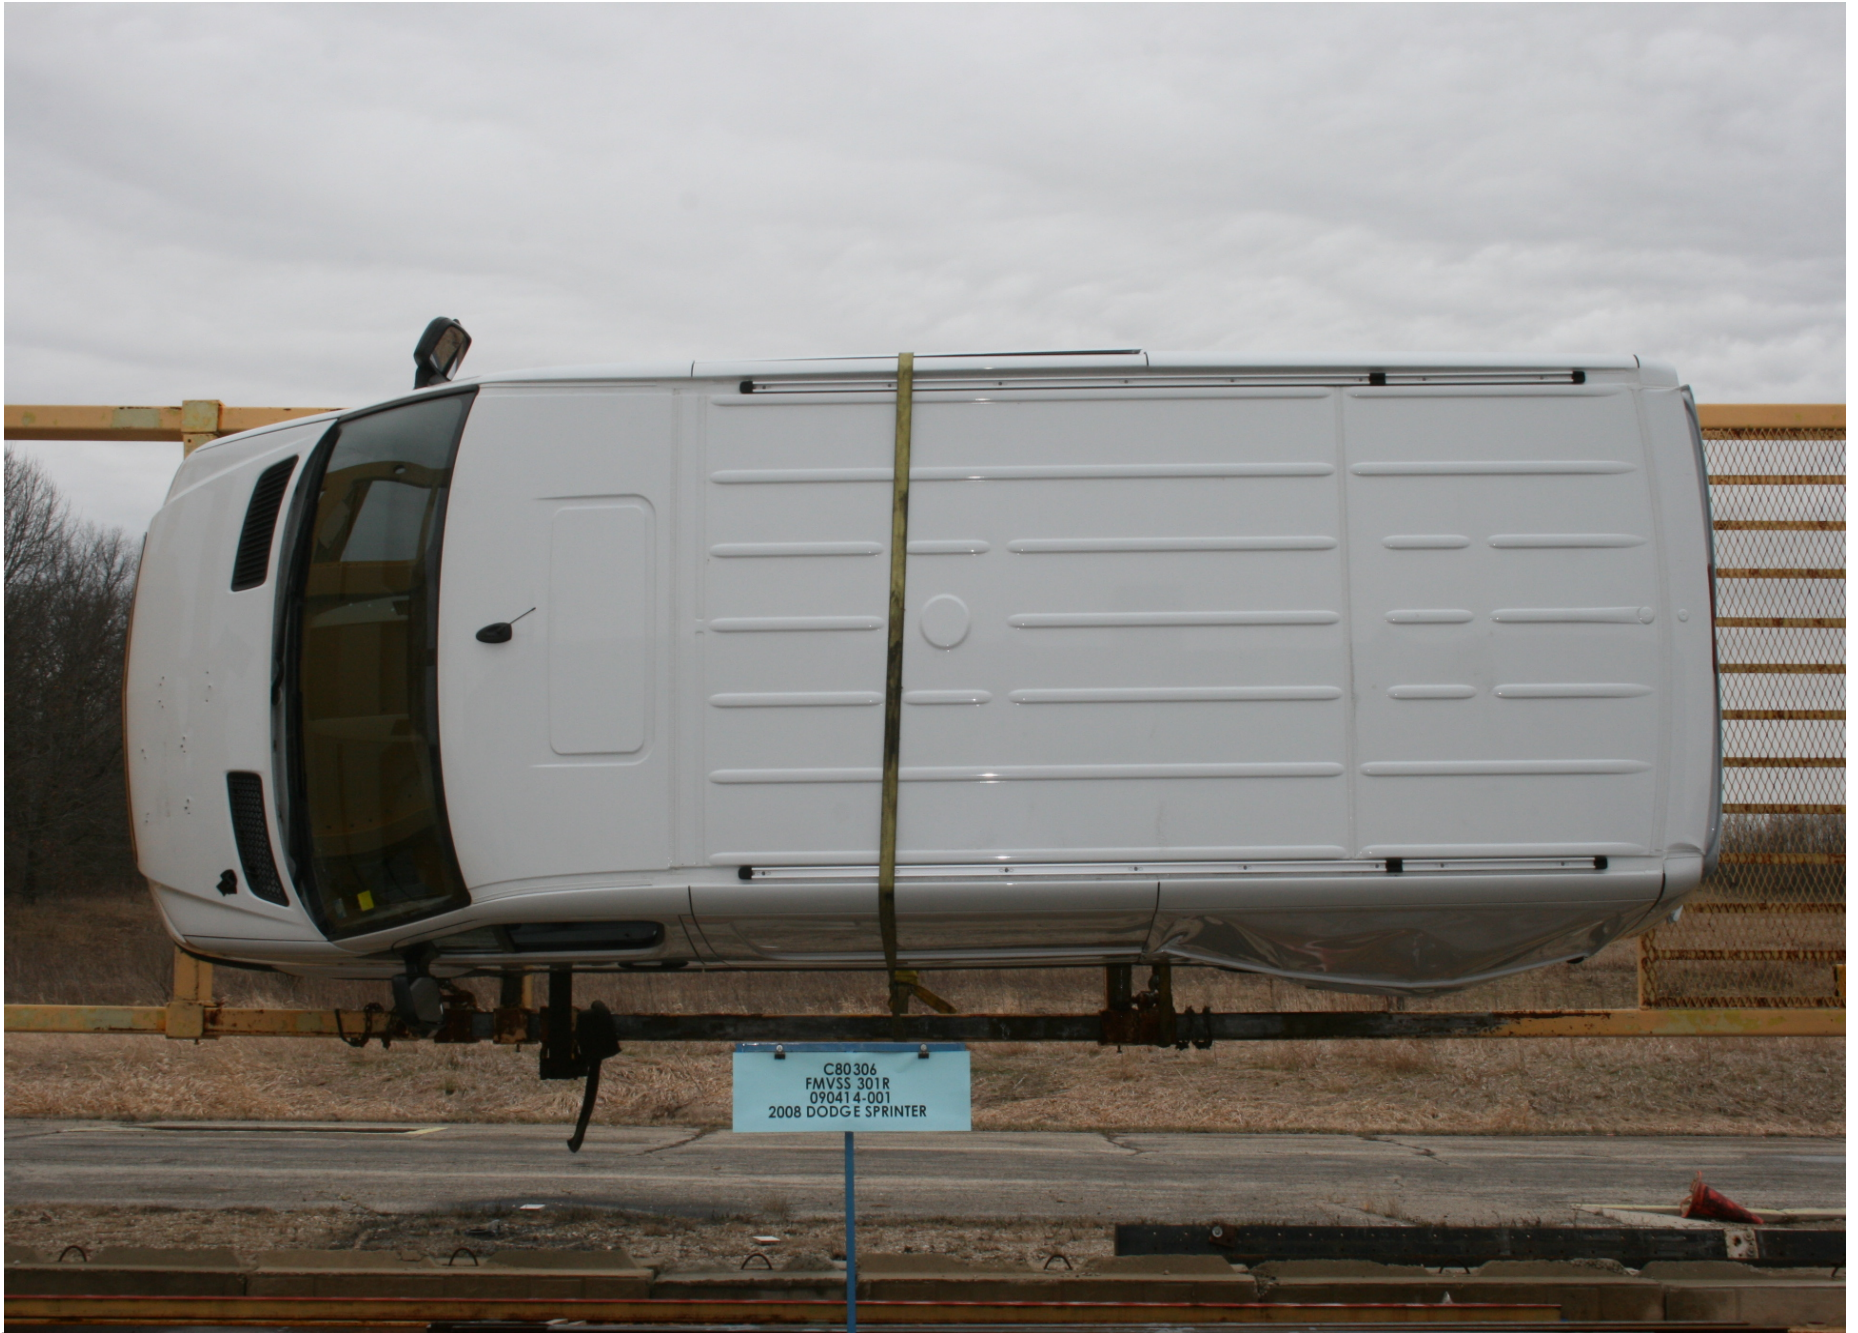
A-38.

Static Rollover at 90 Degrees
