REPORT NUMBER: 301-MGA-2009-001

**SAFETY COMPLIANCE TESTING FOR FMVSS 301R
FUEL SYSTEM INTEGRITY – REAR IMPACT**

**DAIMLER CHRYSLER AG
2008 DODGE SPRINTER 2500 CARGO VAN
NHTSA NUMBER: C80306**

**PREPARED BY:
MGA RESEARCH CORPORATION
5000 WARREN ROAD
BURLINGTON, WI 53105**

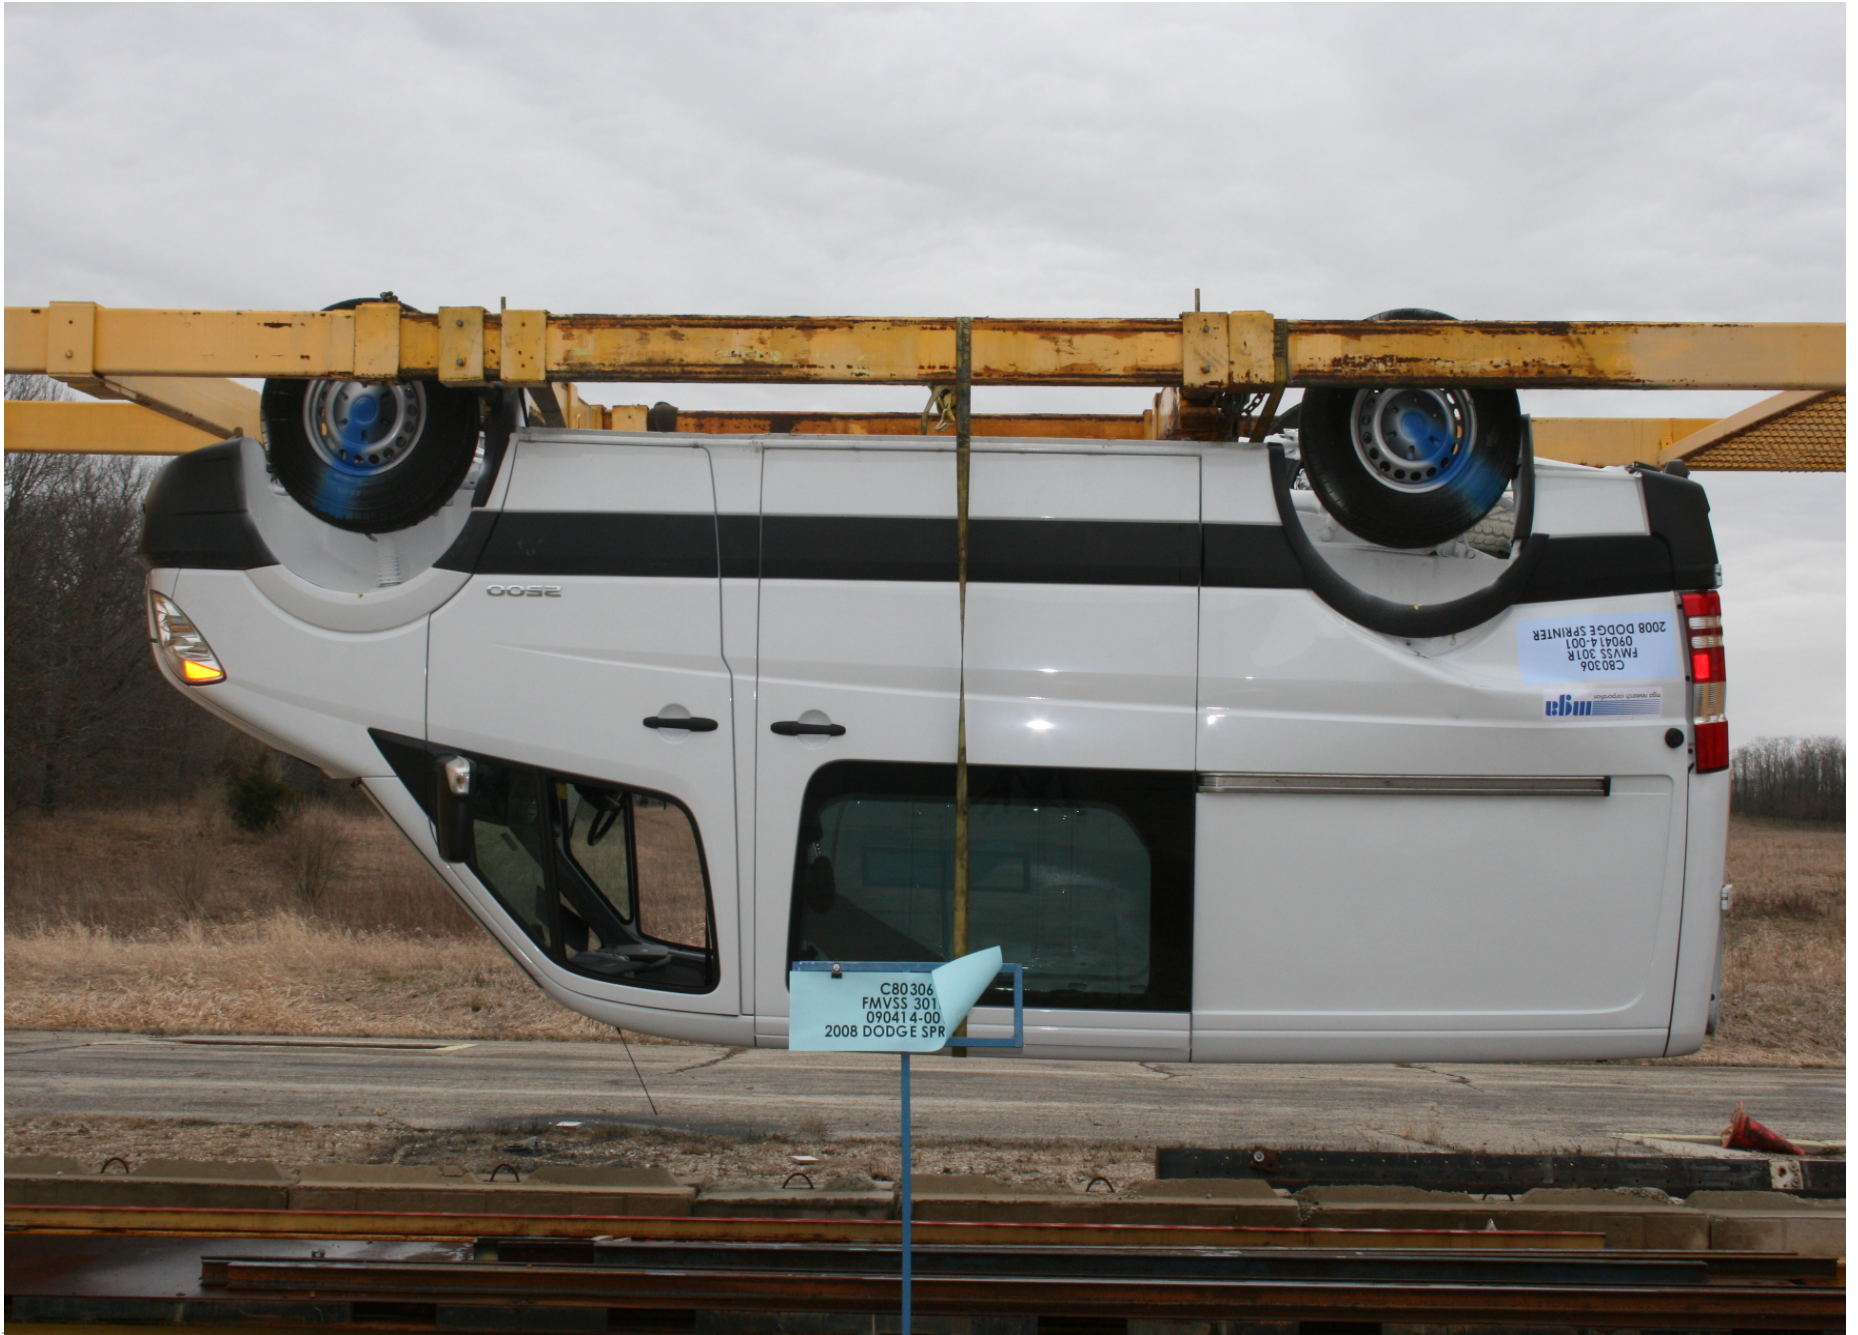
Static Rollover at 180 Degrees

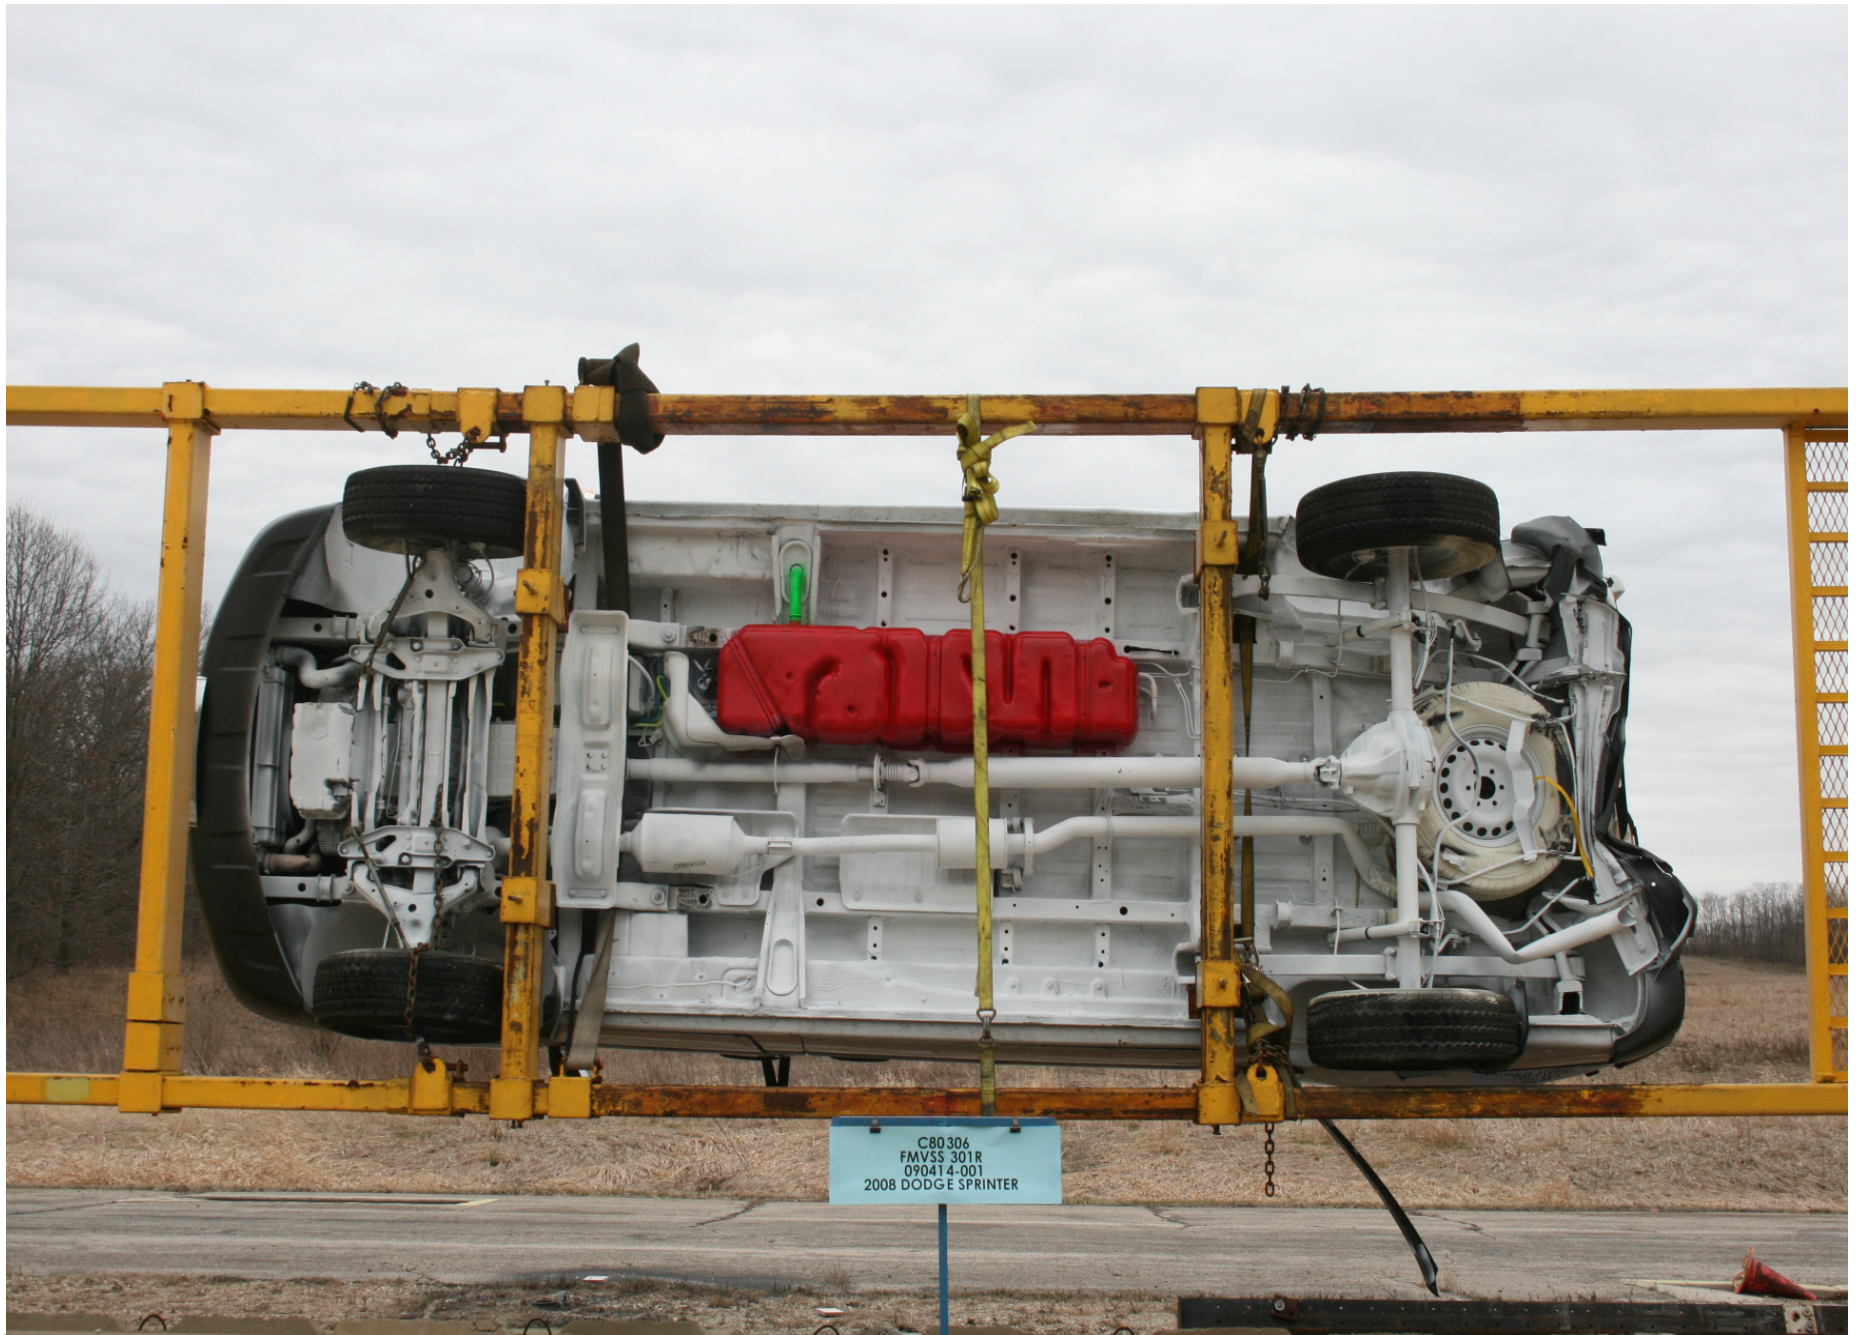
A-40.

Static Rollover at 270 Degrees

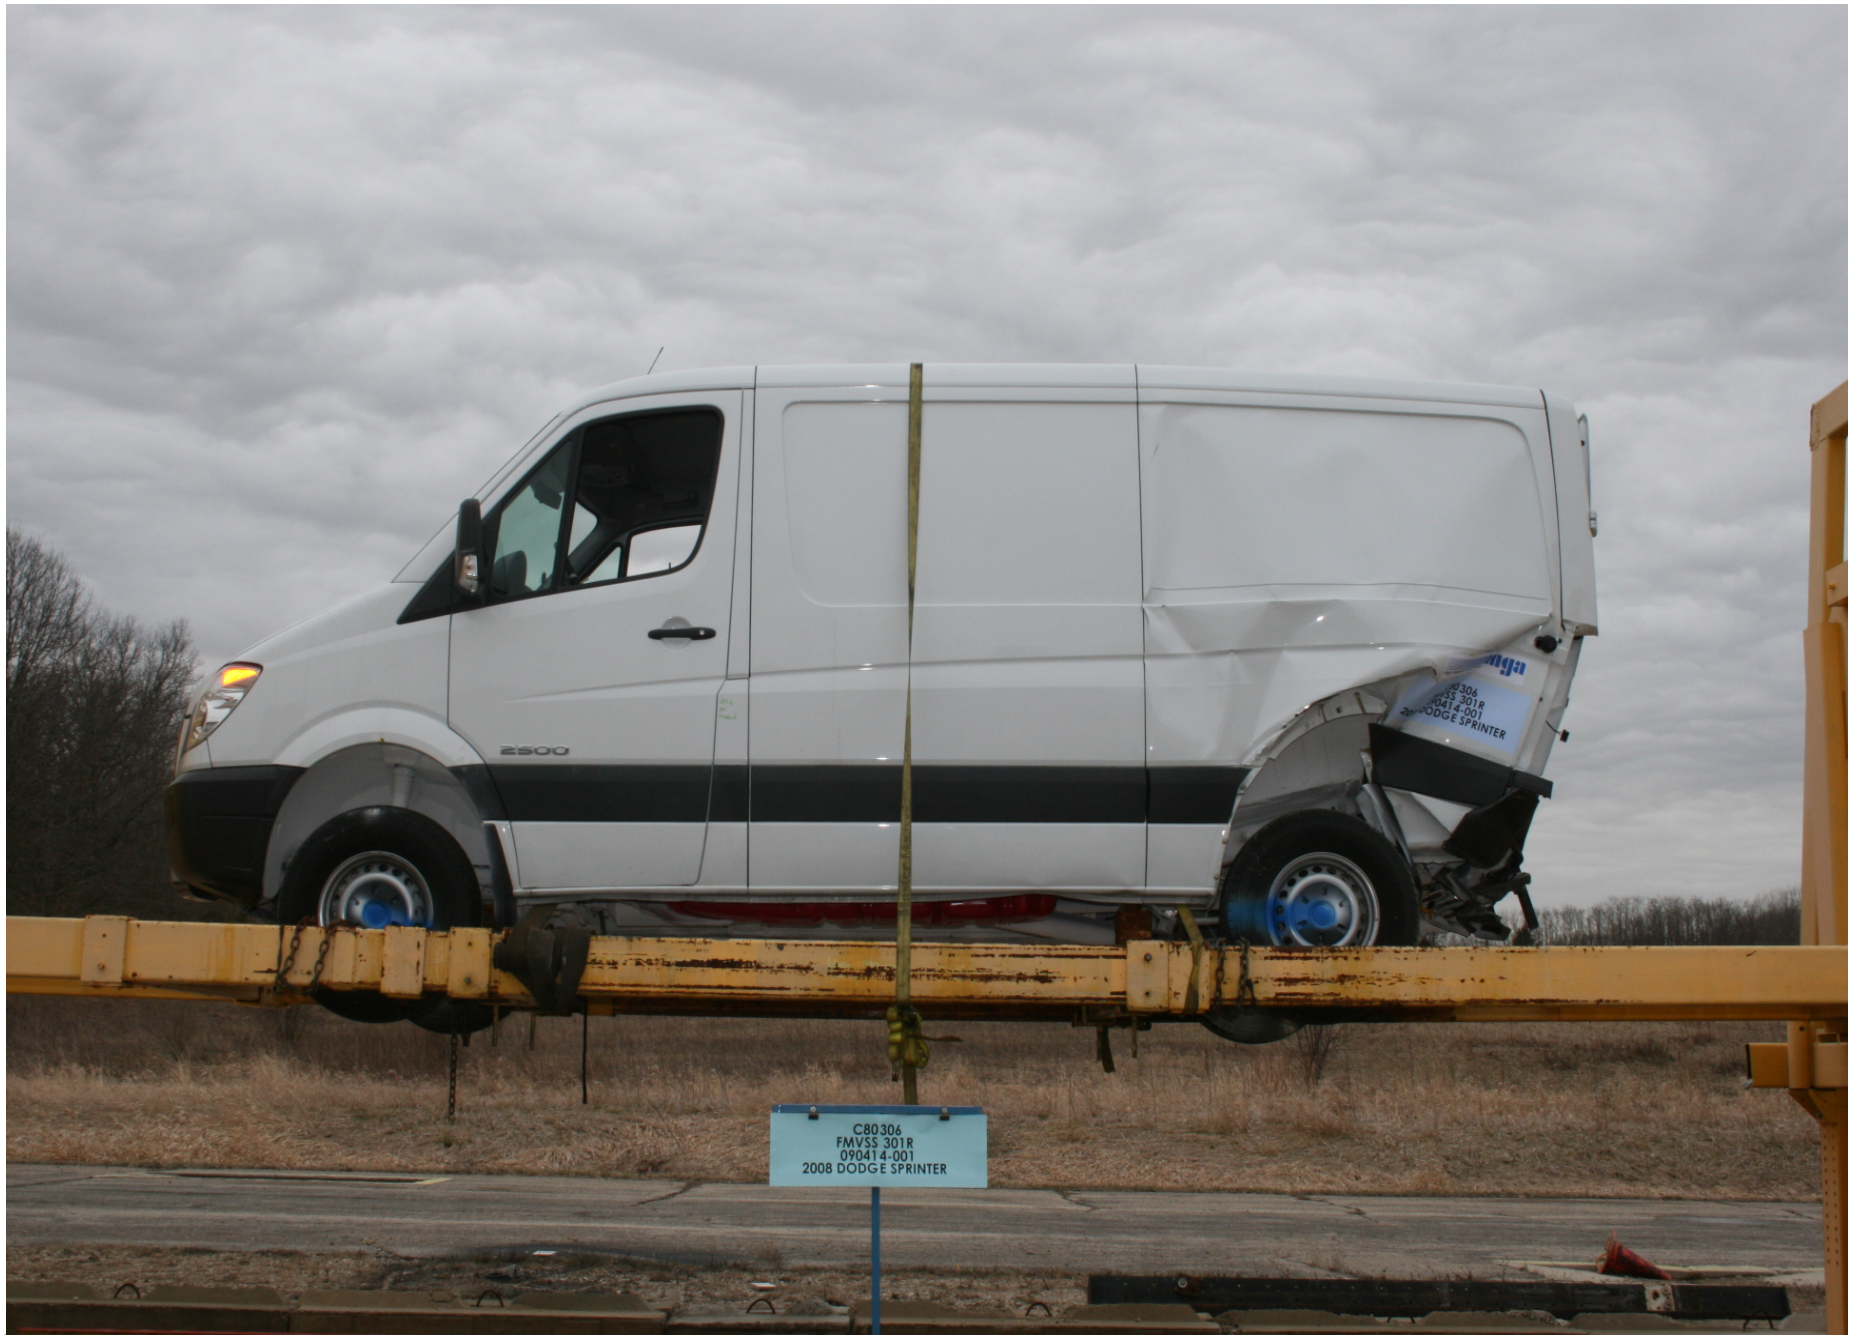
A-41.

Static Rollover at 360 Degrees
