REPORT NUMBER: 301-MGA-2009-008

**SAFETY COMPLIANCE TESTING FOR FMVSS 301R
FUEL SYSTEM INTEGRITY – REAR IMPACT**

**HYUNDAI MOTOR COMPANY
2009 HYUNDAI AZERA GLS
NHTSA NUMBER: C90507**

**PREPARED BY:
MGA RESEARCH CORPORATION
5000 WARREN ROAD
BURLINGTON, WI 53105**

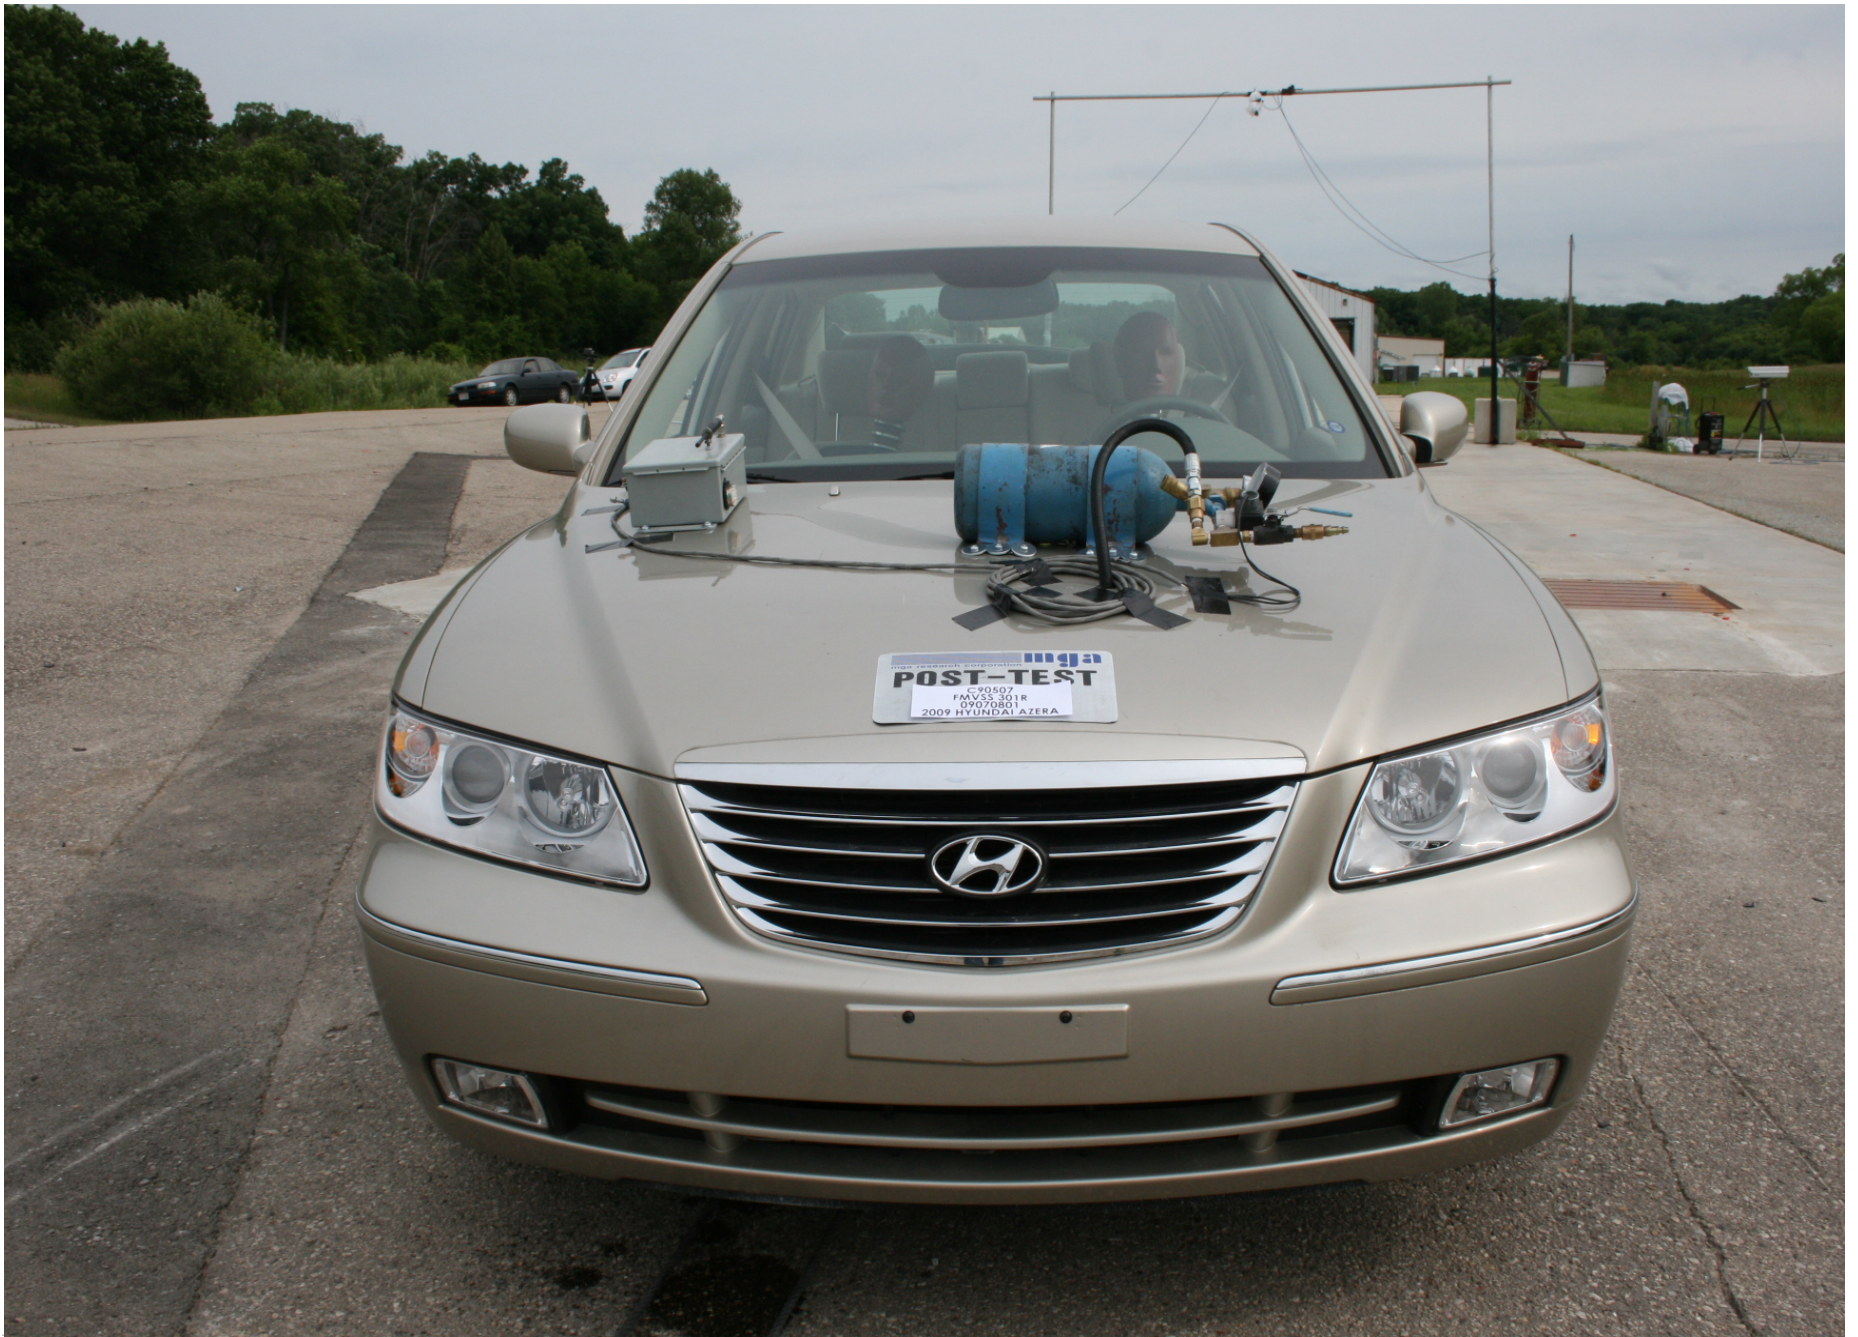
A-4.

Post-Test Front View of Vehicle

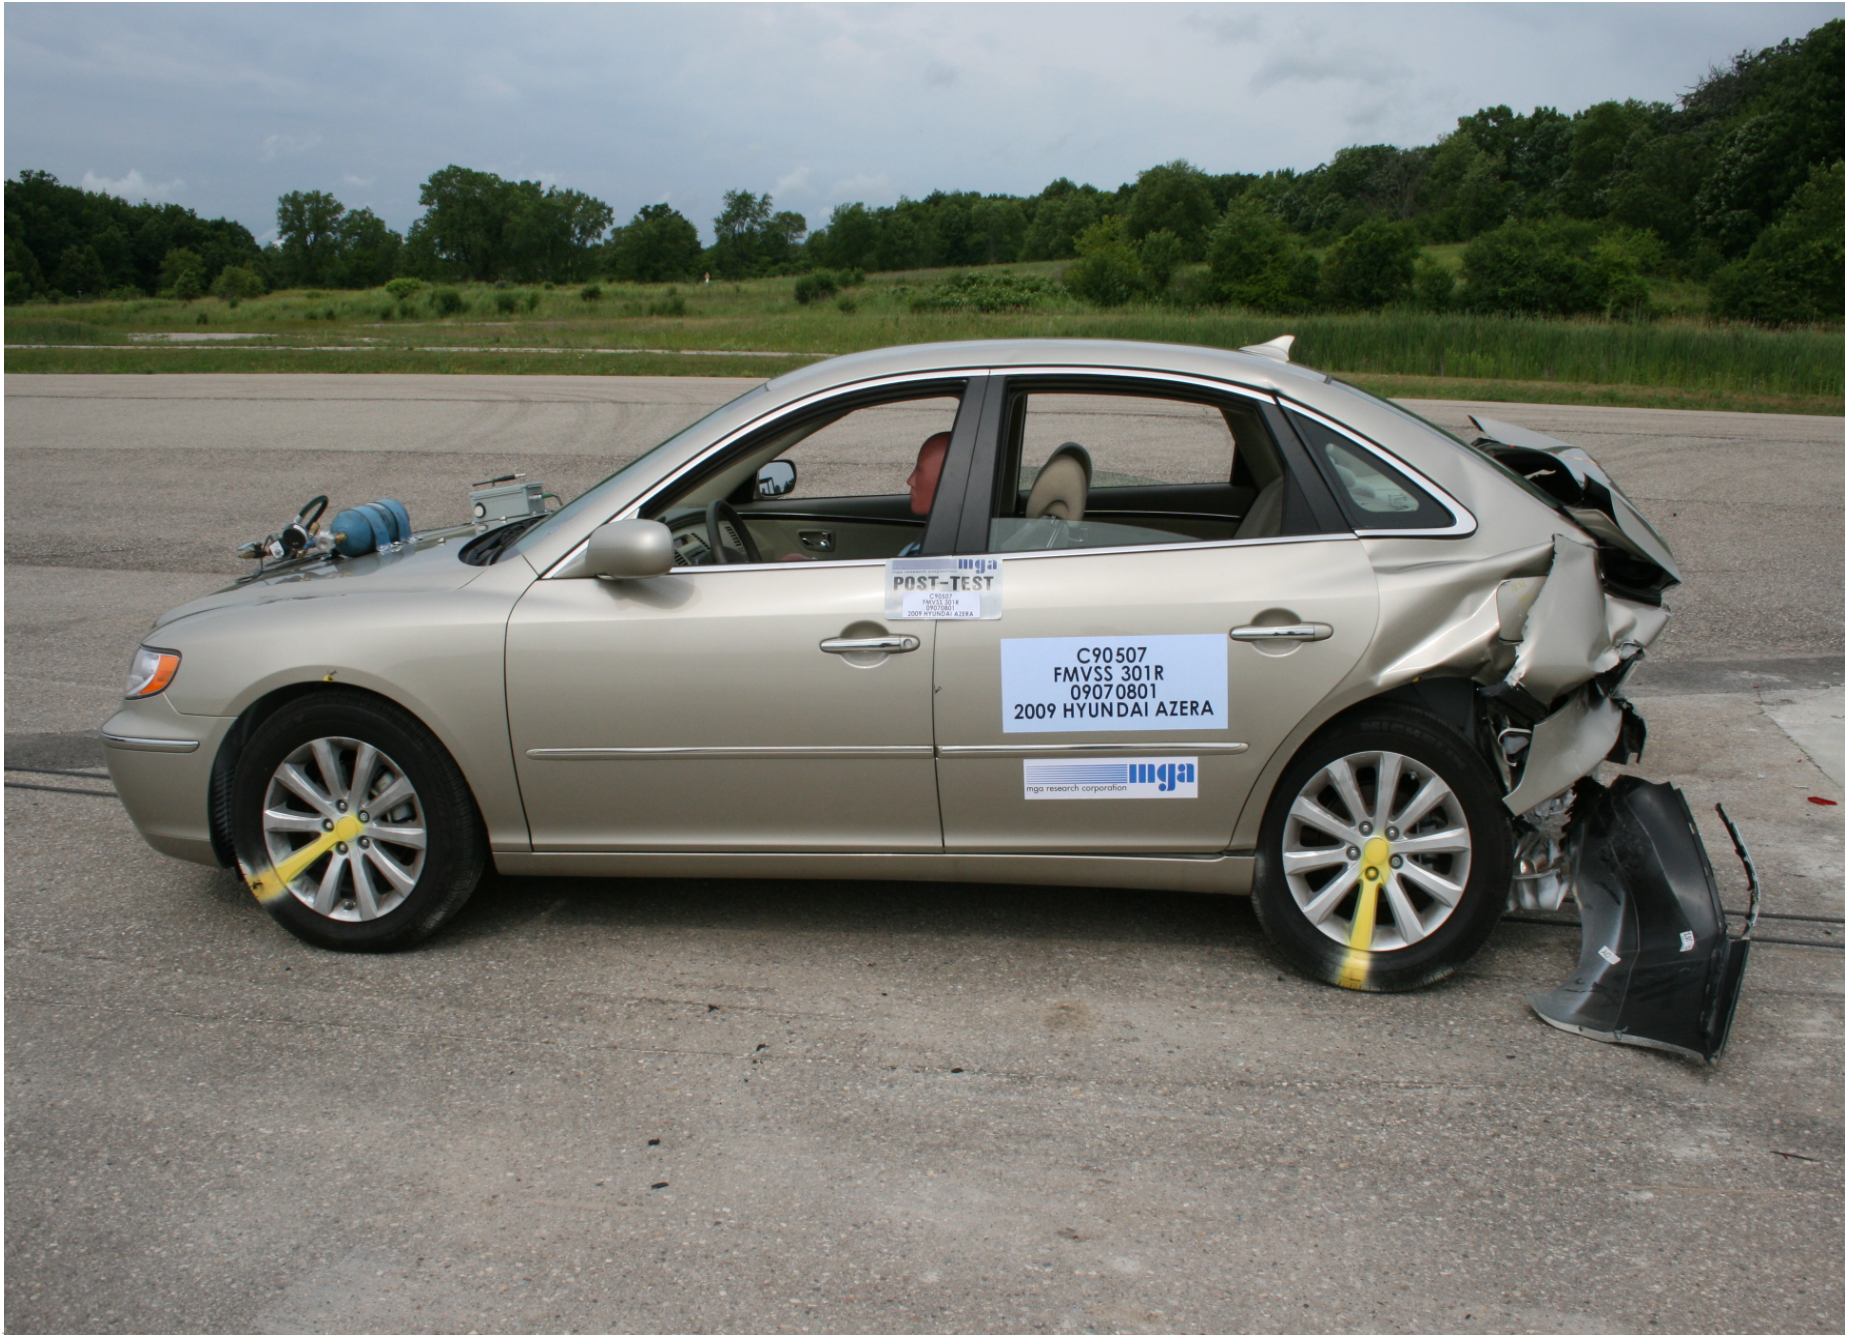
A-6.

Post-Test Left Side View of Vehicle

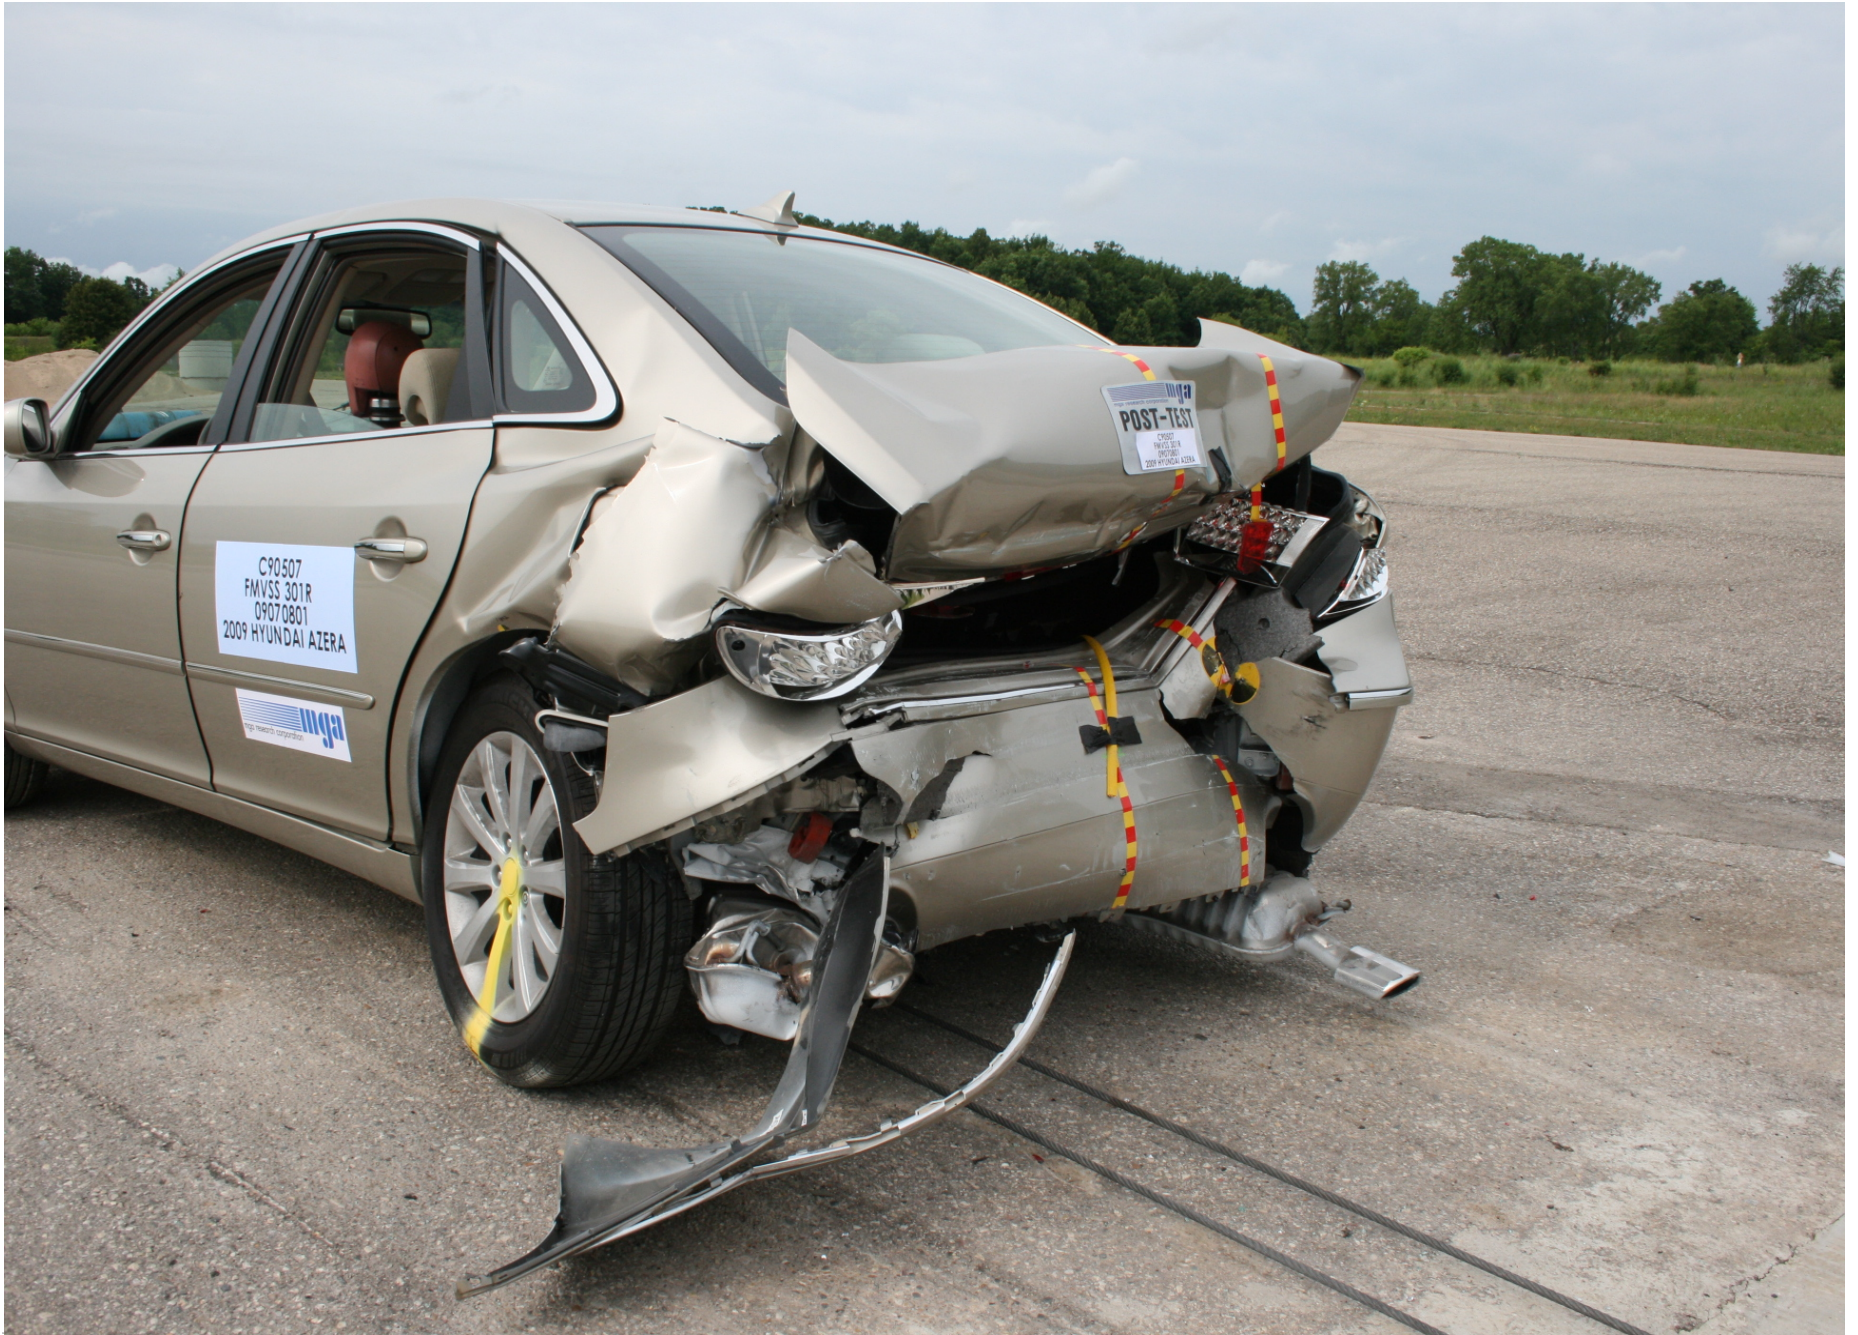
A-8.

Post-Test Left Rear Close-up View of Vehicle

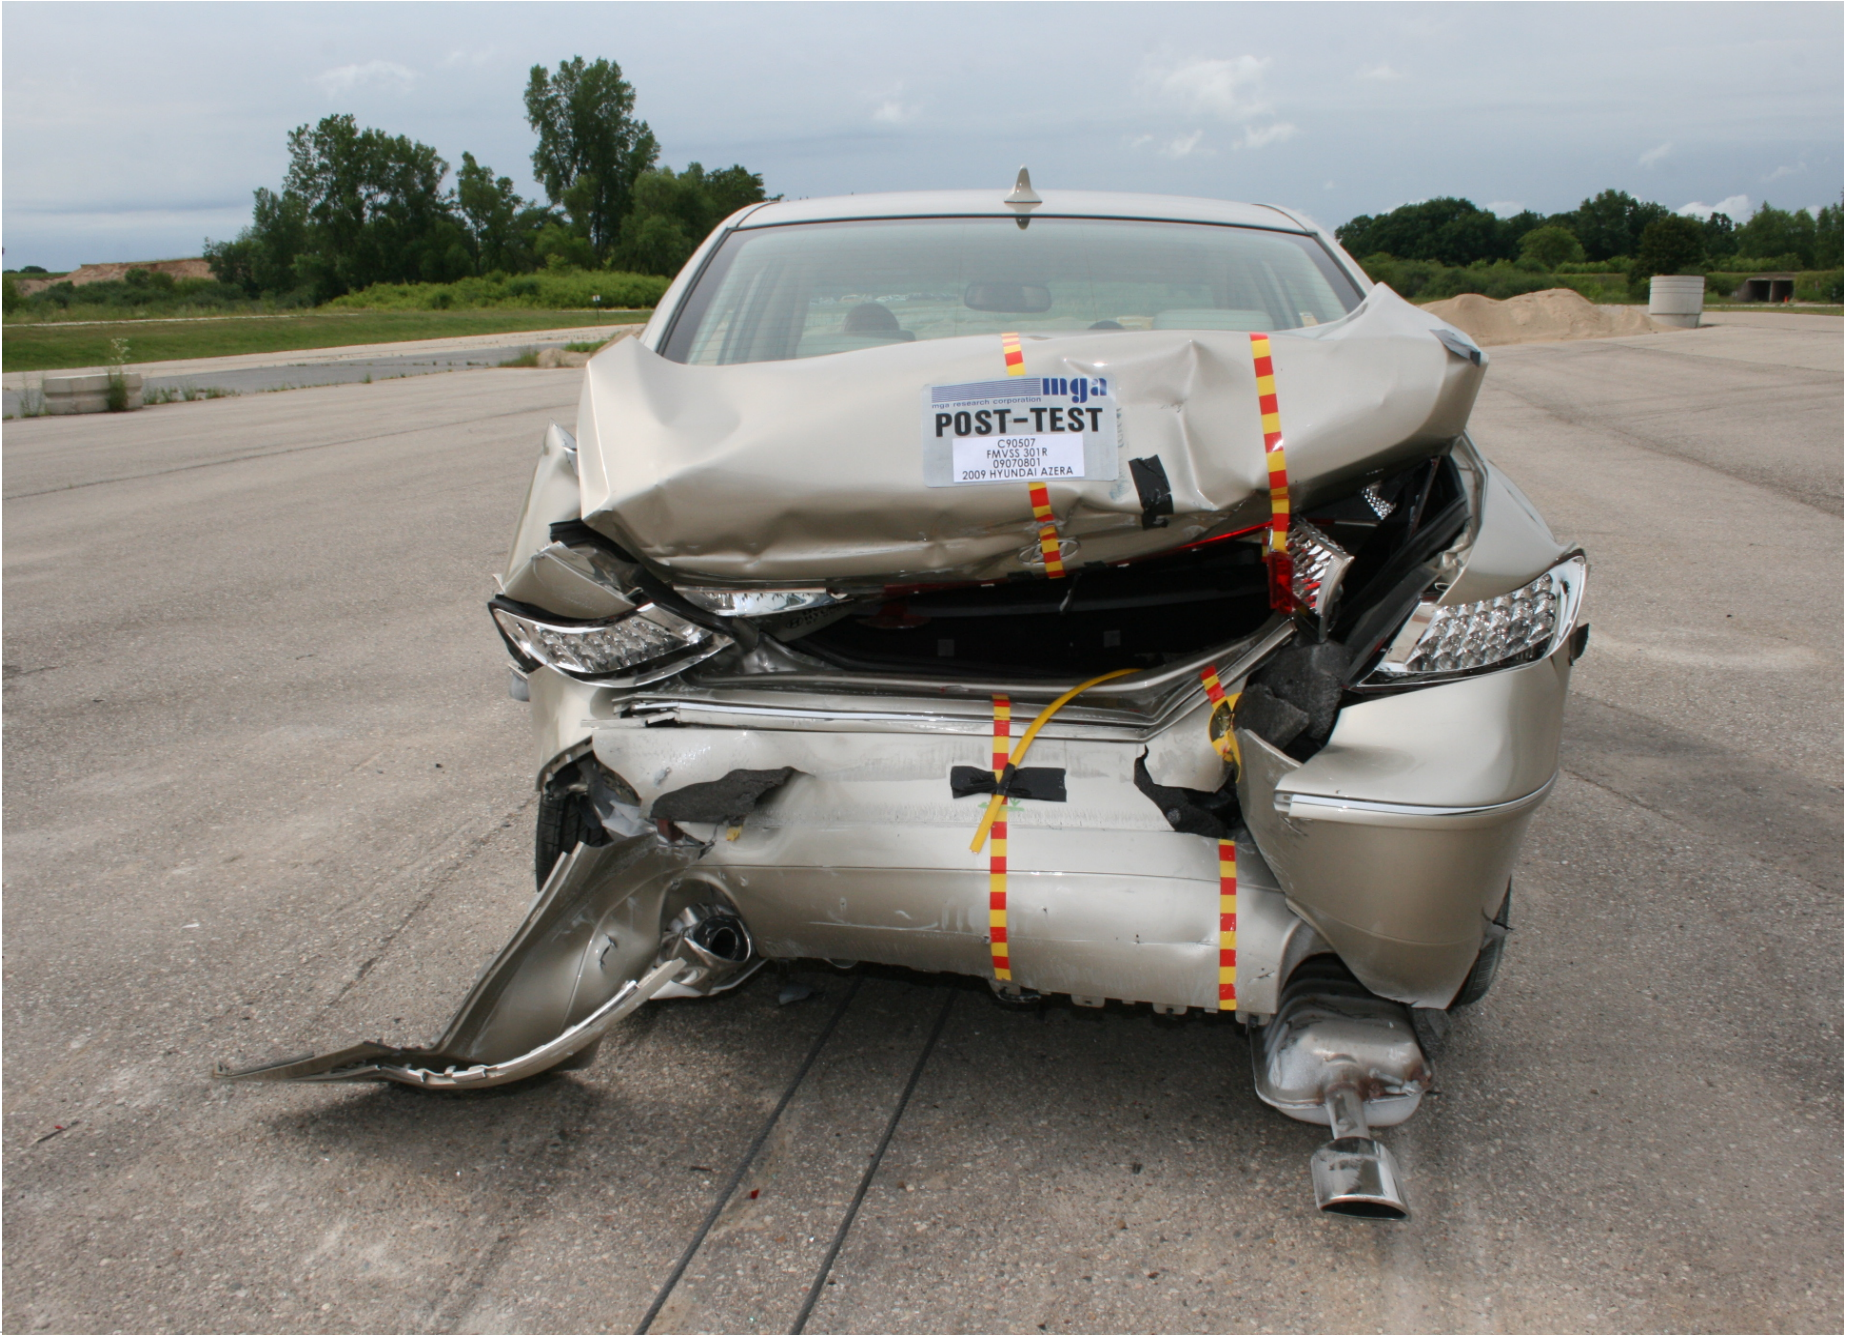
A-14.

Post-Test Rear View of Vehicle

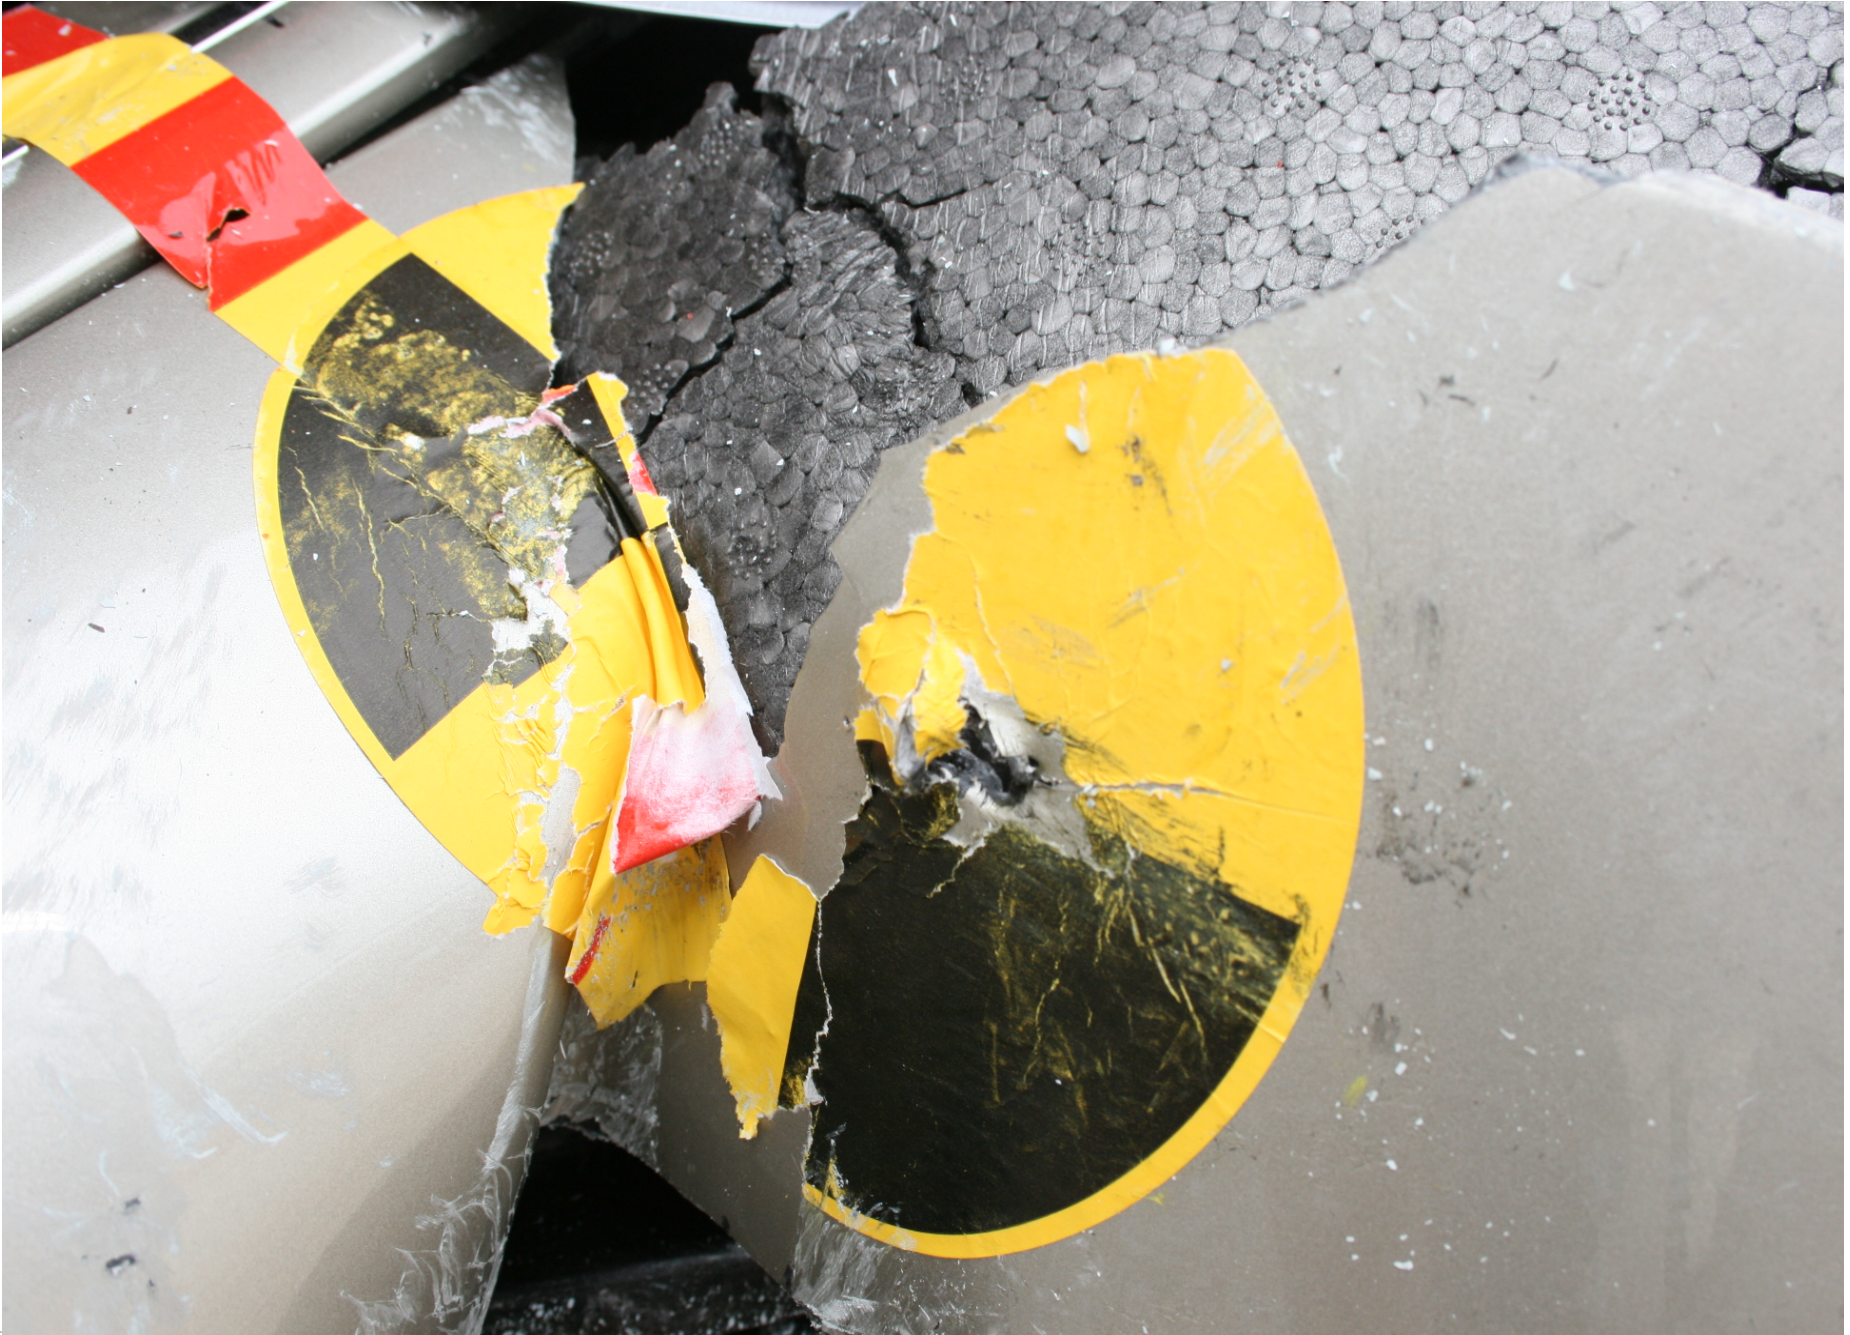
A-21.

Post-Test Impact Point

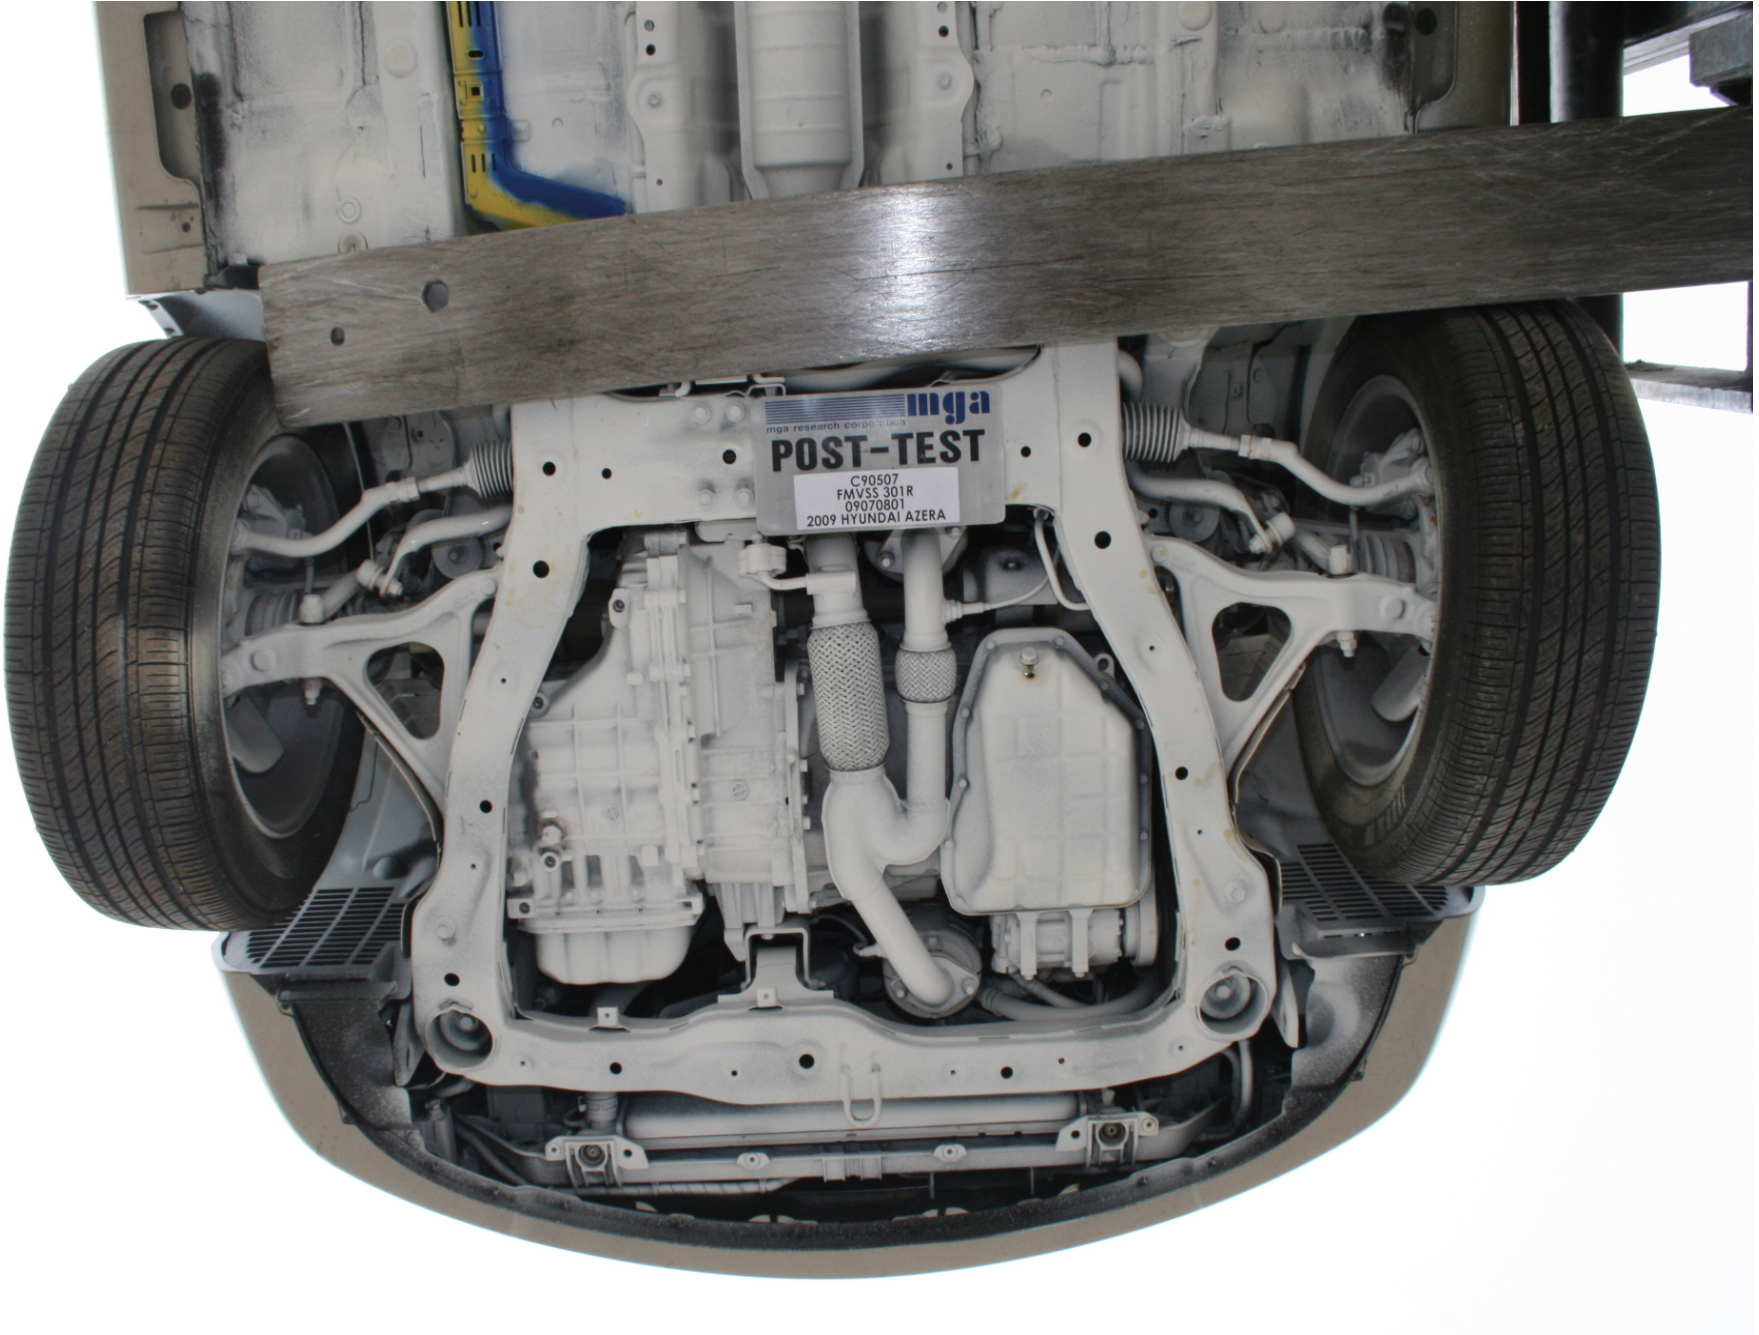
A-23.

Post-Test Underbody View 1

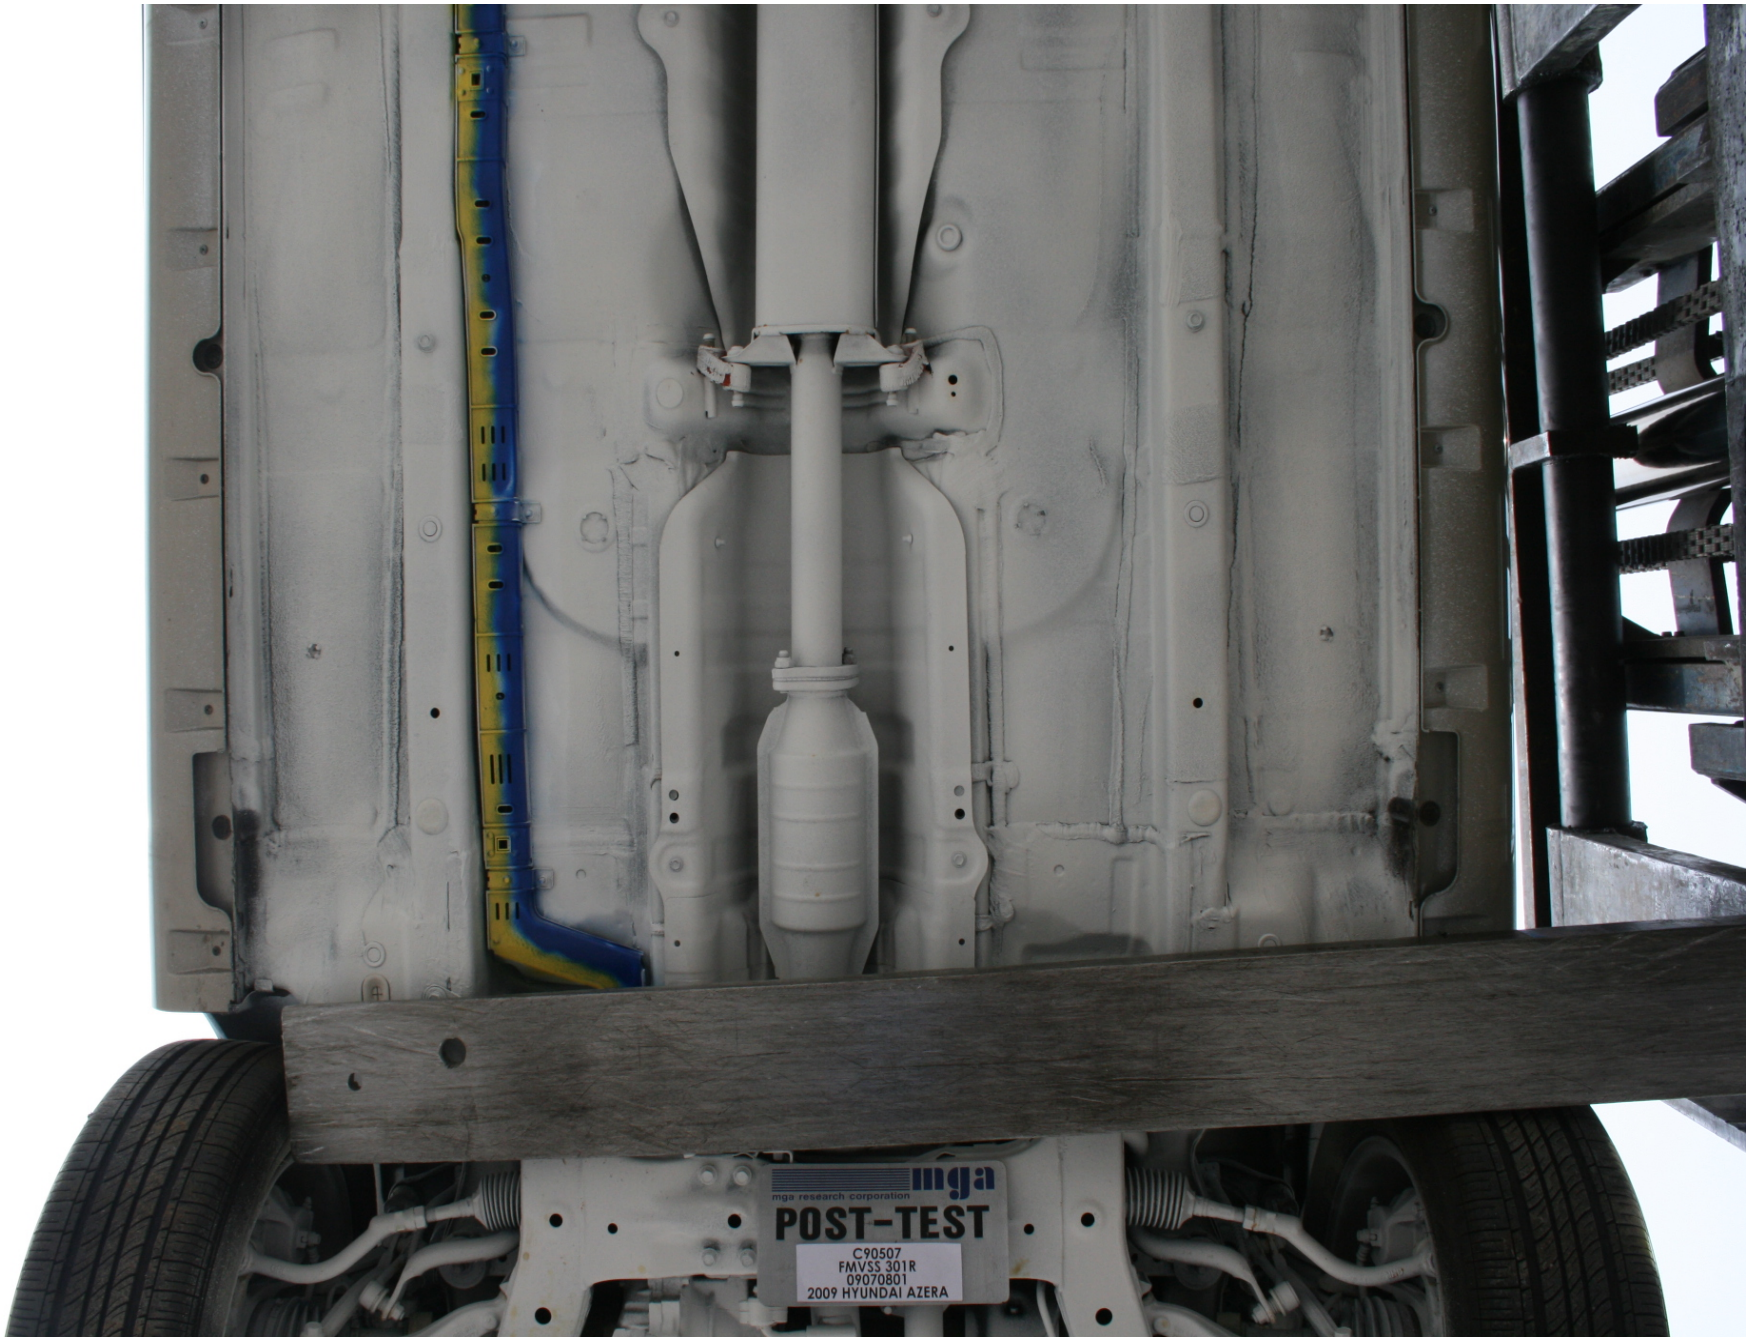
A-25.

Post-Test Underbody View 2

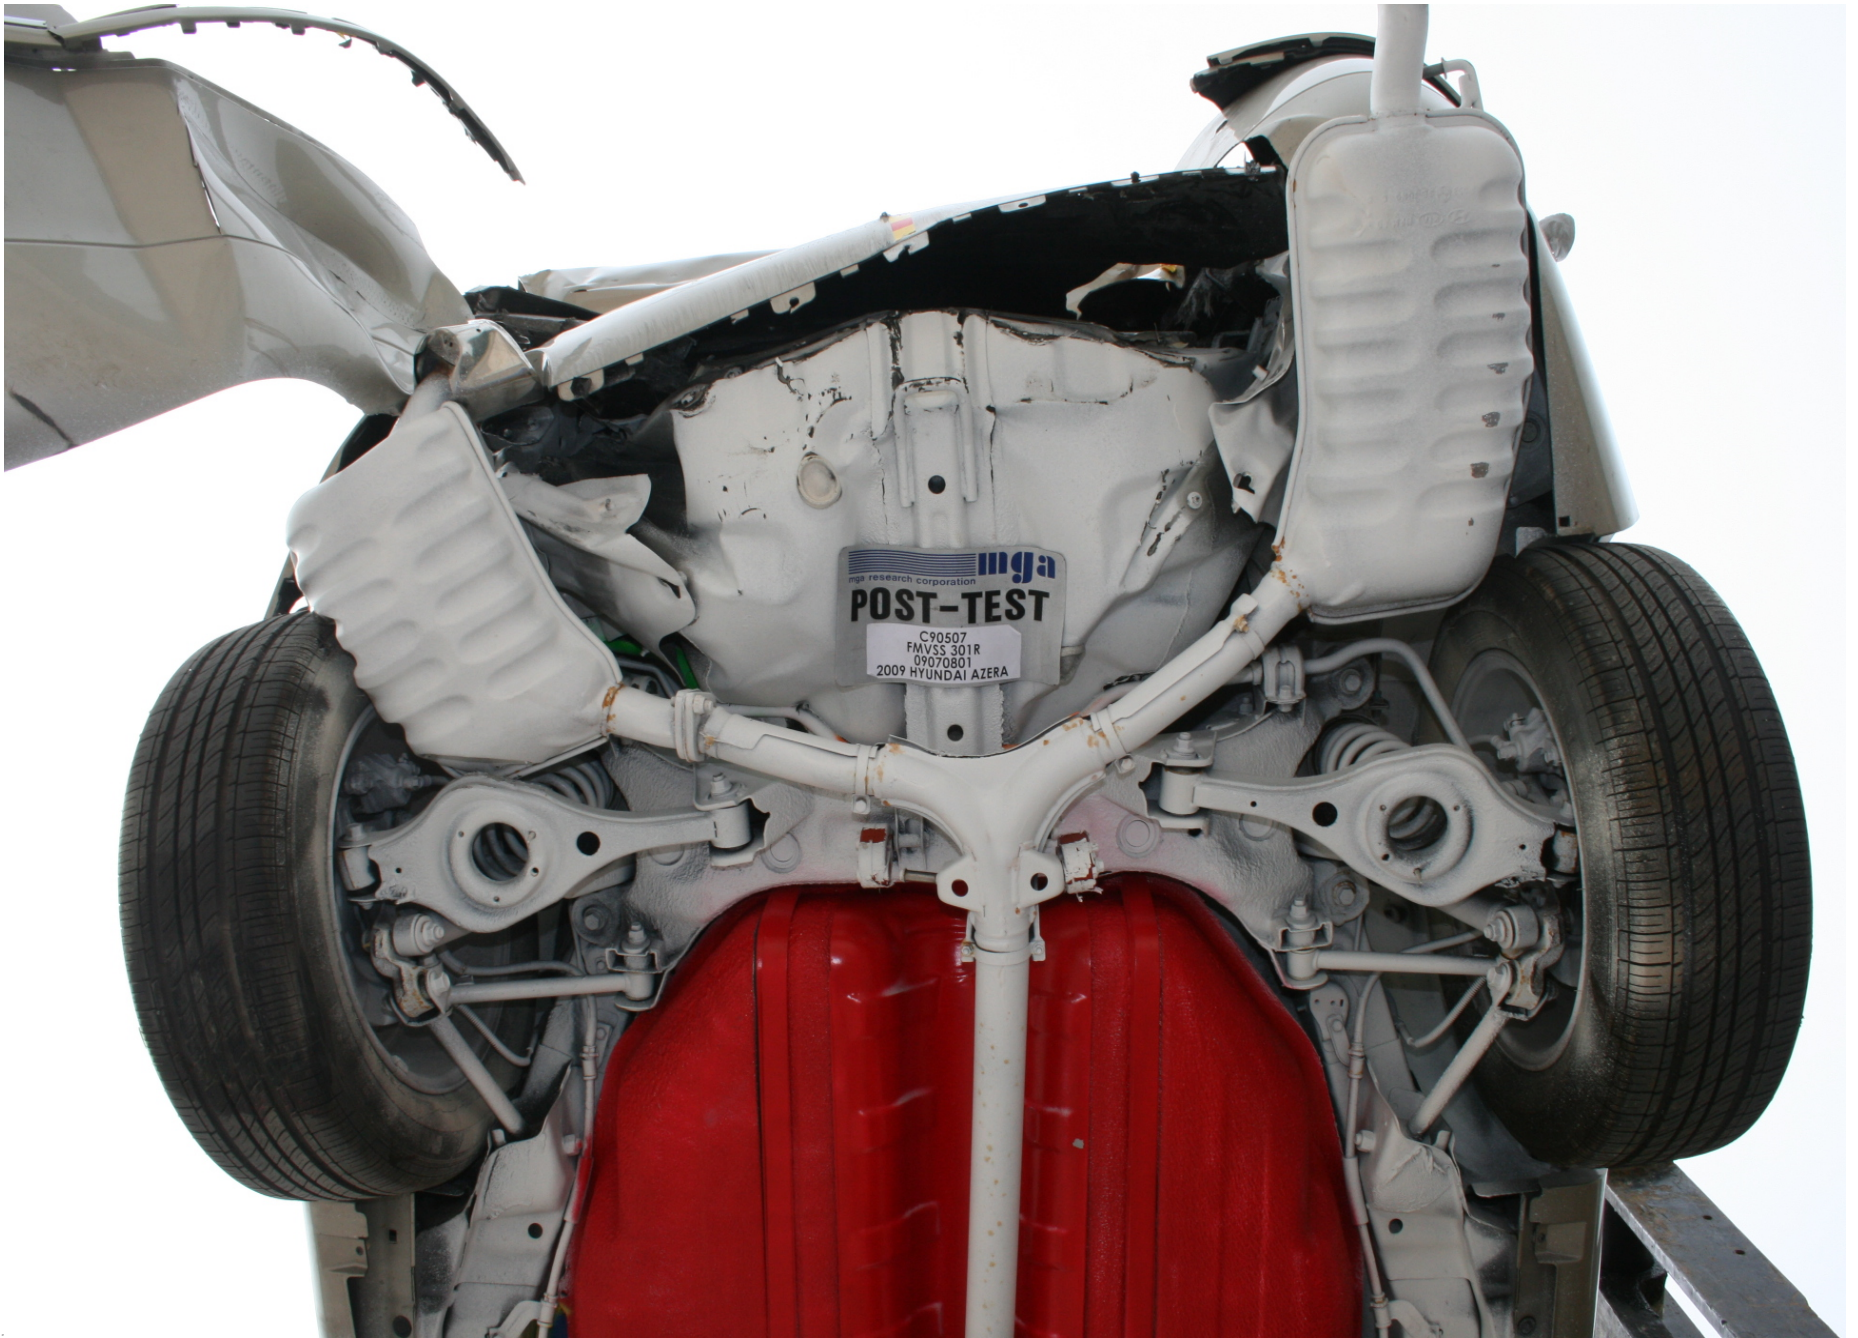
A-27.

Post-Test Underbody View 3

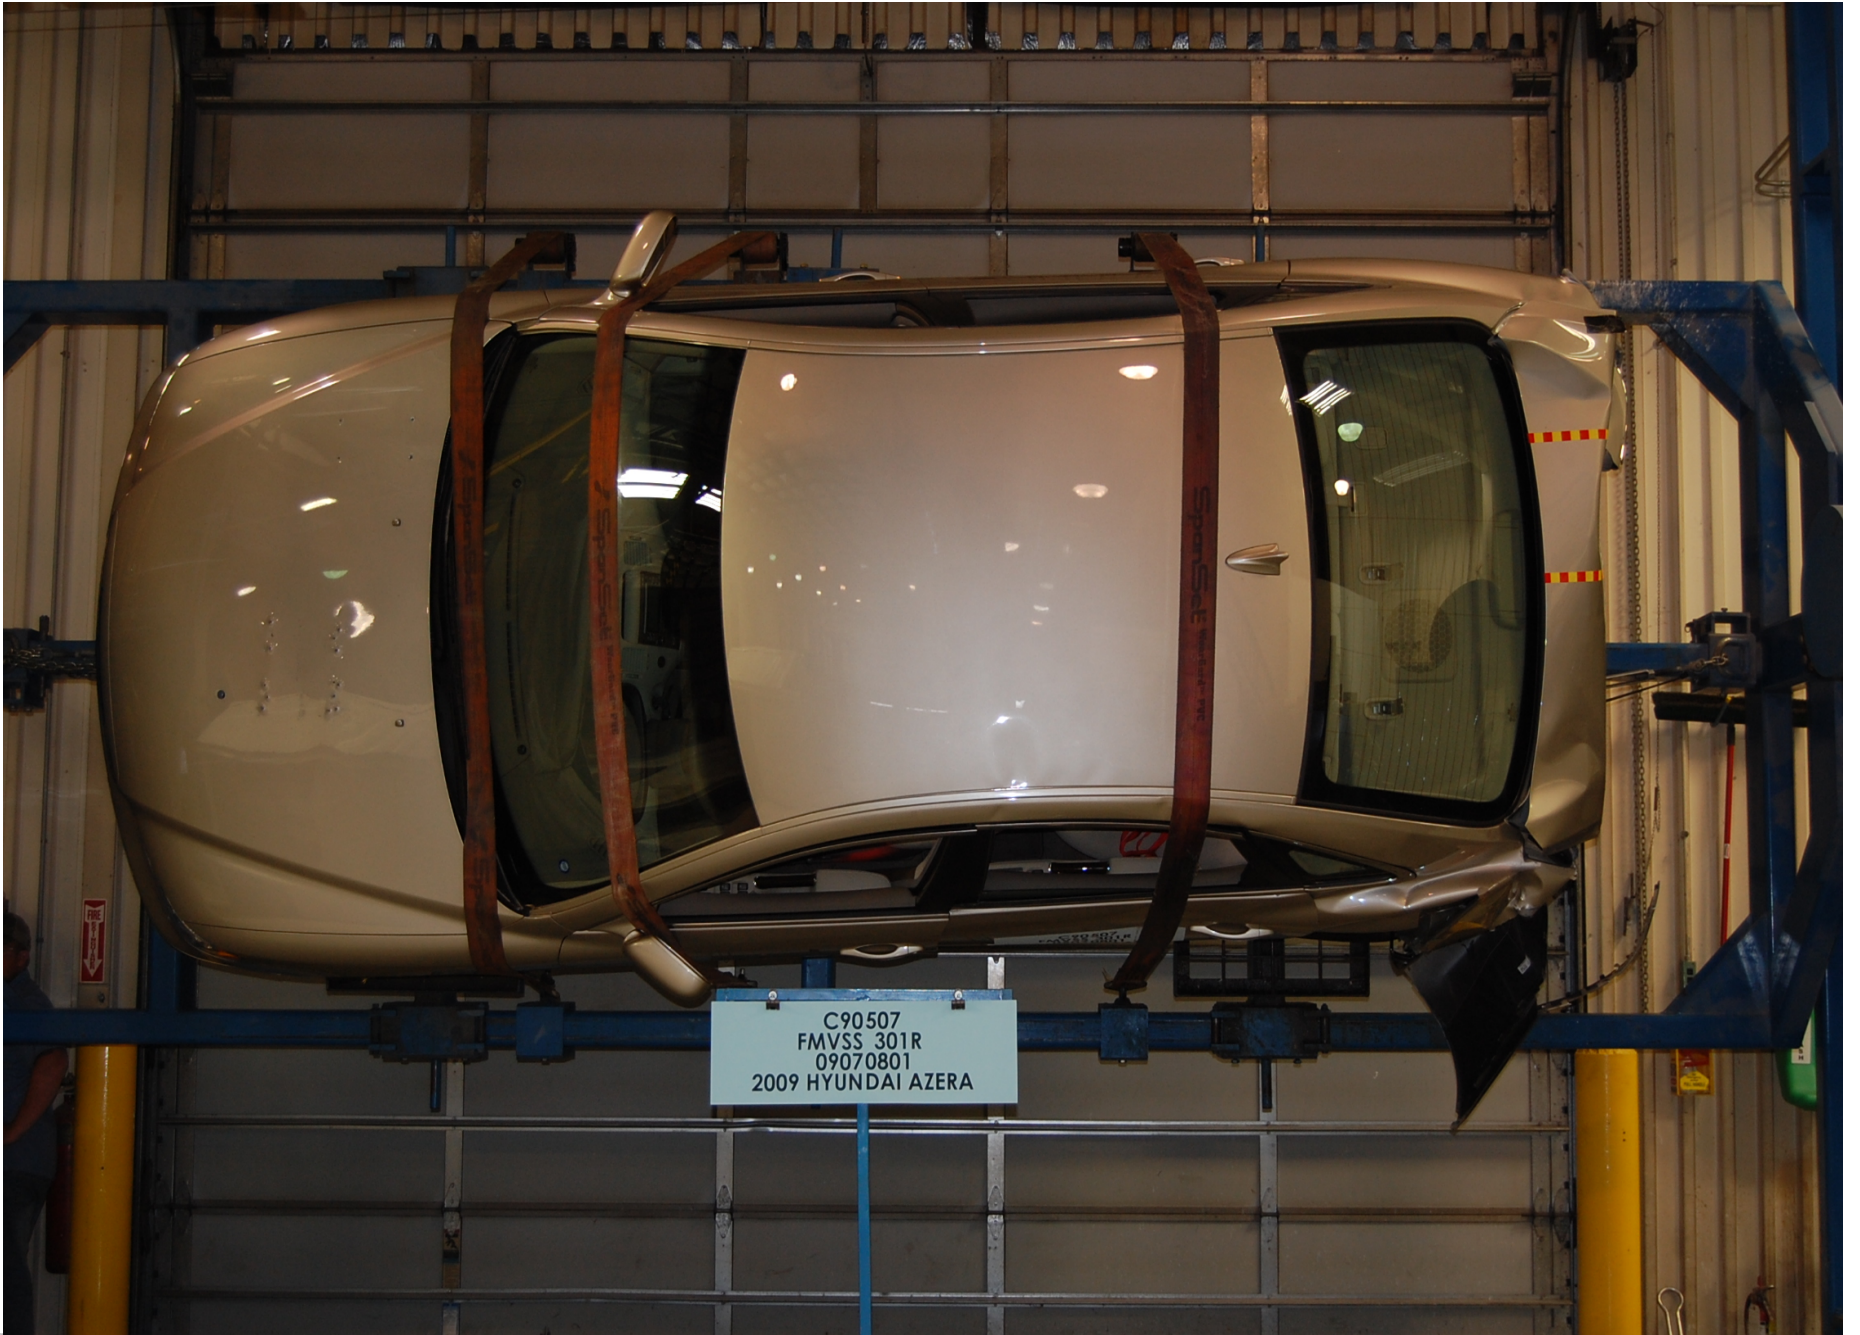
A-36.

Static Rollover at 90 Degrees
