REPORT NUMBER: 301-MGA-2009-008

**SAFETY COMPLIANCE TESTING FOR FMVSS 301R
FUEL SYSTEM INTEGRITY – REAR IMPACT**

**HYUNDAI MOTOR COMPANY
2009 HYUNDAI AZERA GLS
NHTSA NUMBER: C90507**

**PREPARED BY:
MGA RESEARCH CORPORATION
5000 WARREN ROAD
BURLINGTON, WI 53105**

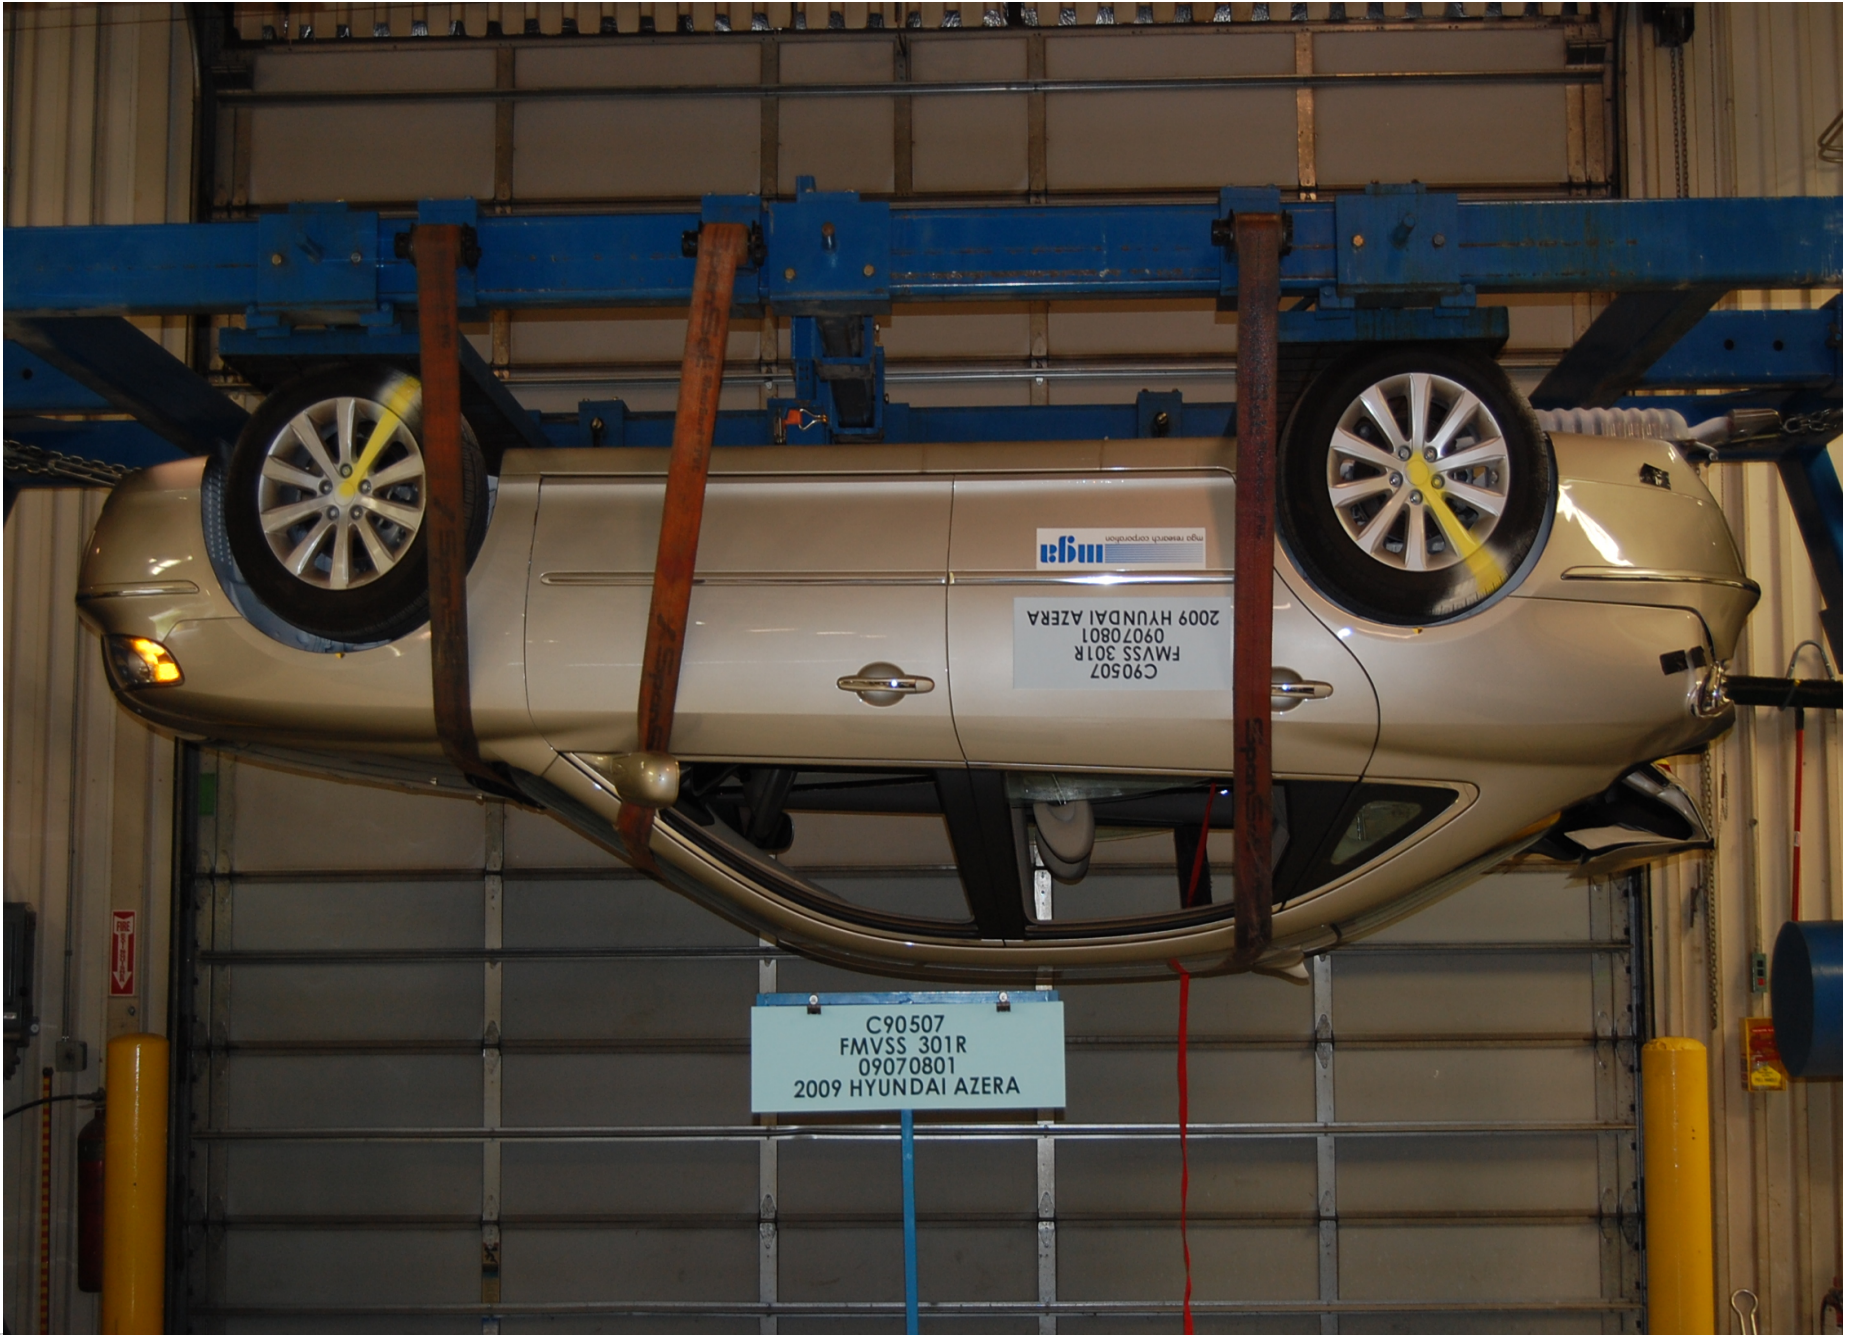
A-37.

Static Rollover at 180 Degrees

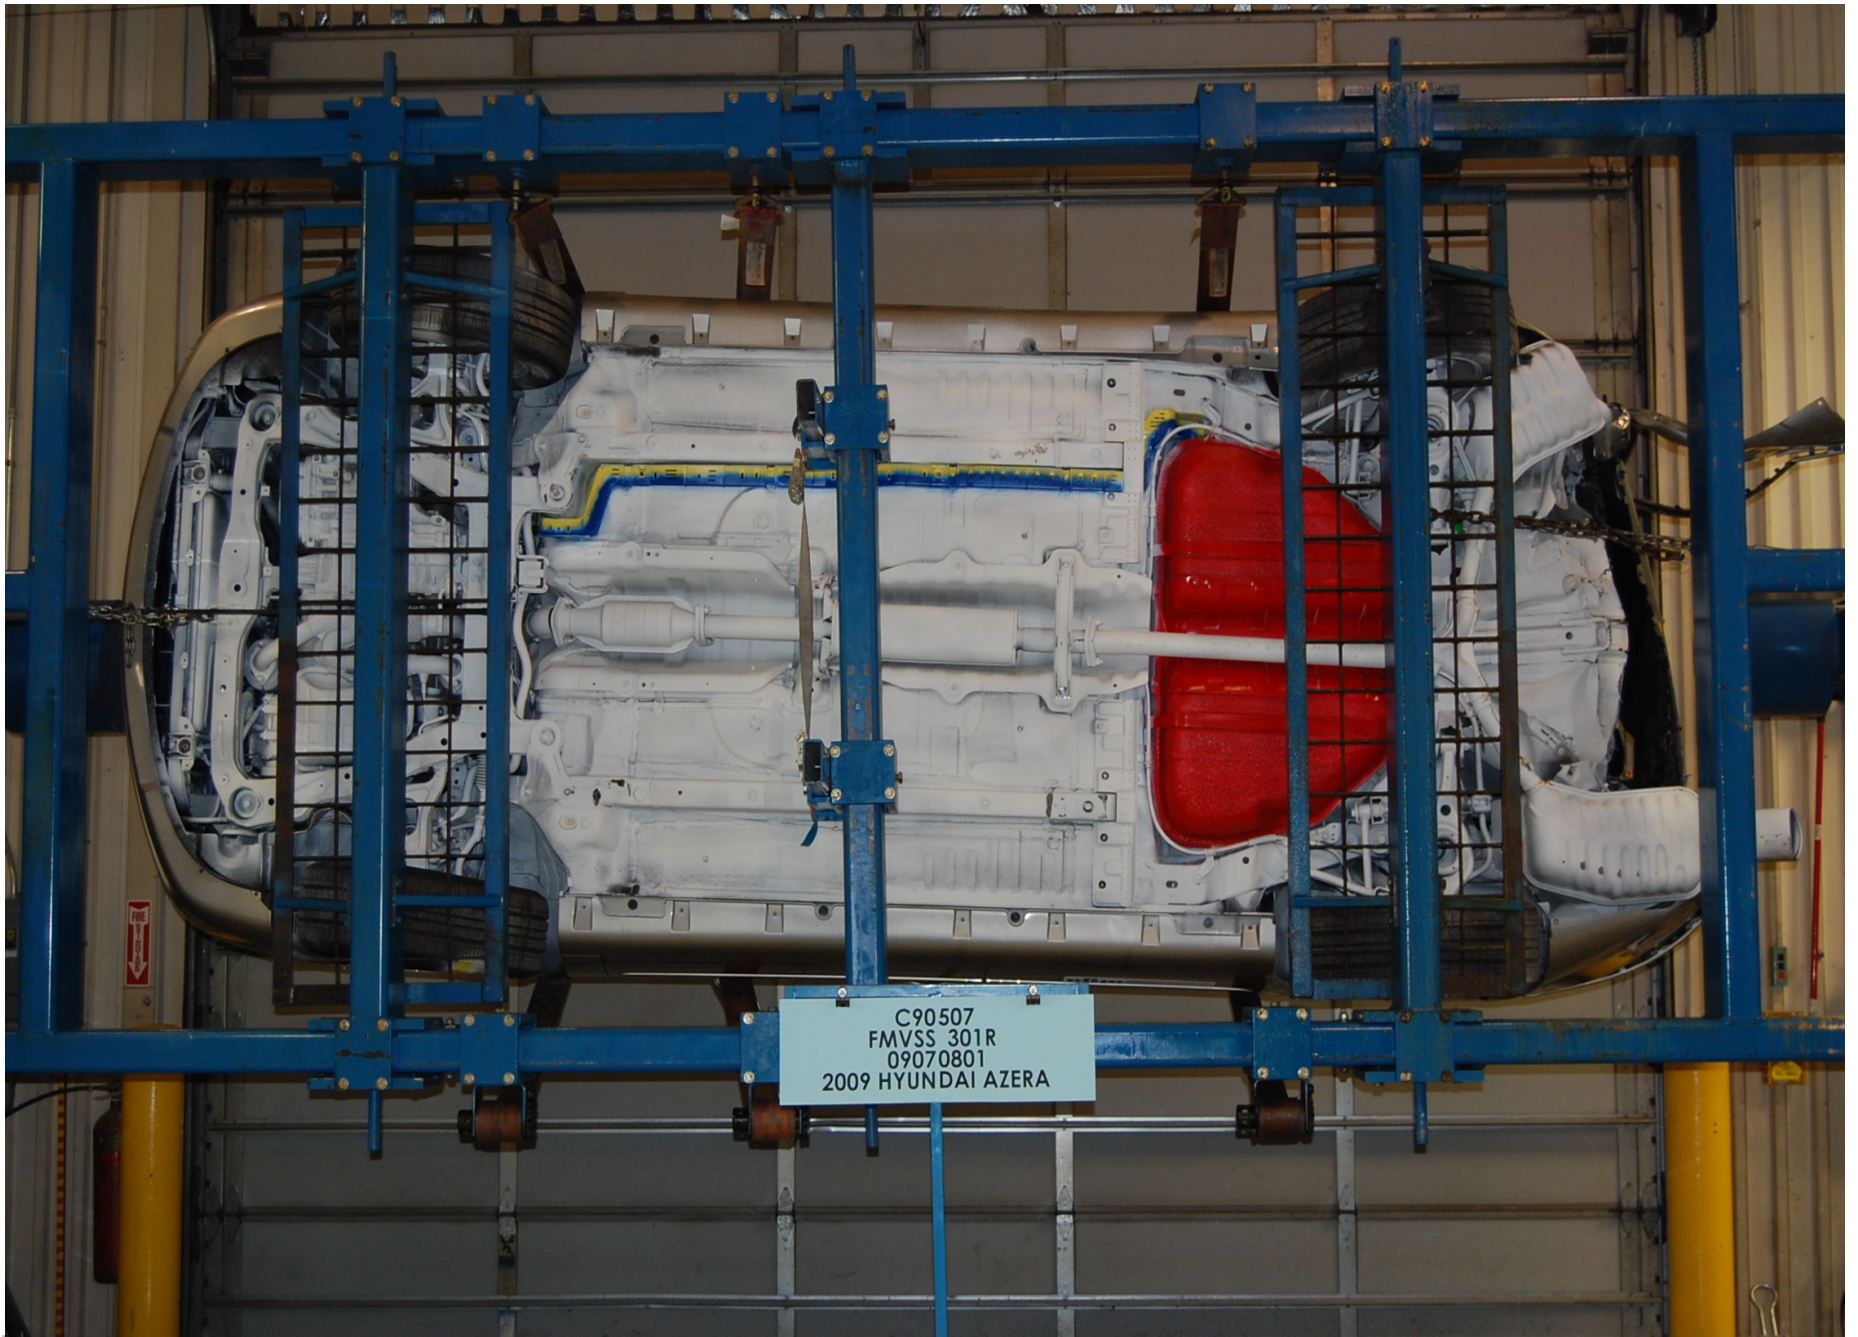
A-38.

Static Rollover at 270 Degrees

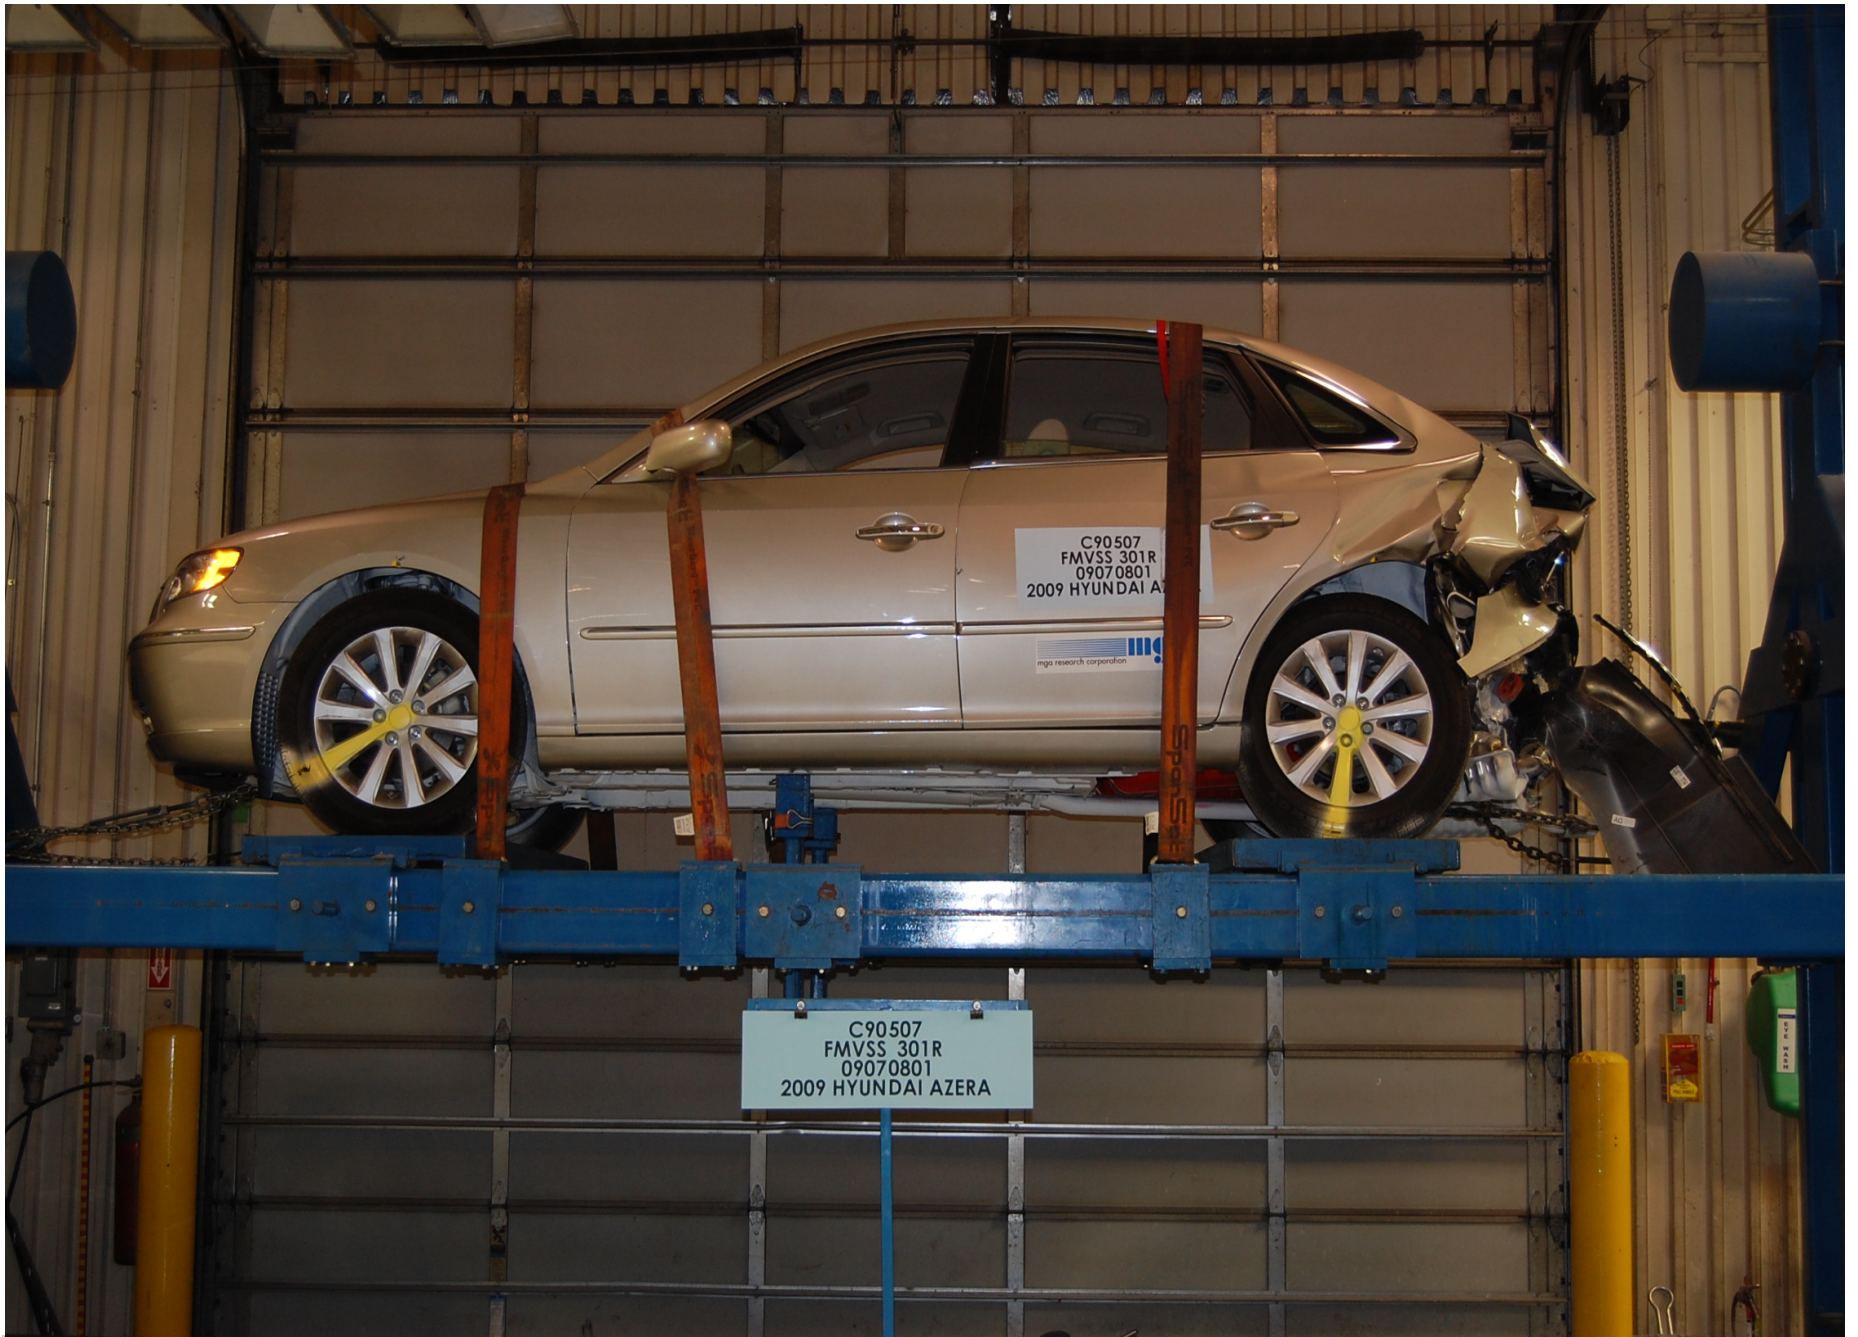
A-39.

Static Rollover at 360 Degrees
