REPORT NUMBER: 301-MGA-2009-006

**SAFETY COMPLIANCE TESTING FOR FMVSS 301R
FUEL SYSTEM INTEGRITY – REAR IMPACT**

**VOLKSWAGEN AG GERMANY
2009 VOLKSWAGEN GTI
NHTSA NUMBER: C95801**

**PREPARED BY:
MGA RESEARCH CORPORATION
5000 WARREN ROAD
BURLINGTON, WI 53105**

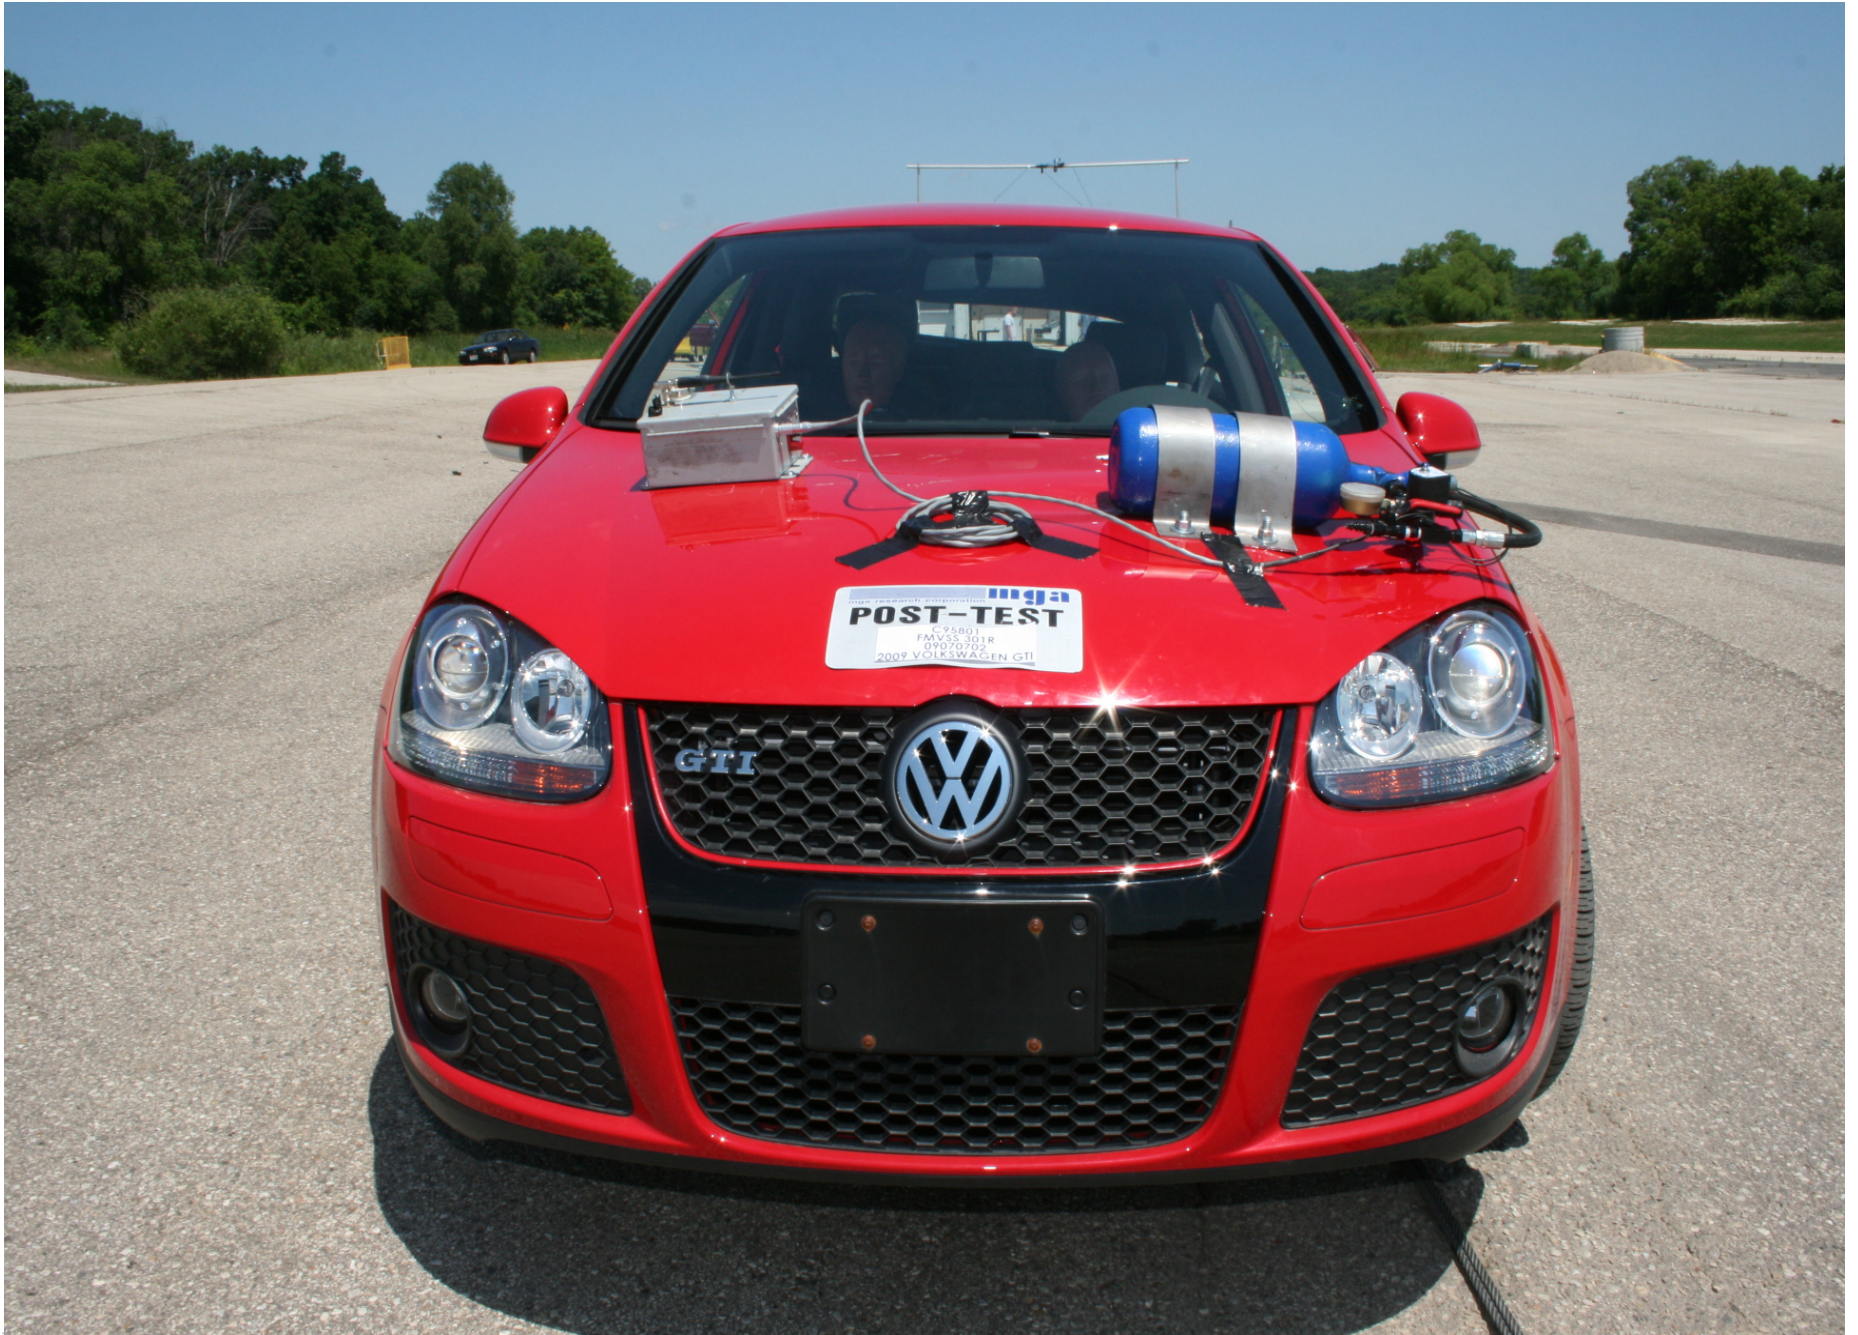
A-4.

Post-Test Front View of Vehicle

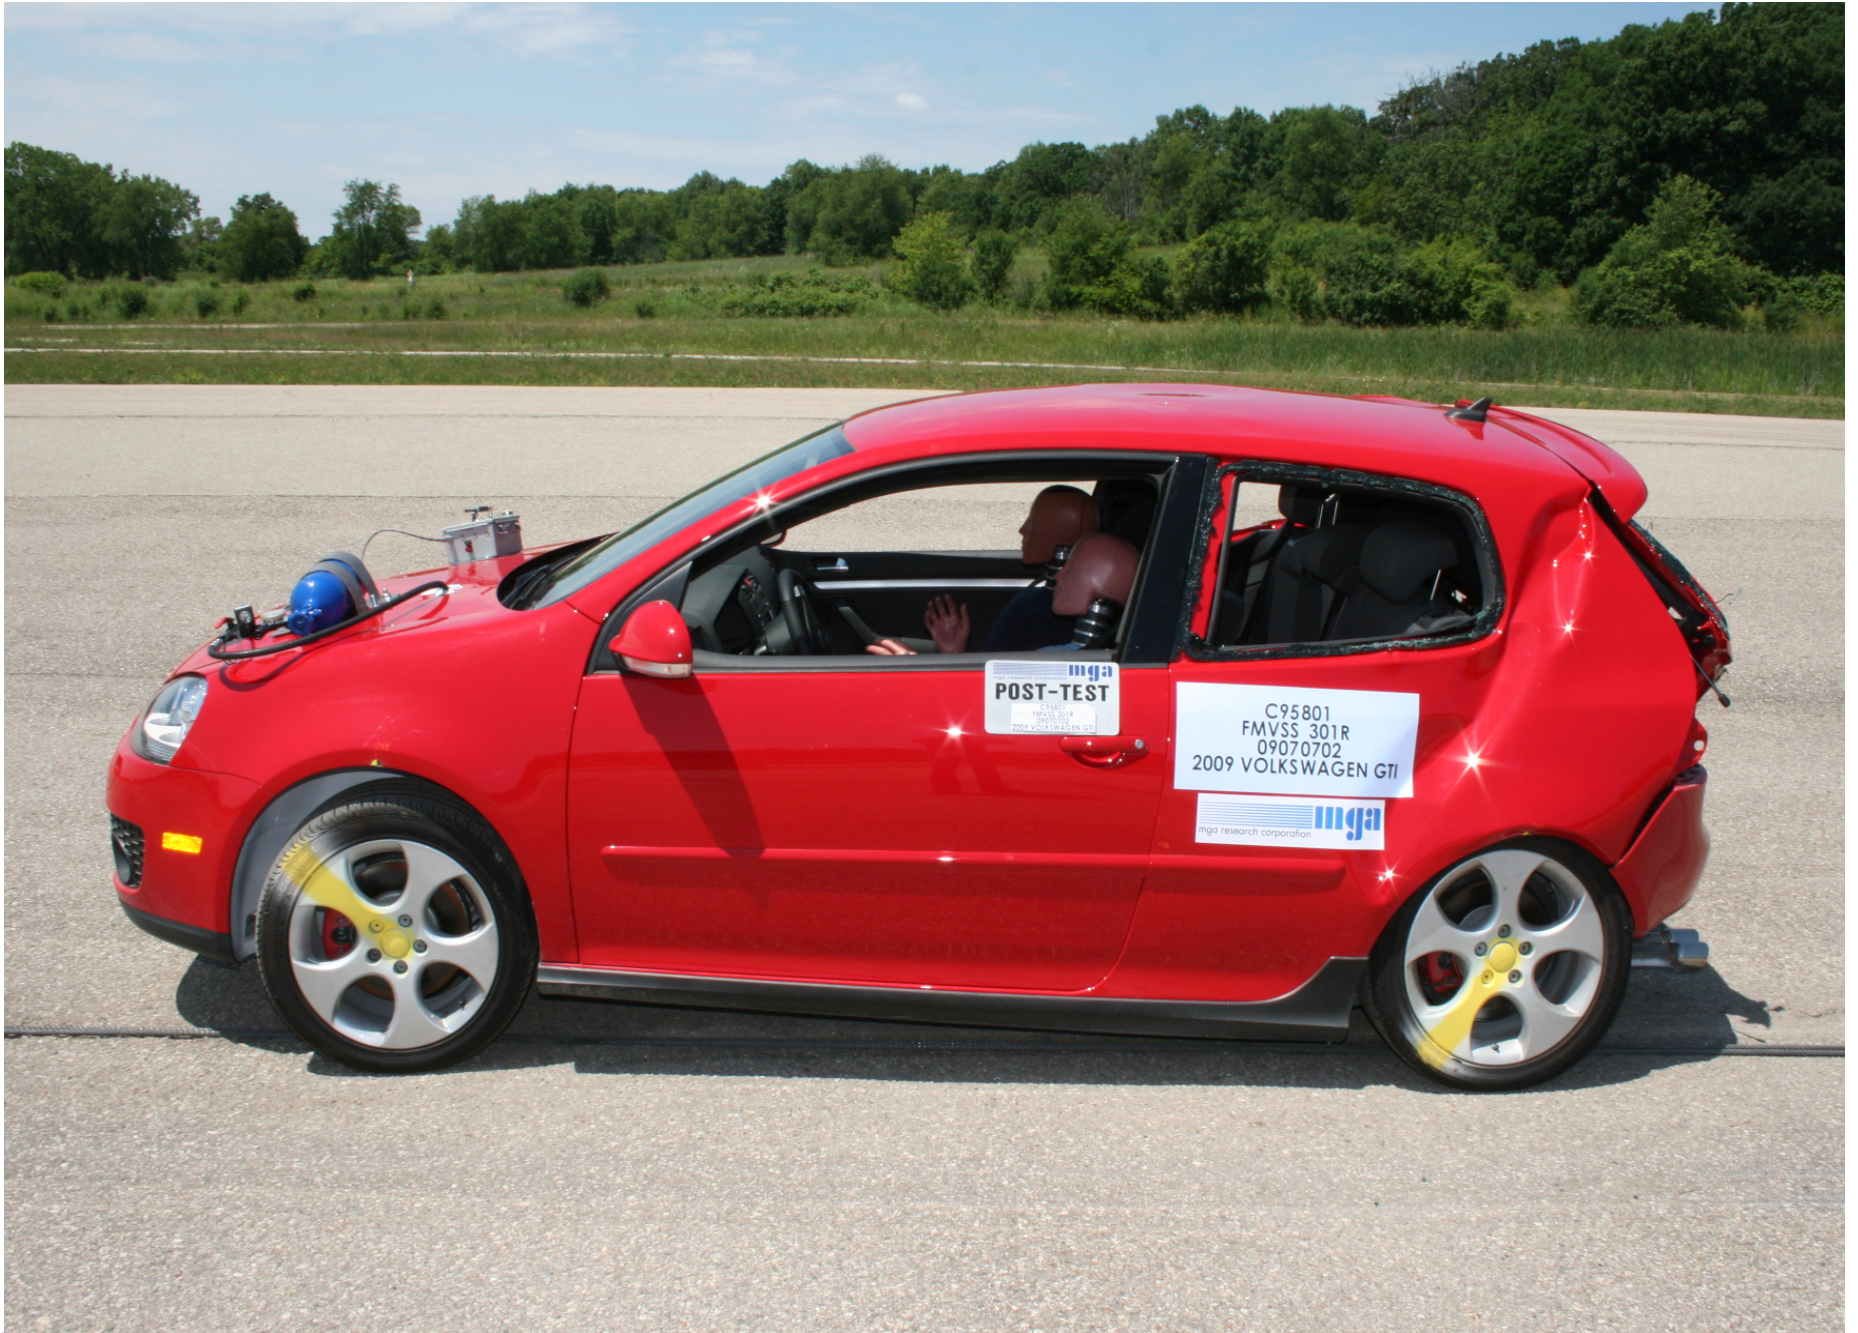
A-6.

Post-Test Left Side View of Vehicle

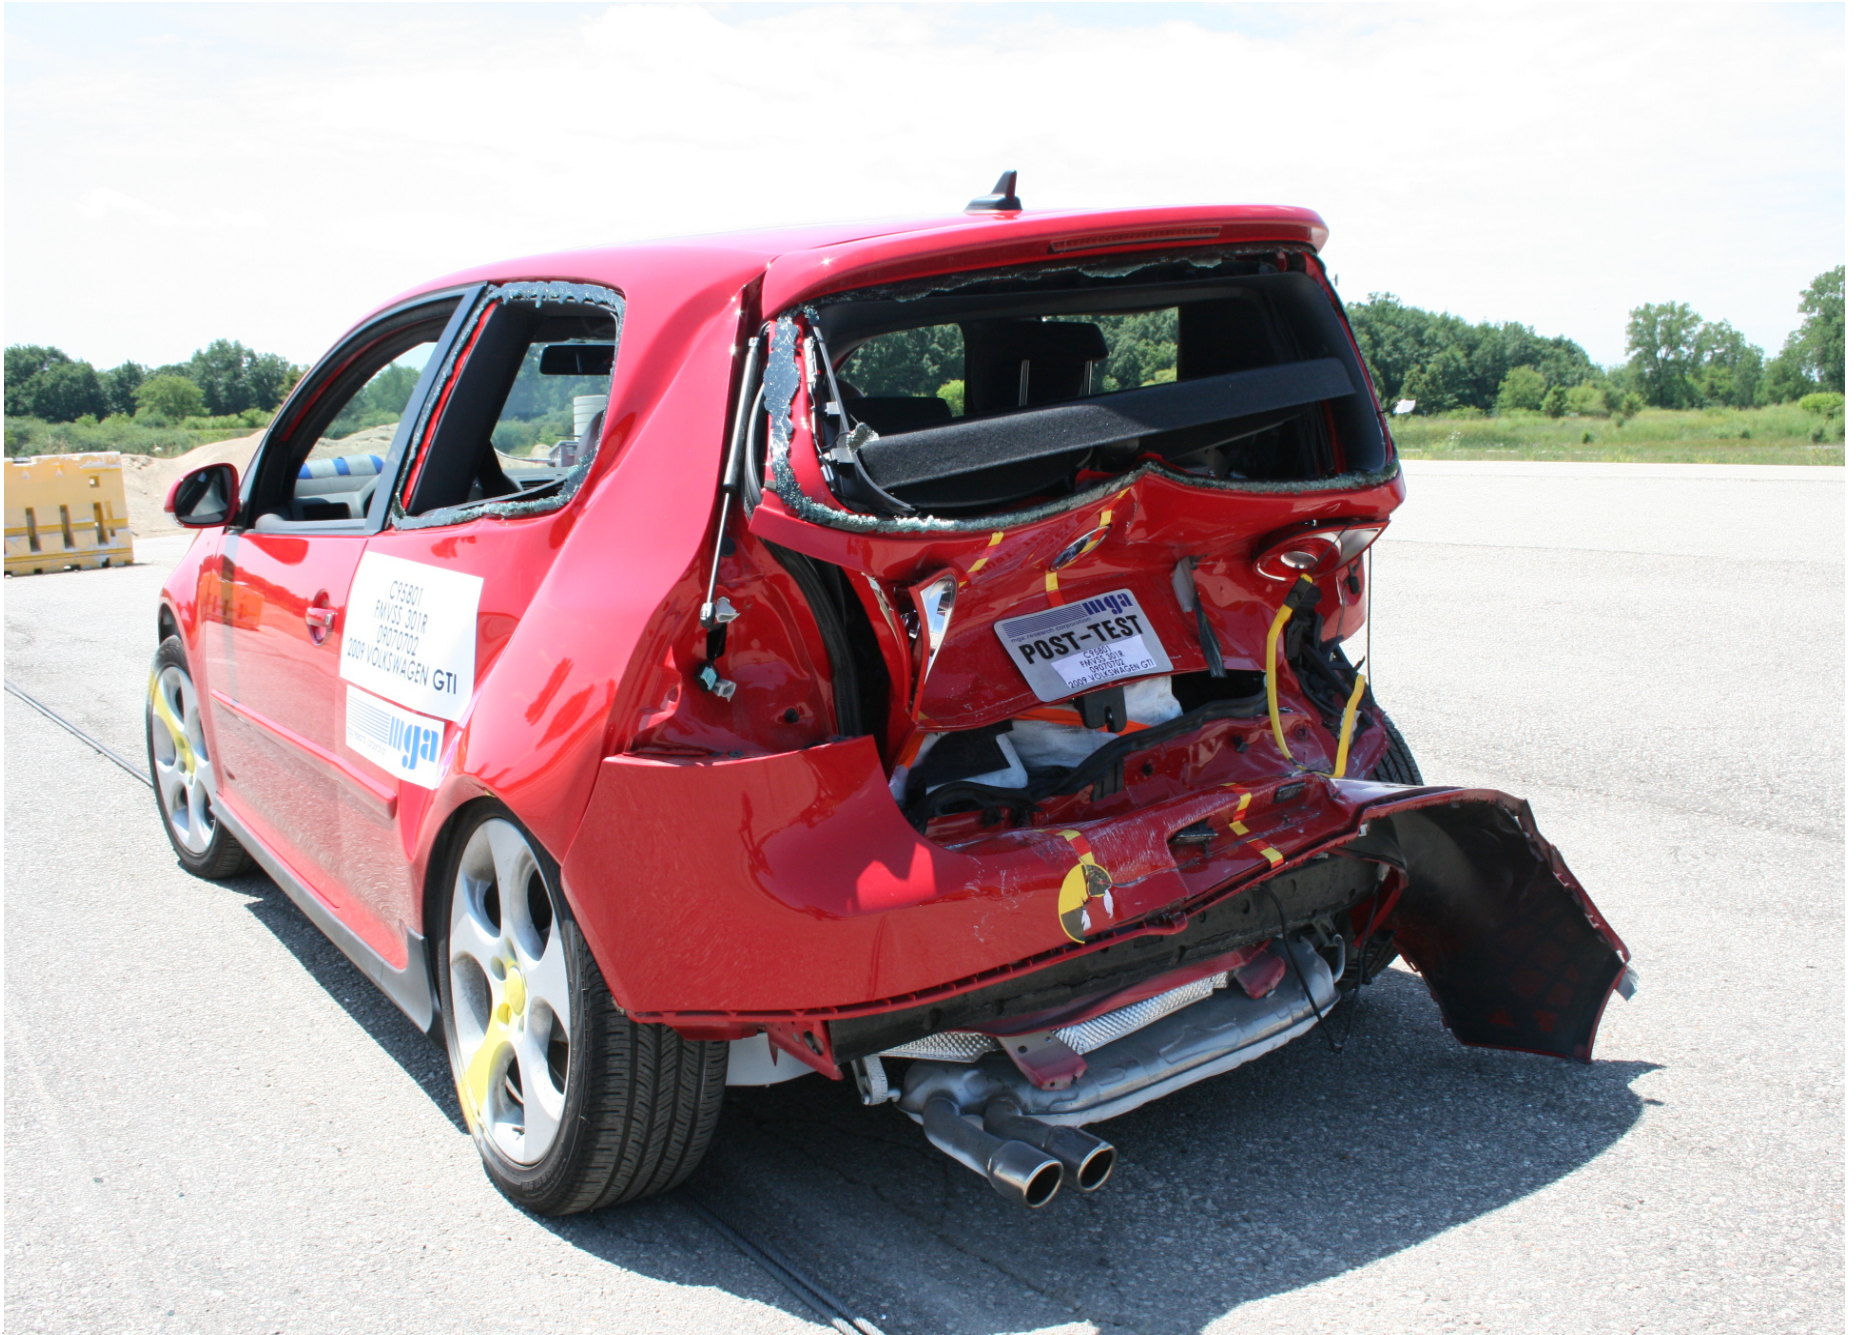
A-8.

Post-Test Left Rear Close-up View of Vehicle

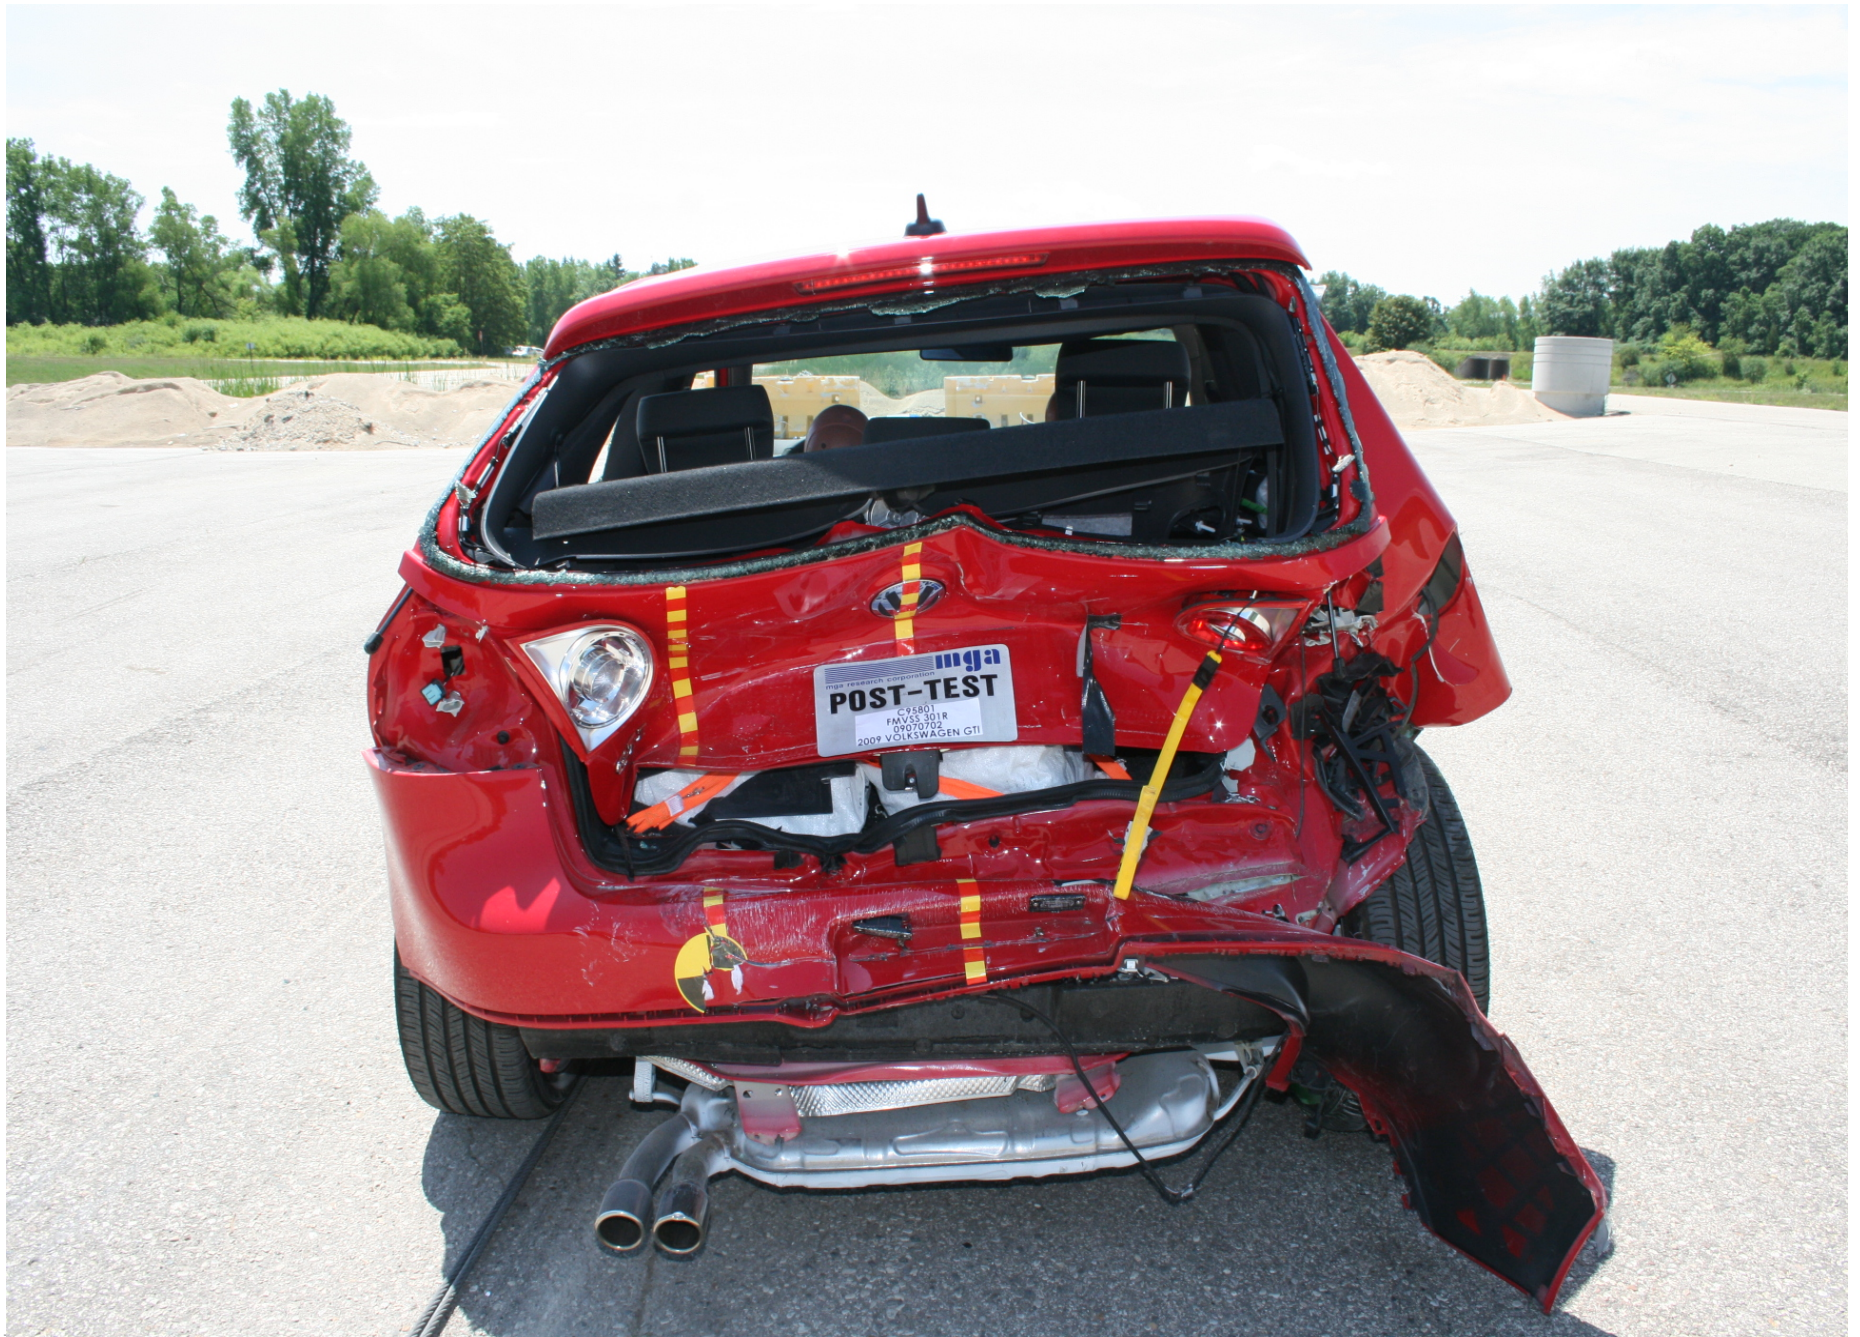
A-14.

Post-Test Rear View of Vehicle

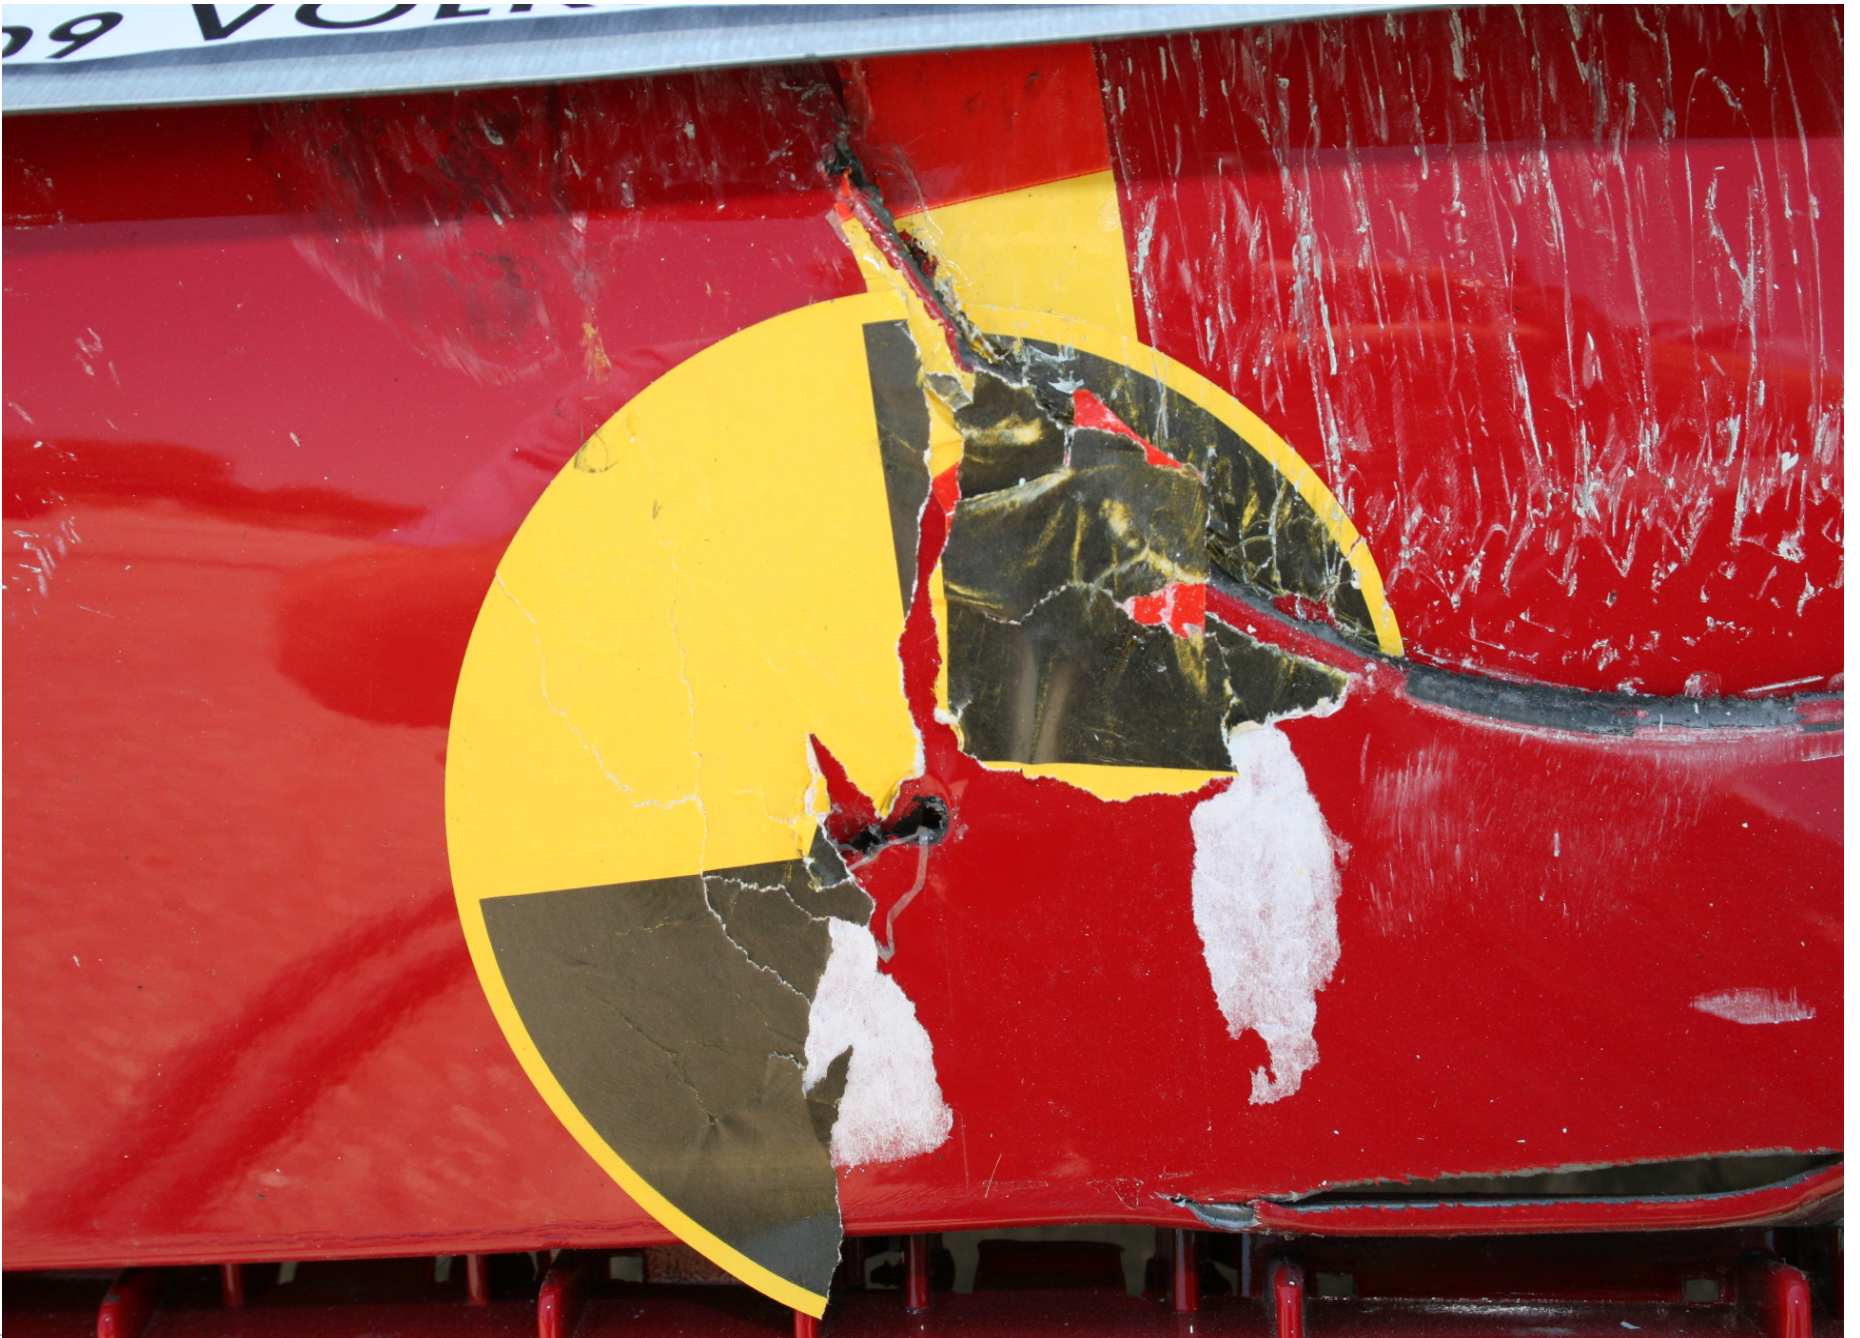
A-22.

Post-Test Impact Point

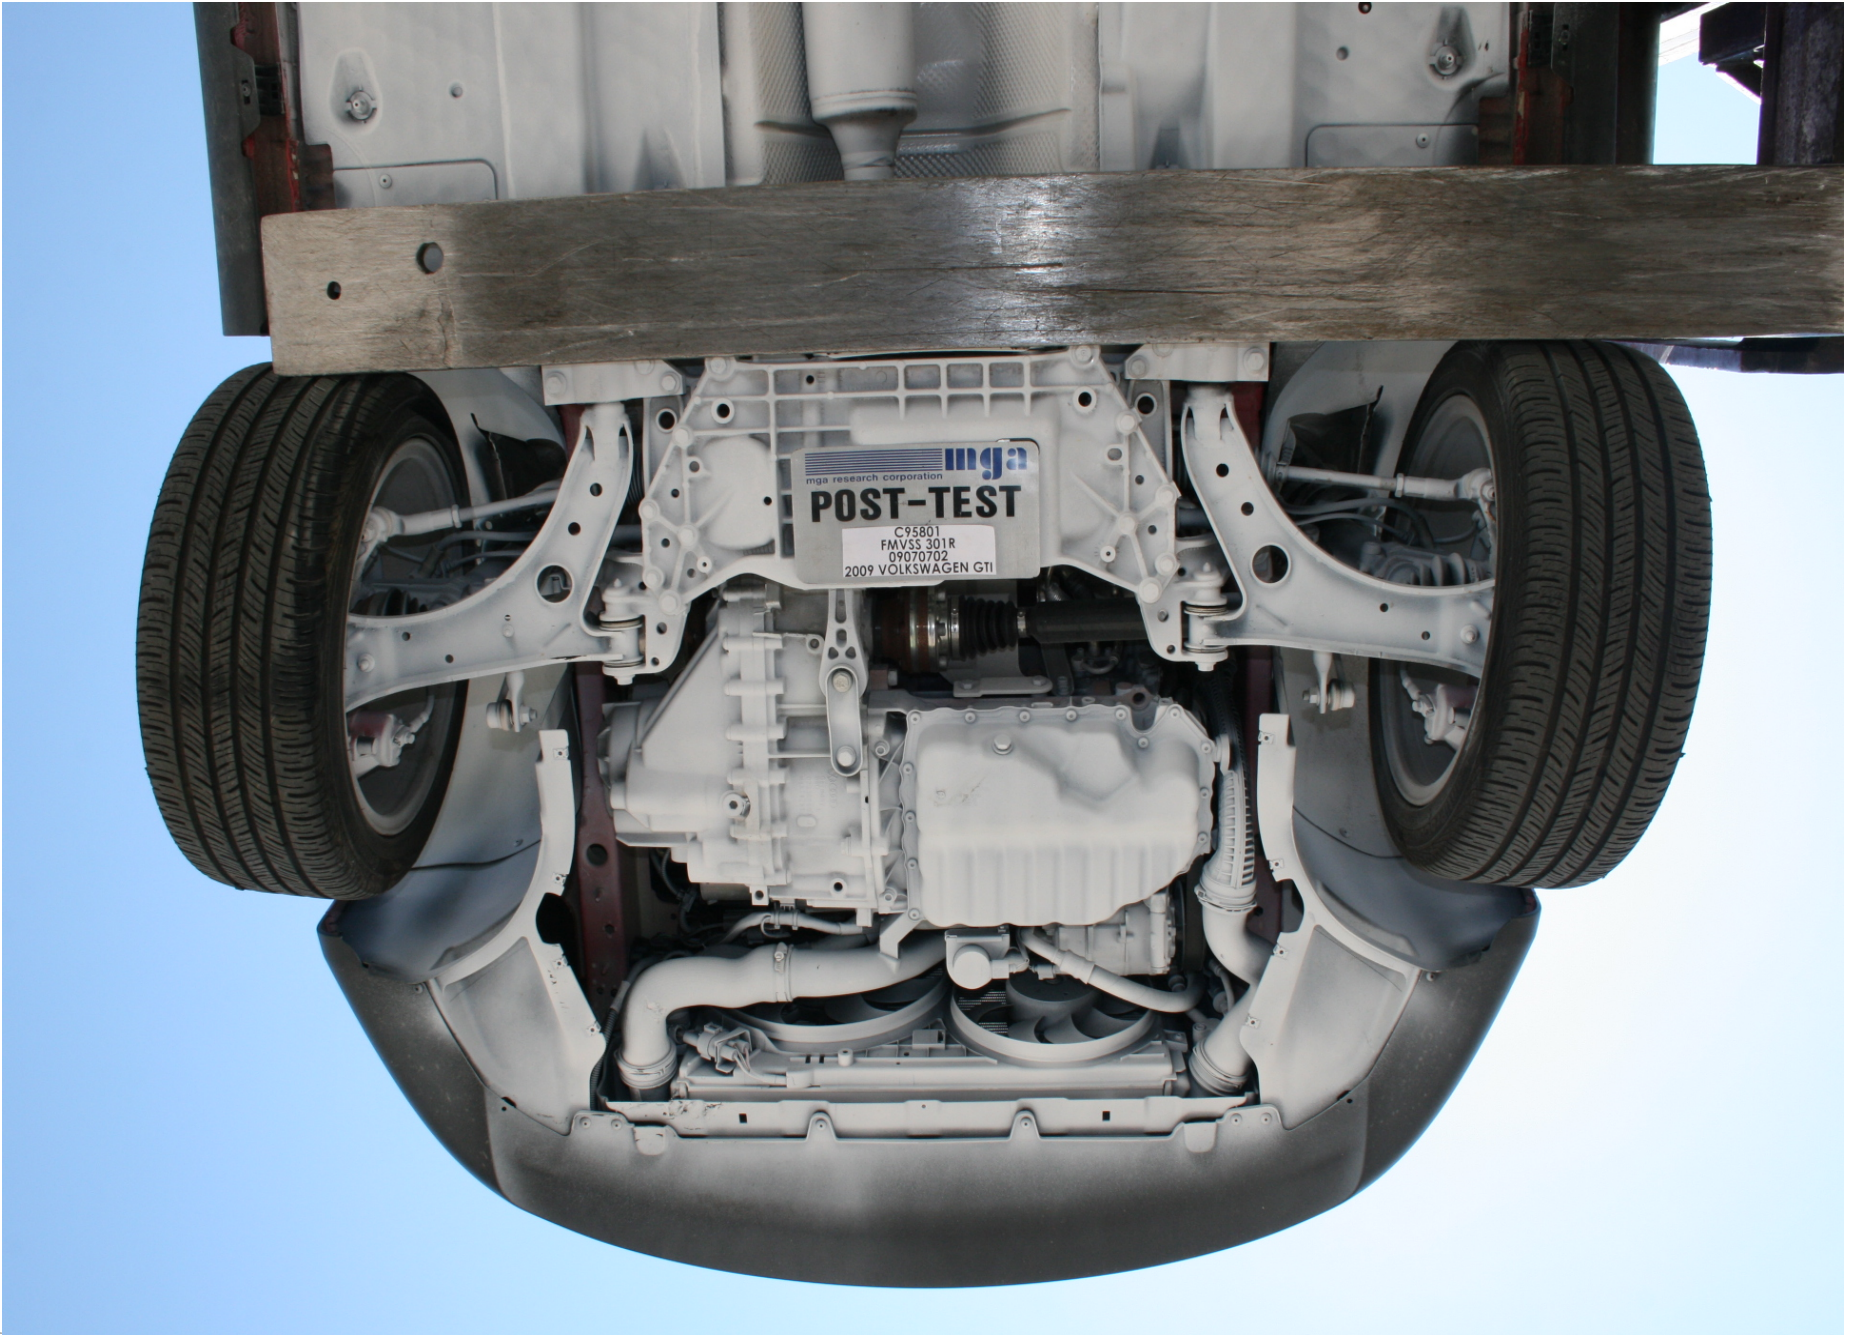
A-24.

Post-Test Underbody View 1

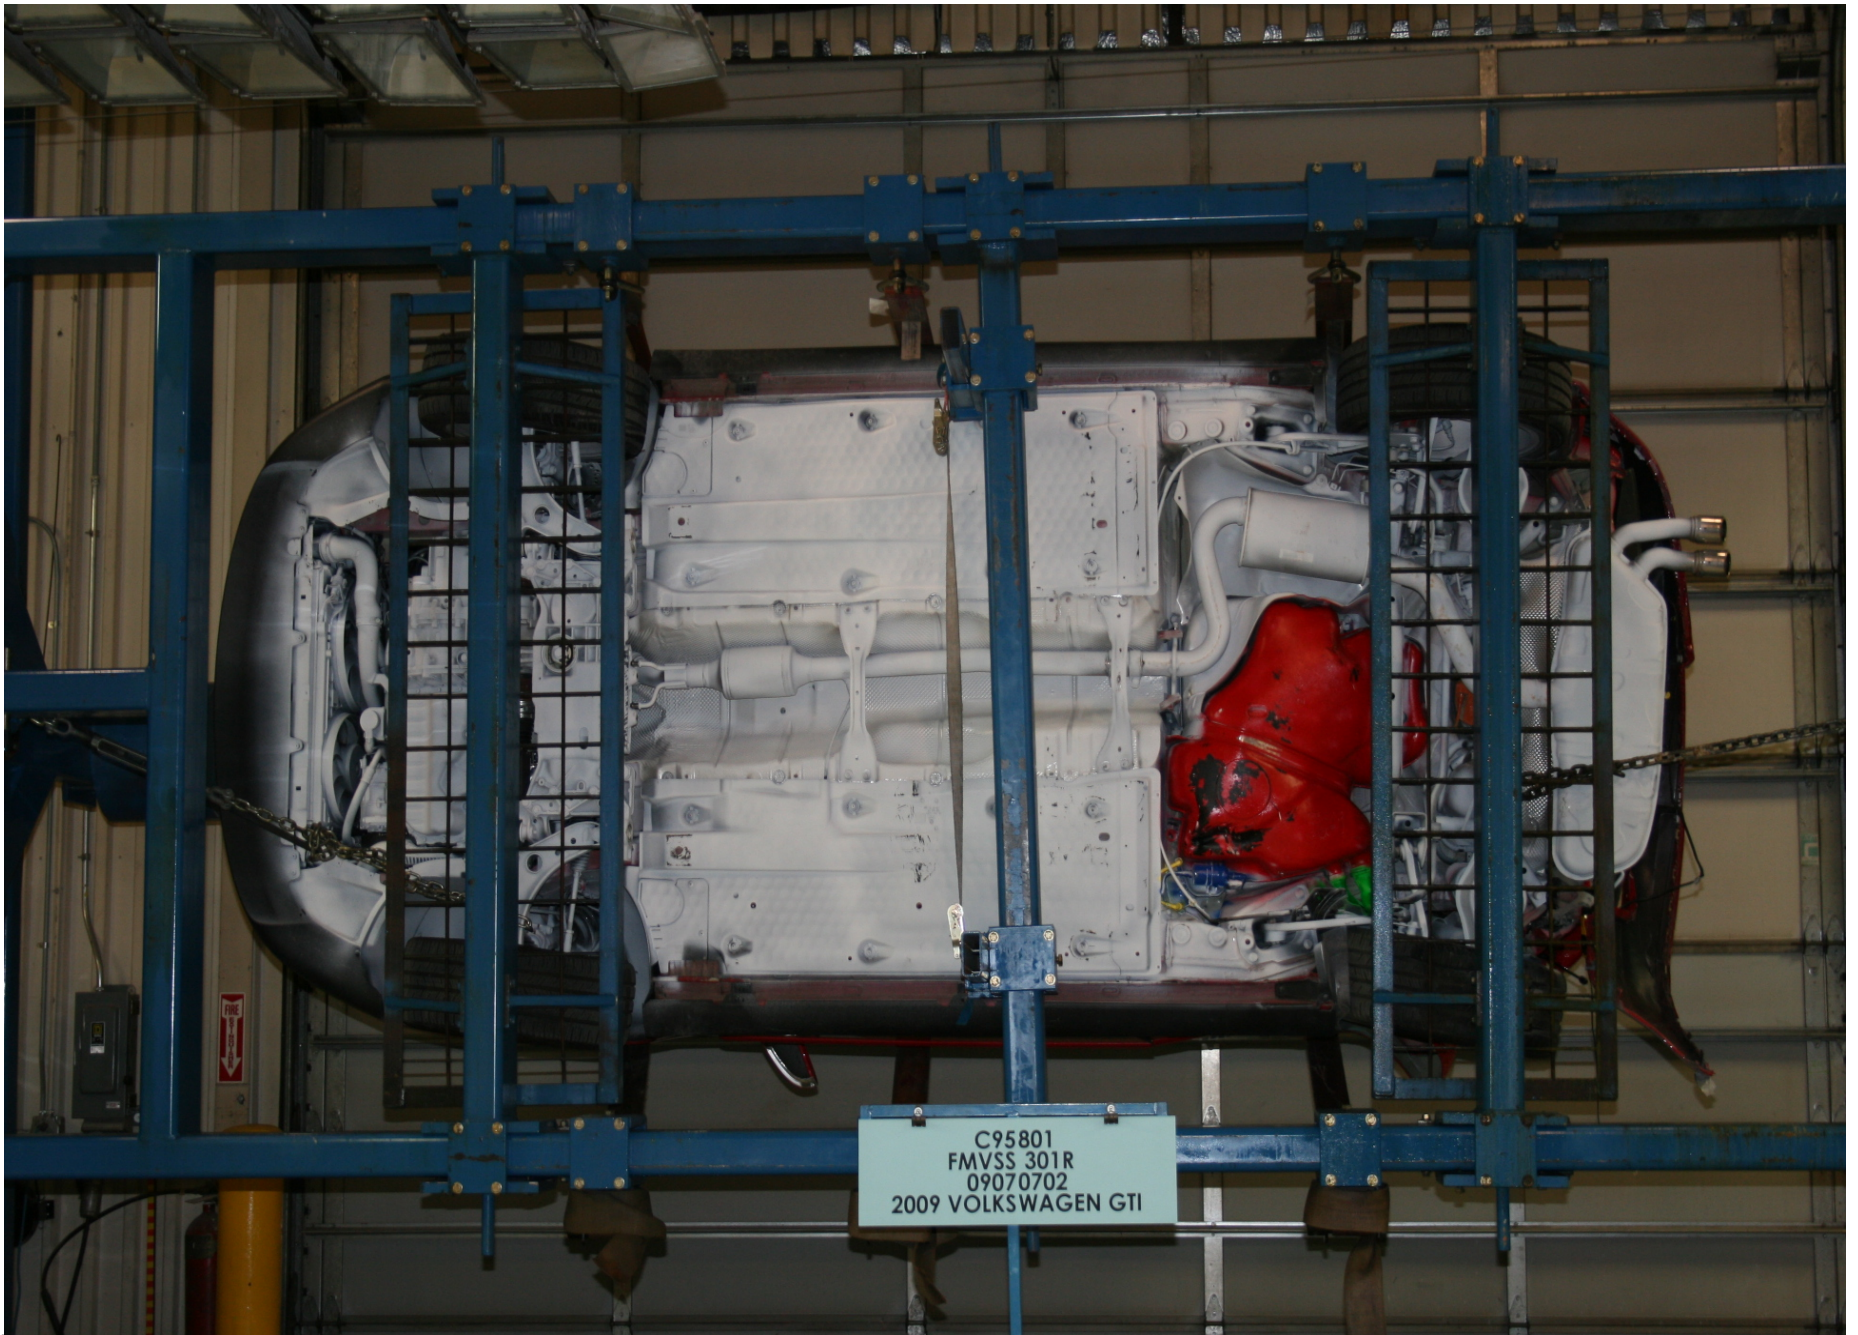
A-37.

Static Rollover at 90 Degrees

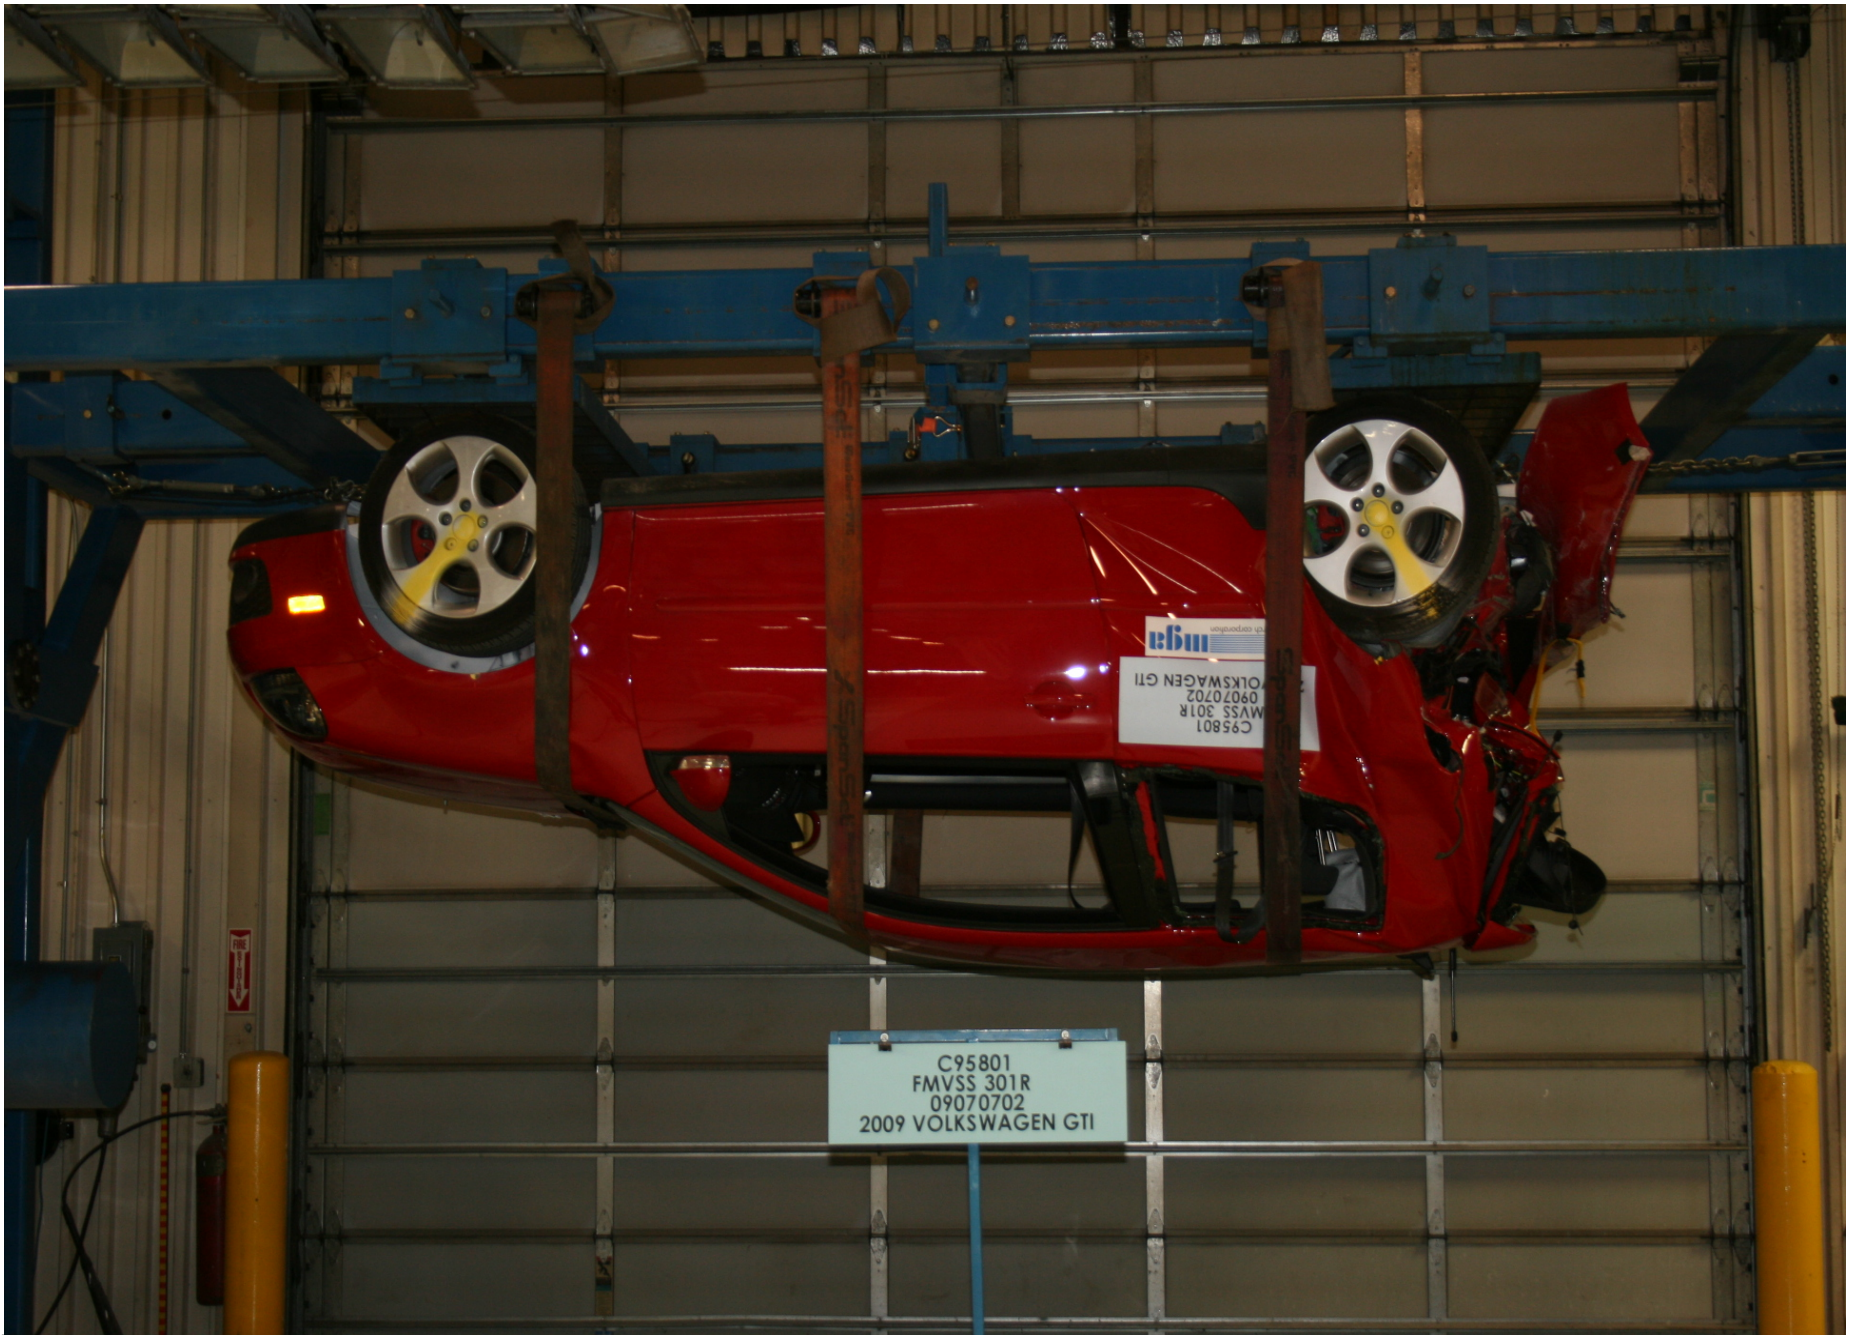
A-38.

Static Rollover at 180 Degrees

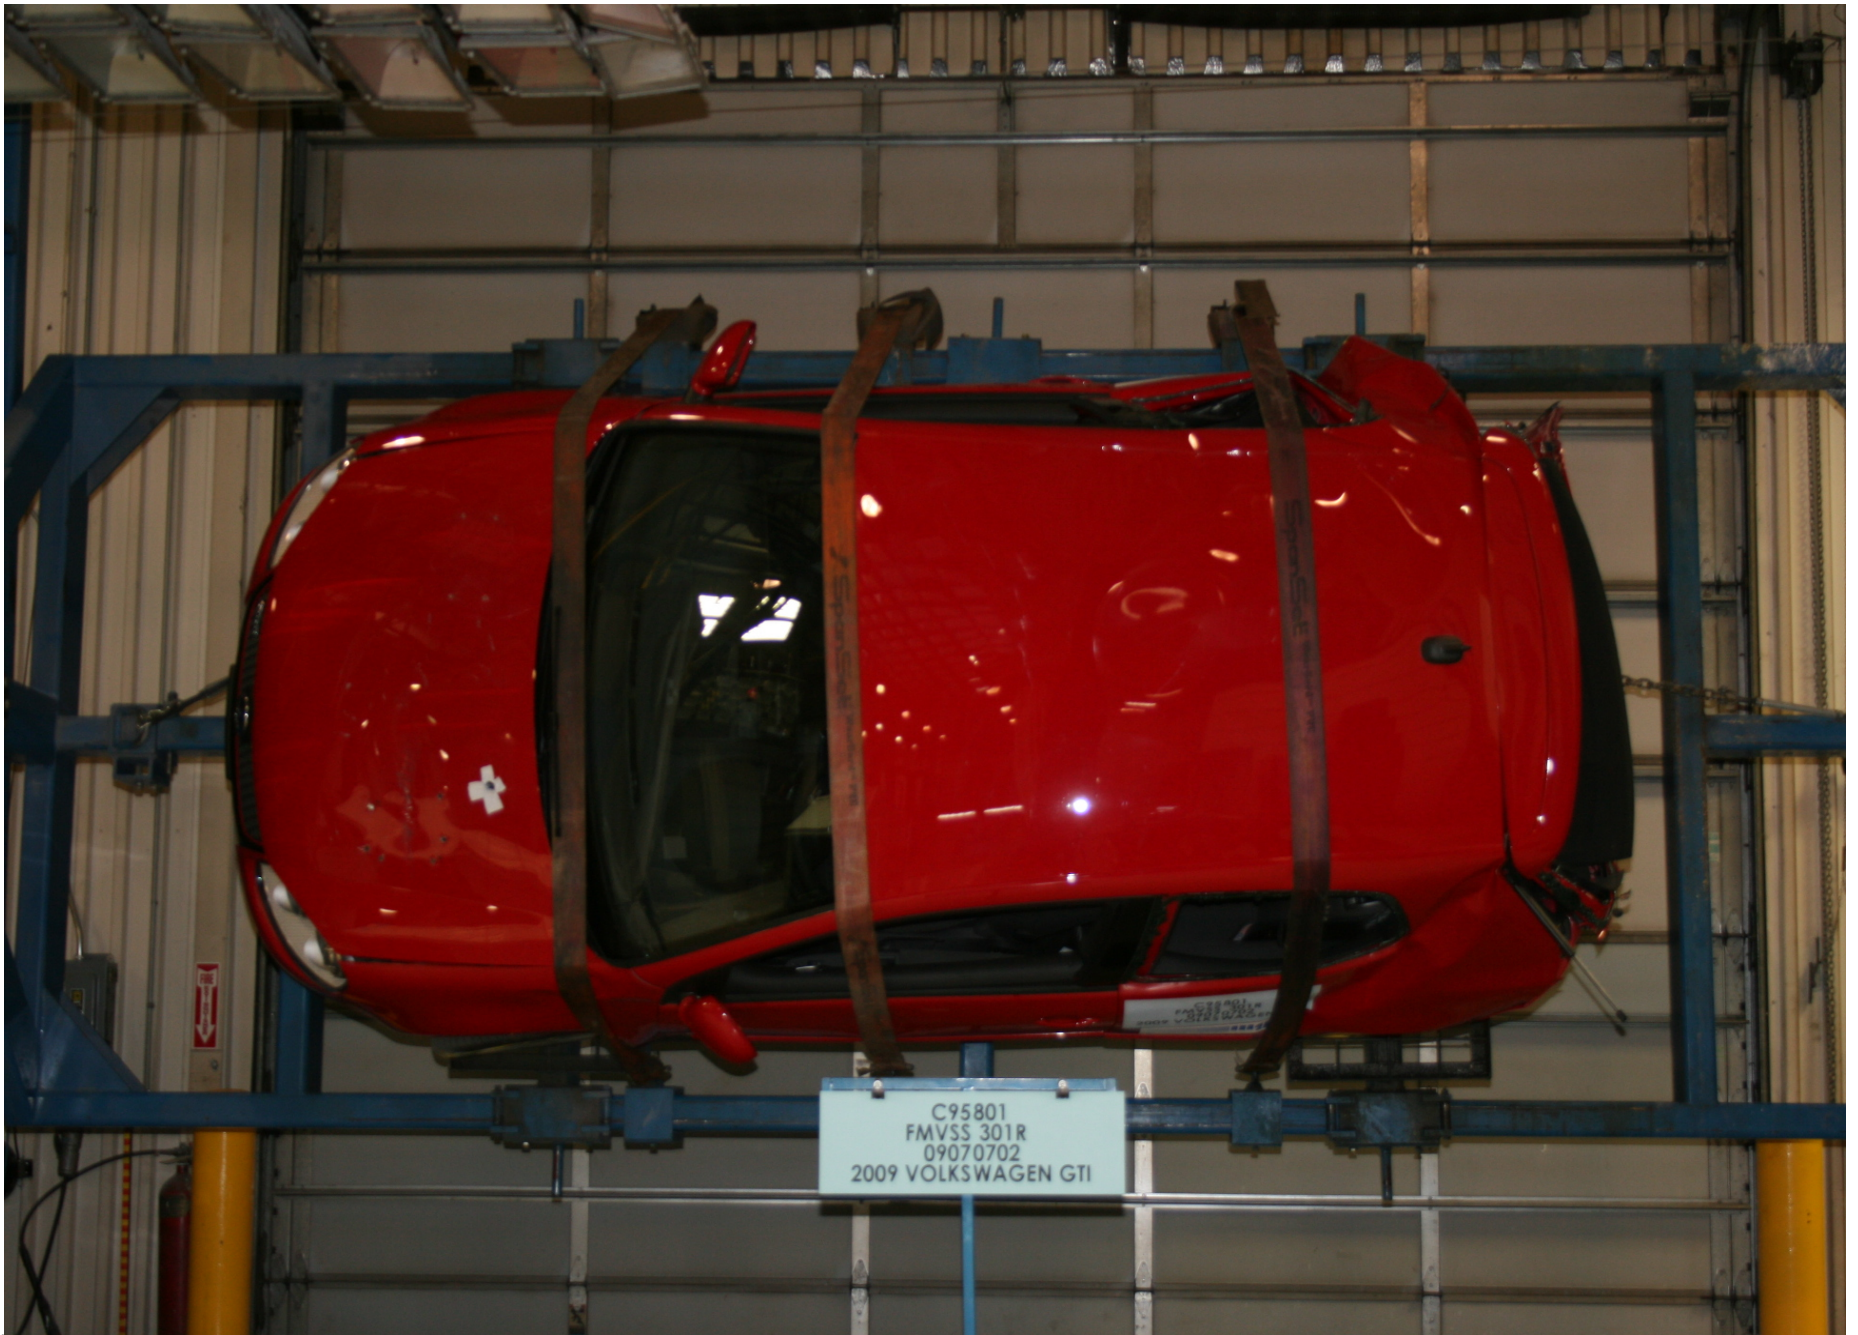
A-39.

Static Rollover at 270 Degrees
