REPORT NUMBER: 301-MGA-2009-006

**SAFETY COMPLIANCE TESTING FOR FMVSS 301R
FUEL SYSTEM INTEGRITY – REAR IMPACT**

**VOLKSWAGEN AG GERMANY
2009 VOLKSWAGEN GTI
NHTSA NUMBER: C95801**

**PREPARED BY:
MGA RESEARCH CORPORATION
5000 WARREN ROAD
BURLINGTON, WI 53105**

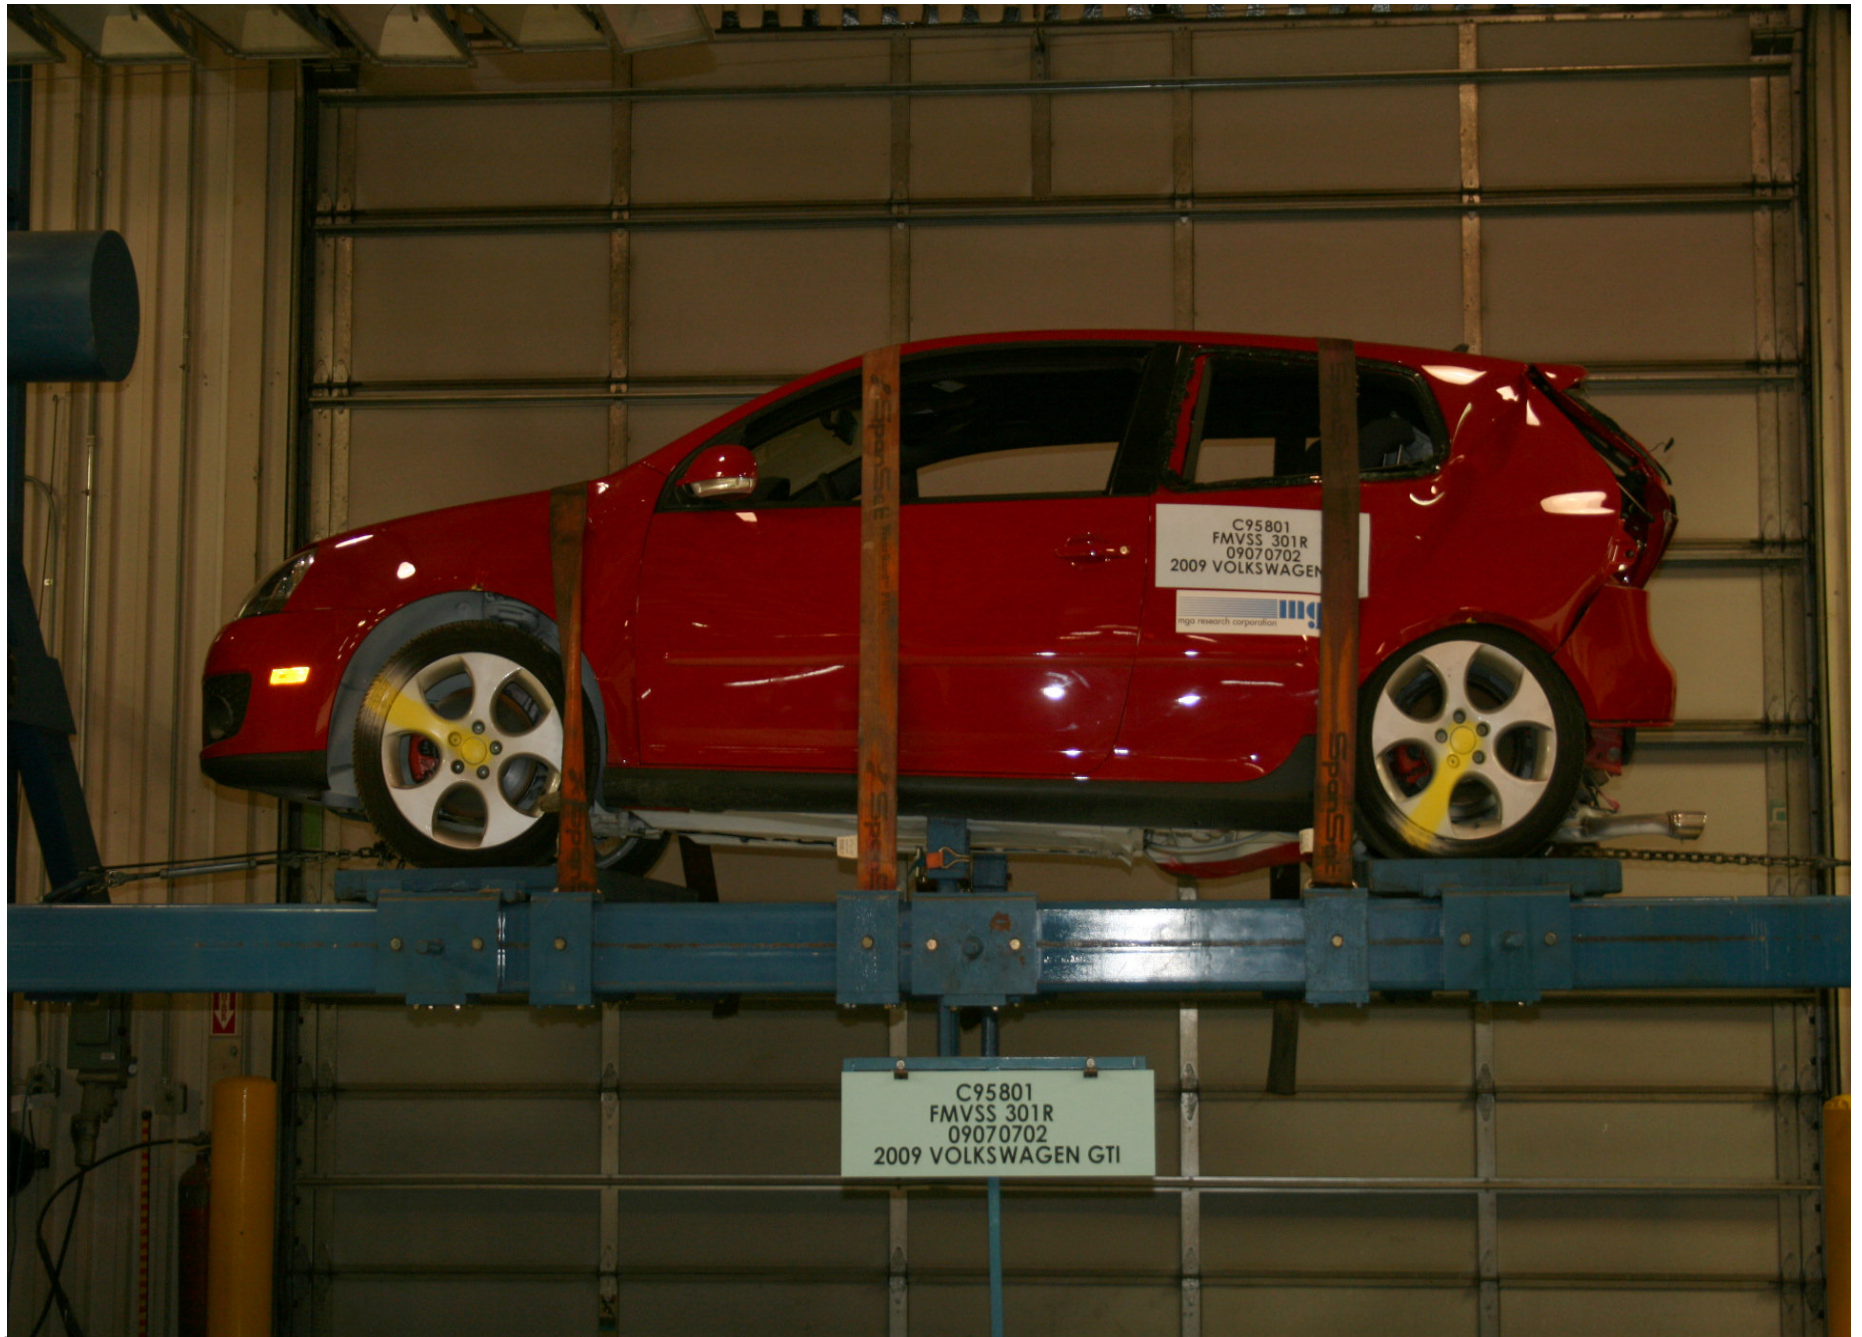
A-40.

Static Rollover at 360 Degrees
