**REPORT NUMBER: 301-MGA-2010-005**

**SAFETY COMPLIANCE TESTING FOR FMVSS 301R  
FUEL SYSTEM INTEGRITY – REAR IMPACT**

**NISSAN MOTOR COMPANY LTD  
2010 NISSAN CUBE  
NHTSA NUMBER: CA5201**

**PREPARED BY:  
MGA RESEARCH CORPORATION  
5000 WARREN ROAD  
BURLINGTON, WI 53105**

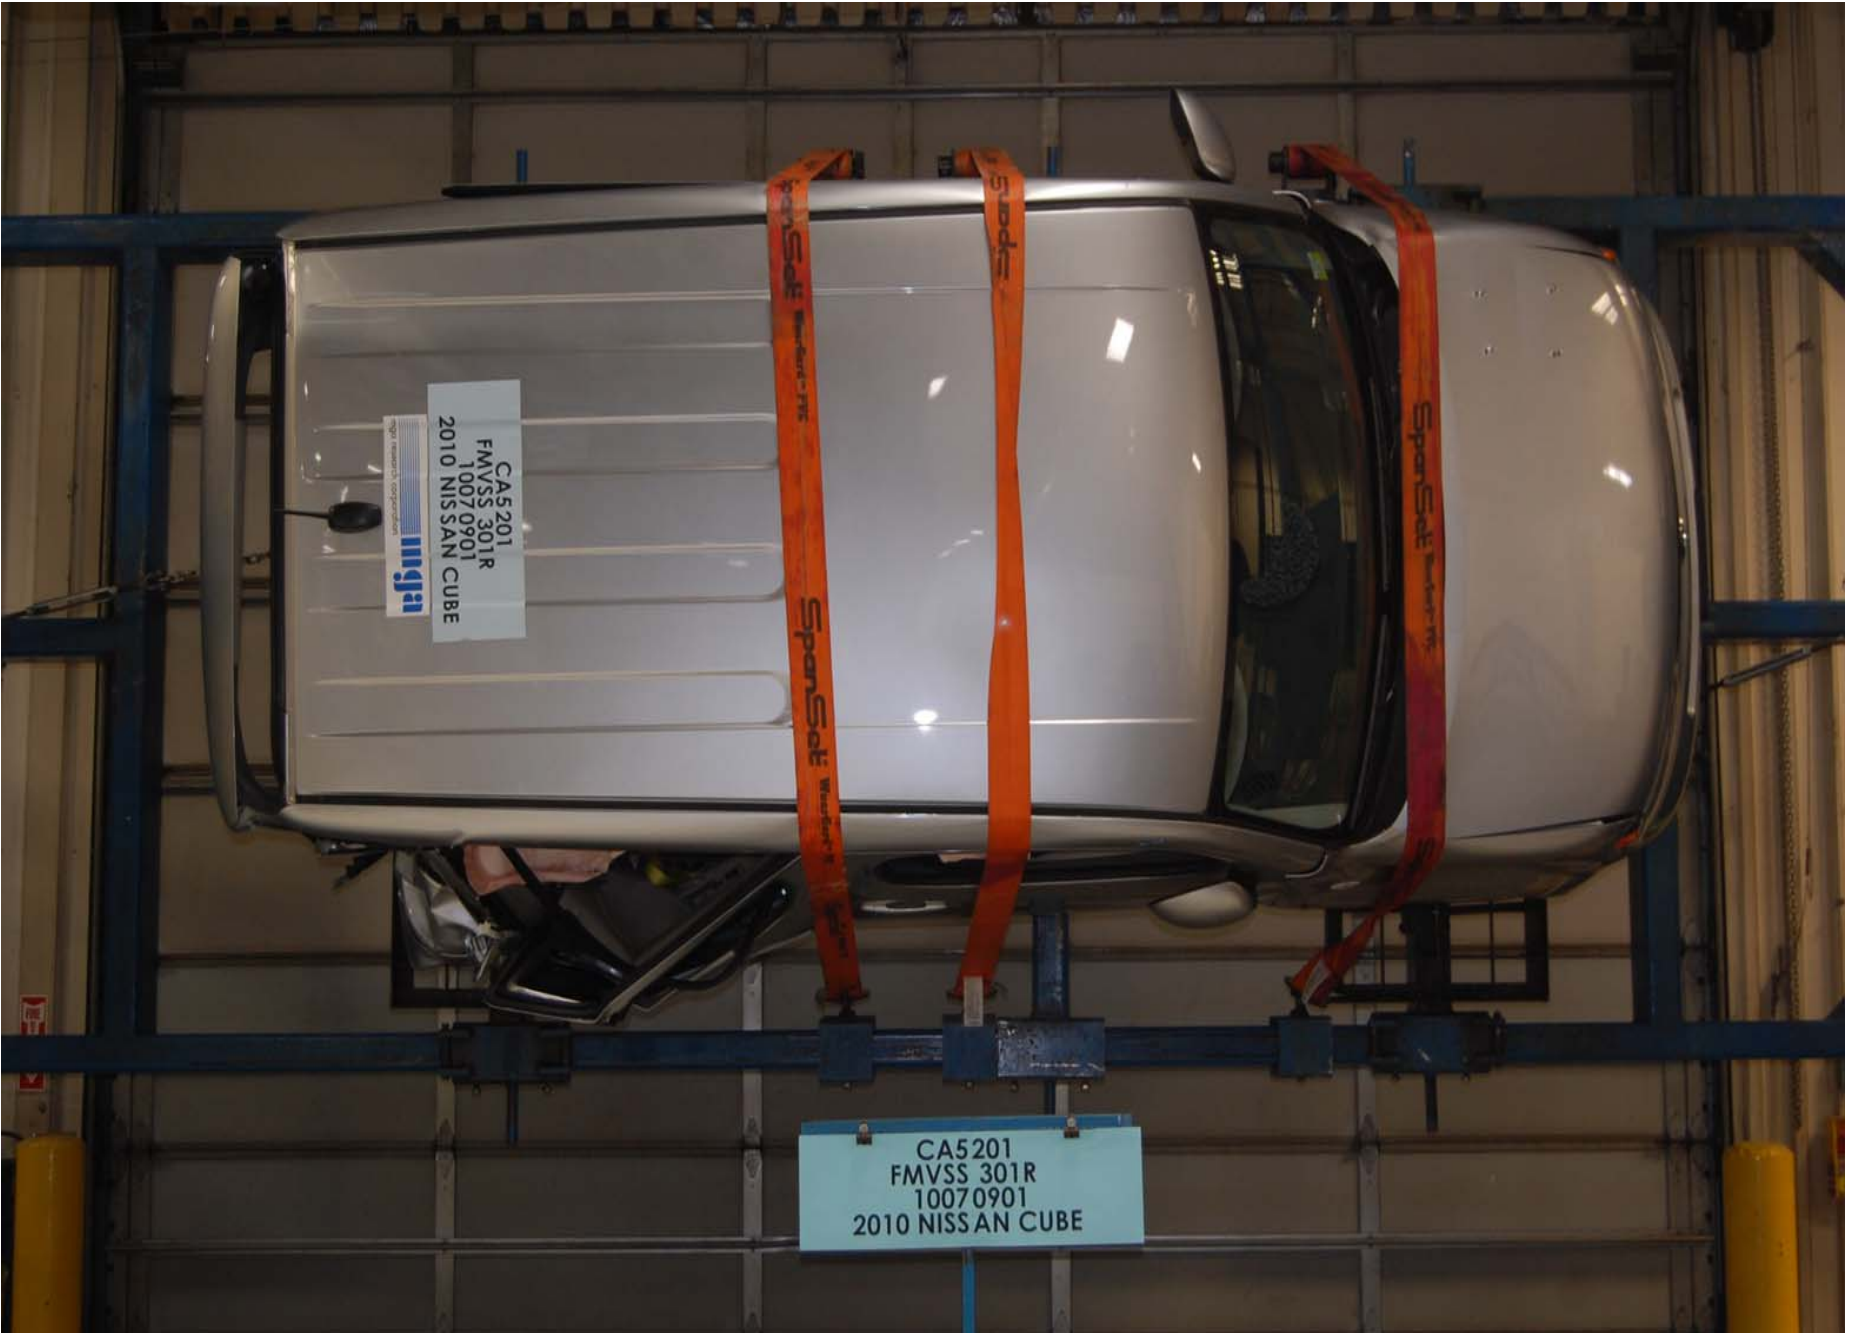
| APPARENT TEST FAILURE DESCRIPTION: | The test vehicle was subjected to a 301R Fuel System Integrity test. During the 301 Static Rollover portion of the test Stoddard spillage was collected and measured. From the onset of rotation at 0 degrees for the first five minutes a total of 358 grams of Stoddard was collected. |
| FMVSS REQUIREMENT, PARAGRAPH(S) : | FMVSS 571.301 S5.6: Fuel Spillage in any rollover test, from the onset of rotational motion, shall not exceed a total of 142 g for the first 5 minutes of testing at each successive 90° increment. |

Static Rollover at 90 Degrees

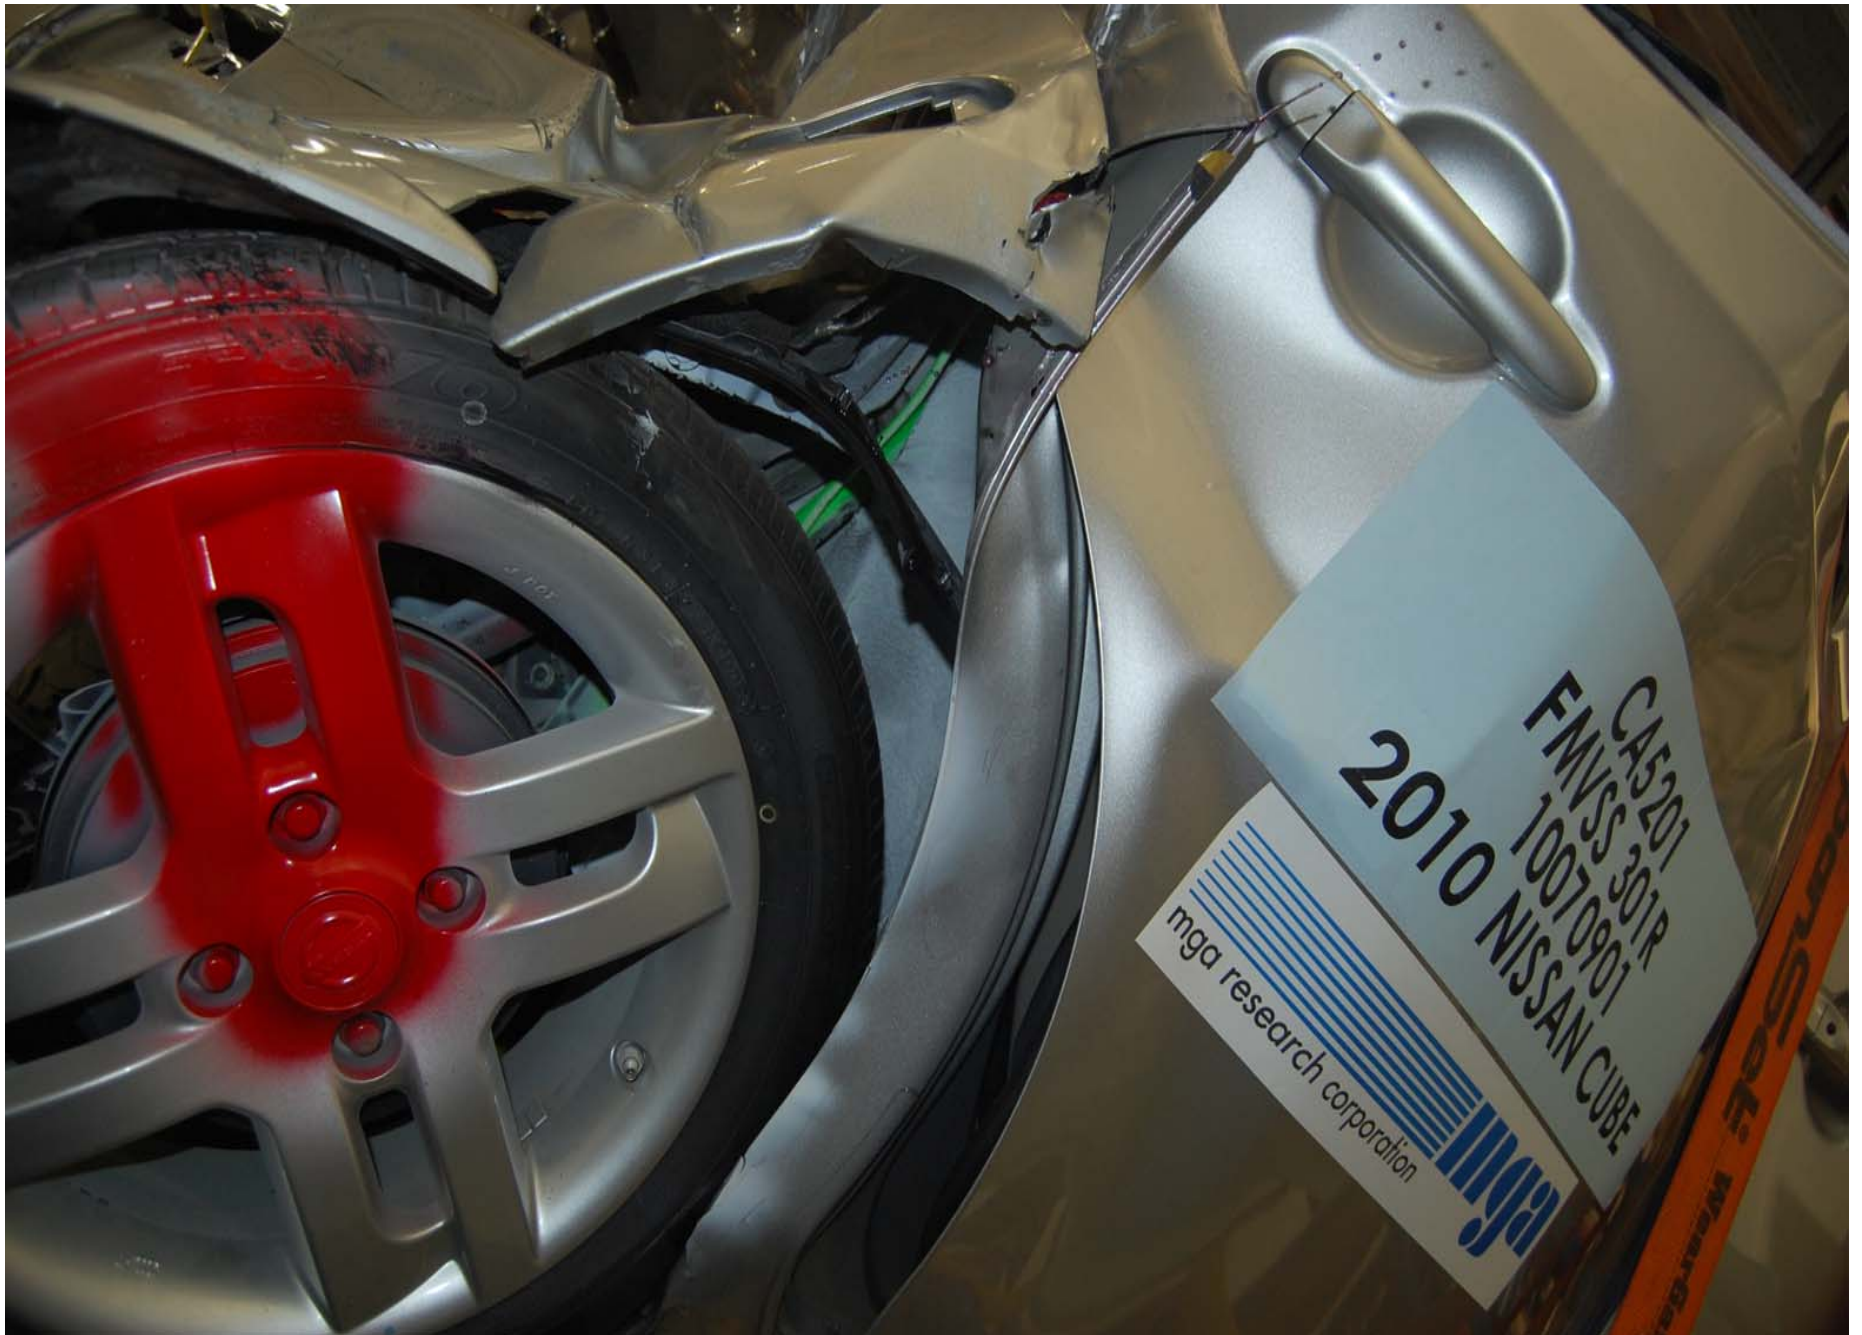
Rotation 90° Clockwise

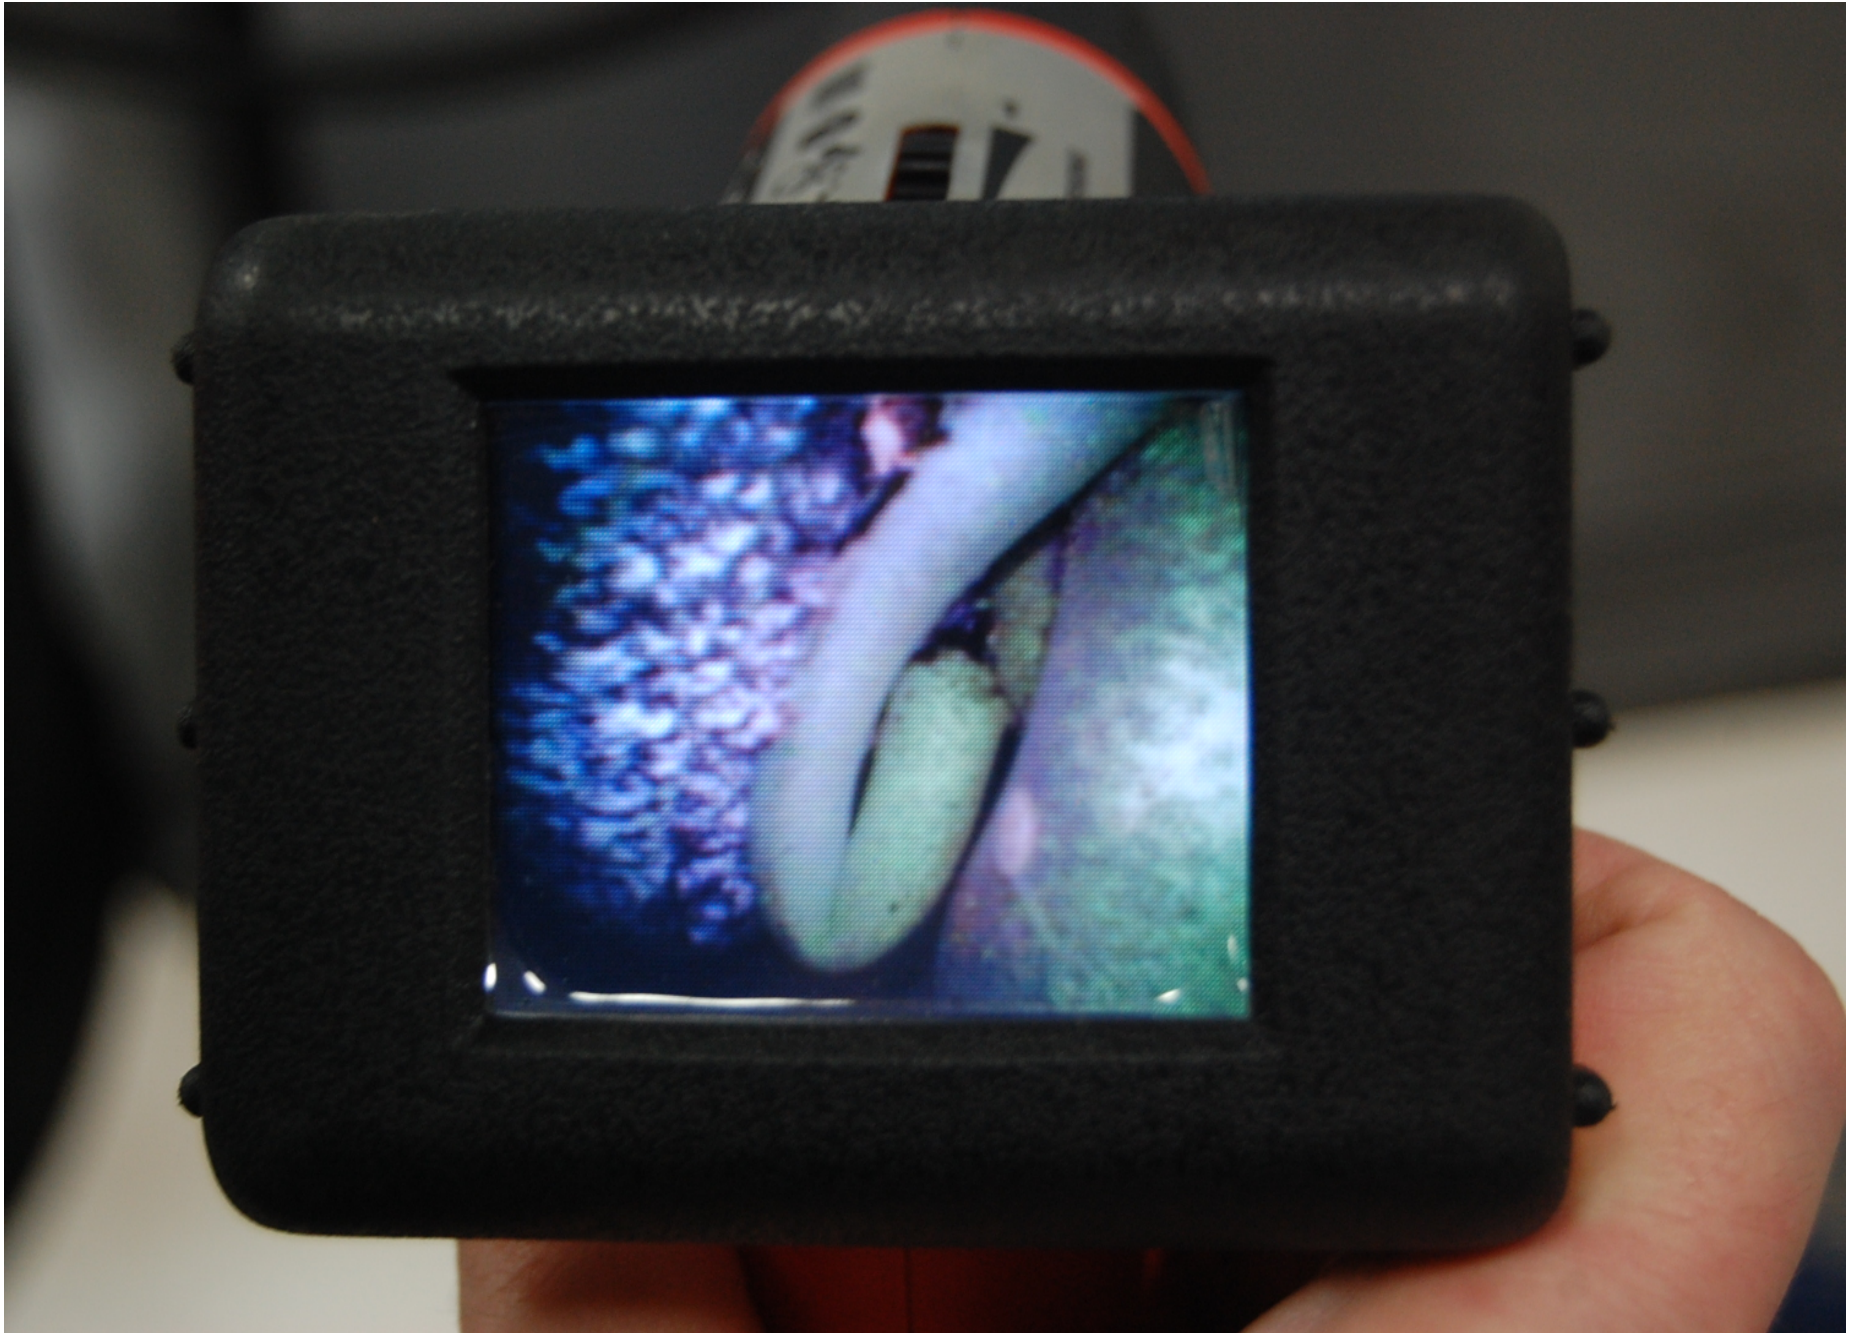
Leak Point at 90°

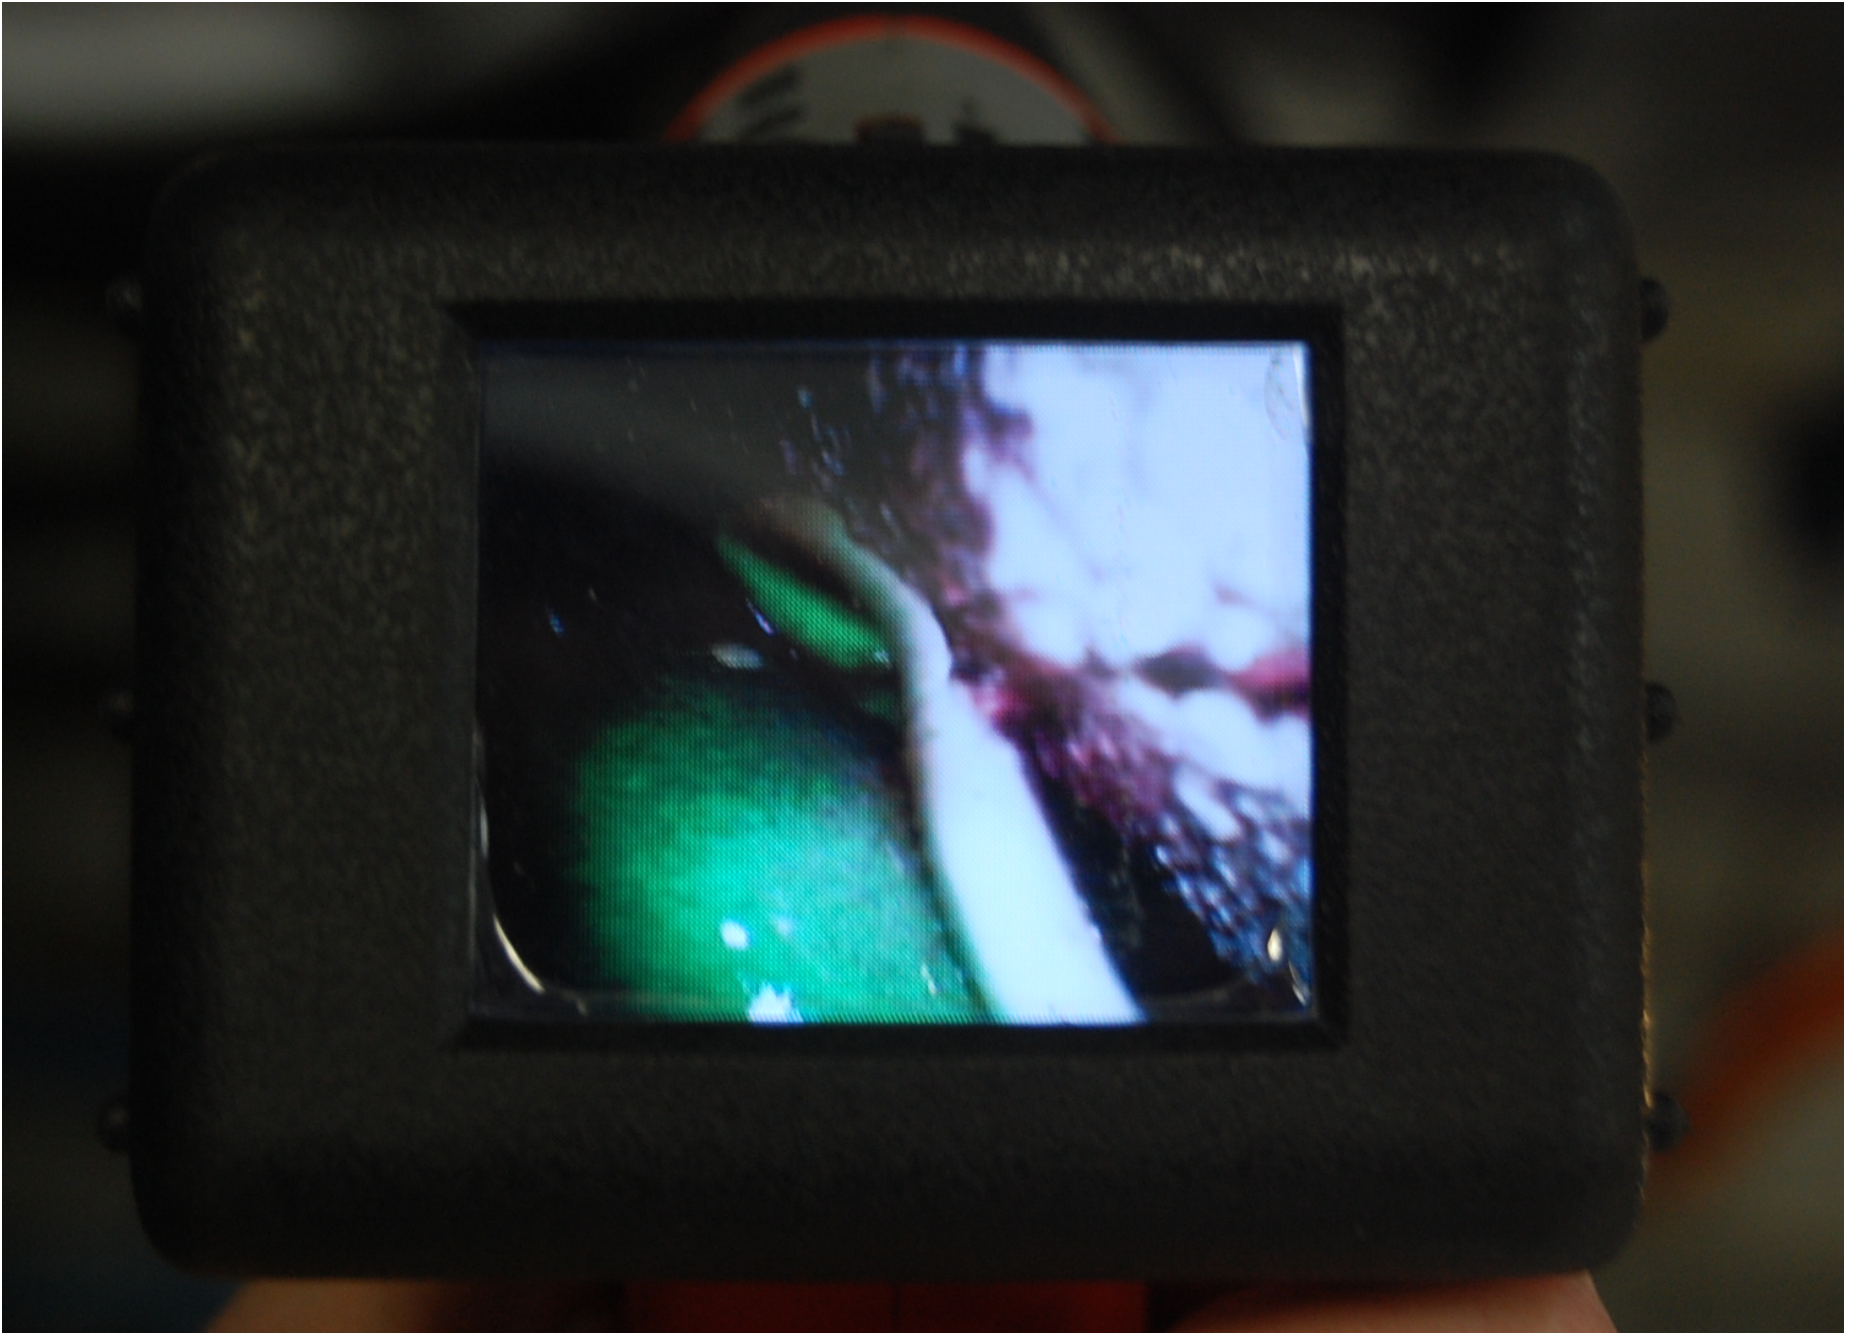
Leak Point Post Inspection
