**REPORT NUMBER: 301-MGA-2011-007**

**SAFETY COMPLIANCE TESTING FOR FMVSS 301R  
FUEL SYSTEM INTEGRITY – REAR IMPACT**

**KIA MOTORS MANUFACTURING  
2011 KIA SORENTO  
NHTSA NUMBER: CB0507**

**PREPARED BY:  
MGA RESEARCH CORPORATION  
5000 WARREN ROAD  
BURLINGTON, WI 53105**

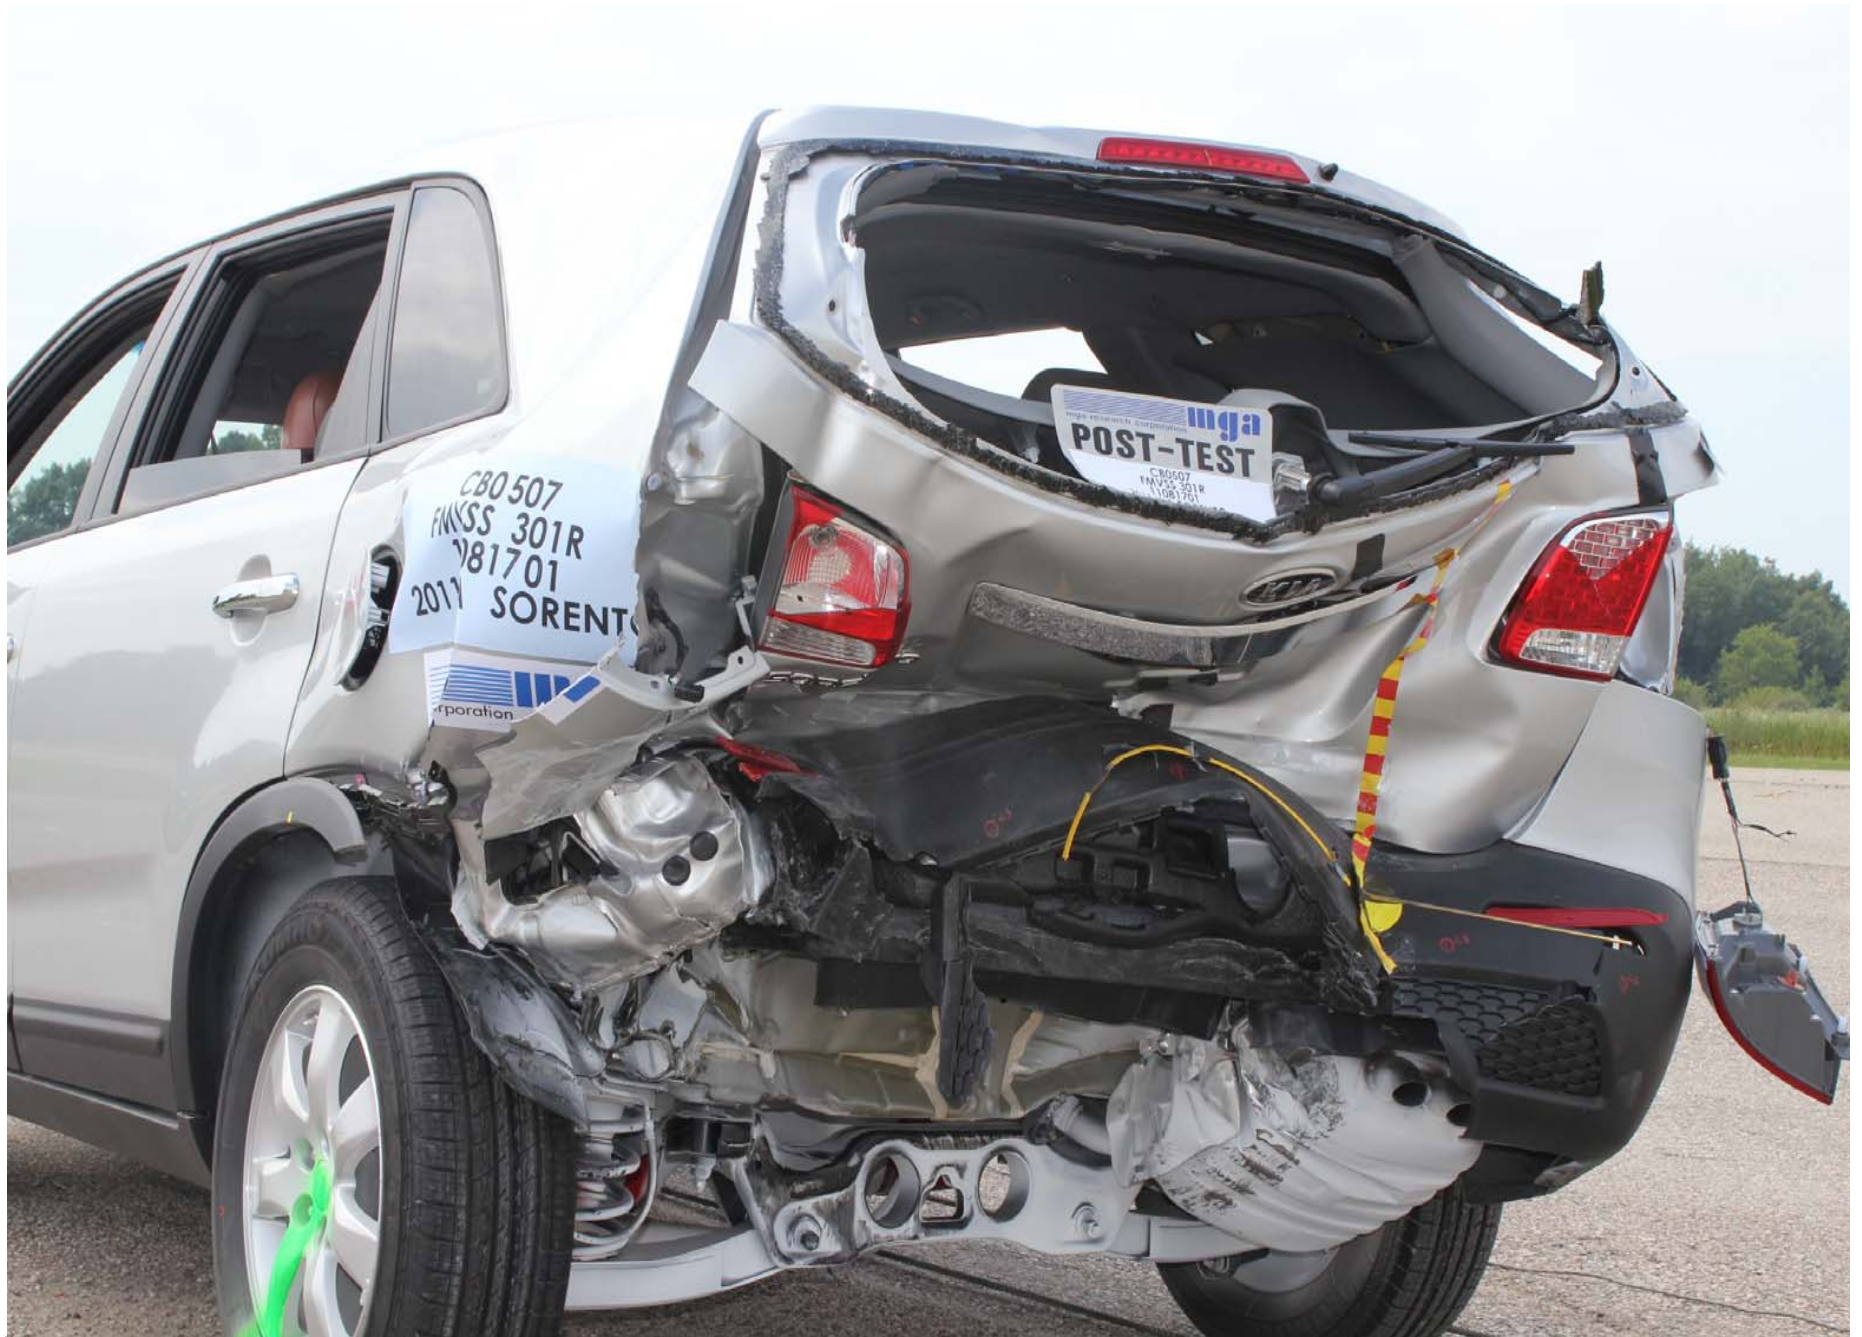
Post-Test Left Rear Close-up View of Vehicle

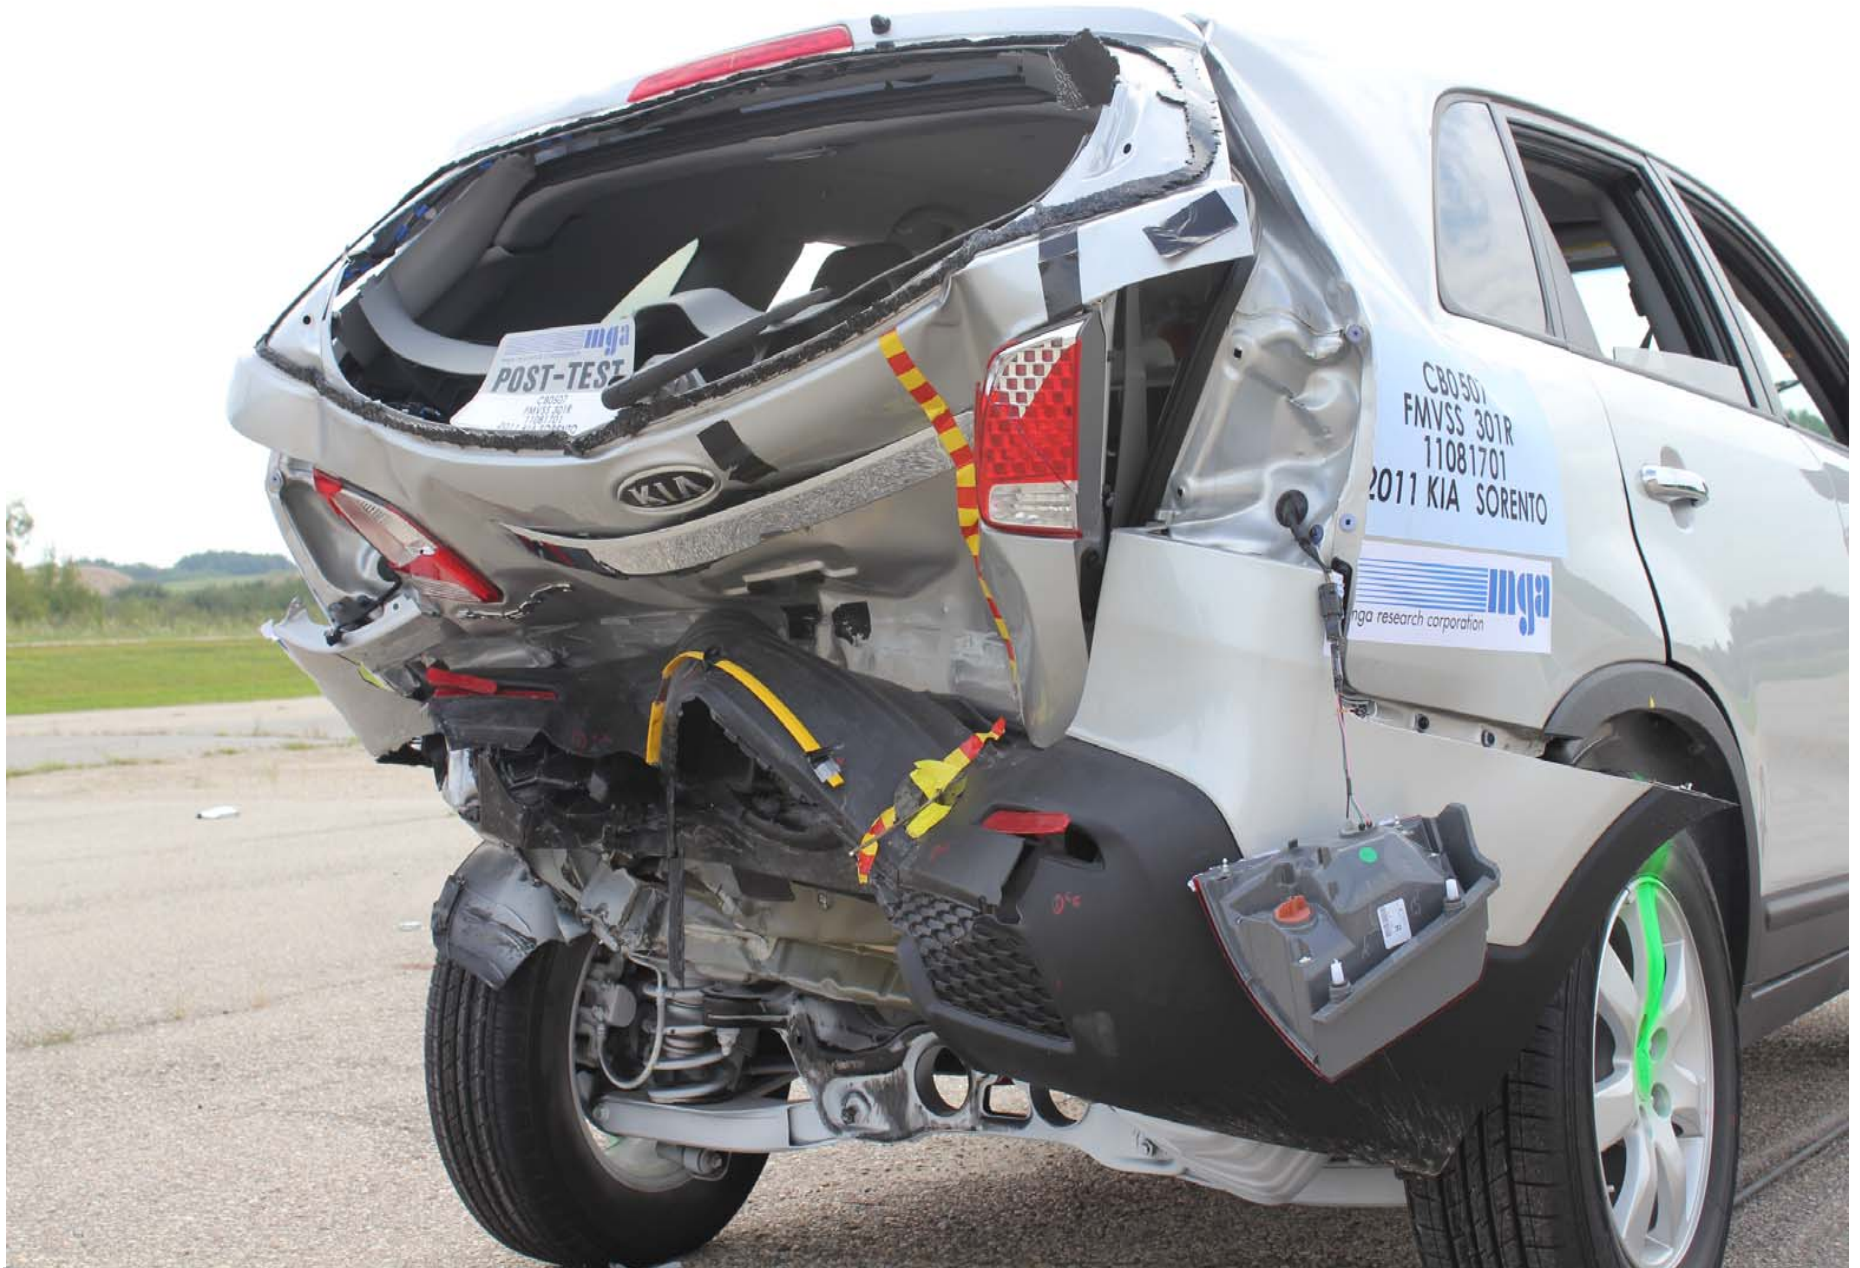
Post-Test Right Rear Close-up View of Vehicle

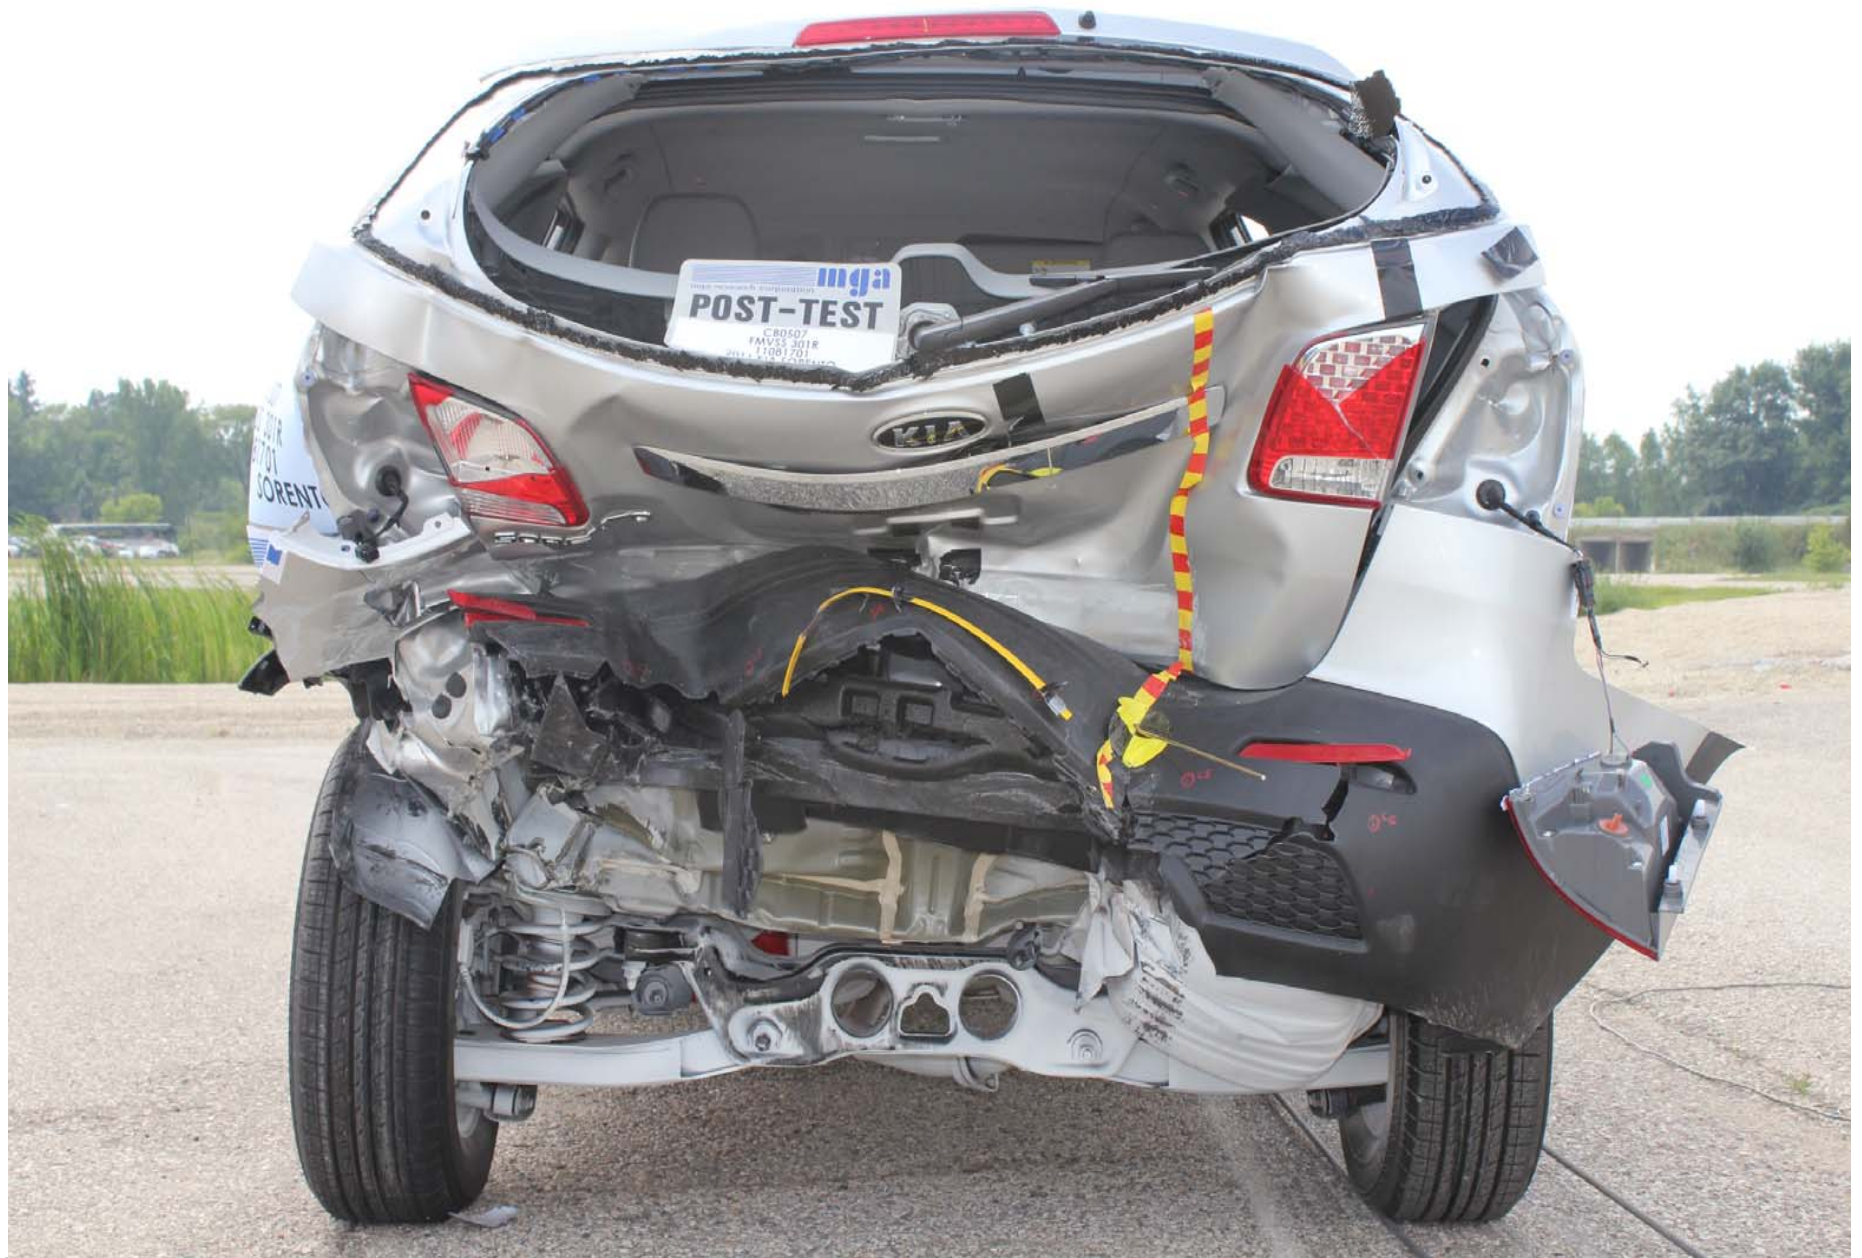
Post-Test Rear View of Vehicle

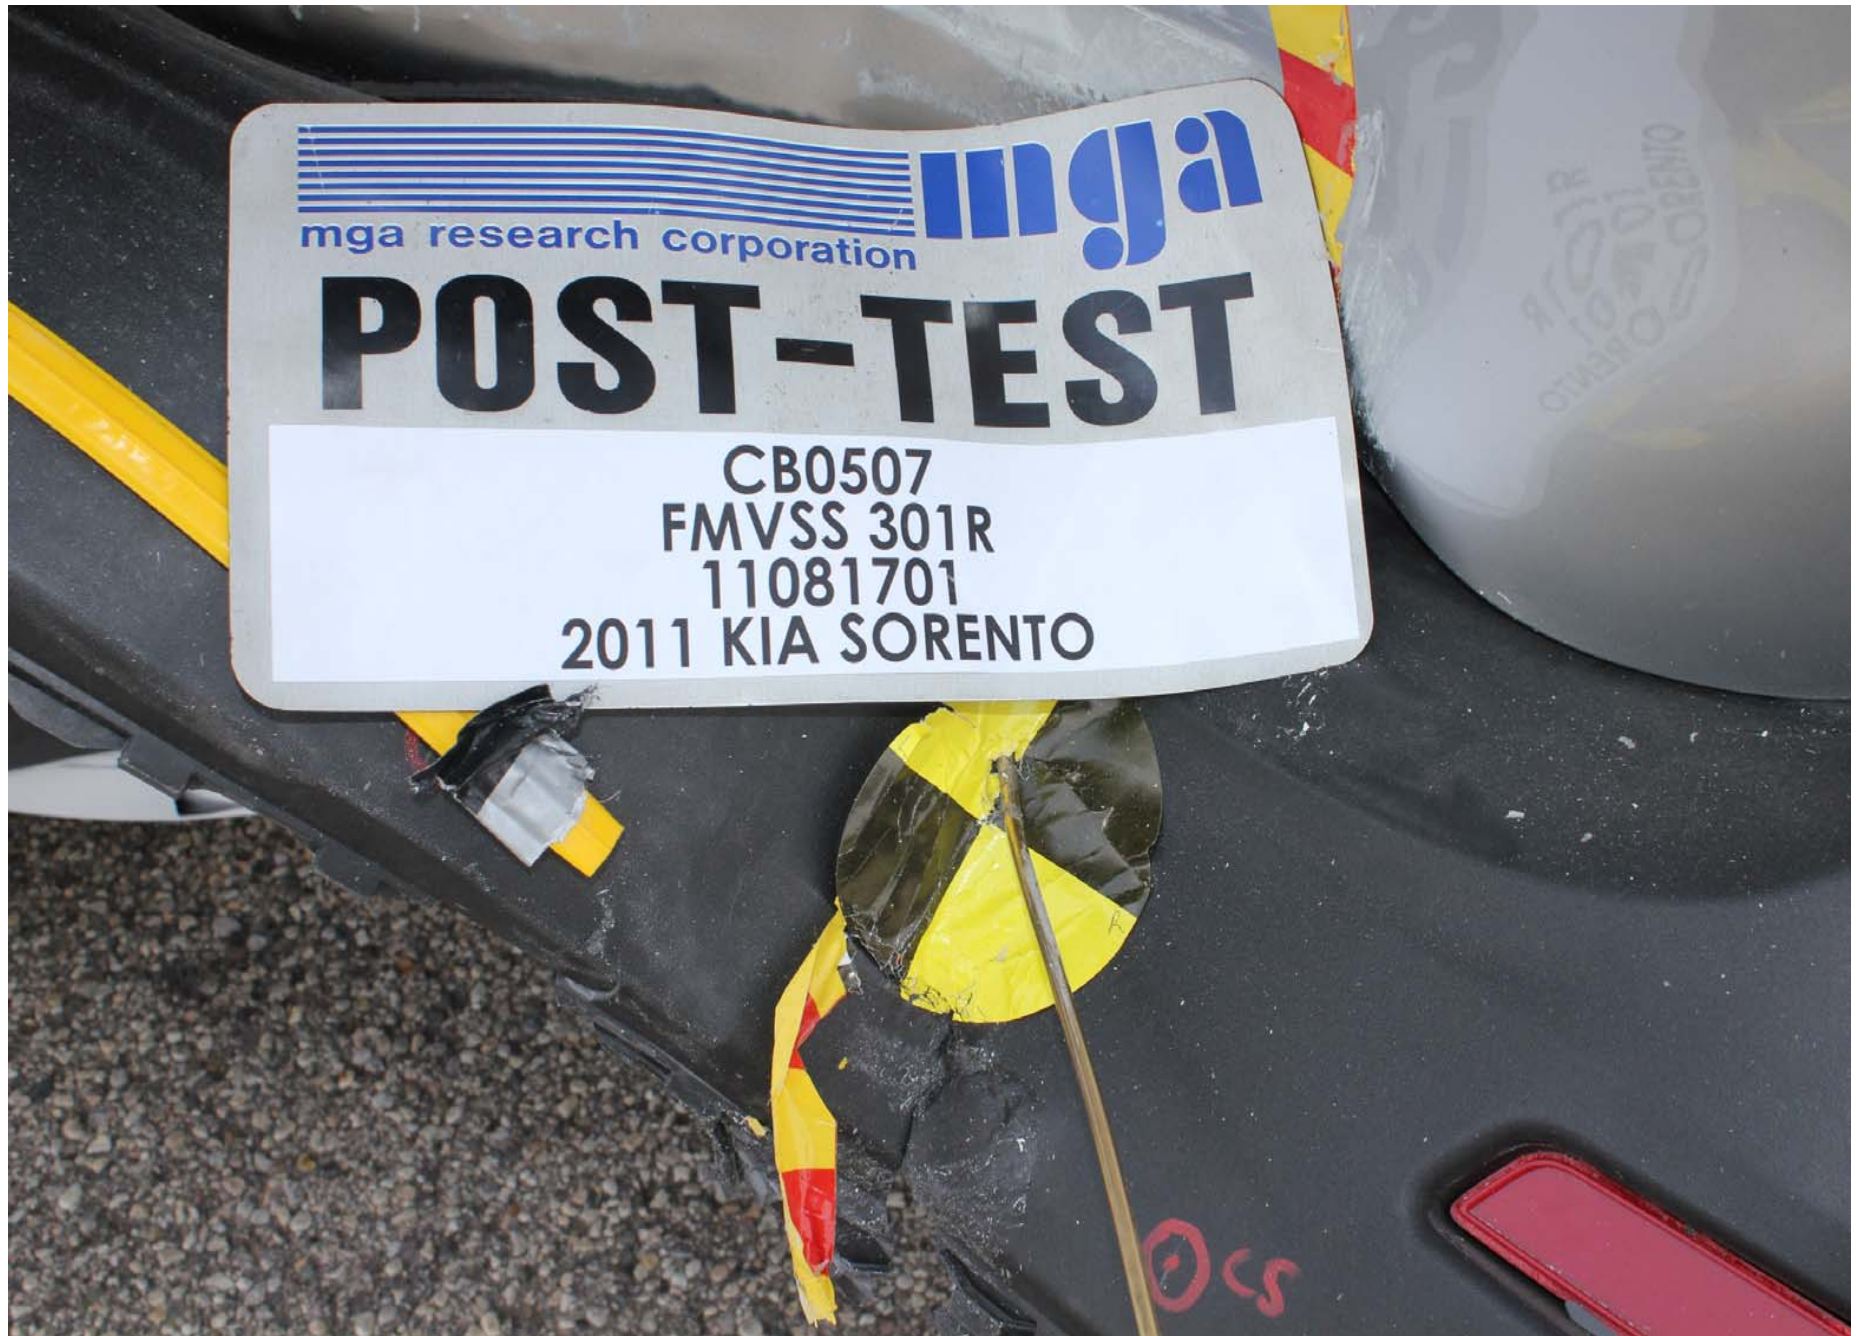
Post-Test Impact Point

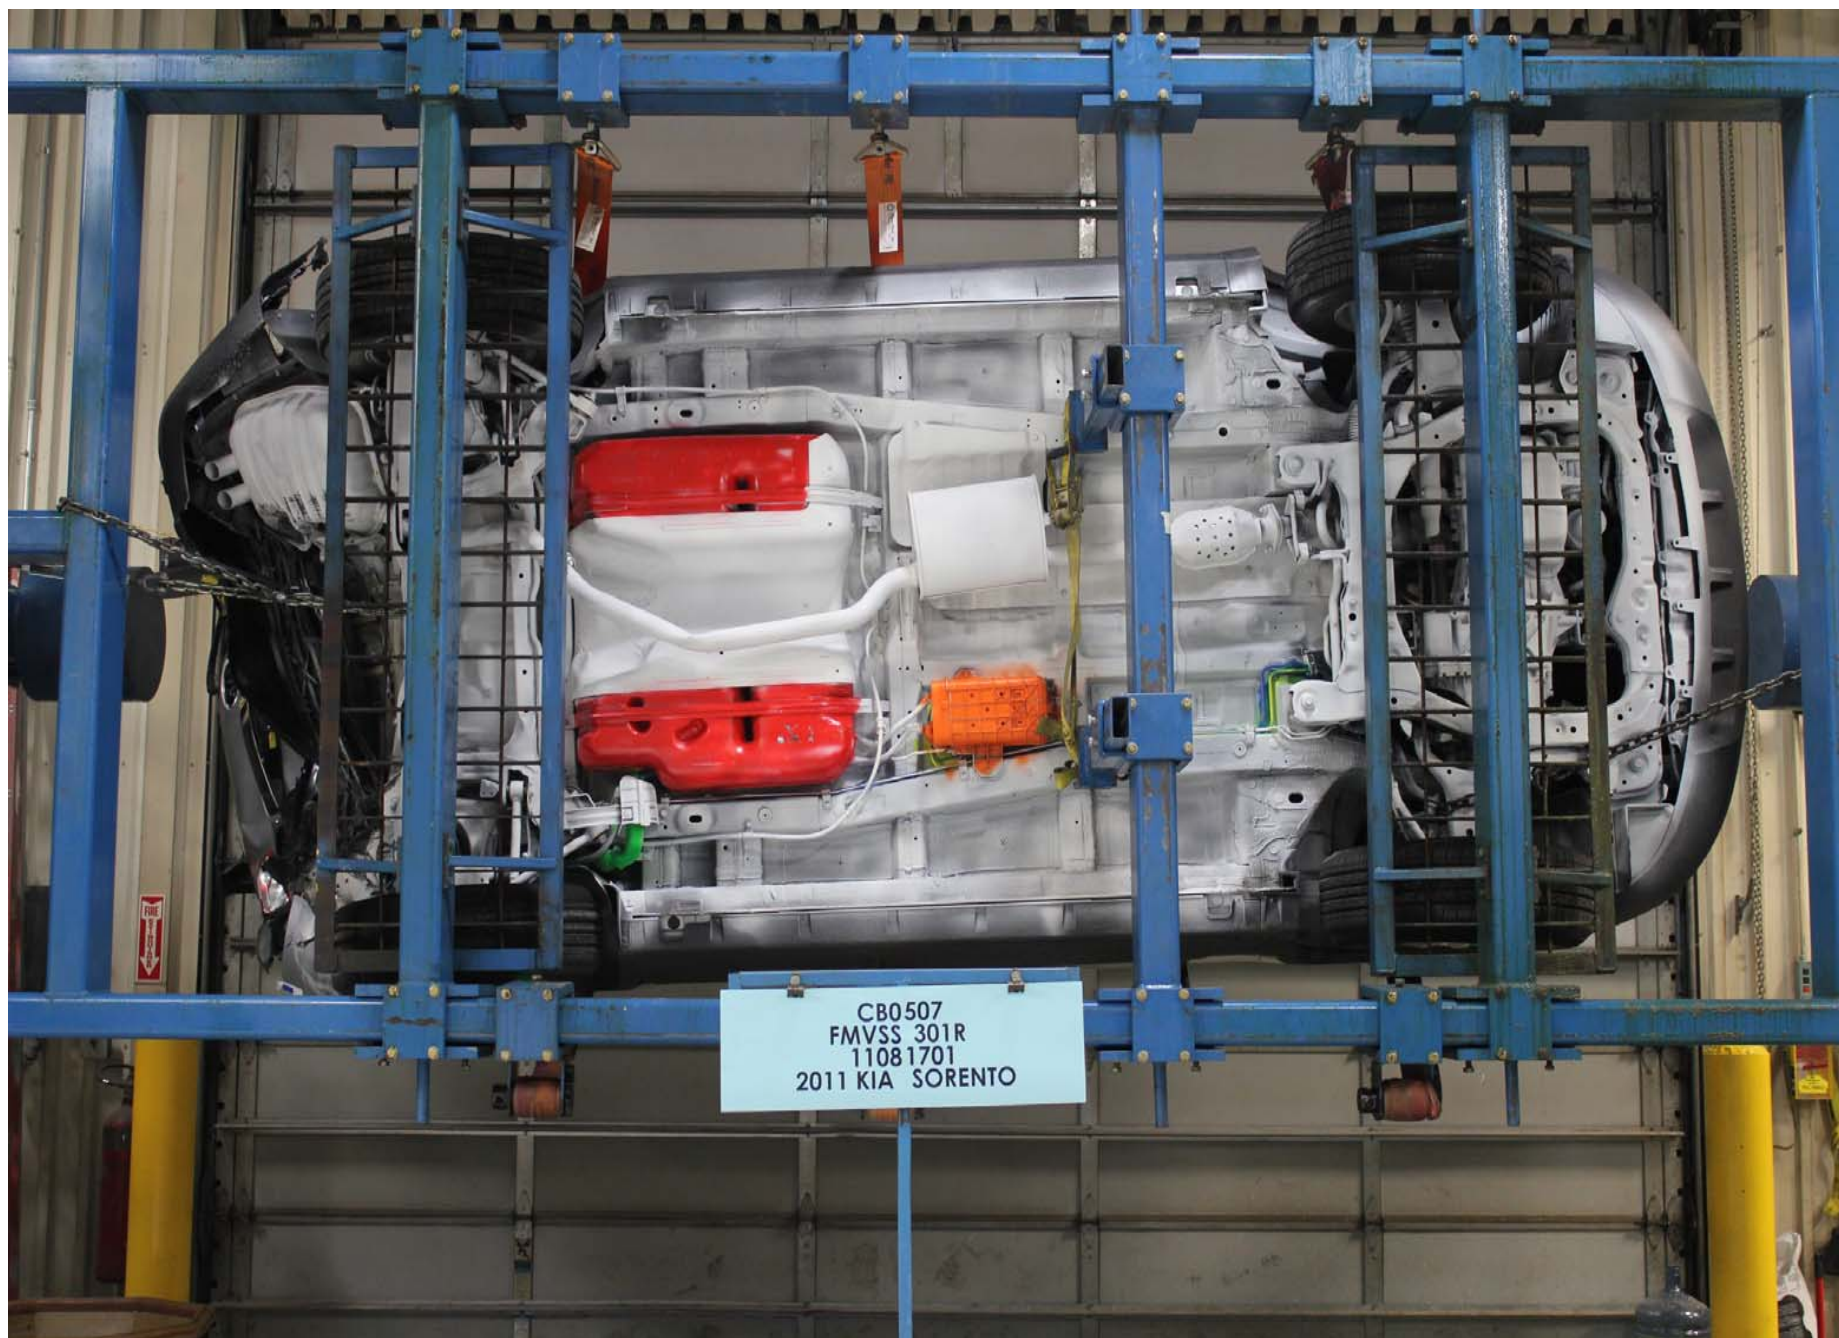
Static Rollover at 90 Degrees

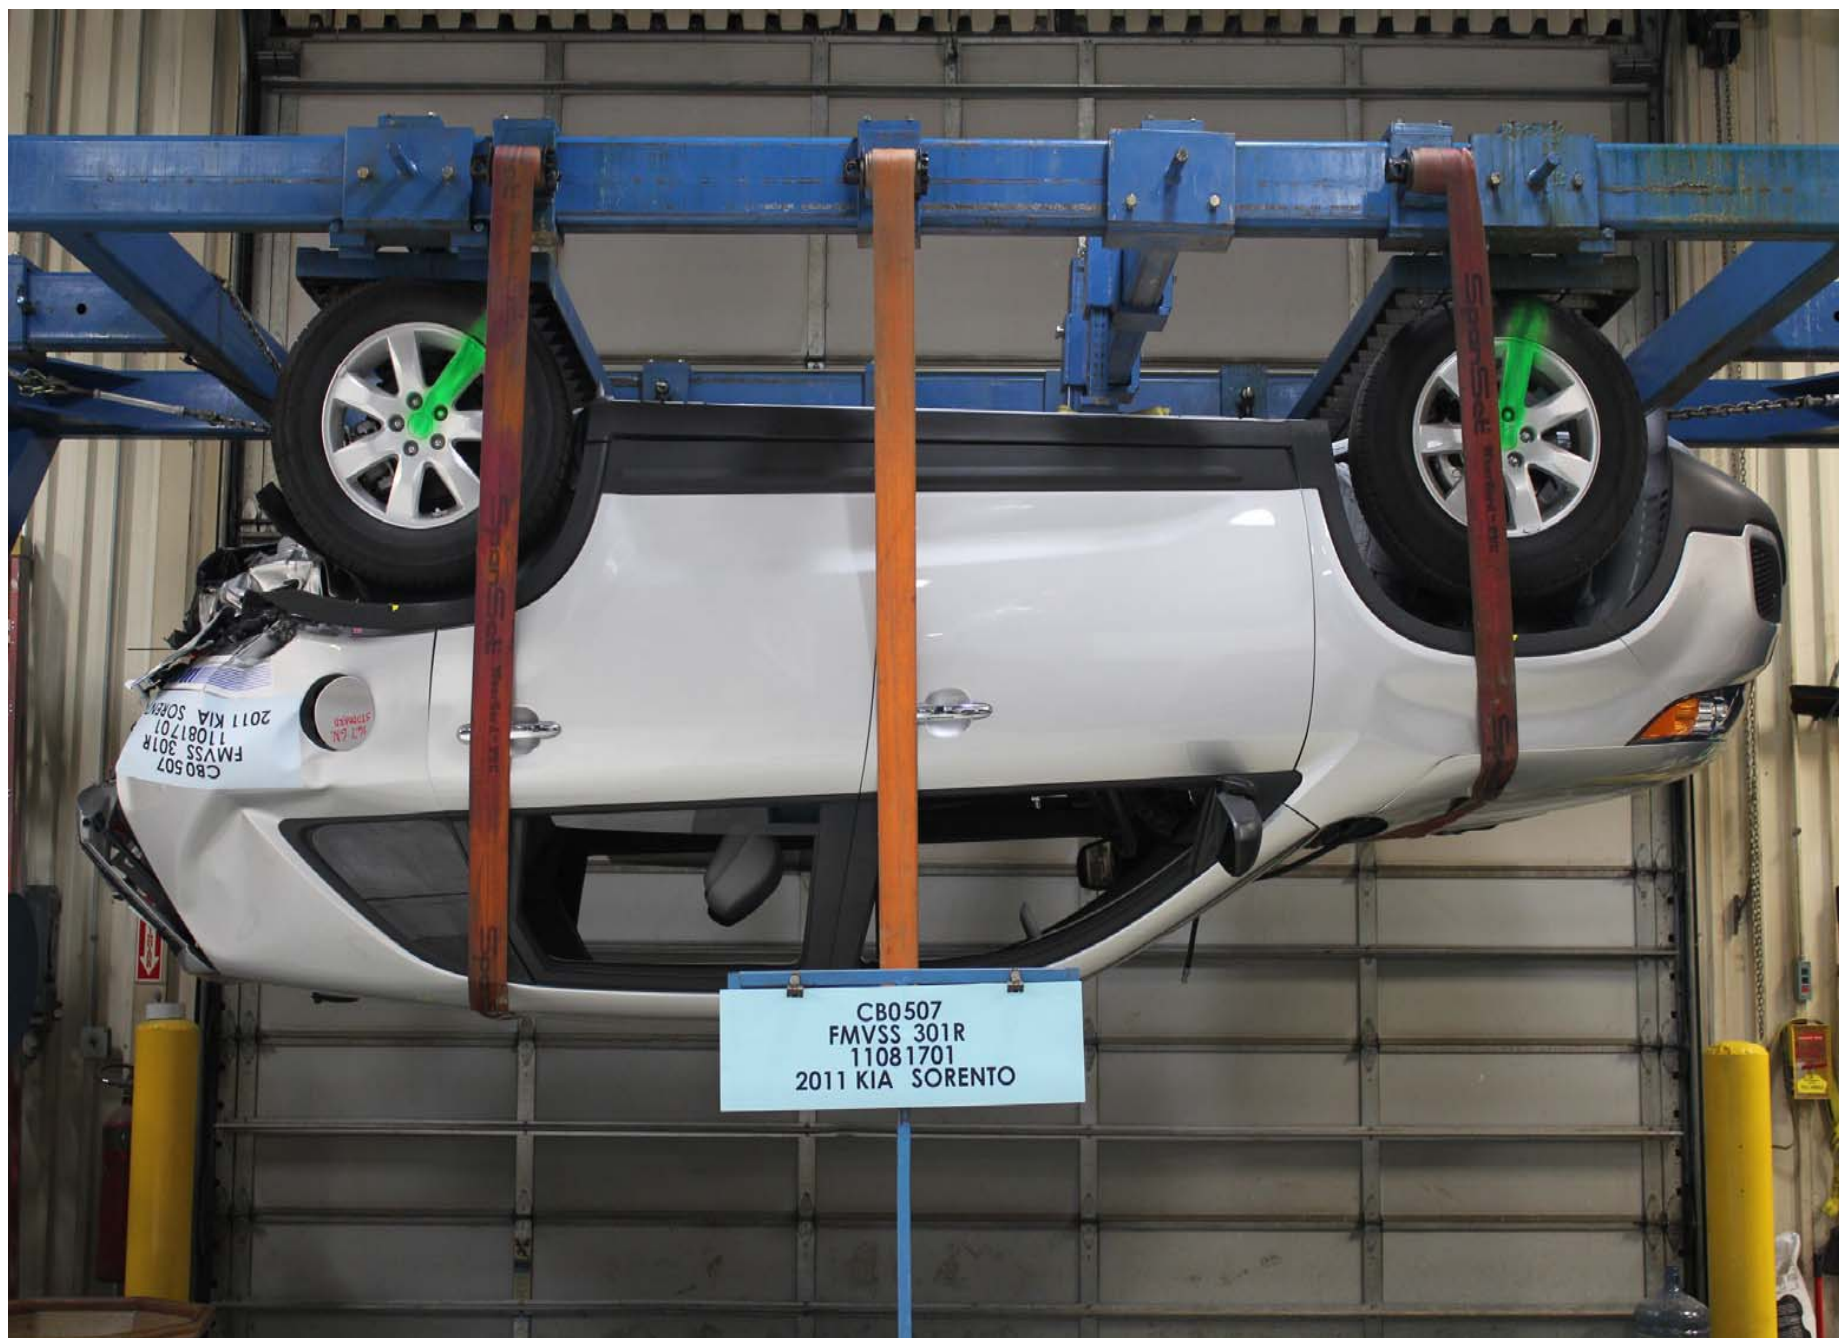
Static Rollover at 180 Degrees

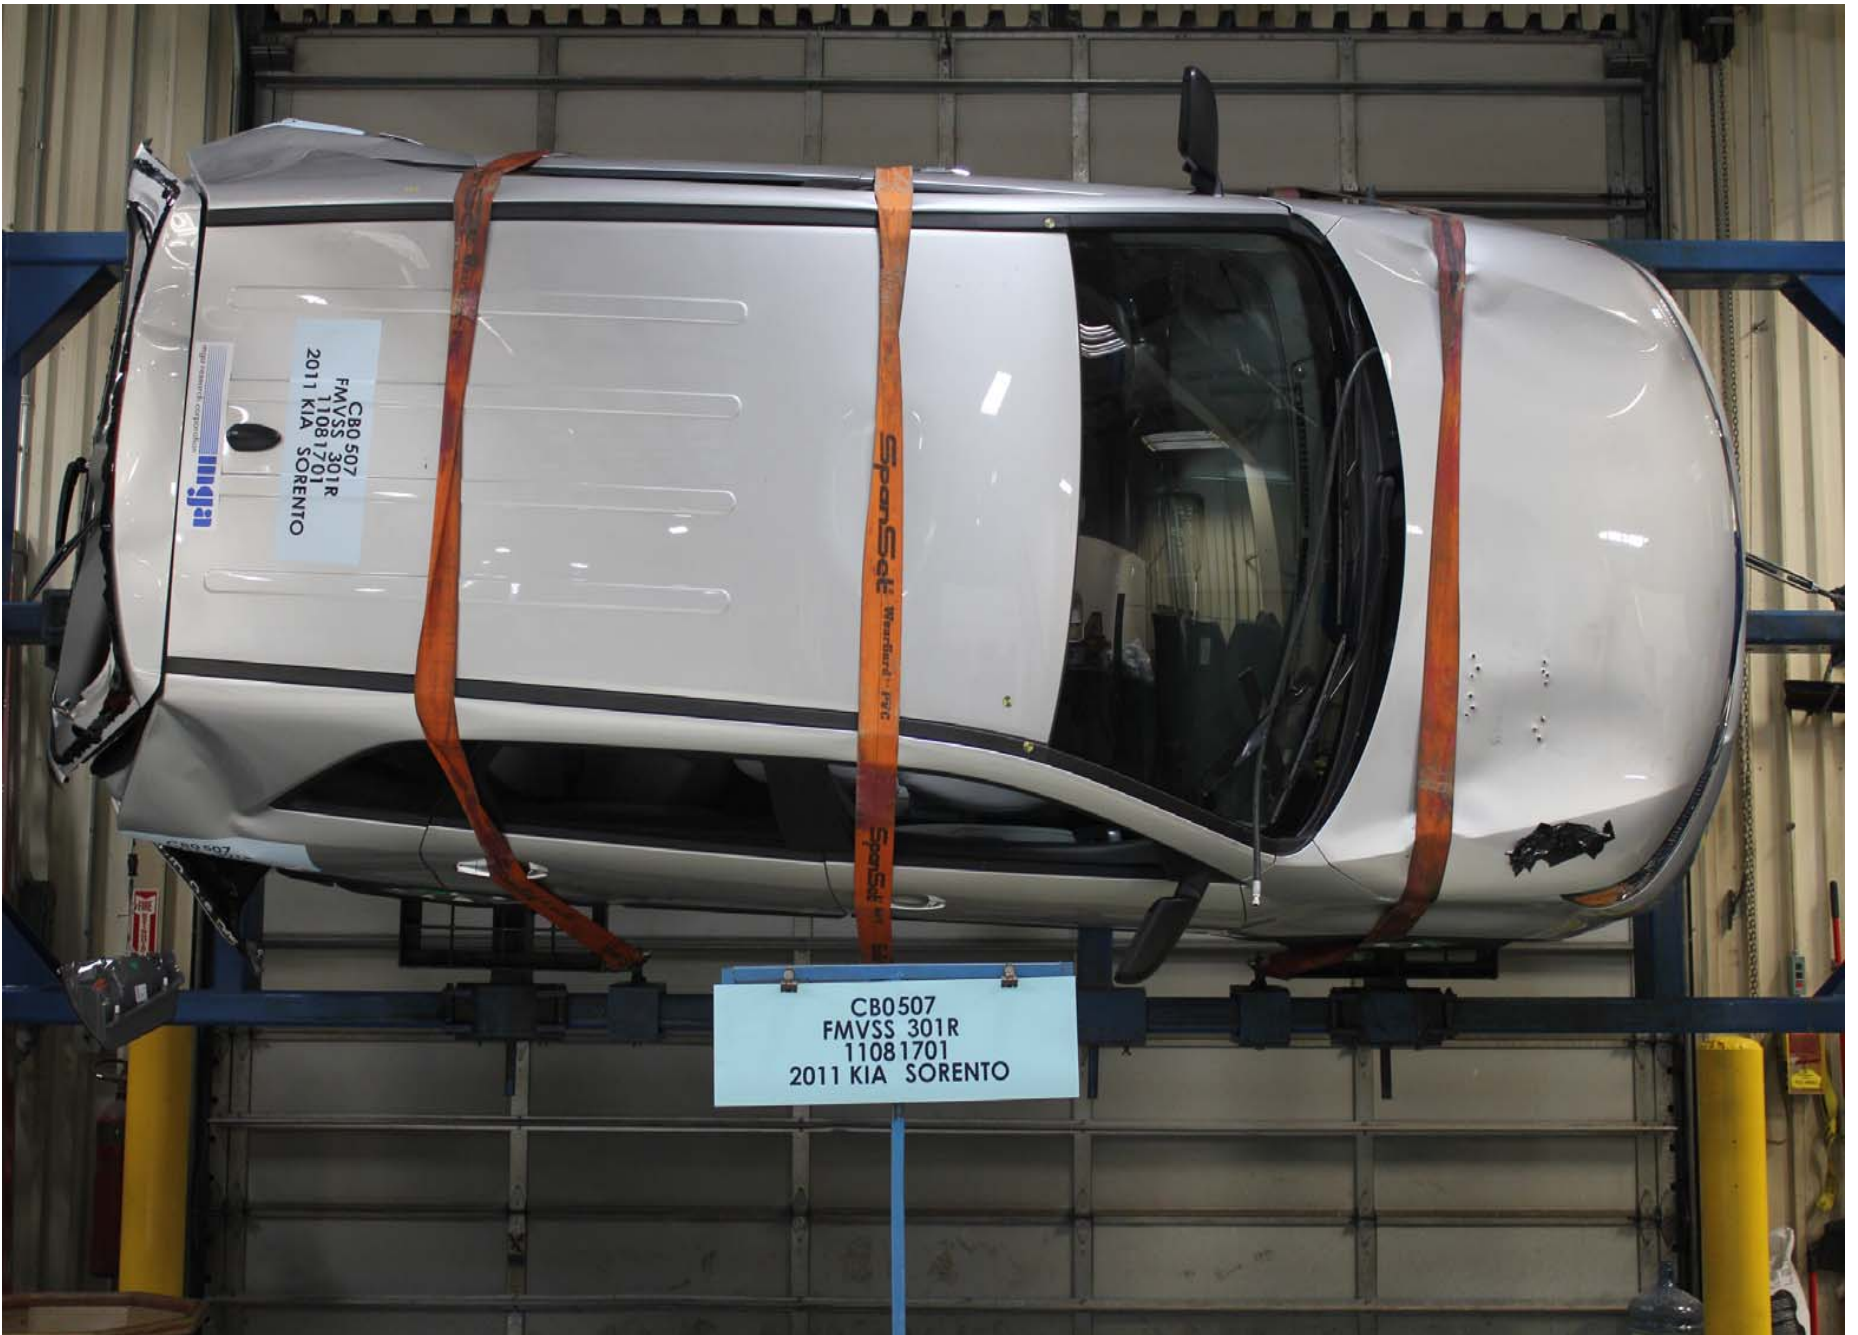
Static Rollover at 270 Degrees

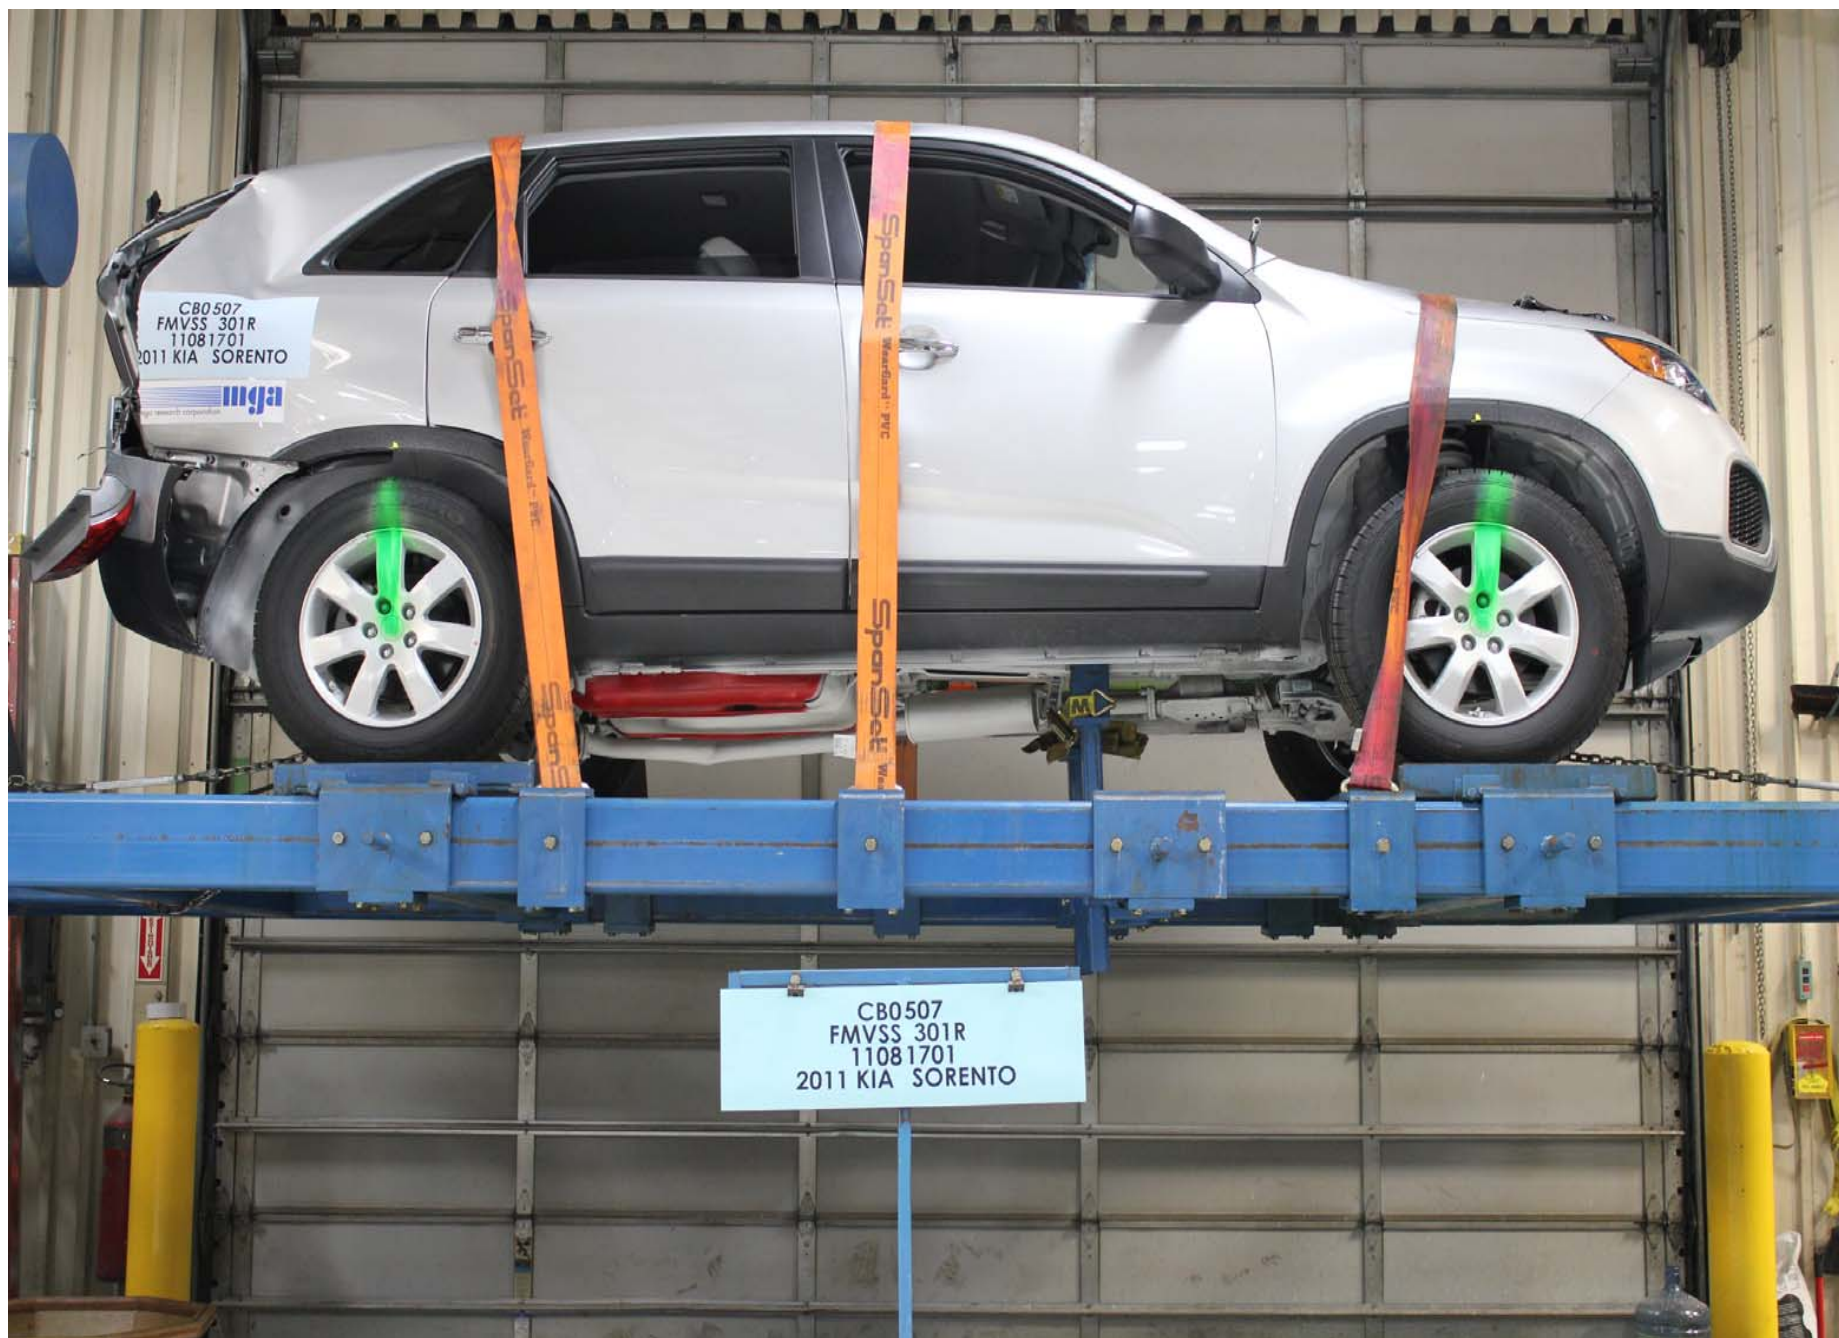
Static Rollover at 360 Degrees
