**REPORT NUMBER: 301-MGA-2011-008**

**SAFETY COMPLIANCE TESTING FOR FMVSS 301R  
FUEL SYSTEM INTEGRITY – REAR IMPACT**

**MAZDA MOTOR CORPORATION  
2011 MAZDA 2 SPORT MT  
NHTSA NUMBER: CB5400**

**PREPARED BY:  
MGA RESEARCH CORPORATION  
5000 WARREN ROAD  
BURLINGTON, WI 53105**

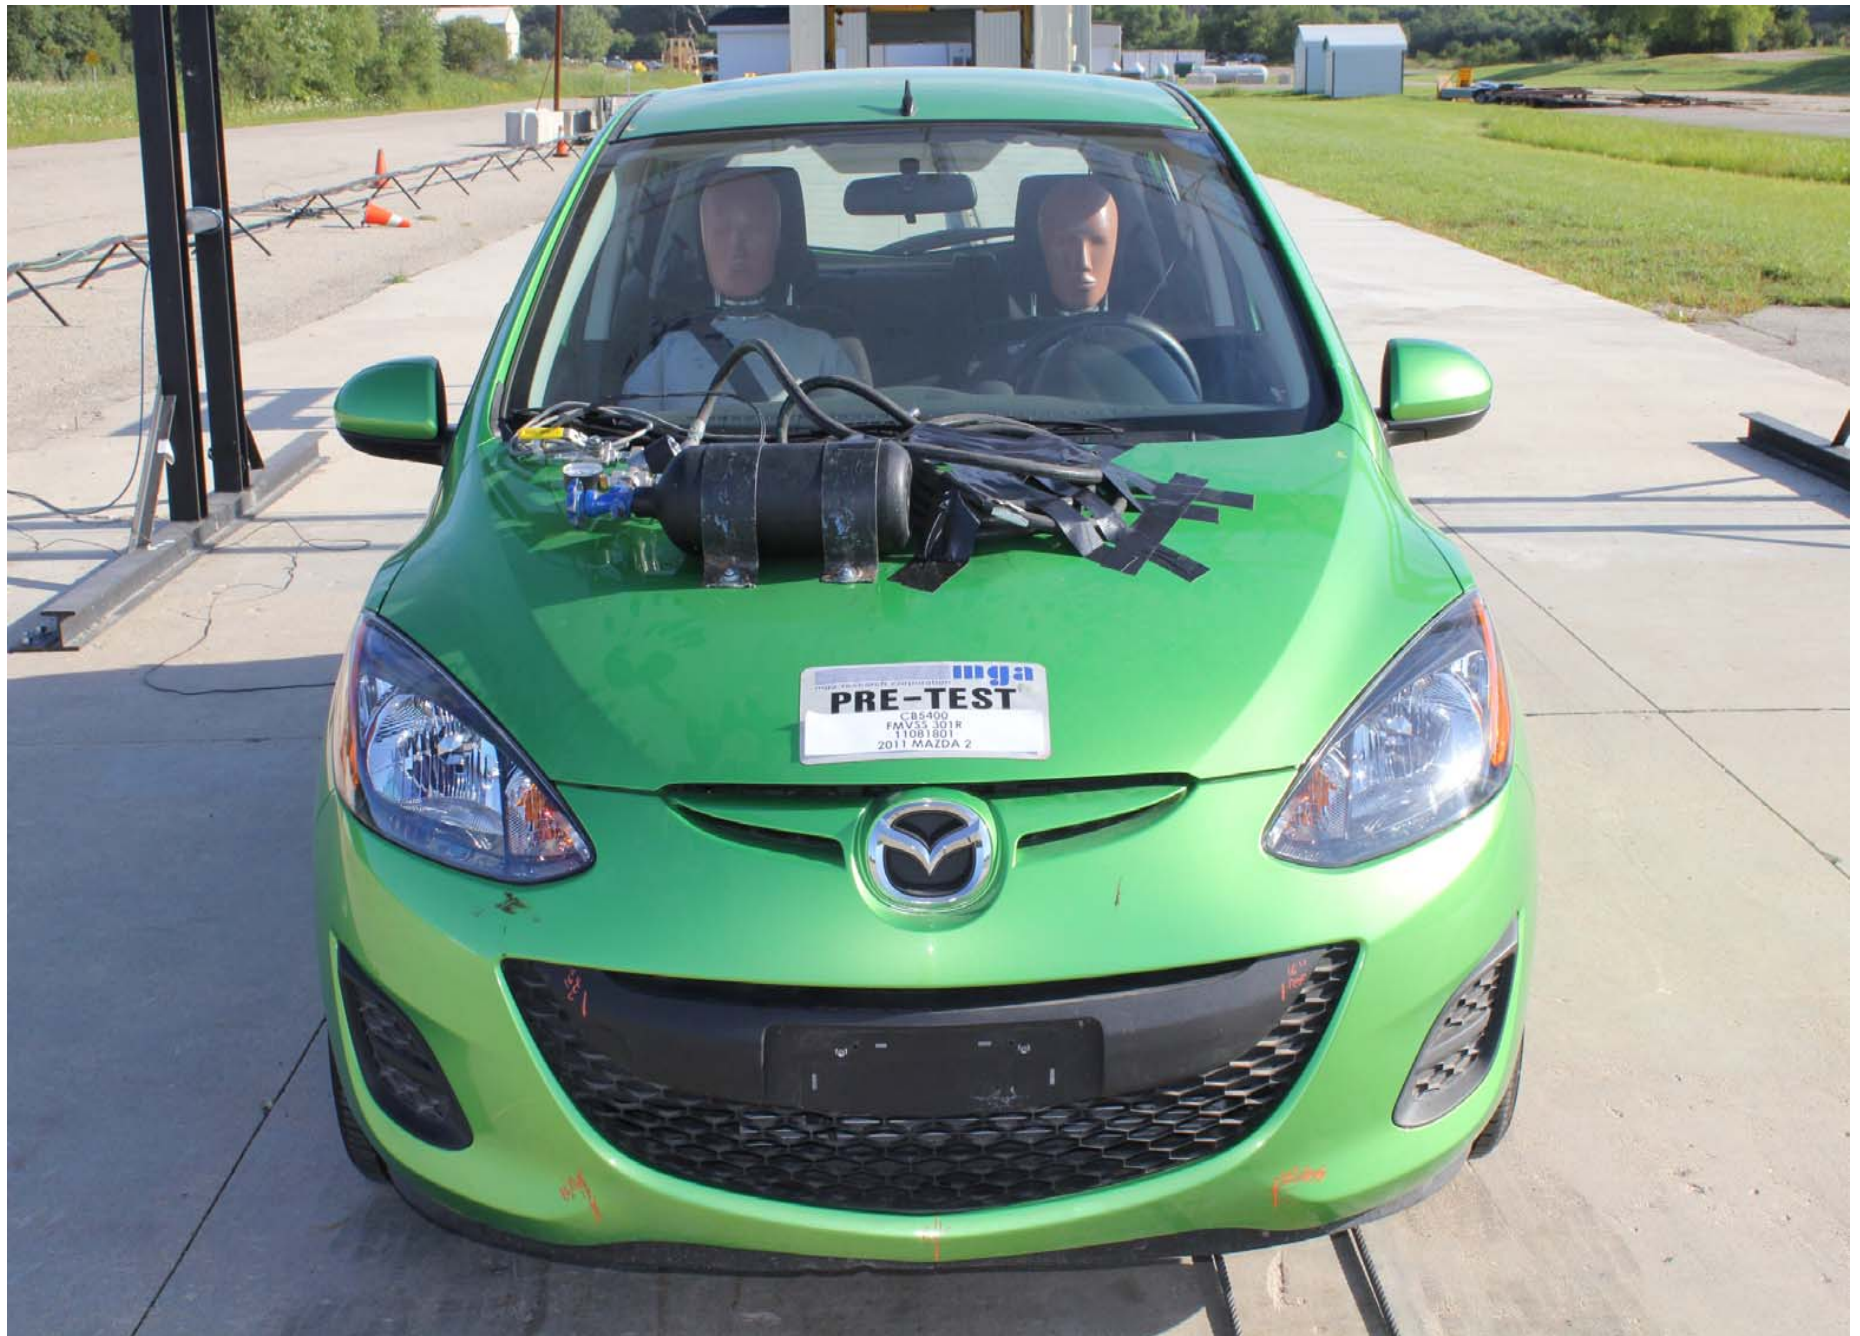
Pre-Test Front View of Vehicle

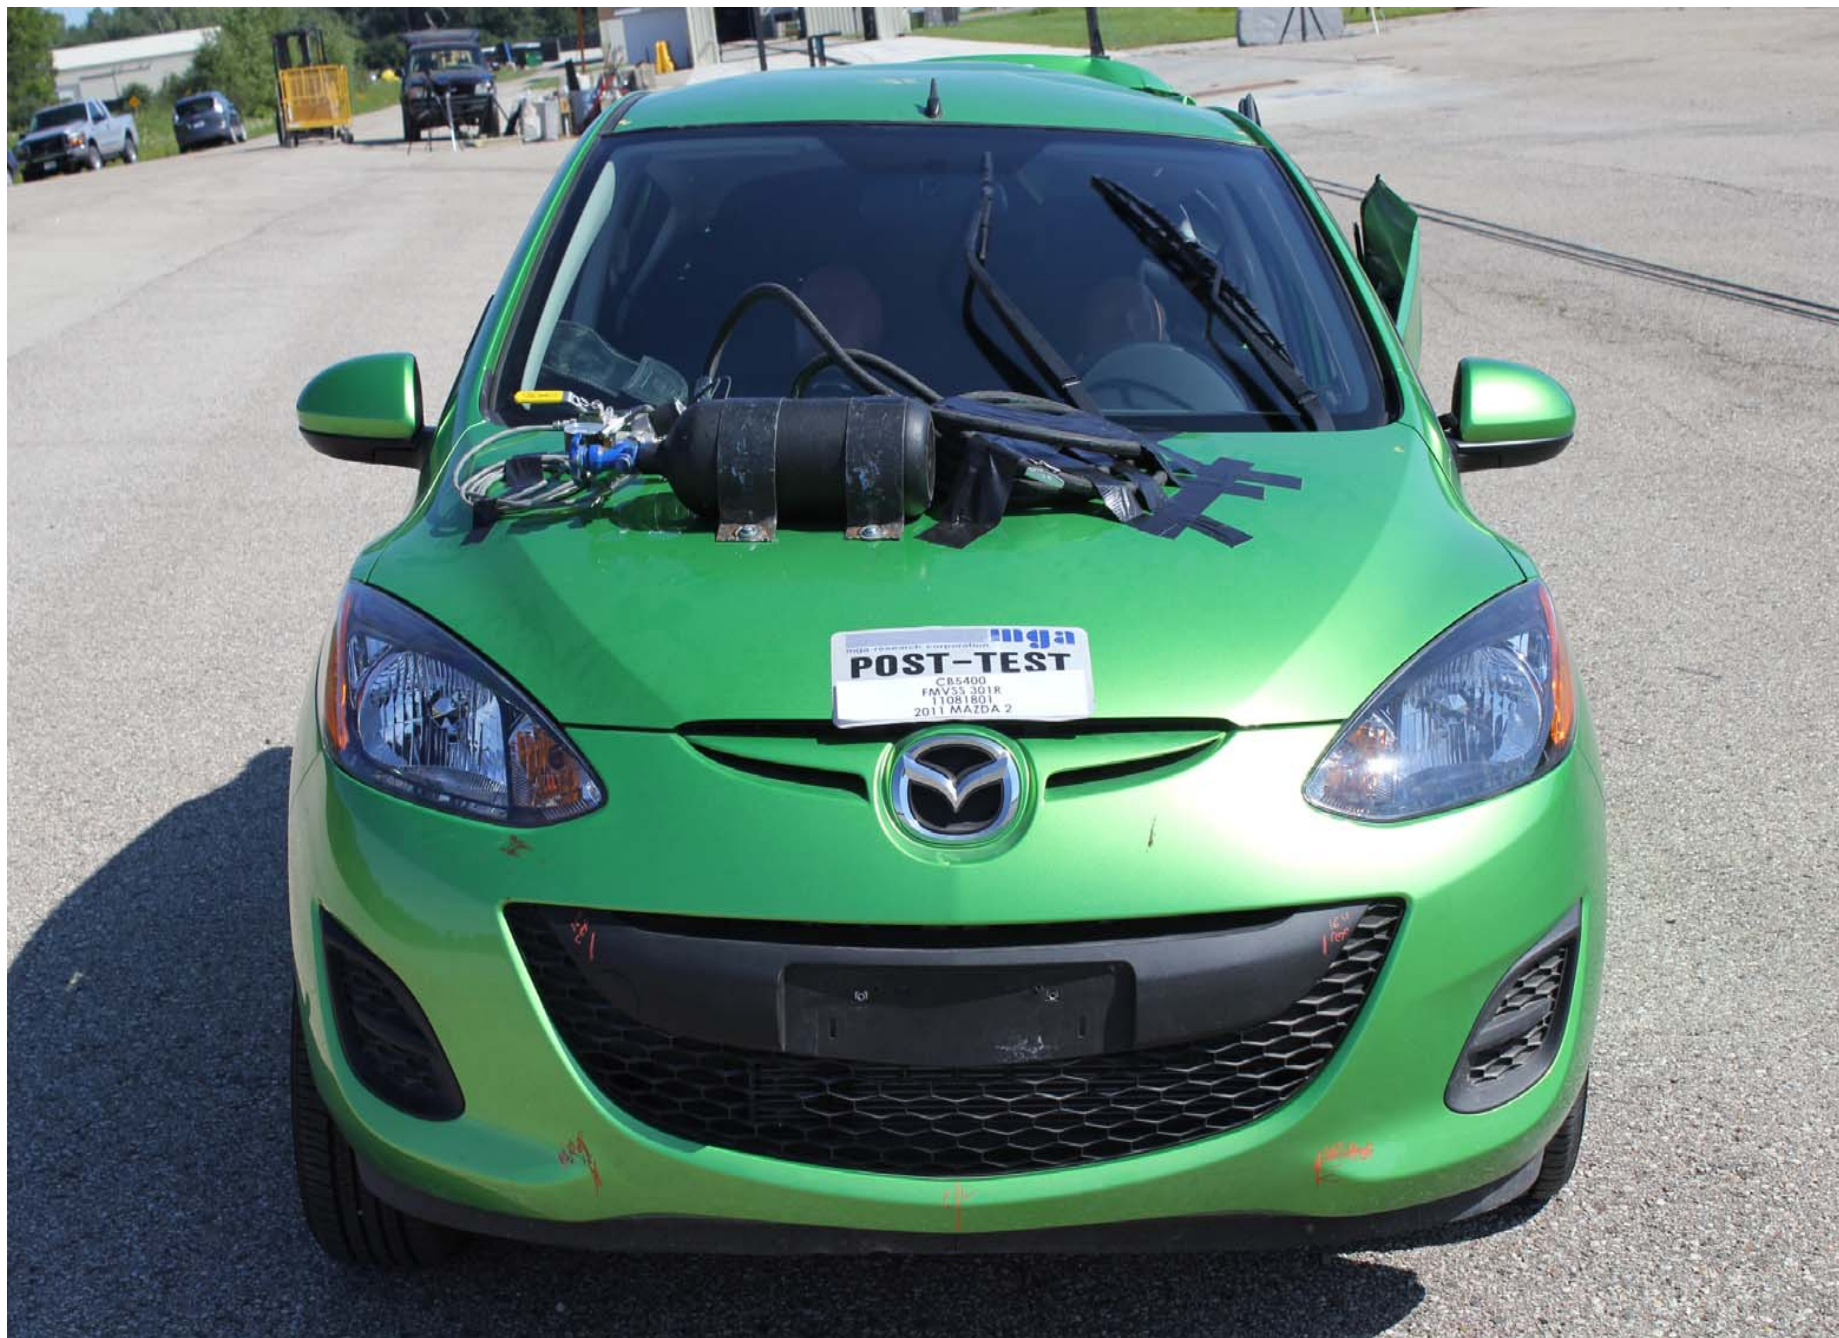
Post-Test Front View of Vehicle

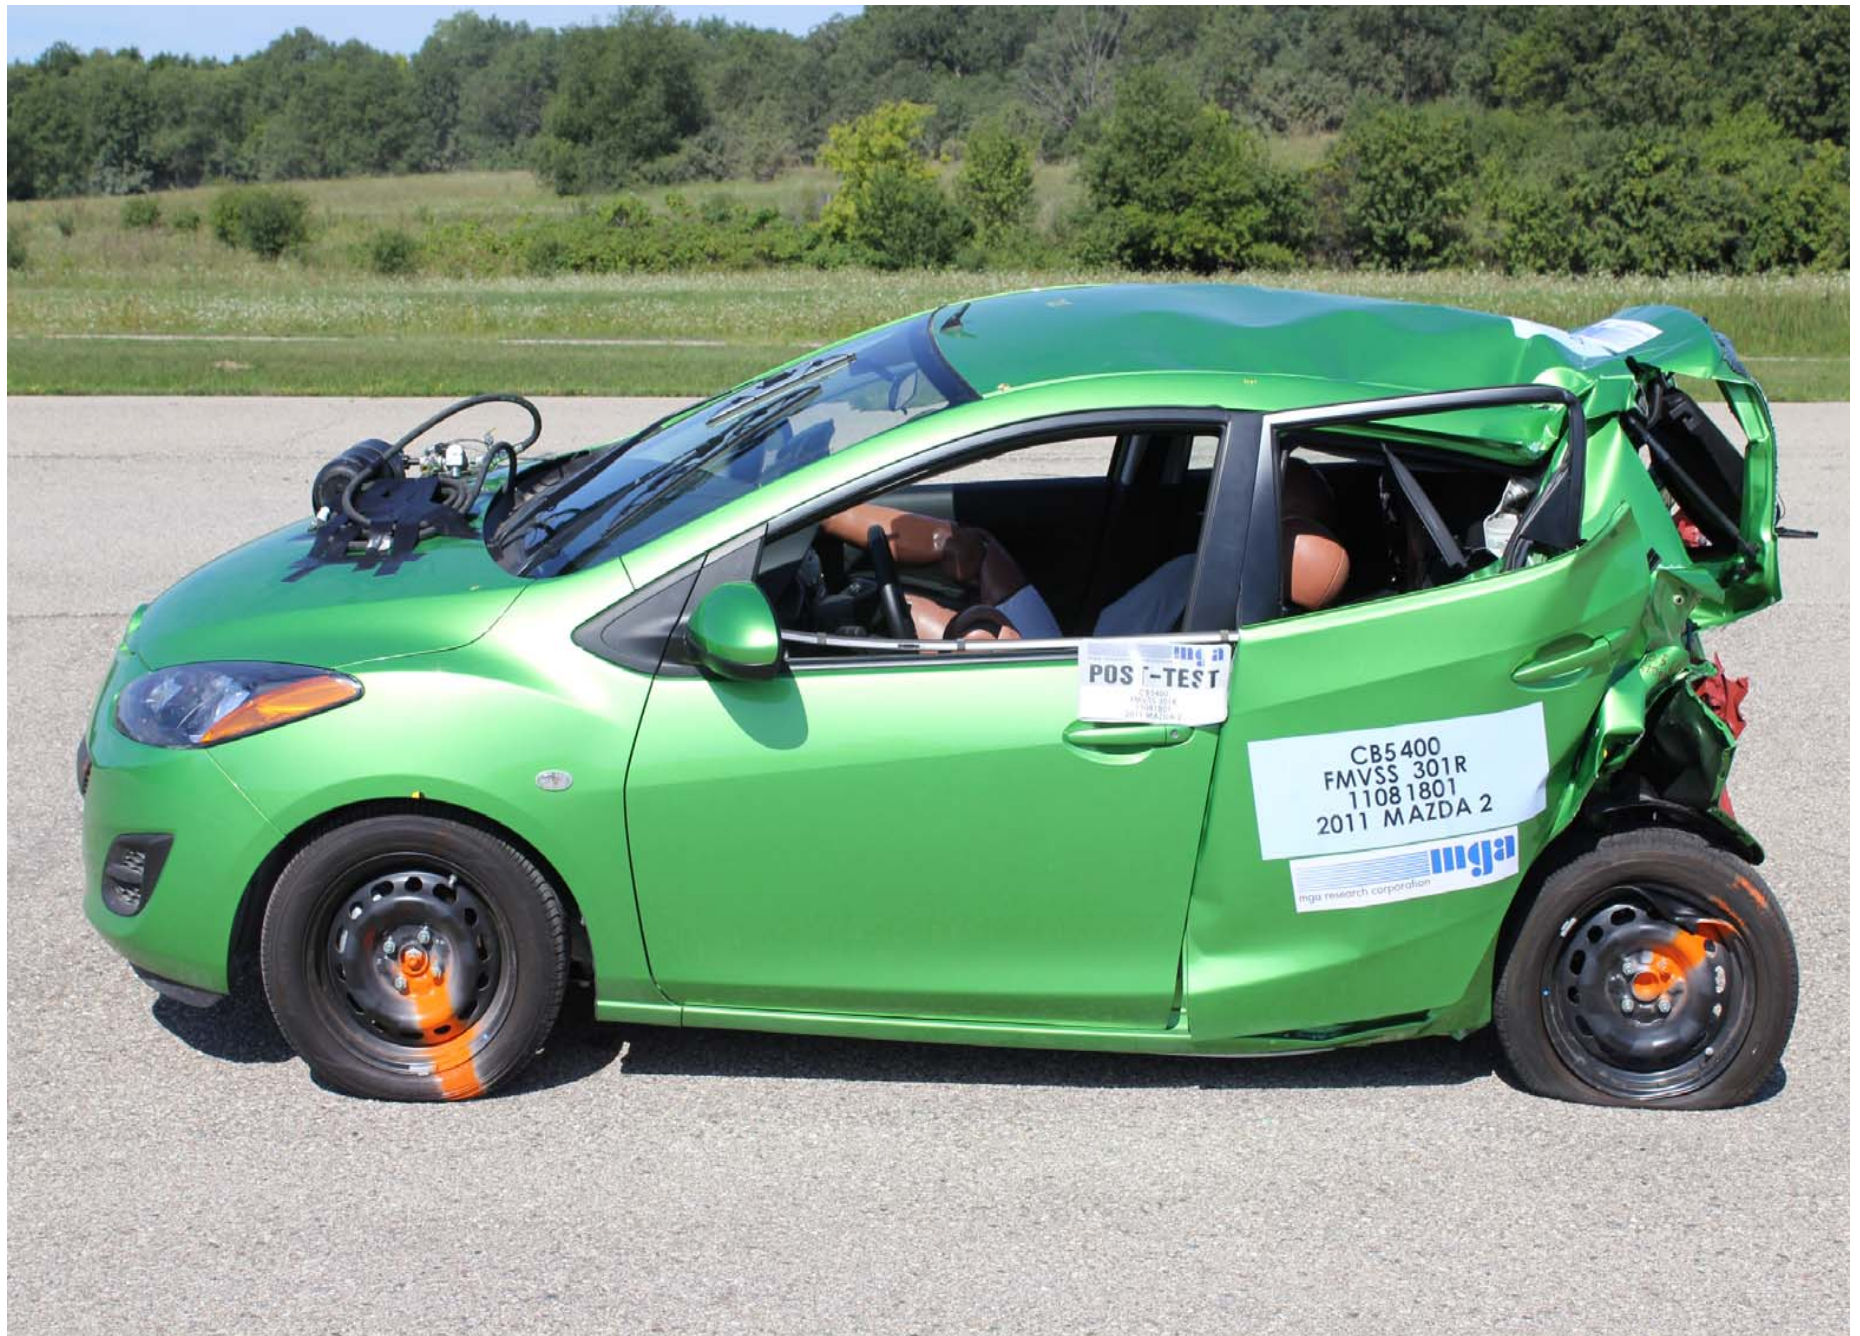
Post-Test Left Side View of Vehicle

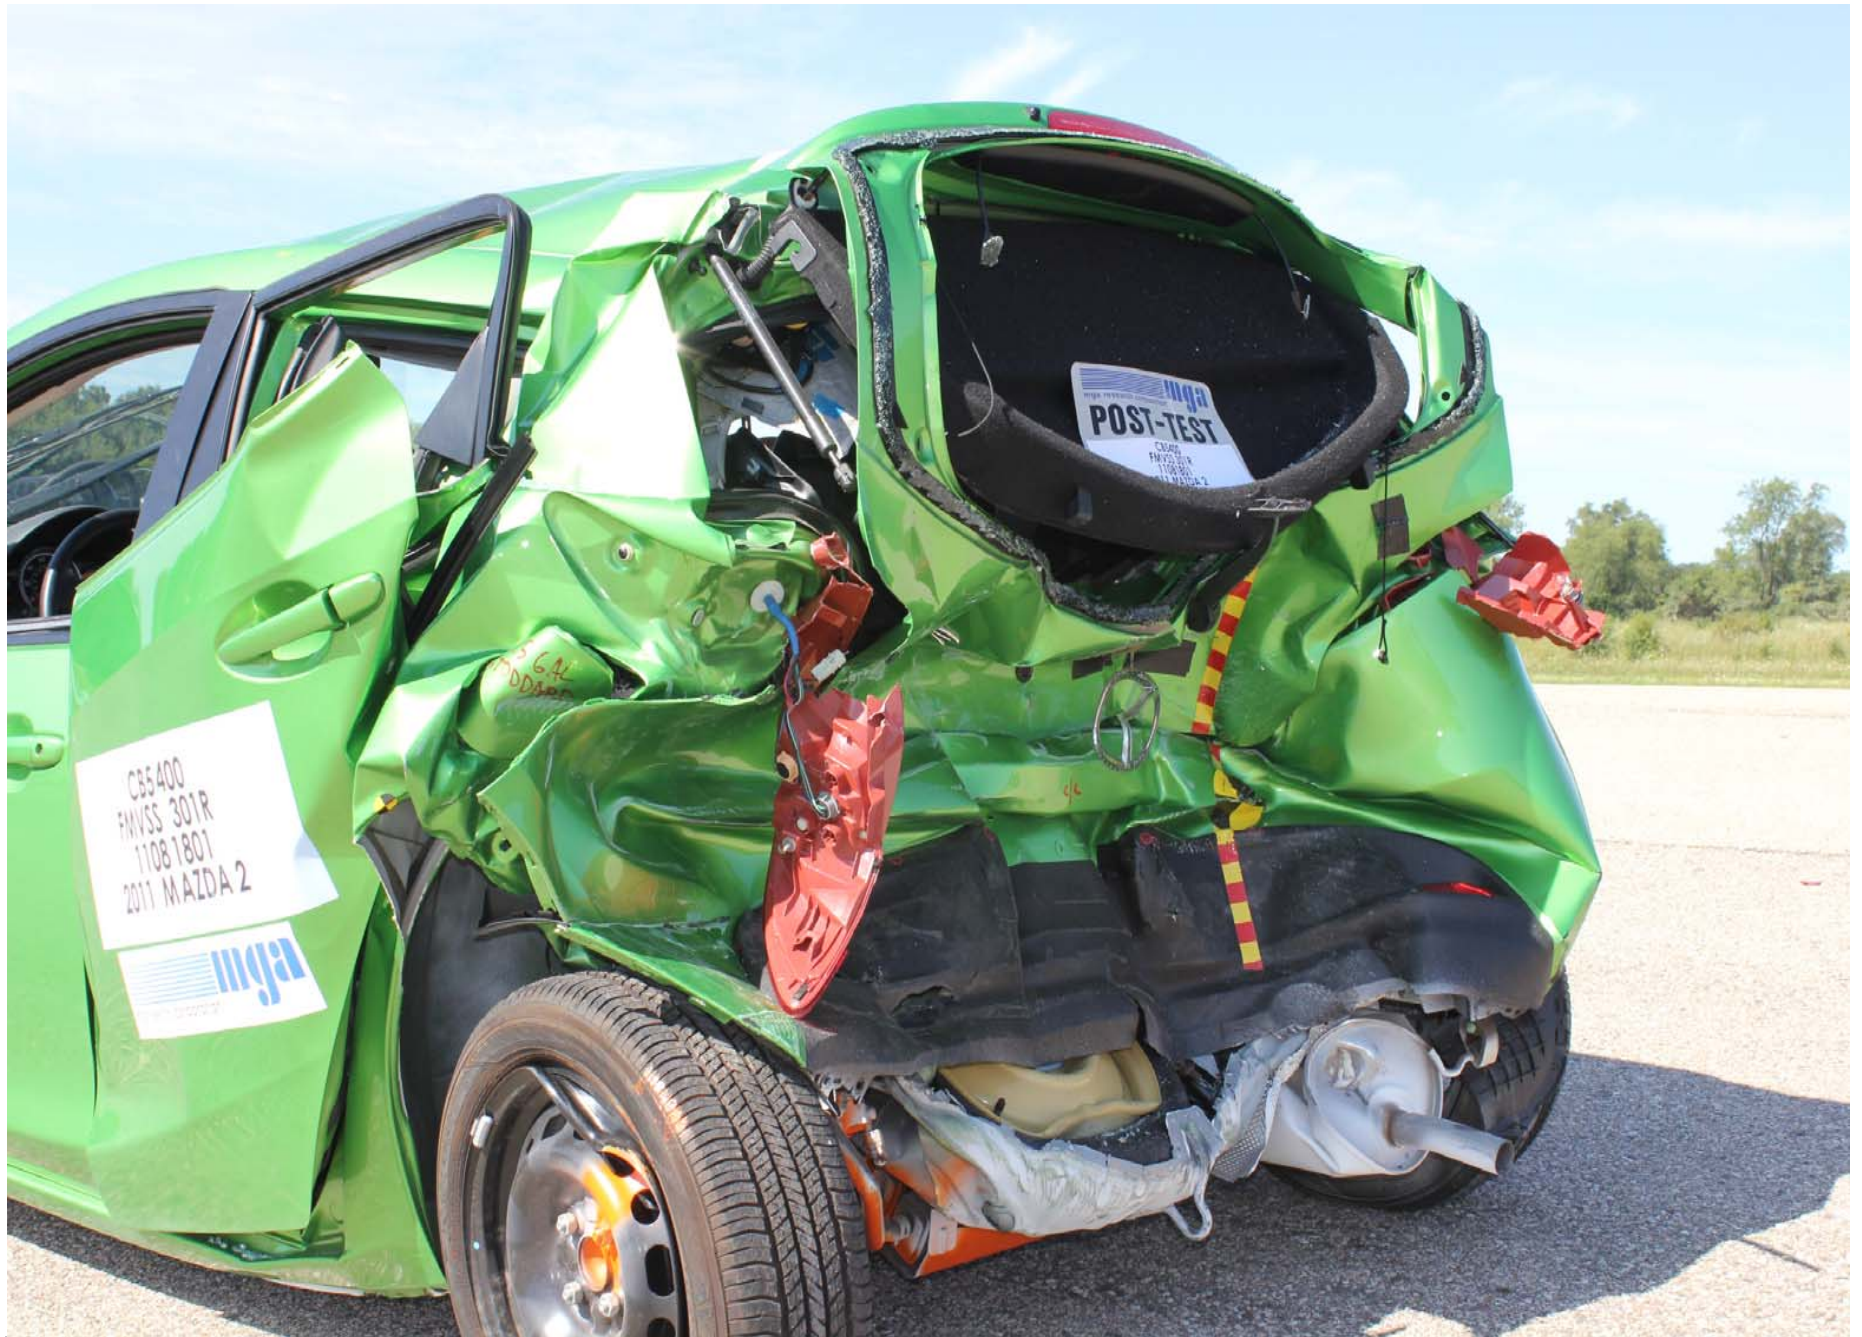
Post-Test Left Rear Close-up View of Vehicle

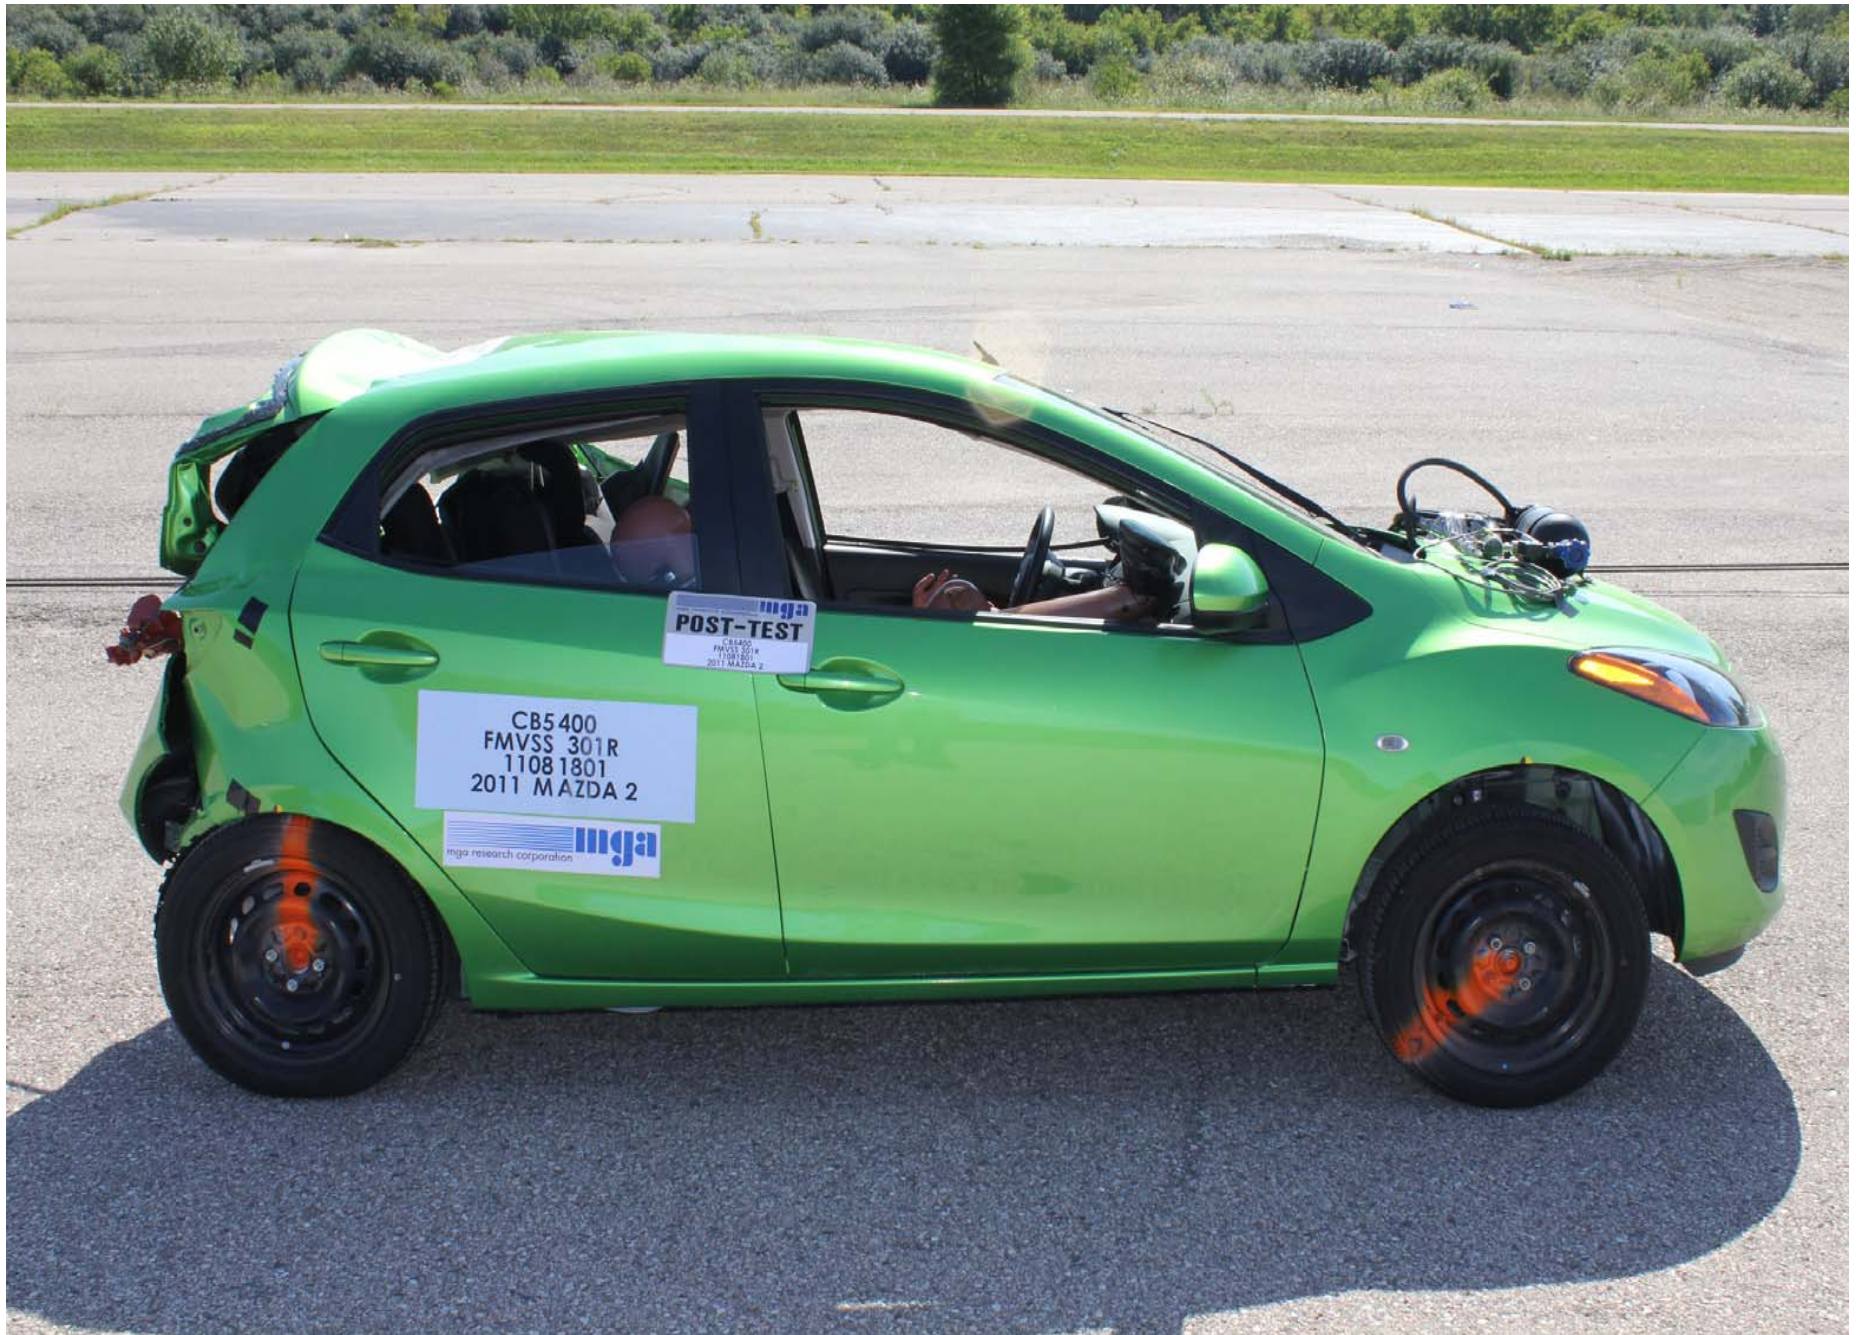
Post-Test Right Side View of Vehicle

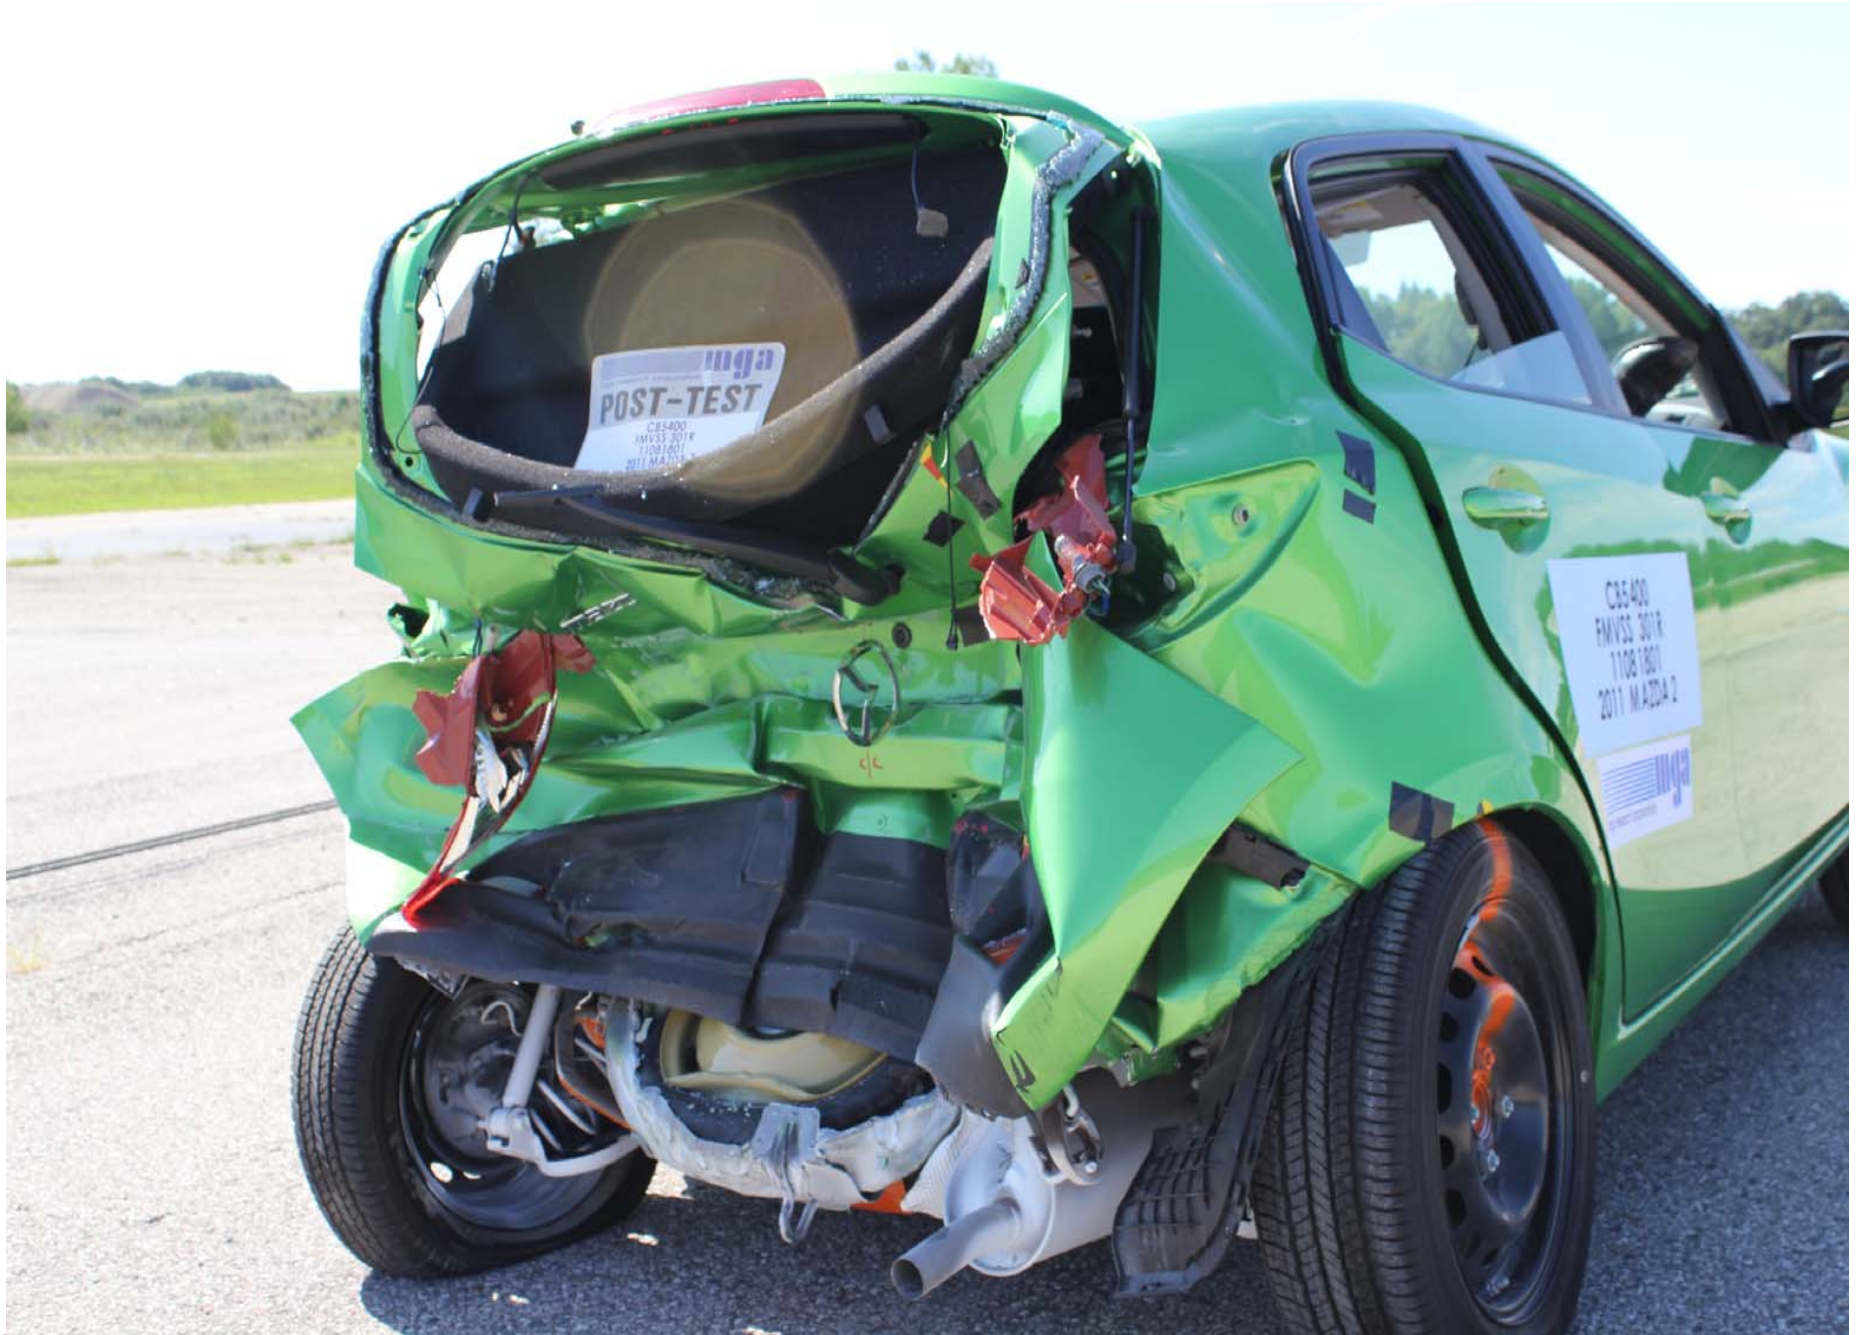
Post-Test Right Rear Close-up View of Vehicle

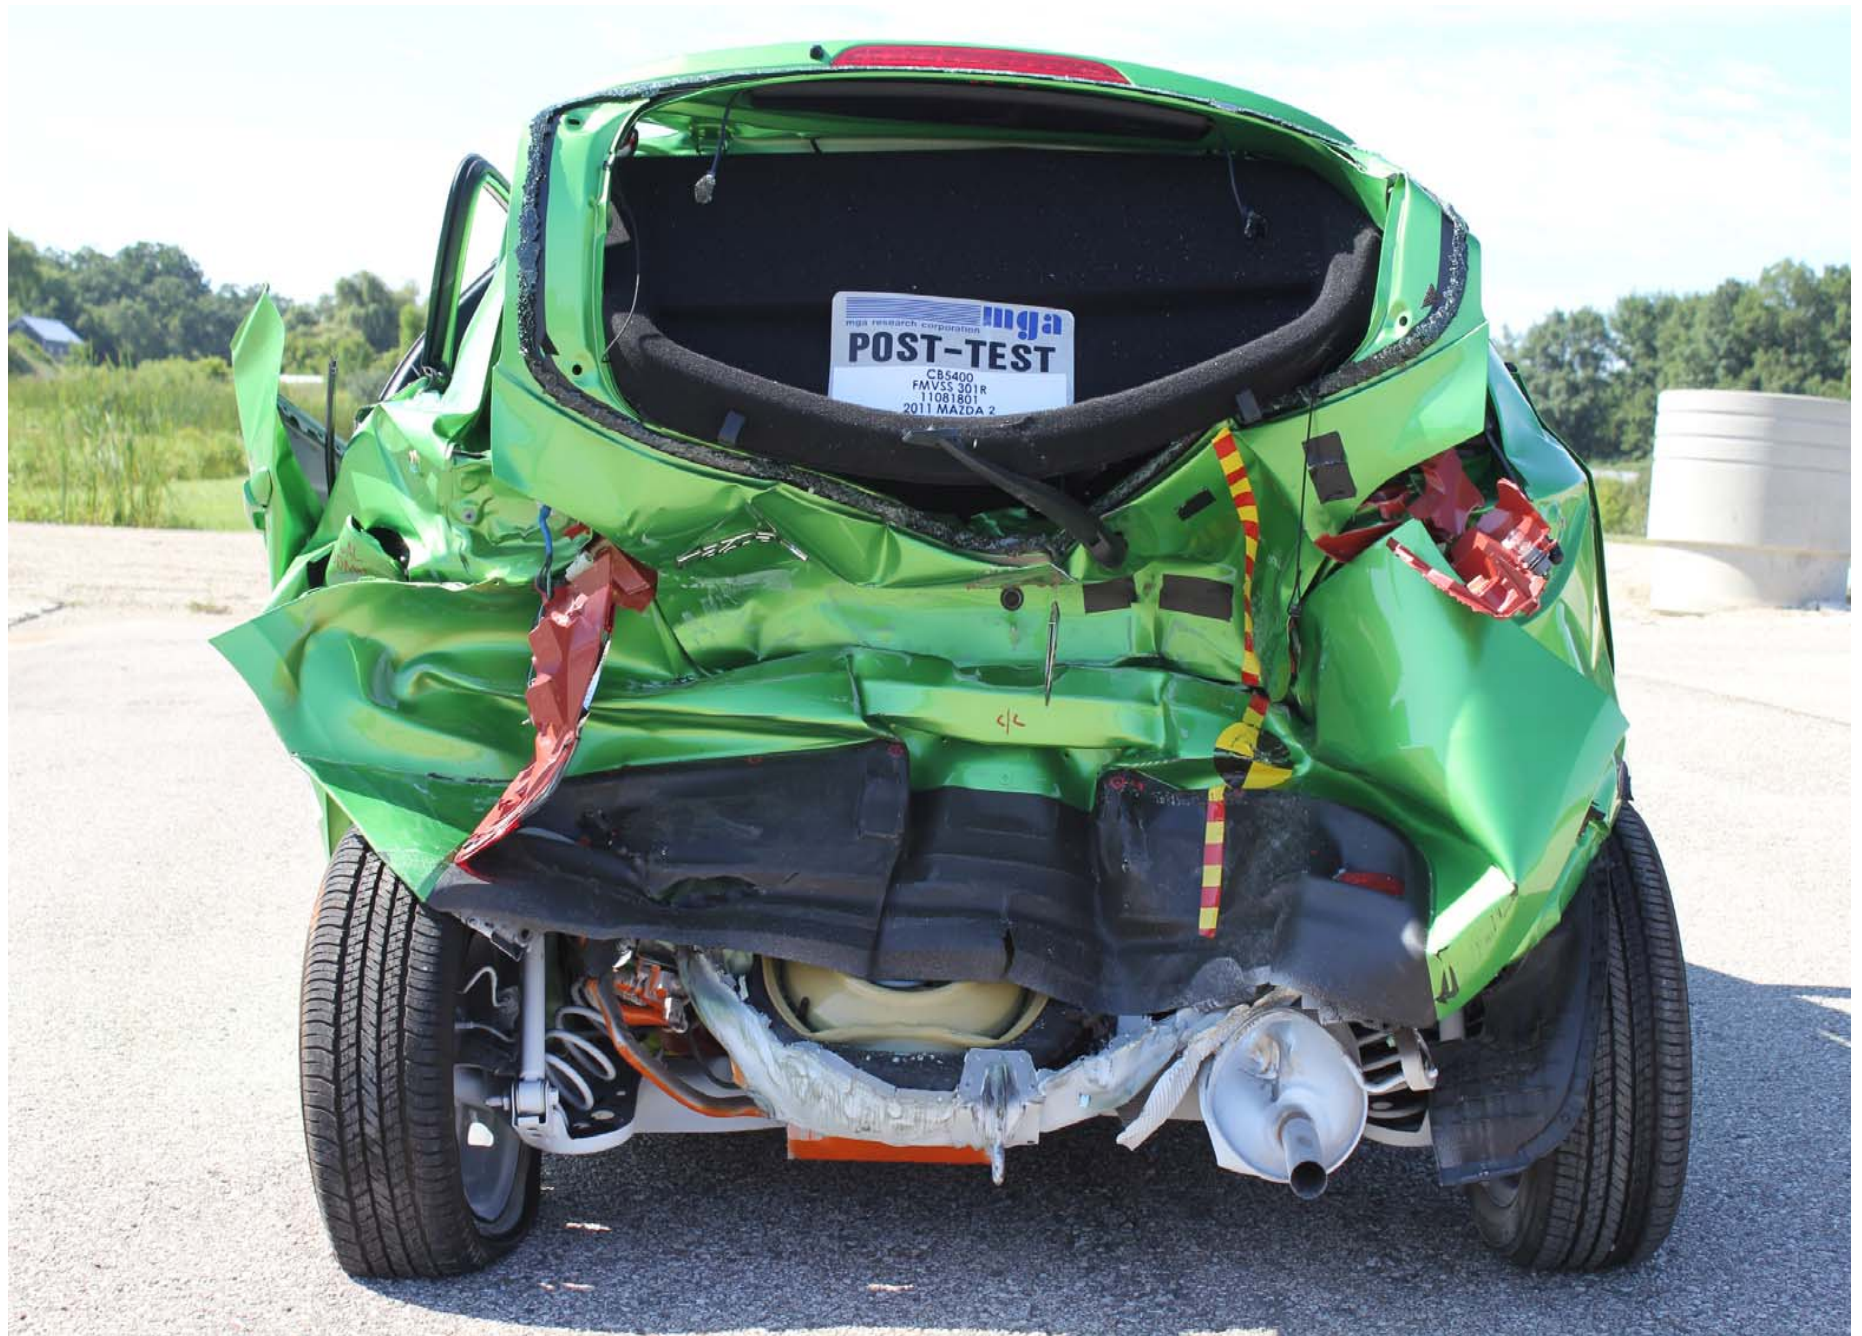
Post-Test Rear View of Vehicle

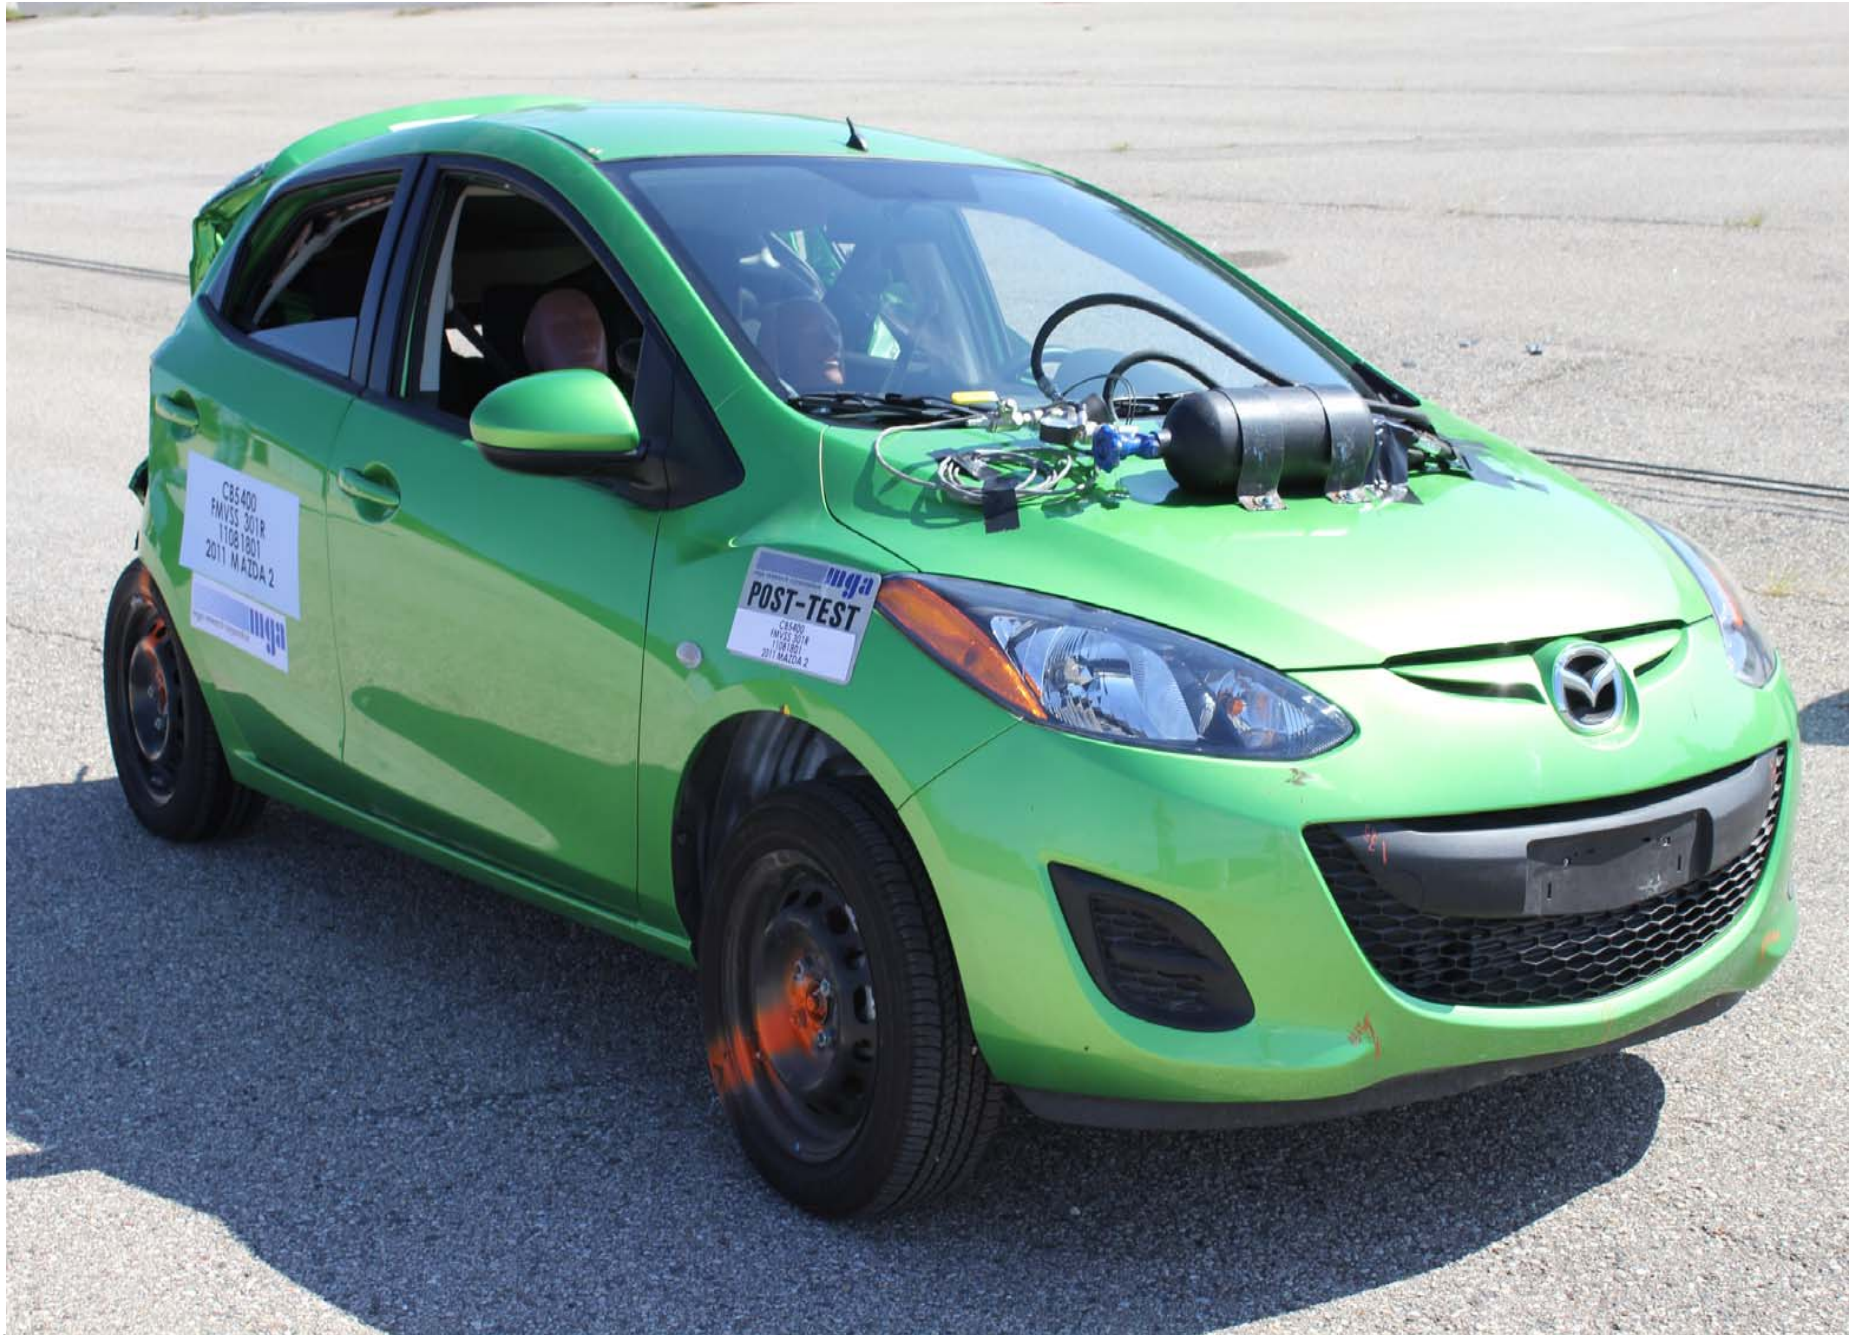
Post-Test  $\frac{3}{4}$  Frontal View From Right Side of Vehicle

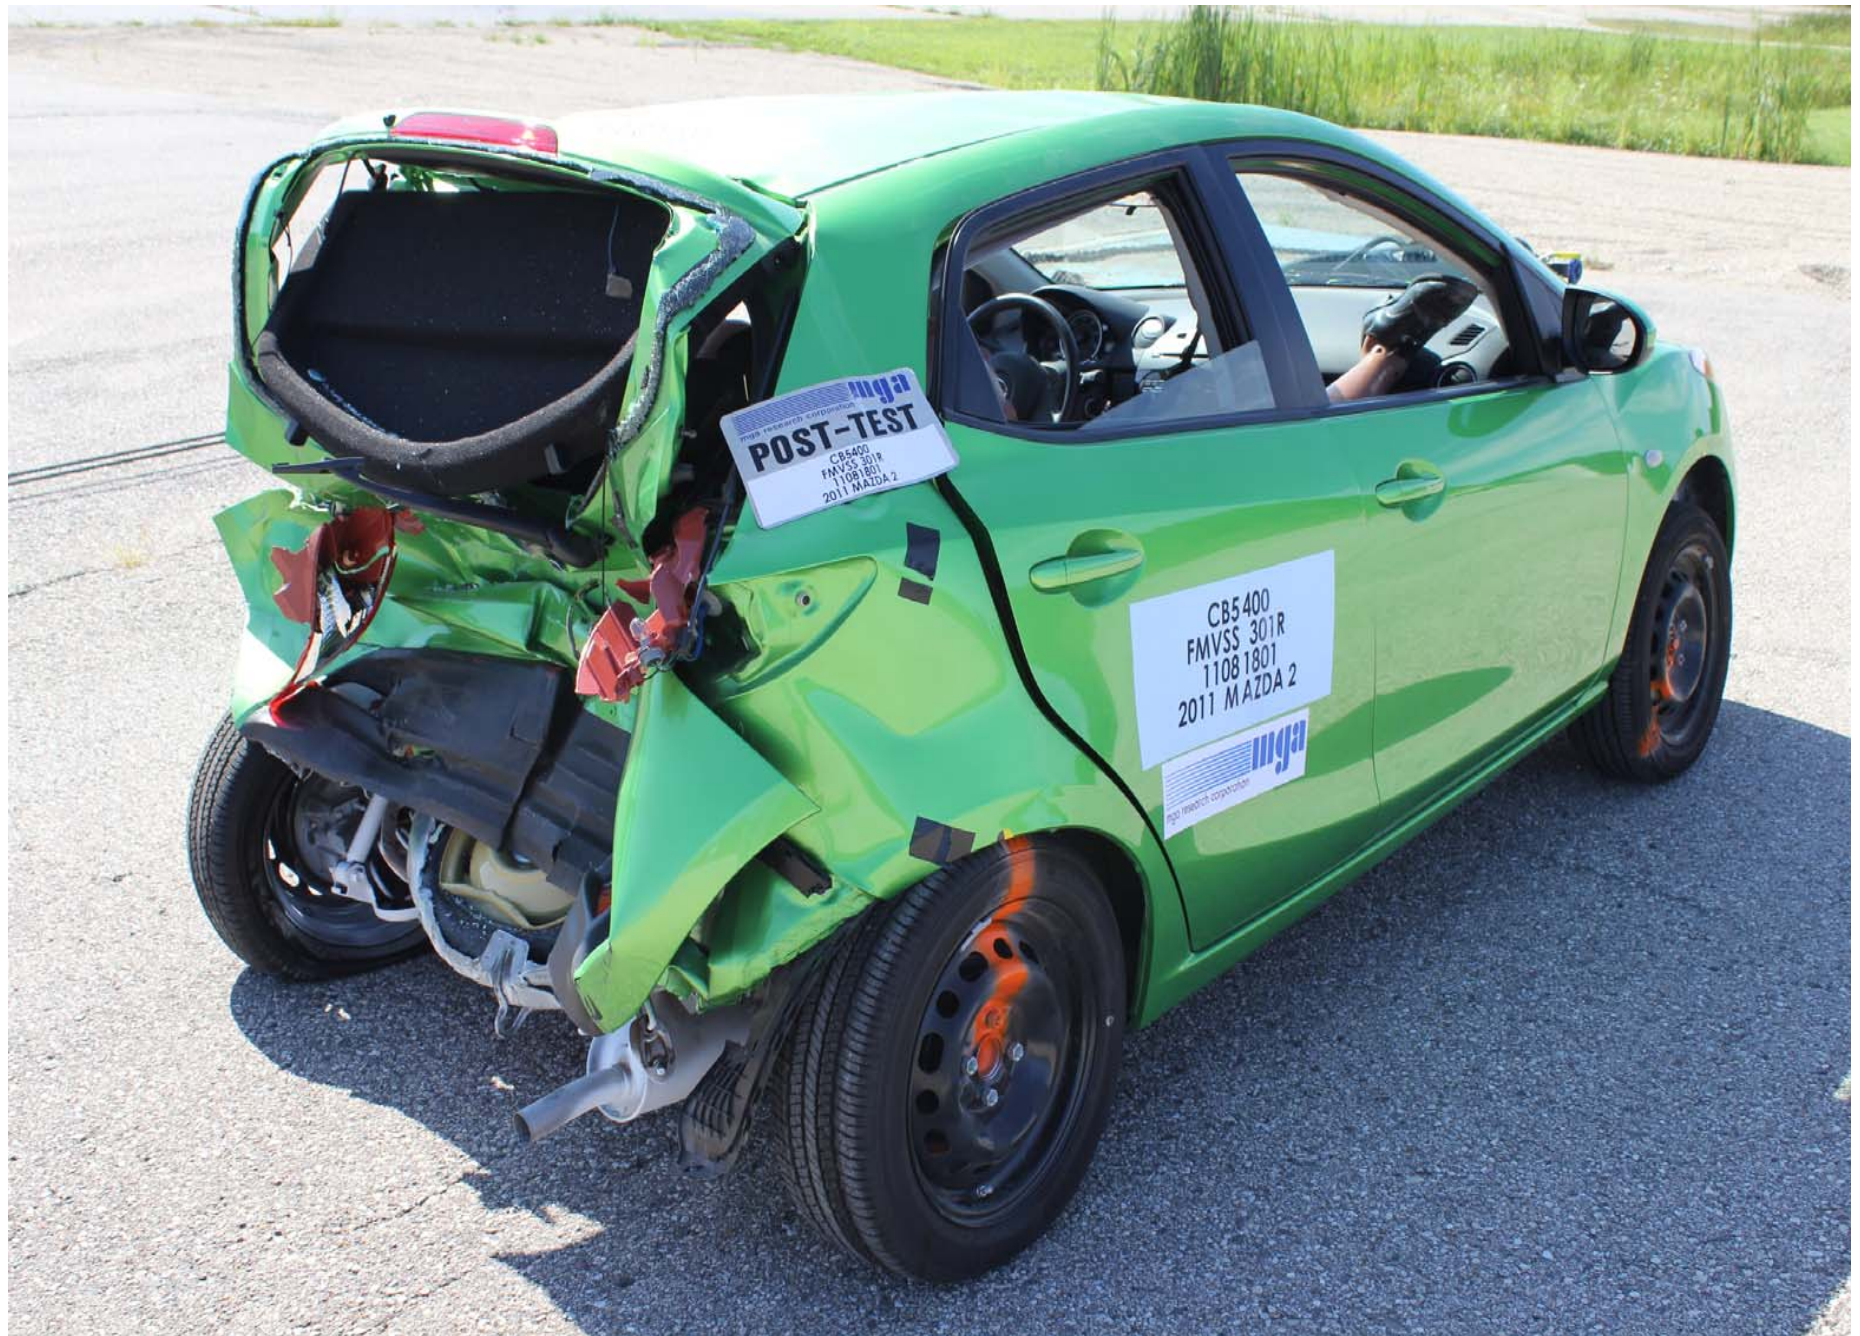
Post-Test  $\frac{3}{4}$  Rear View From Right Side of Vehicle
