**REPORT NUMBER: 301-MGA-2011-008**

**SAFETY COMPLIANCE TESTING FOR FMVSS 301R  
FUEL SYSTEM INTEGRITY – REAR IMPACT**

**MAZDA MOTOR CORPORATION  
2011 MAZDA 2 SPORT MT  
NHTSA NUMBER: CB5400**

**PREPARED BY:  
MGA RESEARCH CORPORATION  
5000 WARREN ROAD  
BURLINGTON, WI 53105**

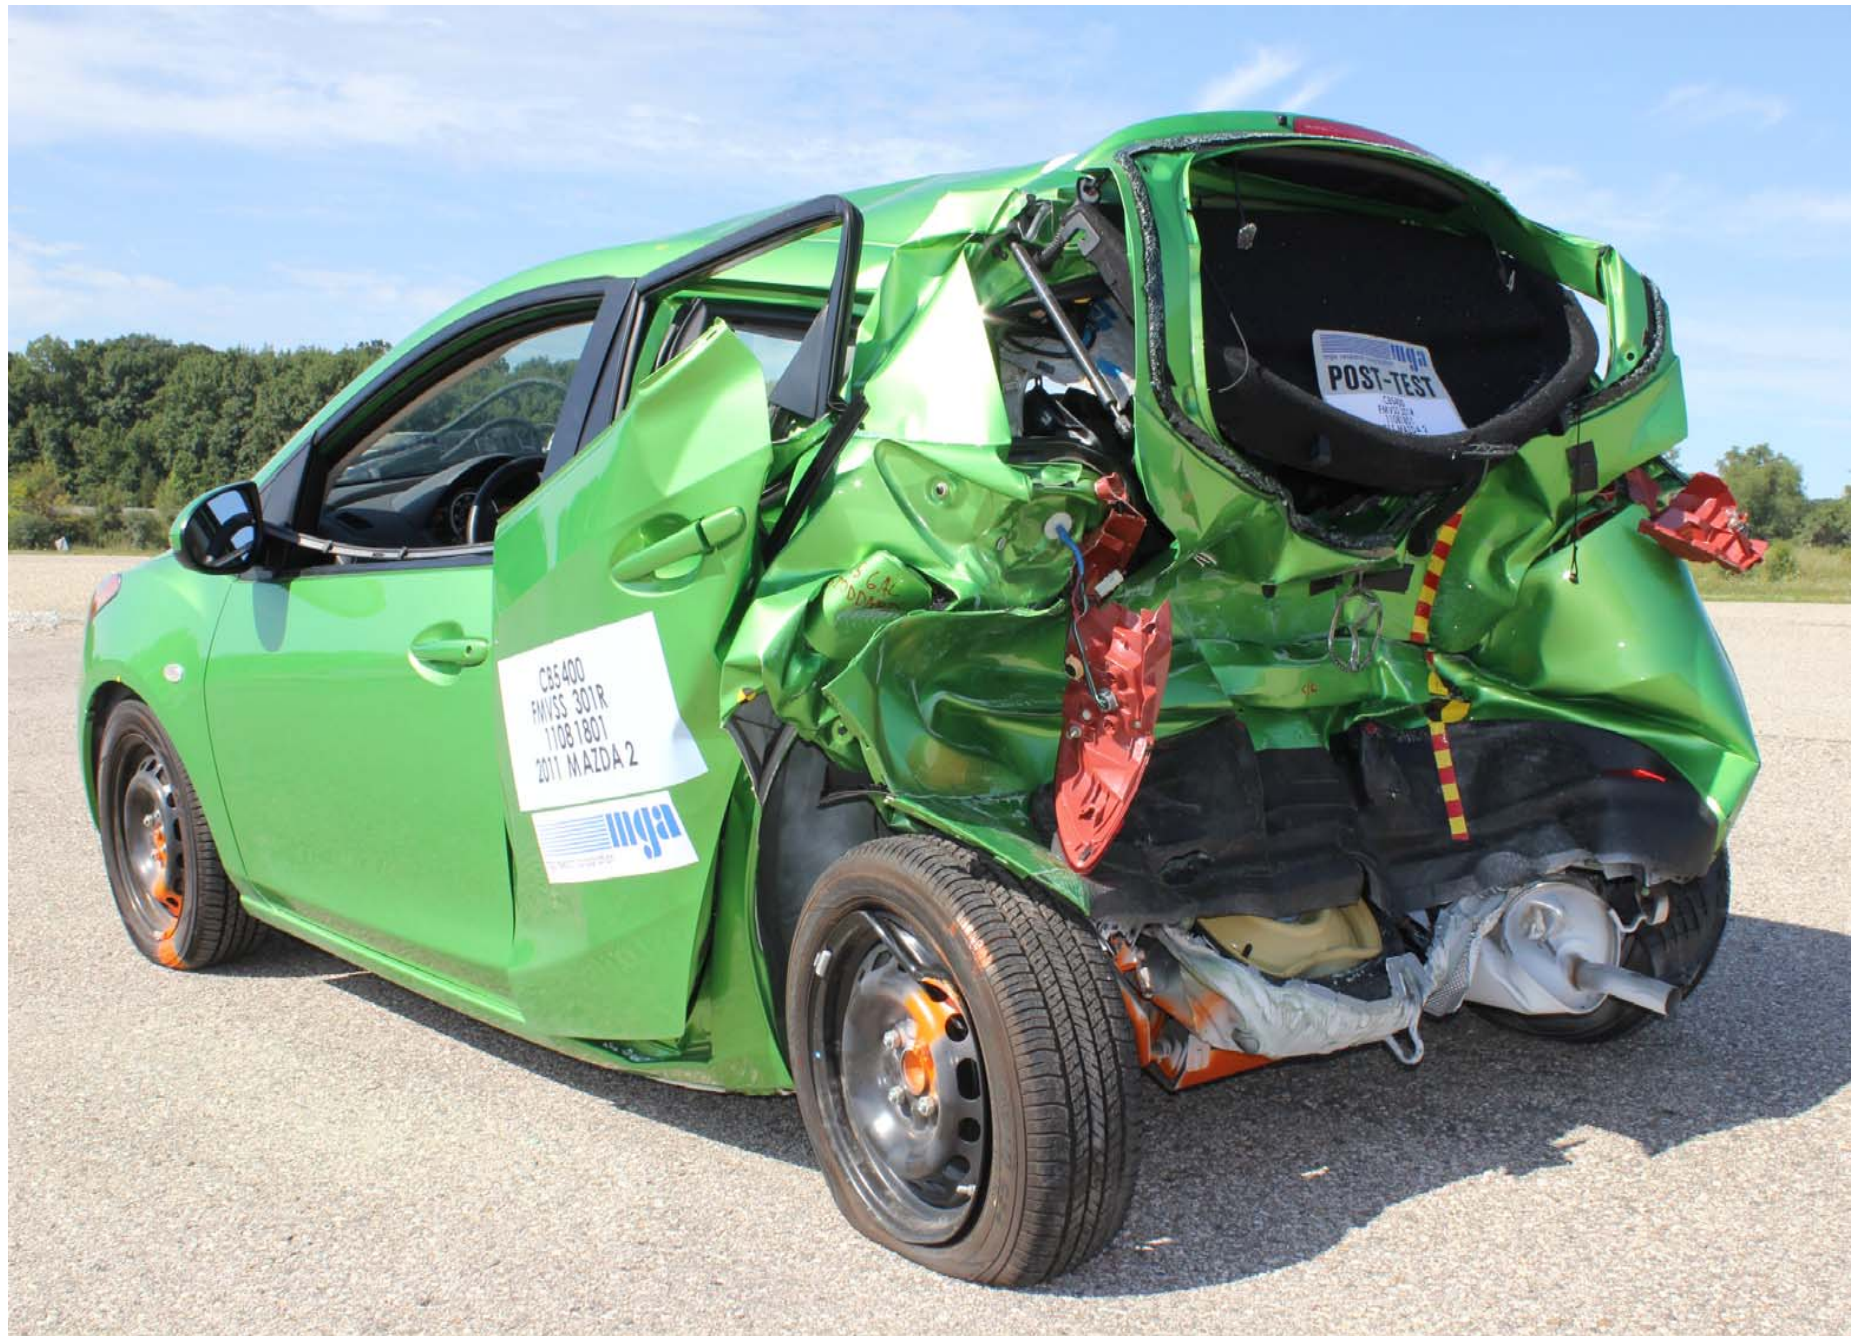
Post-Test ¾ Rear View From Left Side of Vehicle

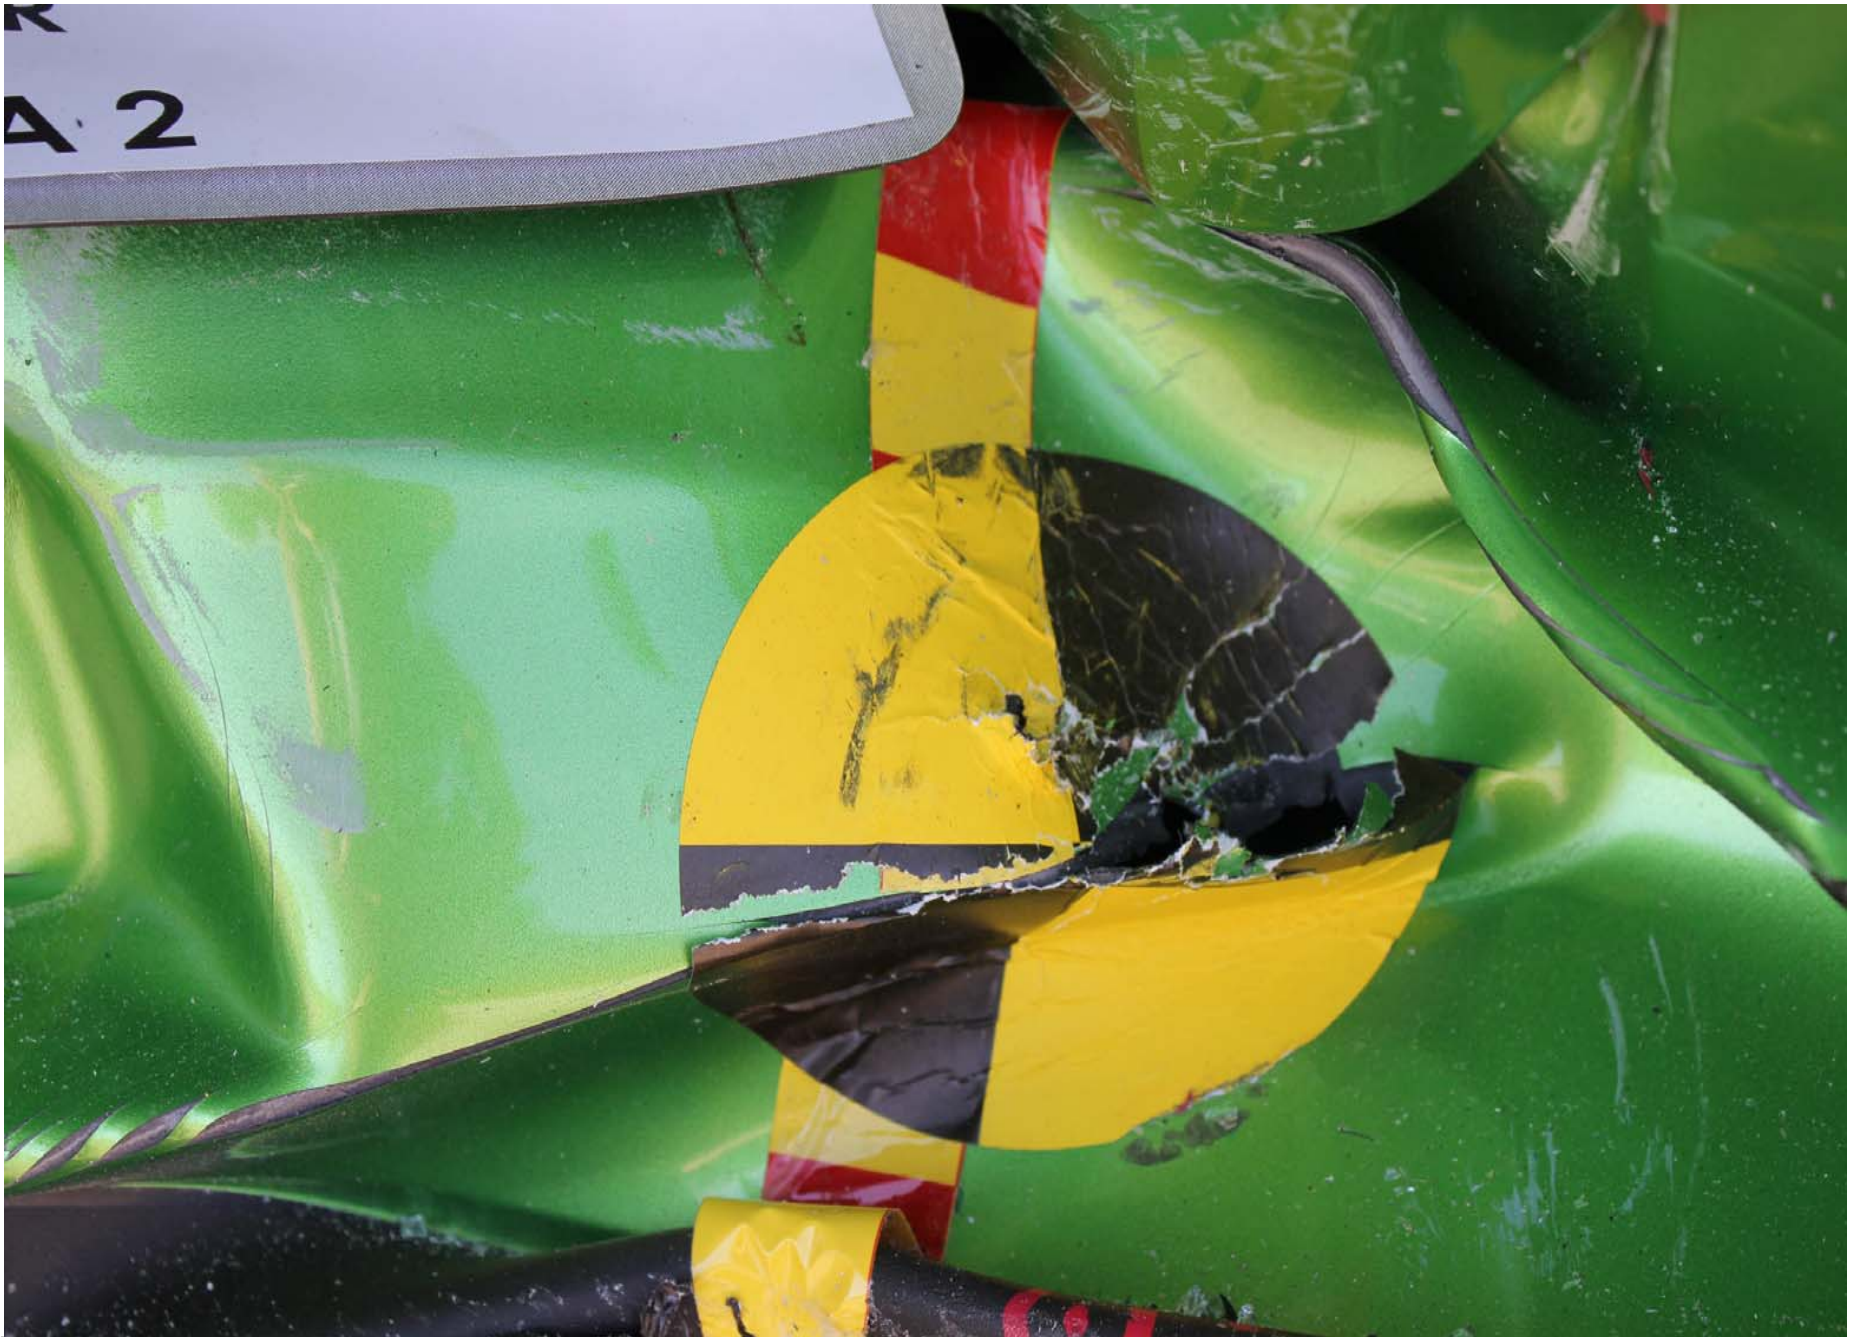
Post-Test Impact Point

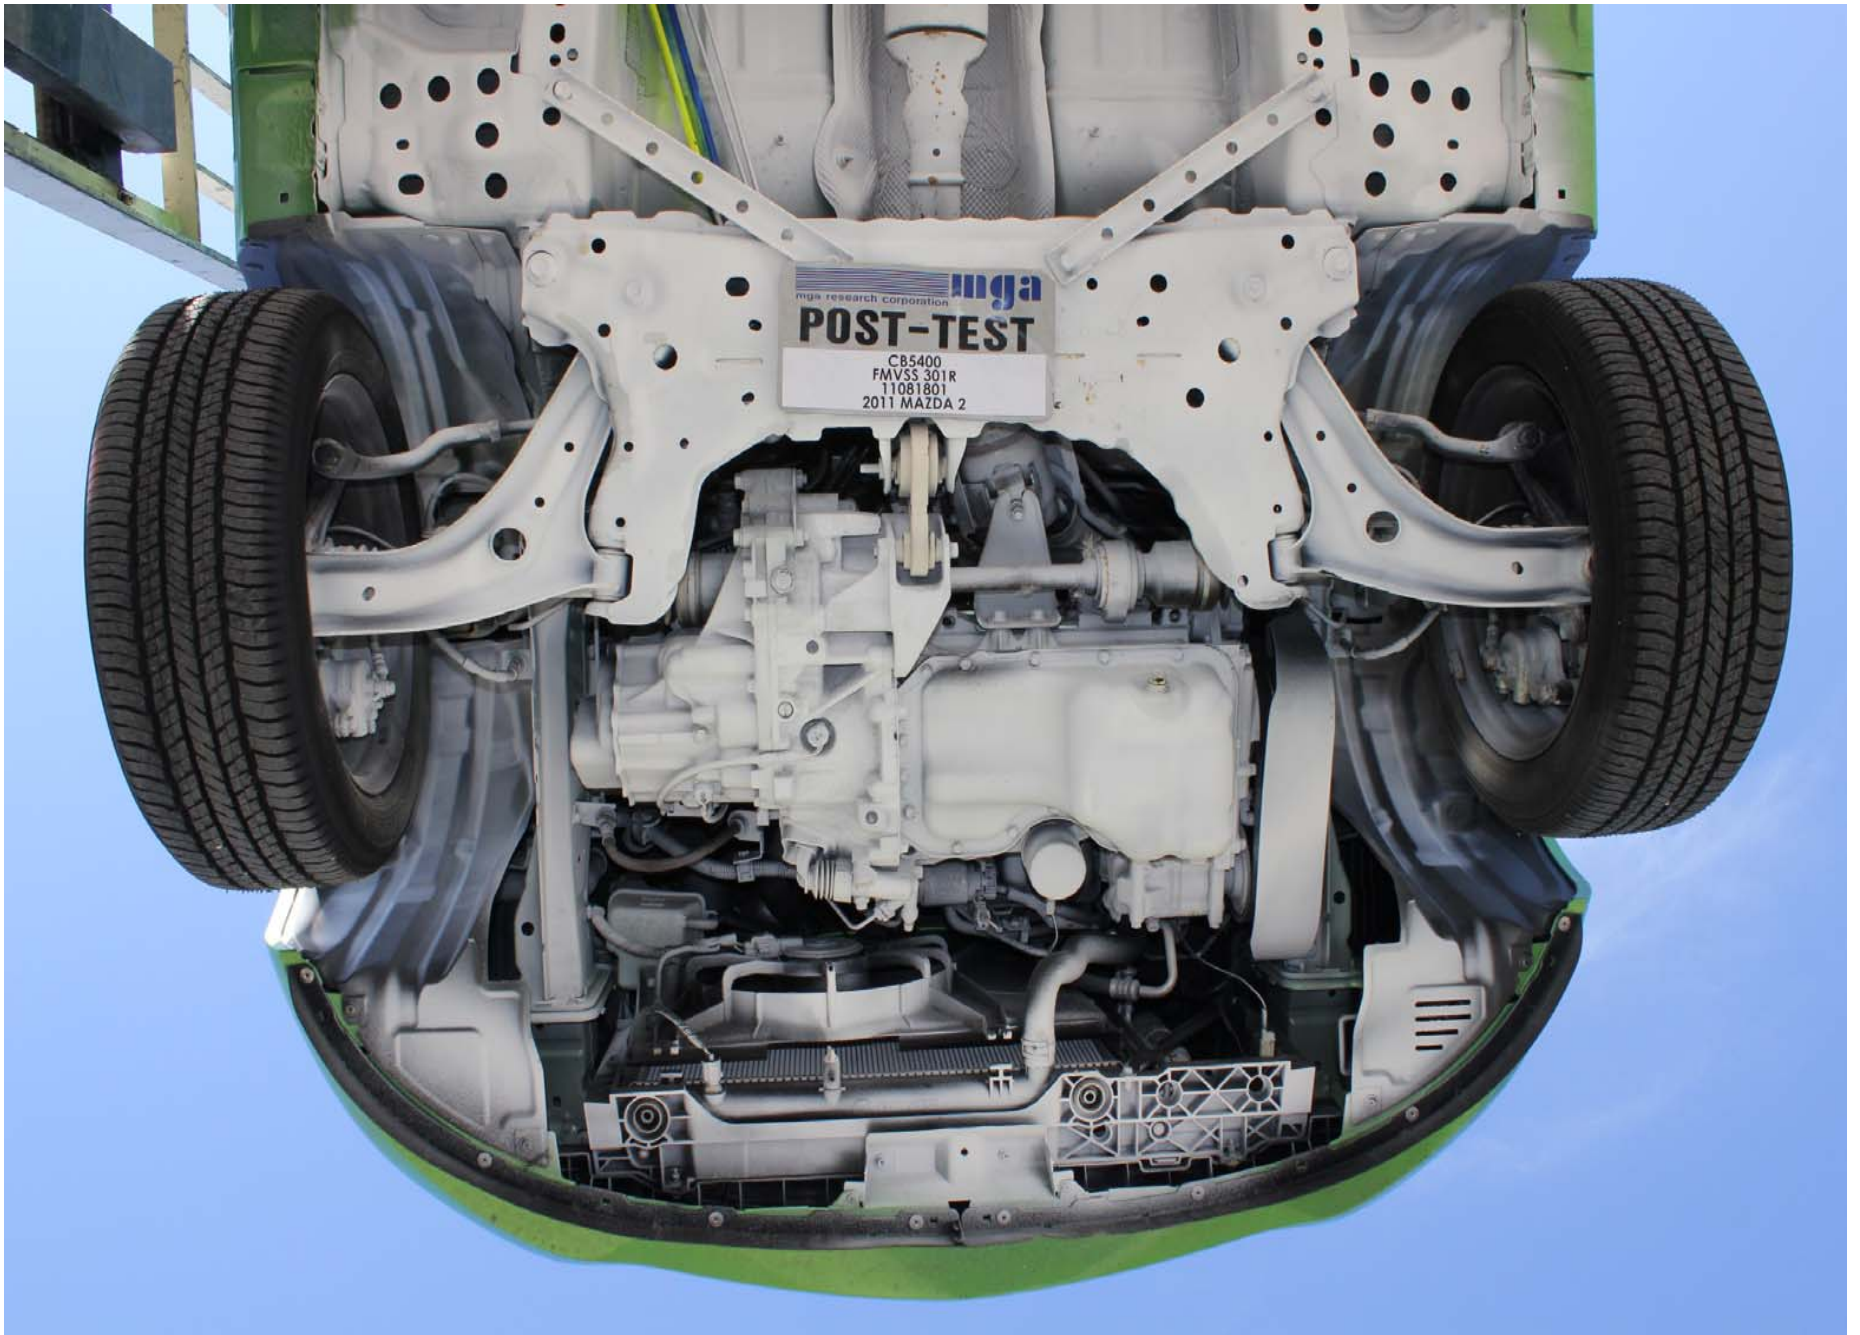
Post-Test Underbody View 1

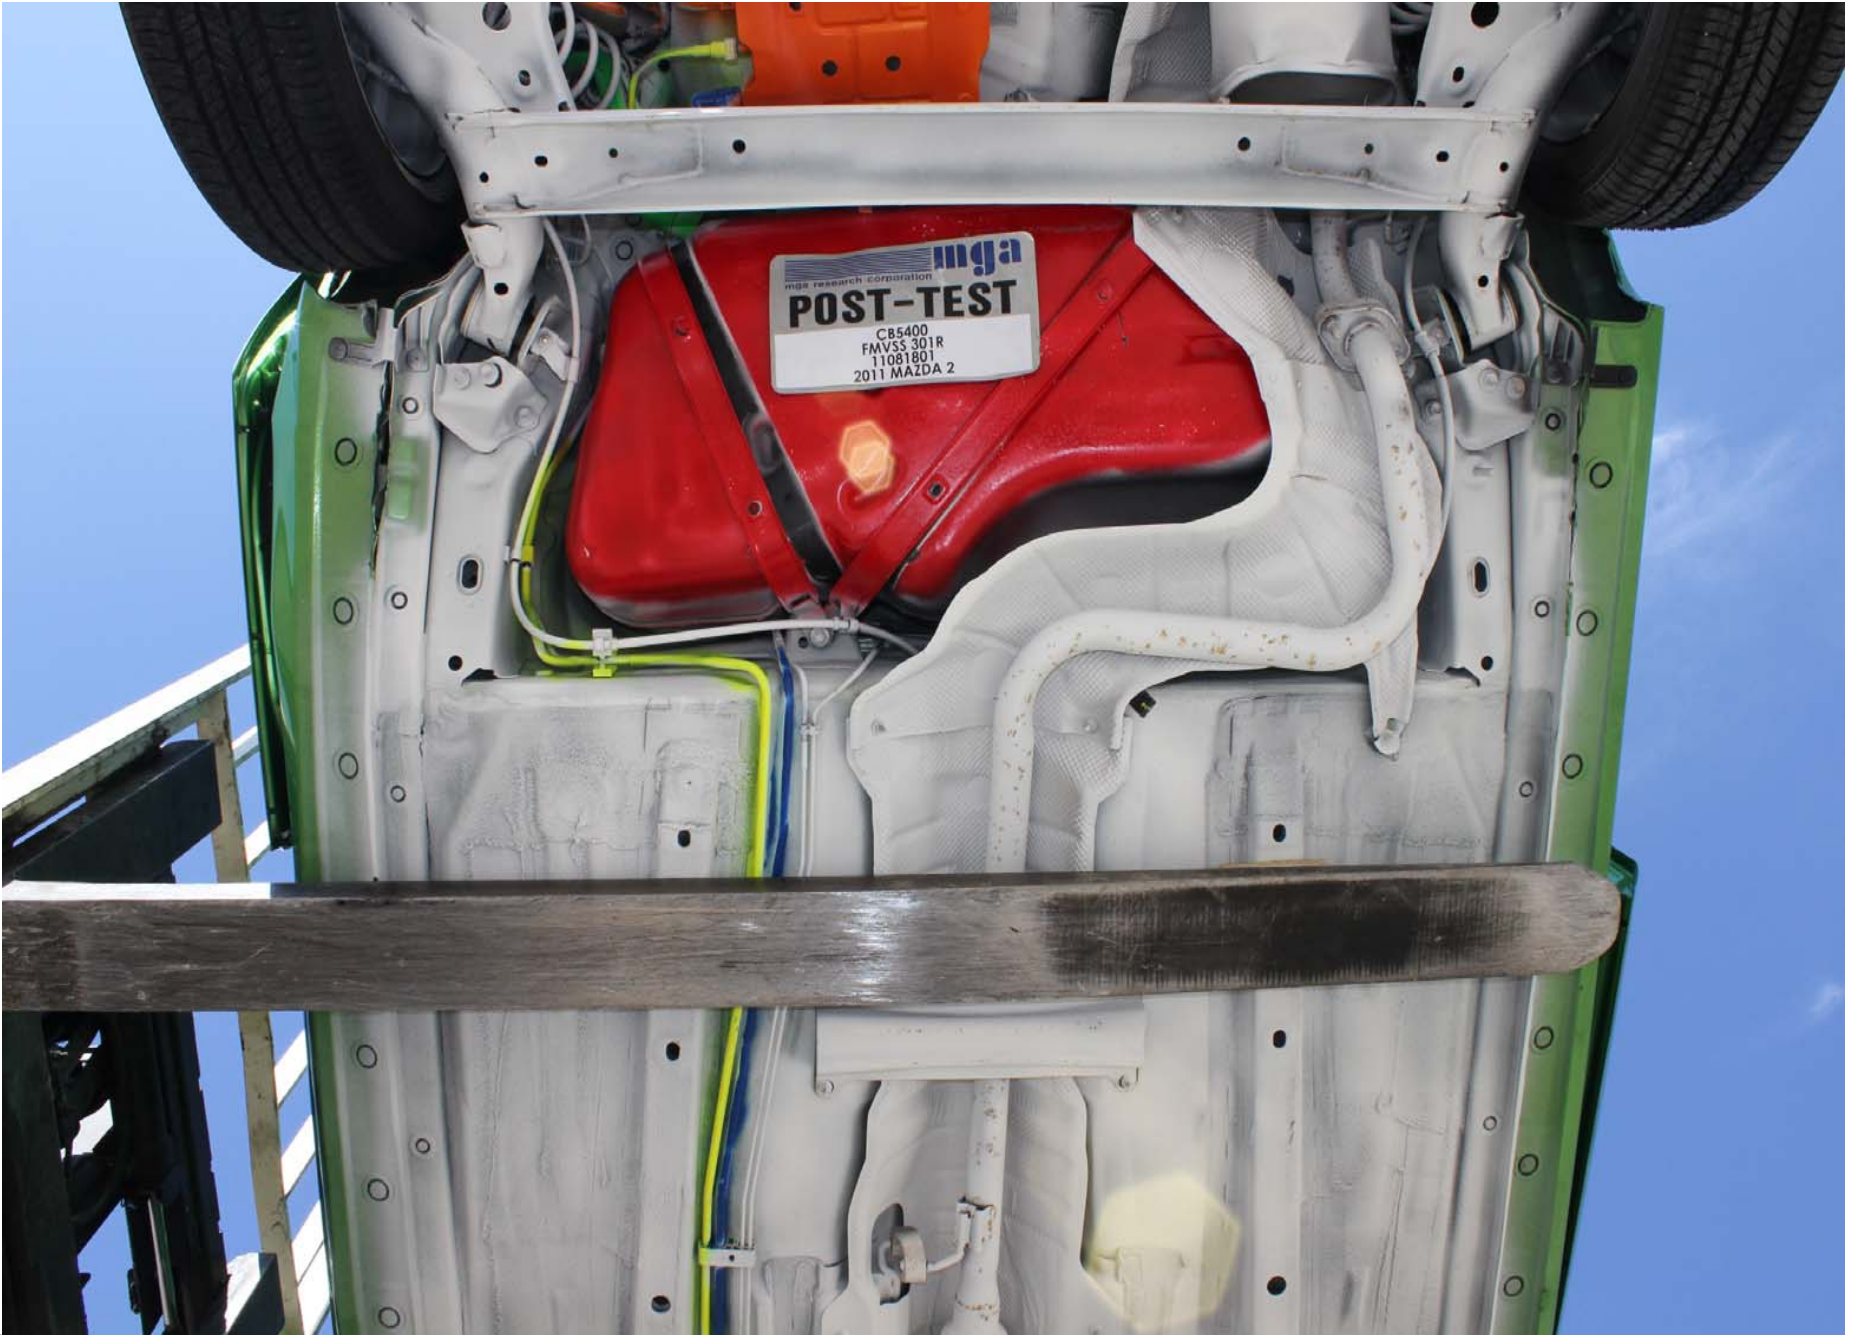
Post-Test Underbody View 2

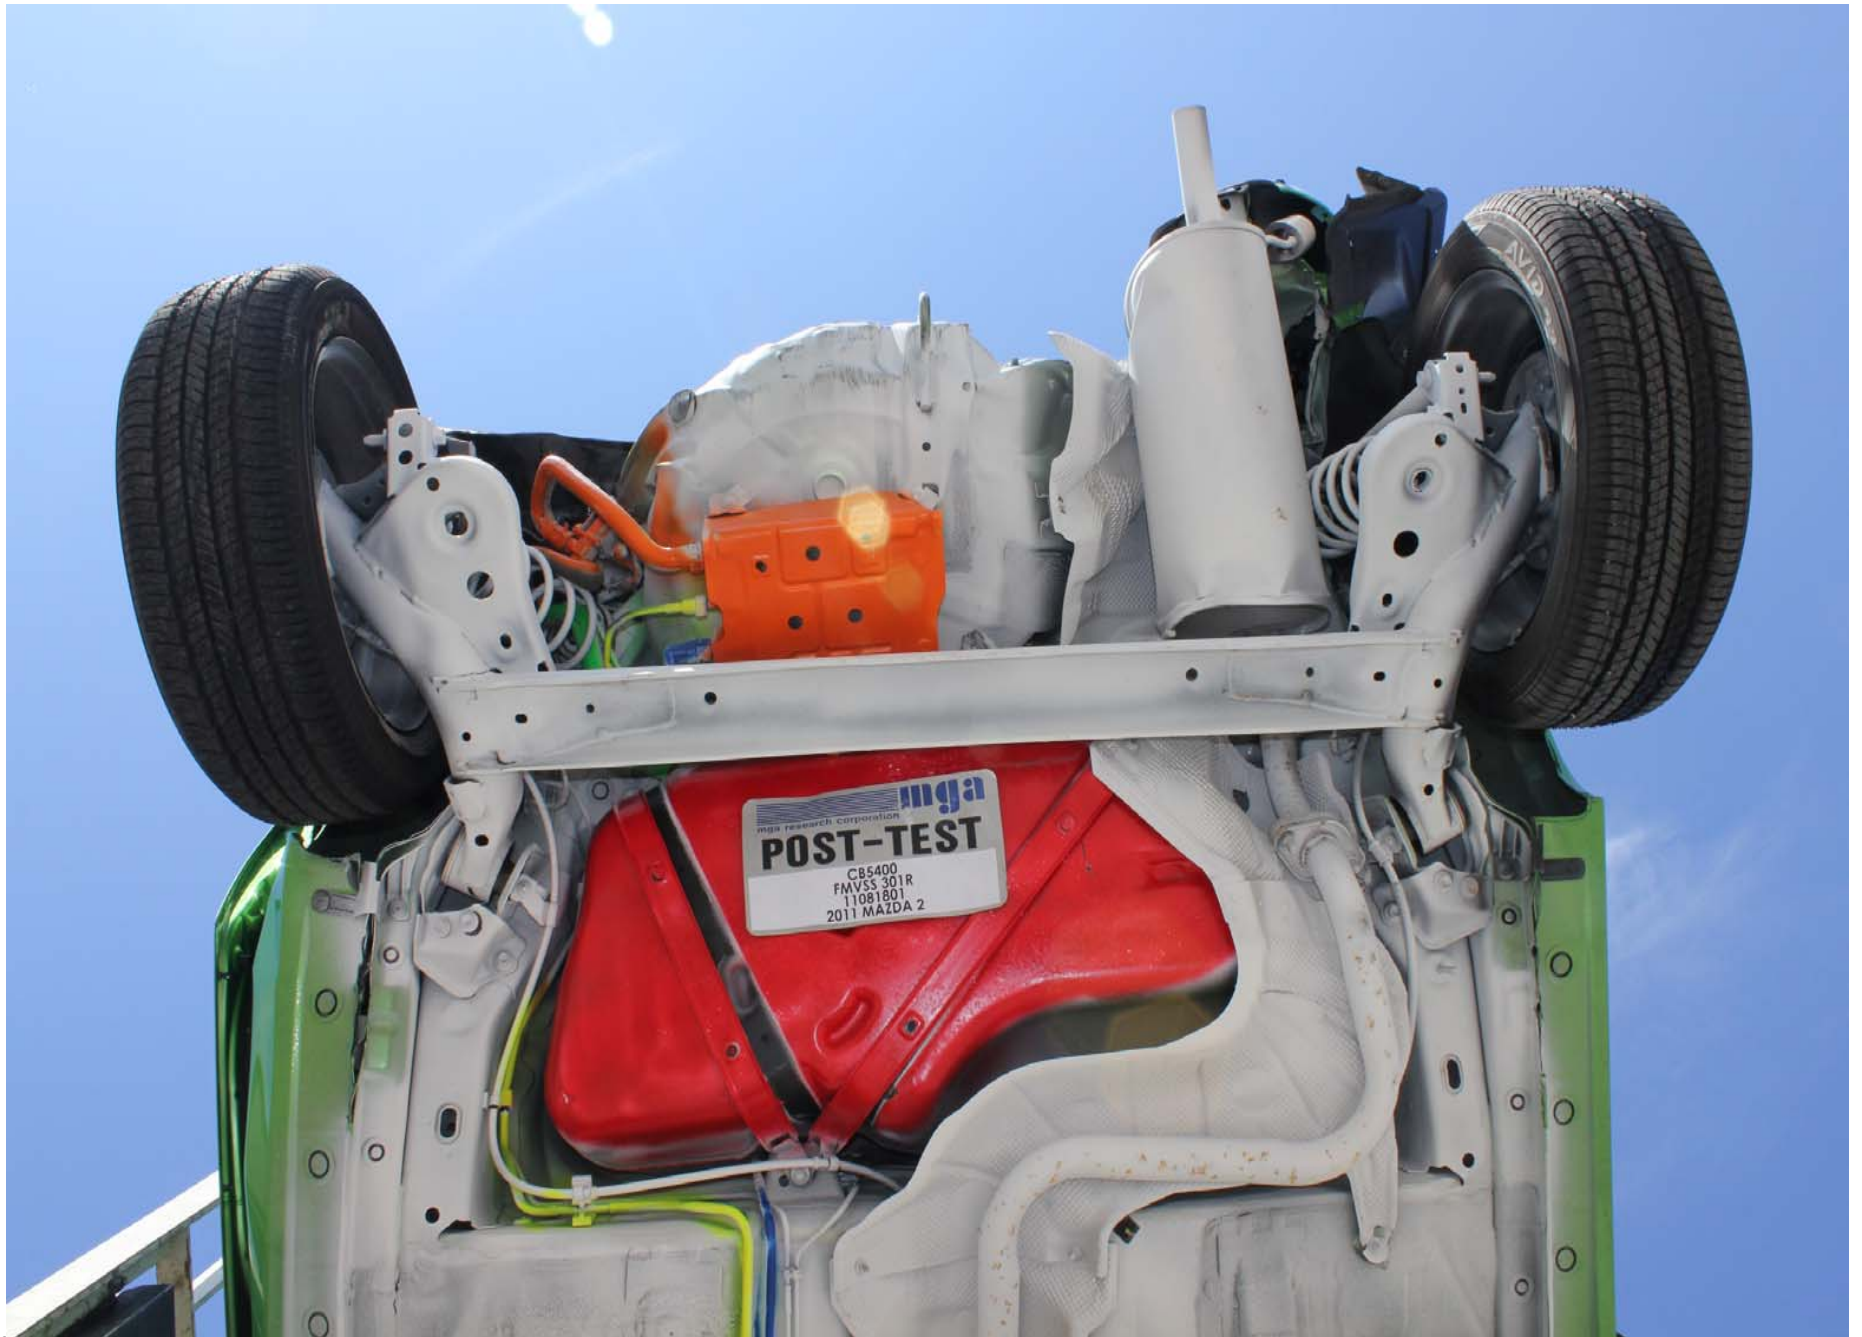
Post-Test Underbody View 3

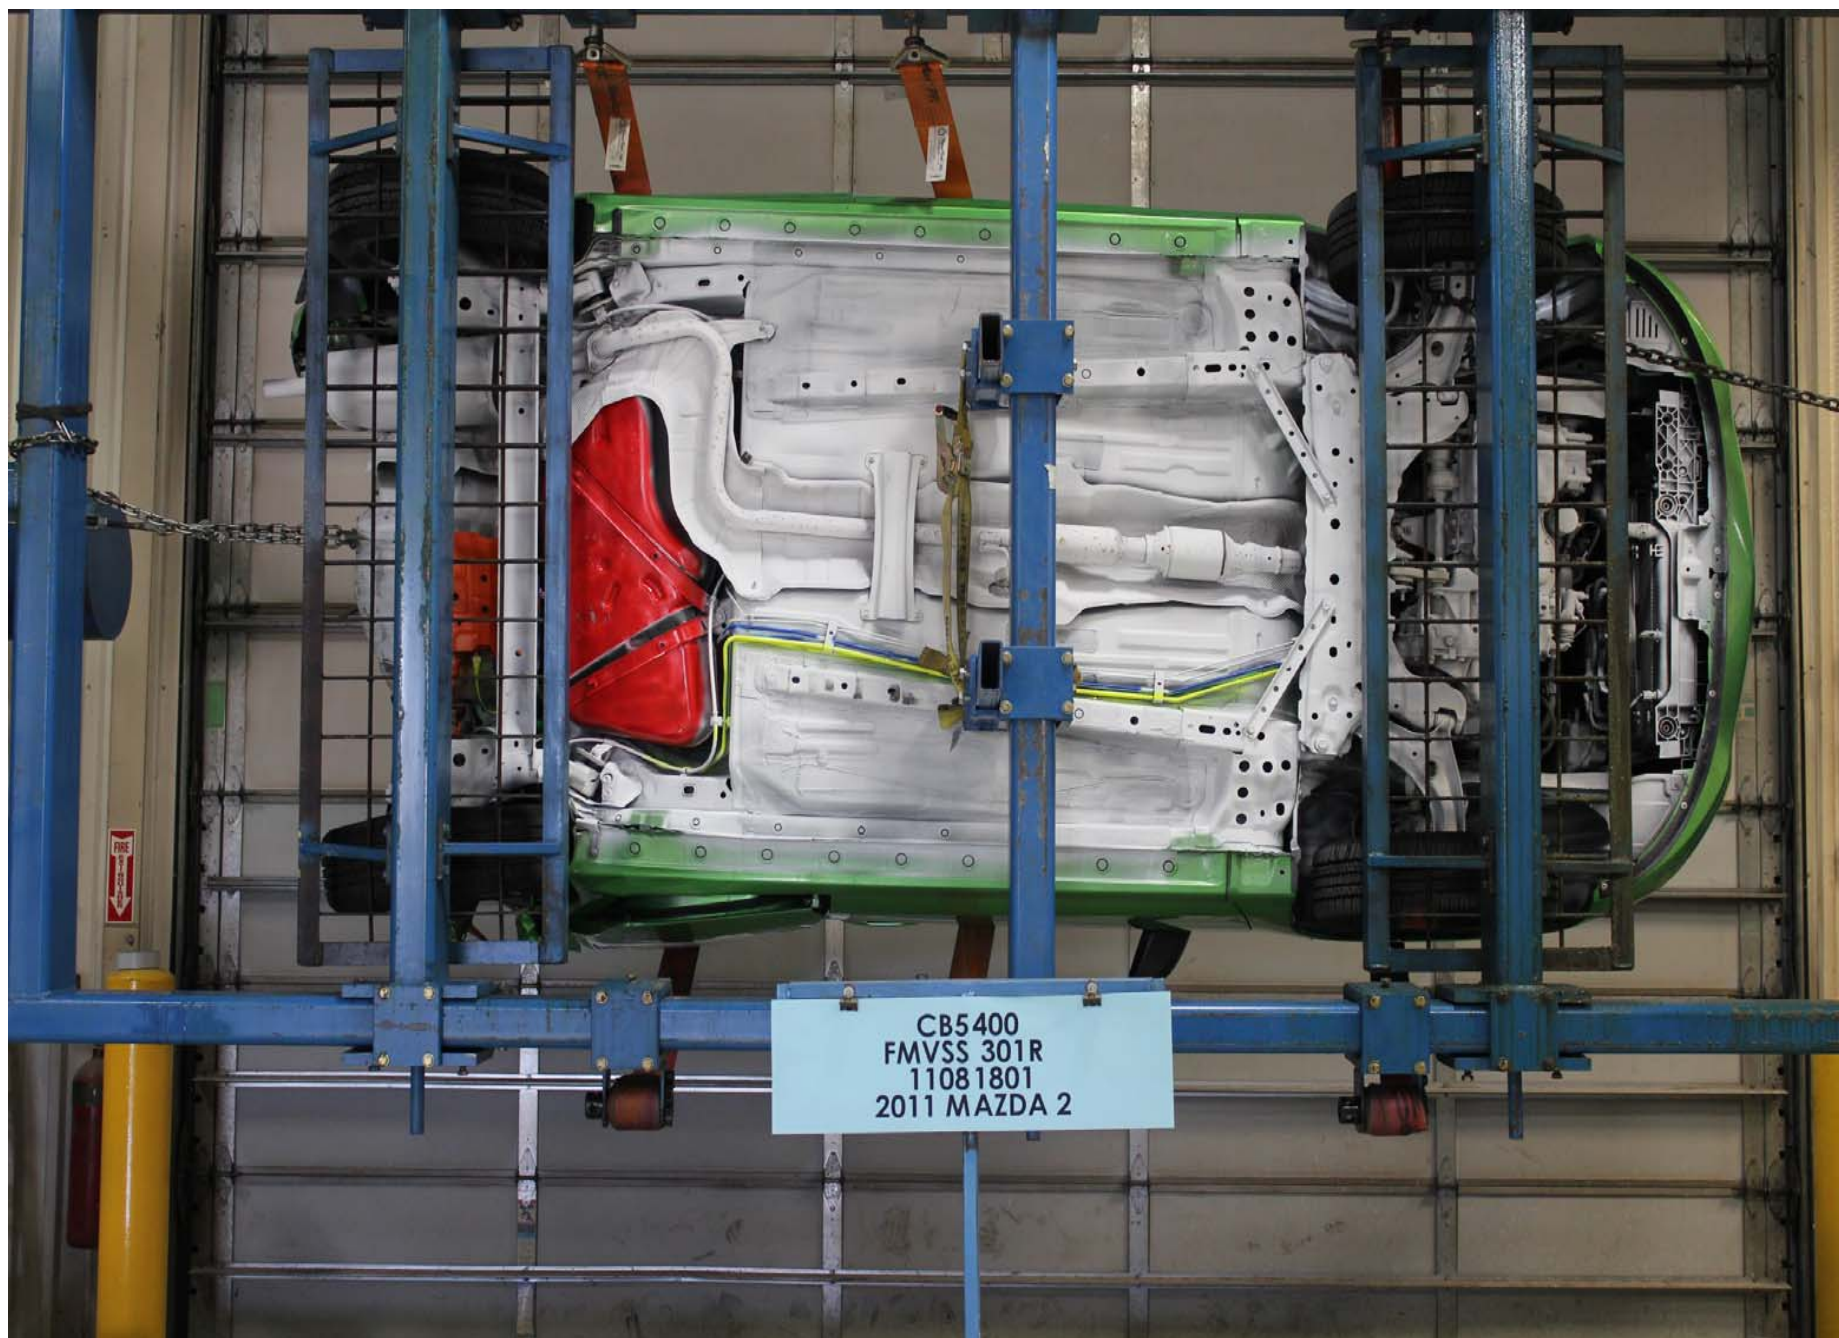
Static Rollover at 90 Degrees

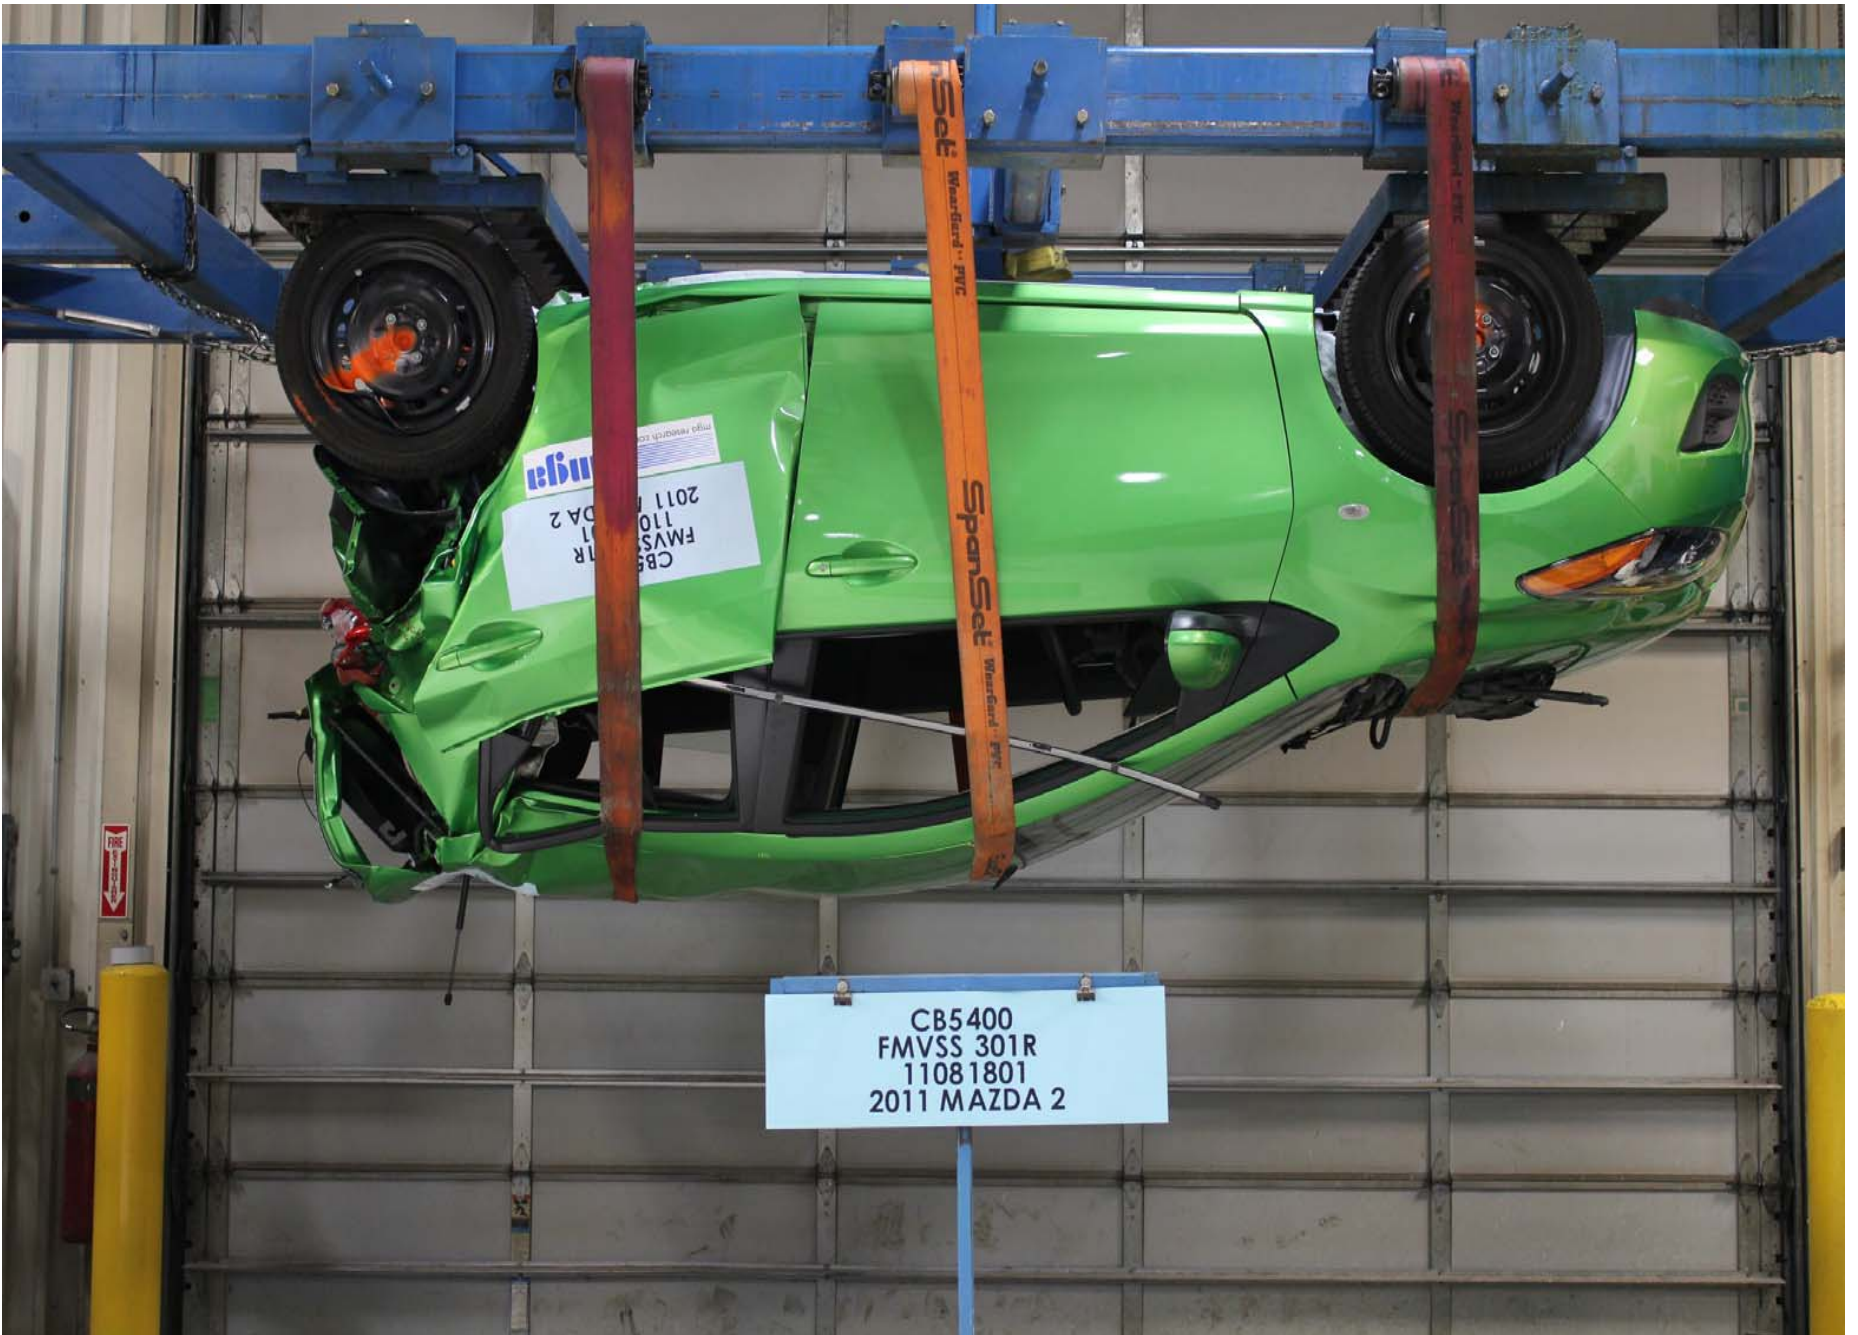
Static Rollover at 180 Degrees

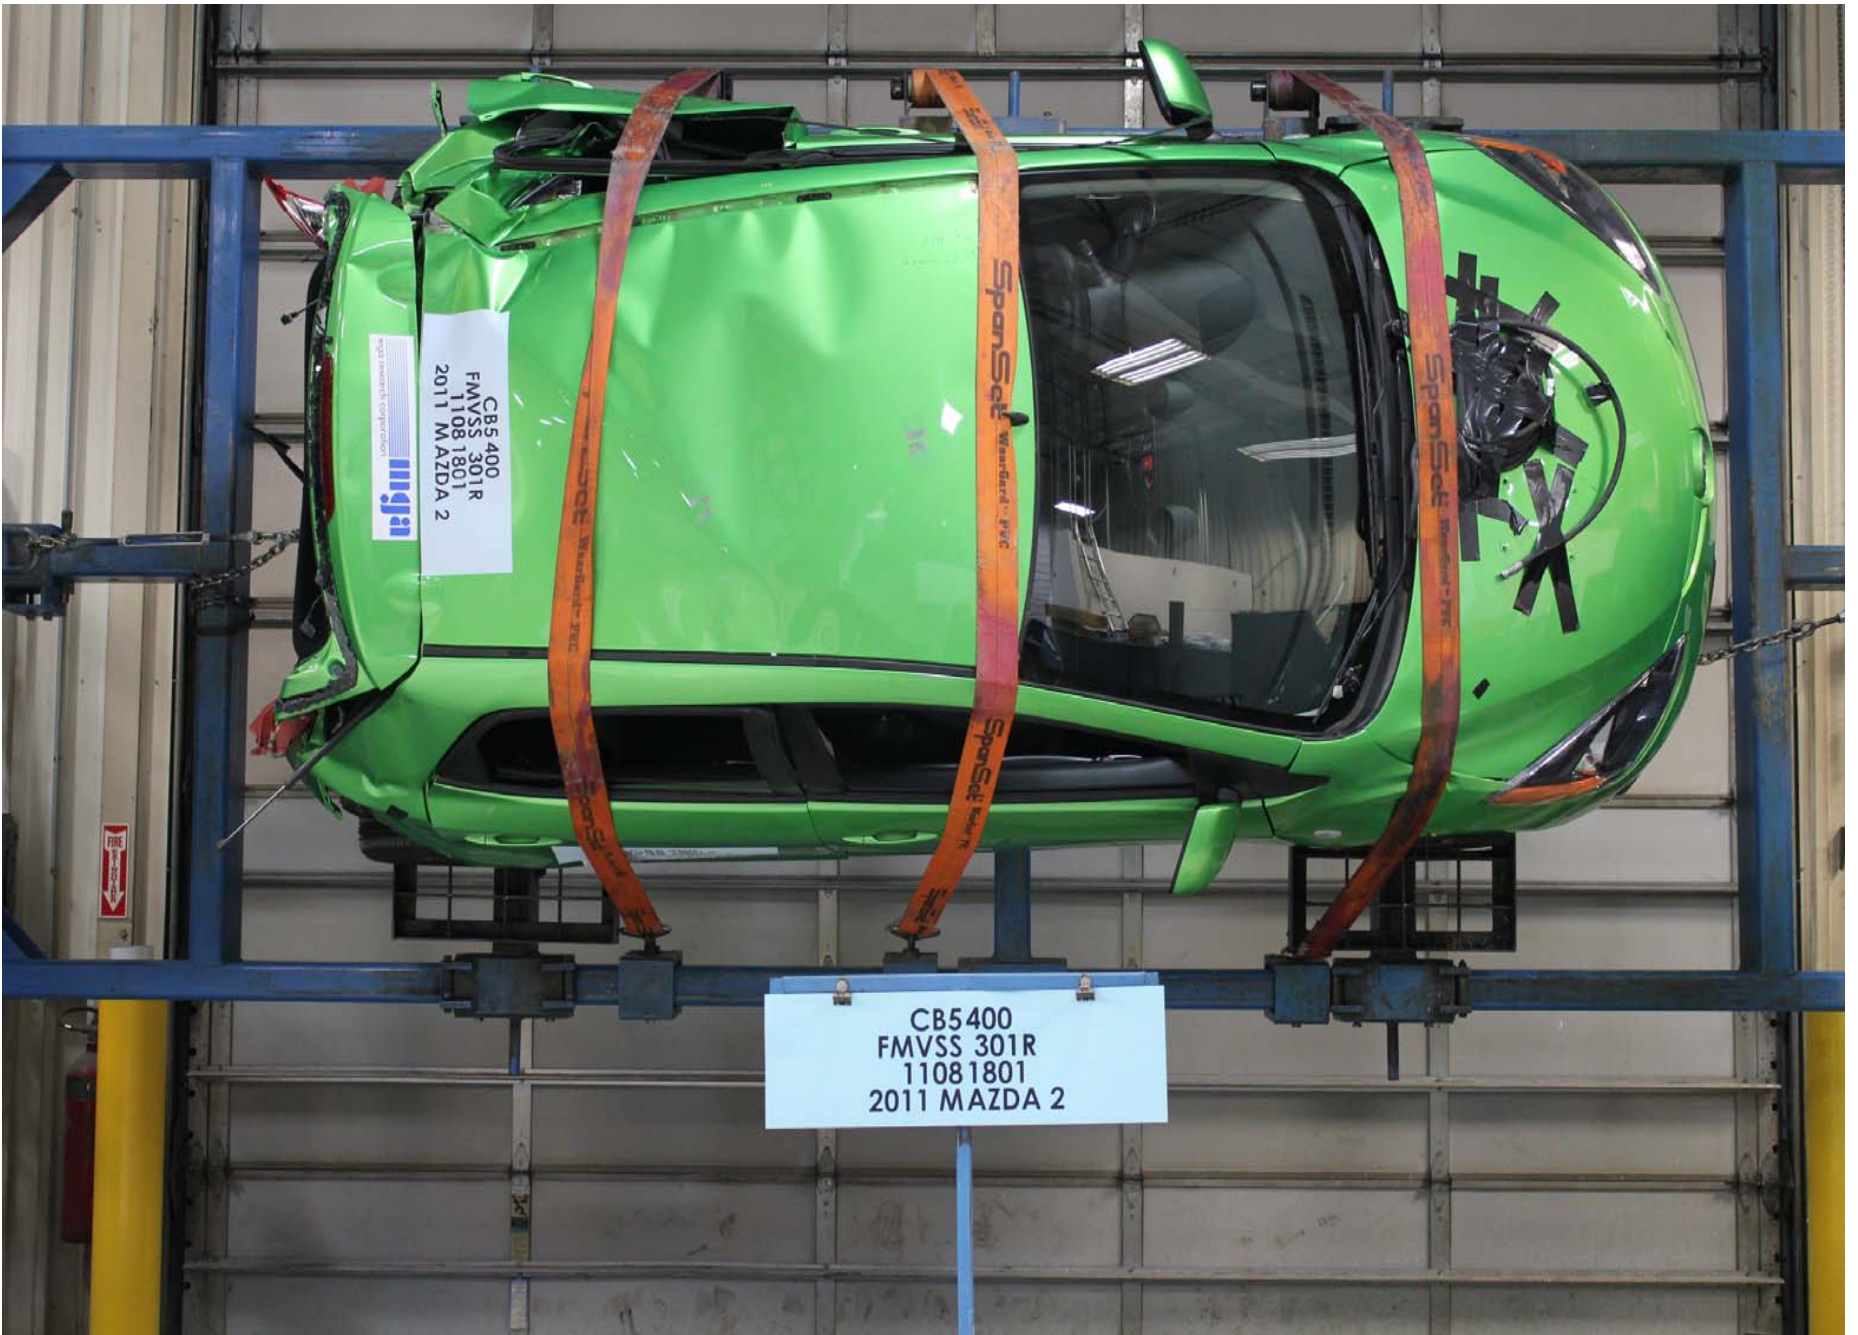
Static Rollover at 270 Degrees

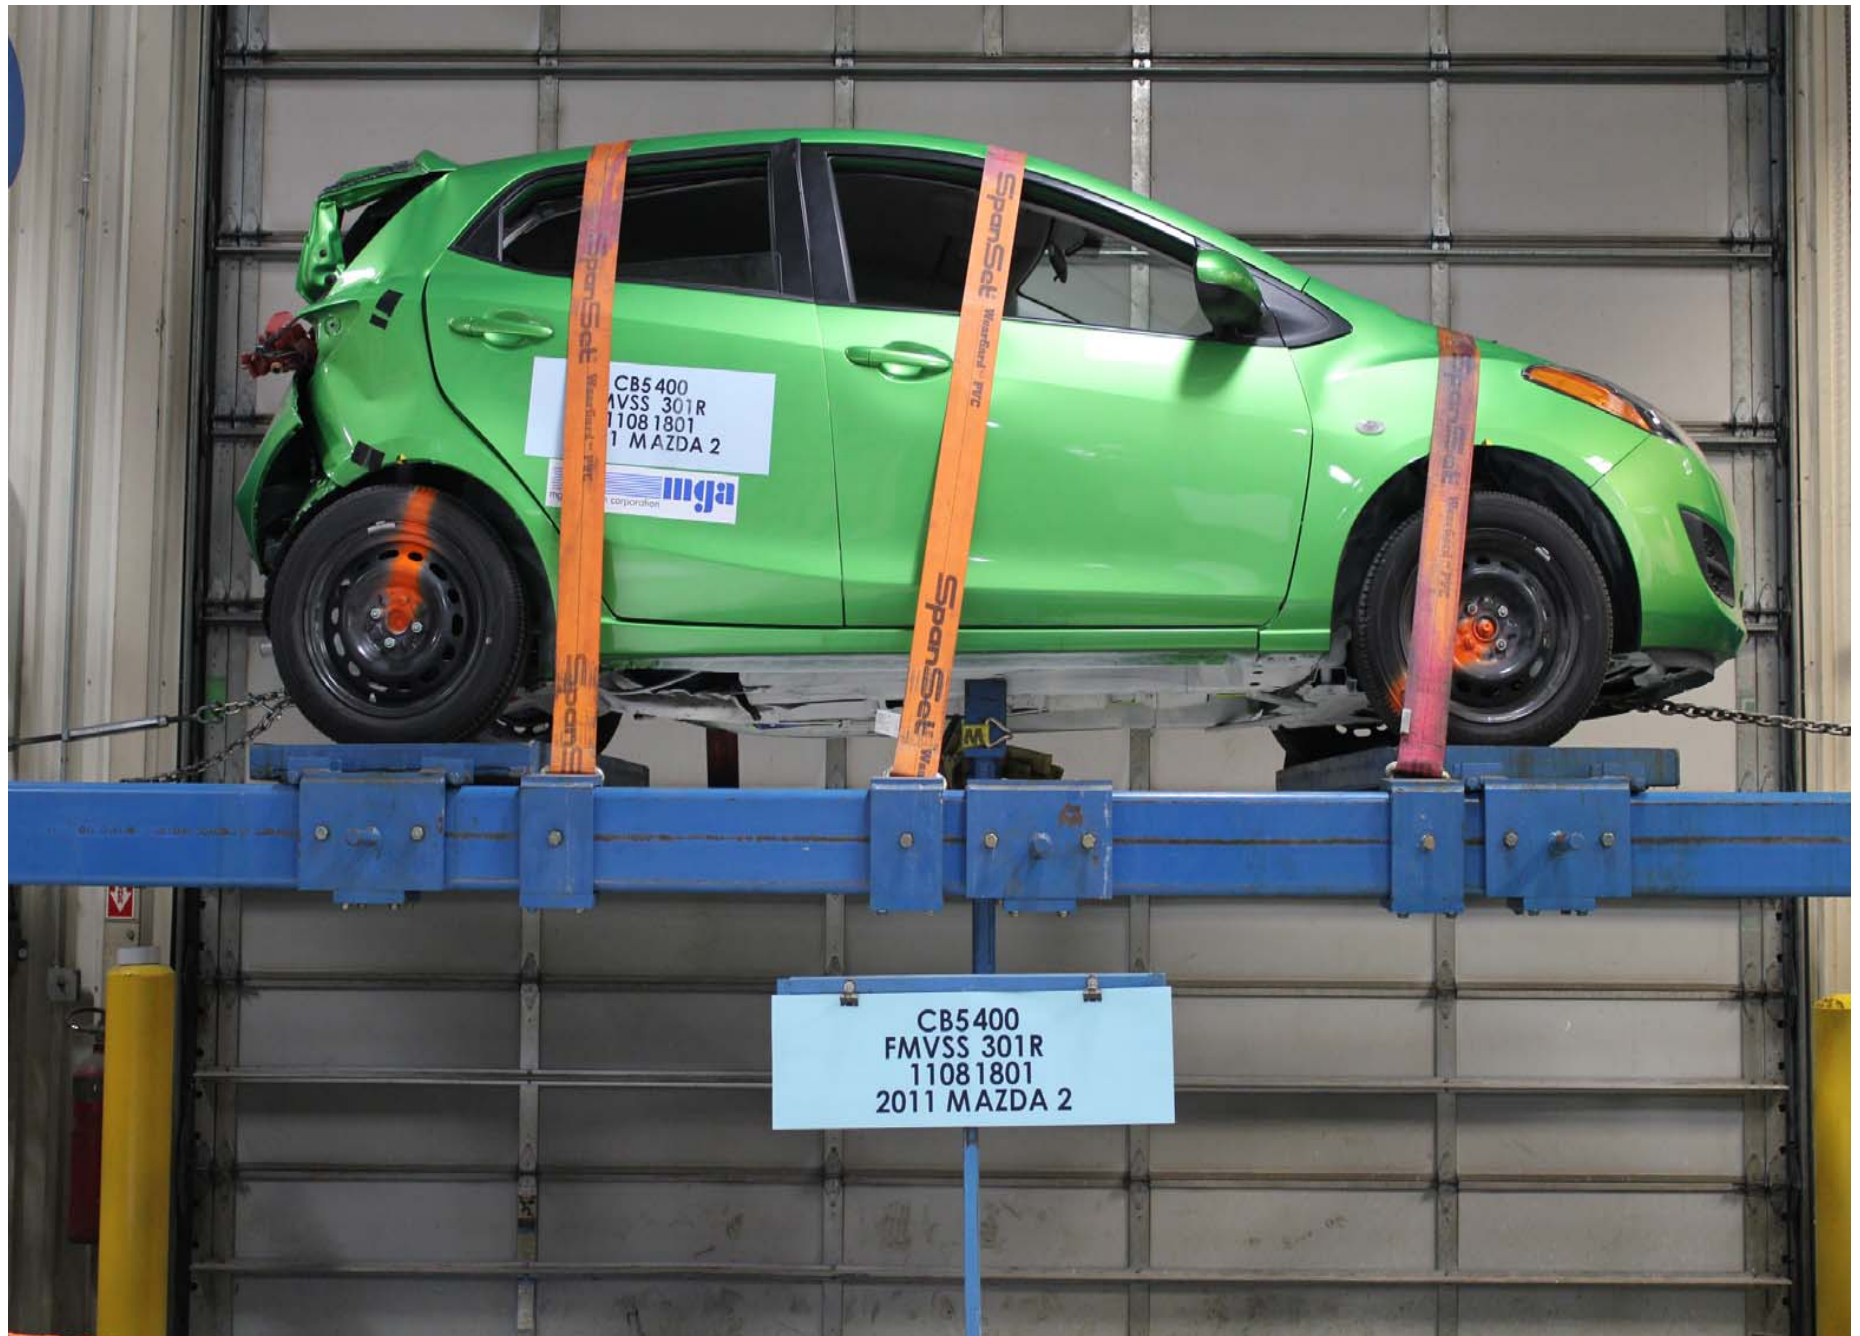
Static Rollover at 360 Degrees
