REPORT NUMBER: 301R/305-CAL-12-005

**SAFETY COMPLIANCE TESTING FOR FMVSS 301 & 305
Fuel System Integrity – Rear Impact
Electric Powered Vehicles: Electrolyte Spillage and Electrical Shock Protection**

**CODA Automotive
2012 CODA CODA
Four Door Sedan**

NHTSA No: CC1002

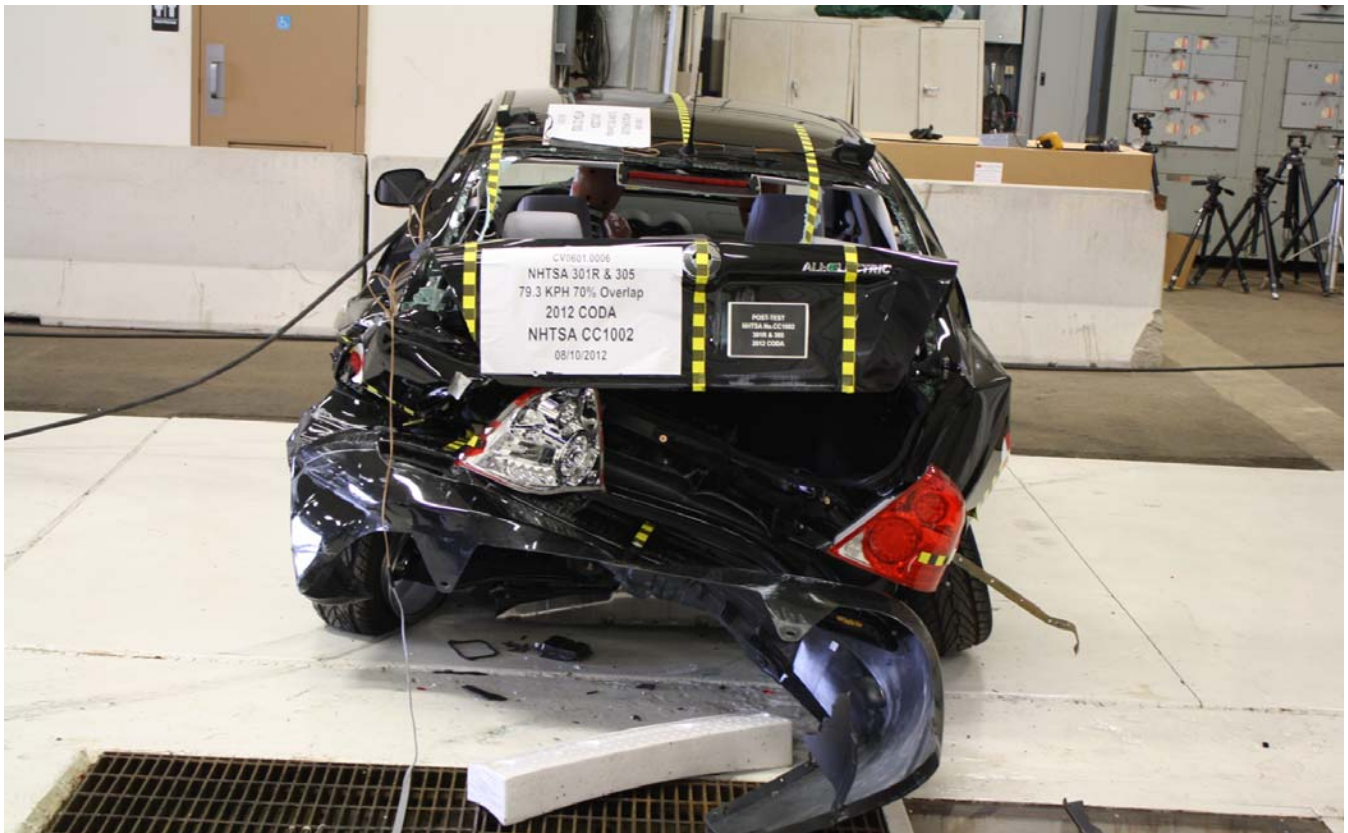
Figure A-20: Post-Test Rear View

Critical Areas of Performance	Observations and Conclusions
Windshield Damage	None
Window Damage	None
Other Notable Effects	Rear windshield shattered on impact

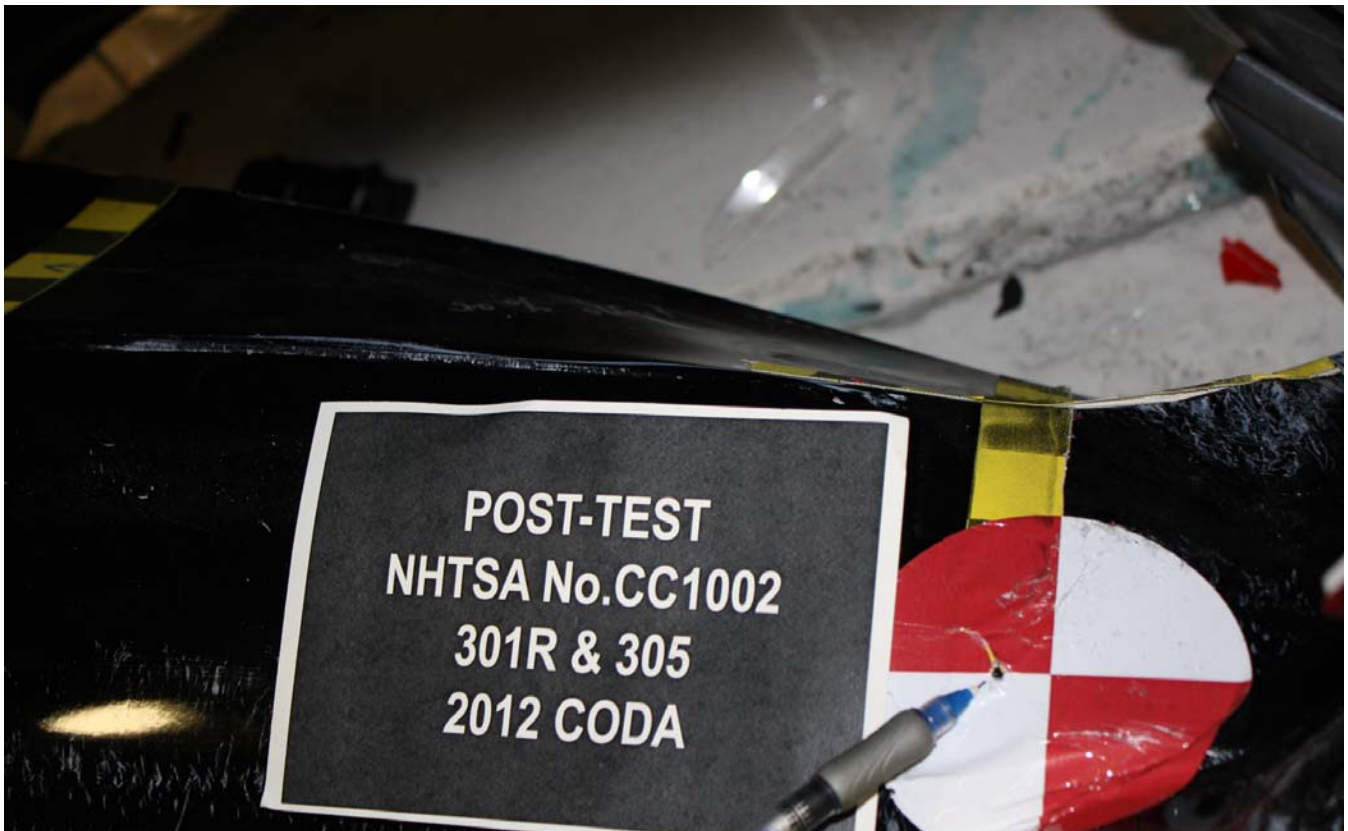
Figure A-30: Post-Test Impact Target View

There was no fuel system fluid spillage following the impact and including all portions of the static rollover test. The maximum vehicle longitudinal crush was 827 millimeters of which the average was 674 millimeters. The vehicle appeared to comply with all the requirements of FMVSS No. 301 "Fuel System Integrity."
