**REPORT NUMBER: TR-P35090-03-NC**  
**SAFETY COMPLIANCE TESTING FOR FMVSS 301R**  
**FUEL SYSTEM INTEGRITY – REAR IMPACT**  
**79.3 KM/H 70% OVERLAP REAR IMPACT**

**MAZDA MOTOR CORPORATION**  
**2015 MAZDA CX-5 SPORT 5-DOOR MPV**

**NHTSA NUMBER: C20155400**

**PREPARED BY:**  
**KARCO ENGINEERING, LLC.**  
**9270 HOLLY ROAD**  
**ADELANTO, CA 92301**

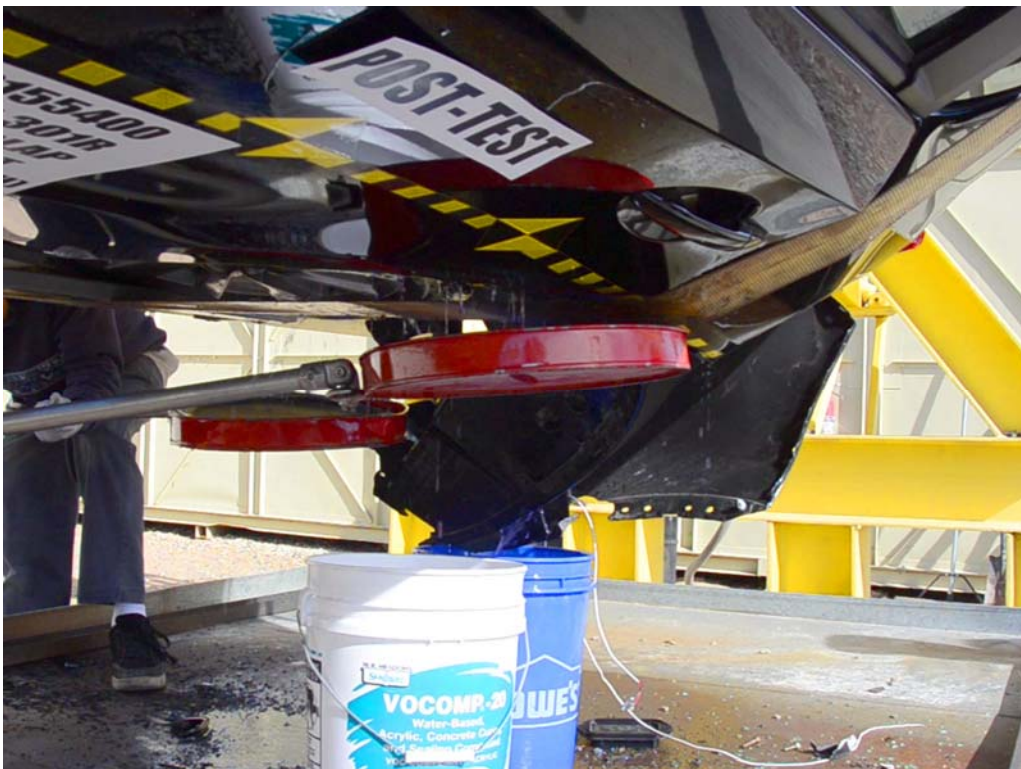
There was no Stoddard solvent leakage immediately after the impact event. During the first 5 minutes of the static rollover test, as the vehicle rolled from the 0° to 90° position, 7,474 g of solvent spillage was collected. The spillage exceeded the maximum 142 g allowed during the first 5 minutes of the static roll. The spillage appeared to come from the area around the fuel filler neck. FMVSS 301 data is summarized in Data Sheets 4 and 5.

FIGURE 34. Solvent Spillage at 90° on FMVSS 301 Static Rollover Device

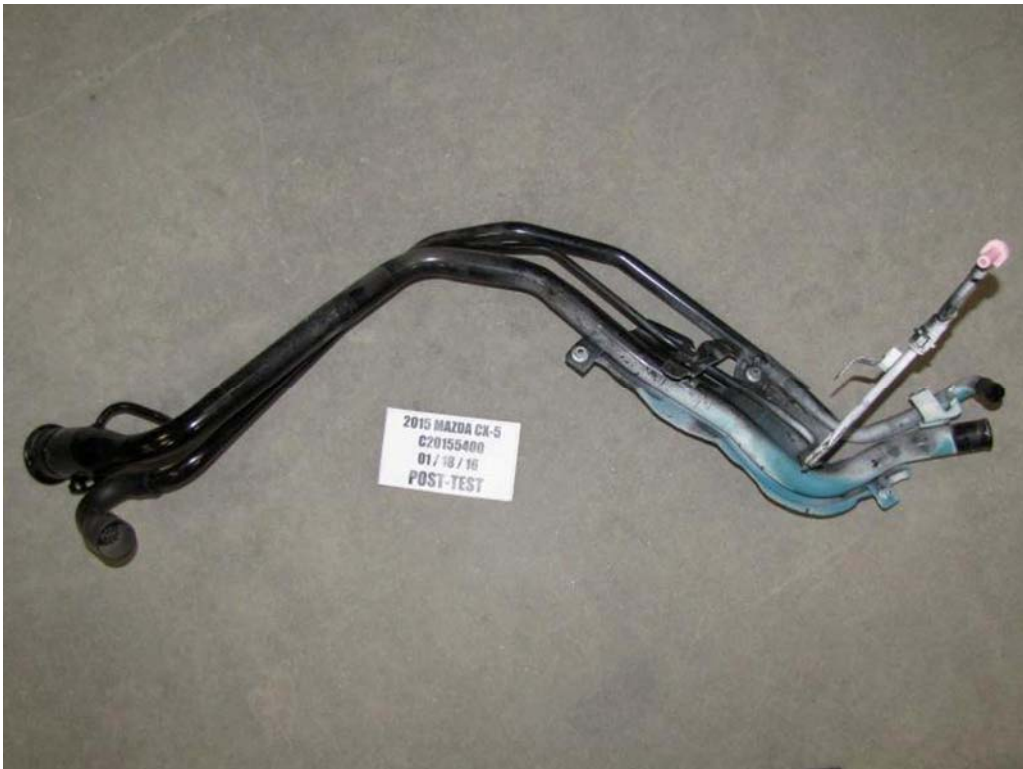
After the test, a tear down and inspection was conducted to determine the source of the solvent leak. A hole was discovered on the fuel filler neck, where a weld attached a bracket to the filler neck broke. The vehicle failed to meet the fuel spillage requirements S5.6 of FMVSS No. 301. Appendix A includes photographs of the fuel filler neck damage.

FIGURE 36. Post-Test View of Fuel Filler Neck Damage

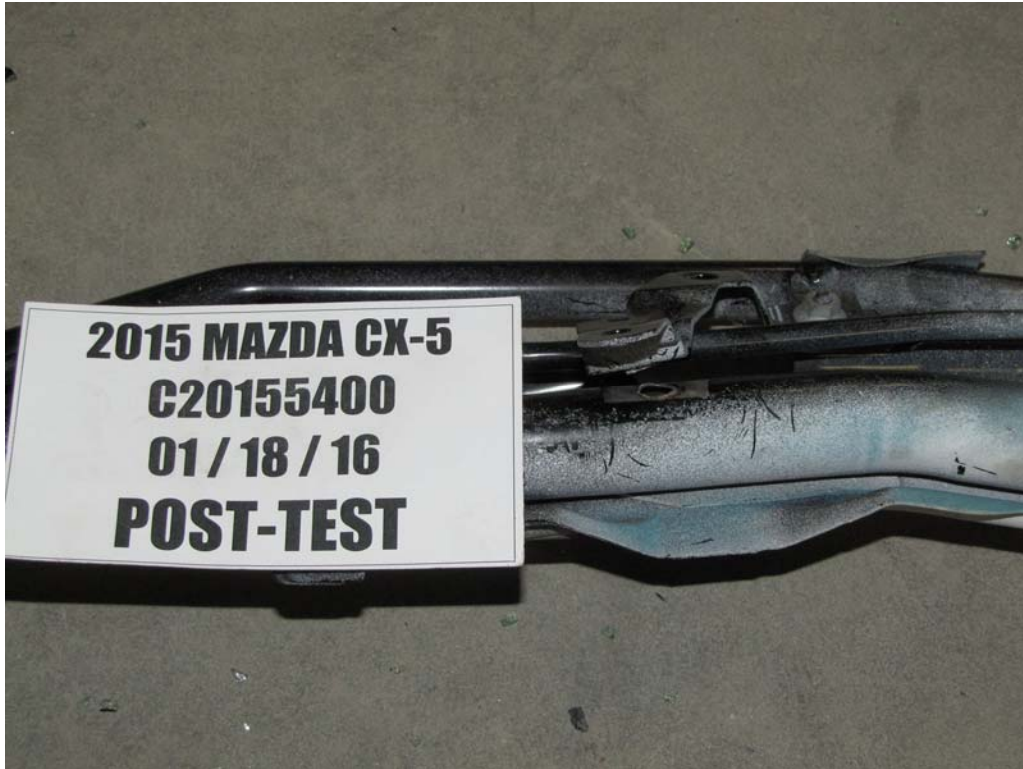
FIGURE 37. Post-Test View of Fuel Filler Neck Damage
