**REPORT NUMBER: NCAP305I-KAR-18-020**

**NEW CAR ASSESSMENT PROGRAM (NCAP)  
FMVSS NO. 305 INDICANT TEST**

**2018 TESLA MODEL 3 LONG RANGE RWD 4-DOOR SEDAN**

**FINAL REPORT**

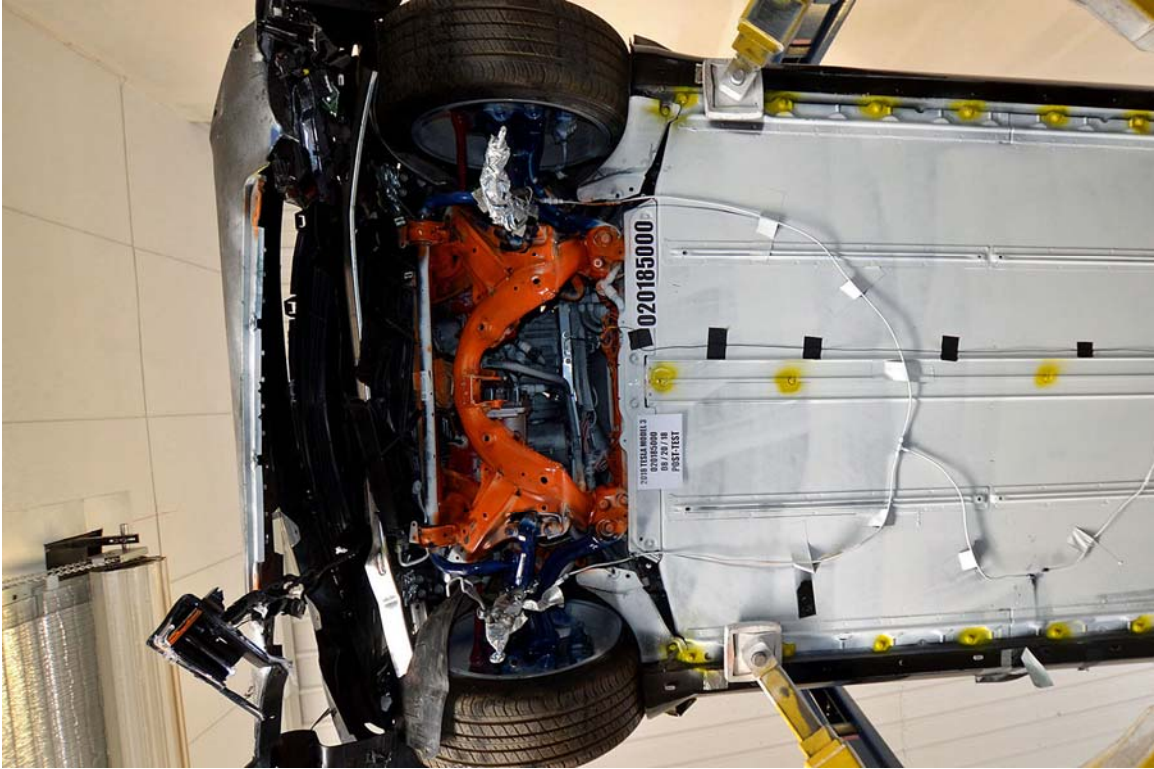
FIGURE 10. Post-Impact Front View of Propulsion Battery

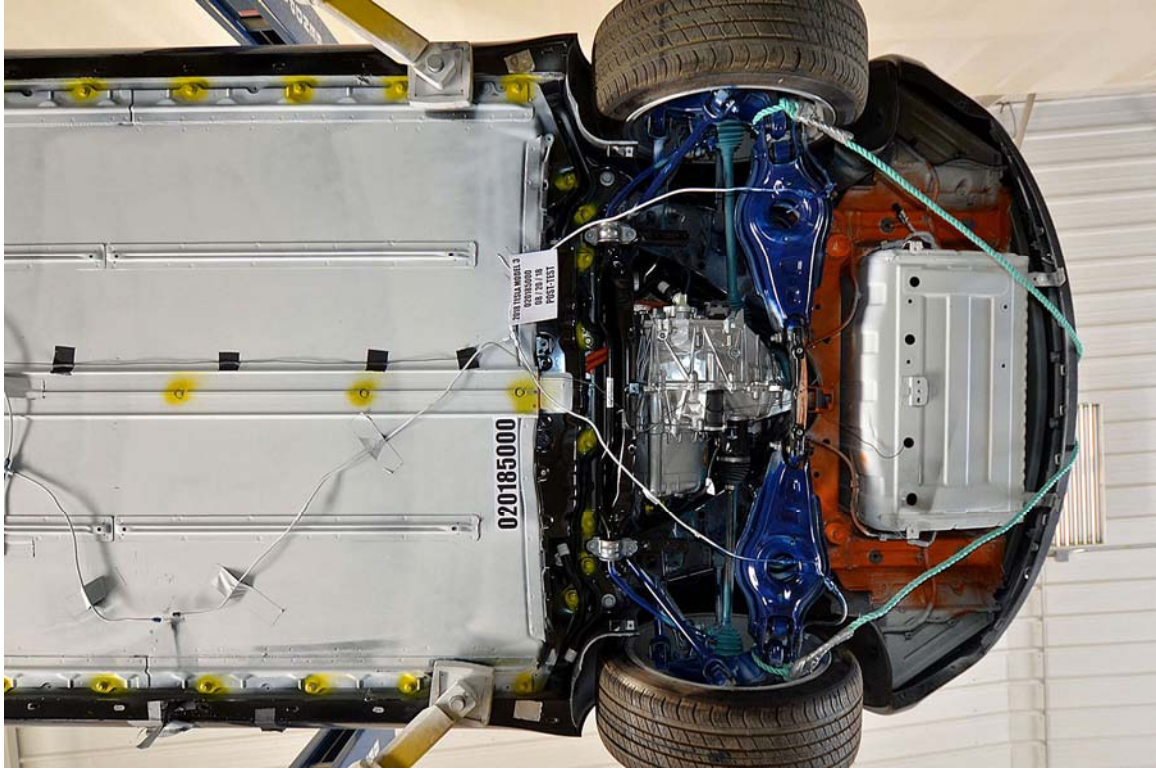
FIGURE 12. Post-Impact Rear View of Propulsion Battery

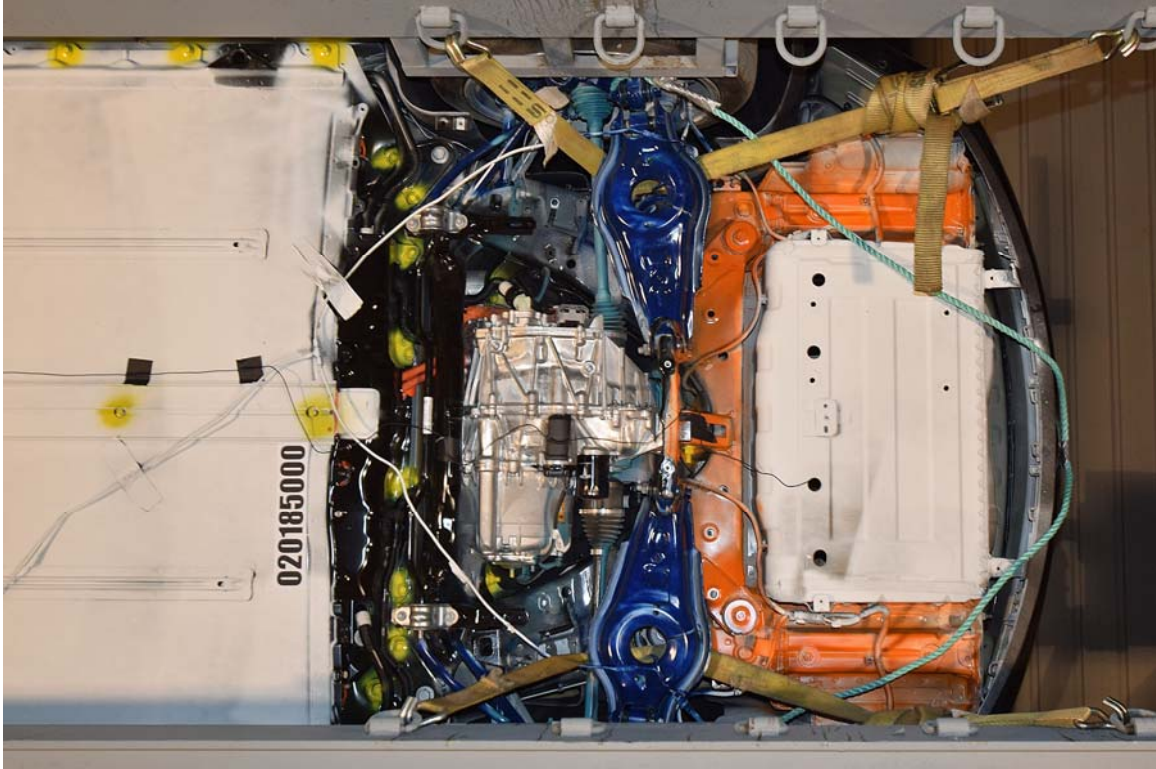
FIGURE 18. Post-Impact View of Electric Propulsion Drive

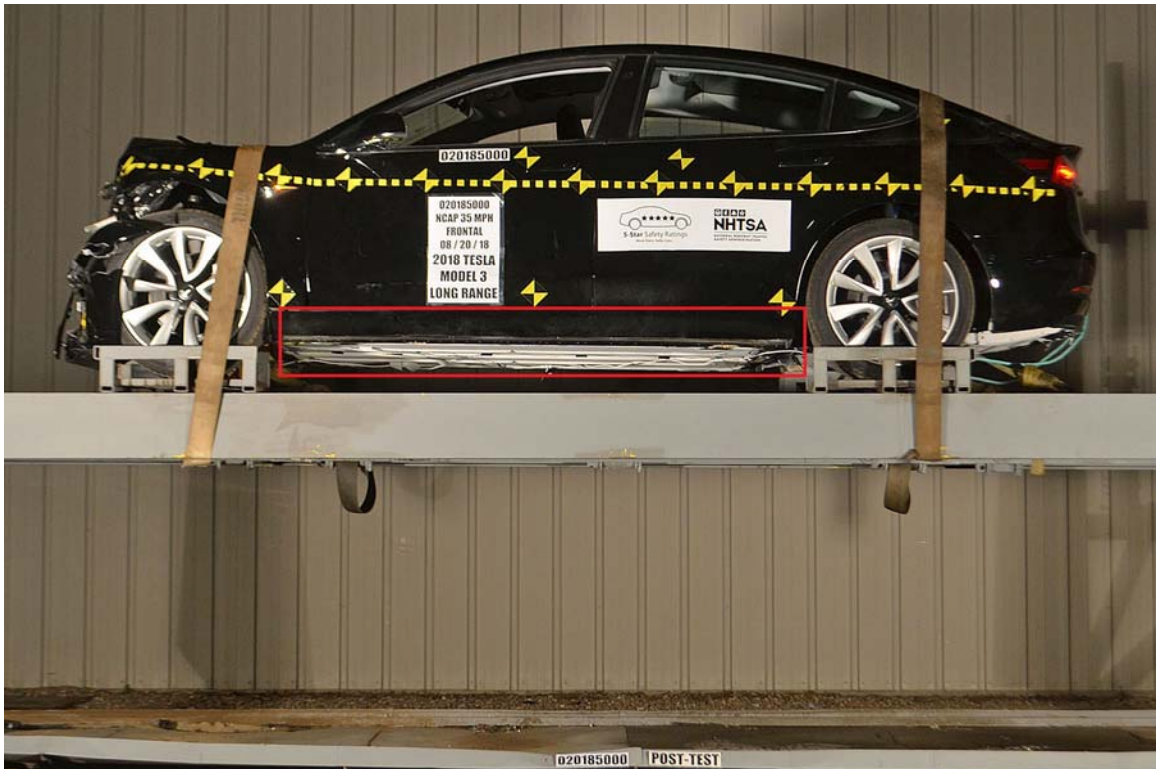
FIGURE 29. FMVSS No. 305 Static Rollover at 0°

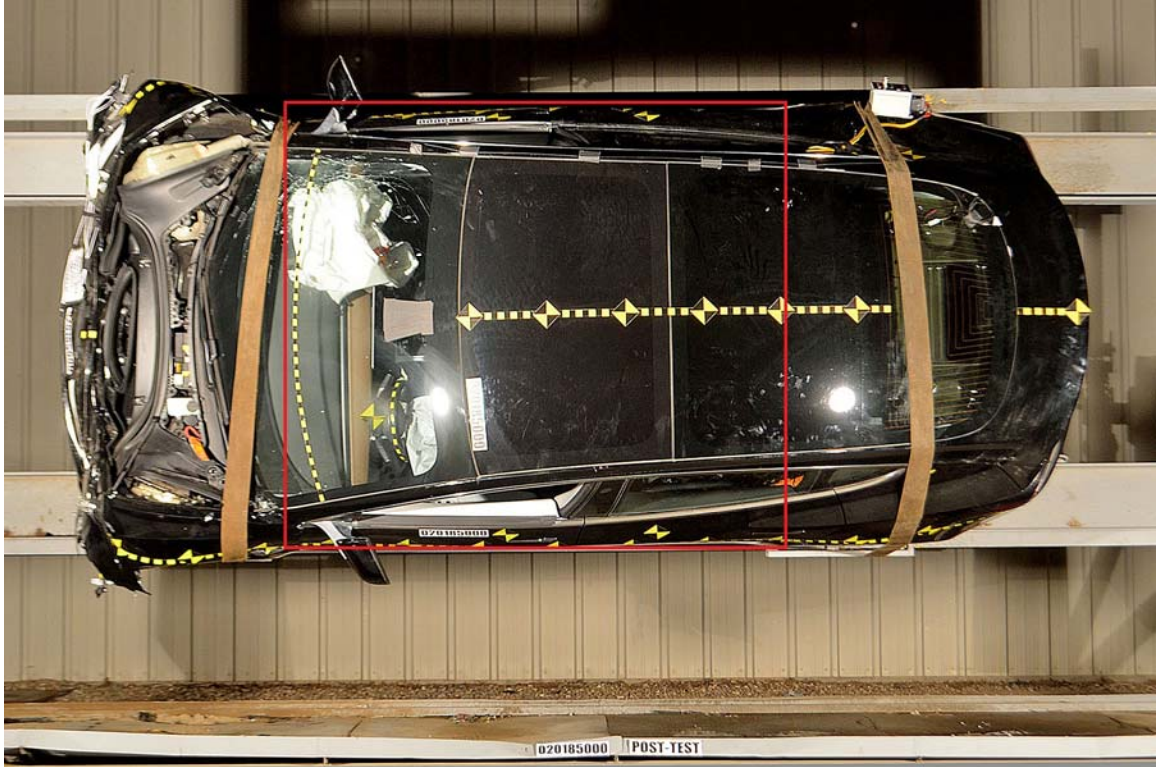
FIGURE 30. FMVSS No. 305 Static Rollover at 90°

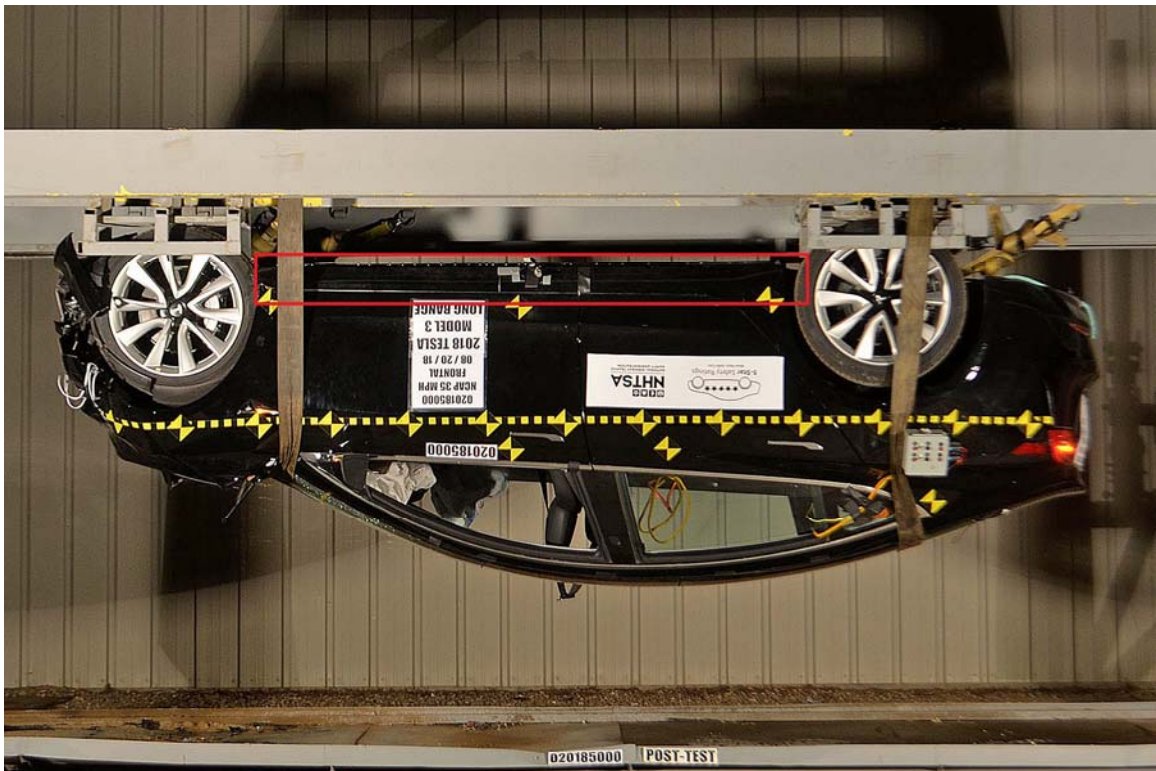
FIGURE 31. FMVSS No. 305 Static Rollover at 180°

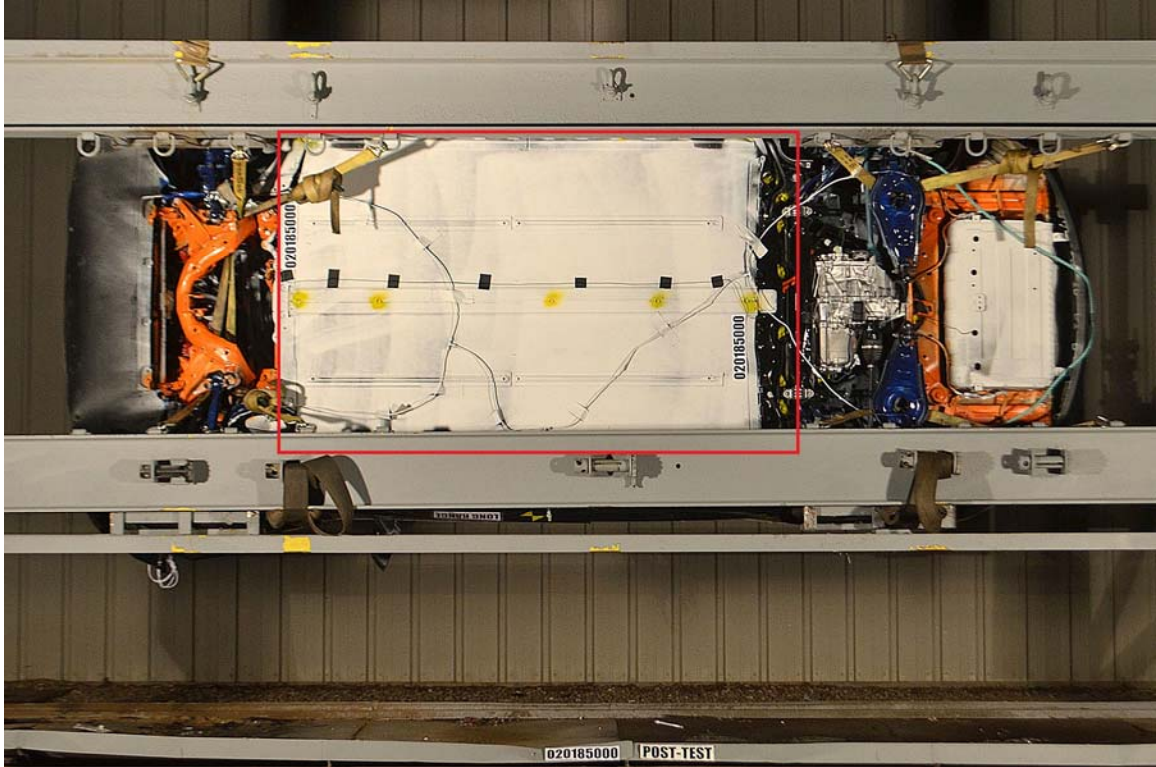
FIGURE 32. FMVSS No. 305 Static Rollover at 270°

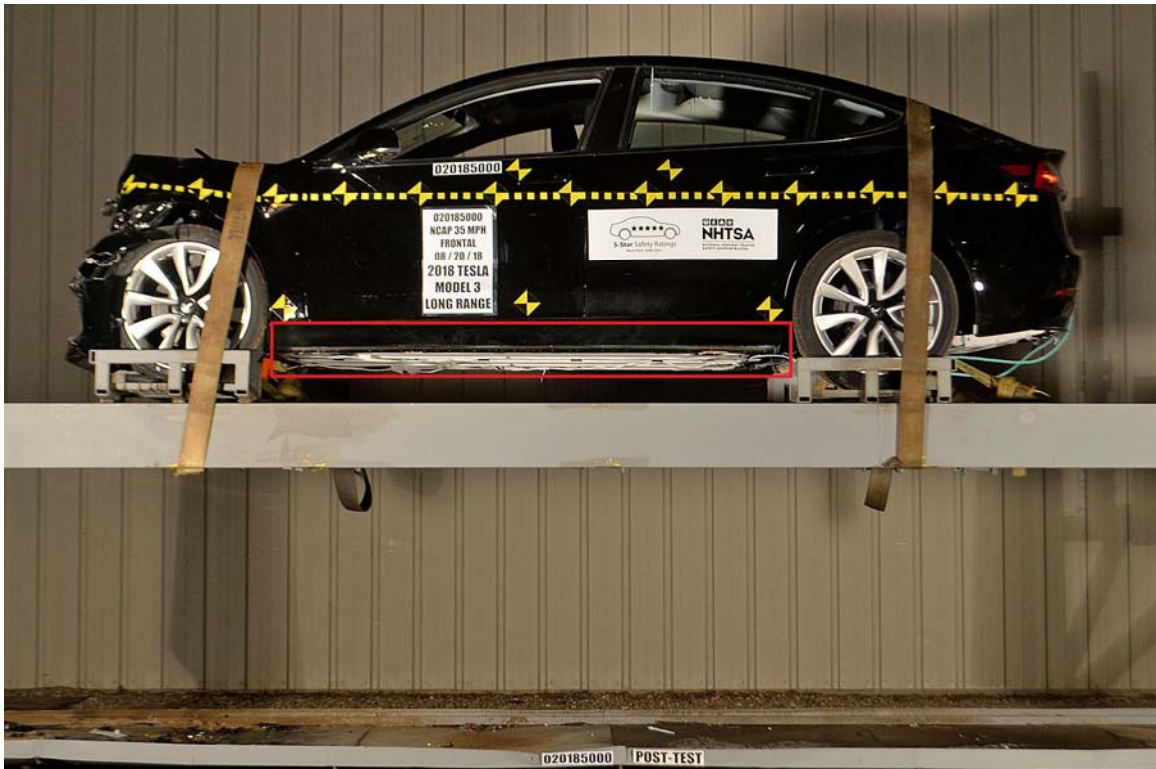
FIGURE 33. FMVSS No. 305 Static Rollover at 360°

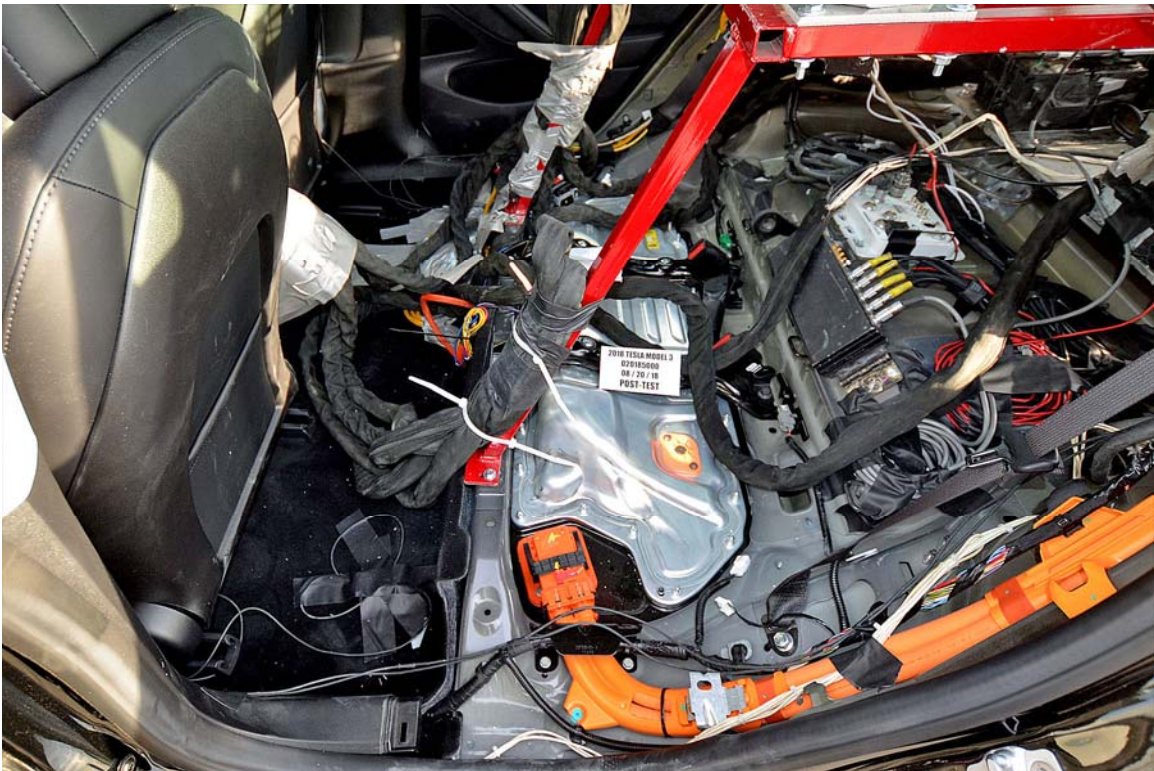
FIGURE 35. Post-Impact View of the Vehicle Passenger Compartment Adjacent to Propulsion Battery
