REPORT NUMBER: NCAP305I-KAR-19-023

**NEW CAR ASSESSMENT PROGRAM (NCAP)
FMVSS NO. 305 INDICANT TEST**

**KIA MOTORS CORPORATION
2019 KIA NIRO HYBRID LX 5-DOOR MPV**

FINAL REPORT

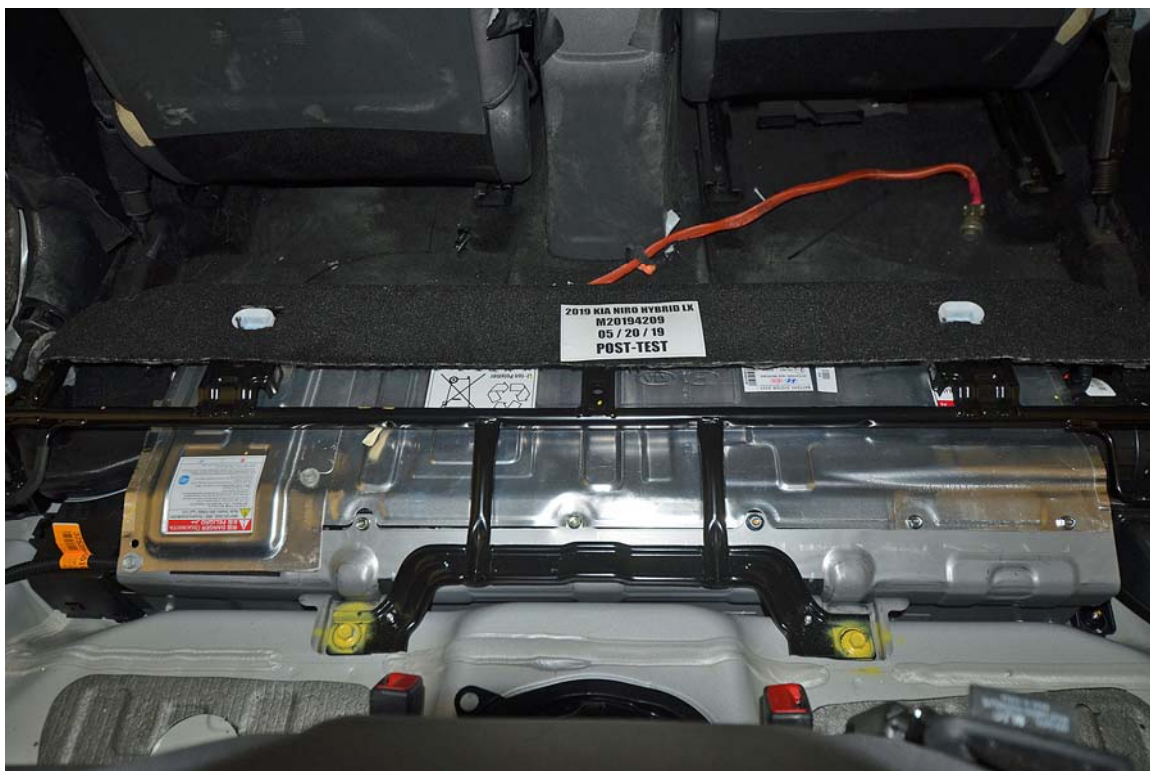
Has the propulsion battery module moved within the passenger compartment: No

Describe any movement: There was no movement of the propulsion battery.

FIGURE 11. Post-Impact Rear View of Propulsion Battery

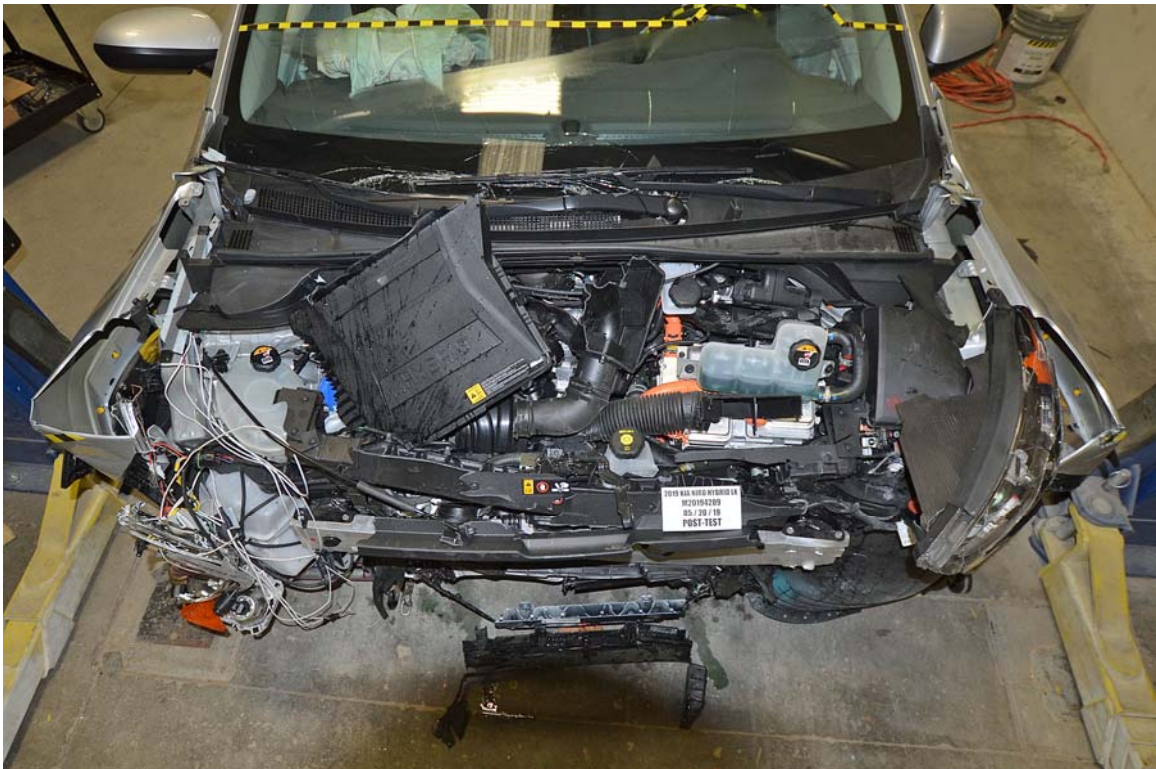
FIGURE 17. Post-Impact View of Electric Propulsion Drive

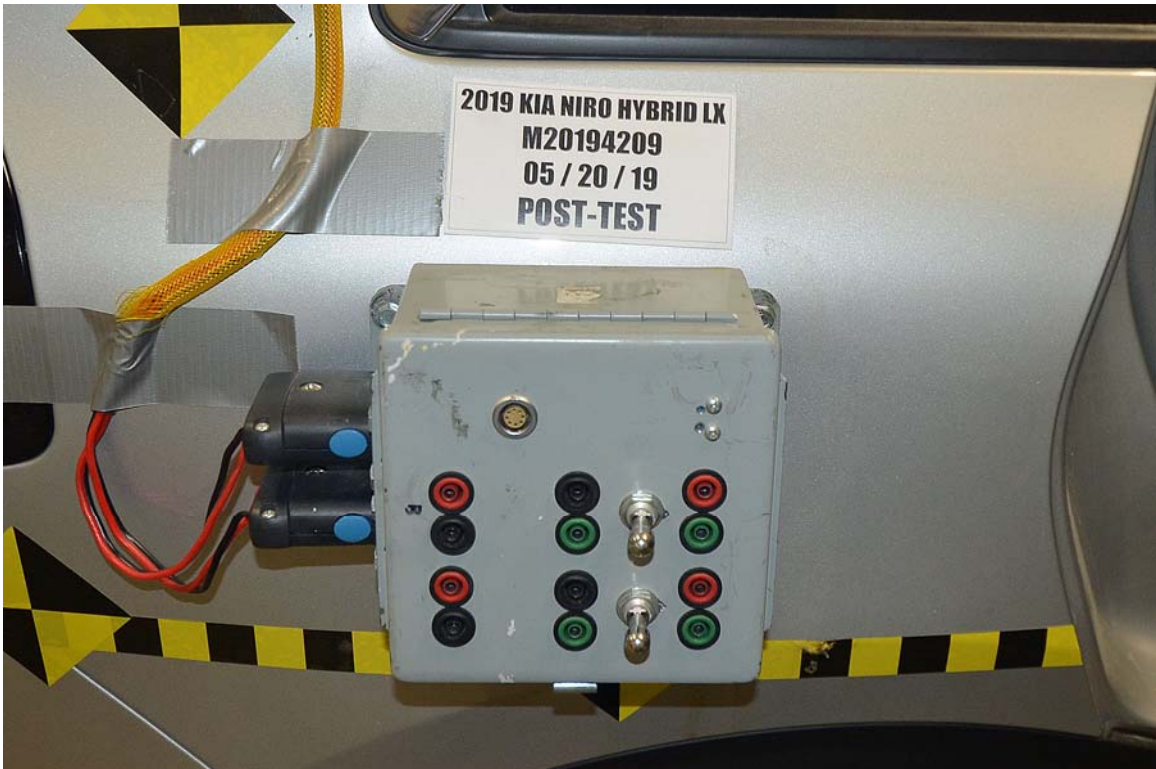
FIGURE 25. Post-Impact View of Installed Test Interface Port

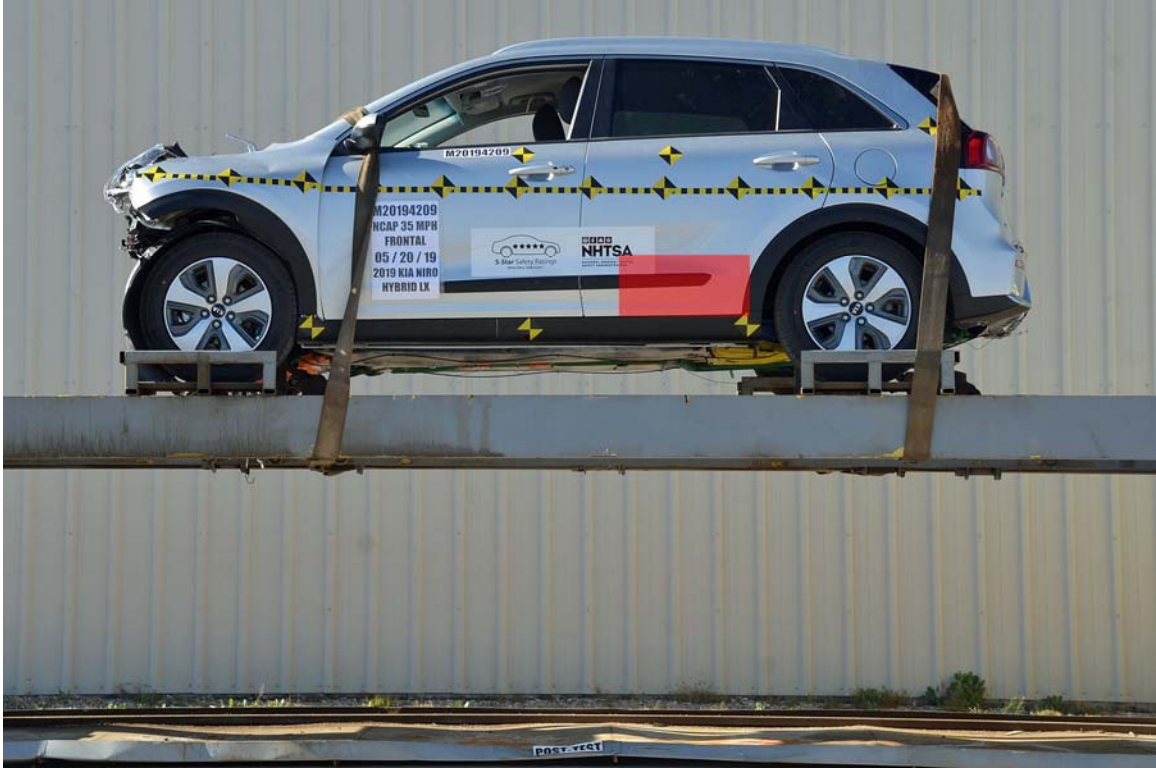
FIGURE 28. FMVSS No. 305 Static Rollover at 0°

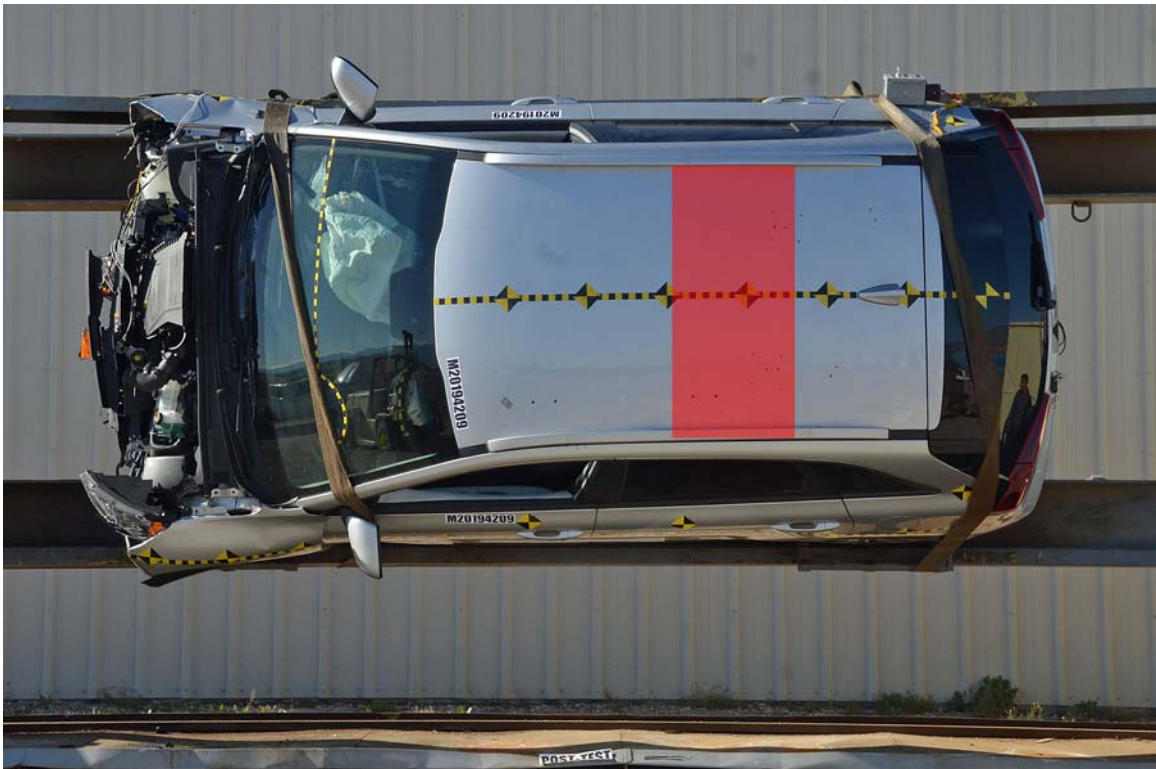
FIGURE 29. FMVSS No. 305 Static Rollover at 90°

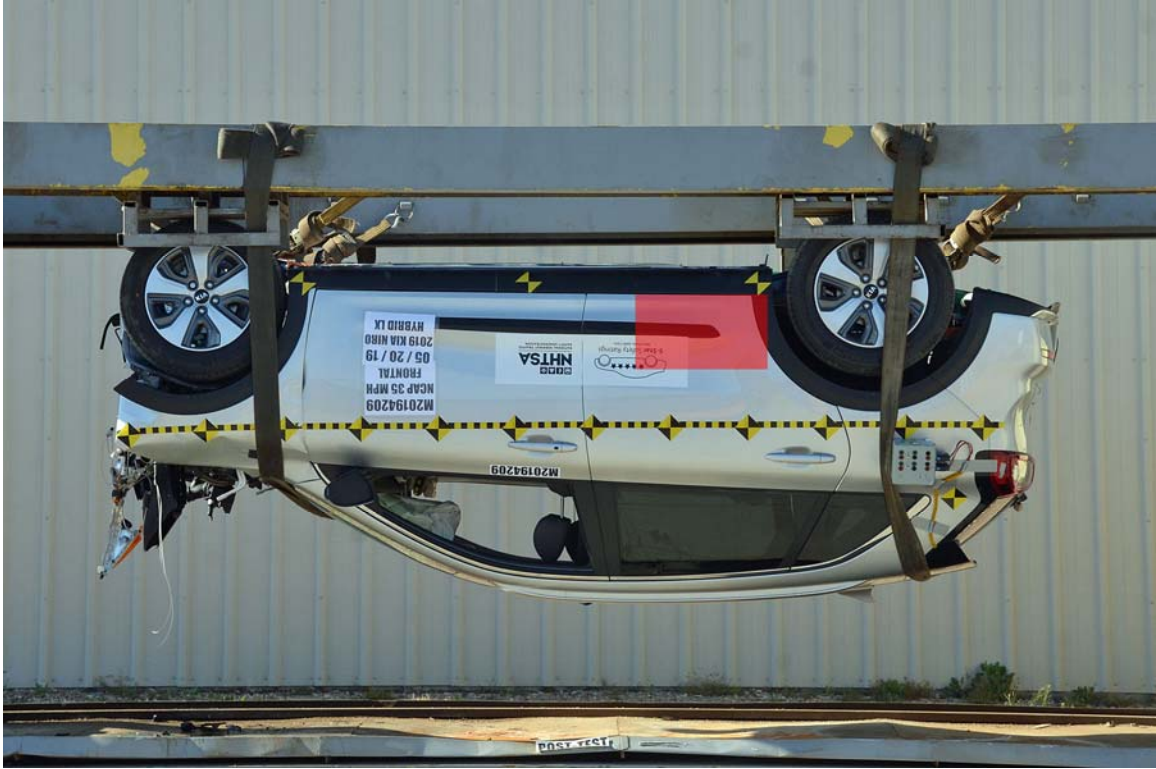
FIGURE 30. FMVSS No. 305 Static Rollover at 180°

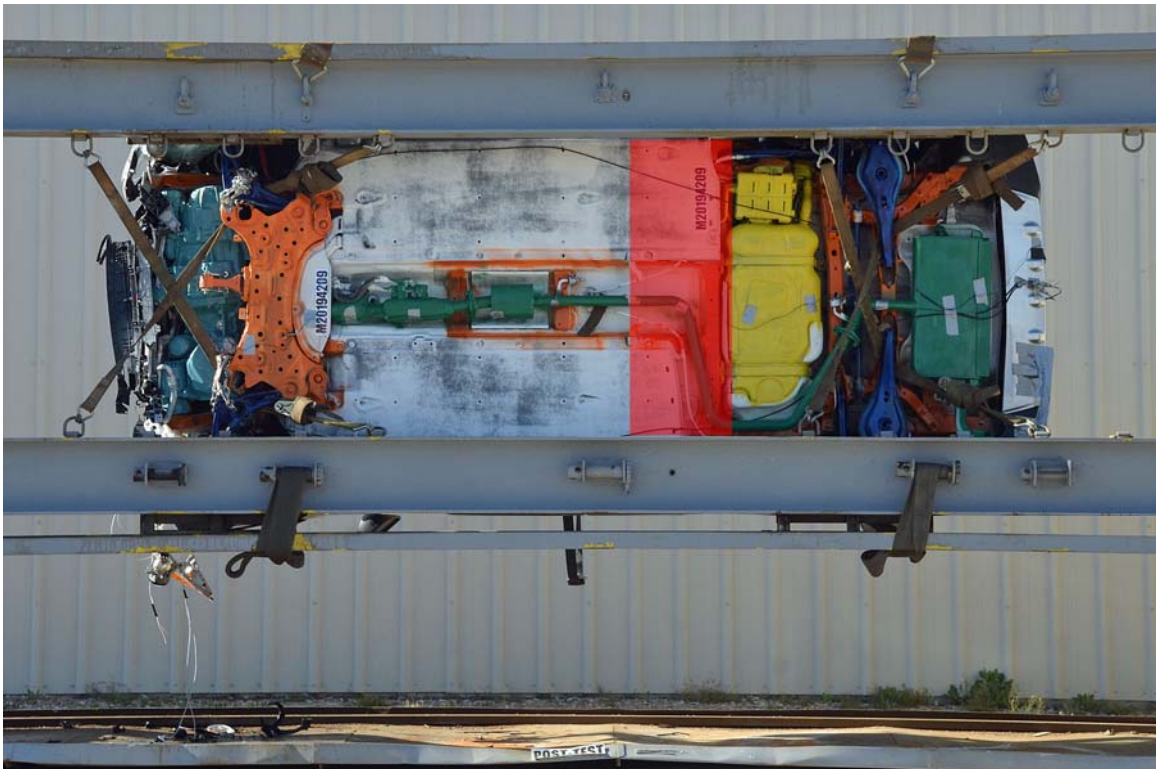
FIGURE 31. FMVSS No. 305 Static Rollover at 270°

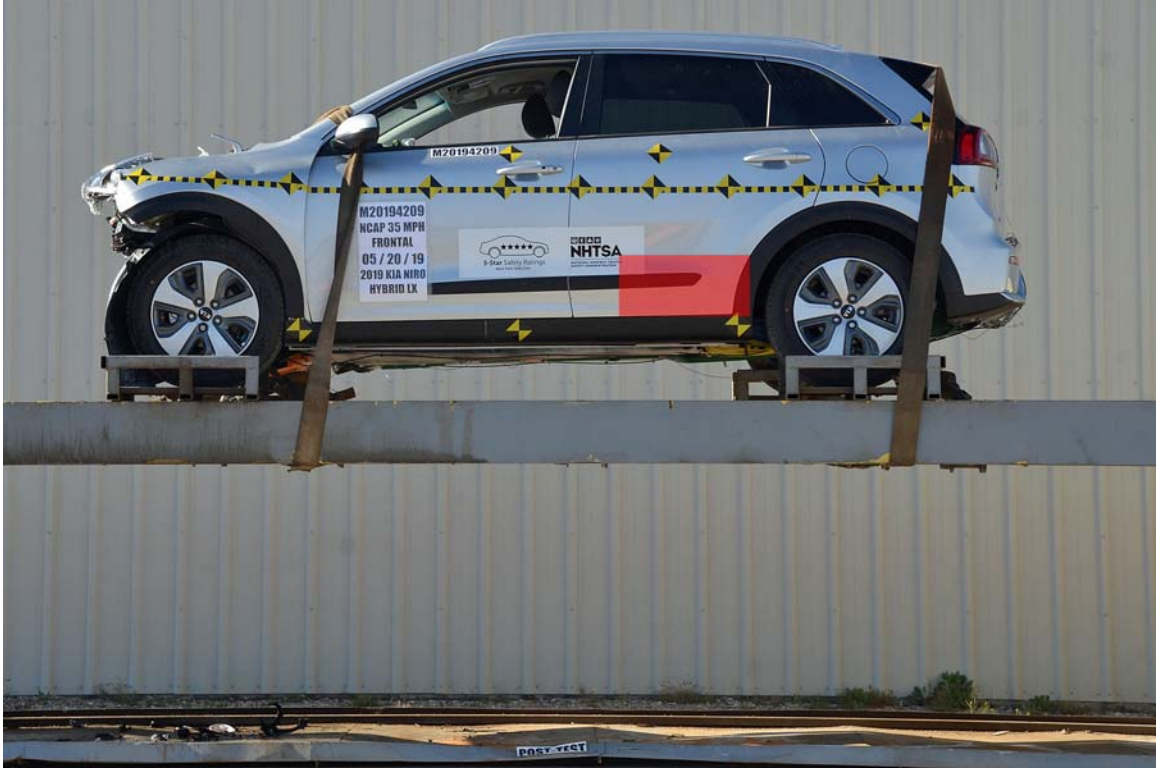
Is the Total Propulsion Battery Electrolyte Spillage Greater Than 5.0 Liters?	No spillage occurred
Is the Propulsion Battery Electrolyte Spillage Visible in the Passenger Compartment?	N/A

FIGURE 32. FMVSS No. 305 Static Rollover at 360°

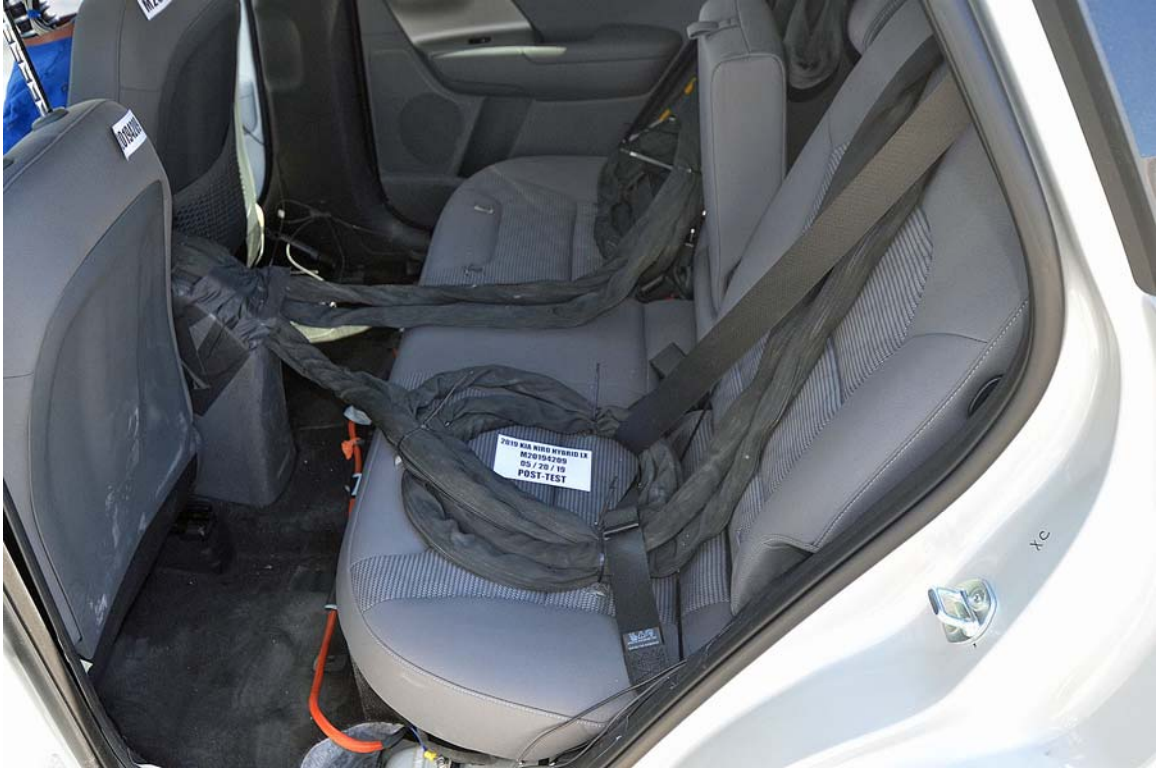
Has an outside propulsion battery component intruded into the passenger compartment: No

Describe any intrusion: There was no intrusion of the propulsion battery into the occupant compartment.

Is there propulsion battery electrolyte spillage visible in the passenger compartment: No

FIGURE 34. Post-Impact View of the Vehicle Passenger Compartment Adjacent to Propulsion Battery
