**REPORT NUMBER: SPNCAP-MGA-2016-023**

**NEW CAR ASSESSMENT PROGRAM (NCAP)  
Side Impact Pole Test**

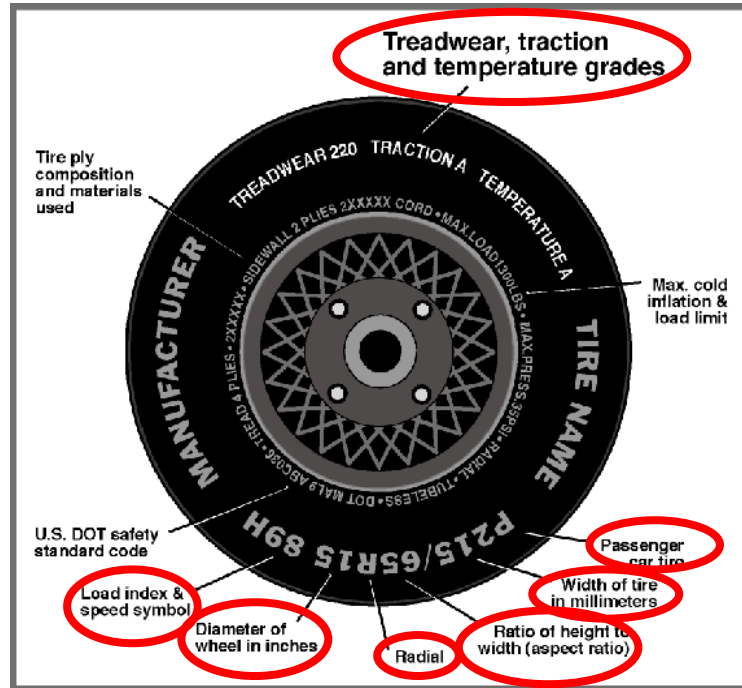
Measured Parameter	Front	Rear
Max. Tire Pressure (kPa)	300	300
Cold Pressure (kPa)	250	250
Recommended Tire Size	225/65R17	225/65R17
Tire Size on Vehicle	225/65R17	225/65R17
Tire Manufacturer	Kumho	Kumho
Tire Model	Solus KH16	Solus KH16
Treadwear	440	440
Traction	A	A
Temperature Grade	A	A
Tire Plies Sidewall	2 Polyester	2 Polyester
Tire Plies Body	2 Polyester, 2 Steel, 1 Nylon	2 Polyester, 2 Steel, 1 Nylon
Load Index/Speed Symbol	100H	100H
Tire Material	Rubber	Rubber
DOT Safety Code Left	C0E6 YP5M 1915	C0E6 YP5M 1915
DOT Safety Code Right	C0E6 YP5M 2115	C0E6 YP5M 2015

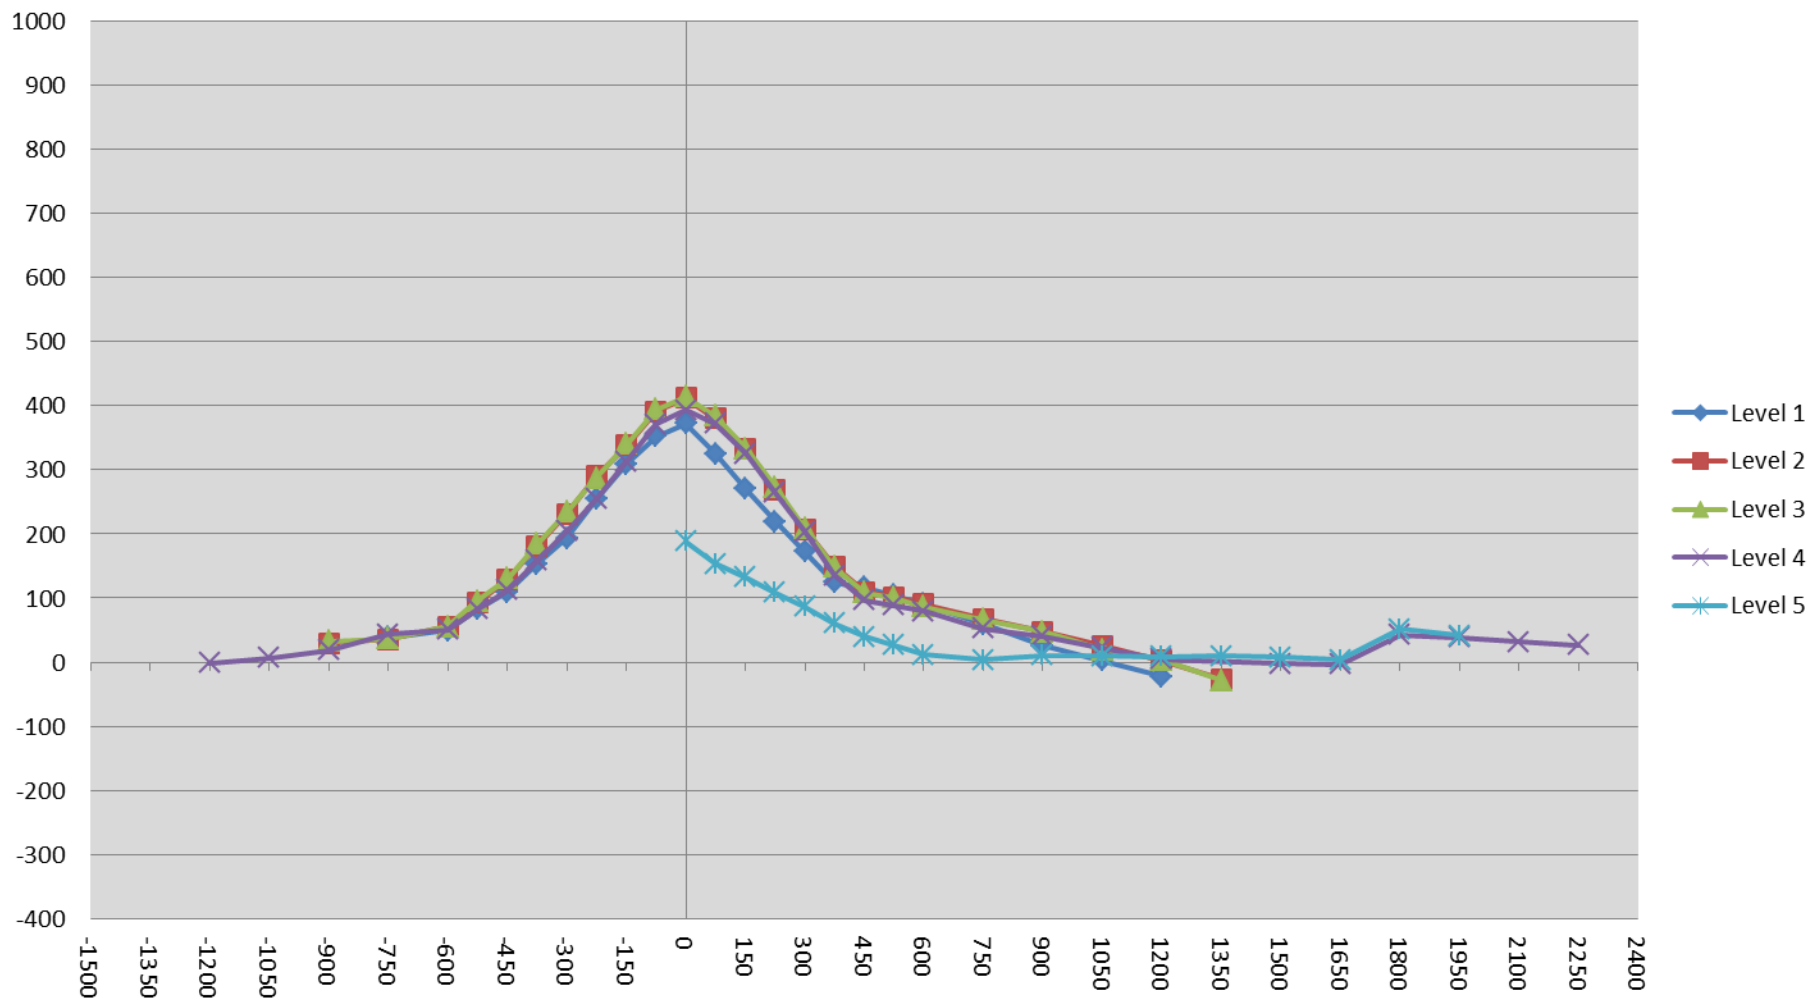
**DATA SHEET NO. 11  
VEHICLE DAMAGE PROFILE DISTANCES**

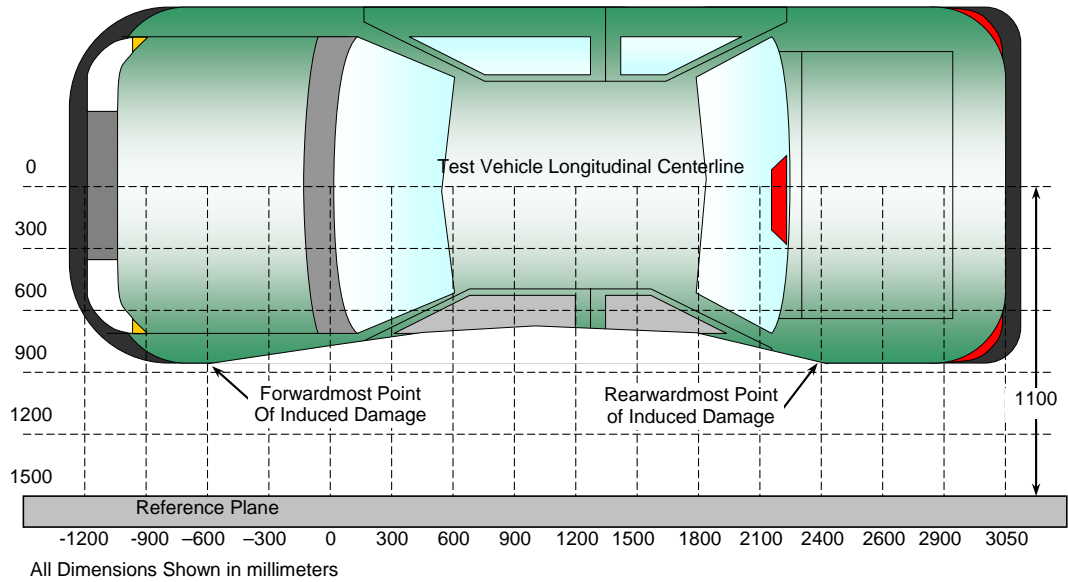
NHTSA No. M20160306  
 Test Date: 10/20/2015

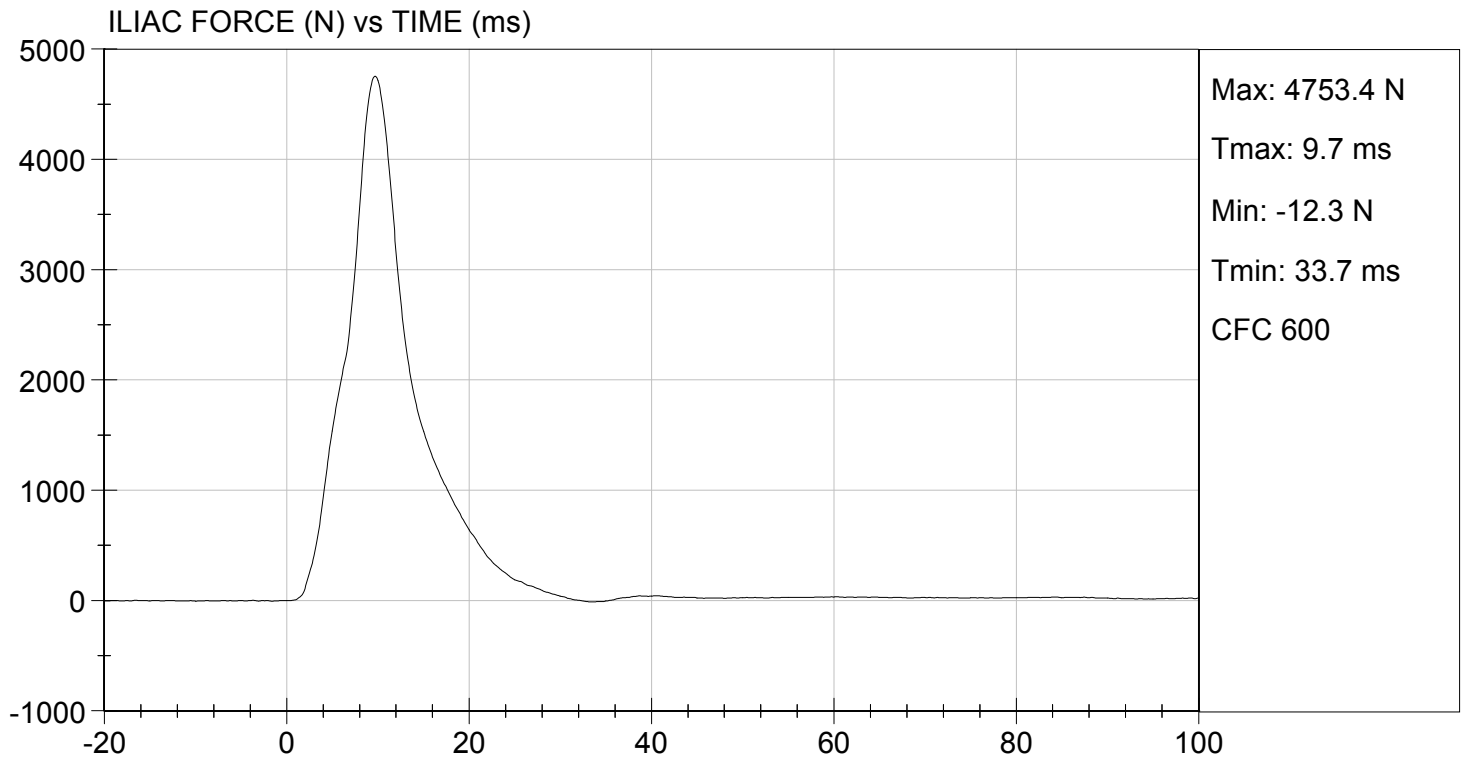
**SID-IIsD External Measurements**  
**SN: 306**
