NEW VEHICLE ASSESSMENT AND
STANDARDS ENFORCEMENT INDICANT
TESTING

FMVSS 212, 219, AND 301-75

CHRYSLER CORPORATION
1979 PLYMOUTH CHAMP 2-DOOR HATCHBACK
NHTSA NO. 790522

FINAL REPORT
JULY 1979

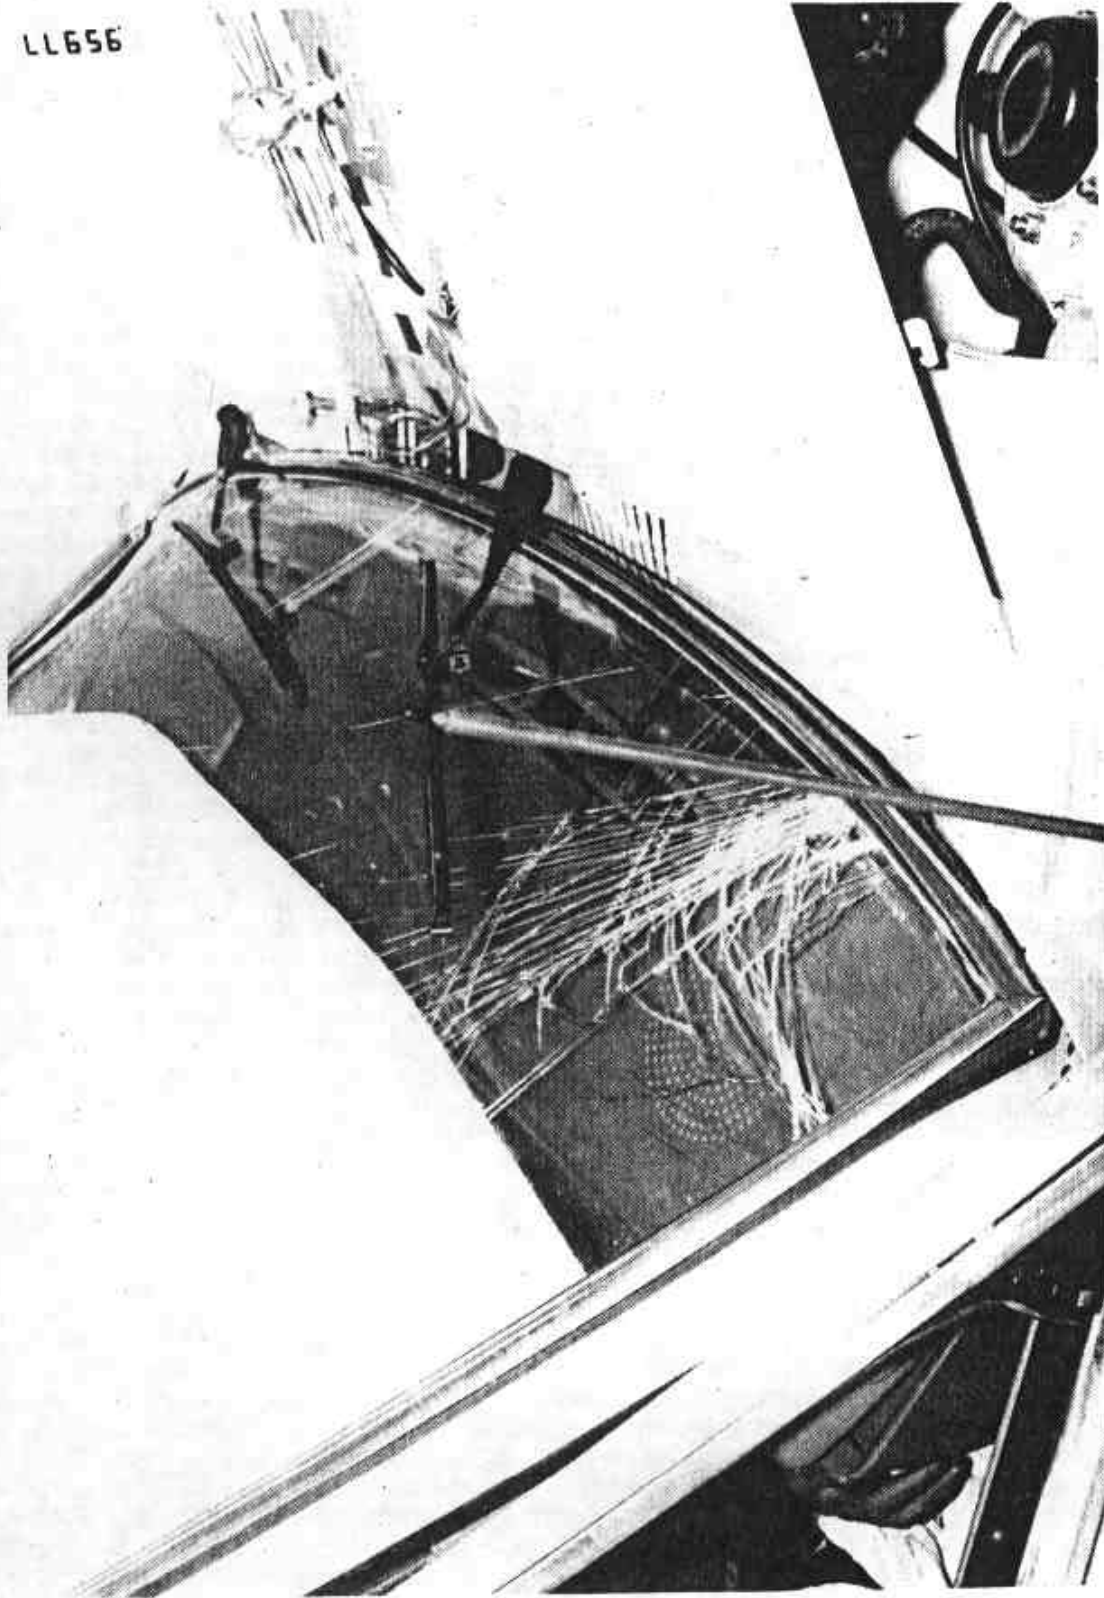
<u>Actual Data</u>	<u>Standard Requirement</u>	<u>Pass/Fail</u>
1. Pre-test Windshield Periphery (in.)	Right	<u>69.3</u>		
	Left	<u>69.3</u>		
	Total	<u>138.6</u>		
2. Post-test Windshield Periphery (in.)	Right	<u>52.3</u>		
	Left	<u>66.3</u>		
	Total	<u>118.6</u>	75% Minimum	<u>Pass</u>

Figure 3-4. Windshield Retention Loss - Right Side View - 1979 Plymouth Champ
2-door Hatchback - NHTSA No. 790522.

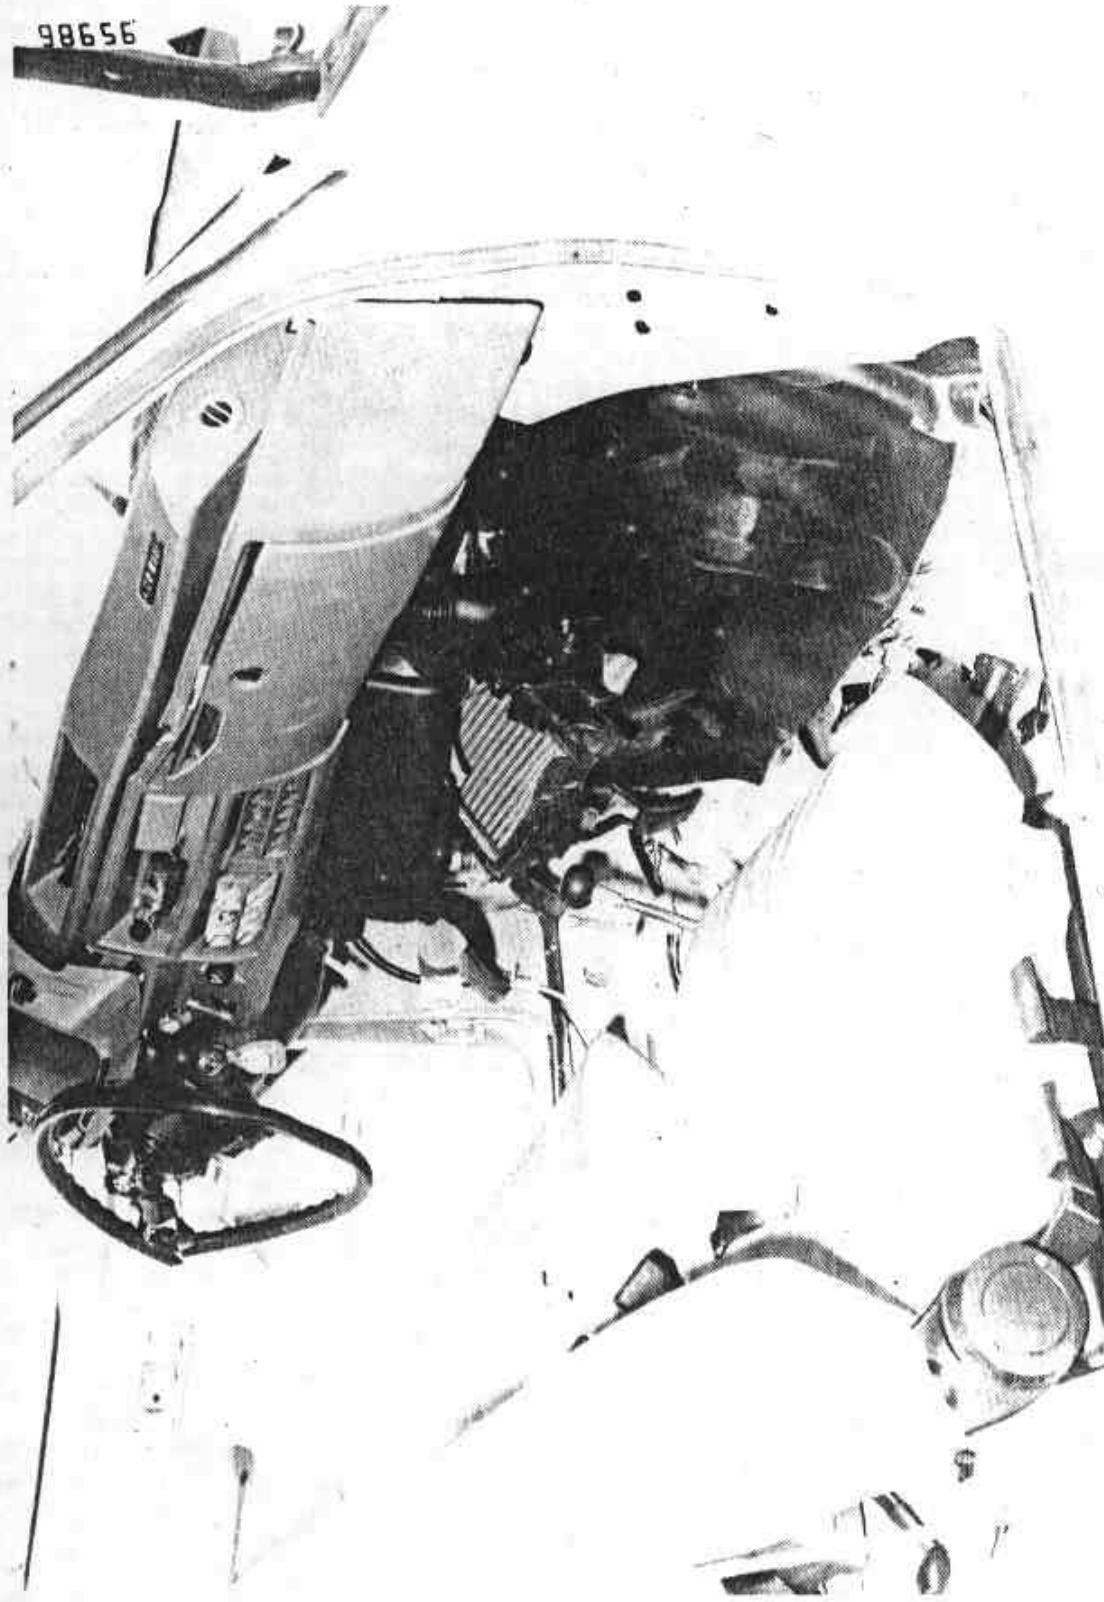
OTHER NOTABLE IMPACT EFFECTS: Steering wheel crushed severely,
exposing steel edges of hub. Displacement of dash panel exposed
metal heater element. Passenger head impact left sharp convex
break in glovebox lid medial to latch.

Figure 4-8. Post-test Passenger Compartment - 1979 Plymouth Champ 2-door Hatchback - NHTSA No. 790522.
