TASK 5 REPORT OF TESTS  
5.5, 5.7, AND 5.8 FOR  
DEVELOPMENT OF COMPLIANCE TEST  
FOR TRUCK REAR  
UNDERRIDE PROTECTION

February 1979

INTERIM REPORT

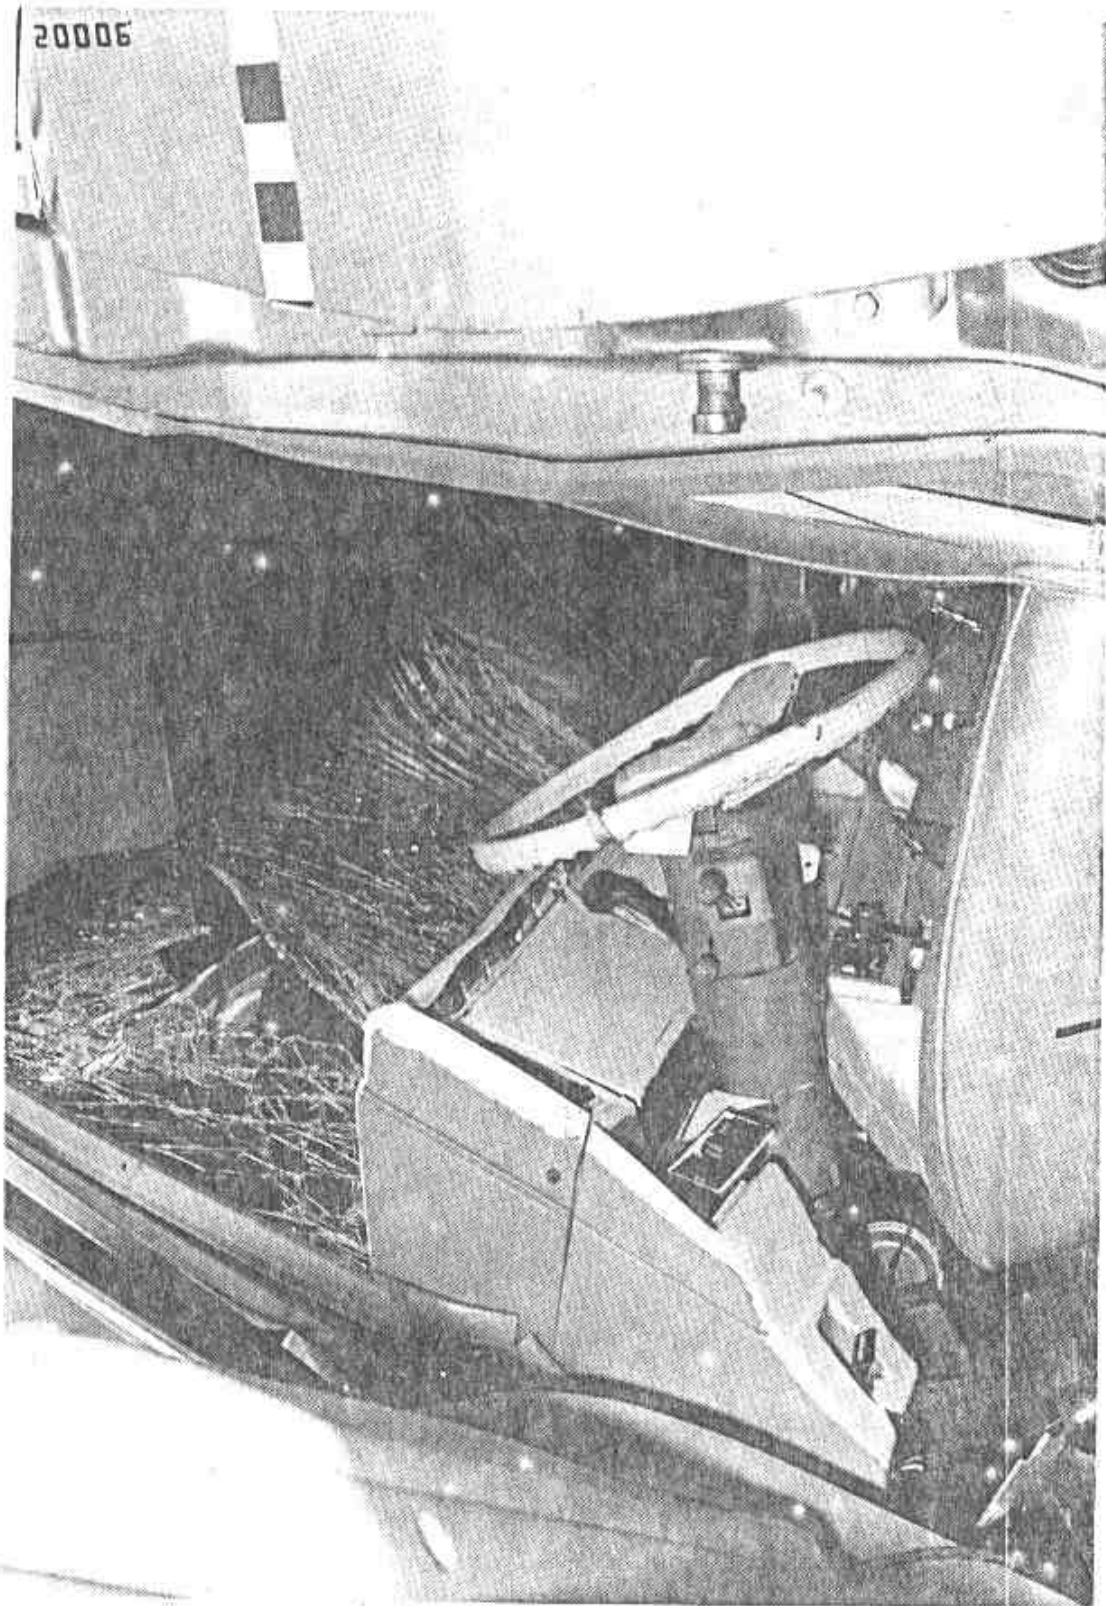
Test 5.5 Post-test View of Driver Compartment Damage.

The driver dummy struck the steering wheel hub with its chest, and its head went over the steering wheel upper rim and struck the dash. The passenger dummy struck the top of the dash with its head. Both dummies struck the lower dash area with their knees. Static deformation of the pertinent areas of the vehicle (including steering wheel movement), and photographs of the pre- and post-test crash damage documentation are shown in Appendix A.
