OCCUPANT RESPONSE  
AND  
VEHICLE ACCELERATION  
IN A  
30-MPH FRONTAL CRASH TEST

GENERAL MOTORS CORPORATION  
1978 OLDSMOBILE CUTLASS TWO-DOOR SEDAN  
NHTSA 780115

FINAL REPORT

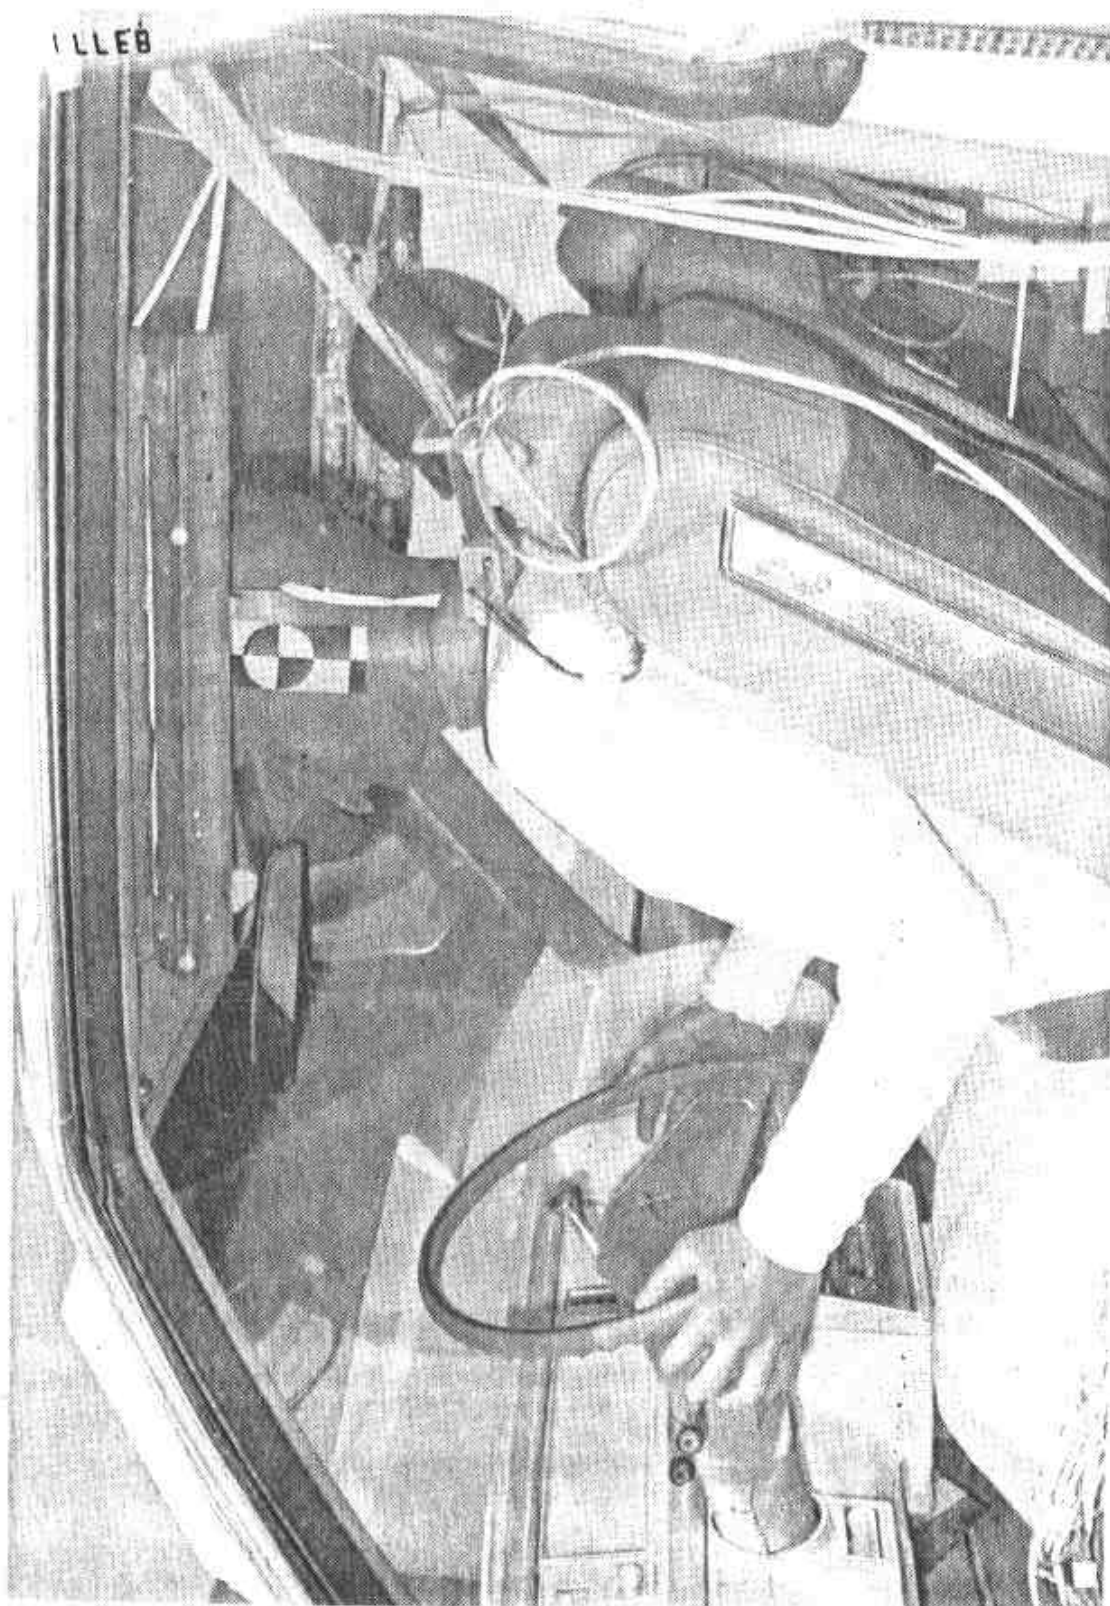
Figure 3-1. Pre-test View of Driver Dummy - 1978 Oldsmobile Cutlass Two-Door Sedan -  
NHTSA 780115.

Figures 3-1 through 3-4 are pre-test and post-test views of the occupant compartment, restraint systems, and dummies.

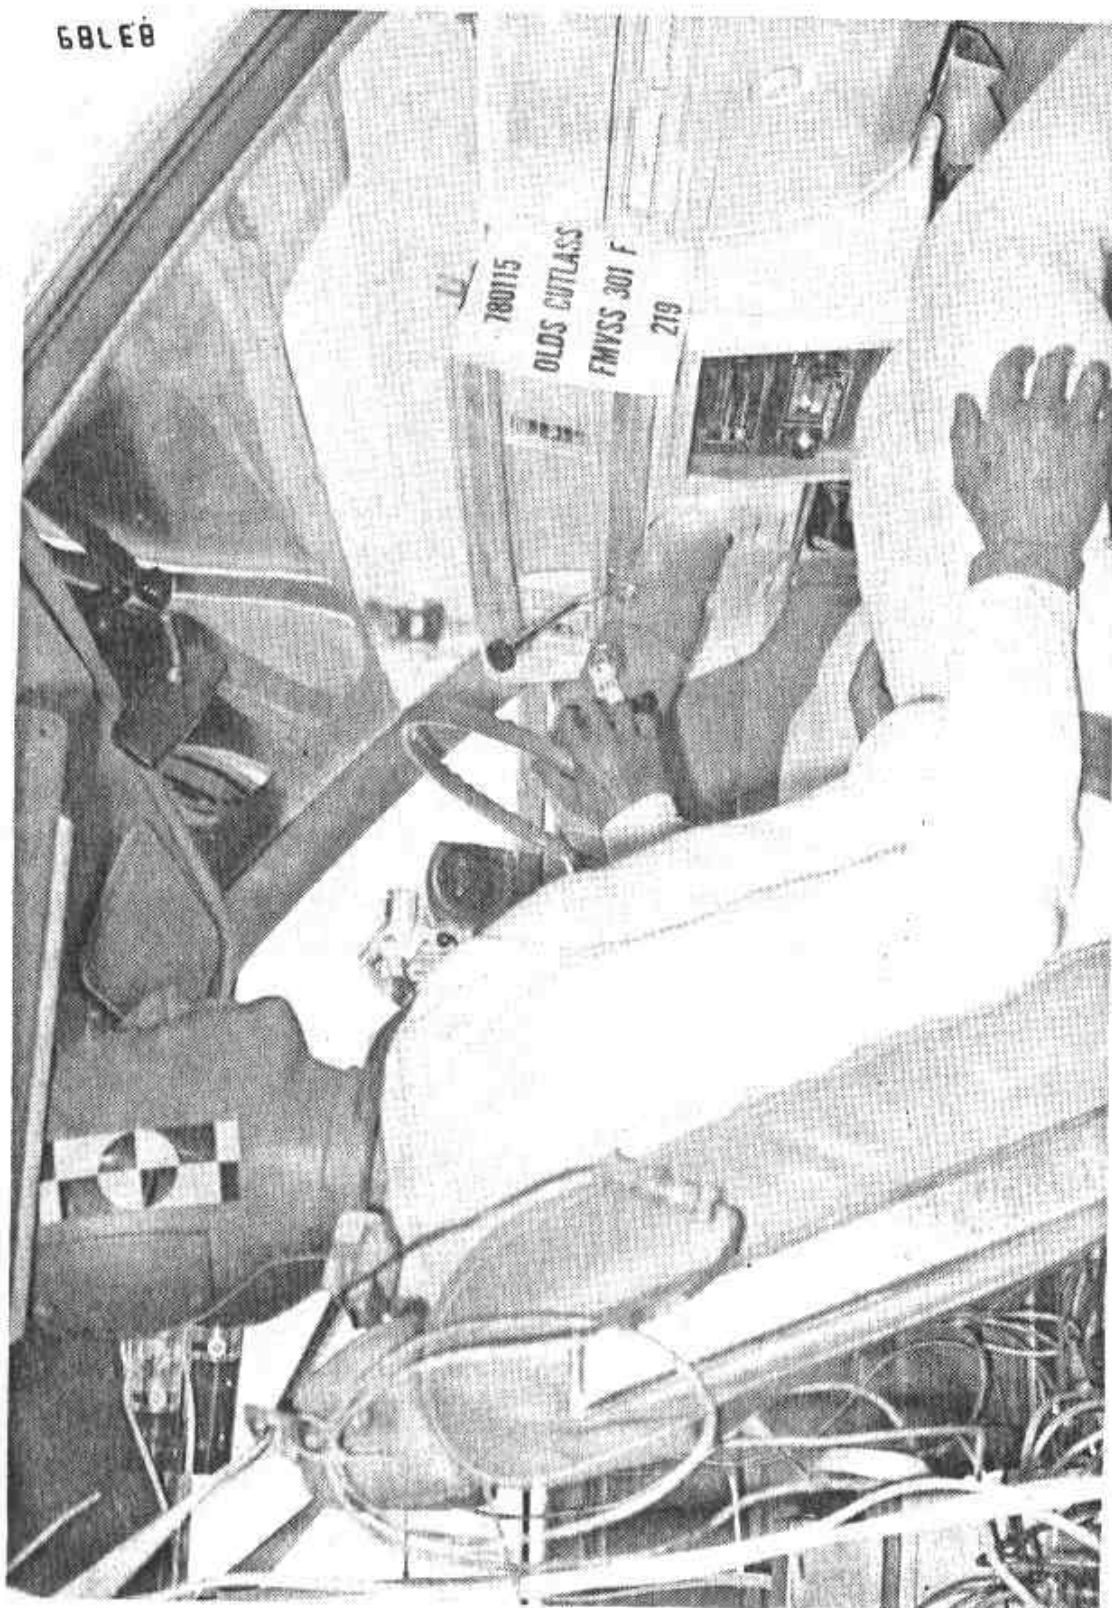
Figure 3-2. Pre-test View of Passenger Dummy - 1978 Oldsmobile Cutlass Two-Door Sedan - NHTSA 780115.

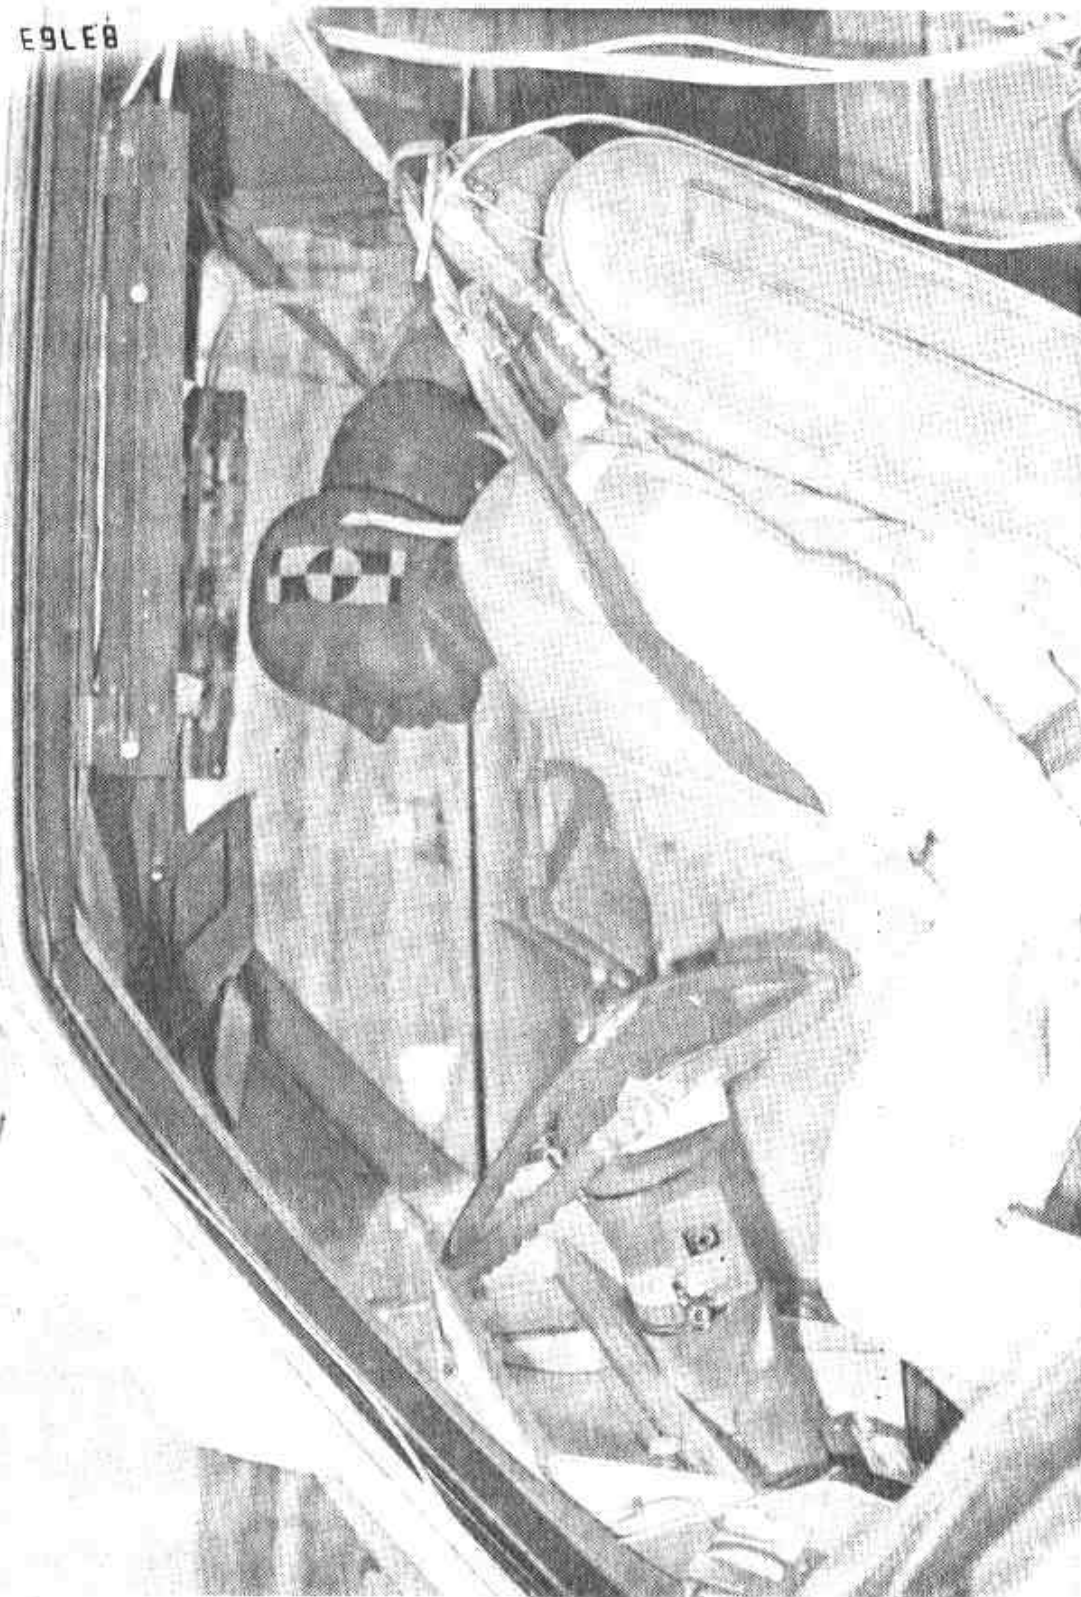
Figure 3-3. Post-test View of Driver Dummy - 1978 Oldsmobile Cutlass Two-Door Sedan - NHTSA 780115.

- The front fenders impacted both front wheels
- The steering wheel deformed at the top
- Roof damage was noted to the "B" pillar

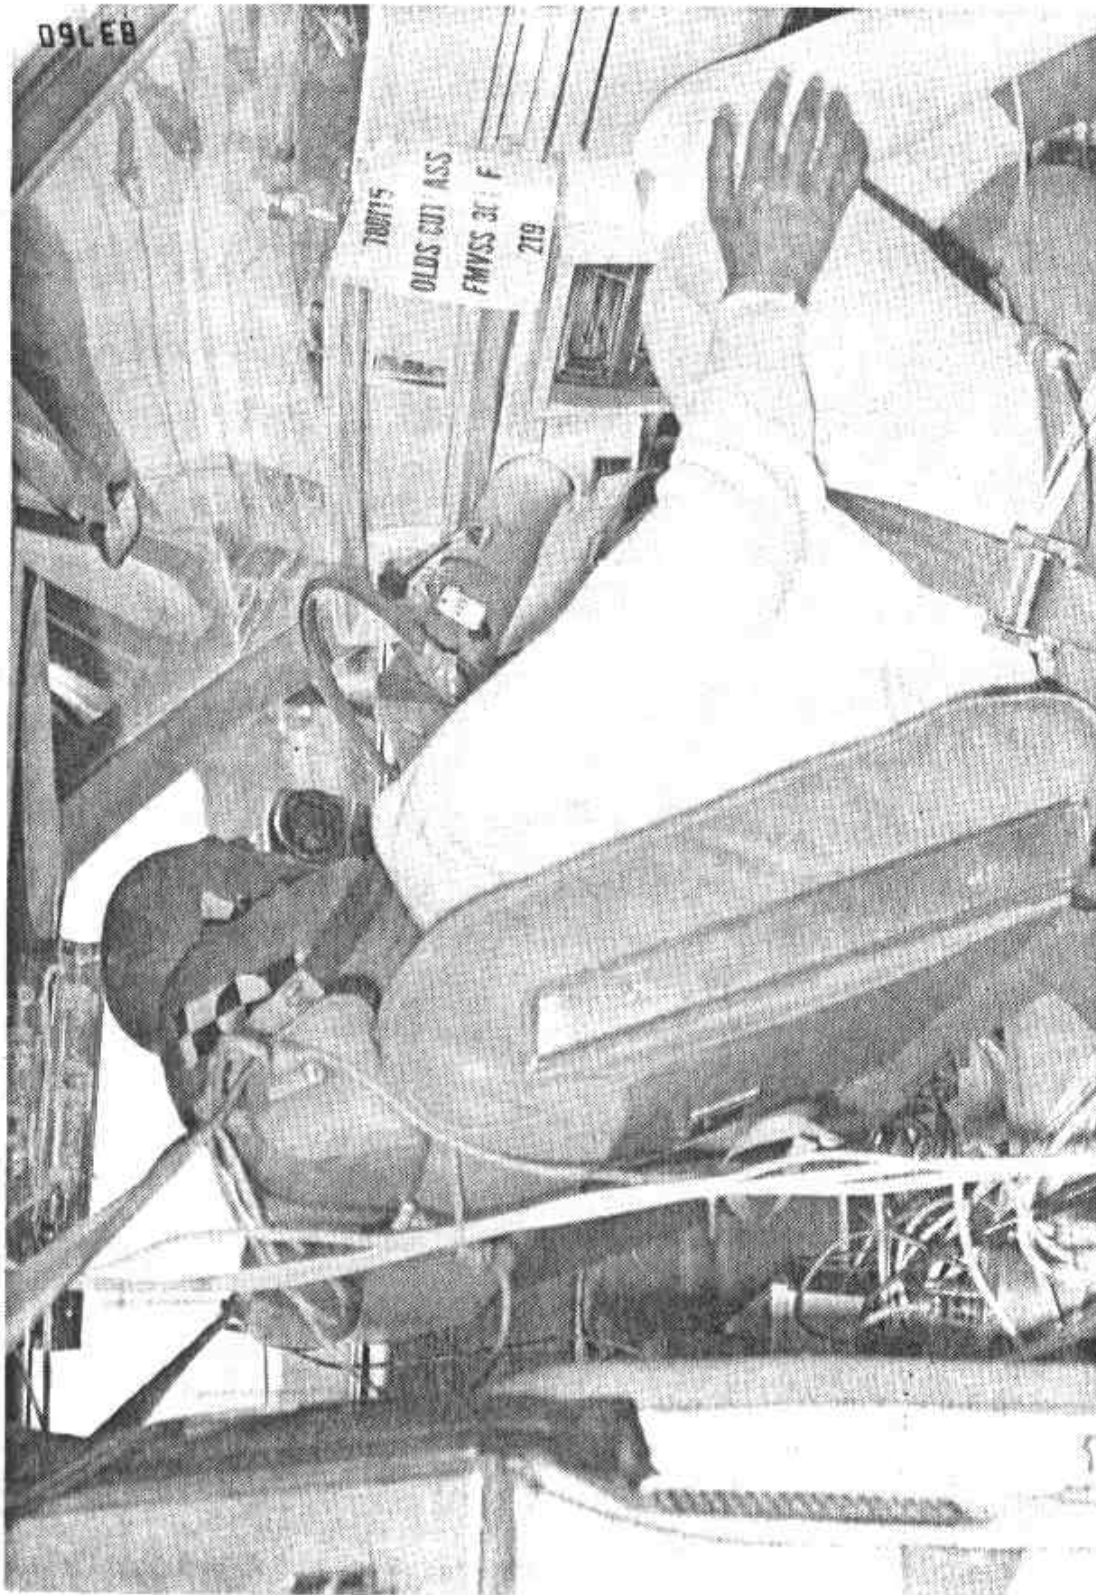
Figure 3-4. Post-test View of Passenger Dummy - 1978 Oldsmobile Cutlass Two-Door Sedan - NHTSA 780115.
