FMVSS 301-75 STANDARDS ENFORCEMENT TESTING  
OF FUEL SYSTEM INTEGRITY

Fiat Motors of North America  
1978 Fiat 124 Spider Two-Door Convertible  
NHTSA 780538

FINAL REPORT

| 4. Title and Subtitle FINAL REPORT OF FMVSS 301-75<br>STANDARDS ENFORCEMENT TESTING OF FUEL SYSTEM<br>INTEGRITY - 1978 FIAT 124 SPIDER TWO-DOOR CON-<br>VERTIBLE - NHTSA 780538 | | | | 5. Report Date<br>May 1978 | |

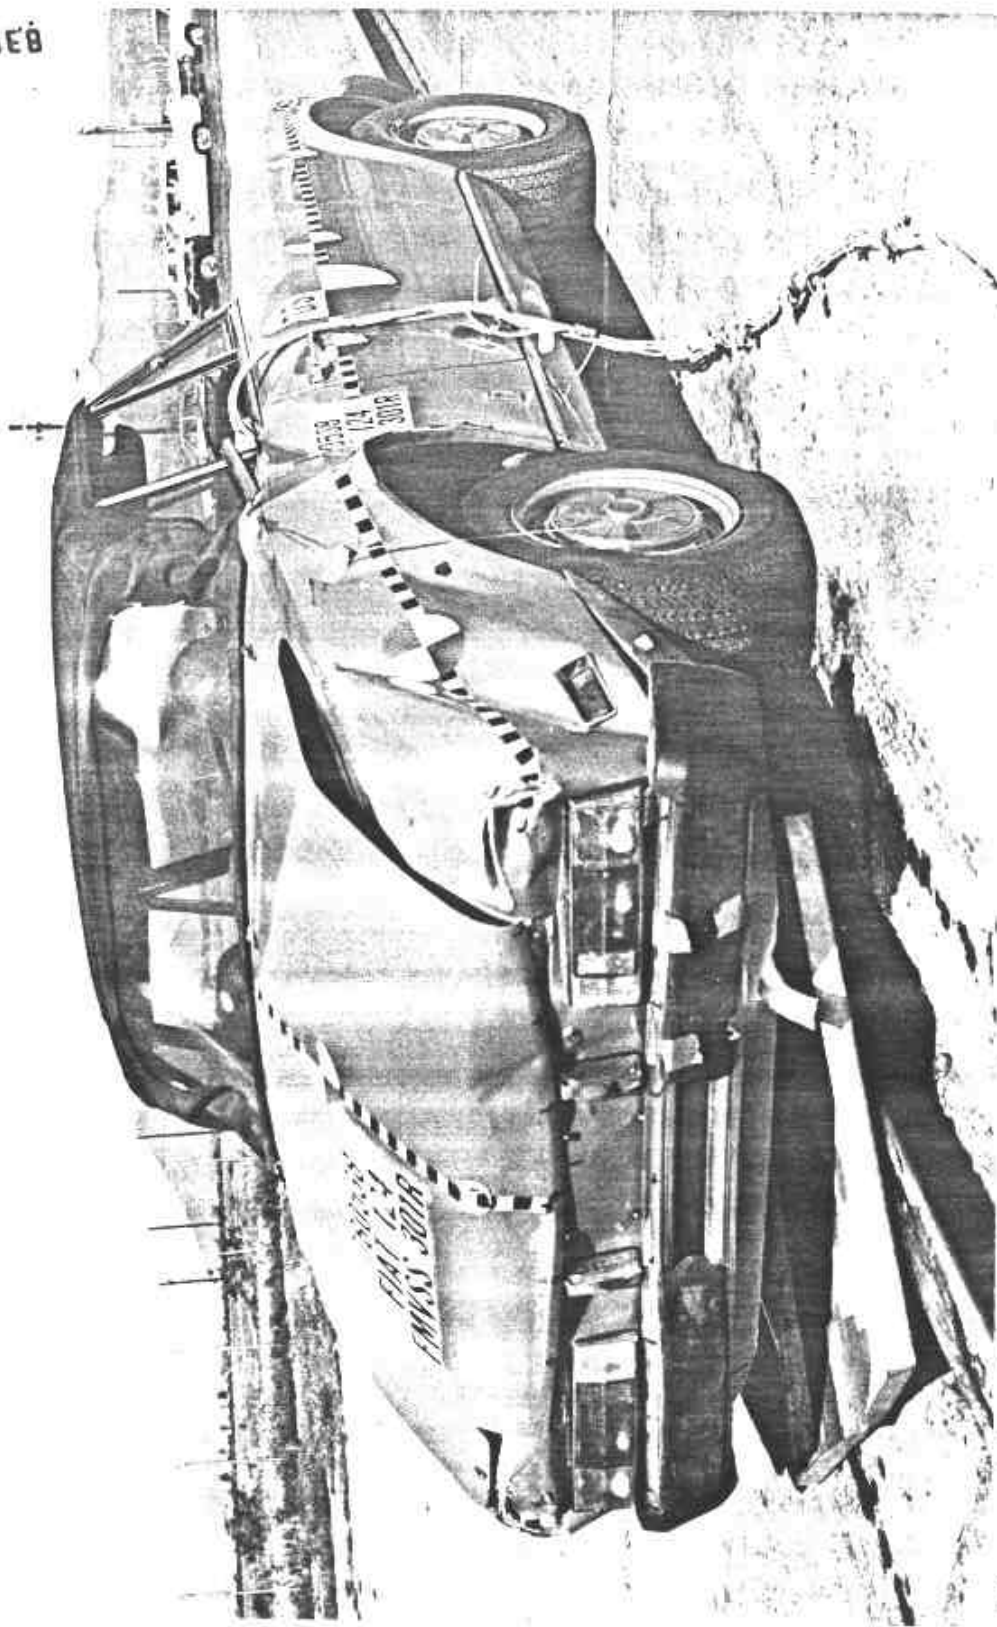
Figure 4-4. Post-test Rear View - 1978 Fiat 124 Spider Two-Door Convertible - NHTSA 780538.

Trunk and rear sidewall damage to edge of sill on both doors.

Trunk latch remained secure.

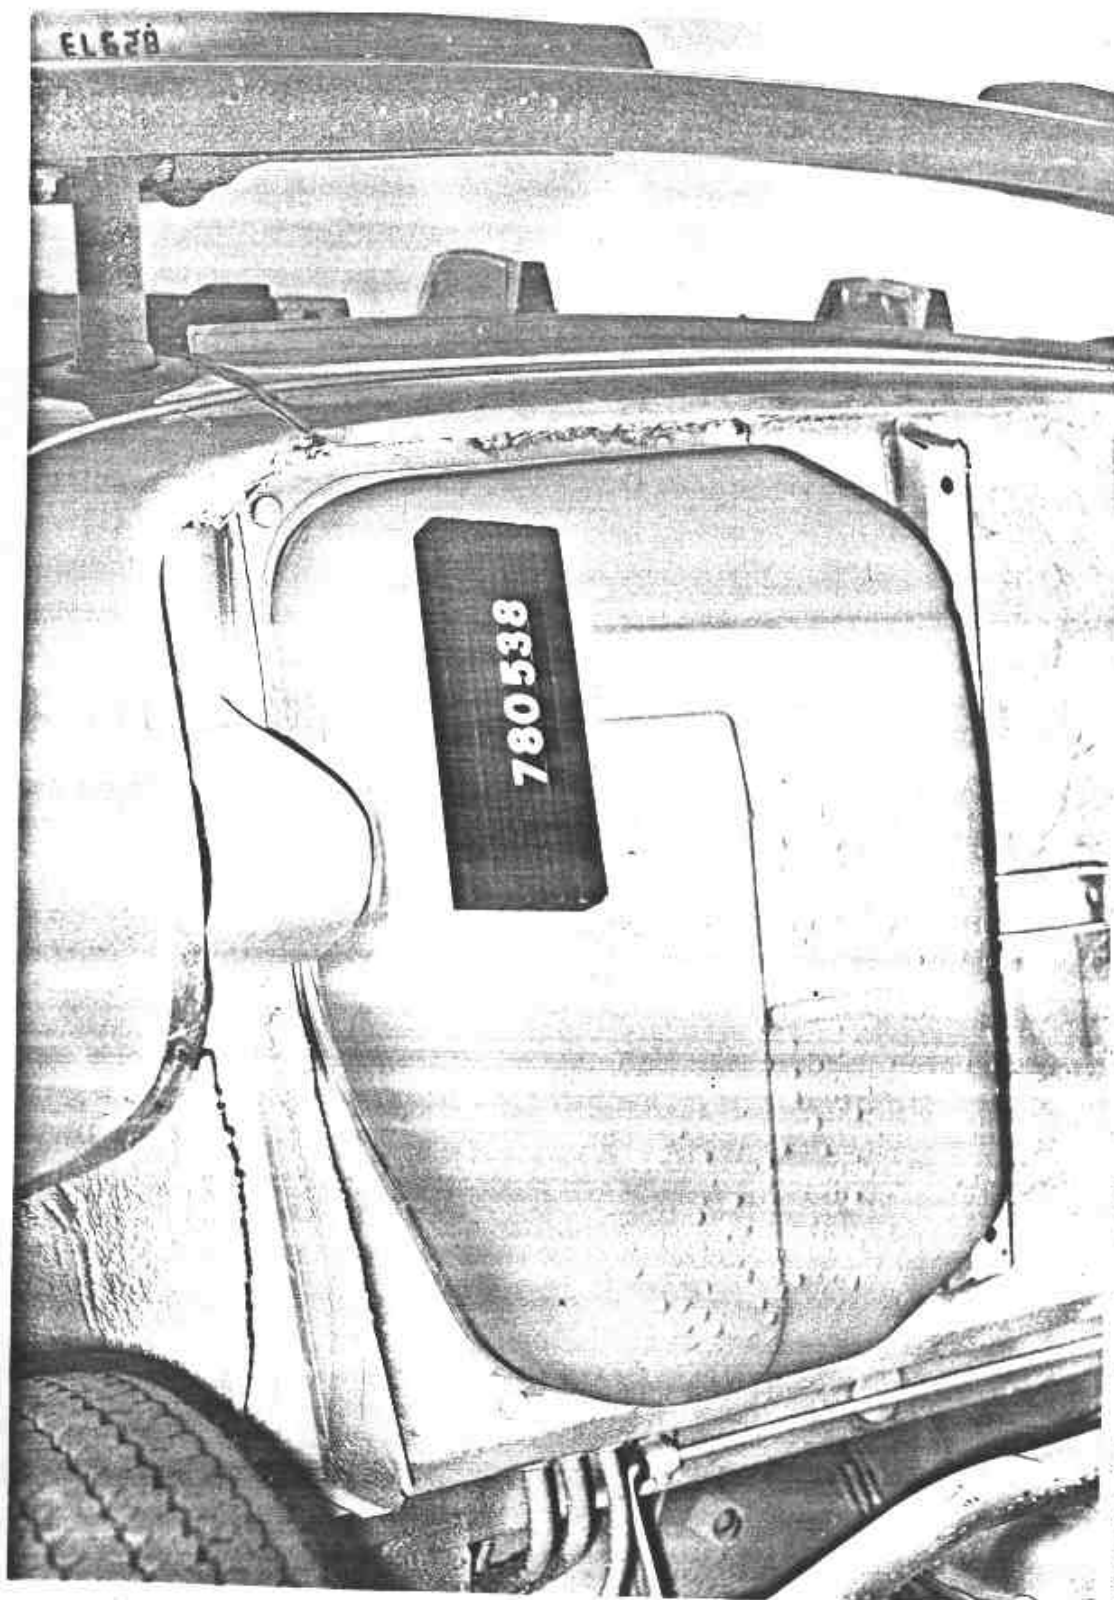
Figure 4-5. Pre-test View of Fuel Tank - 1978 Fiat 124 Spider Two-Door Convertible - NHTSA 780538.

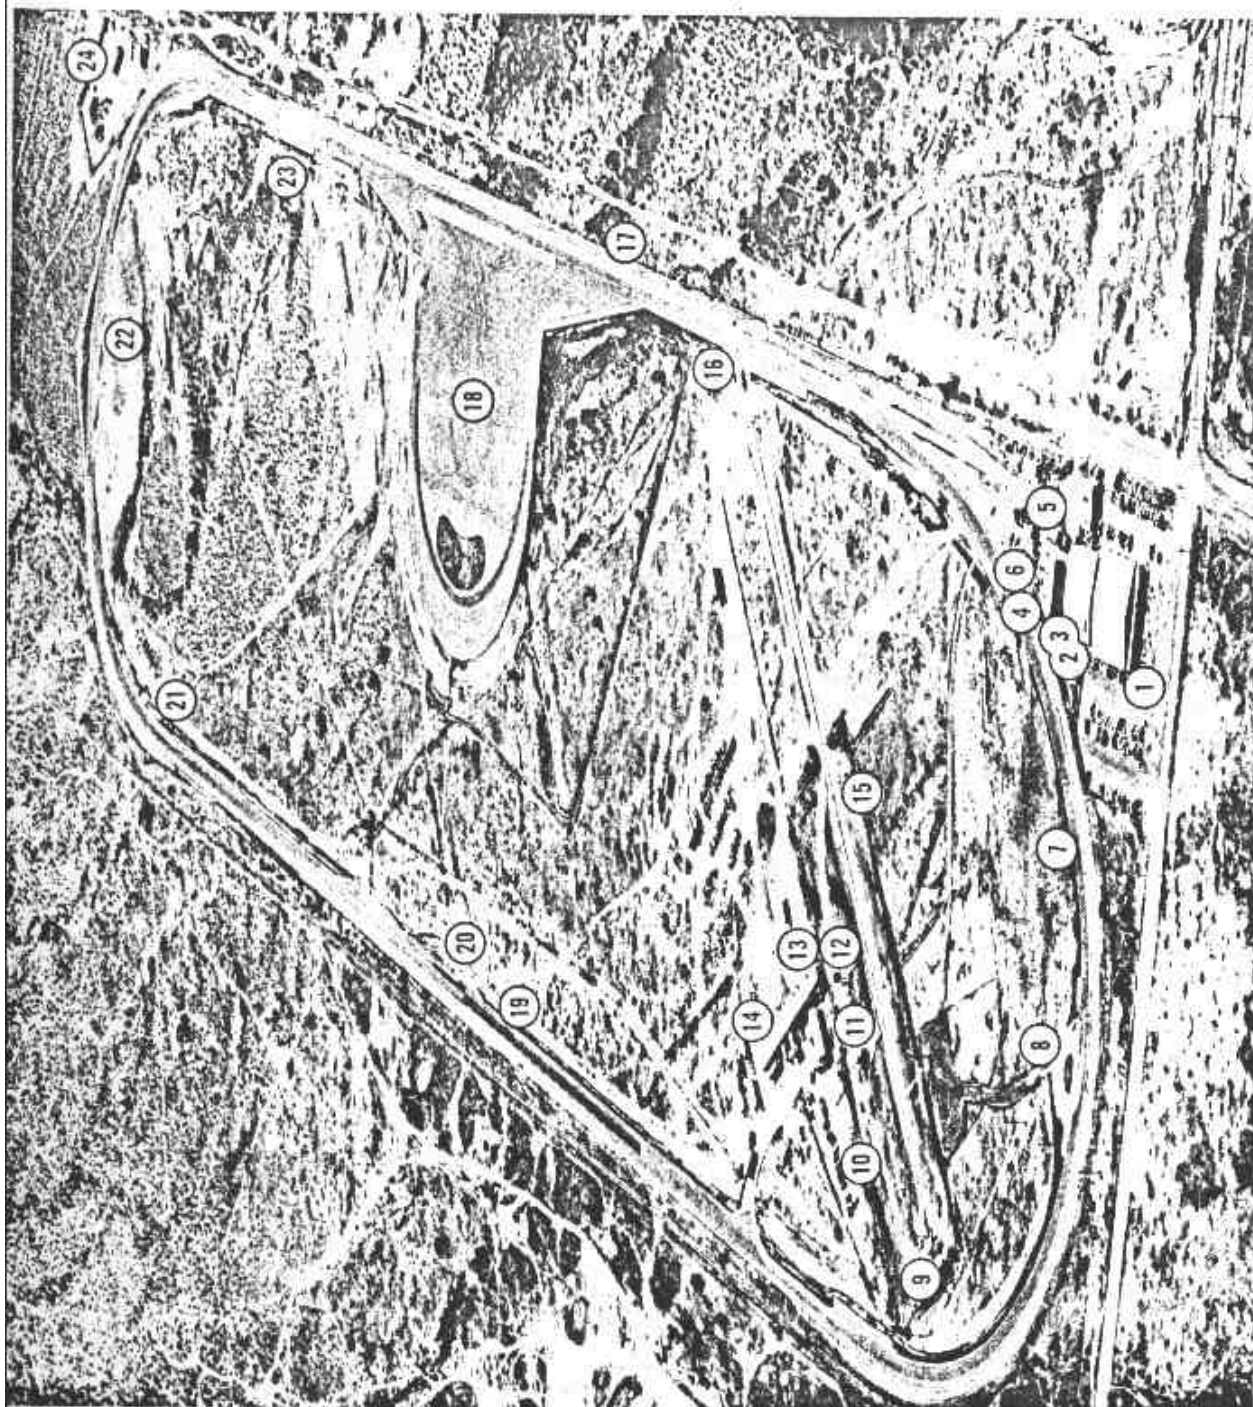
FMVSS 301-75 impact tests are conducted at the Dynamic Science, Inc. Deer Valley Facility in Phoenix, Arizona. Figure 5-1 is an overall aerial view of that facility.

1. ENGINEERING/ADMINISTRATION CENTER
2. MECHANICAL/INSTRUMENTATION SHOPS
3. DUMMY CALIBRATION LABORATORY
4. GARAGE/MAINTENANCE SHOP
5. ENVIRONMENTAL CHAMBER
6. STATIC CRUSH FACILITY
7. TWO-MILE OVAL
8. TURNAROUND (TYPICAL OF TWO)
9. BARRIER IMPACT FACILITY
10. DROP TOWER/SLED TEST FACILITY
11. CENTRAL DATA ACQUISITION AND CONTROL STATION
12. PENDULUM FACILITY
13. NONMETALLICS LABORATORY
14. TEST SERVICE FACILITY
15. VEHICLE-TO-VEHICLE TEST FACILITY
16. ROLLOVER TEST FACILITY
17. RIDE QUALITY COURSE
18. SKID PAD
19. HIGH AND LOW SKID NUMBER BRAKING LANES
20. SALT WATER TROUGH
21. BELGIAN BLOCK
22. PARKING BRAKE TEST RAMP
23. PULL-OFF AREA (TYPICAL OF THIRTEEN)
24. BALLISTIC TEST RANGE

Figure 5-1. The Dynamic Science, Inc. Deer Valley Facility.
