FMVSS 301-75 STANDARDS ENFORCEMENT TESTING  
OF FUEL SYSTEM INTEGRITY

General Motors Corporation  
1978 Pontiac Lemans Two-Door Sedan  
NHTSA 780118

FINAL REPORT

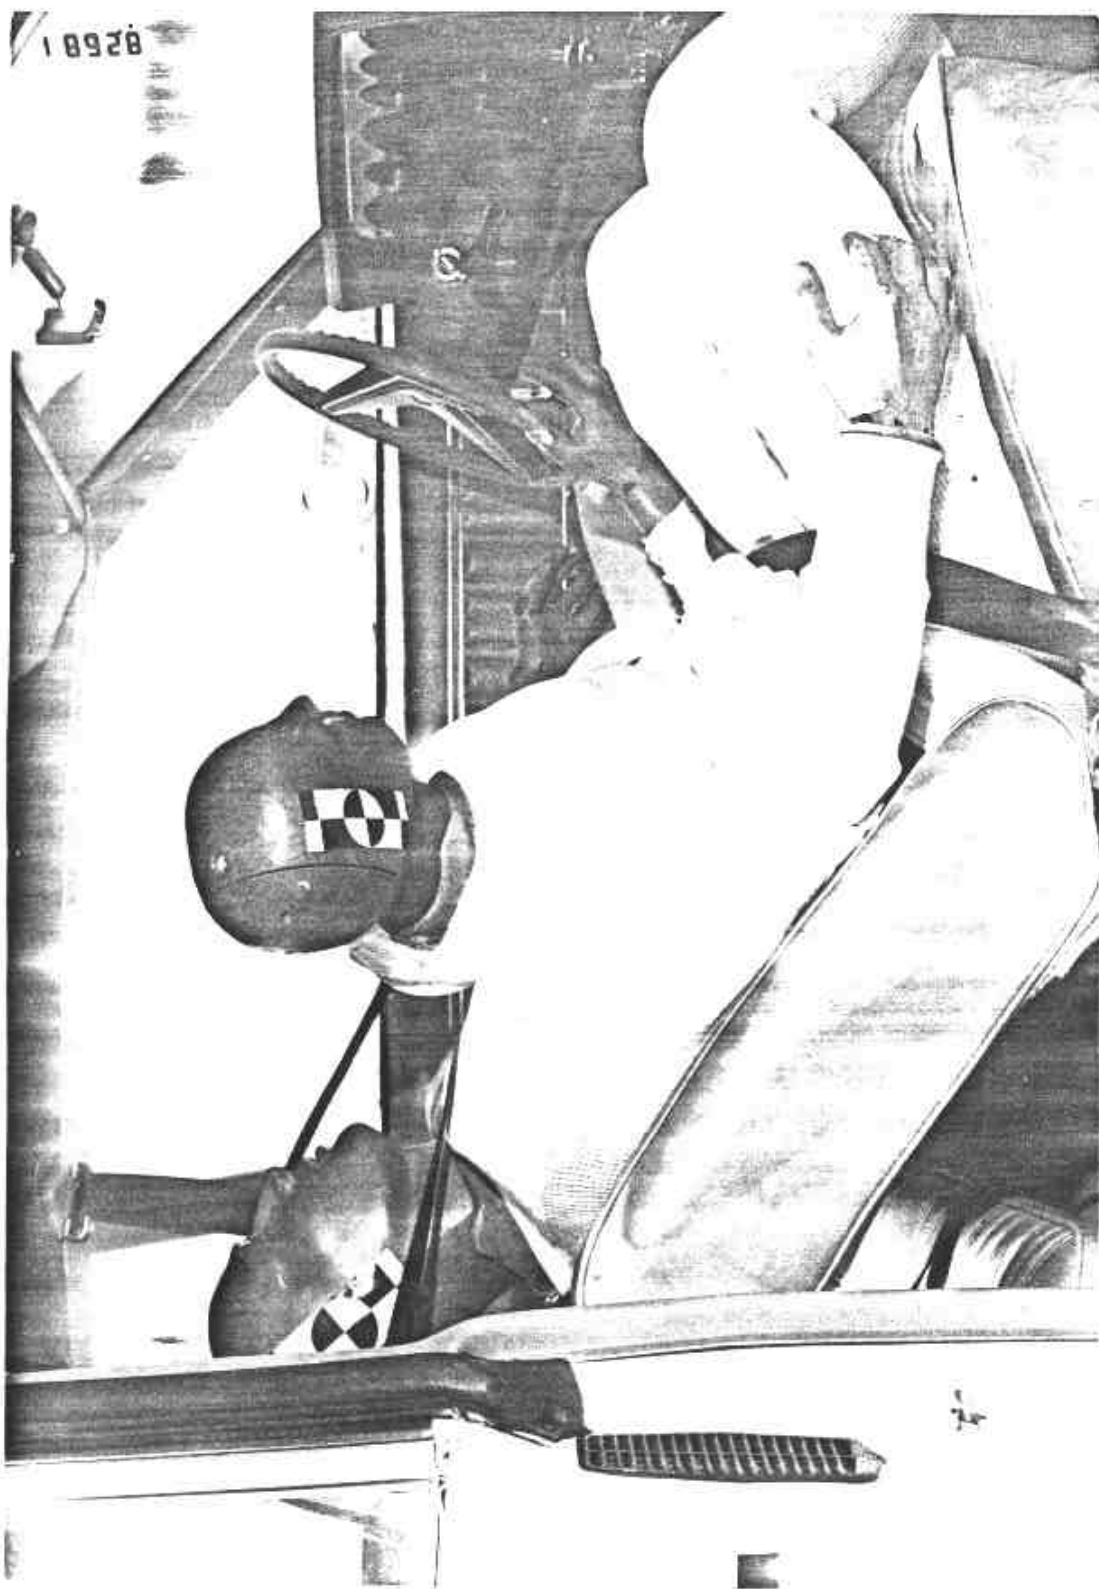
Figure 4-7. Post-test View of Dummies - 1978 Pontiac Lemans Two-Door Sedan - NHTSA 780118.

Both seat backs deformed into rear seat area.

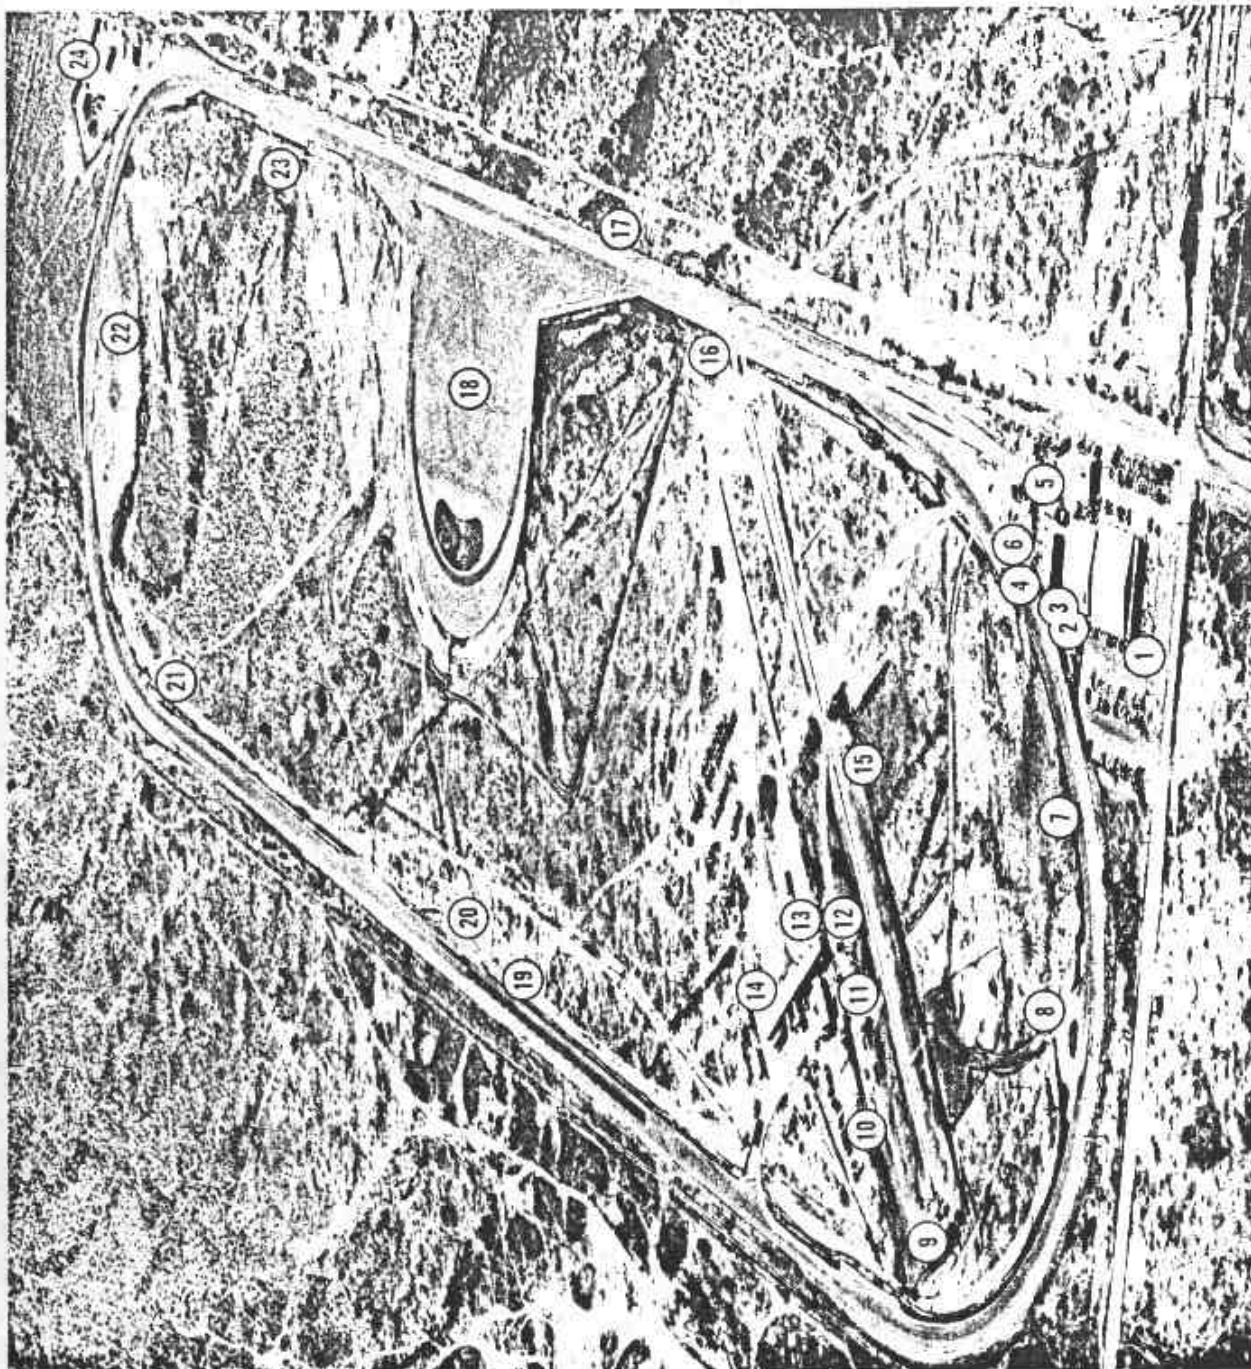
Figure 5-1. The Dynamic Science, Inc. Deer Valley Facility.

FMVSS 301-75 impact tests are conducted at the Dynamic Science, Inc. Deer Valley Facility in Phoenix, Arizona. Figure 5-1 is an overall aerial view of that facility.

1. ENGINEERING/ADMINISTRATION CENTER
2. MECHANICAL/INSTRUMENTATION SHOPS
3. DUMMY CALIBRATION LABORATORY
4. GARAGE/MAINTENANCE SHOP
5. ENVIRONMENTAL CHAMBER
6. STATIC CRUSH FACILITY
7. TWO-MILE OVAL TURNAROUND (TYPICAL OF TWO)
8. BARRIER IMPACT FACILITY
9. DROP TOWER/SLED TEST FACILITY
10. CENTRAL DATA ACQUISITION AND CONTROL STATION
11. PENDULUM FACILITY
12. NONMETALLICS LABORATORY
13. TEST SERVICE FACILITY
14. VEHICLE-TO-VEHICLE TEST FACILITY
15. ROLLOVER TEST FACILITY
16. RIDE QUALITY COURSE
17. SKID PAD
18. HIGH AND LOW SKID NUMBER BRAKING LANES
19. SALT WATER TROUGH
20. BELGIAN BLOCK PARKING BRAKE TEST RAMP
21. PULL-OFF AREA (TYPICAL OF THIRTEEN)
22. BALLISTIC TEST RANGE
