NEW VEHICLE ASSESSMENT AND  
STANDARDS ENFORCEMENT INDICANT  
TESTING

FMVSS 212, 219, AND 301-75

TOYO KOGYO CO., LTD.  
1980 MAZDA 626  
NHTSA NO. 800560

FINAL REPORT

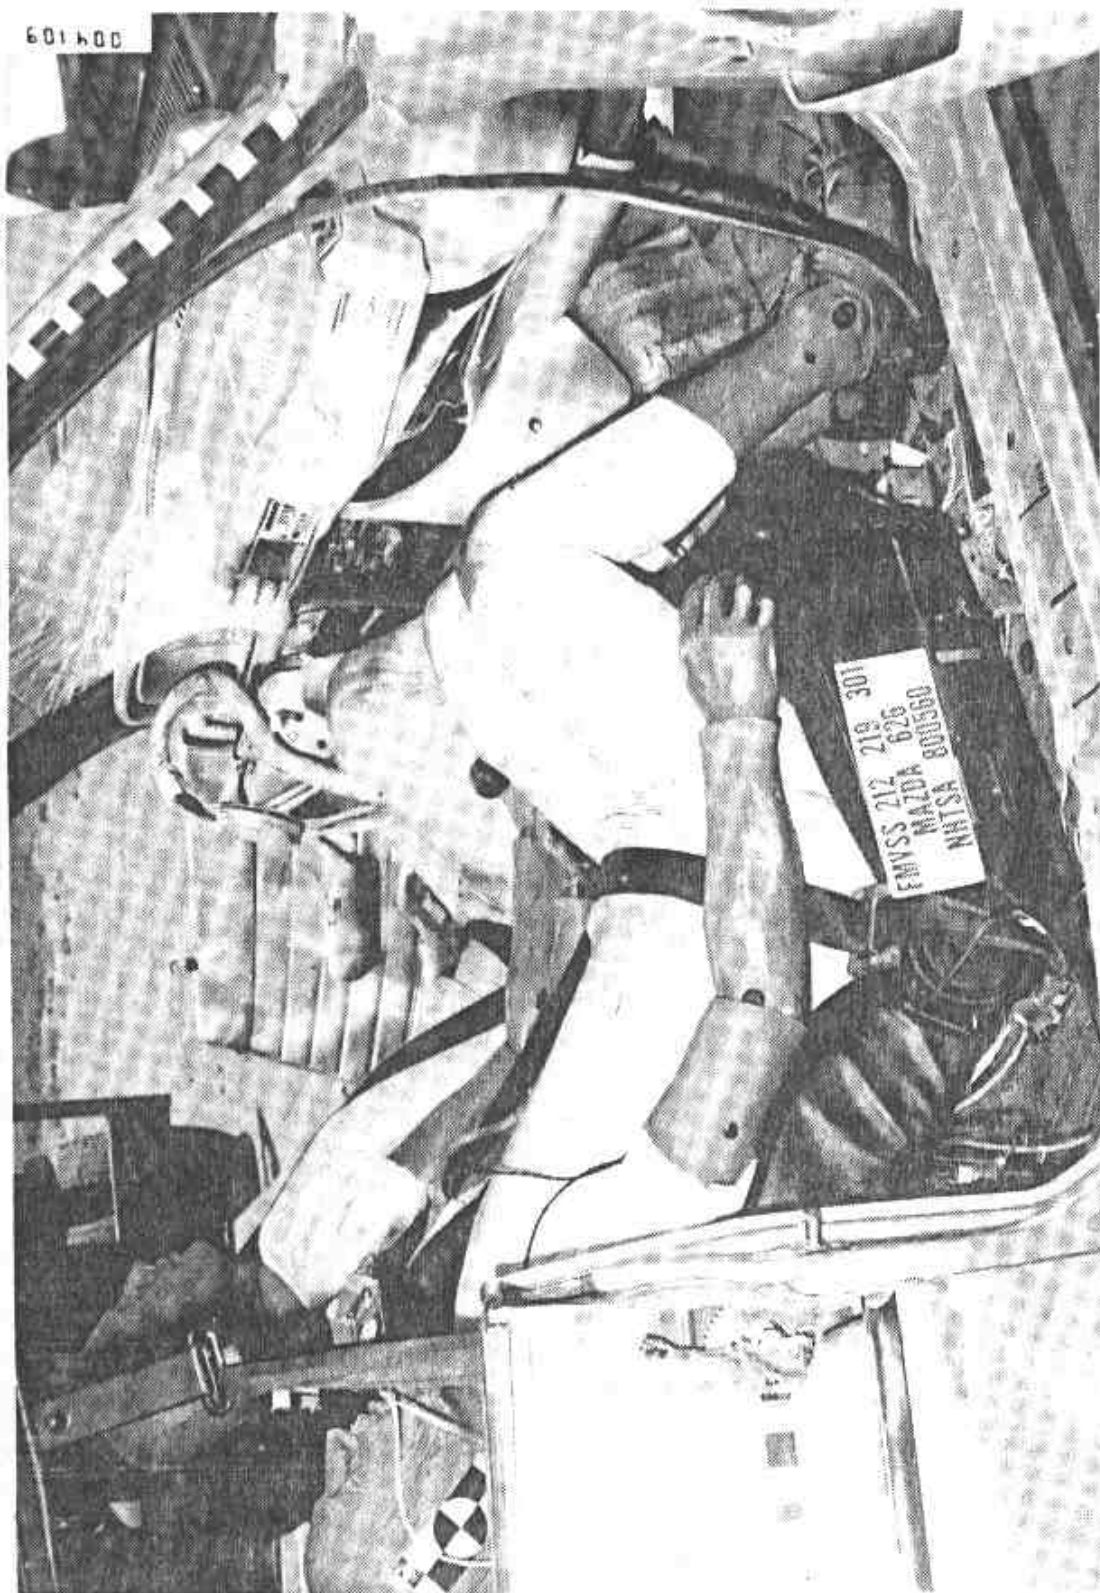
Figure A-9. Post-test Passenger Position - 1980 Mazda 626 - NHTSA 800560.

PASSENGER - Struck upper dash with center of face and rebounded into seatback, causing a total failure of the latch mechanism. The seatback was fully extended to the rear. Dummy came to rest reclining in seat.
