January 1981
Final Report

DOT HS-806-059

Compliance Techniques for Pedestrian Protection

Feasibility Study

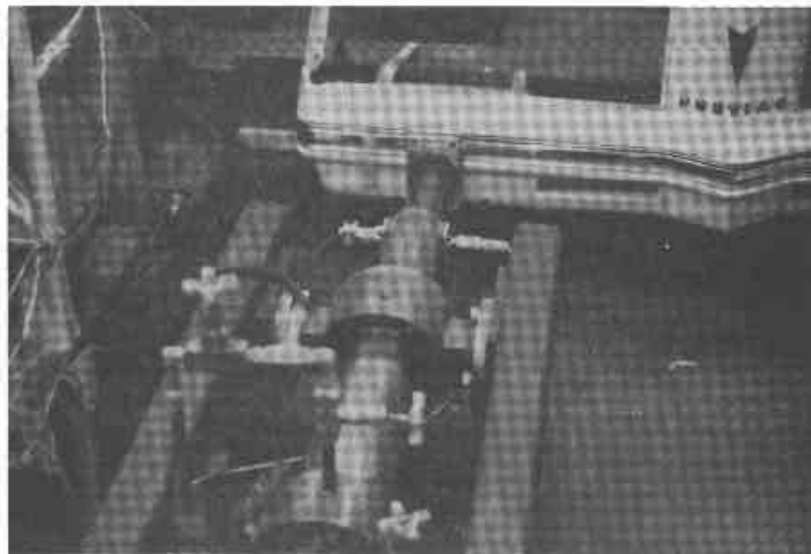
FIGURE 5. PARTIAL VEHICLE TEST ARTICLE
MOUNTED ON FIXTURE

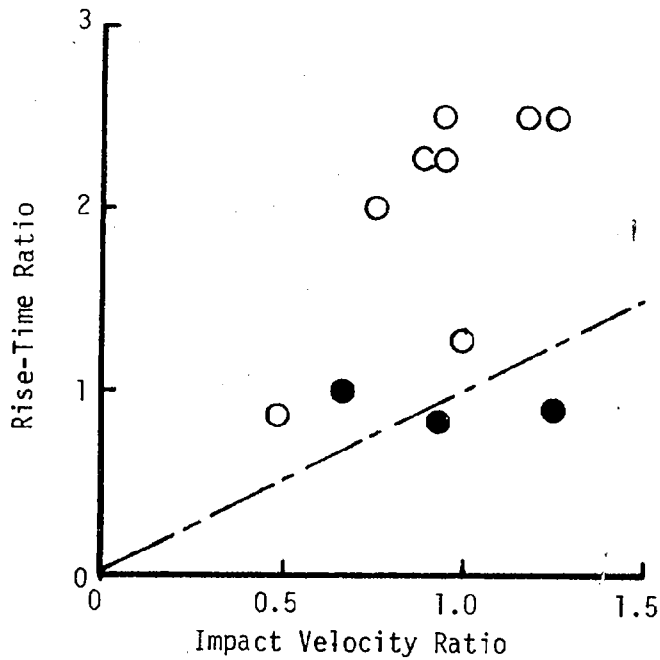
1. Ratios are striker-to-cadaveric response.
2. Open symbols denote rigid bumper; filled symbols denote soft bumper
3. Cadaveric response data from Ped I; pneumatic impactor striker data from Ped III. See Table 2 of Reference 8.

FIGURE 8. COMPARISON OF PNEUMATIC IMPACTOR STRIKER WITH CADAVERIC KNEE-LEG RESPONSES OBTAINED FROM SLED TESTS

materials and the total mass of the ram assembly (i.e., striker and guide tube). After considerable experimentation, a striker configuration (Configuration 1 in Table 8) was found that would produce a response much like the initial part of the waveform observed for rigid bumper impacts upon the knee area of cadaveric specimens. This configuration was subsequently modified into Configuration 2 after additional tests with both rigid and soft bumper configurations. Efforts to obtain further simplification of the striker resulted in Configuration 3. Eventually, Configuration 4, shown in Figure 7, was adopted as a tentative "standard configuration" for soft bumper experiments, because it was discovered that the styrafoam layer was only needed as a mechanical fuse device when unacceptably hard surfaces were being evaluated. Initial waveform data (peak force and rise time) generated by a developmental striker configuration for the knee-leg body form are compared in Figure 8 with data obtained in Ped I experiments with cadaveric specimens.

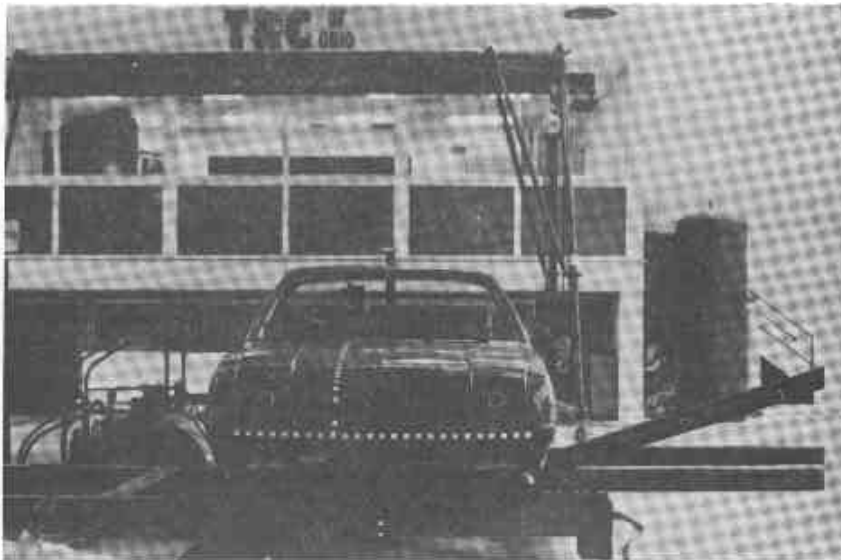
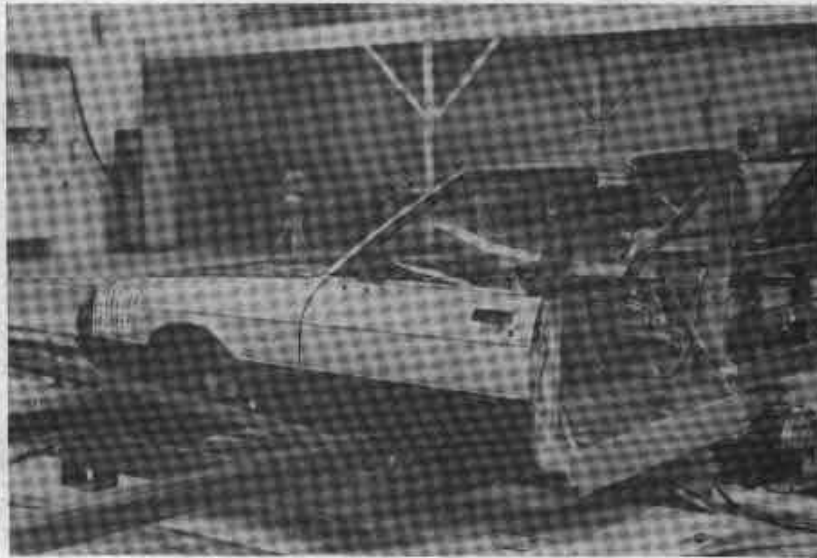
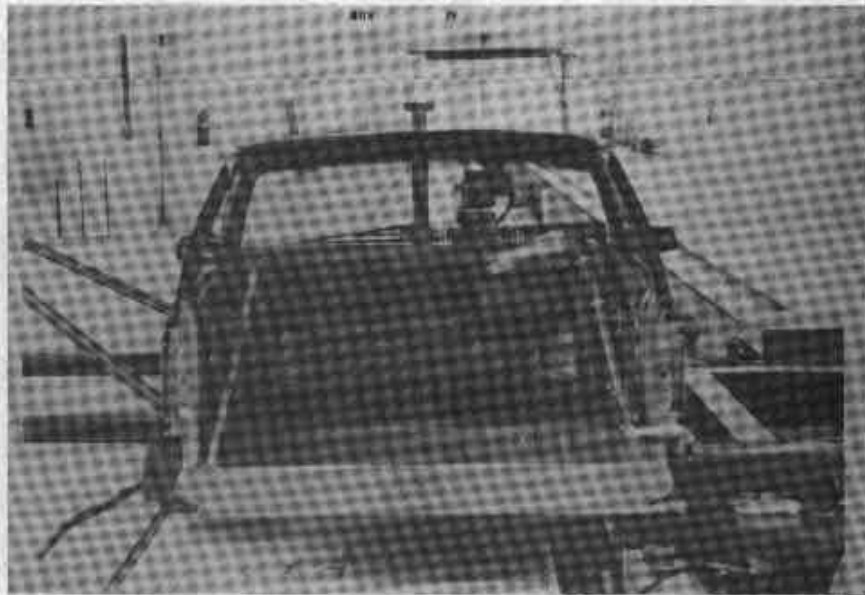
FIGURE 9. PHOTOGRAPHS OF PARTIAL VEHICLE TEST BUCK INSTALLATION IN 24-INCH HYGE SLED FACILITY

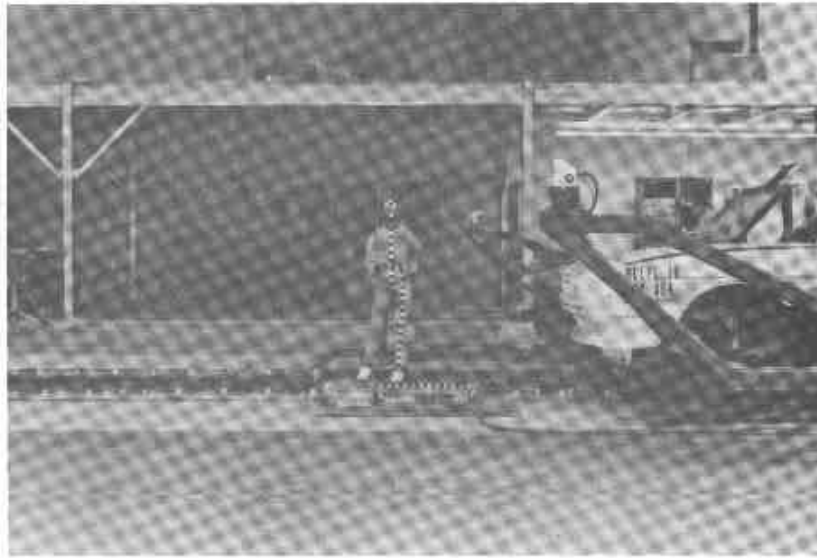
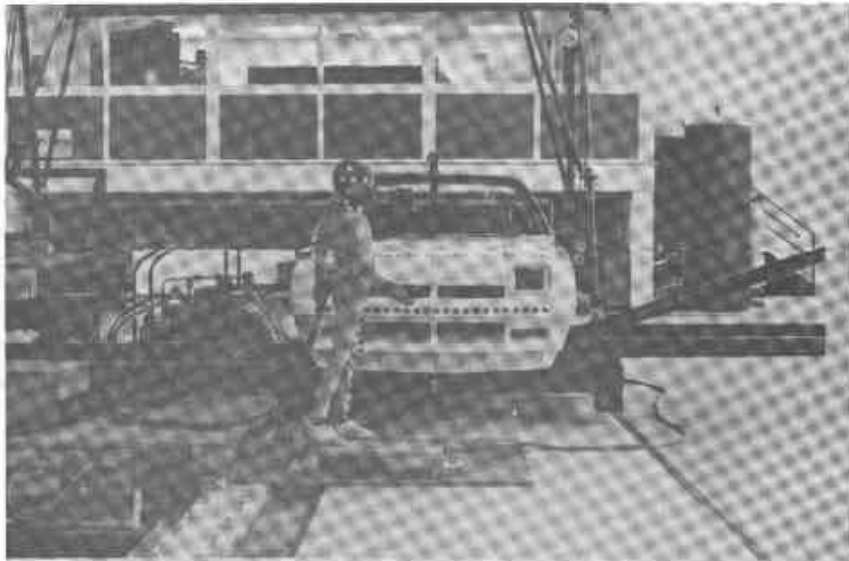
FIGURE 11. PHOTOGRAPHS ILLUSTRATING INITIAL POSITION OF ANTHROPOMORPHIC DUMMIES RELATIVE TO TEST VEHICLE

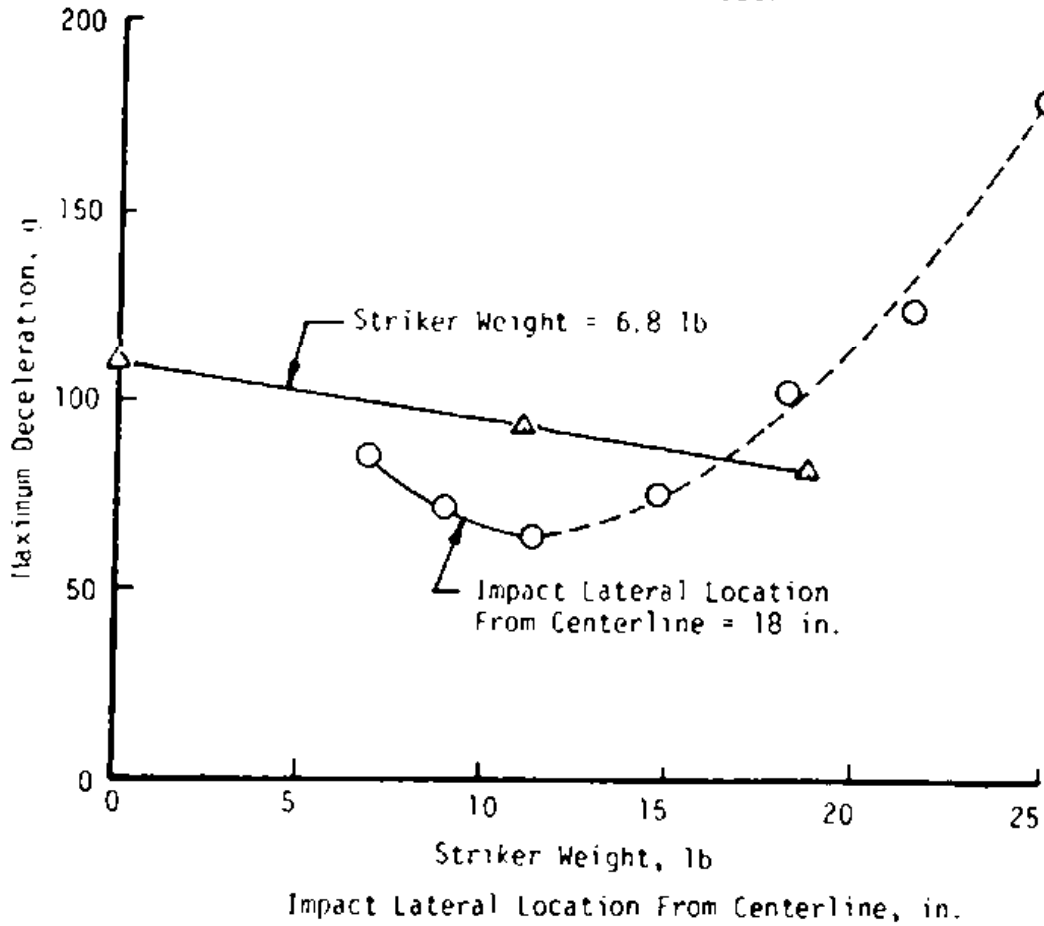
- NOTES: 1. Data corrected to impact velocity of 25 mph as necessary.
 2. Dashed line indicates energy absorber bottomed out.

FIGURE 17. MAXIMUM DECELERATION OBTAINED FOR LEMANS MOD I BUMPER WITH PNEUMATIC IMPACTOR

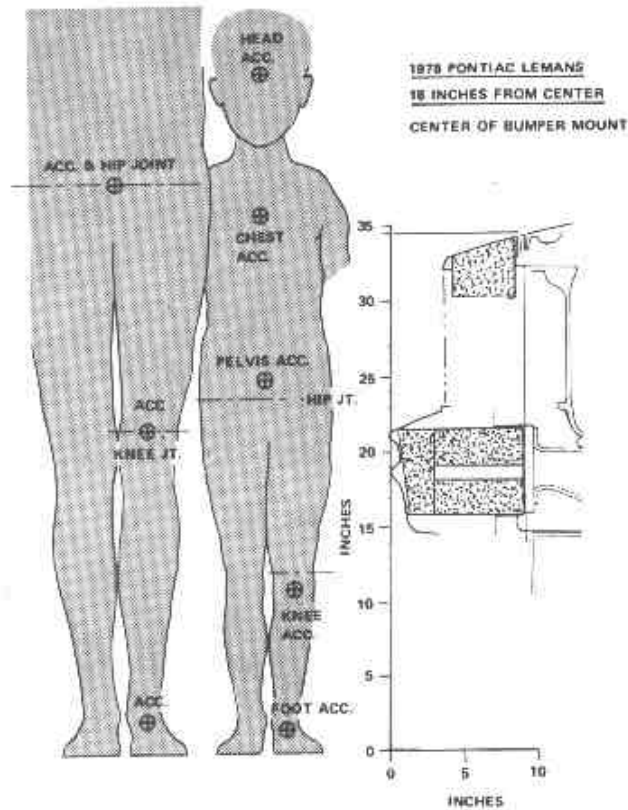
FIGURE 24. ADULT AND 6-YEAR-OLD CHILD DUMMY RELATIVE TO LEMANS VEHICLE FRONT

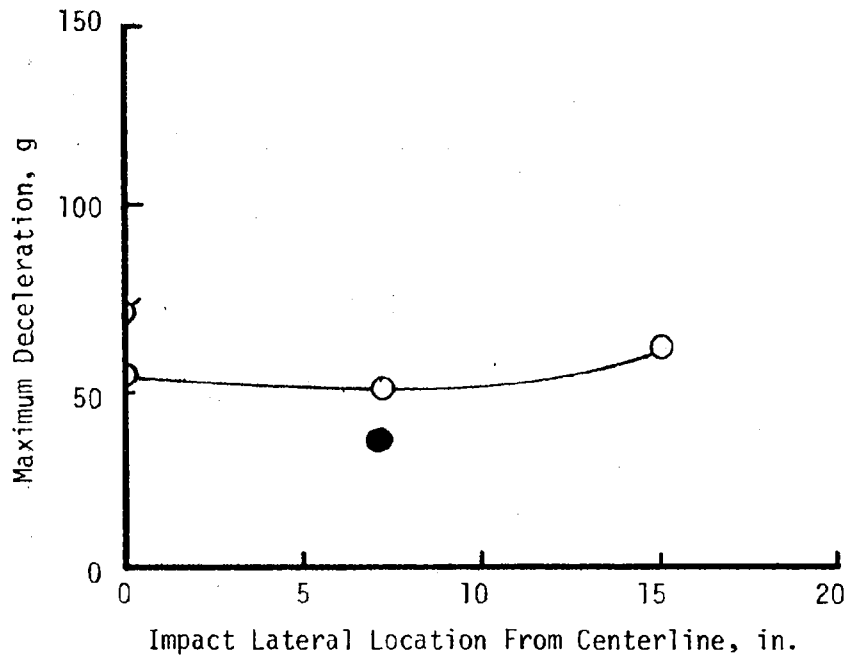
- NOTES: 1. Unflagged symbols denote foam density of 4.1 pcf; flagged symbol denotes foam density of 5.1 pcf (reference configuration)
2. Open symbols denote impact velocity of 25 mph; filled symbol denotes impact velocity of 20 mph.

FIGURE 25. MAXIMUM DECELERATION OF CHILD DUMMY PELVIS FROM IMPACT BY CALSPAN RSV IN SLED TEST

- (1) For a fixed foam density of 4.1 pcf and an impact speed of 25 mph, the maximum deceleration levels recorded for the child dummy's pelvic region vary with the lateral location of bumper contact much like the trend indicated by pneumatic impactor data, i.e., peak deceleration tends to increase with increasing outboard distance from centerline. For the same test conditions as the child, the maximum deceleration levels experienced by the adult dummy's knee exhibit an unexpected behavior in that maximum deceleration levels do not vary significantly with outboard distance.

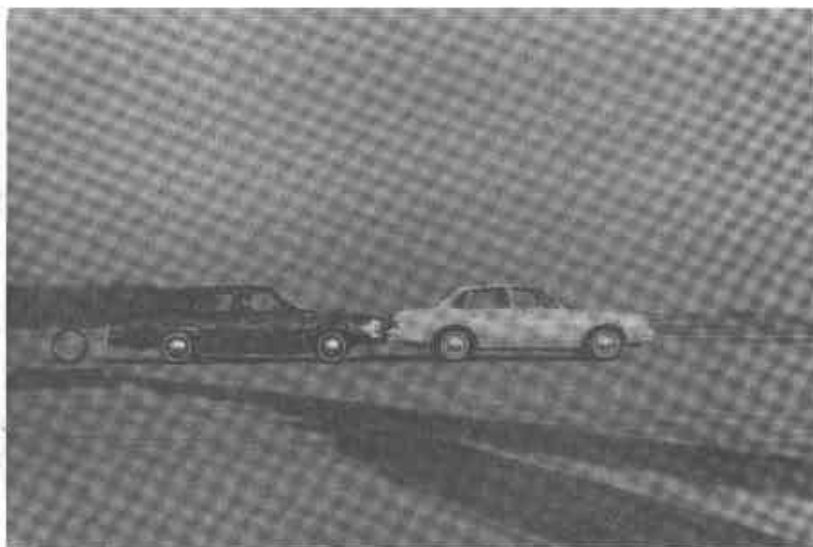
- Notes: (1) Run No. 1.
(2) Vehicle B struck by Vehicle A.
(3) Actual impact speed - 5 mph.
(4) Apparent damage - none to either vehicle.

FIGURE A-1. 5-MPH FRONT-TO-REAR COLLISION
AT INSTANT OF IMPACT; STOCK
FRONT BUMPER

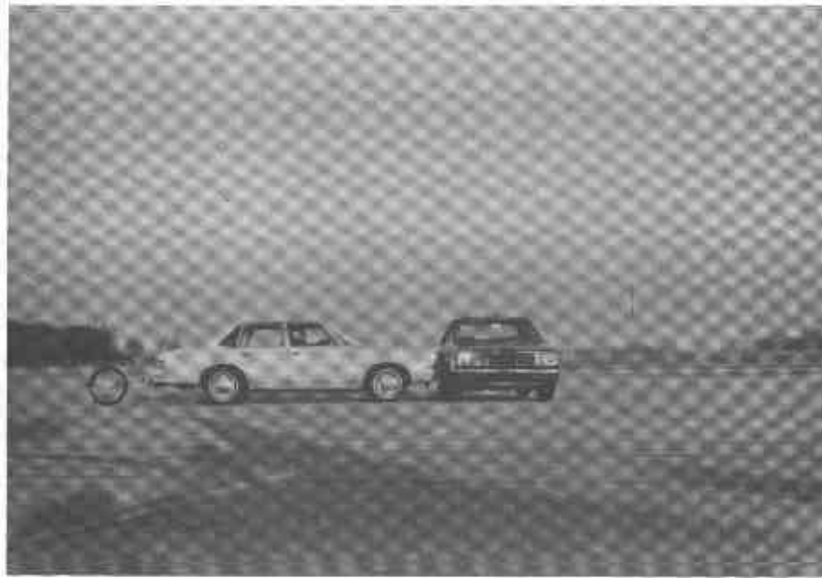
(a) At Instant of Impact

(b) Apparent Damage to Vehicle A

FIGURE A-2. 5-MPH FRONT-TO-SIDE COLLISION: STOCK FRONT BUMPER

- Notes:
- (1) Run No. 2.
 - (2) Vehicle A struck by Vehicle B
 - (3) Actual impact speed - 4.7.
 - (4) Apparent damage - none to Vehicle B, see Figure A-2(b) for damage to Vehicle A.

(c) Side View of Damage

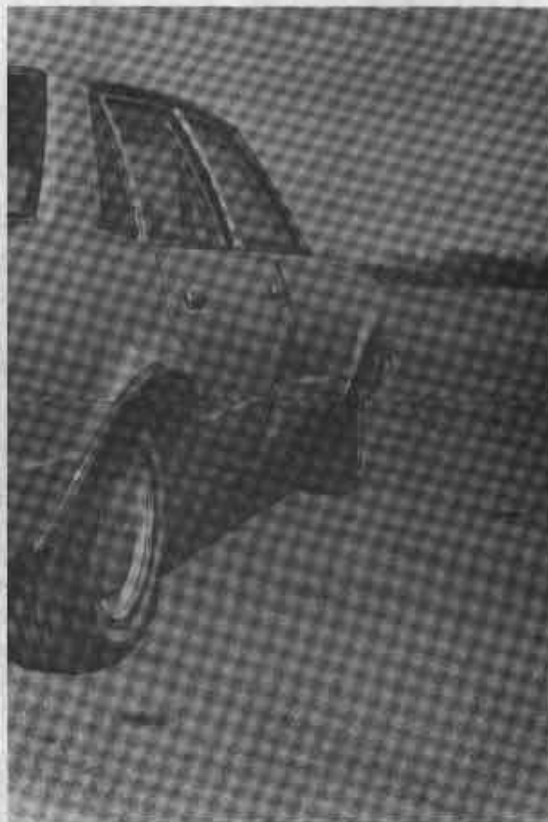
- (1) Run No. 7 (repeat of Run No. 2)
- (2) Vehicle B struck by Vehicle A
- (3) Actual impact speed - 5.0 mph
- (4) Apparent damage - none to Vehicle A

(d) Three-Quarter Rear View of Damage

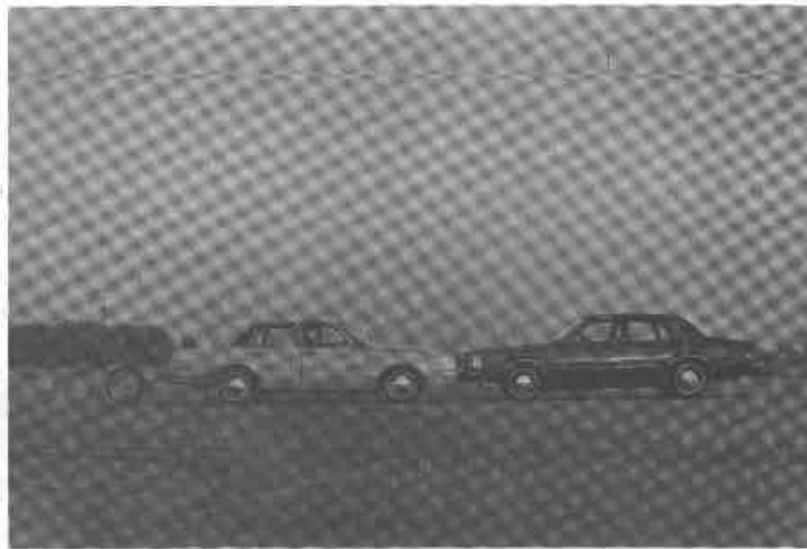
- Notes: (1) Run No. 3.
(2) Vehicle A struck by Vehicle B.
(3) Actual impact speed - 10.1 mph.
(4) Apparent damage - none to either vehicle.

FIGURE A-3. 10-MPH FRONT-TO-FRONT COLLISION AT INSTANT OF IMPACT: STOCK FRONT BUMPERS

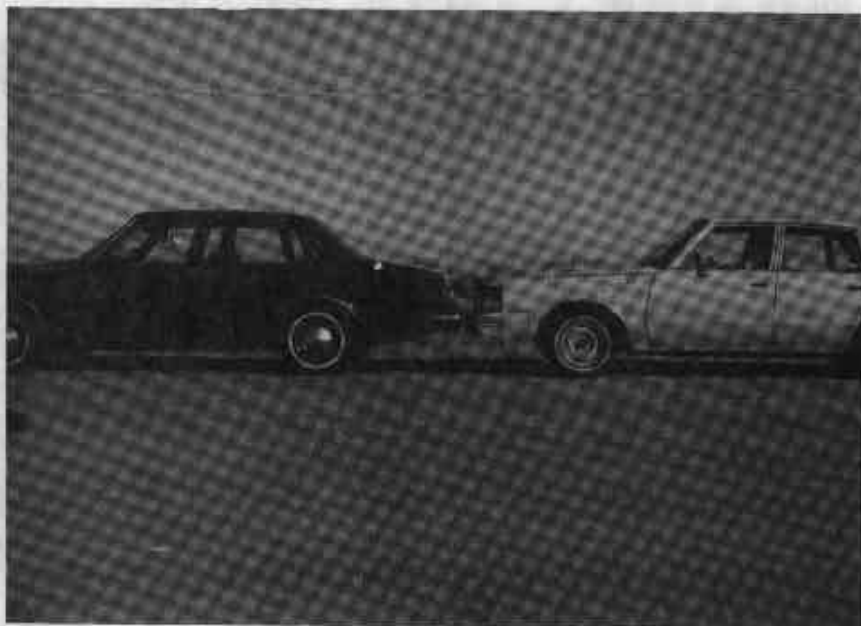
- Notes: (1) Run No. 4.
(2) Vehicle A struck by Vehicle B.
(3) Actual impact speed - 5.3 mph.
(4) Apparent damage - none to either vehicle.

FIGURE A-4. 5-MPH FRONT-TO-REAR COLLISION; PRETEST
ALIGNMENT: MODIFIED FRONT BUMPER

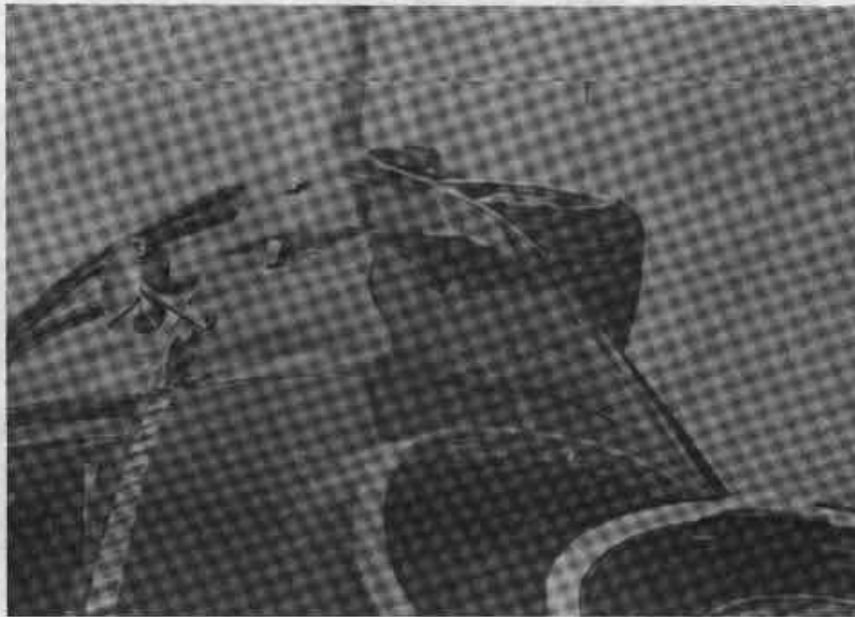
FIGURE A-5. (Continued)

(a) Overhead View of Pretest Alignment

(b) End View of Pretest Alignment

- Notes:
- (1) Run No. 5.
 - (2) Vehicle A struck by Vehicle B.
 - (3) Actual impact speed - 5.3 mph.
 - (4) Apparent damage - none to Vehicle B.

(c) End View of Damage

(d) Side View of Damage

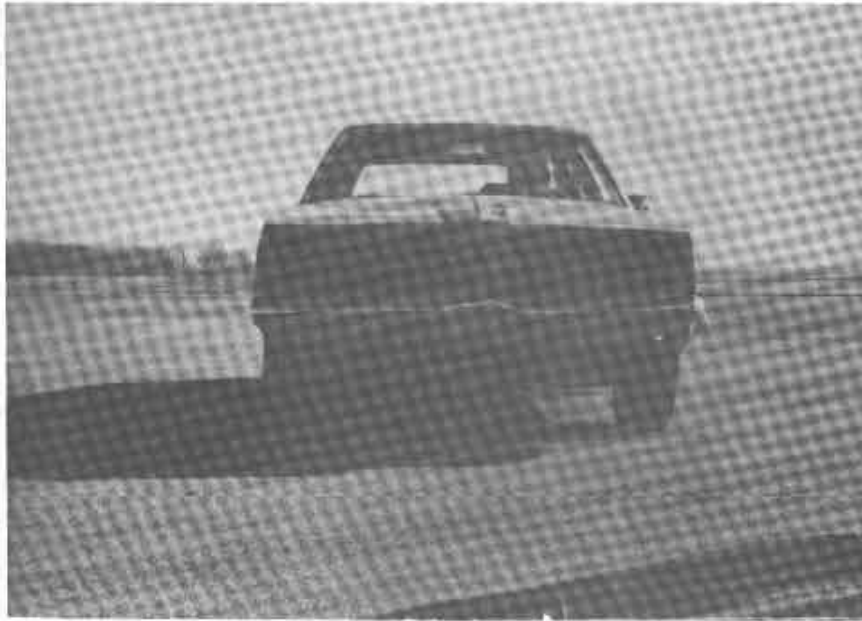
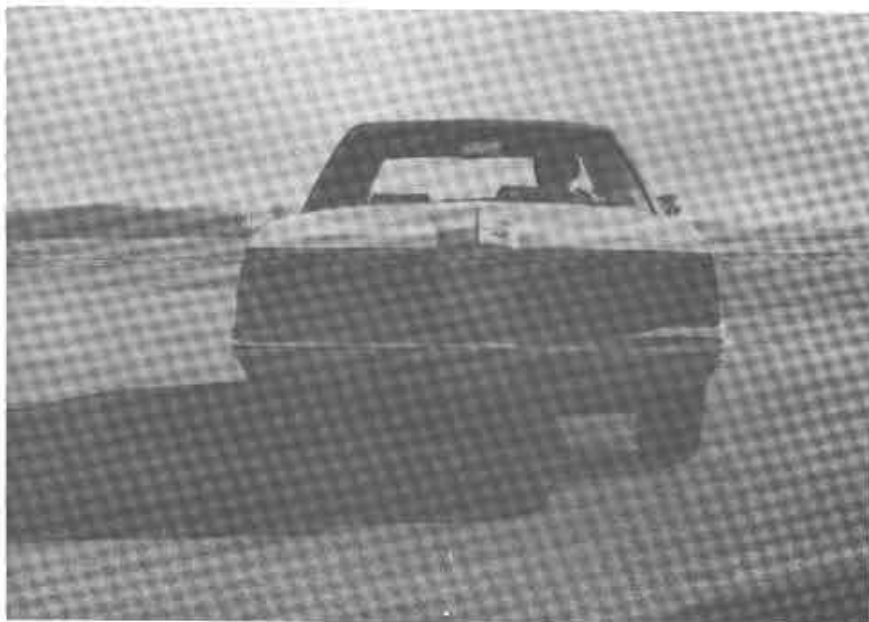
- Notes: (1) Run No. 6.
(2) Vehicle A struck by Vehicle B.
(3) Actual impact speed - 10.1 mph.
(4) Apparent damage - none to Vehicle A.

(a) Pretest Alignment

FIGURE A-6. 10-MPH FRONT-TO-FRONT COLLISION; STOCK (LEFT) VS. MODIFIED (RIGHT) BUMPERS

(b) Fascia (and Foam EA) Deformation

(c) Fascia (and Foam EA) Contours Restored; No Permanent Damage
