NEW VEHICLE ASSESSMENT AND  
STANDARDS ENFORCEMENT INDICANT  
TESTING

FMVSS 212, 219, AND 301-75

GENERAL MOTORS CORPORATION  
1980 OLDSMOBILE CUTLASS

NHTSA NO. 800132

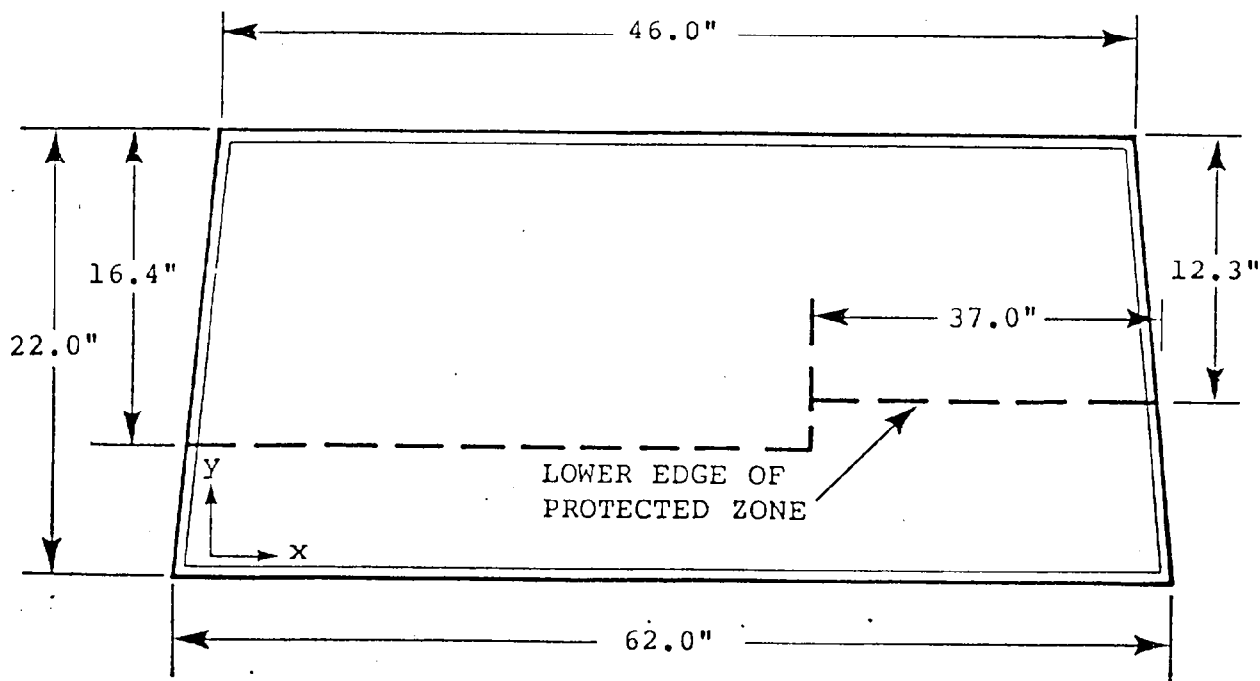
FRONT VIEW OF WINDSHIELD

With the zero coordinate for the X-Y grid located at the lower right corner (passenger side) of the windshield, record the following positions:

- C. Record any windshield retention clips or brackets used to ensure that the windshield would not disengage from the body.  
 A 3.5-inch wide metal molding is secured across the bottom windshield edge by three bolts and two windshield wiper rests.

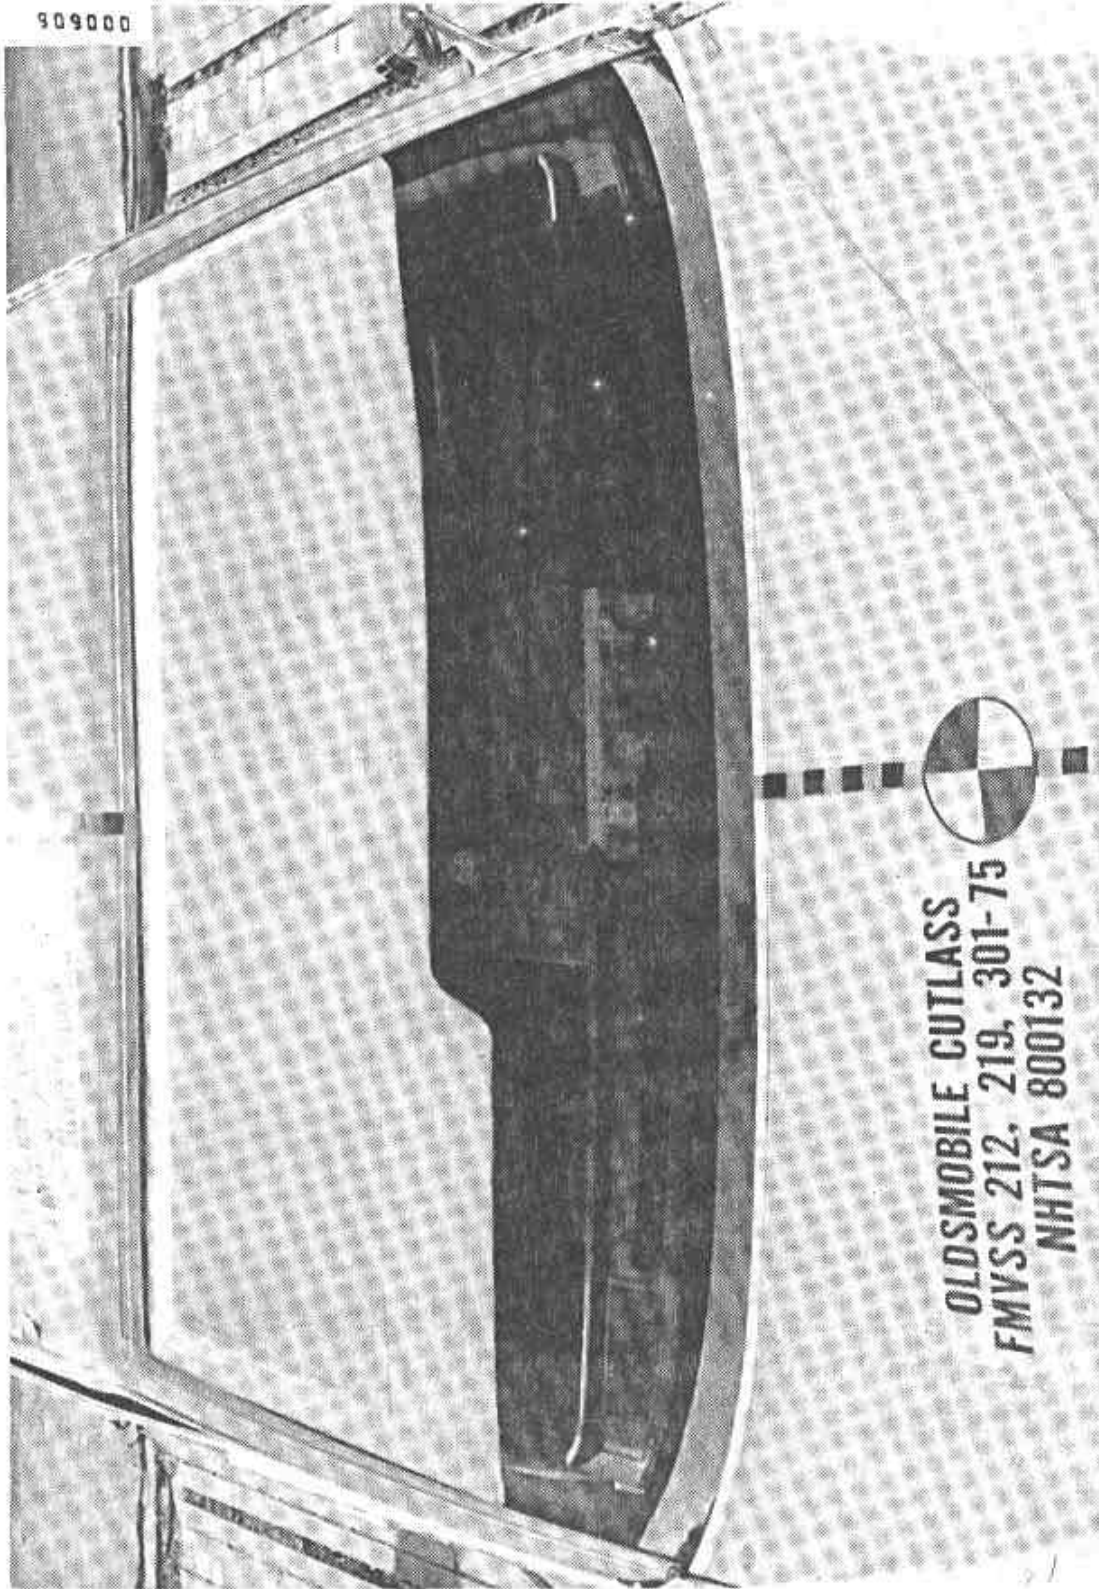
FIGURE 3-1. PRE-TEST WINDSHIELD - OVERALL VIEW - 1980 OLDSMOBILE CUTLASS - NHTSA 800132.

Details of windshield mounting (method of retention, type of trim, etc.): The windshield is held in place on the top, left, and right sides by a one-inch wide black mastic, and is overlaid on these sides by a one-inch wide rubber-lined metal molding. The bottom edge is held by a black mastic at least one inch wide and is overlaid with a 3.5-inch wide metal molding which is secured to the vehicle by three bolts and two windshield wiper rests. This strip interlocks with the side moldings.

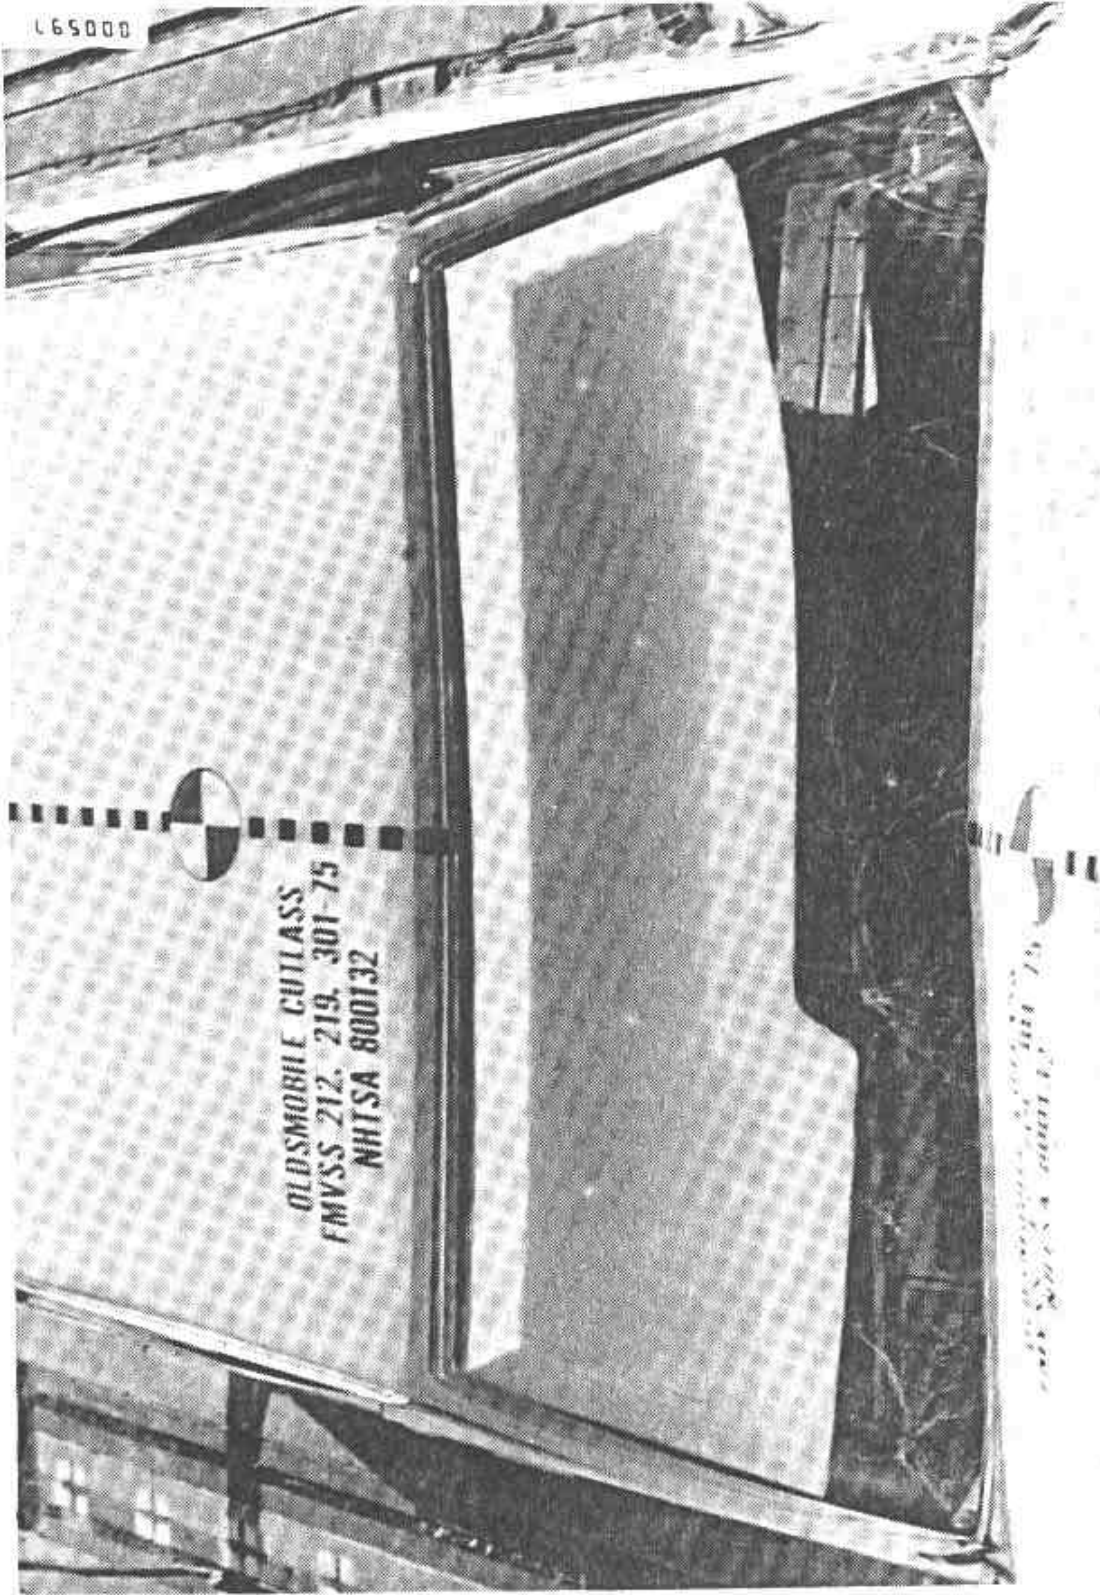
FIGURE 3-2. POST-TEST WINDSHIELD - OVERALL VIEW - 1980 OLDSMOBILE CUTLASS - NHTSA 800132.

<u>WINDSHIELD PERIPHERY</u>	
	<u>Pre-test</u>	<u>Post-test</u>
<u>RIGHT SIDE</u>	76.0	76.0
<u>LEFT SIDE</u>	76.0	76.0
<u>***TOTAL***</u>	152.0	152.0

AREA OF RETENTION FAILURE (as noted): None.

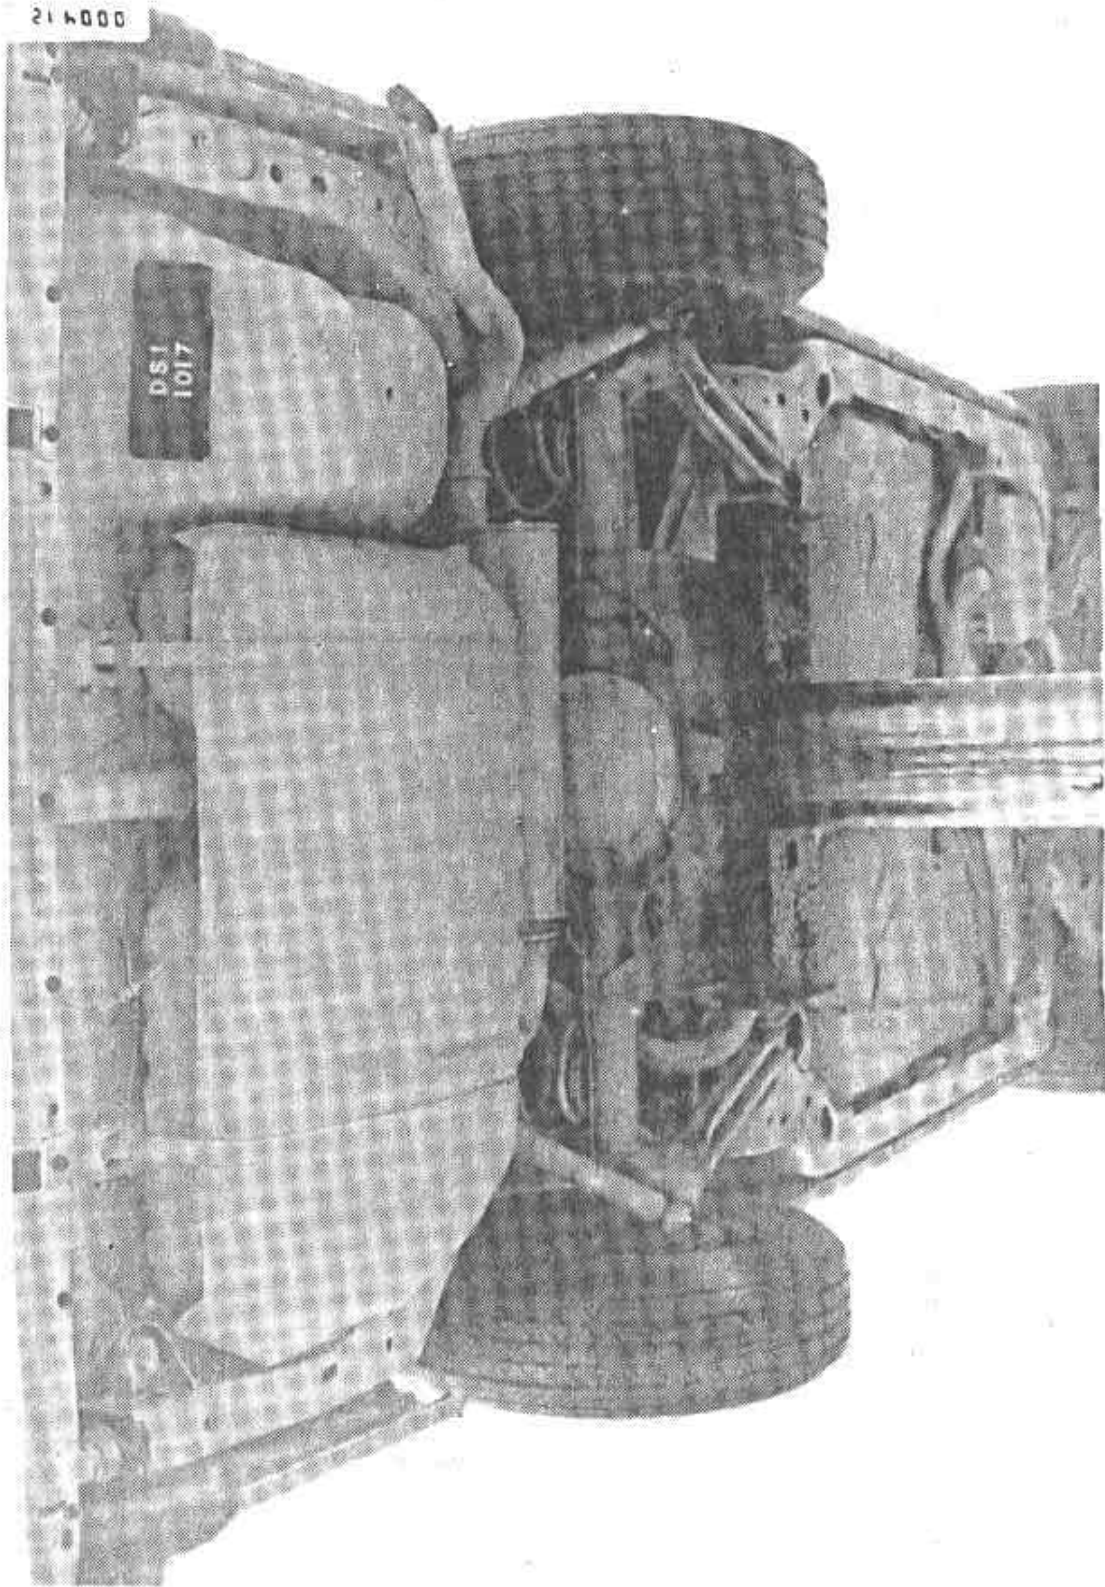
FIGURE 3-3. PRE-TEST VIEW OF FUEL TANK - 1980 OLDSMOBILE CUTLASS - NHTSA 800132.

Details of Fuel Tank, Filler Pipes, and Connections: The rectangular metal fuel tank is attached to trunk floor by two metal straps. The sender tubes exit front center of tank and proceed forward along floorpan to engine. The fuel filler tube and cap are located behind the fold-down license plate. The cap has an extended threaded area on one end which is designed to release any remaining fuel tank pressure while the cap is being removed.

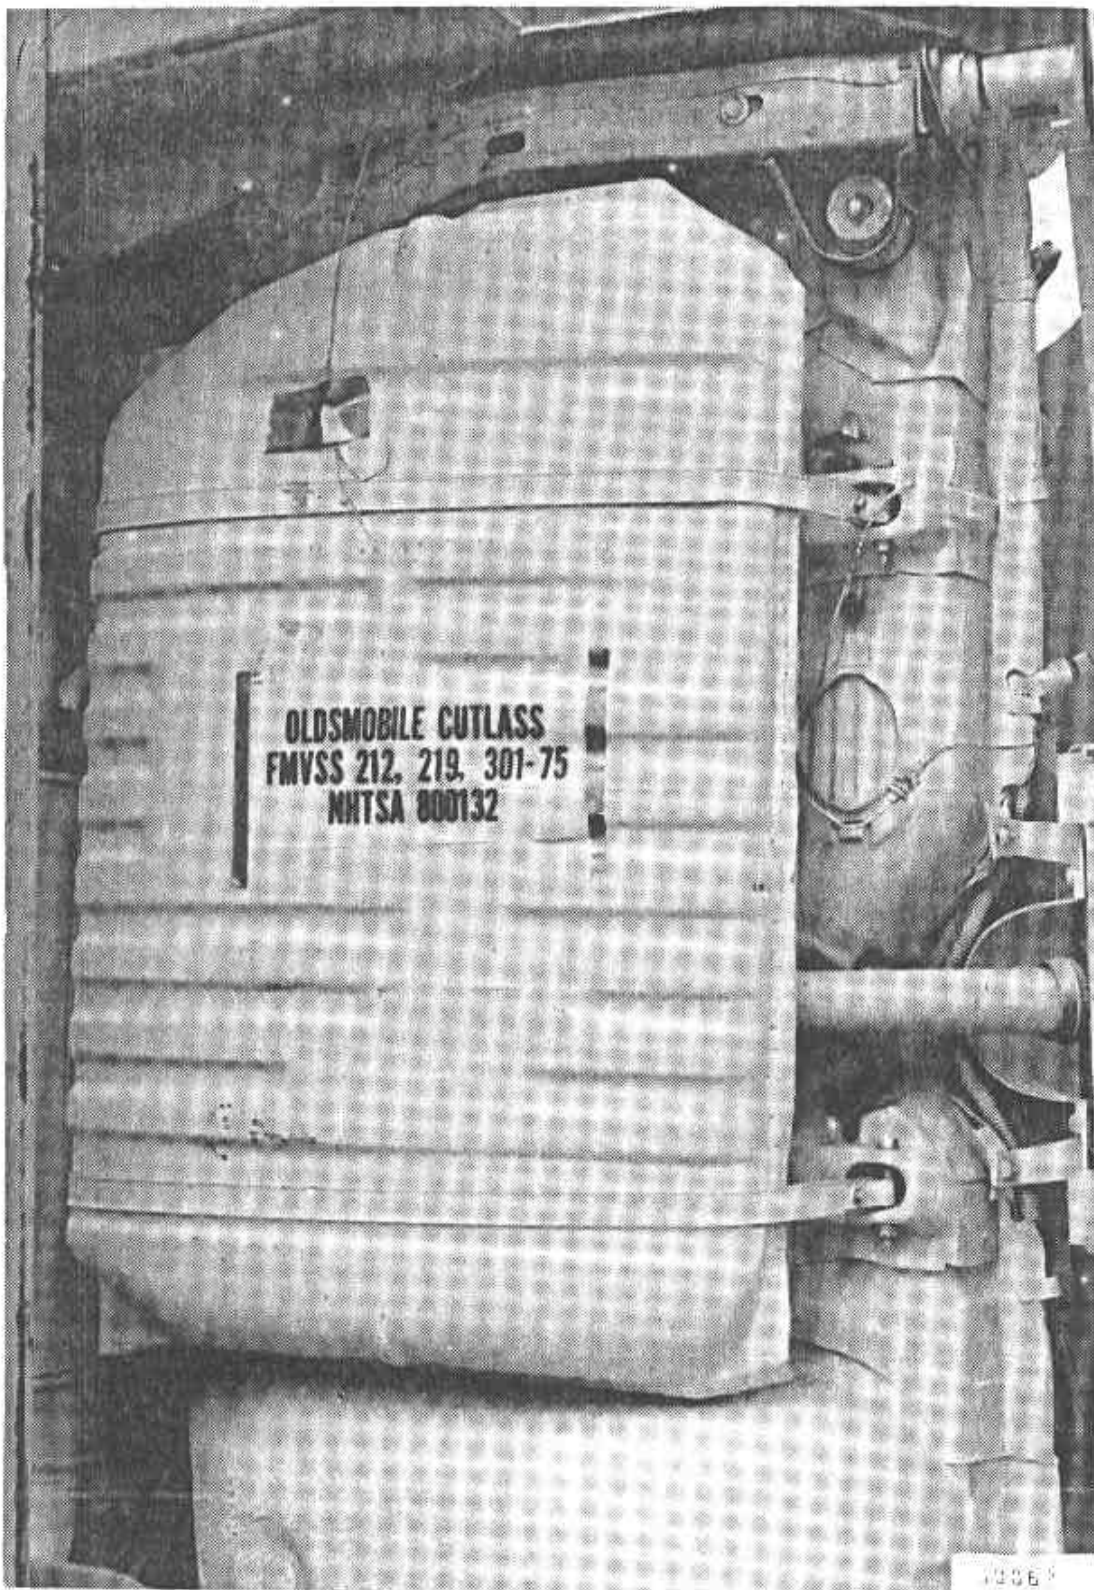
FIGURE 3-4. POST-TEST VIEW OF FUEL TANK - 1980 OLDSMOBILE CUTLASS - NHTSA 800132.  
3-14

B. SOLVENT SPILLAGE DETAILS: None.

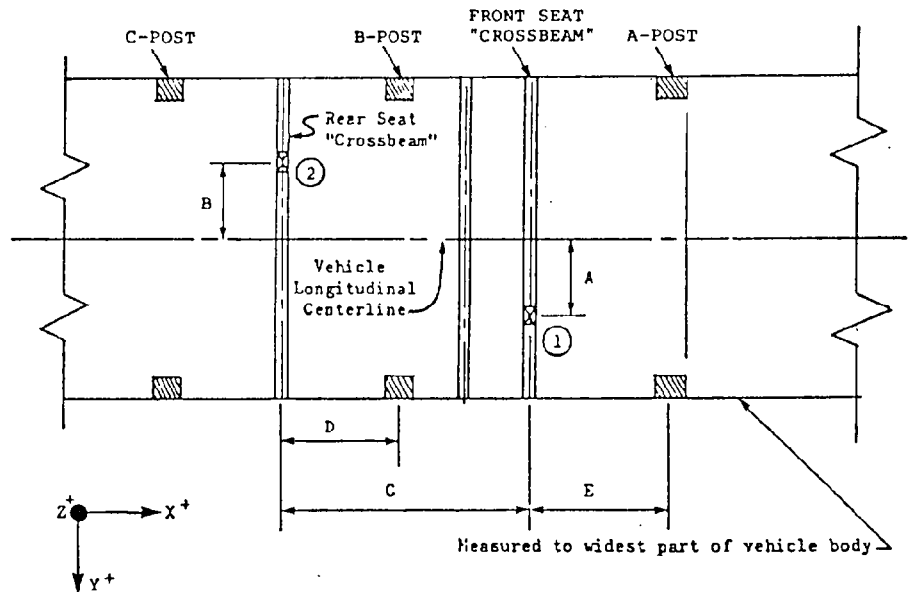
TEST VEHICLE ACCELEROMETER LOCATION DEFINITION AND DATA SUMMARY

Dim.	Length (in.)
A	14.0
B	14.0
C	35.5
D	9.0
E	19.0

No.	Location Description	Component Direction			Data Summary					
					Peak G @ msec					
		X	Y	Z	X		Y		Z	
			"+"	"-"	"+"	"-"	"+"	"-"	"+"	"-"
1	Front Seat "Crossbeam"	✓	✓	✓	4.1 @ 156	39.0 @ 76	25.3 @ 66	21.0 @ 61	29.9 @ 64	25.0 @ 36
2	Rear Seat "Crossbeam"	✓		✓	7.7 @ 156	59.9 @ 78	@	@	21.6 @ 71	24.4 @ 39

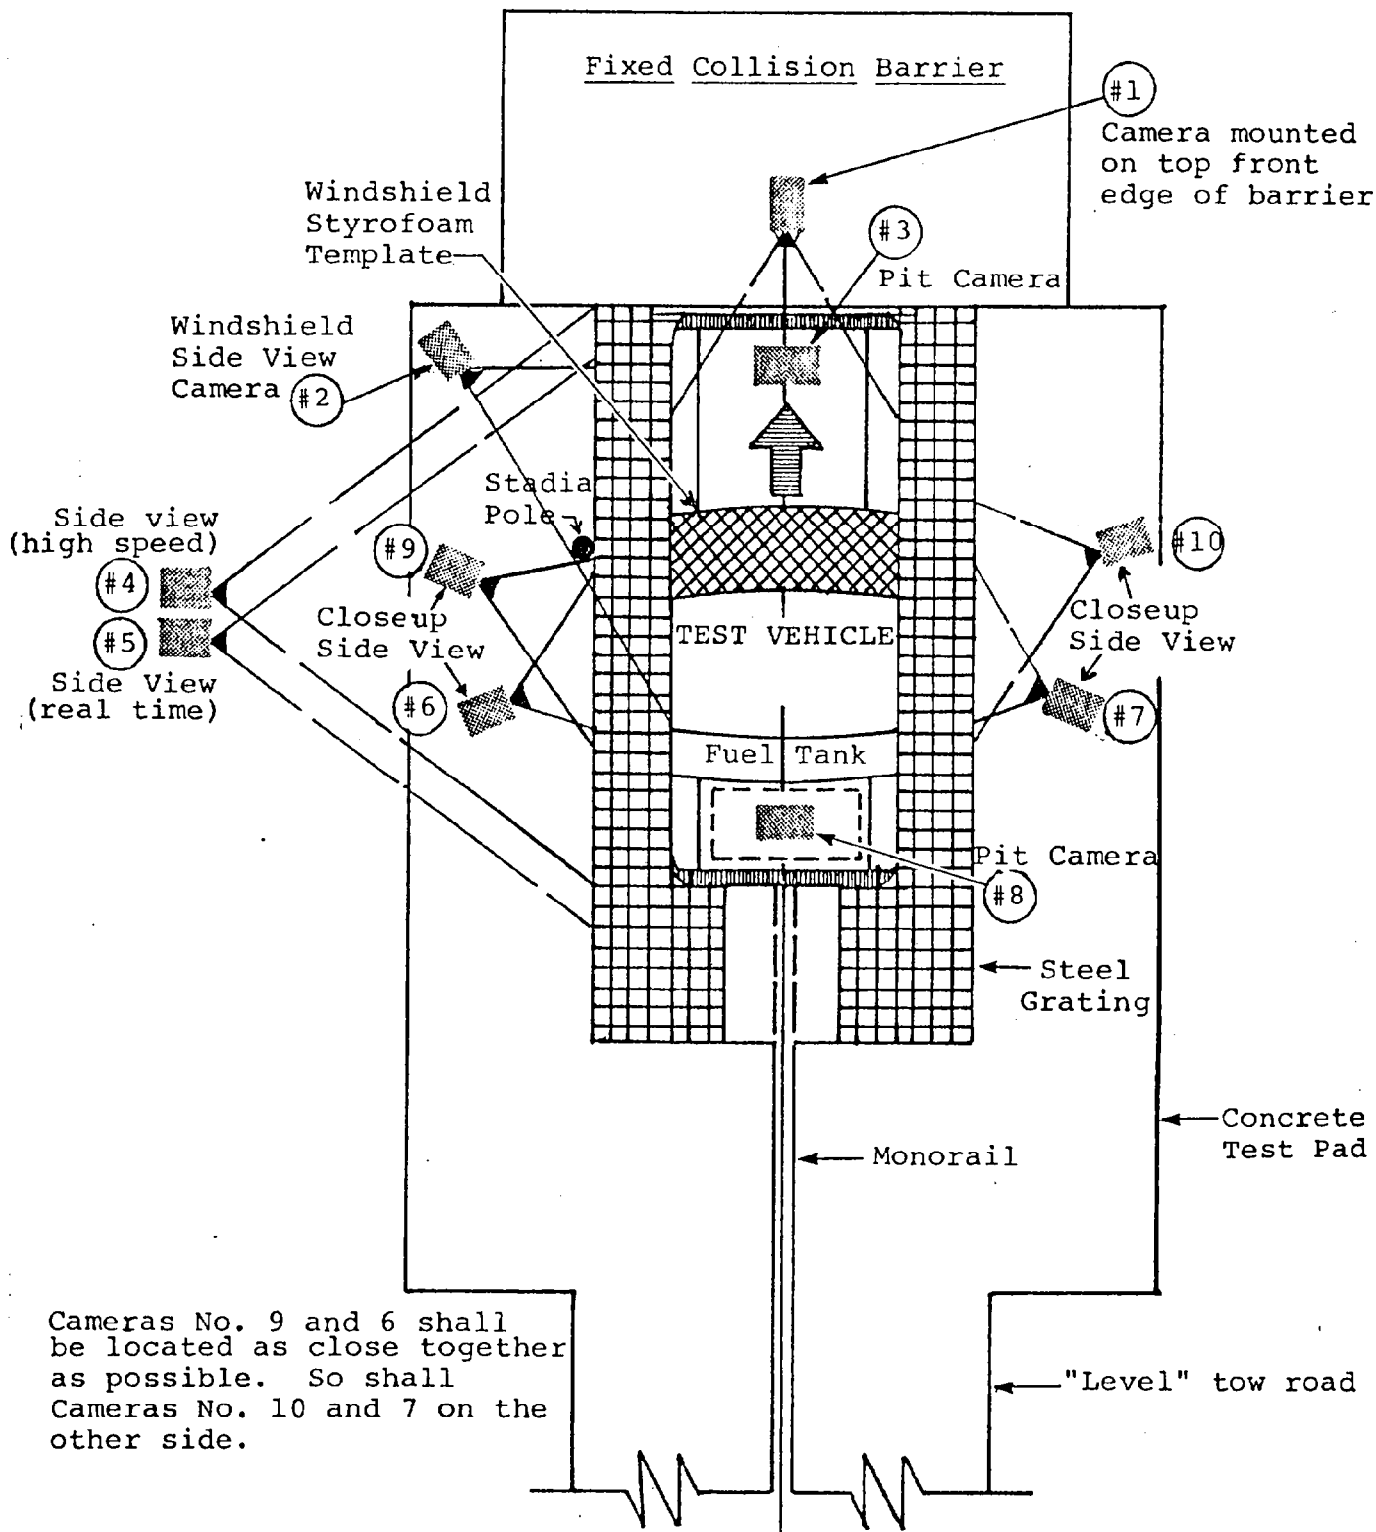
Cameras No. 9 and 6 shall be located as close together as possible. So shall Cameras No. 10 and 7 on the other side.

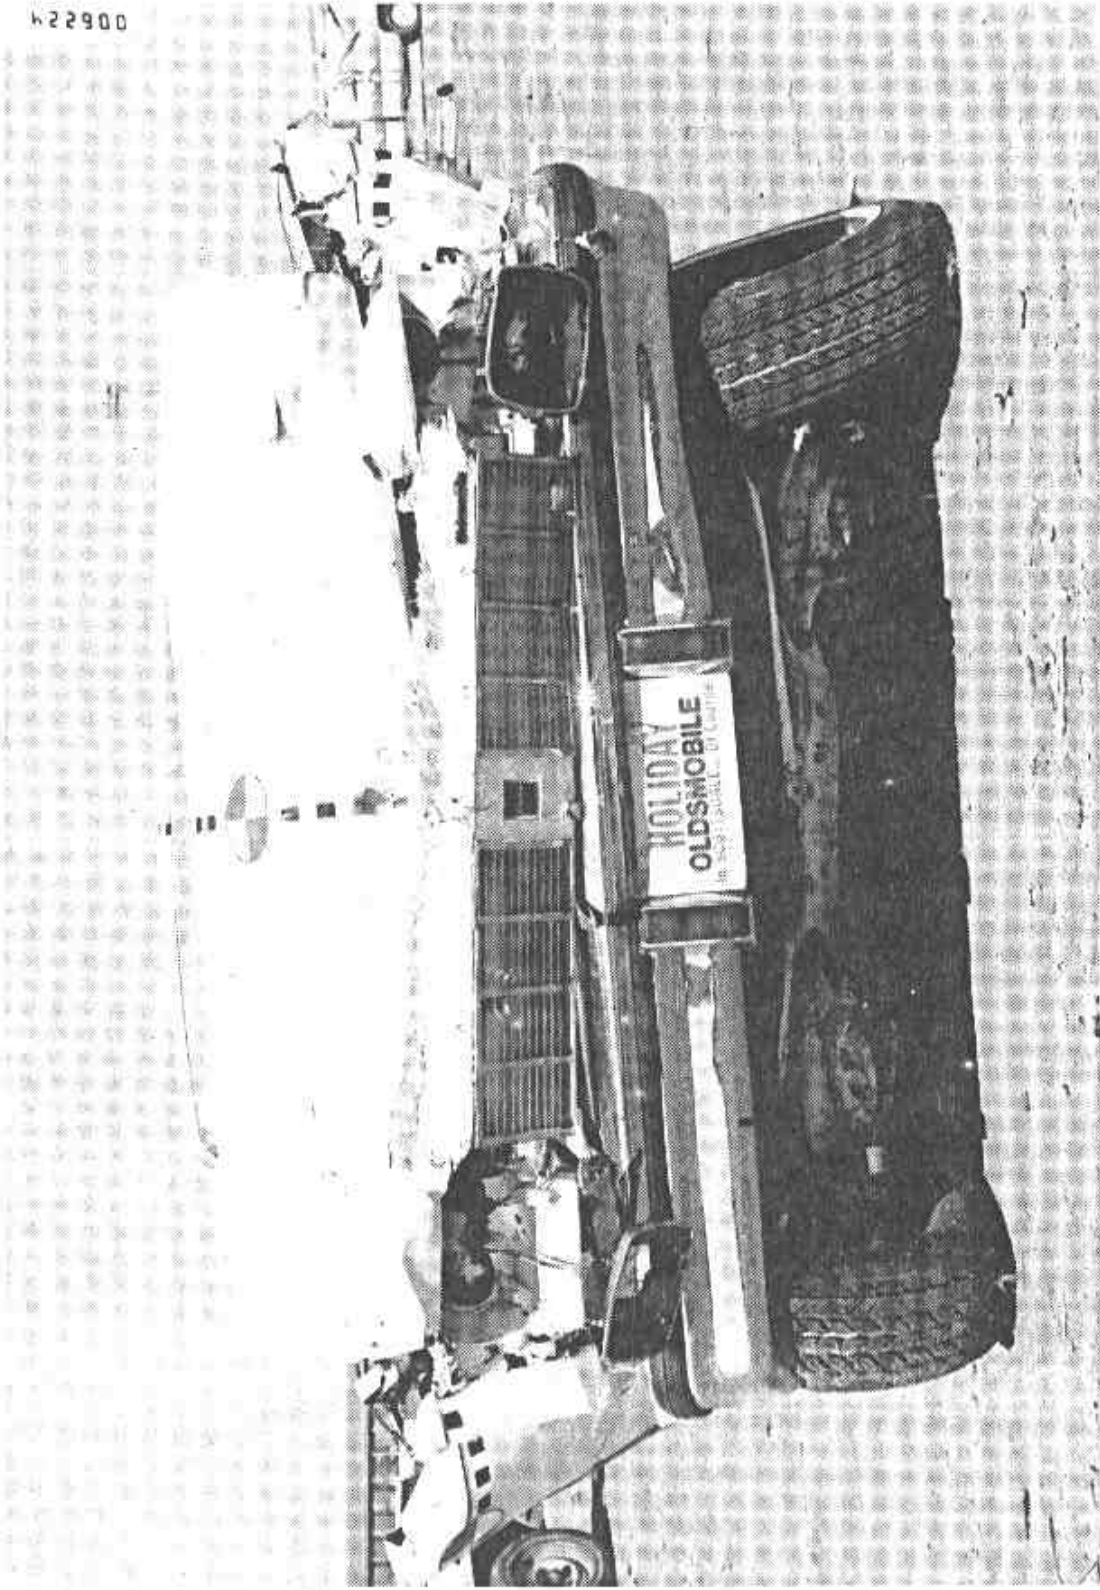
FIGURE A-2. POST-TEST FRONT VIEW - 1980 OLDSMOBILE CUTLASS - NHTSA 800132.

Crush Details:  Both front wheels were pinned by crushed sheet metal.

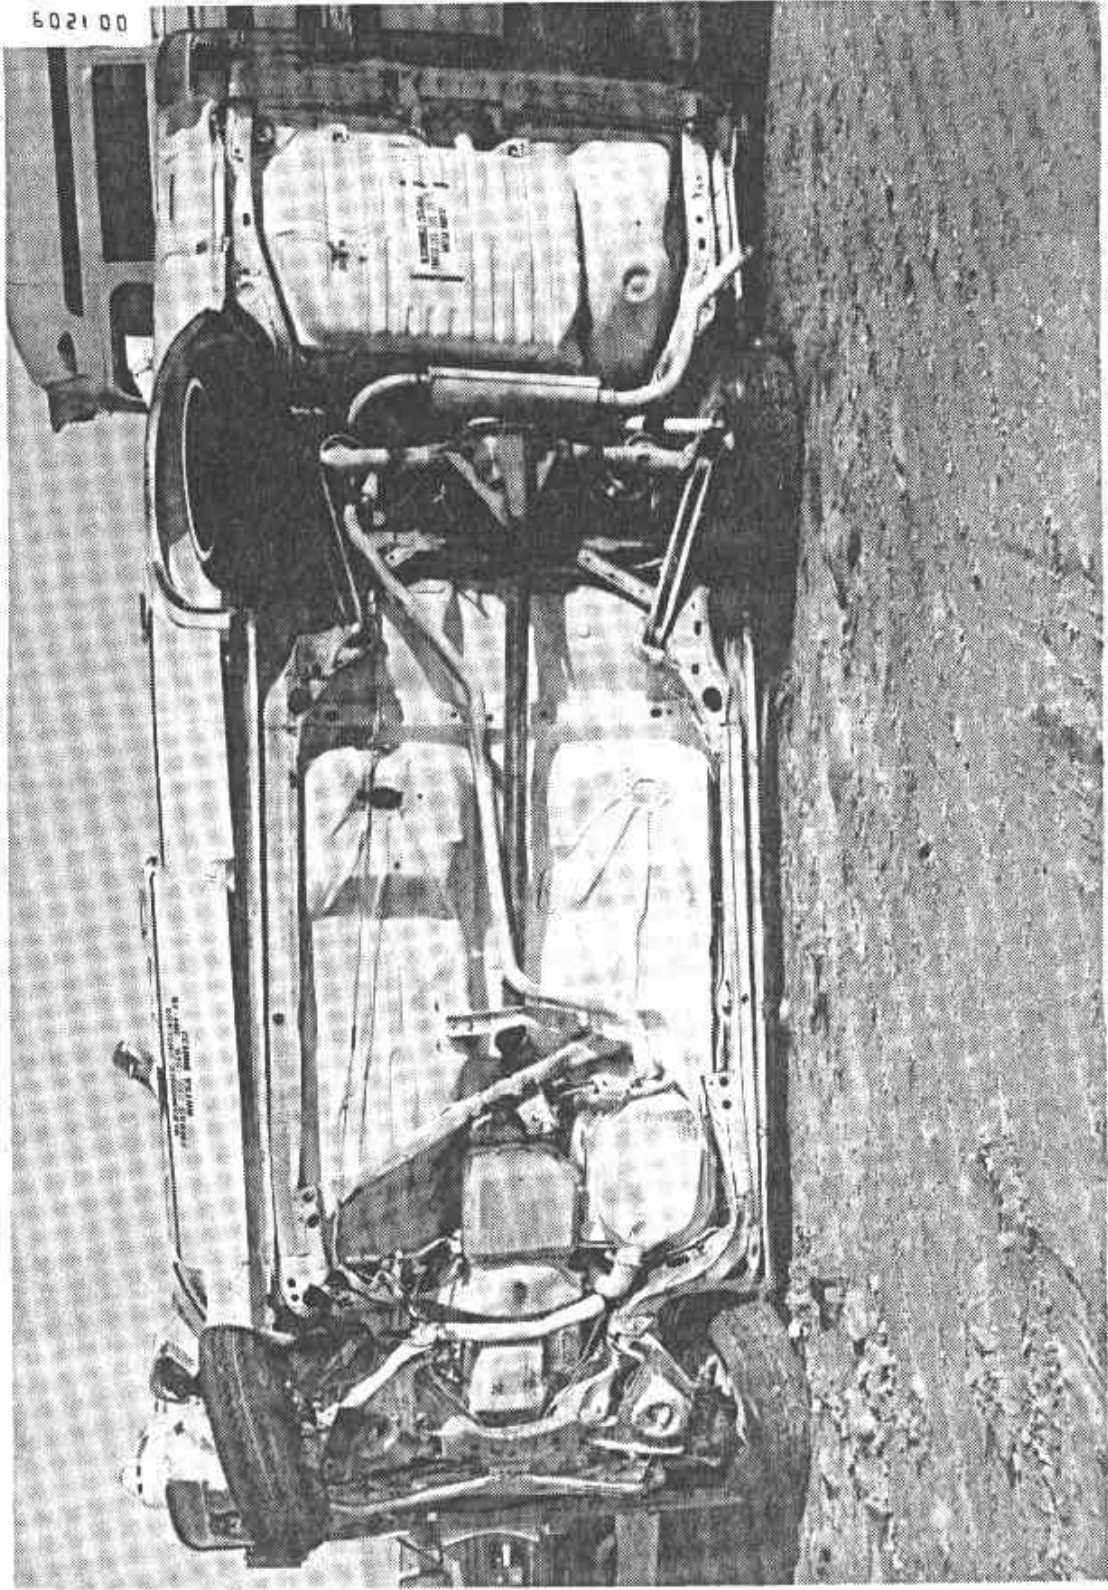
FIGURE A-3. POST-TEST OVERALL UNDERSIDE VIEW - 1980 OLDSMOBILE CUTLASS - NHTSA 800132.

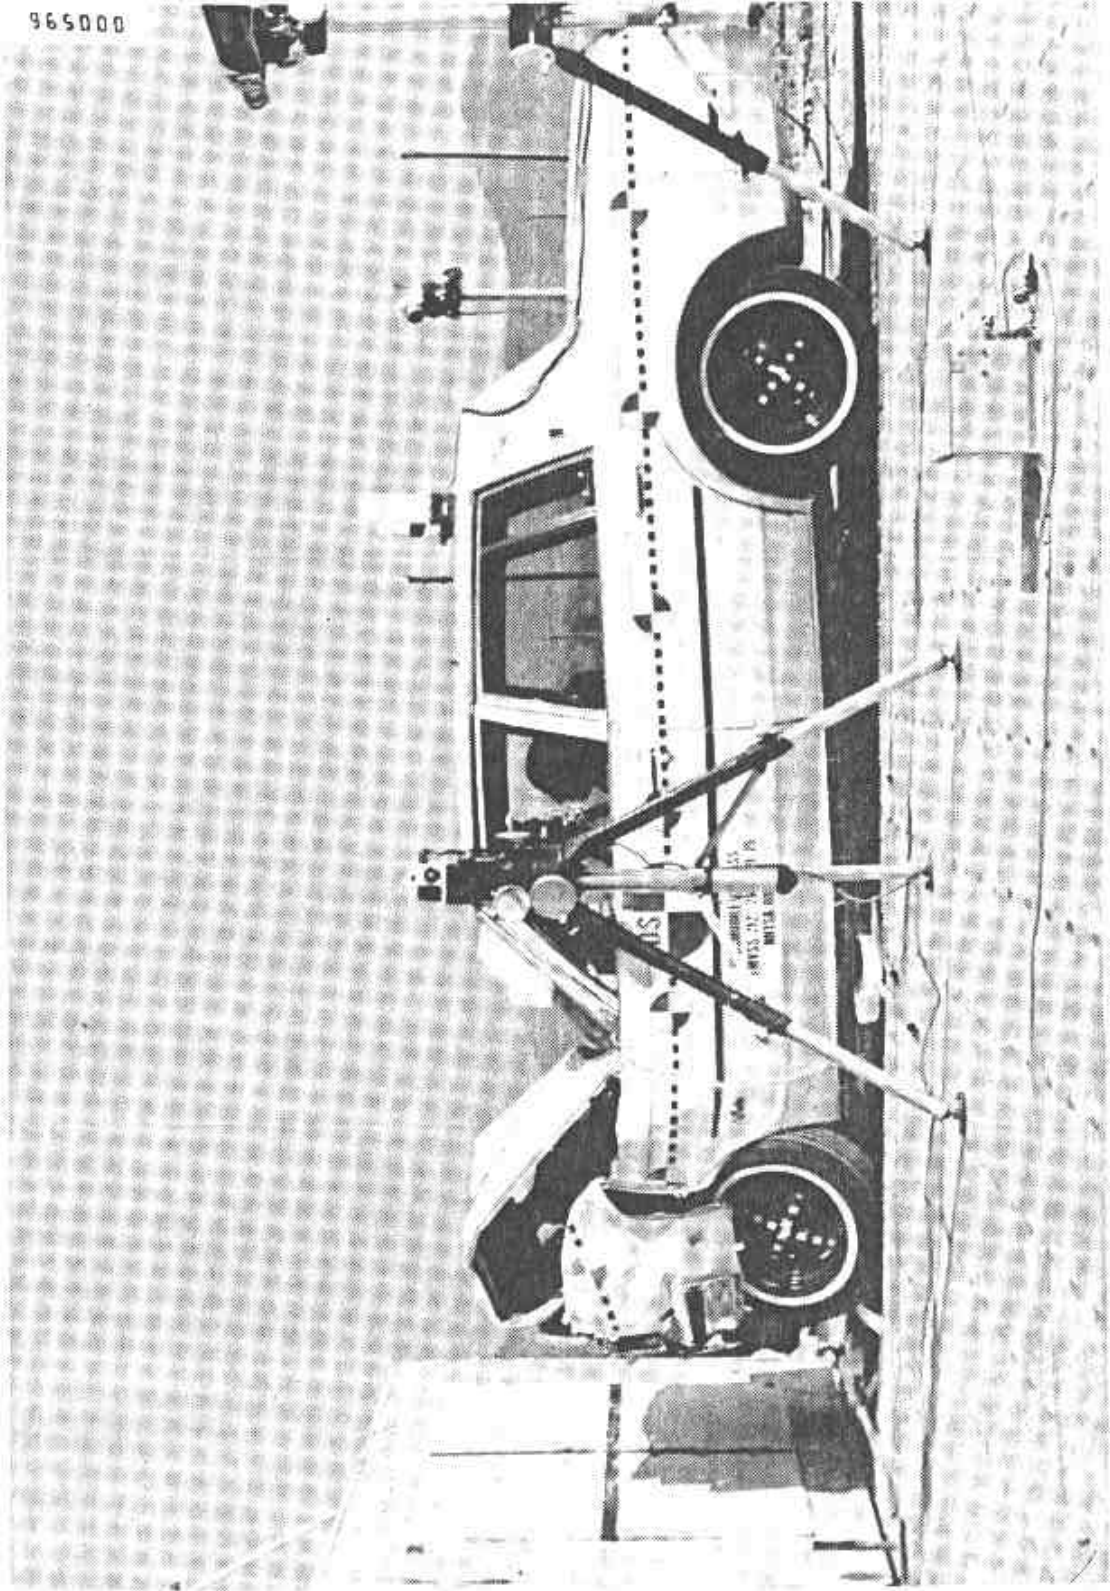
FIGURE A-5. POST-TEST SIDE VIEW - 1980 OLDSMOBILE CUTLASS - NHTSA 800132.

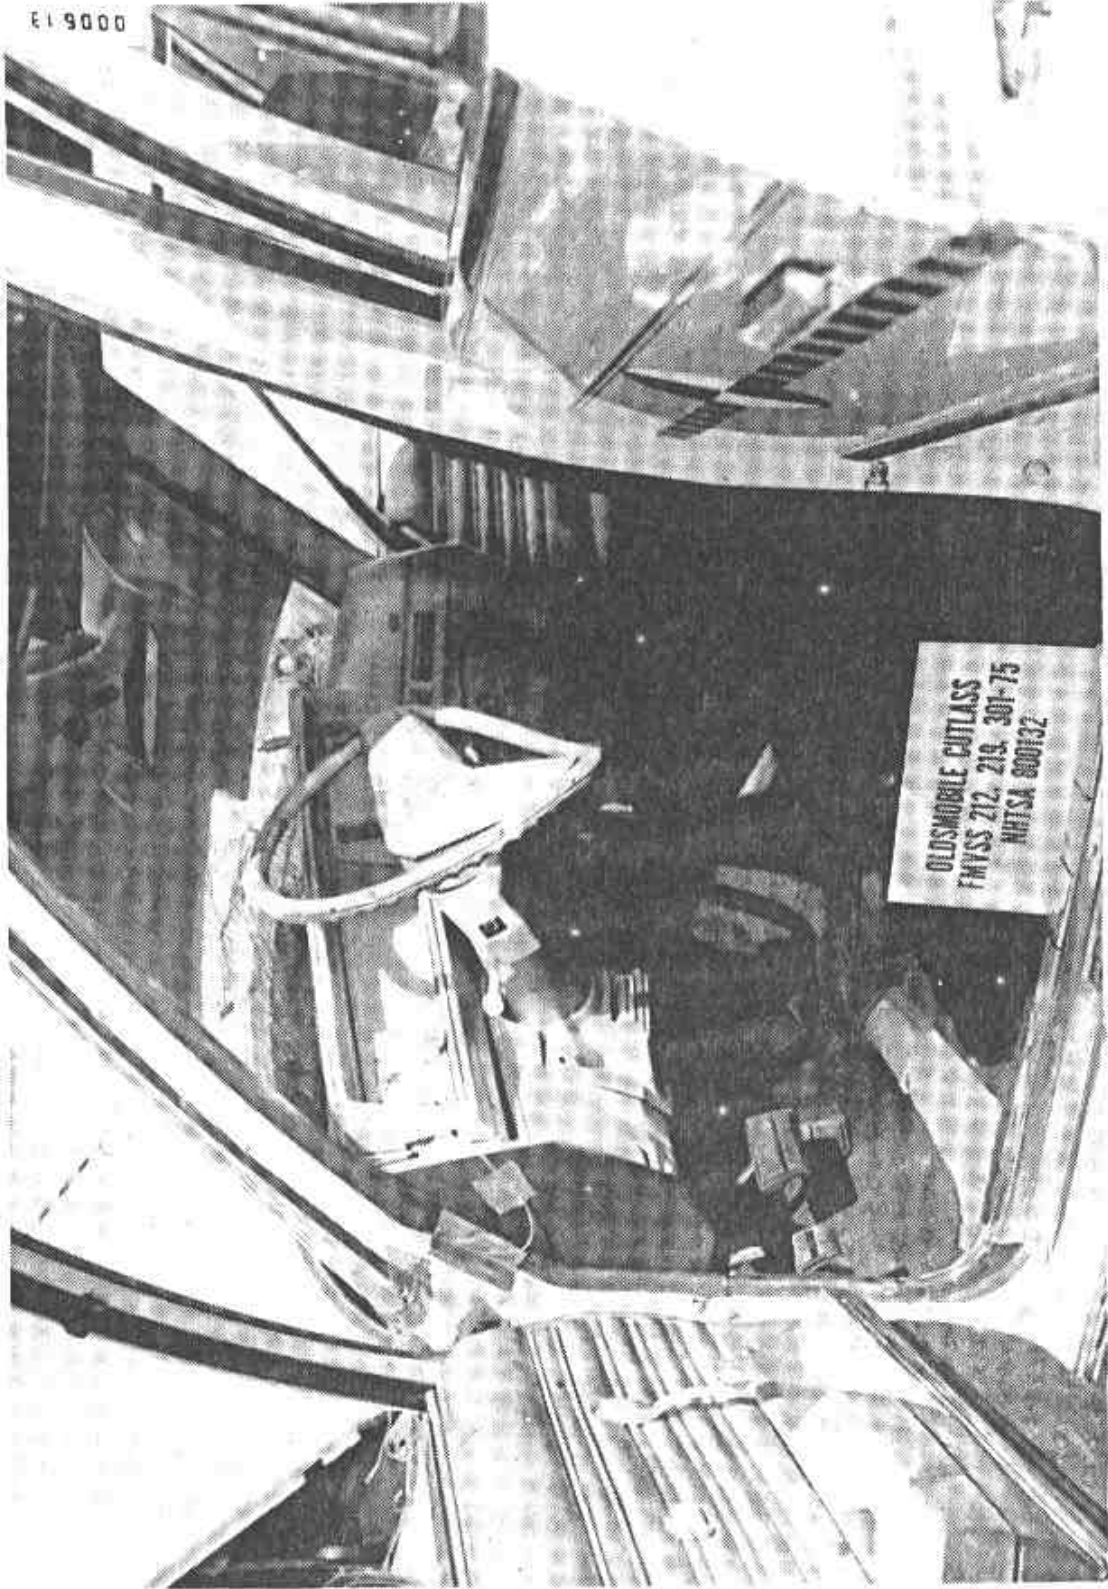
FIGURE A-8. POST-TEST DRIVER COMPARTMENT - 1980 OLDSMOBILE CUTLASS - NHTSA 800132.

<u>Driver</u>		<u>Passenger</u>	
Head	<u>Steering Wheel Rim</u>		<u>Left Knee</u>	
	<u>and Hub</u>			
Chest	<u>Lower Steering Wheel</u>		<u>None</u>	
	<u>Rim</u>			
Abdomen	<u>Lower Steering Wheel</u>		<u>None</u>	
	<u>Rim</u>			
Left Knee	<u>Dash</u>		<u>Dash</u>	
Right Knee	<u>Dash</u>		<u>Dash</u>	
	<u>Front</u>		<u>Rear</u>	
<u>DOOR OPENING</u>	<u>Left</u>	<u>Right</u>	<u>Left</u>	<u>Right</u>
Easy				
Difficult		X	X	X
Tools Required	X			
<u>SEAT BACK</u>				
Failure	<u>No</u>	<u>No</u>		
<u>GLAZING DAMAGE</u>				
Windshield	<u>Cracked</u>			
Backlight	<u>None</u>			
Others	<u>None</u>	<u>None</u>	<u>None</u>	<u>None</u>
<u>OTHER NOTABLE IMPACT EFFECTS: Both front wheels pinned by crushed sheet metal. No windshield intrusion or loss of retention.</u>
