REPORT NO. 301-AETL-79-086-671-1489-86

NEW VEHICLE ASSESSMENT AND STANDARDS  
ENFORCEMENT INDICANT TESTING  
OF  
FMVSS 301-75  
FUEL SYSTEM INTEGRITY

MITSUBISHI MOTORS CORPORATION  
1979 DODGE COLT - 2 DOOR HATCHBACK  
NHTSA 790532

FINAL REPORT

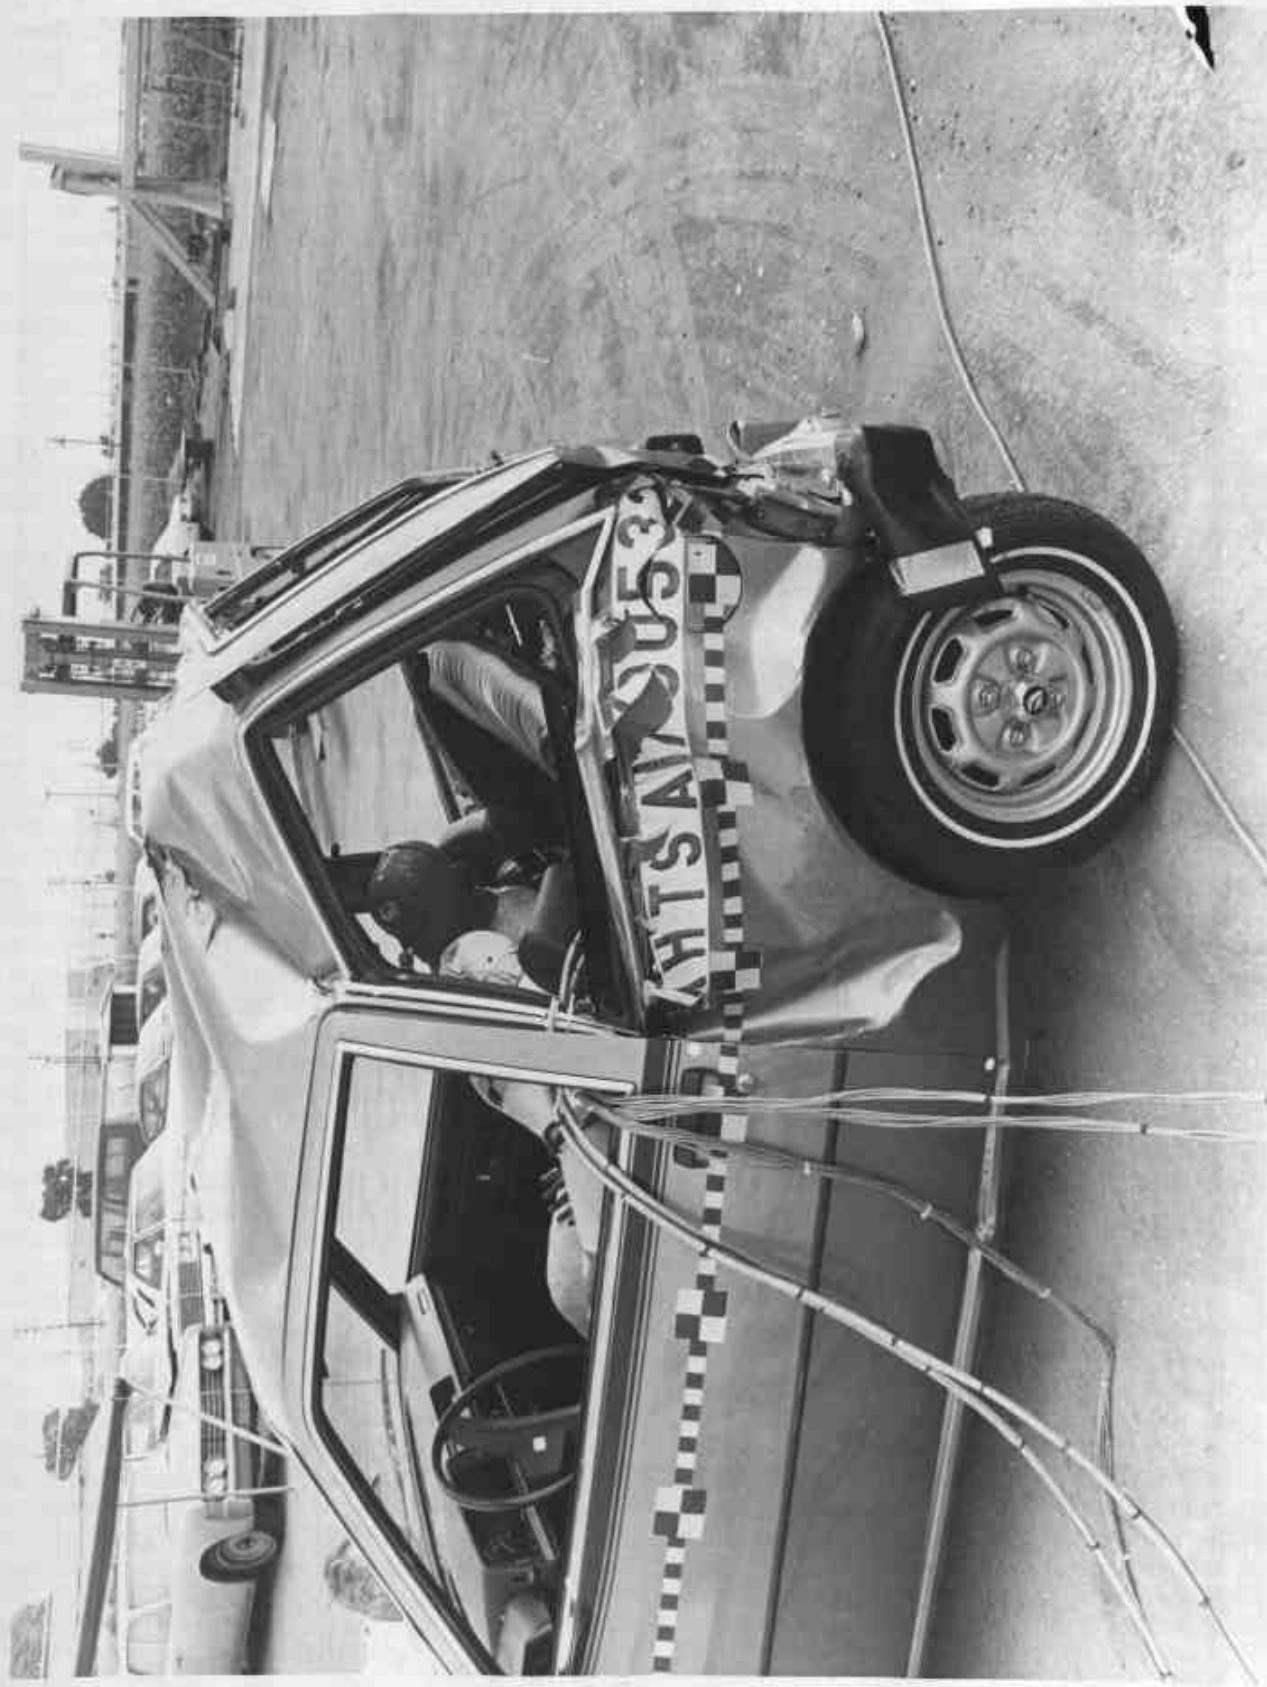
Post-Impact, Left Side View

Post-impact inspection of the test vehicle revealed almost all crush occurred rearward of the front doors. The hatchback window and both rear quarter windows shattered. The windshield was cracked. The roof buckled upward and both "B" posts deformed inward. The body pan buckled under both "B" posts and both rear wheels were jammed. The spare tire well rotated upward and forward and the spare tire remained inflated. Both front seat
