REPORT NO. 301-AETL-80-001-971-3882-1

NEW VEHICLE ASSESSMENT  
AND  
STANDARDS ENFORCEMENT INDICANT TESTING

FMVSS 301-75

VOLKSWAGENWERK AG  
1980 VOLKSWAGEN RABBIT - 2 DOOR CONVERTIBLE  
NHTSA 800550

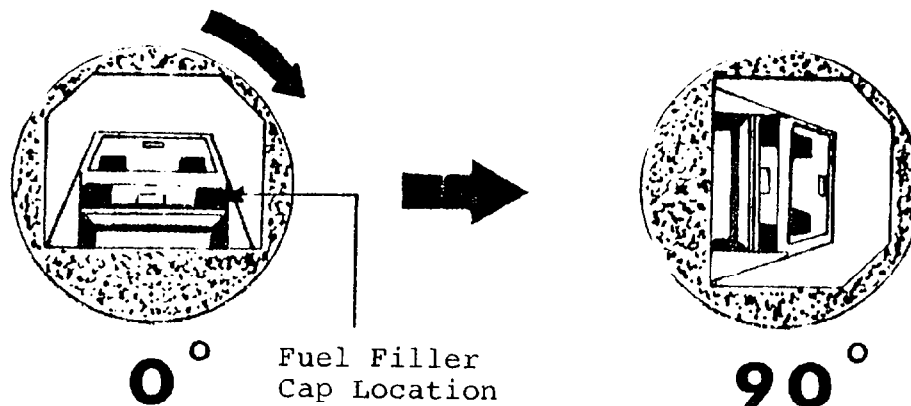
TABLE VII  
FUEL SYSTEM INTEGRITY - FMVSS 301-75  
STATIC ROLLOVER

| | Actual | Max. Allowed |
|---|---|---|
| Fuel spillage during 5 minute period from onset of rotation | 86.87 oz.<br>(17.37 oz./min.) | 5 ounces |
| Fuel spillage during 6th minute period from onset of rotation | 22.48 oz. | 1 ounce |
| Fuel spillage during 7th minute period from onset of rotation | 21.71 oz. | 1 ounce |

Fuel Spillage Location: Fuel filler cap area

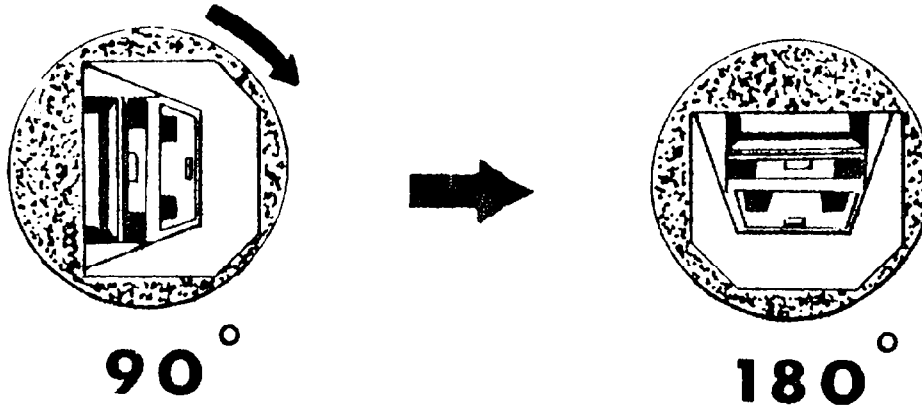
TABLE VIII

| | Actual | Max. Allowed |
|---|---|---|
| Fuel spillage during 5 minute period from onset of rotation | 31.81 oz.<br>(6.36 oz./min.) | 5 ounces |
| Fuel spillage during 6th minute period from onset of rotation | 1.17 oz. | 1 ounce |
| Fuel spillage during 7th minute period from onset of rotation | 1.15 oz. | 1 ounce |

Fuel Spillage Location: Fuel filler cap area

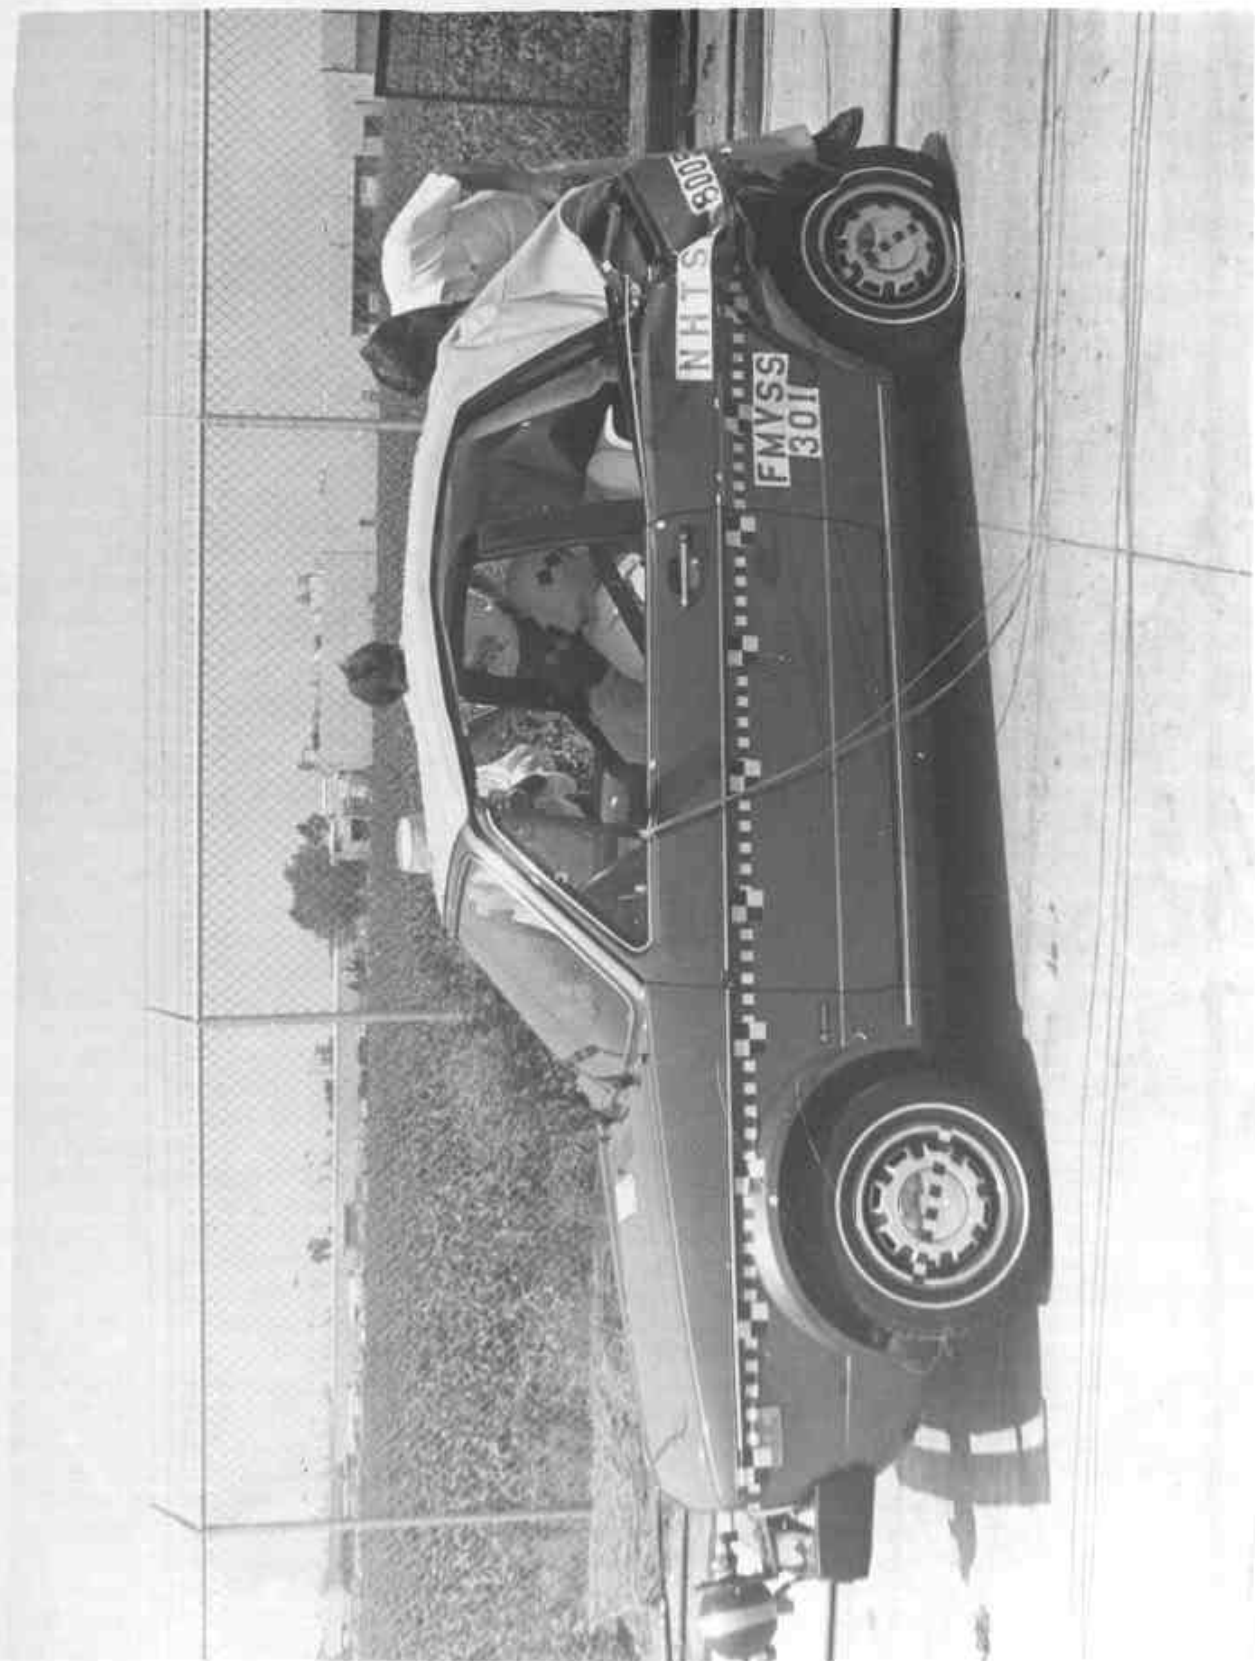
Figure 3-3  
1980 Volkswagen Rabbit - 2 Door Convertible  
NHTSA 800550  
Post-Impact, Left Side View

Crush Details: Rear window and both rear quarter windows shattered, both  
rear tires flat, roof buckled over left "B" post, both dummies hit rear  
seat back.

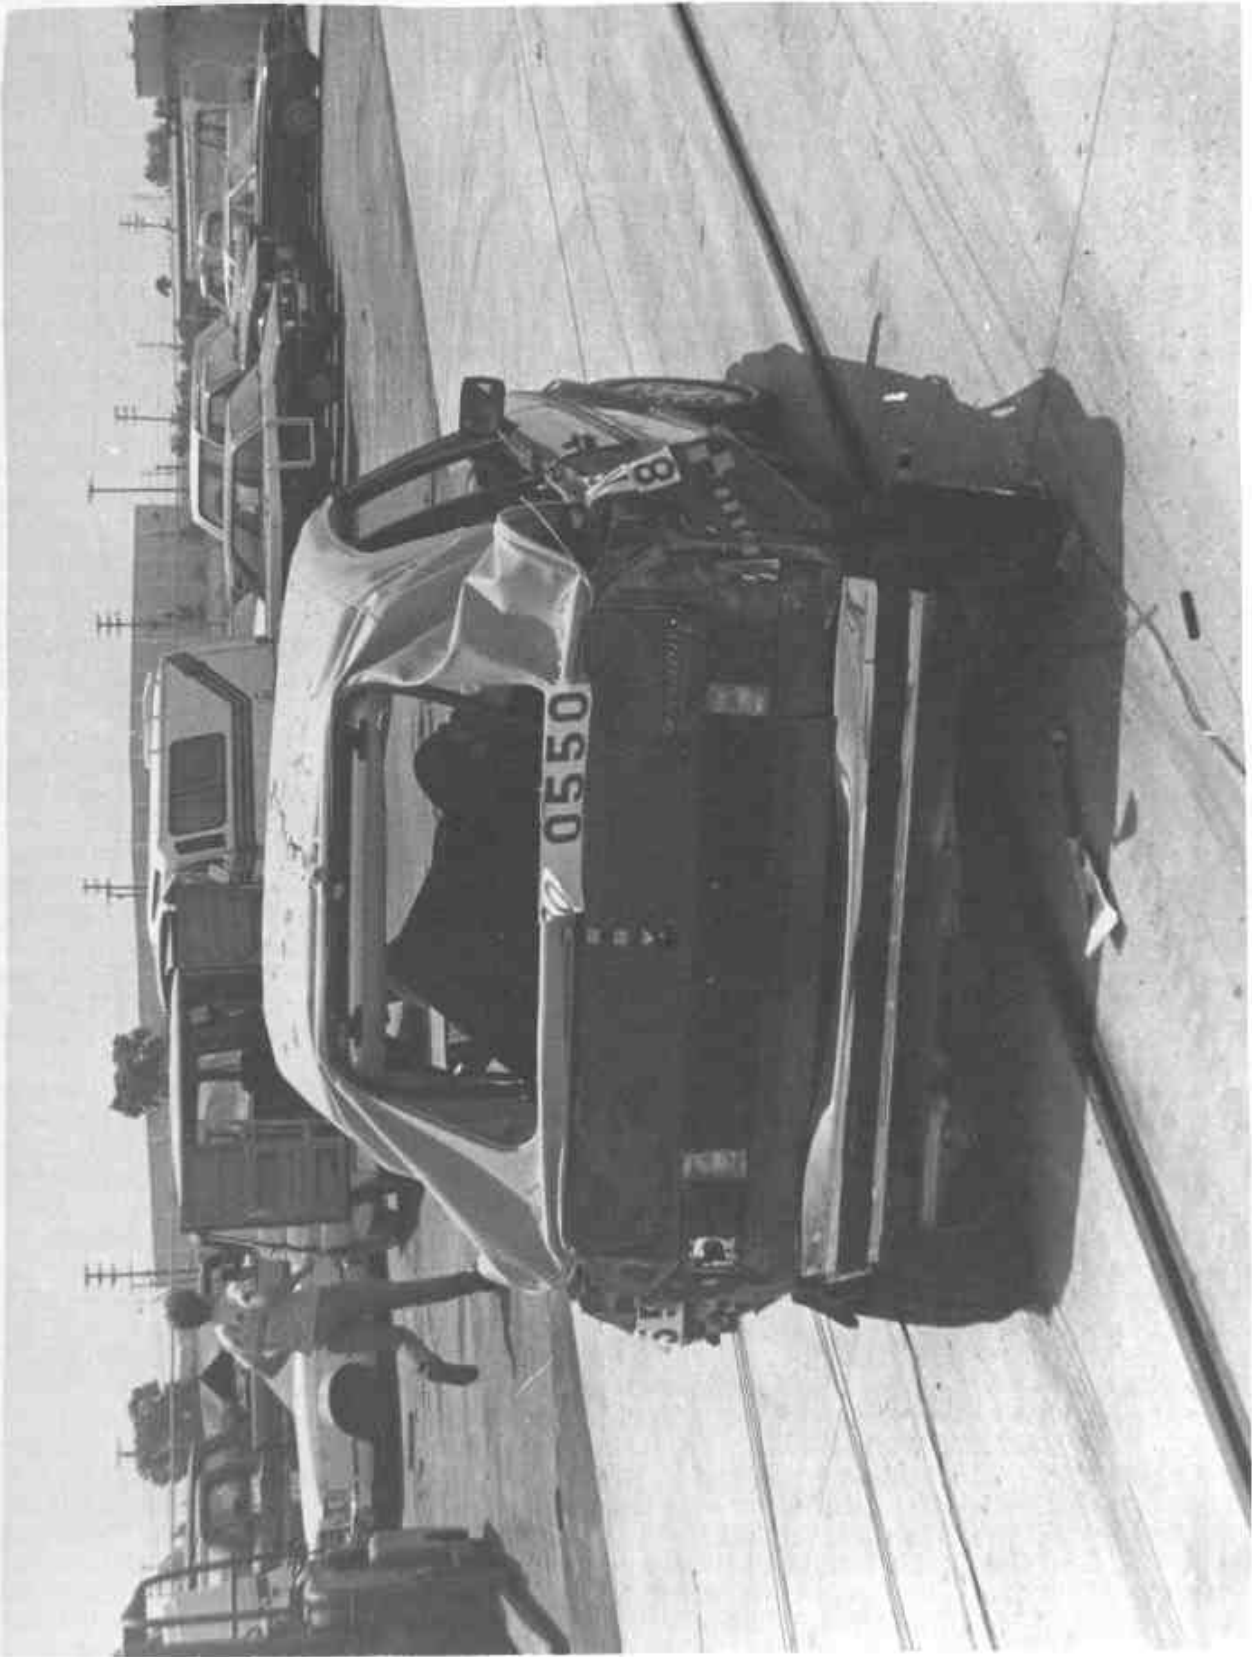
Figure 3-4

Post-Impact, Full Rear View

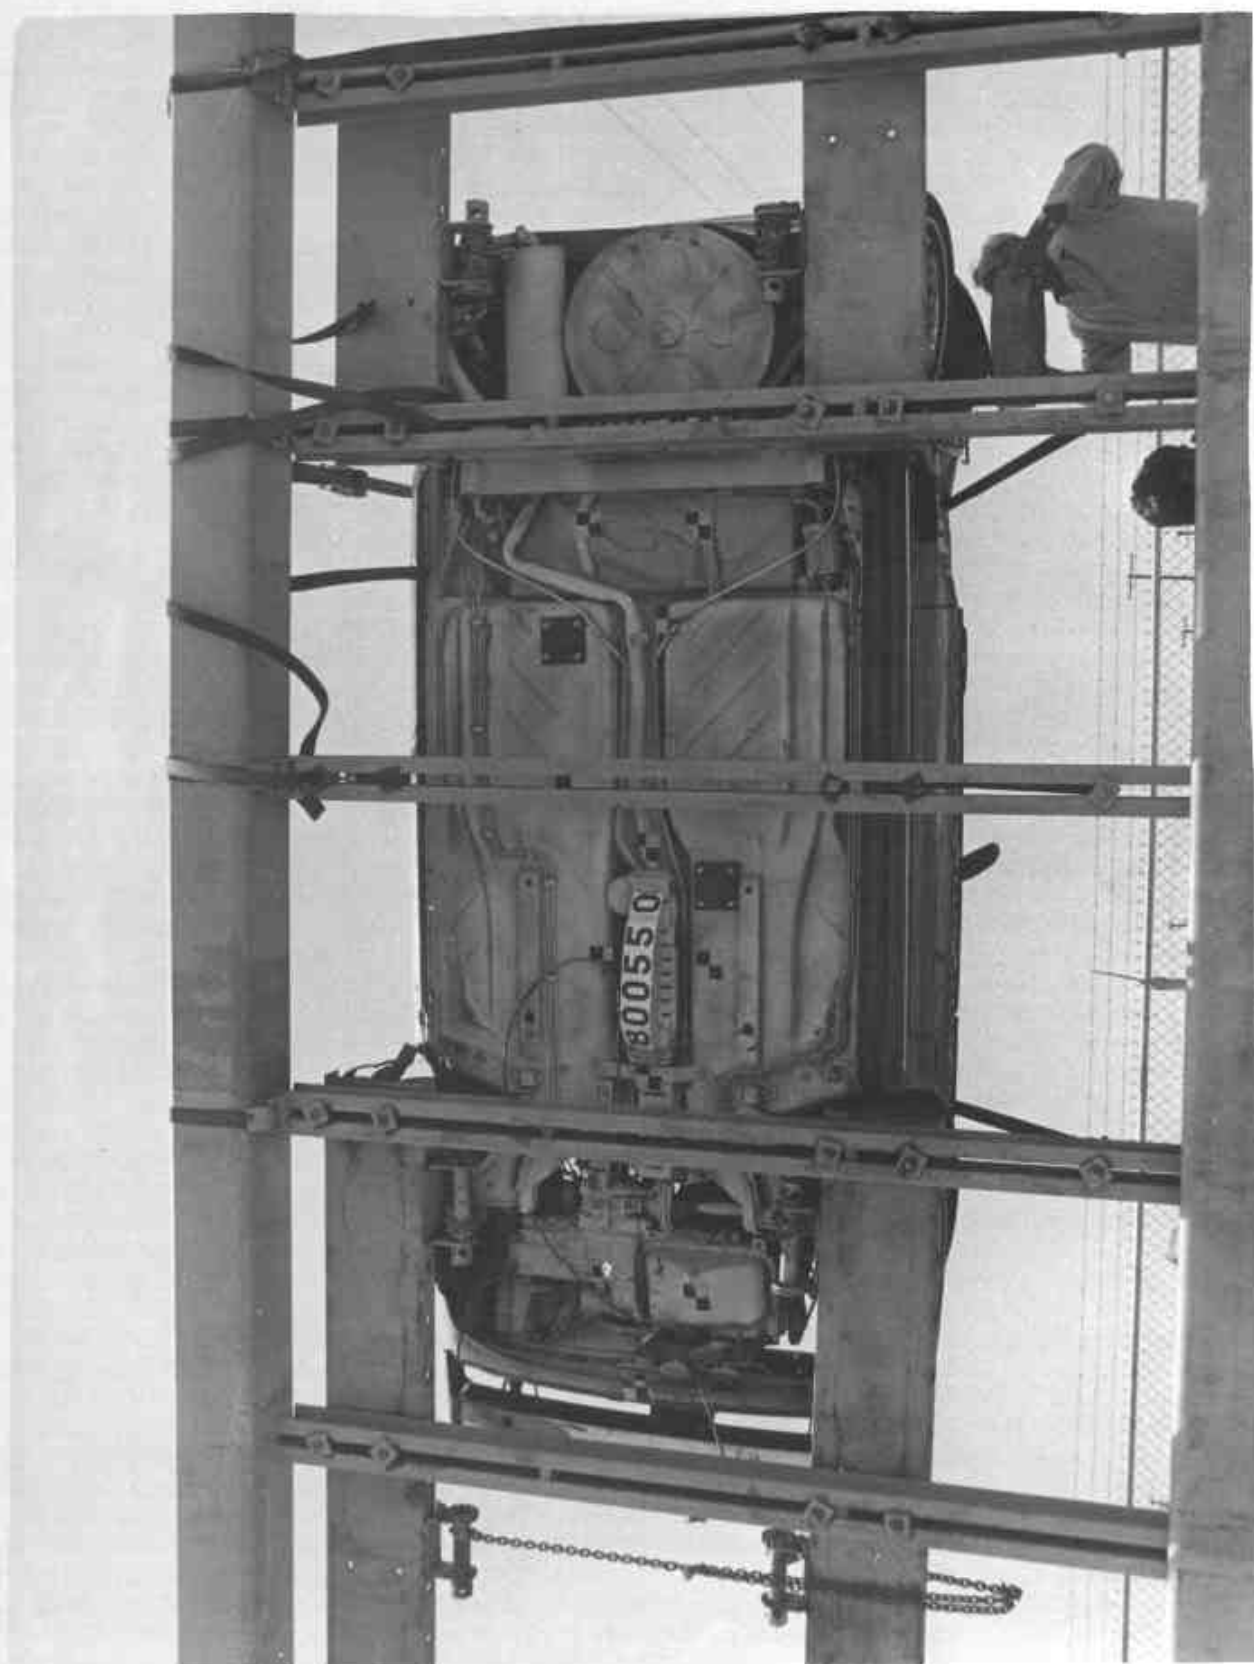
Figure 3-6  
1980 Volkswagen Rabbit - 2 Door Convertible  
NHTSA 800550  
Post-Impact, Rollover Test, 90° Increment

No fuel spillage was recorded following the moving barrier impact, nor during the time period before the start of the rollover test. However, fuel spillage was noted emitting from the fuel filler cap area as the vehicle was being rotated to the first 90° test increment (right side down). The fuel spillage continued after the initiation of the rollover test and thru the 180° test increment. The fuel spillage diminished to zero during the first five (5) minutes at the 270° test increment. The collectable fuel spillage from the test increment time periods were as stated herein.

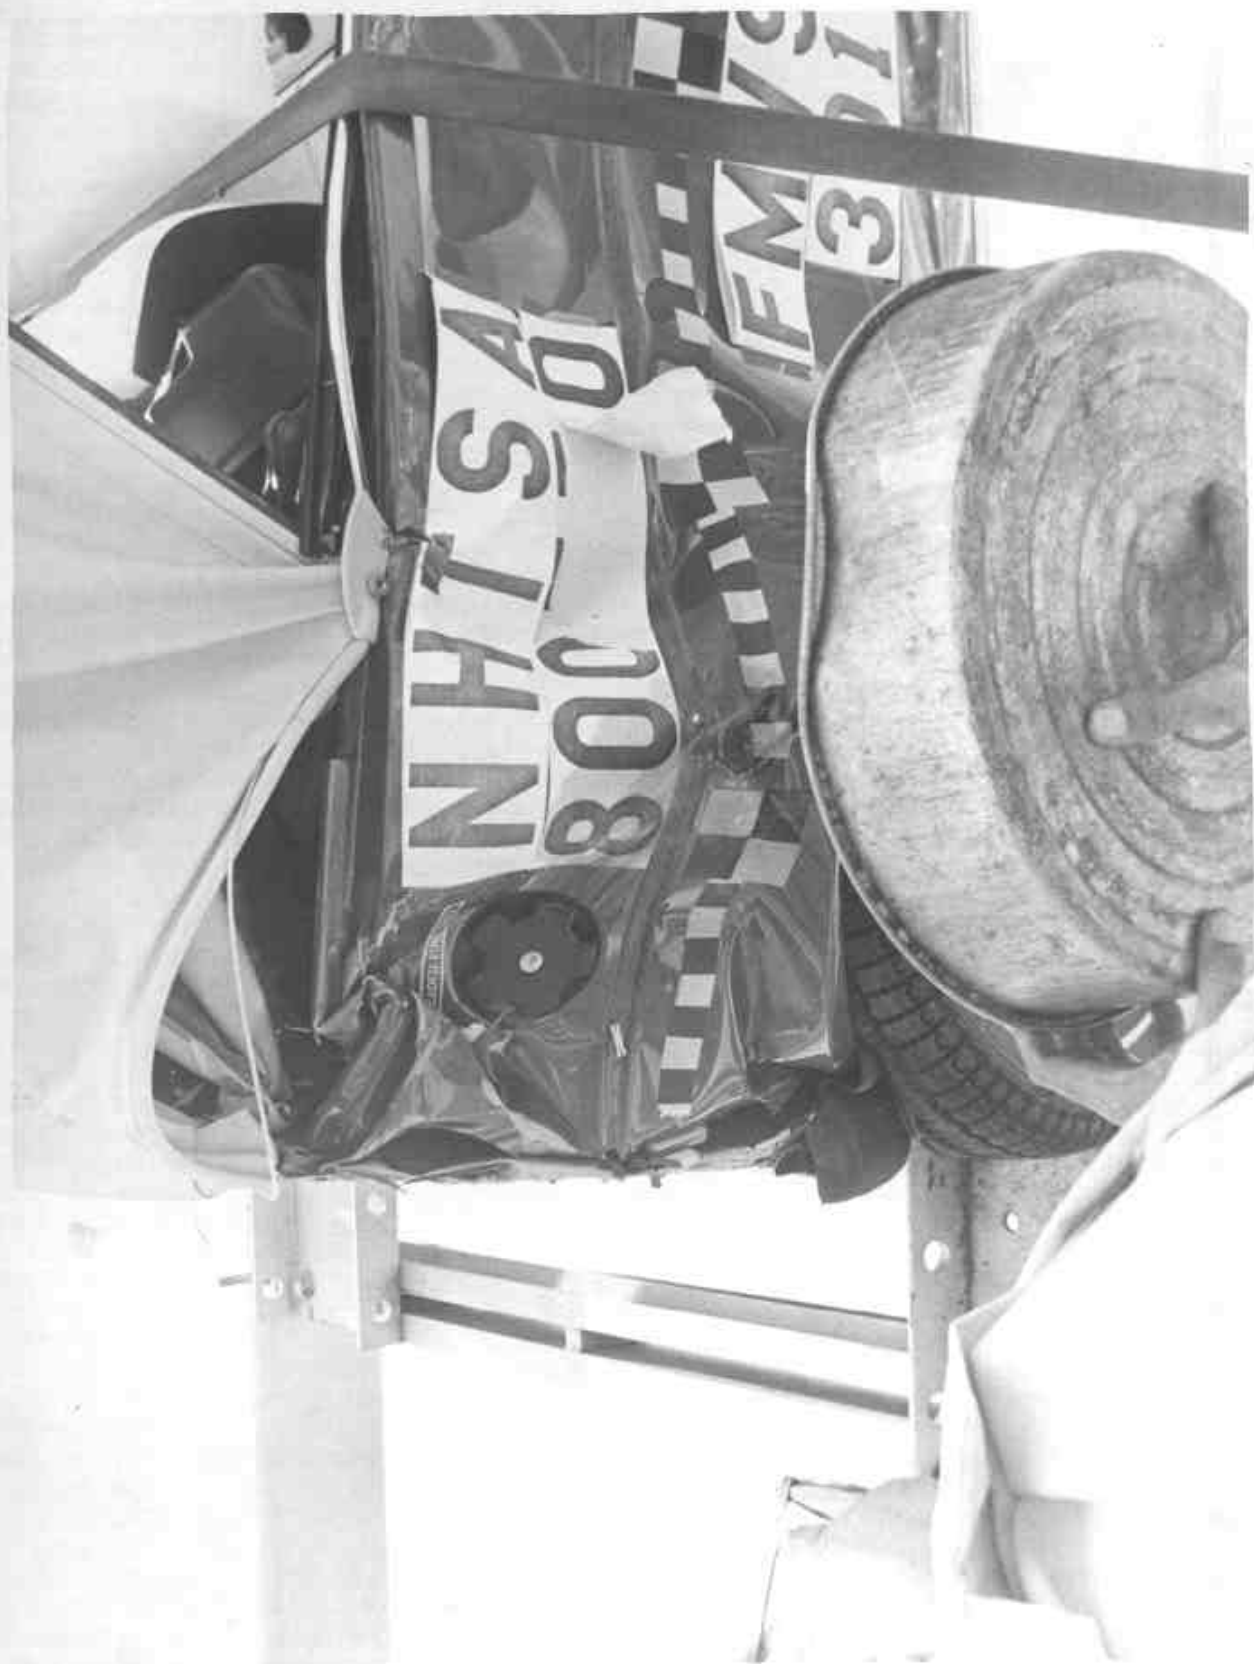
Figure 3-7

Post-Impact, Fuel Spillage, 90° Increment

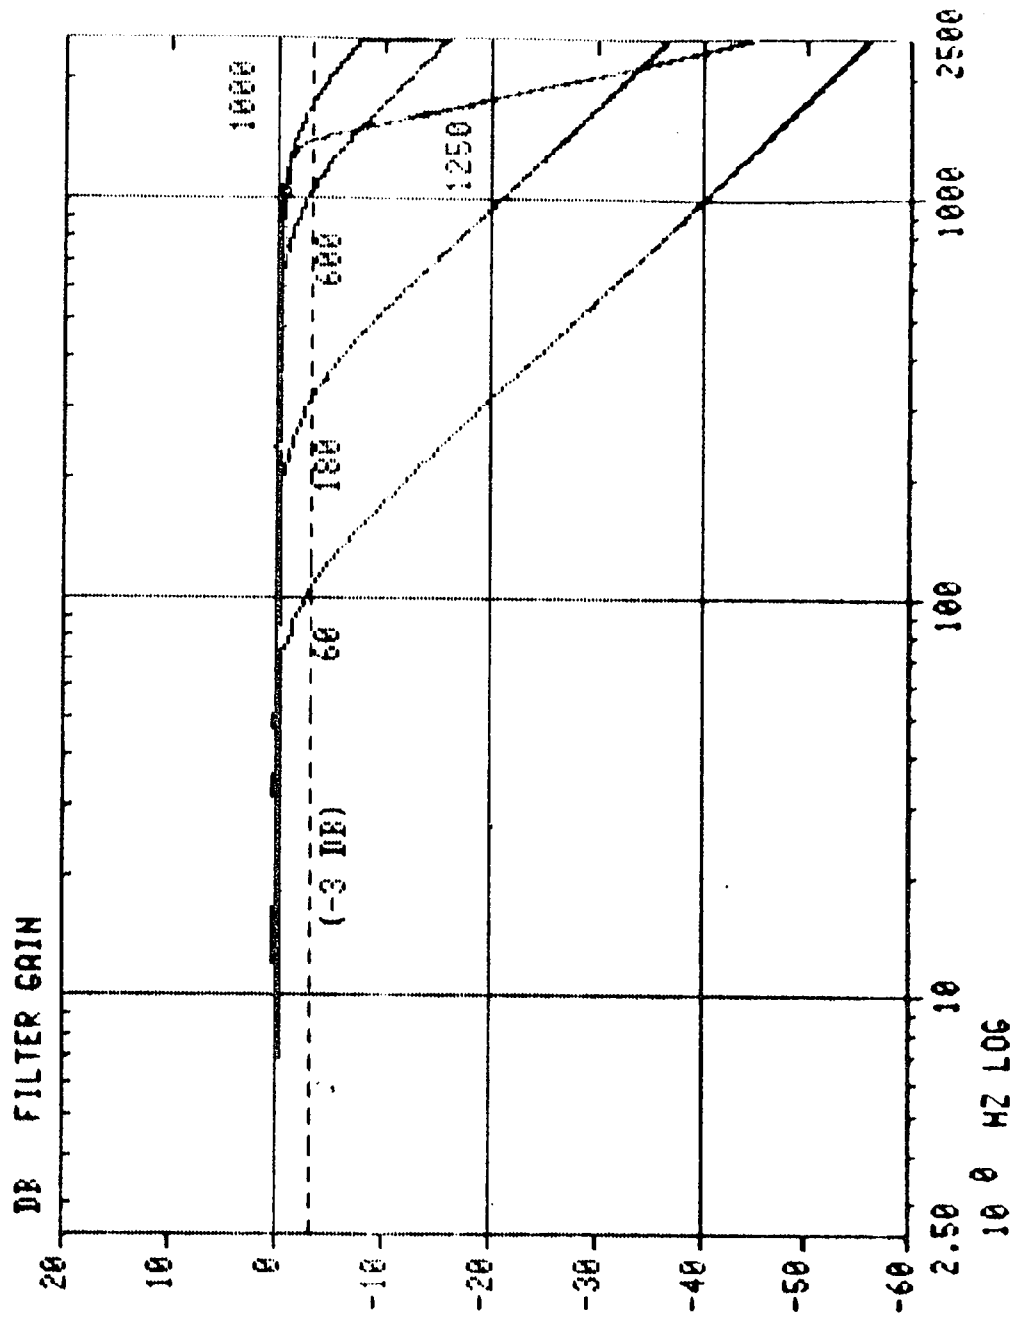
FIGURE 5-2

A 1250 Hz predigitizing analog filter with a rolloff of 60 db/octave, shown in figure 5-2, was applied to all data. Also shown in figure 5-2 are SAE class 60 and class 180 filters. These filters are in accordance with SAE J211A, Instrumentation for Impact Tests. These SAE recommended filters are quadratic double pole with 65% damping and a 12 db/octave rolloff. They are applied using a fast fourier transform of the data, frequency domain multiplication, and an inverse fast fourier transform of the product. The class 60 filters is applied to vehicle acceleration and belt restraint forces. The class 180 filter is applied to chest acceleration. SAE filters were not applied to head accelerations and femur forces.

COMPARISON PLOT OF SAE CLASS 60, 180, 600, 1000 FILTERS AND  
THE DATA ANALYSIS 1250 HZ PREDICTIZING ANALOG FILTER.

SAE FILTERS ROLL OFF IS 12DB/OCT, ANALOG FILTER ROLL OFF IS 60DB/OCT
