REPORT NO. 301-AETL-80-008-971-3882-8

NEW VEHICLE ASSESSMENT  
AND  
STANDARDS ENFORCEMENT INDICANT TESTING

FMVSS 301-75

TOYO KOGYO COMPANY, LTD.  
1980 MAZDA 626 - 4 DOOR SEDAN  
NHTSA 800561

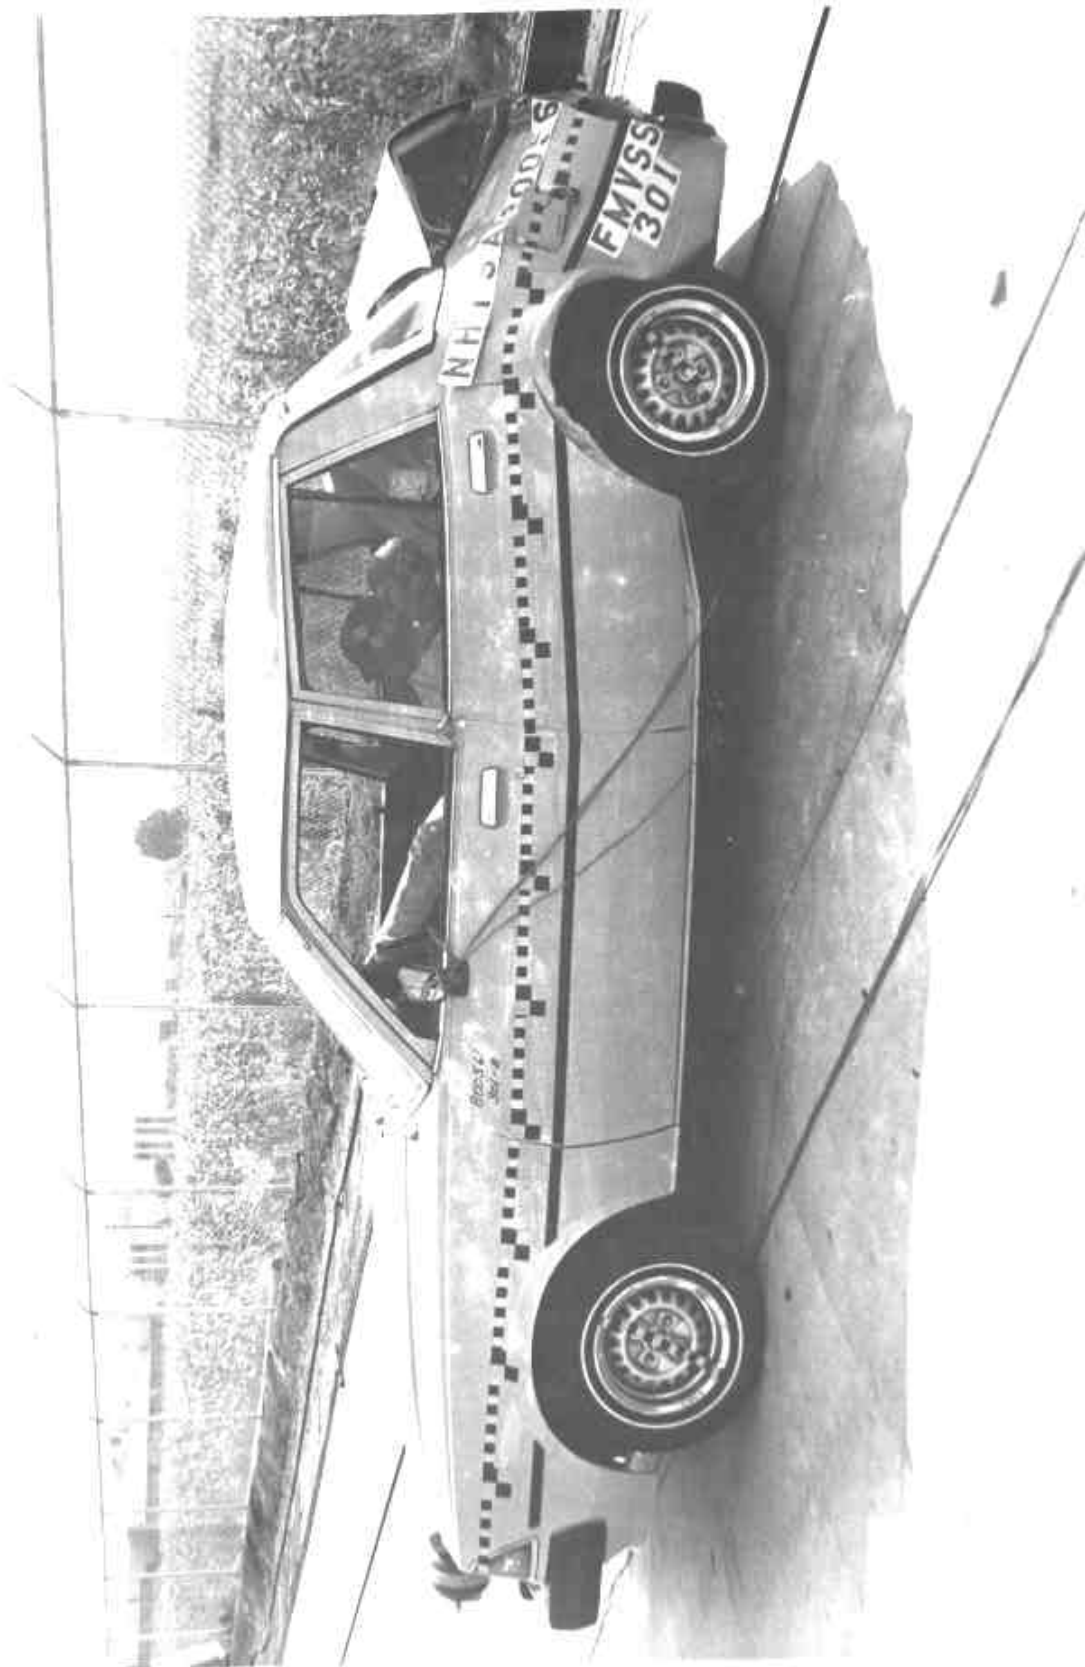
Figure 3-4  
1980 Mazda 626 - 4 Door Sedan  
NHTSA 800561  
Post-Impact, Left Side View

Crush Details: Roof buckled over both "B" and "C" posts, all doors were jammed, both dummies made contact with rear seat back, both front seat backs bent backward onto rear seat cushion.
