NEW VEHICLE ASSESSMENT AND  
STANDARDS ENFORCEMENT INDICANT  
TESTING

FMVSS 212, 219, AND 301-75

FORD MOTOR COMPANY  
1979 MERCURY BOBCAT 2-DOOR HATCHBACK  
NHTSA No. 790211

FINAL REPORT

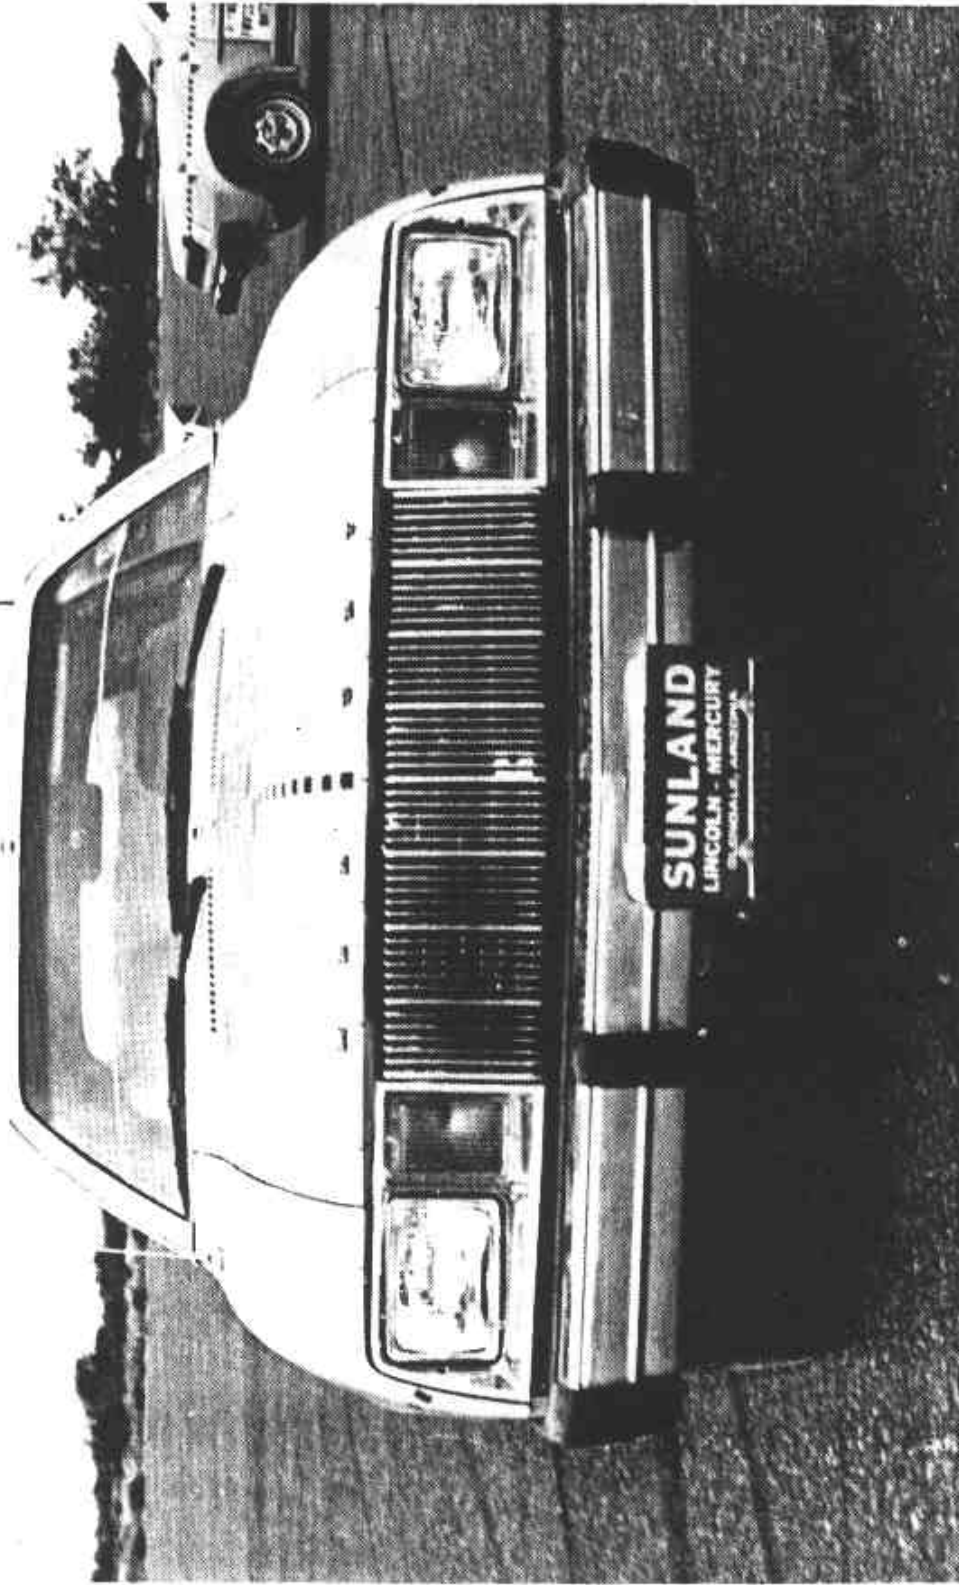
Figure 2-1. Pre-test Front View - 1979 Mercury Bobcat 2-door Hatchback - NHTSA 790211.

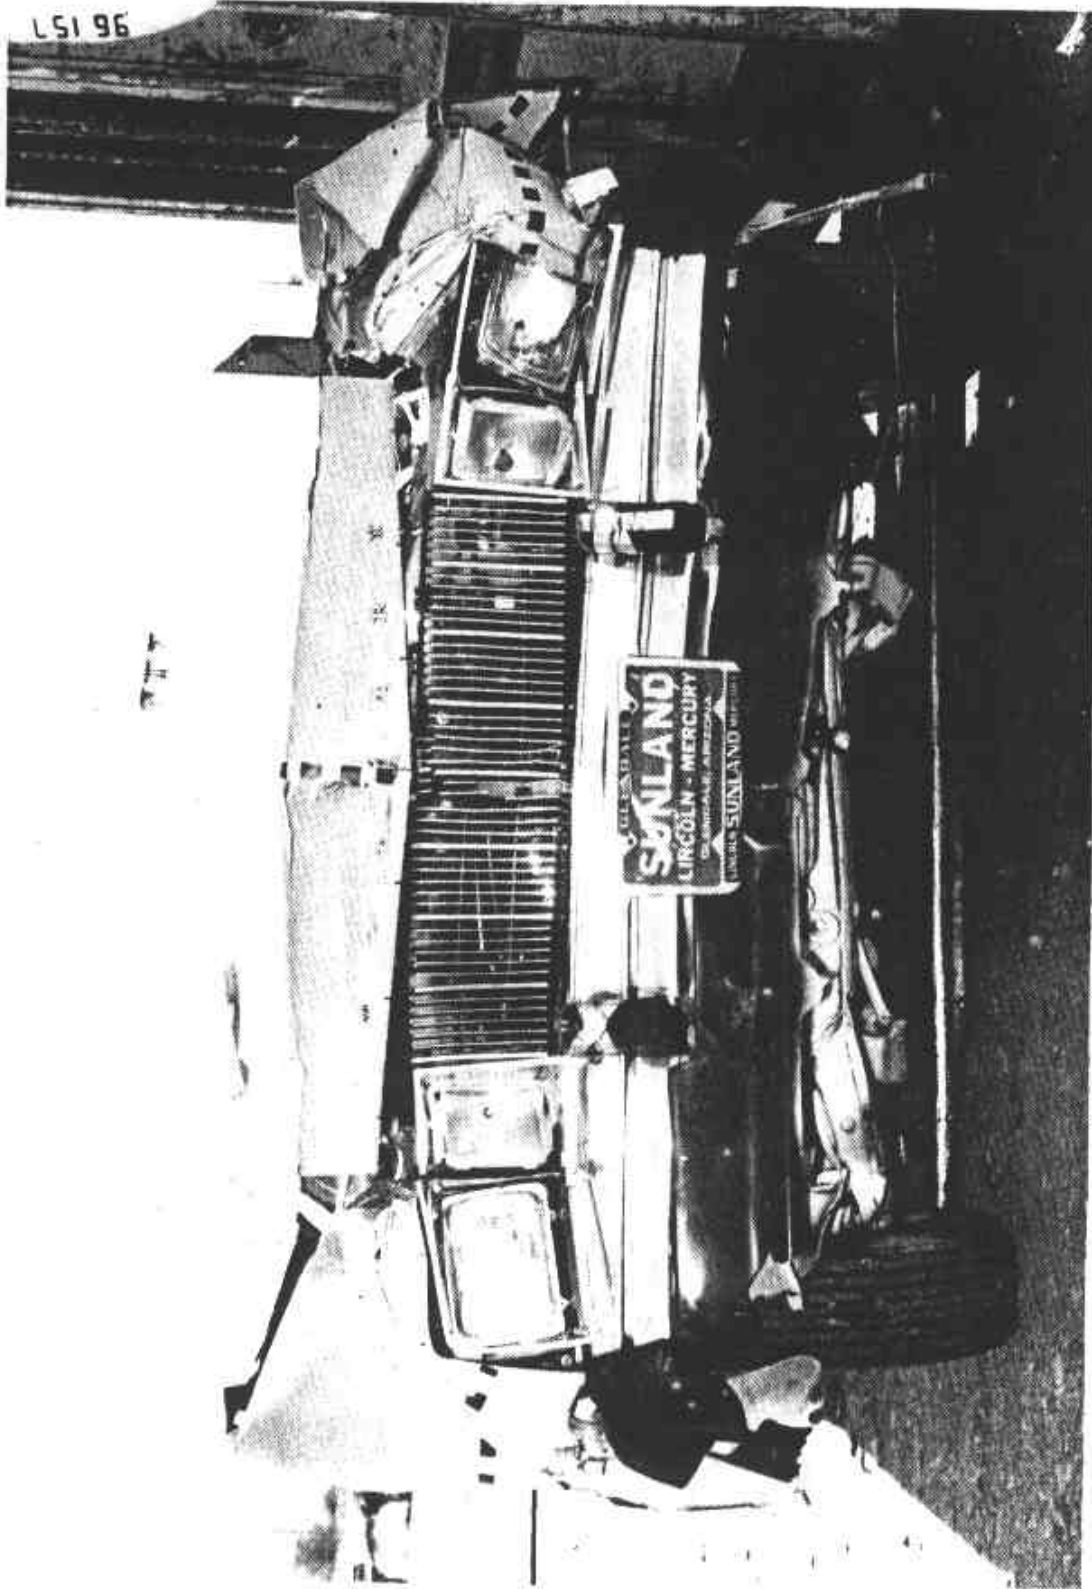
Figure 2-2. Post-test Front View - 1979 Mercury Bobcat 2-door Hatchback - NHTSA 790211.

Overall Length of Pre-test = R 166.5 L 166.5 inches  
 Test Vehicle Post-test = R 146.5 L 146.4 inches  
 CRUSH = R 20.0 L 20.1

FOR FRONTAL IMPACTS, distance from front of test vehicle to the  
 barrier after impact = 36.0 inches

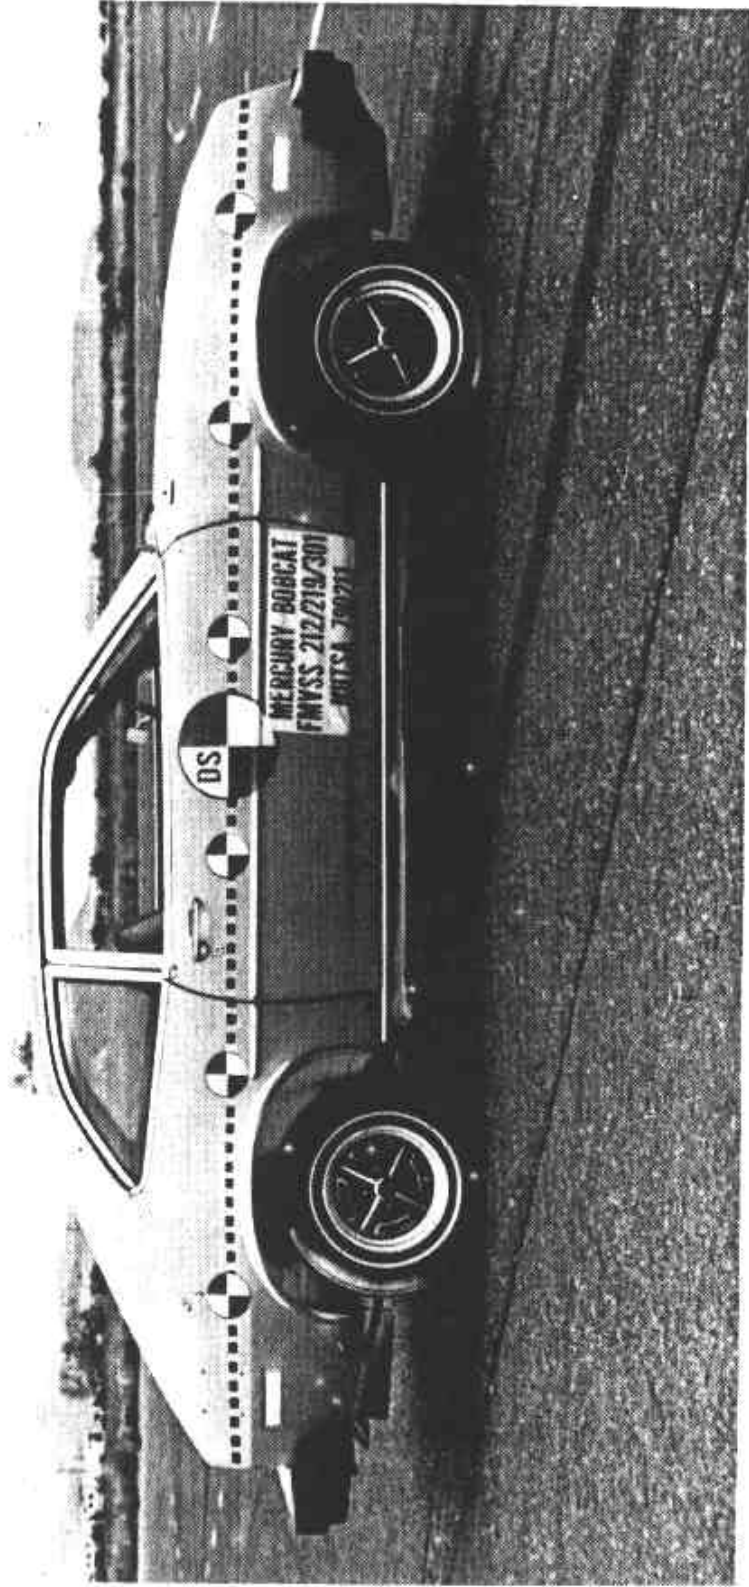
Figure 2-3. Pre-test Side View - 1979 Mercury Bobcat 2-door Hatchback - NHTSA 790211.

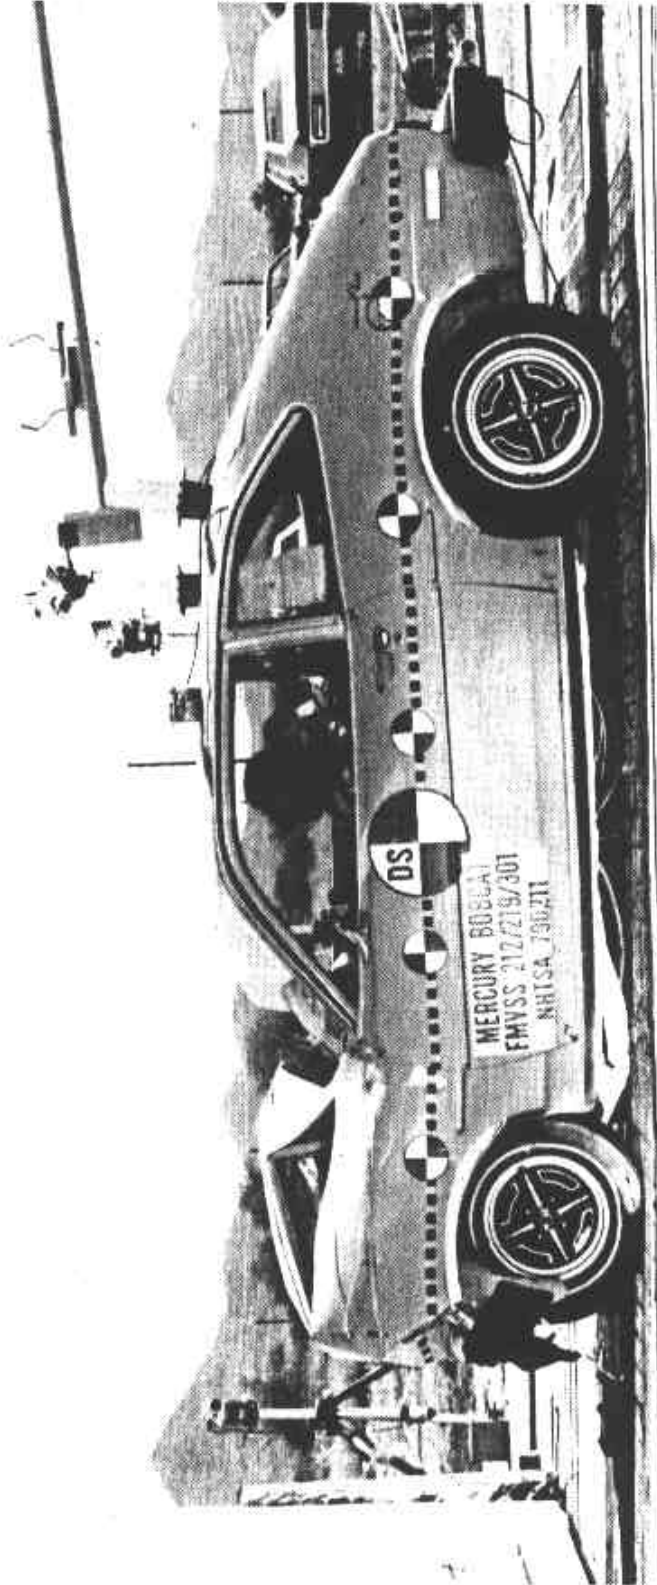
Figure 2-4. Post-test Left Side View - 1979 Mercury Bobcat 2-door Hatchback - NHTSA 790211.

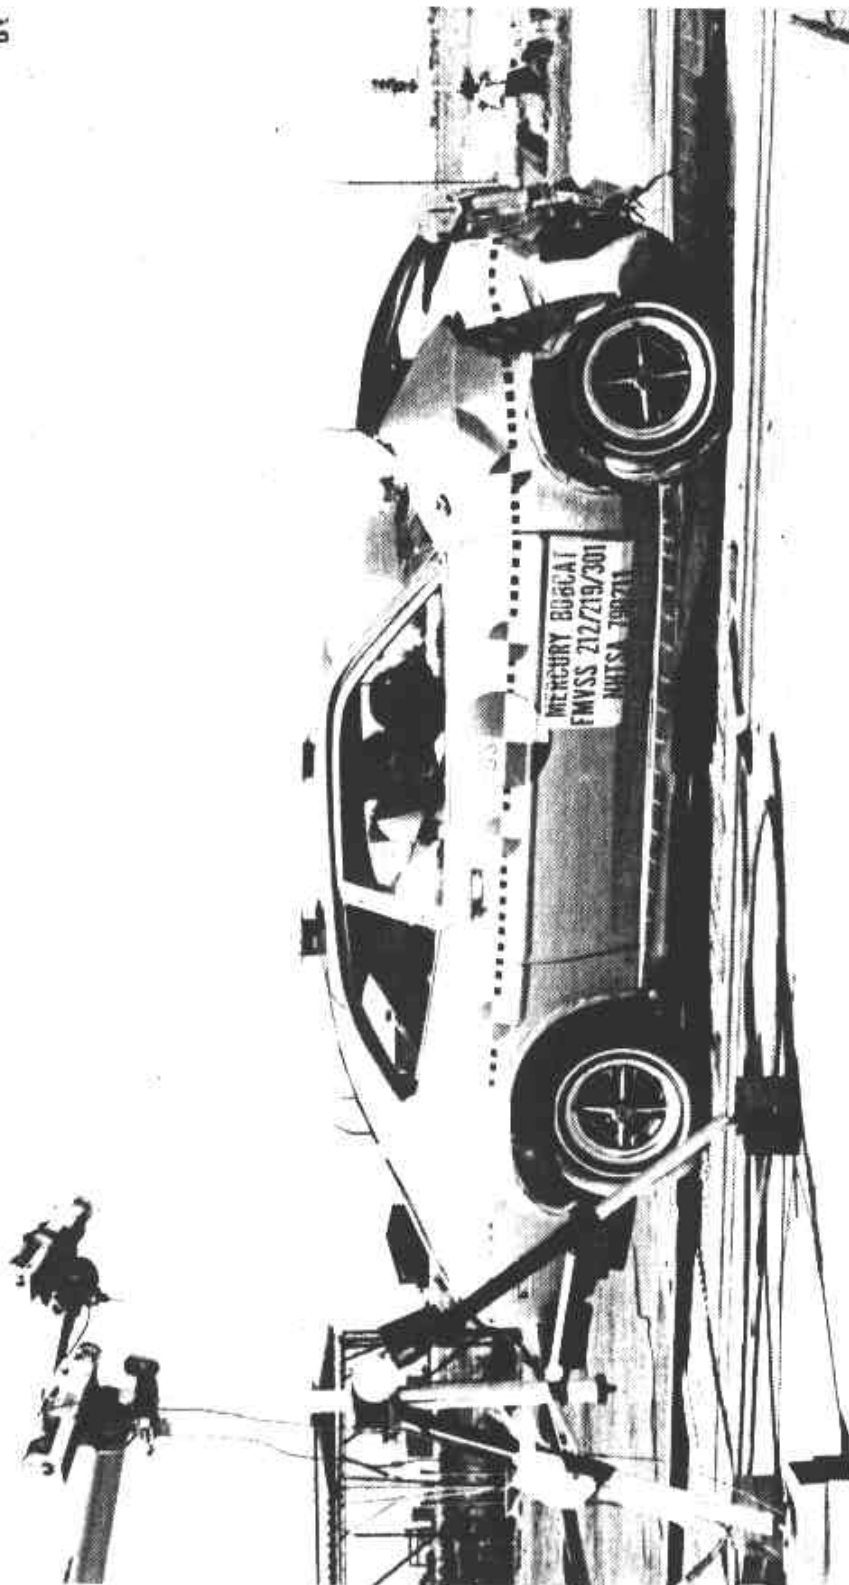
Figure 2-5. Post-test Right Side View - 1979 Mercury Bobcat 2-door Hatchback - NHTSA 790211.

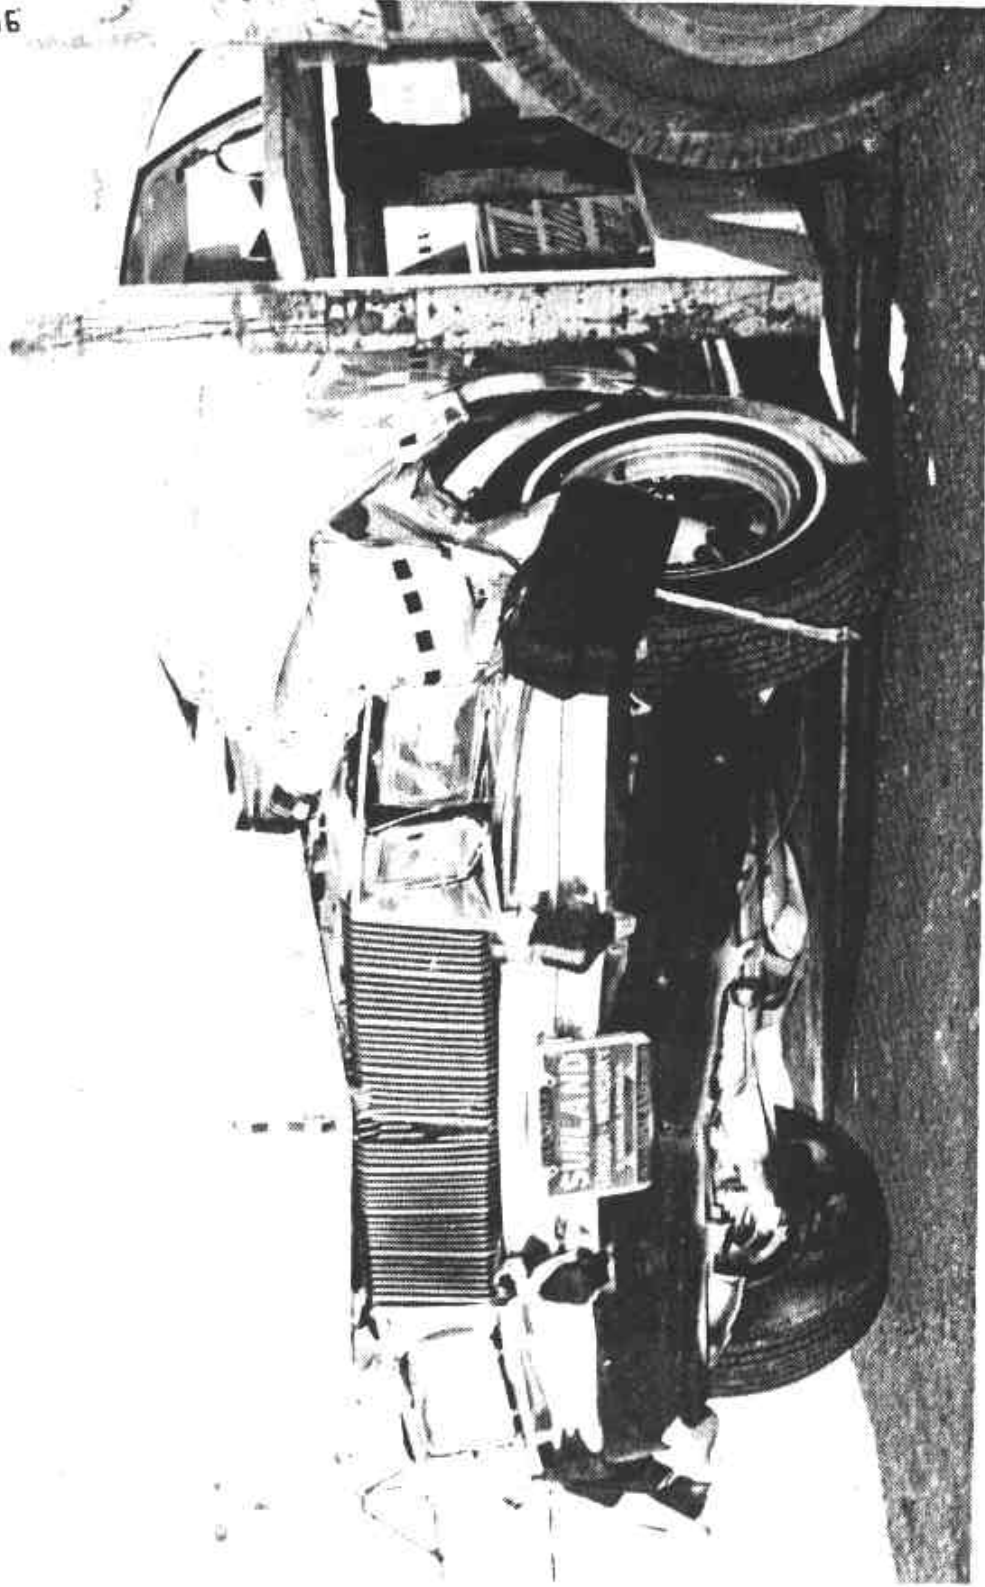
Figure 2-6. Post-test Left Front Quarter View - 1979 Mercury Bobcat 2-door Hatchback - NHTSA 790211.

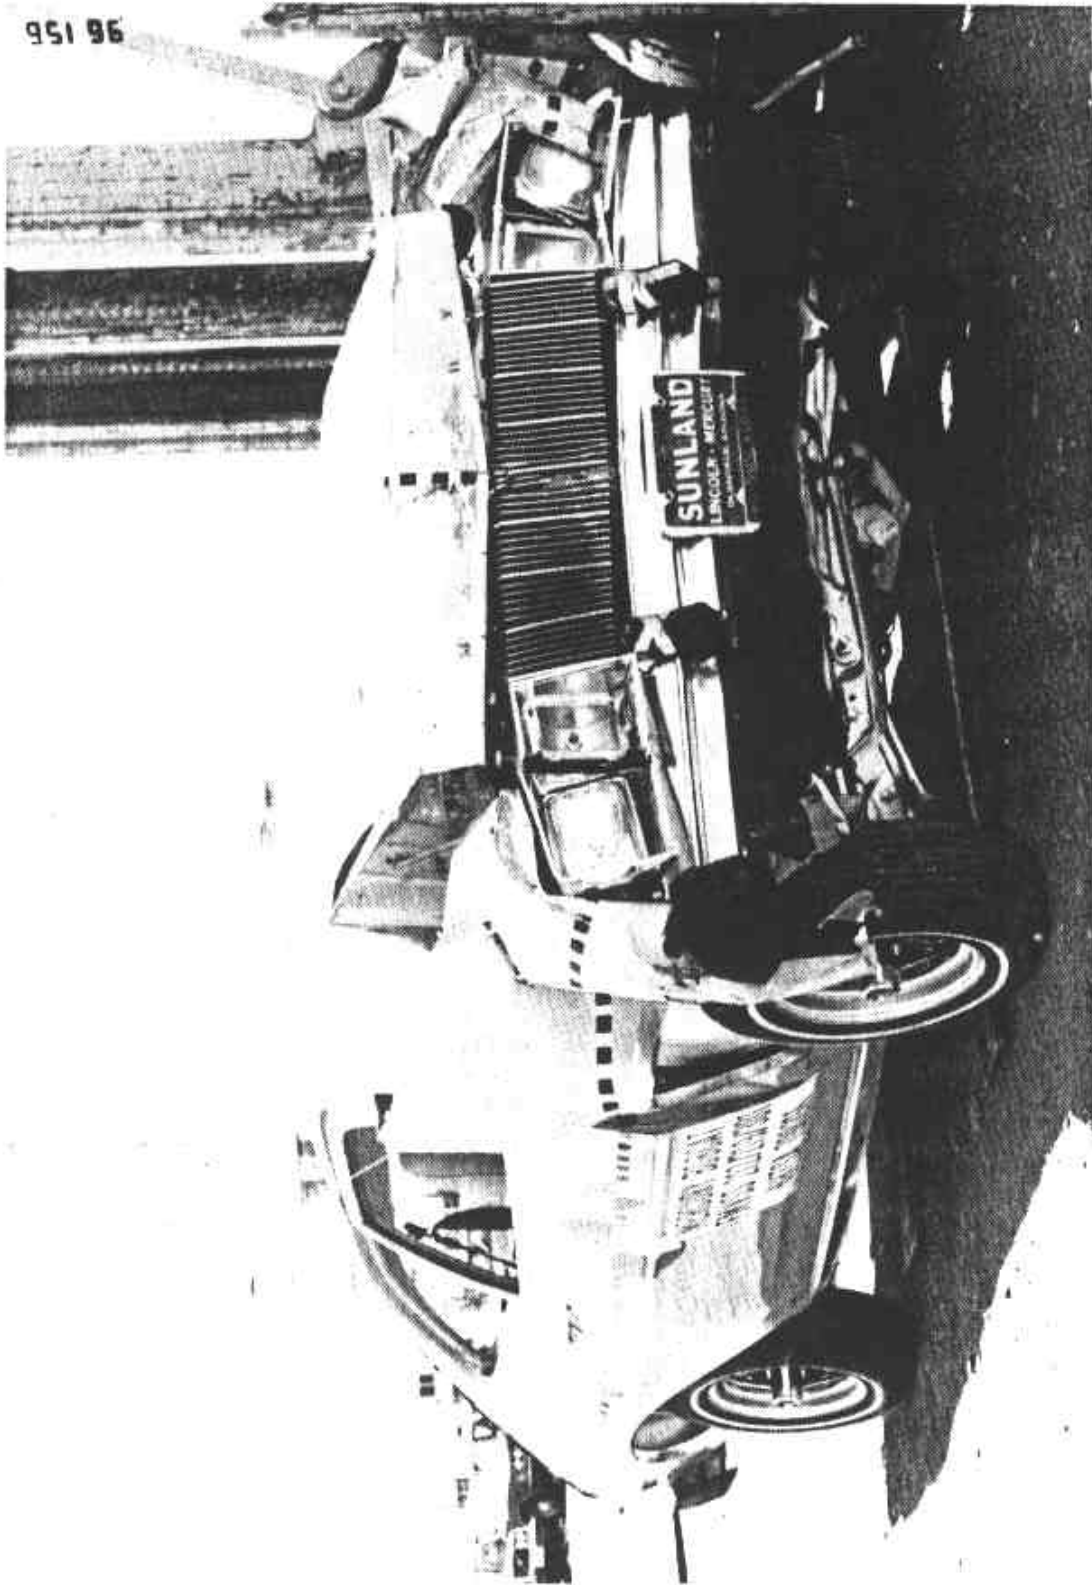
Figure 2-7. Post-test Right Front Quarter View - 1979 Mercury Bobcat 2-door Hatchback - NHTSA 790211.

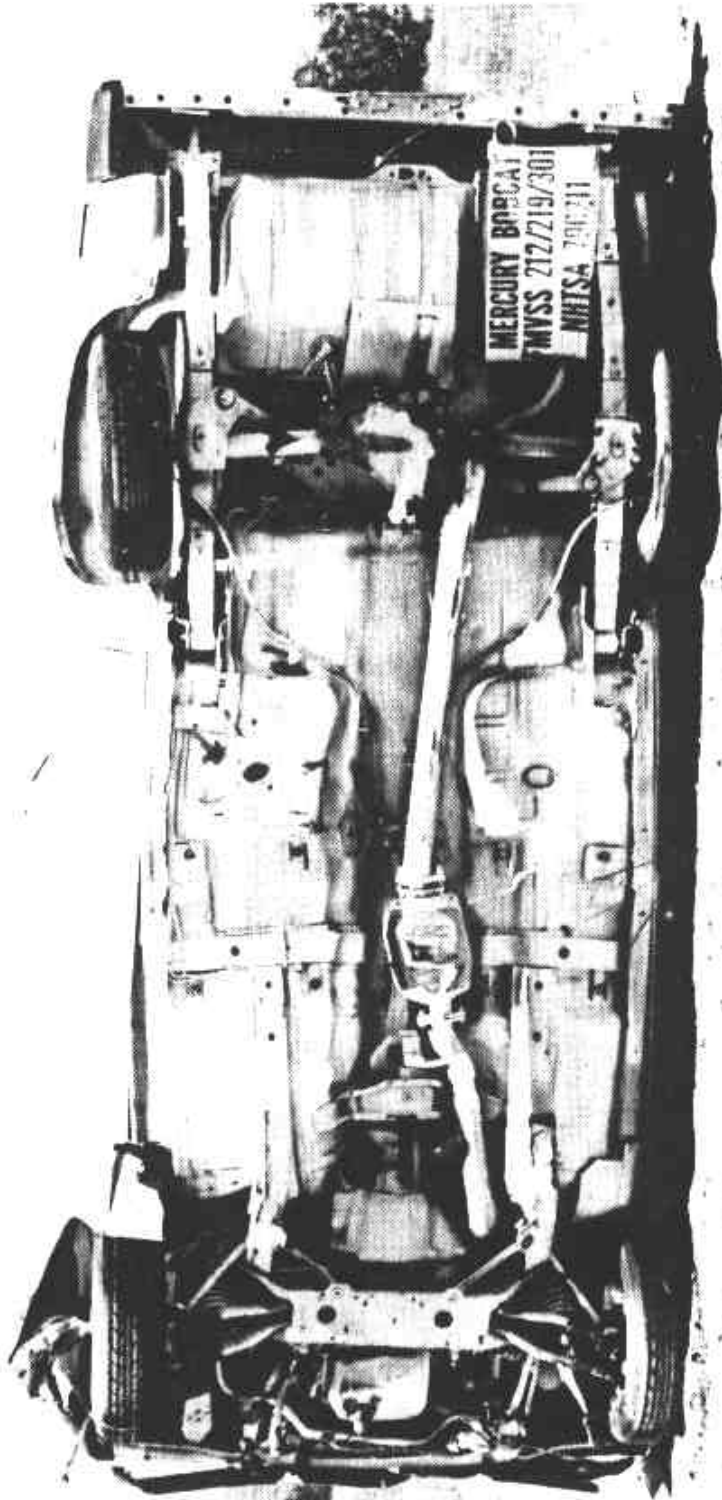
Figure 2-8. Post-test Overall Underside View - 1979 Mercury Bobcat 2-door Hatchback - NHTSA 790211.

OTHER NOTABLE IMPACT EFFECTS: Drive shaft U-joint tore off at rear differential.

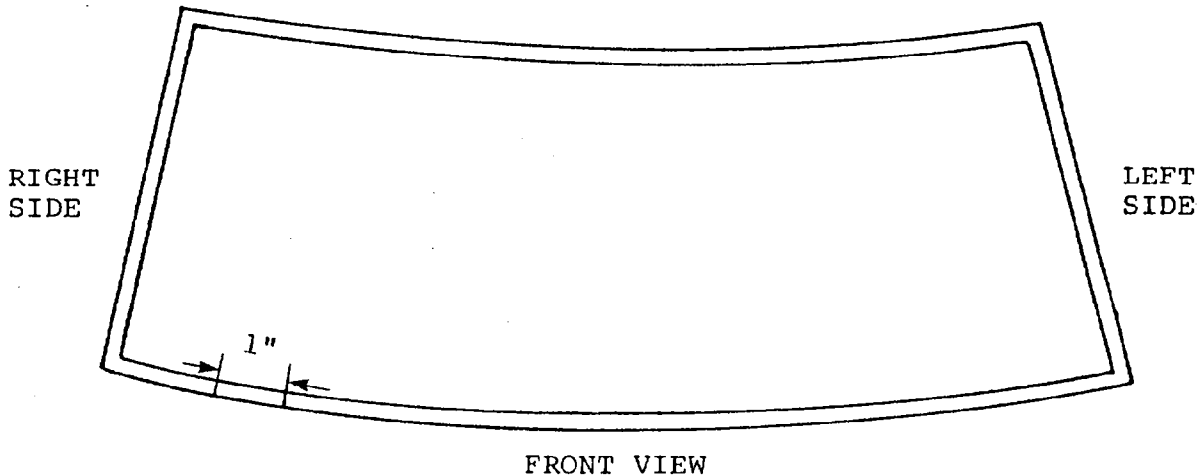
Details of Windshield Mounting: The windshield is secured to the body by a 3/4-inch wide mastic on all sides. A 3/4-inch wide chrome molding borders the windshield on the top, right and left sides. A one-inch wide molding borders the bottom edge.

Area of Retention Failure (as noted):

<u>Actual Data</u>	<u>Standard Requirement</u>	<u>Pass/Fail</u>
1. Pre-test Windshield Periphery (in.)	Right	<u>65</u>		
	Left	<u>65</u>		
	Total	<u>130</u>		
2. Post-test Windshield Periphery (in.)	Right	<u>64</u>		
	Left	<u>65</u>		
	Total	<u>129</u>	75% Minimum	<u>Pass</u>

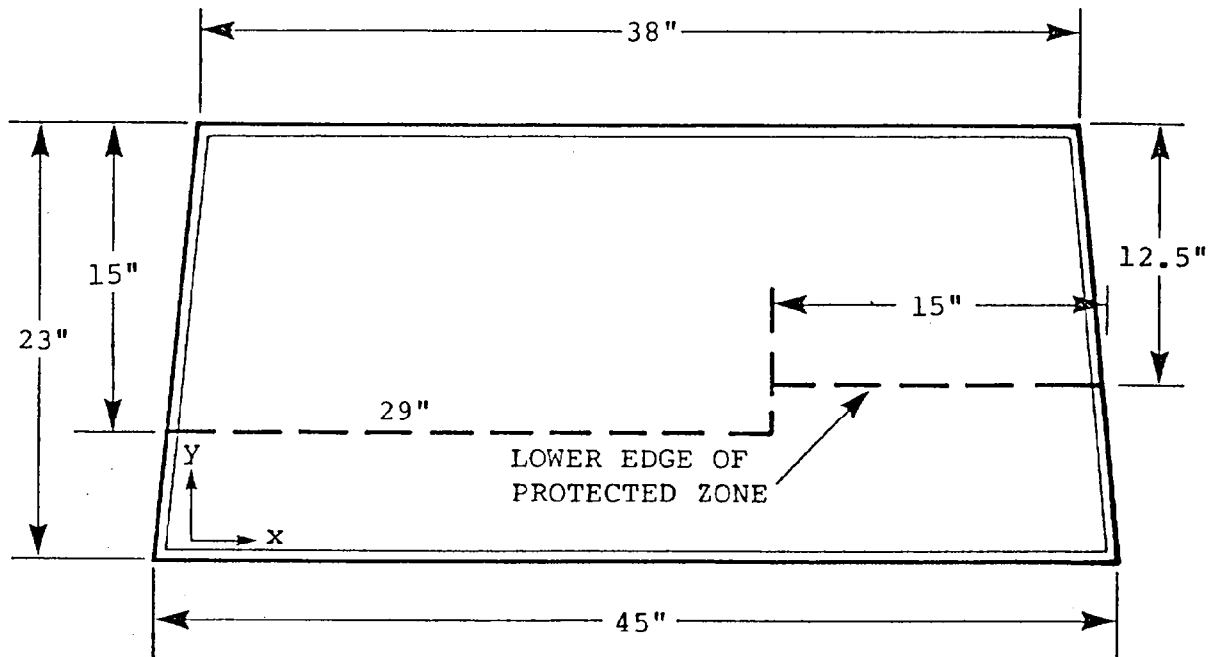
1. PROTECTED ZONE DEFINITION:

FRONT VIEW OF WINDSHIELD

Zone Intrusion Description/Cause: No intrusion noted

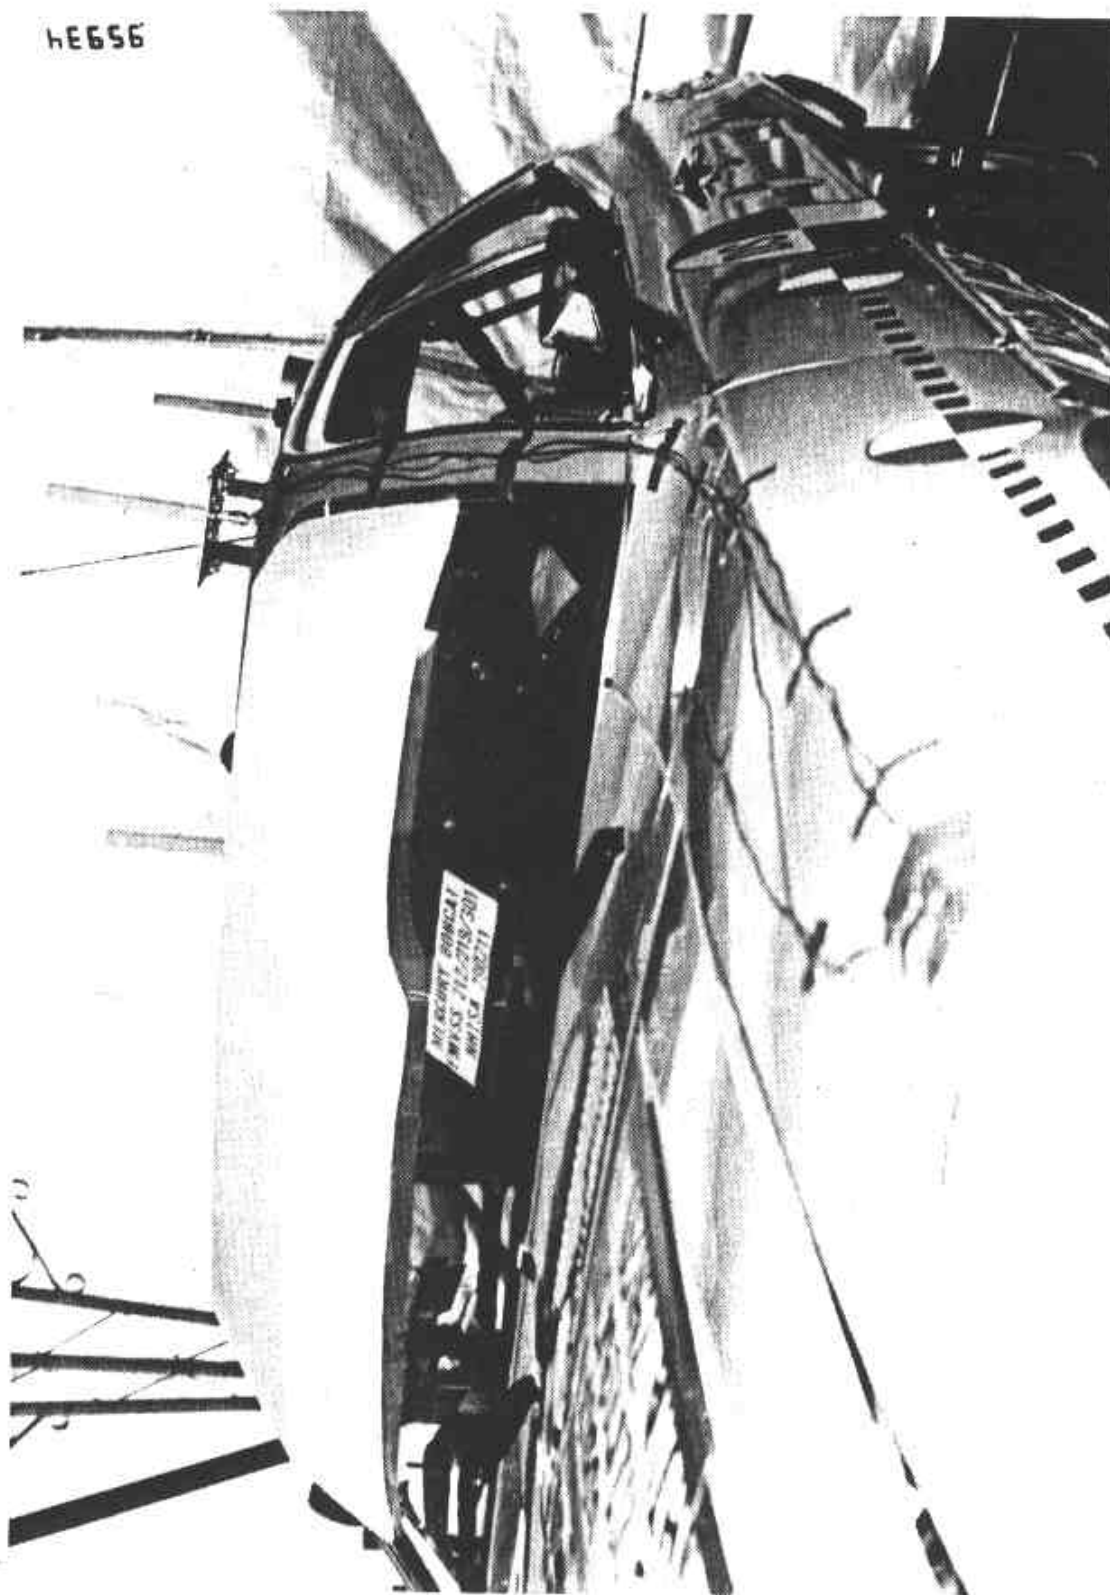
Figure 3-1. Pre-test Windshield - Overall View - 1979 Mercury Bobcat 2-door Hatchback - NHTSA 790211.

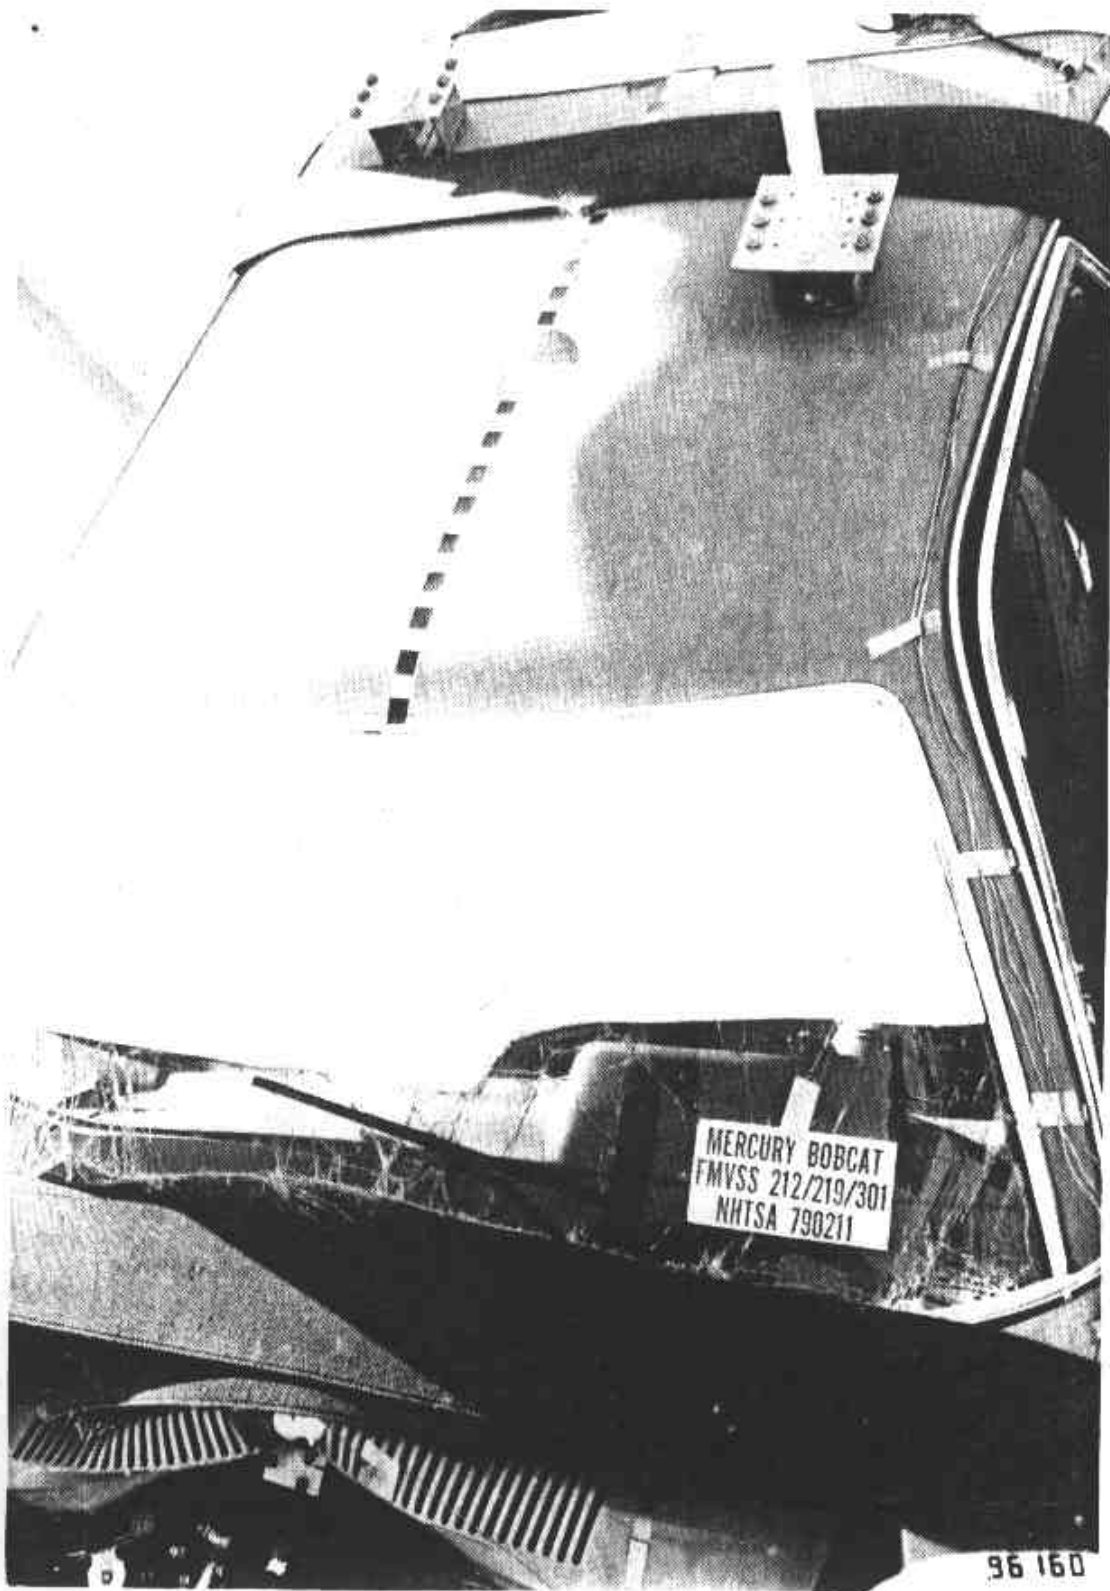
Figure 3-2. Post-test Windshield - Overall View - 1979 Mercury Bobcat 2-door Hatchback - NHTSA 790211.

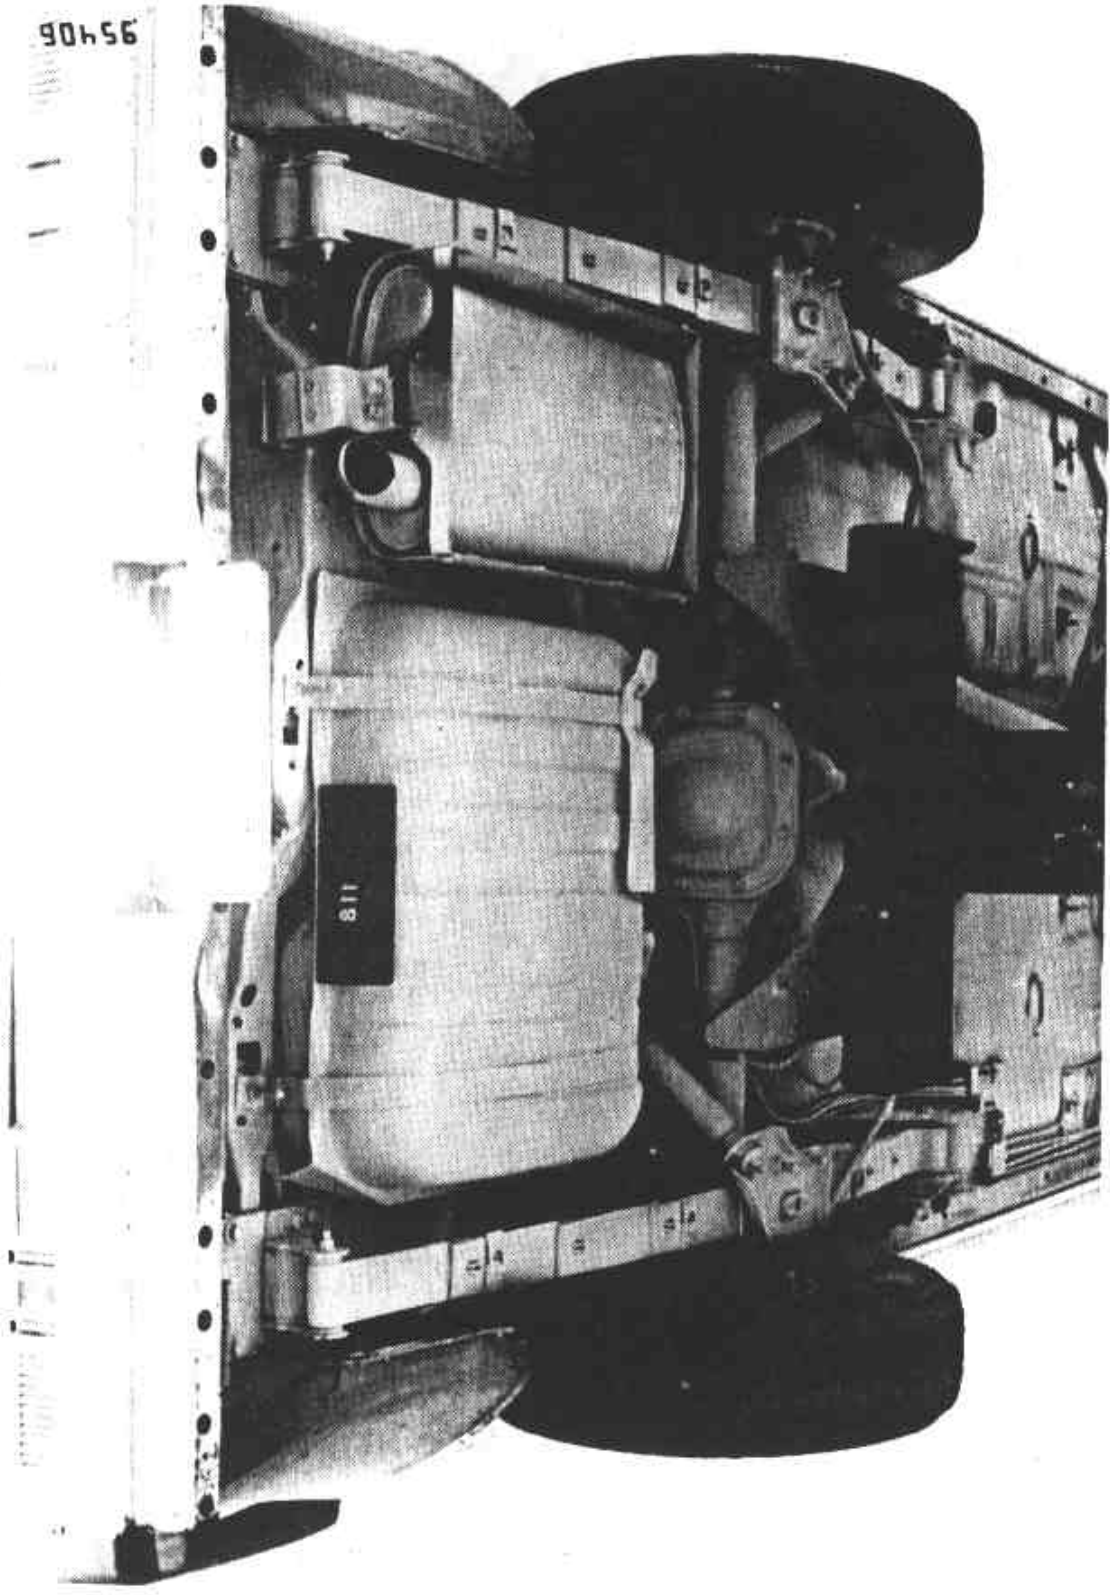
Figure 3-3. Pre-test View of Fuel Tank - 1979 Mercury Bobcat 2-door Hatchback - NHTSA 790211.

Details of Fuel Tank, Filler Pipes, and Connections:  
The fuel tank is located below the trunk and aft of the rear wheels. The tank is held in place by two tank straps. A plastic shield covers the portion of the tank just aft of the rear axle. The filler tube fits through a grommet on the upper left side of the tank, and terminates at the exterior of the body just aft of the rear wheel on the left side. The tube is sealed by a twist-type cap.

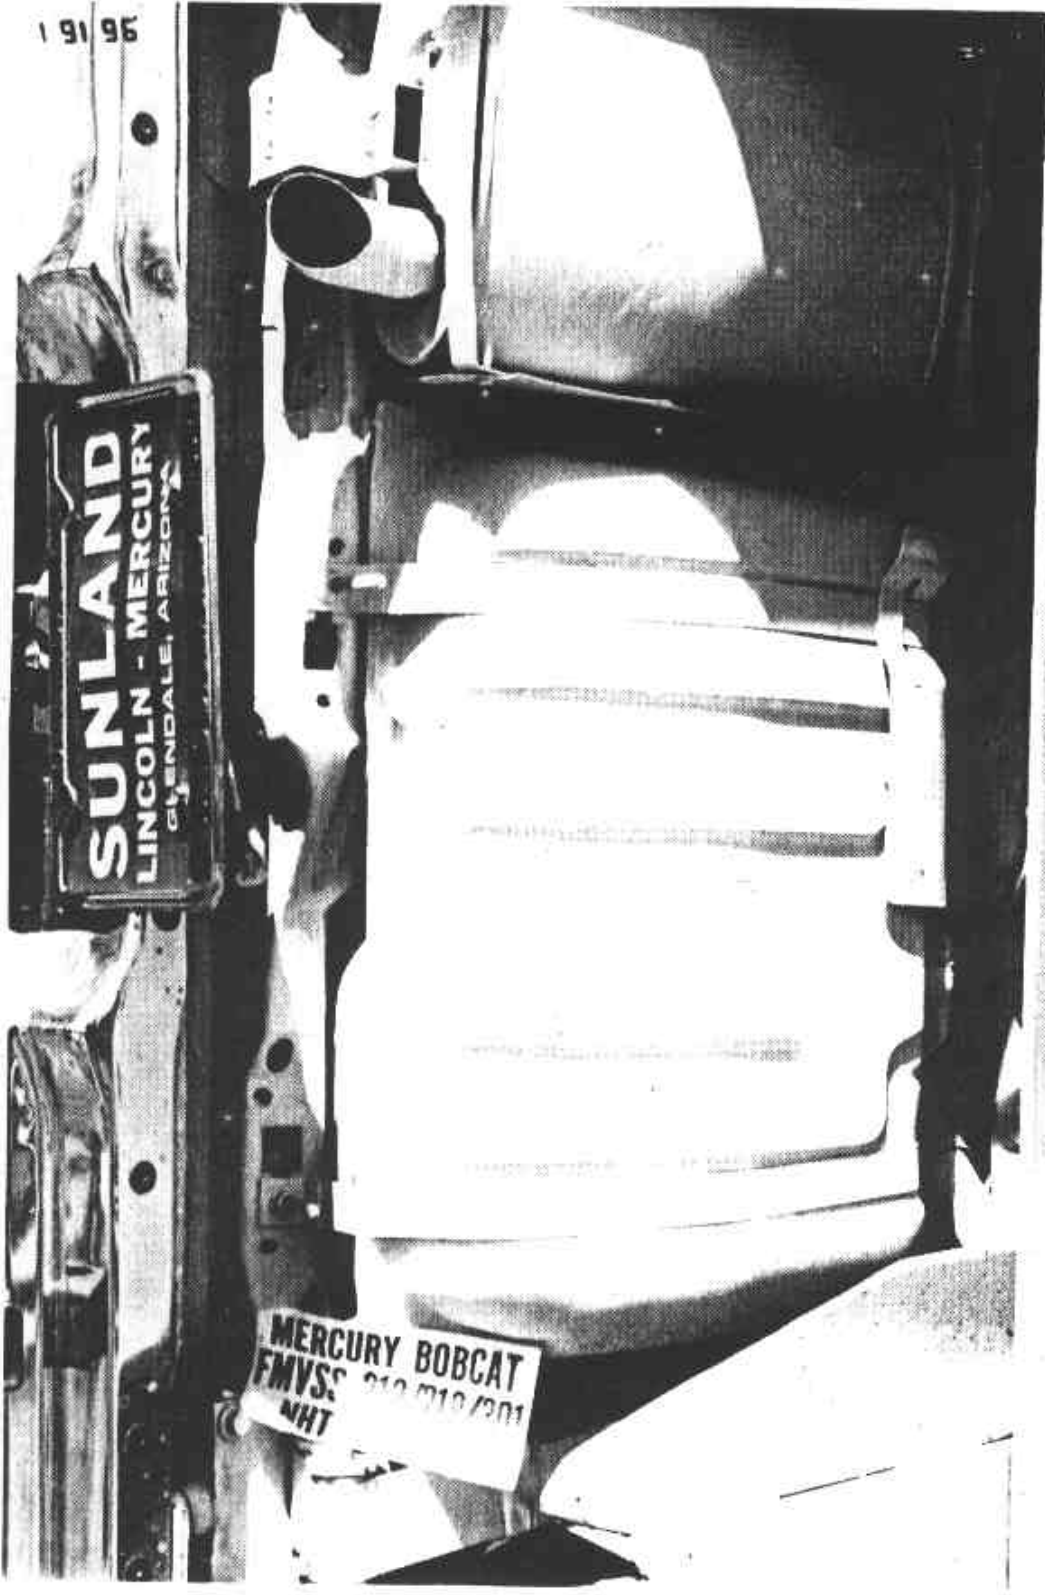
Figure 3-4. Post-test View of Fuel Tank - 1979 Mercury Bobcat 2-door Hatchback - NHTSA 790211.

<u>Actual Data</u>	<u>Standard Requirement</u>	<u>Pass/Fail</u>
1. Transimpact Fluid Loss (oz)	<u>0.0</u>	1 oz maximum	<u>Pass</u>
2. Post-impact Fluid Loss (oz) (30-minute period post-impact)	<u>0.0</u>	1 oz/minute maximum	<u>Pass</u>

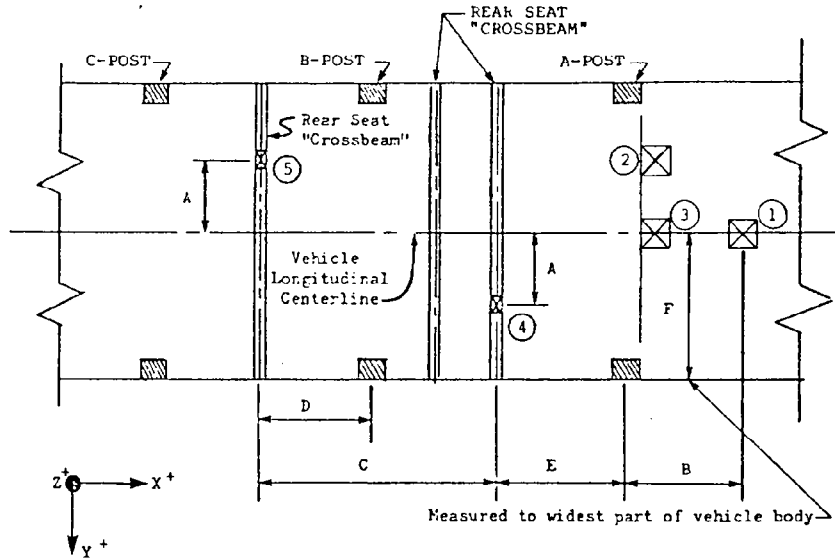
TEST VEHICLE ACCELEROMETER LOCATION DEFINITION AND DATA SUMMARY

Dim.	Length (in.)
A	11.5(5) 16.0(4)
B	40.0
C	33.5
D	1.0
E	13.0
F	32.0

No.	Location Description	Component Direction		Data Summary									
				Peak G @ MSEC									
				X	Y	Z	X		Y		Z		
X	Y	Z	"+"	"-"	"+"	"-"	"+"	"-"	"+"	"-"			
1	Engine	✓	✓				12.5	139.9				28.9	17.9
							@ 65	@ 34	@	@	@	@ 42	@ 66
2	Firewall above steering column	✓	✓				19.5	39.6				29.7	23.6
							@ 57	@ 31	@	@	@	@ 44	@ 56
3	Firewall @ vehicle centerline	✓	✓				33.1	58.3				45.9	32.5
							@ 18	@ 58	@	@	@	@ 41	@ 51
4	Below front seat area	✓	✓	✓			15.5	41.0	26.4	34.1	61.9	37.3	
							@ 11	@ 57	@ 10	@ 14	@ 46	@ 50	
5	Below rear seat area	✓	✓				2.9	51.3				41.8	37.6
							@ 158	@ 57	@	@	@	@ 18	@ 22

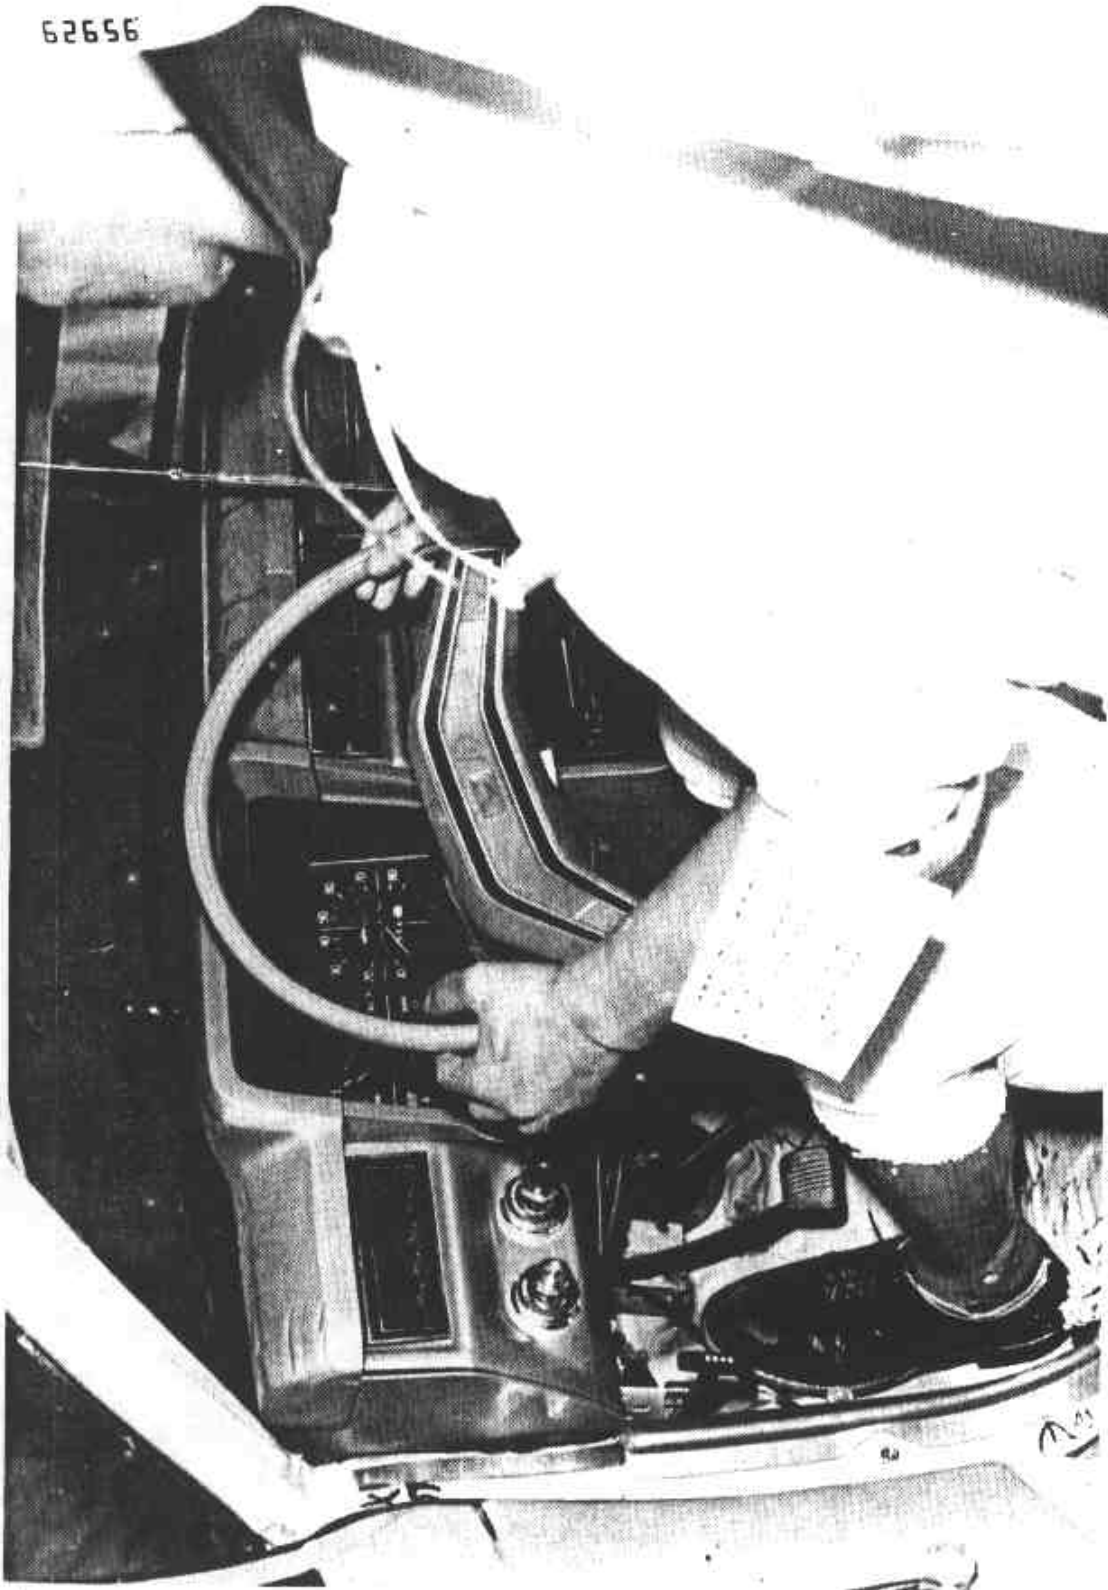
Figure 4-1. Pre-test Driver Dummy Position - 1979 Mercury Bobcat 2-door Hatchback - NHTSA 790211.
