NEW VEHICLE ASSESSMENT AND  
STANDARDS ENFORCEMENT INDICANT  
TESTING

FMVSS 212, 219, AND 301-75

FORD MOTOR COMPANY  
1979 MERCURY BOBCAT 2-DOOR HATCHBACK  
NHTSA No. 790211

FINAL REPORT

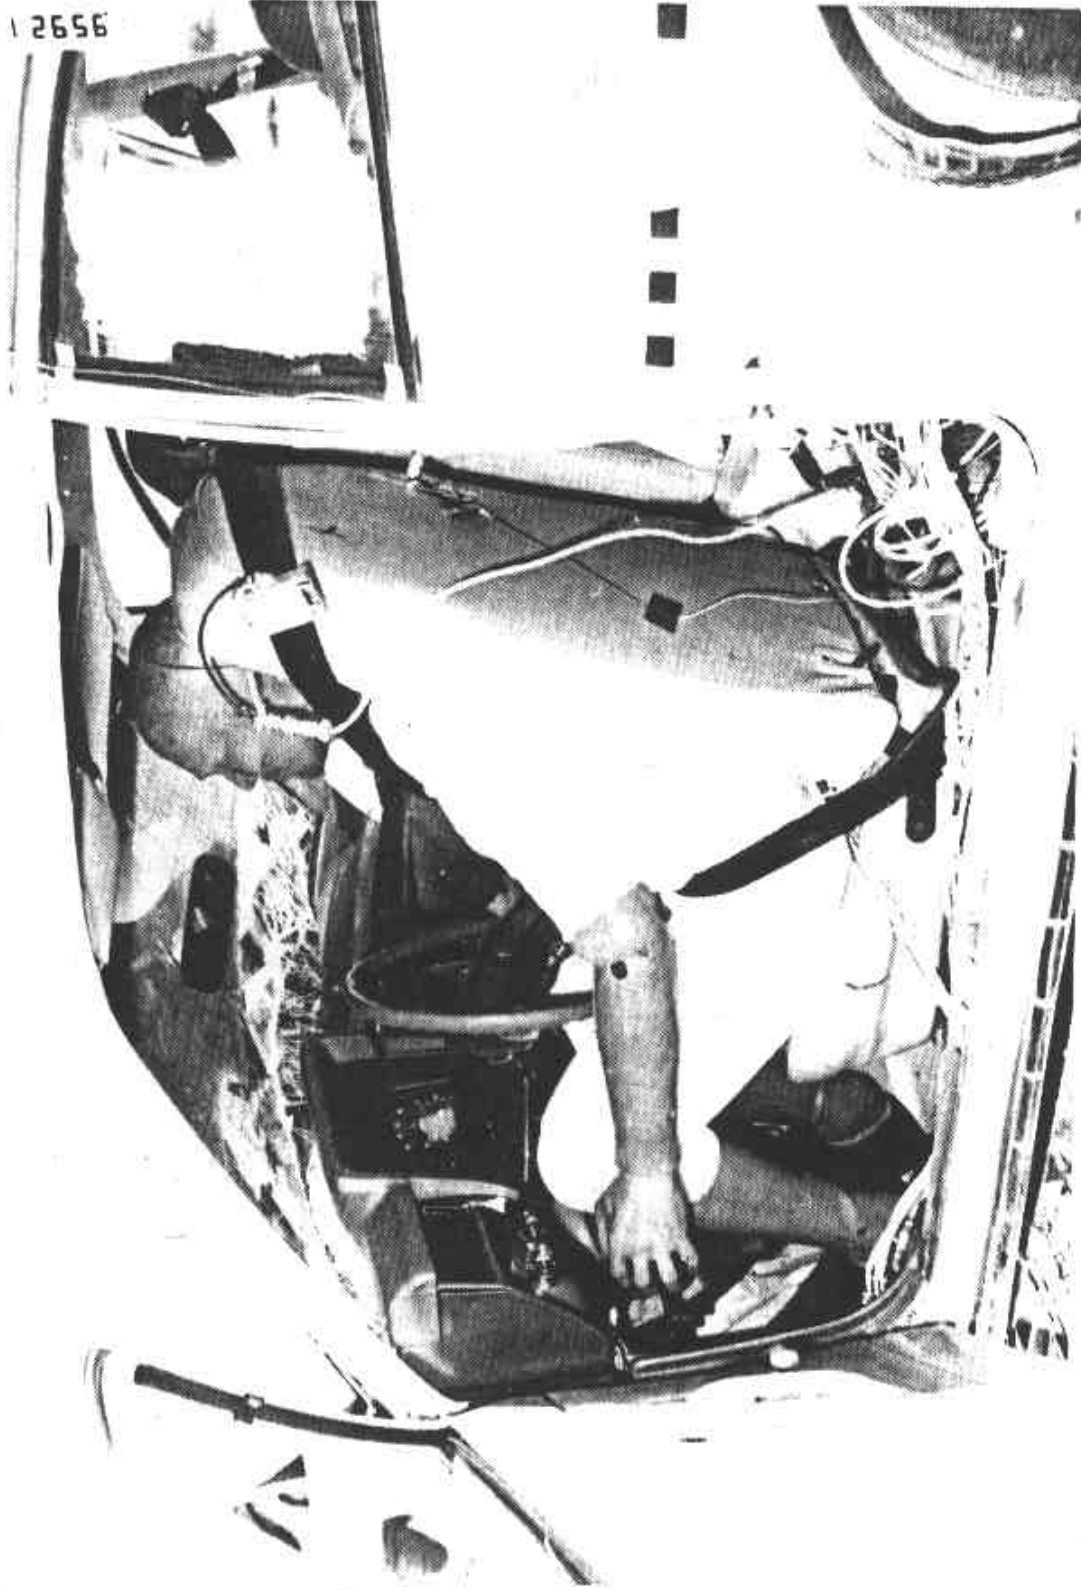
Figure 4-2. Post-test Driver Dummy Position - 1979 Mercury Bobcat 2-door Hatchback  
- NHTSA 790211.

<u>Driver</u>	<u>Passenger</u>	<u>Child</u>
Head	<u>Top of Steering Wheel</u>	<u>Dash</u>	<u>Seat Back</u>
Chest	<u>Steering Wheel</u>	<u>None</u>	<u>None</u>
Abdomen	<u>None</u>	<u>None</u>	<u>None</u>
Left Knee	<u>Dash</u>	<u>Glove Box</u>	<u>None</u>
Right Knee	<u>Dash</u>	<u>Glove Box</u>	<u>None</u>

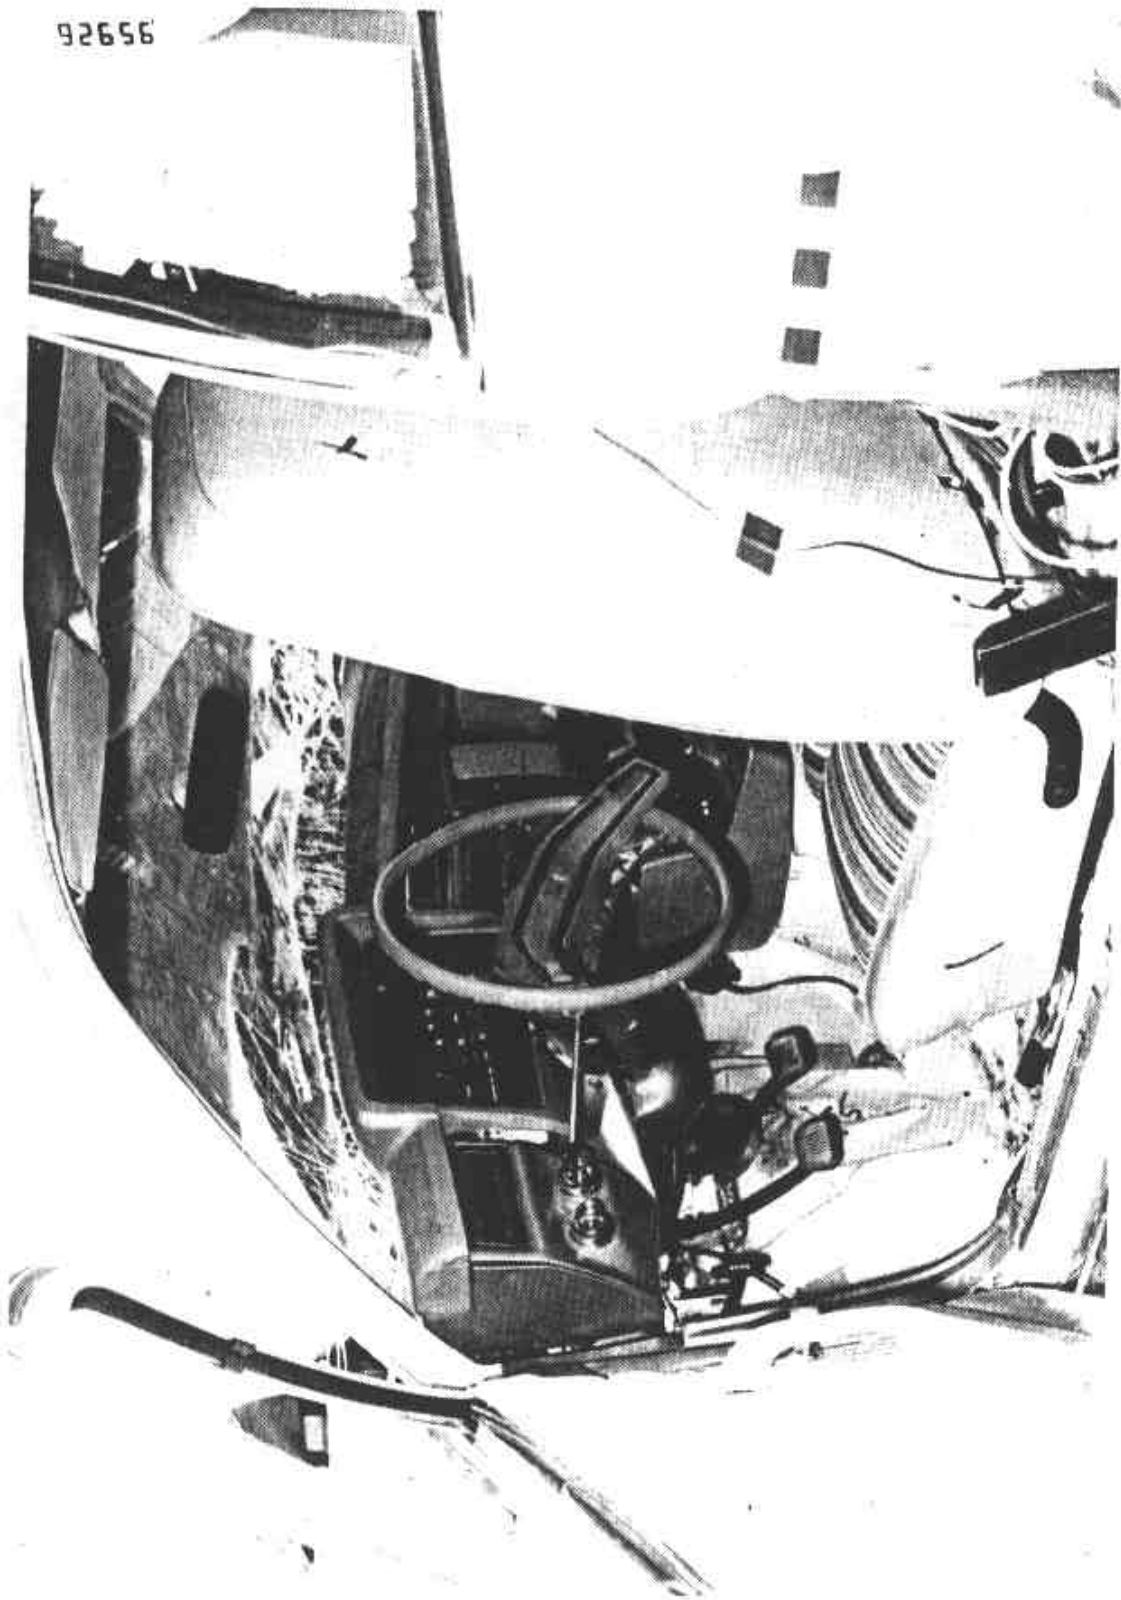
Figure 4-4. Post-test Driver Compartment - 1979 Mercury Bobcat 2-door Hatchback  
- NHTSA 790211.

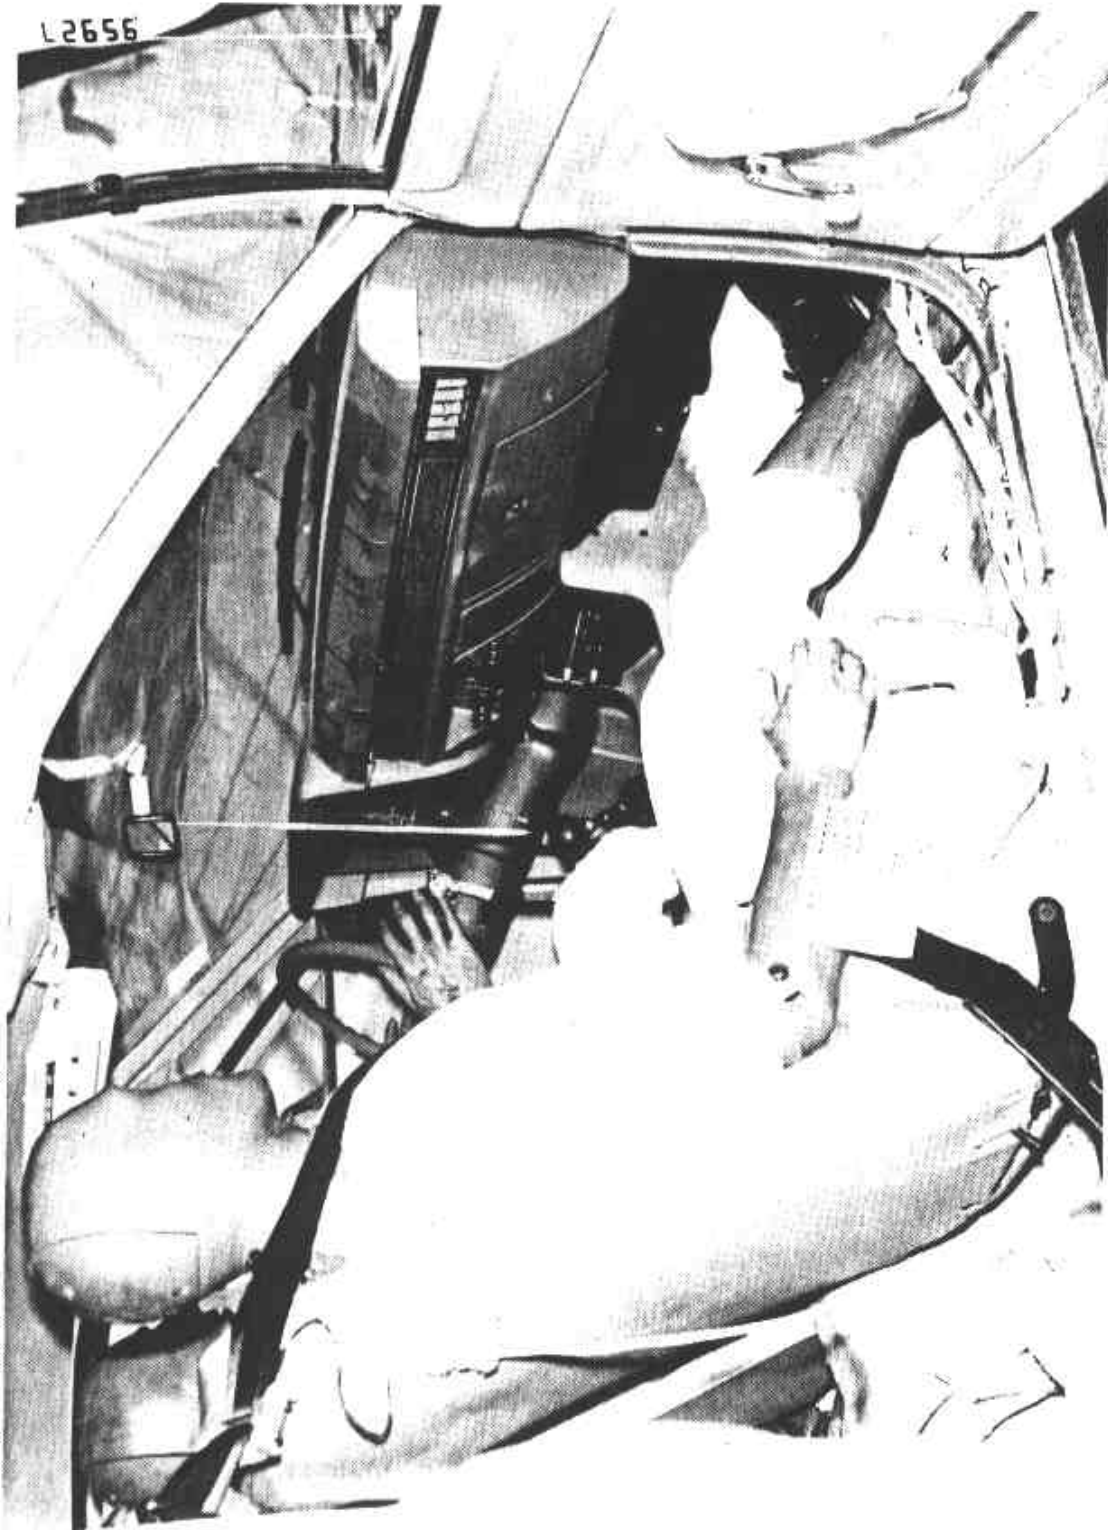
Figure 4-5. Pre-test Passenger Dummy Position - 1979 Mercury Bobcat 2-door Hatchback - NHTSA 790211.

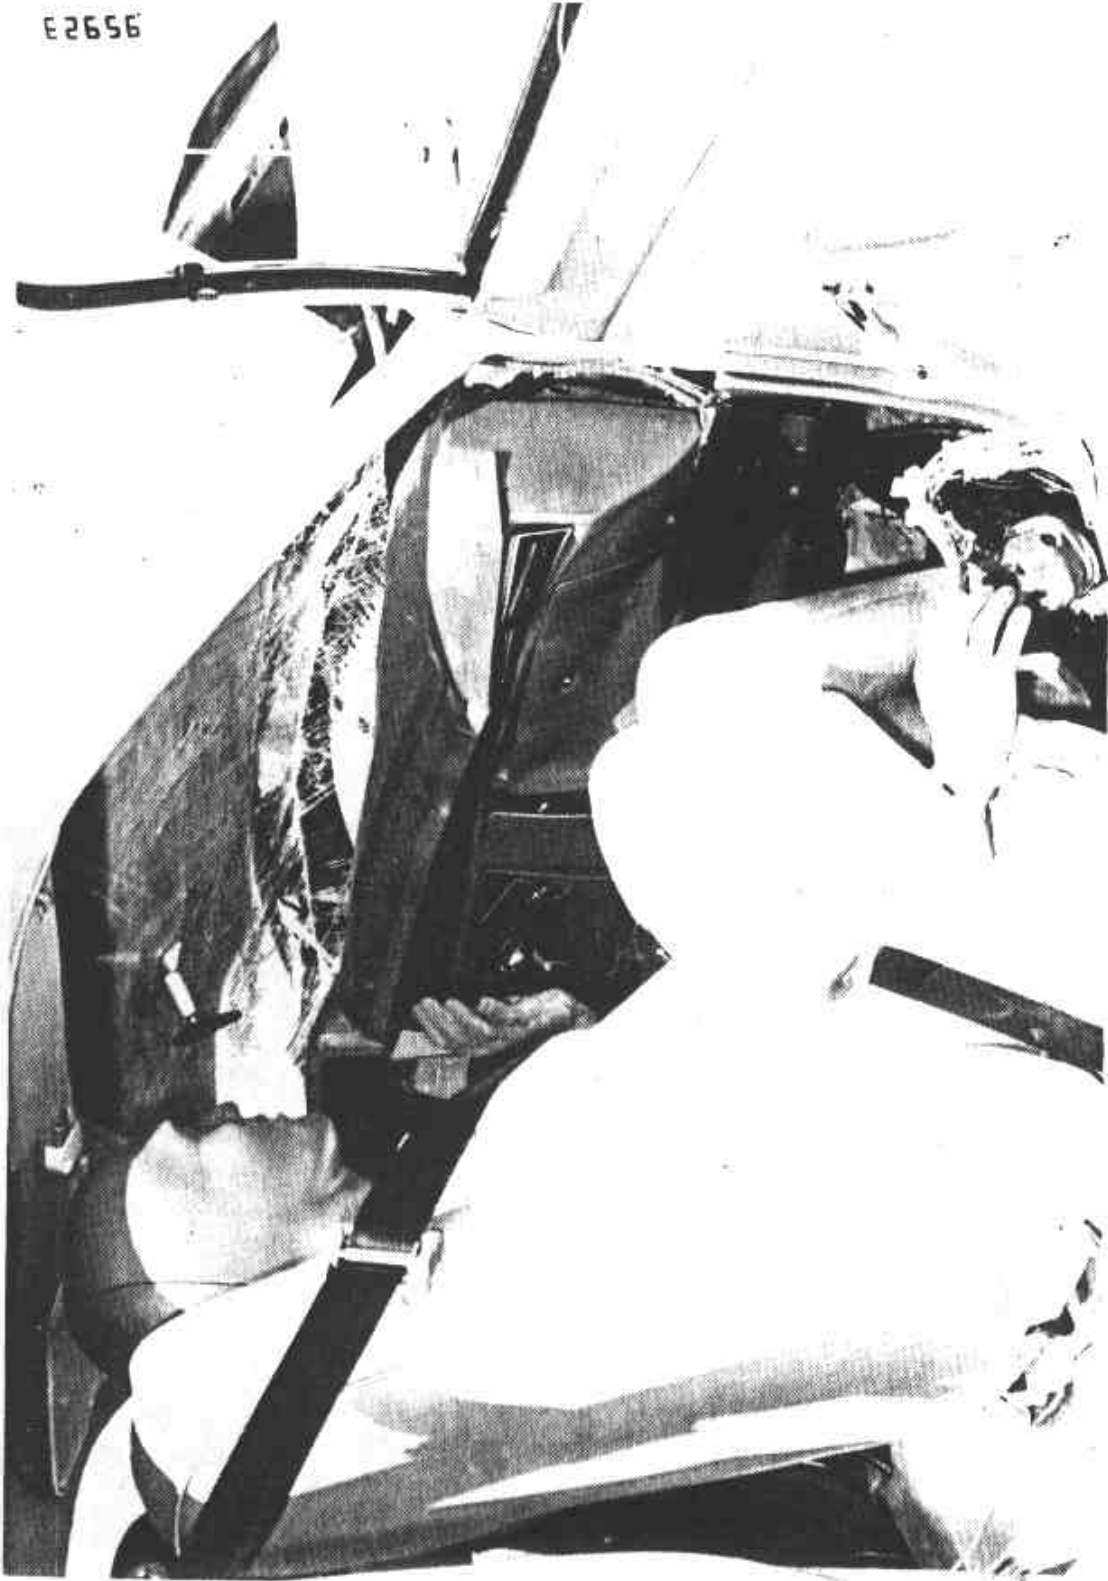
Figure 4-6. Post-test Passenger Dummy Position - 1979 Mercury Bobcat 2-door Hatchback  
- NHTSA 790211.

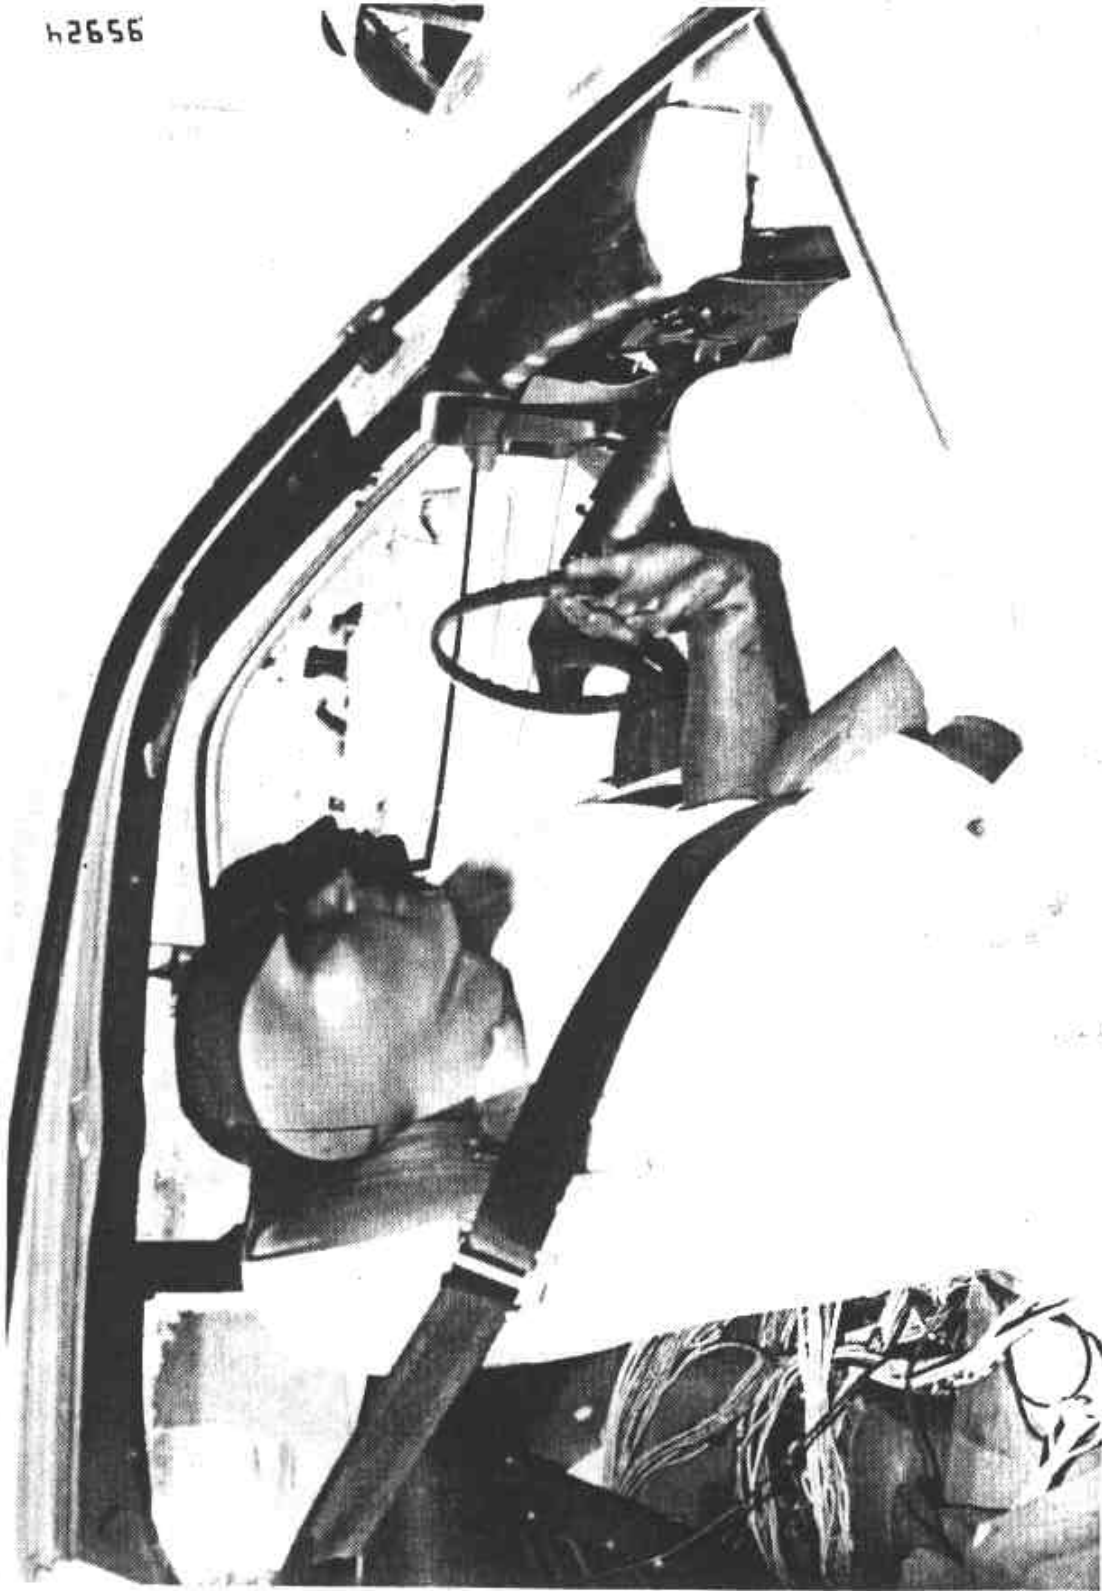
Figure 4-7. Post-test Passenger Dummy Position - 1979 Mercury Bobcat 2-door Hatchback  
- NHTSA 790211.

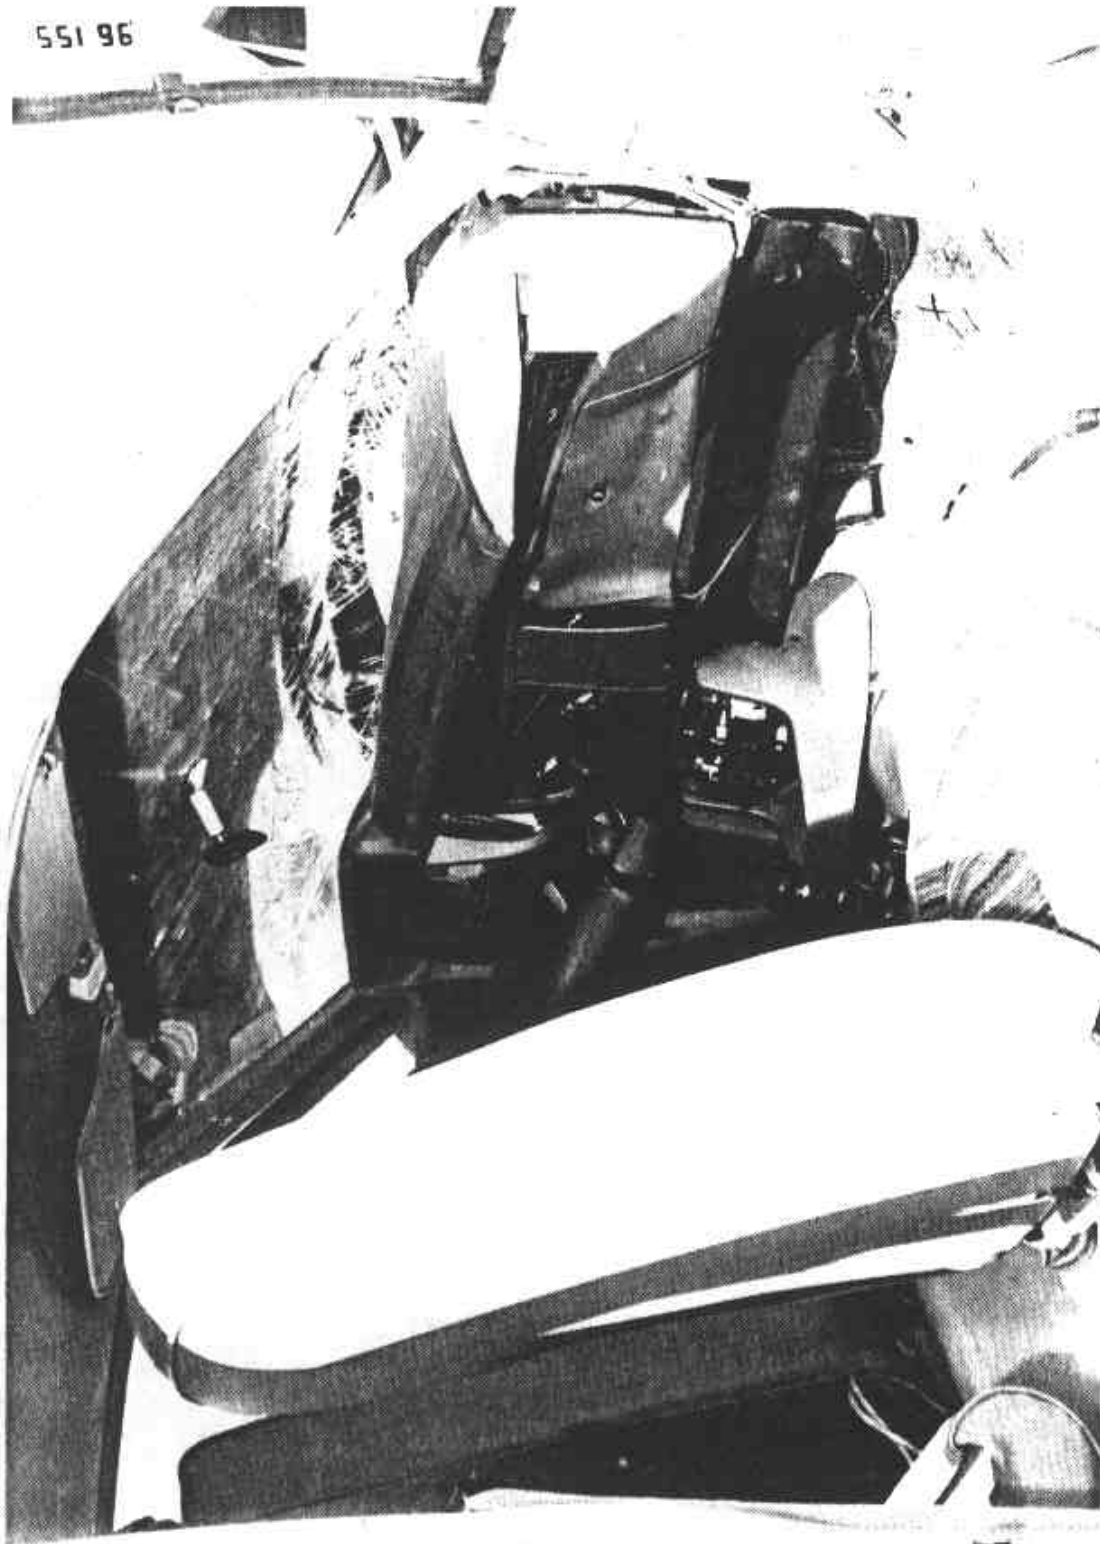
Figure 4-8. Post-test Passenger Compartment - 1979 Mercury Bobcat 2-door Hatchback -  
NHTSA 790211.

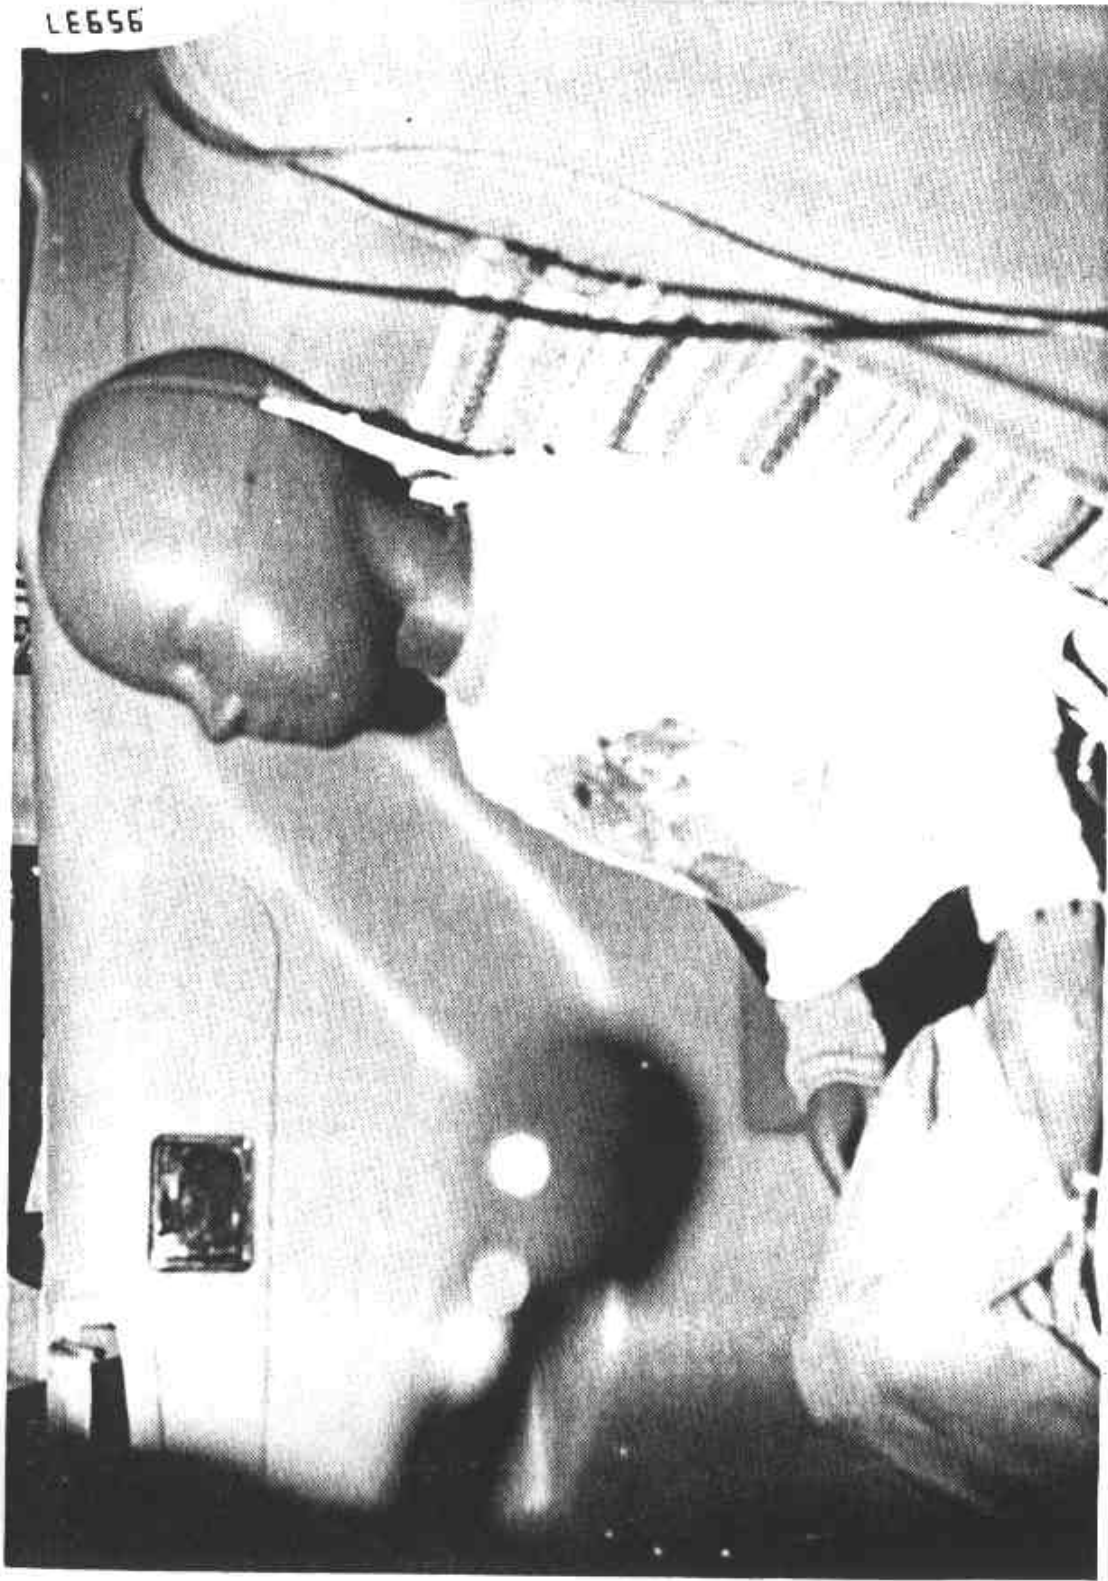
Figure 4-9. Pre-test Child Dummy Position - 1979 Mercury Bobcat 2-door Hatchback - NHTSA 790211.

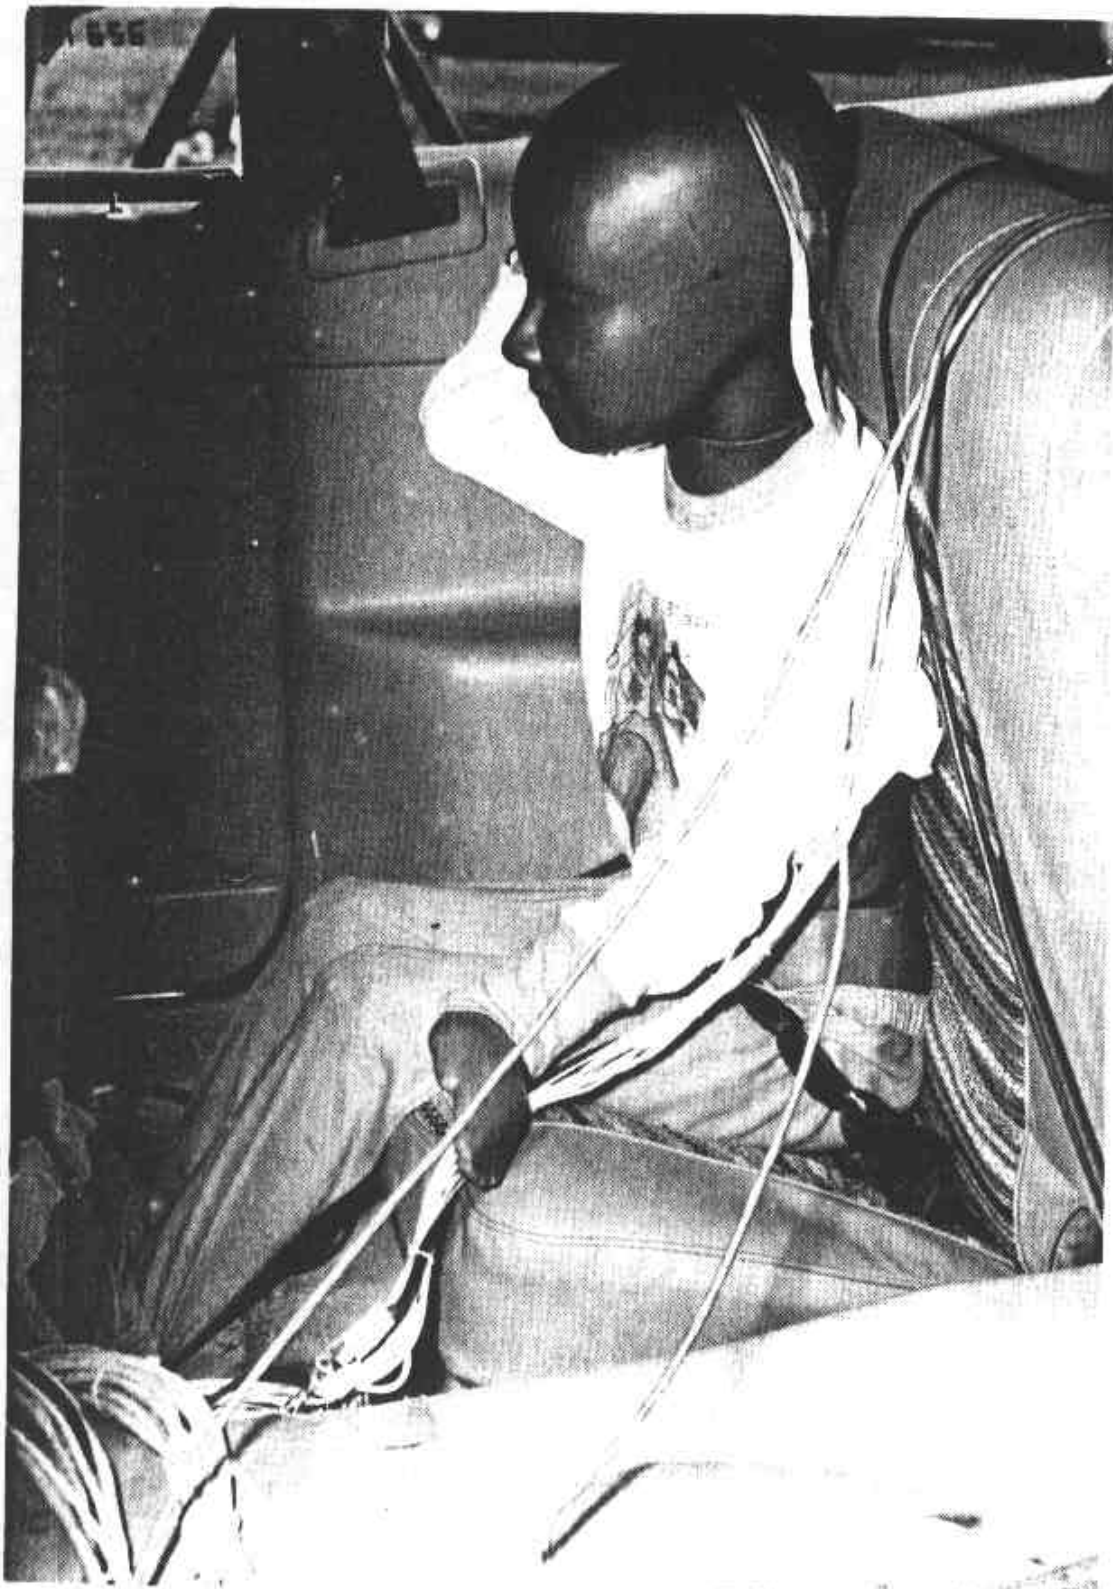
Figure 4-10. Post-test Child Dummy Position - 1979 Mercury  
Bobcat 2-door Hatchback - NHTSA 790211.  
4-20

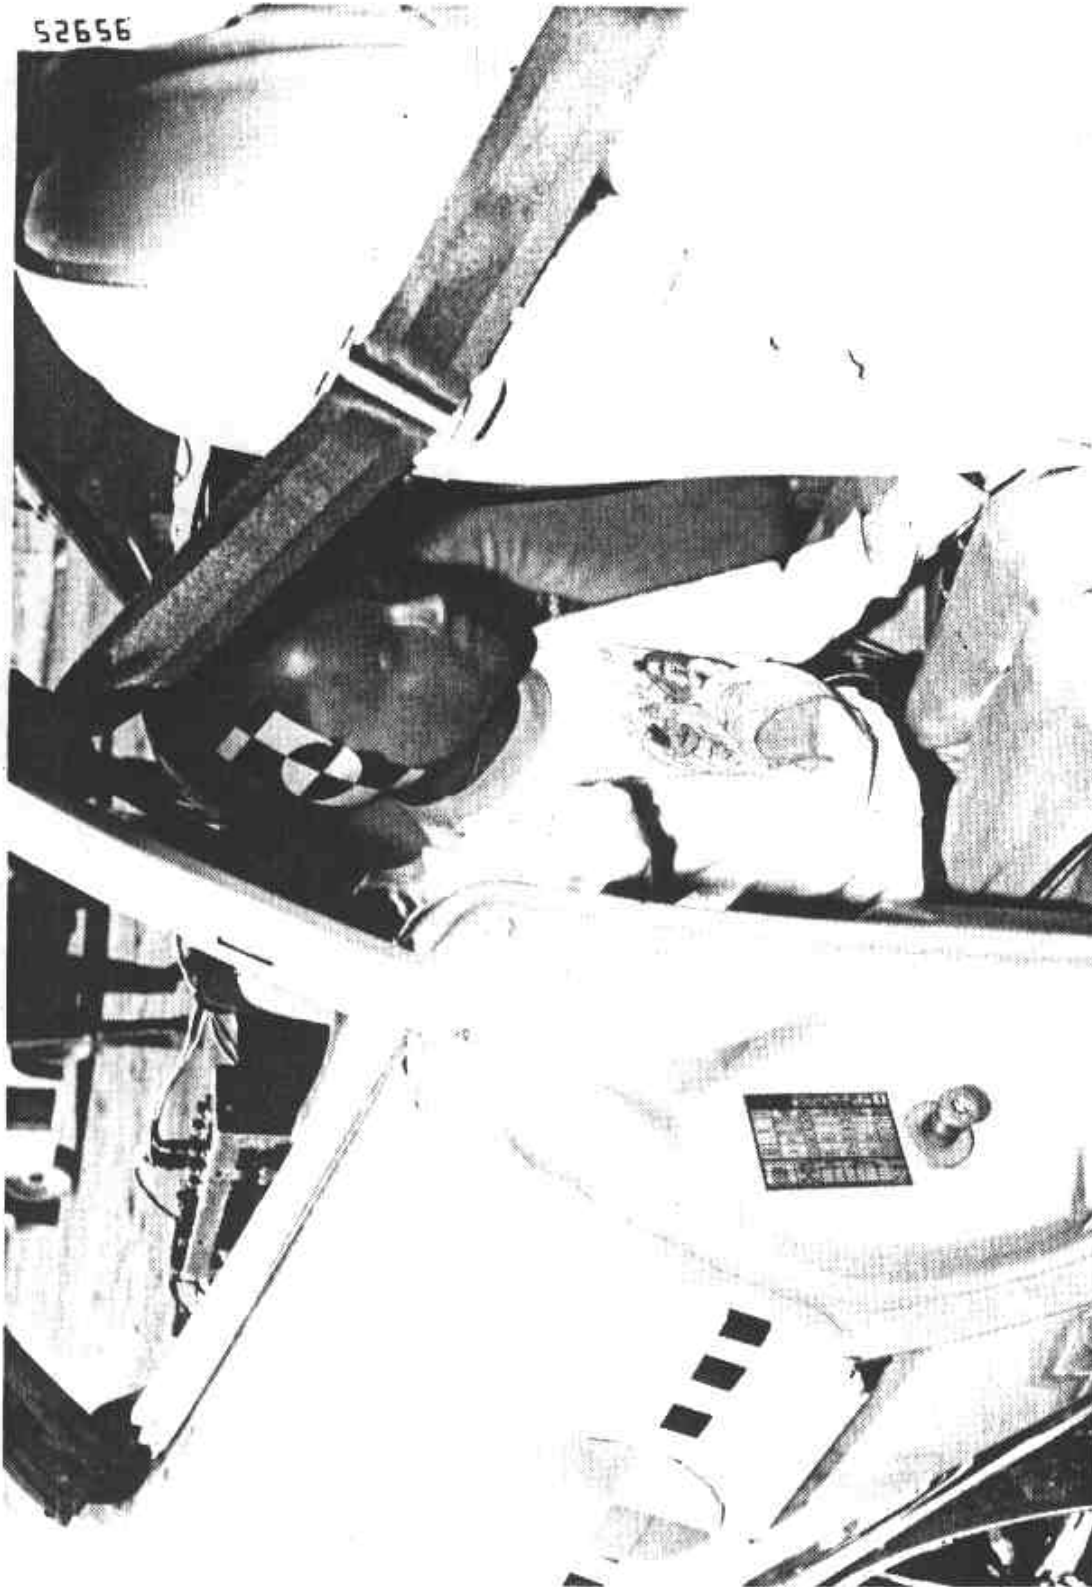
Figure 4-11. Post-test Child Dummy Position - 1979 Mercury Bobcat 2-door Hatchback - NHTSA 790211.

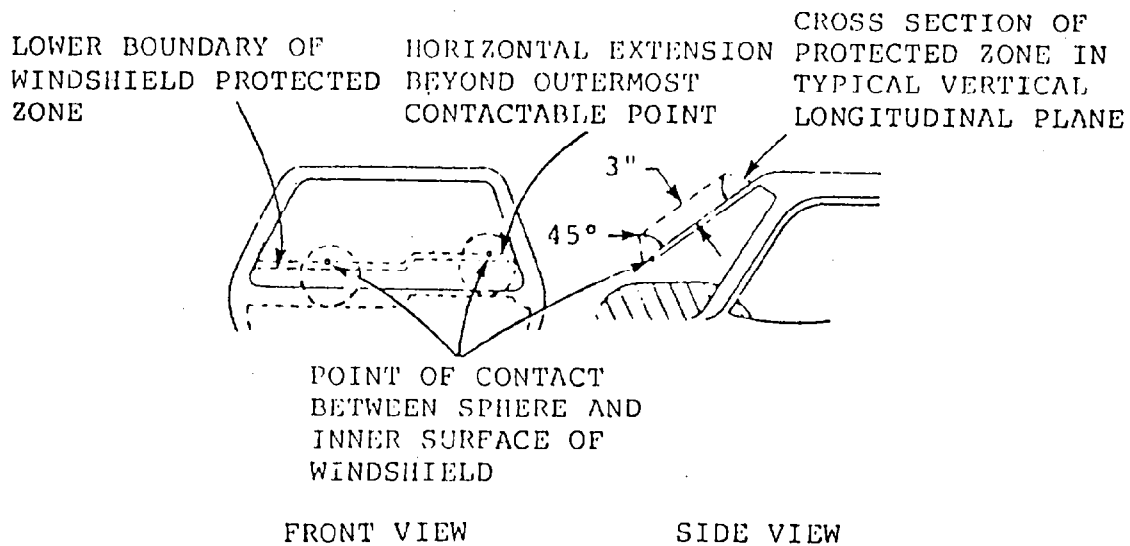
In order to determine whether or not there is any penetration into the protected zone, FMVSS No. 219 specifies that a template be formed of Styrofoam, type DB, cut cell, conforming to the shape of the zone and attached to the windshield. The Styrofoam exhibits essentially only plastic deformation characteristics, making it excellent for recording possible intrusion but difficult to shape to the windshield contour. The ultimate thickness of 3 inches is achieved by laminating six 1/2-inch-thick layers which can be individually bent to the windshield curvature, an operation not possible with 3-inch-thick Styrofoam because of its brittleness. The laminations are glued together in place on the windshield and the 45° bevel is applied to the perimeter of the template after it is bonded to the windshield.

Figure A-3. Windshield Protected Zone.

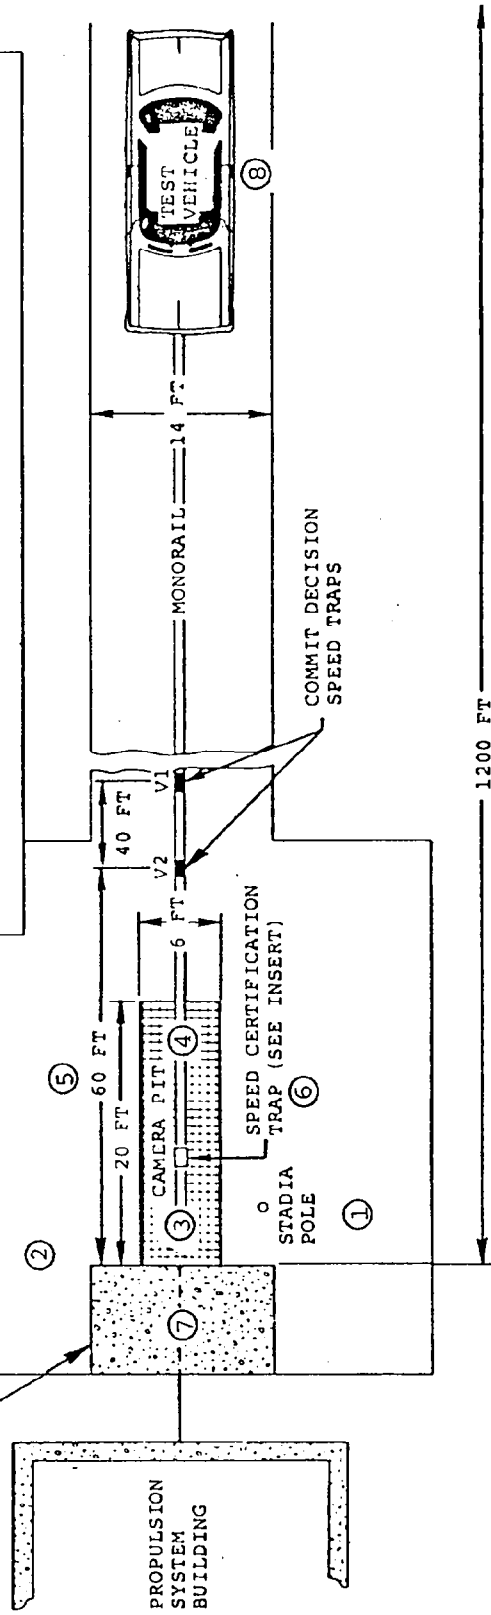
- ① LEFT SIDE OVERALL
- ② OFFBOARD RIGHT WIND-SHIELD
- ③ PIT (FRONT)
- ④ PIT (REAR)
- ⑤ RIGHT SIDE CLOSEUP PASSENGER DRIVER
- ⑥ LEFT SIDE CLOSEUP
- ⑦ BARRIER
- ⑧ OFFBOARD RIGHT CHILD
- ⑨ OFFBOARD RIGHT CLOSEUP

FIXED COLLISION BARRIER PER PART 571-1.1, PARA. 571-3-11242, 7-14-70

Figure A-4. FMVSS 301-75 and 219 (Frontal Impact Test) Barrier Test Site Layout.
