TASK 5 REPORT OF TESTS  
5.1, 5.2, AND 5.3 FOR  
DEVELOPMENT OF COMPLIANCE TEST  
FOR TRUCK REAR  
UNDERRIDE PROTECTION

November 1978

INTERIM REPORT

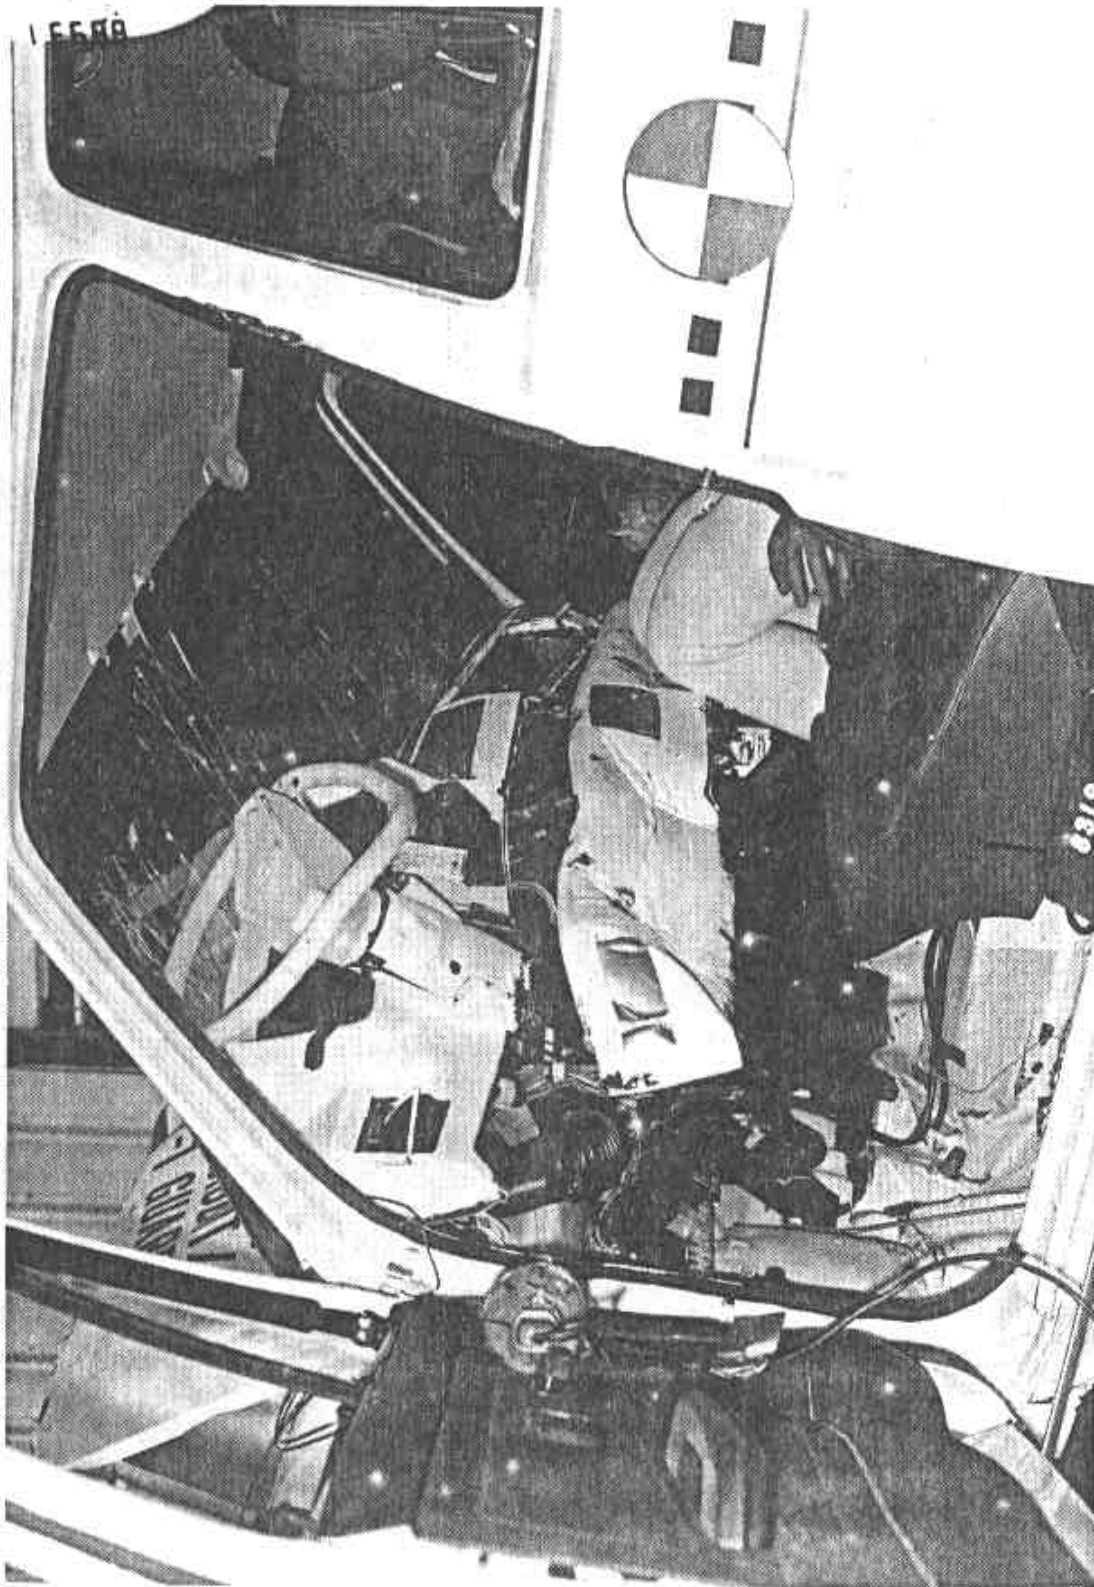
Test 5.3 Post-test View of Driver Compartment Damage.

The steering wheel moved rearward in the occupant compartment and rotated upward so that it made an angle of approximately 90 degrees with the ground. The driver dummy hit the steering wheel with his head and chest. The passenger dummy hit the dash board above the glove compartment. Both dummies hit the knee bolsters causing the knee bolster on the driver's side to break away from the dash panel. Static deformation of the pertinent areas of the vehicle (including steering wheel movement), and photographs of the pre- and post-test vehicle conditions are shown in Appendix C.
