OCCUPANT RESPONSE  
AND  
VEHICLE ACCELERATION  
IN A  
30-MPH FRONTAL CRASH TEST

VOLKSWAGEN OF AMERICA, INC.  
1978 VOLKSWAGEN RABBIT FOUR-DOOR  
CUSTOM HATCHBACK  
NHTSA 780526

FINAL REPORT

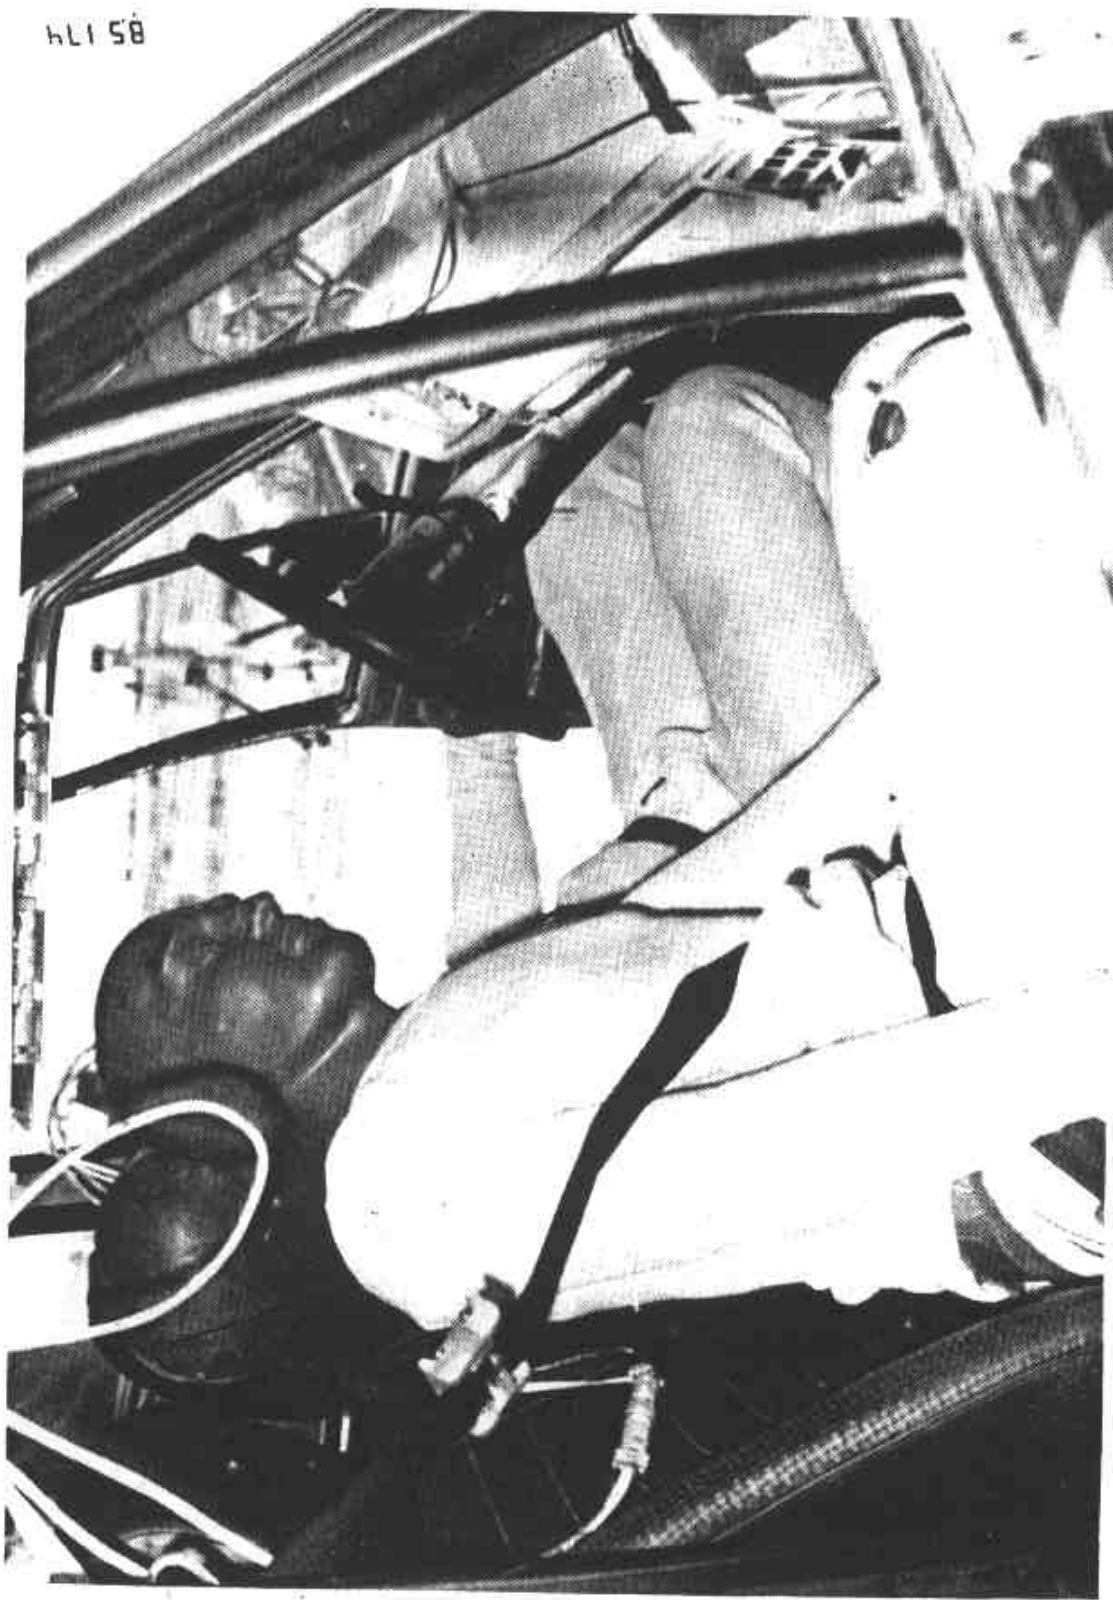
Figure 3-4. Post-test View of Passenger Dummy - 1978 Volkswagen Rabbit Four-Door Custom Hatchback - NHTSA 780526.

Figures 3-1 through 3-4 are pre-test and post-test views of the occupant compartment, restraint systems, and dummies.

- Steering wheel and dash rotated upward.
- Body damage to "B" pillar.
- Right wheel rotated to right, independent of left.
- Both front wheels locked up.
- Both front doors bowed out at forward edge.
