OCCUPANT RESPONSE  
AND  
VEHICLE ACCELERATION  
IN A  
30-MPH FRONTAL CRASH TEST

GENERAL MOTORS CORPORATION  
1978 BUICK LESABRE TWO-DOOR SEDAN  
NHTSA 780109

FINAL REPORT

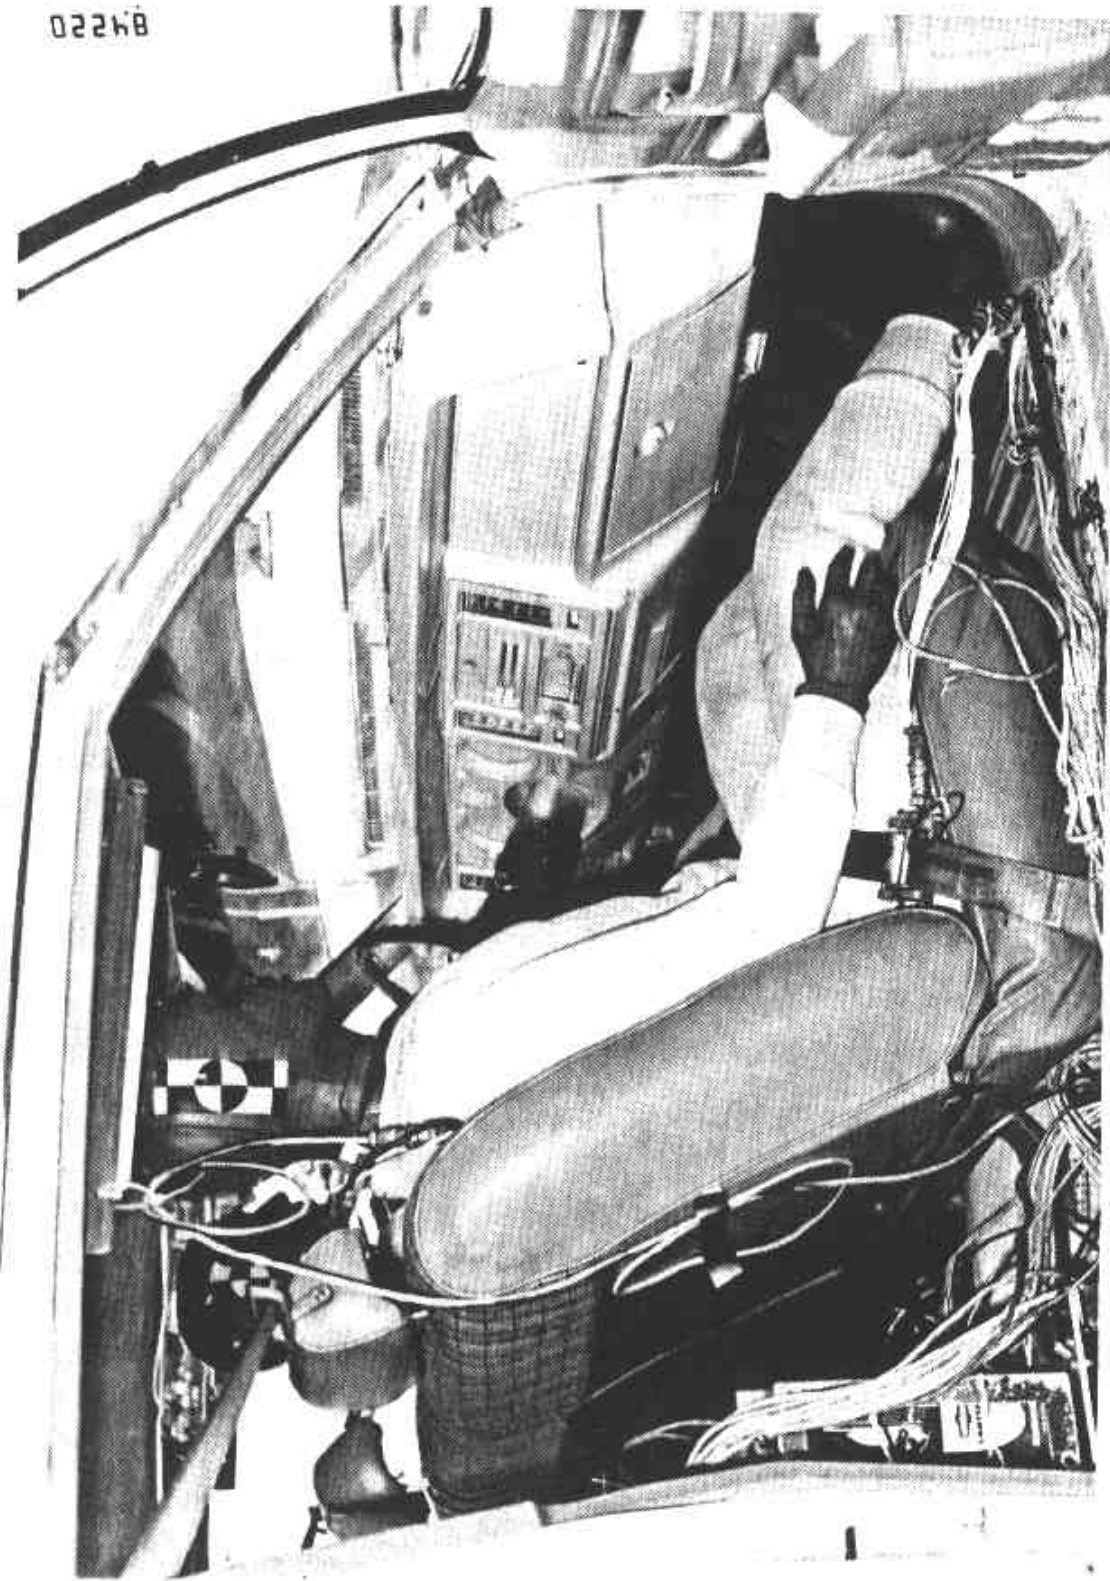
Figure 3-2. Pre-test View of Passenger Dummy - 1978 Buick LeSabre Two-Door Sedan -  
NHTSA 780109.

Figures 3-1 through 3-3 are pre-test and post-test views of the occupant compartment, restraint systems, and dummies.

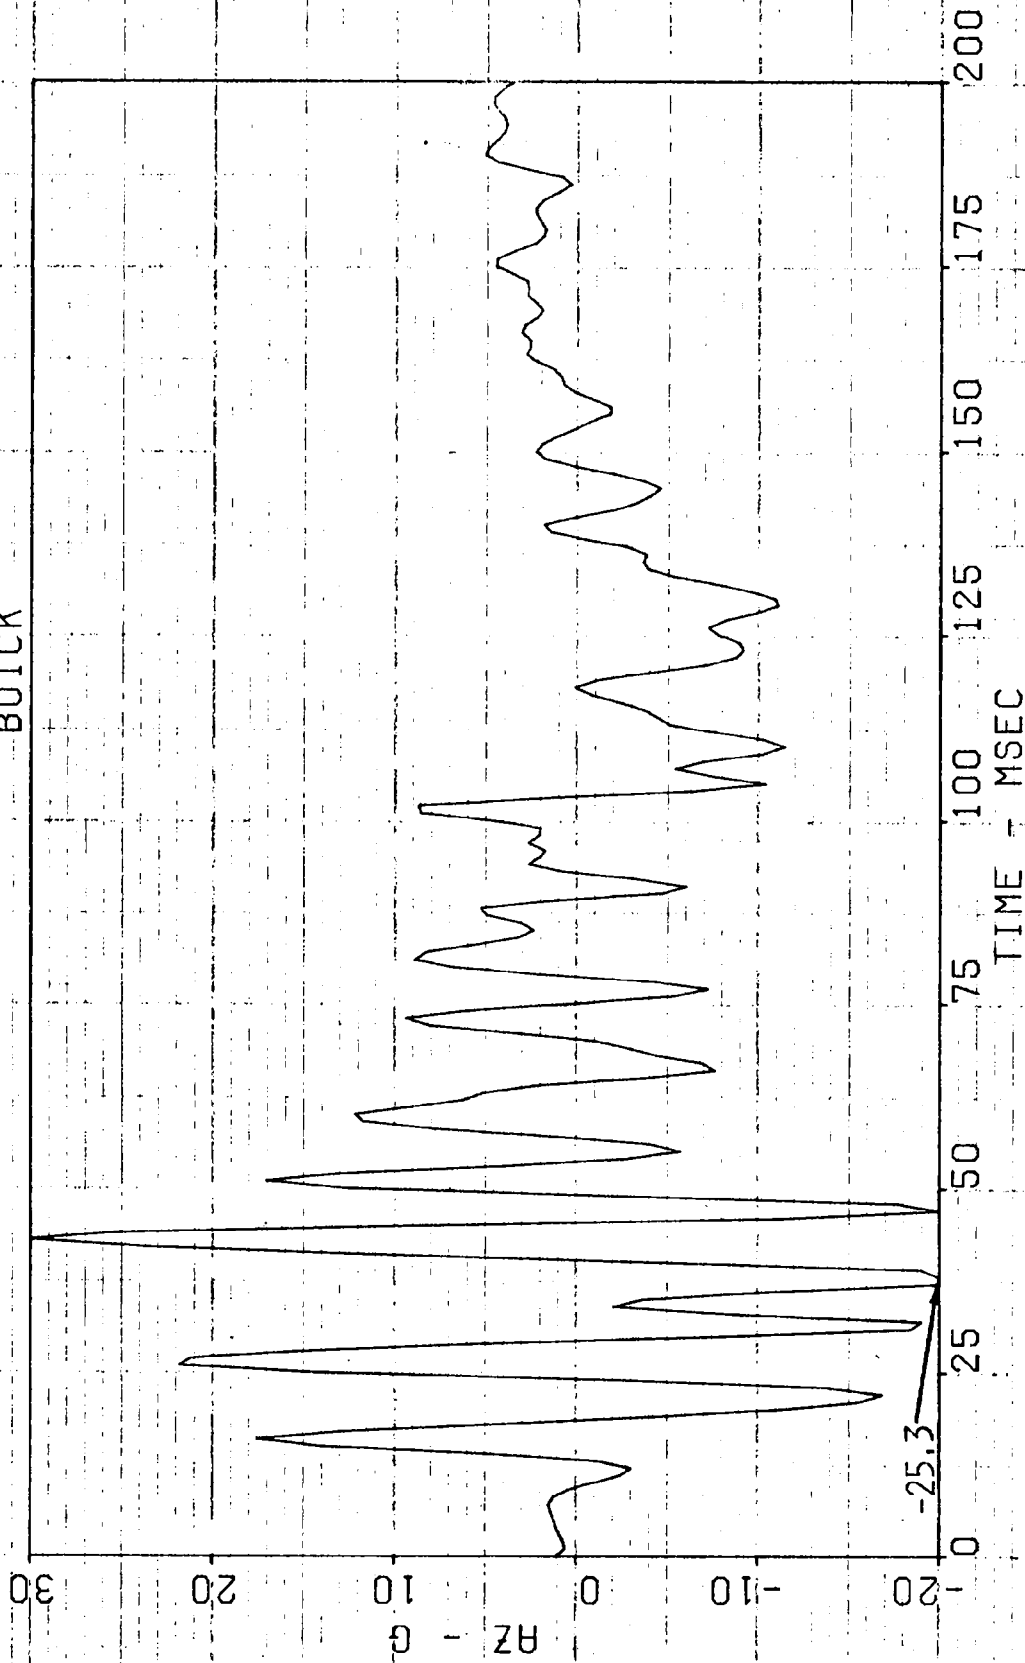
DATE 5-17-78 FILTER 315/100 LOCATION 104 TEST NO 062378  
FRONT/BARR  
BUICK
