Dynamic Science Report No. 212-DYS-79-014  
Dynamic Science Report No. 219-DYS-79-013  
Dynamic Science Report No. 301-DYS-79-027

NEW VEHICLE ASSESSMENT AND  
STANDARDS ENFORCEMENT INDICANT  
TESTING

FMVSS 212, 219, AND 301-75

GENERAL MOTORS CORPORATION  
1979 OLDSMOBILE CUTLASS 2-DOOR SEDAN  
NHTSA NO. 790107

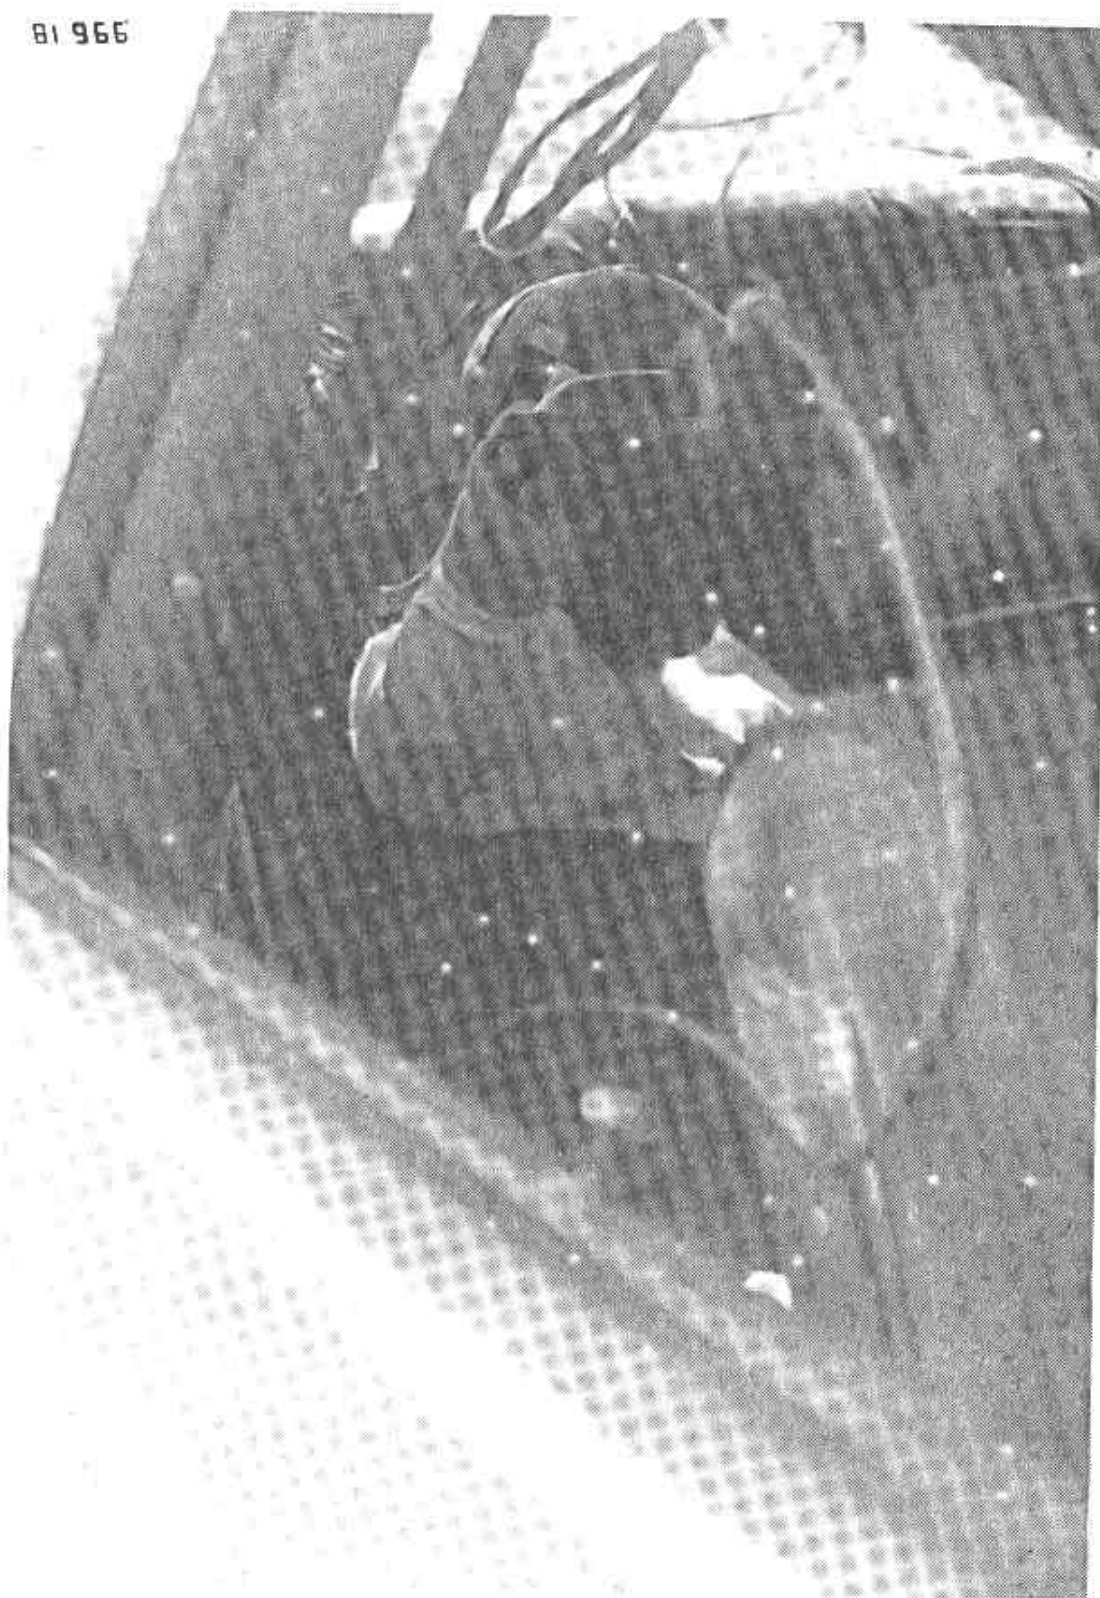
Figure 4-12. Post-test Child Dummy Position - 1979  
Oldsmobile Cutlass - NHTSA 790107.

CHILD - Struck Framework of passenger seat bottom with forehead, as well as striking its own legs. Dummy head grazed upper passenger seat back on rebound, and came to rest upright with left arm overhead and right arm flung to the side.
