LIGHT TRUCK AGGRESSIVITY STUDY

TEST REPORT 2

TRUCK-TO-CAR 90° LEFT SIDE

IMPACT TESTS

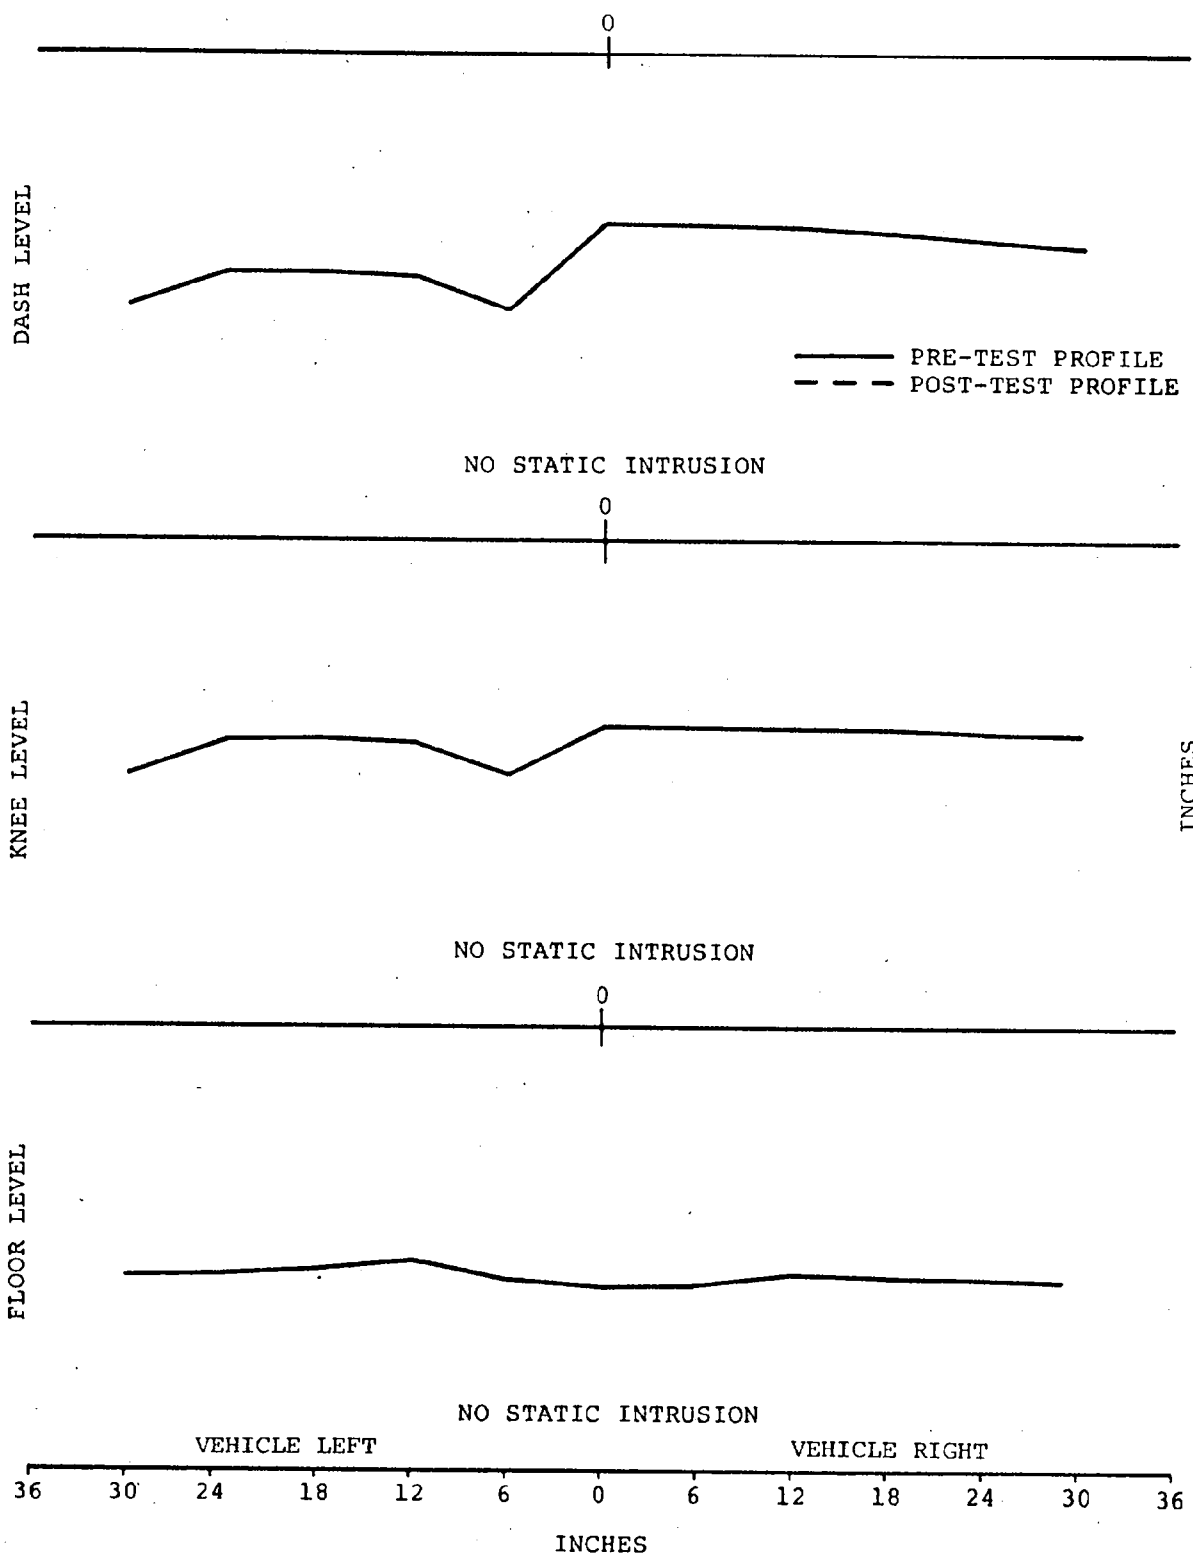
Figure 2-10. Chevrolet C-10 Truck Interior Intrusion (Test 3051-3).
