REPORT NO. 6525-V-40

NEW CAR ASSESSMENT AND STANDARDS  
ENFORCEMENT INDICANT TESTING  
FMVSS NOS. 212, 219 AND 301-75

Ford Motor Company  
1981 Ford Escort 2-Door Hatchback  
NHTSA 308-40-503

CALSPAN CORPORATION  
ADVANCED TECHNOLOGY CENTER  
P. O. BOX 400  
BUFFALO, NEW YORK 14225

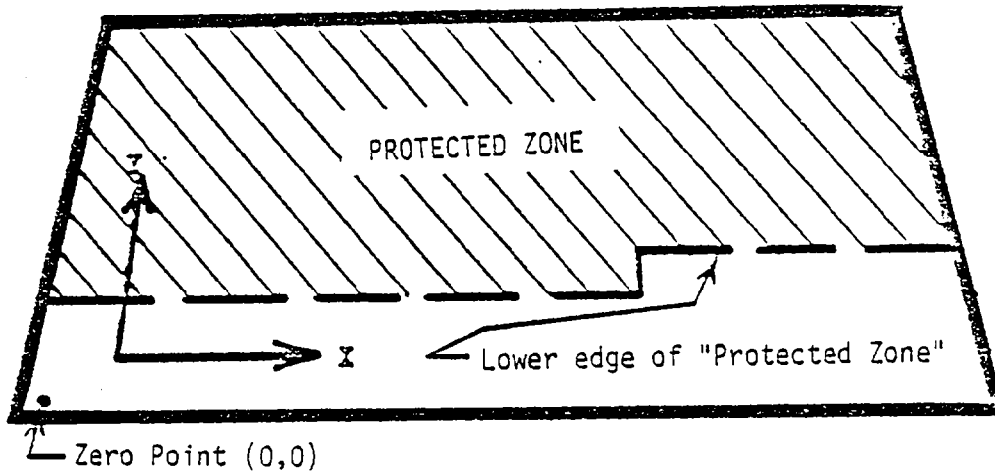
FIGURE 1 WINDSHIELD ZONE INTRUSION, FMVSS 219 - DATA SHEET

FRONT VIEW

With the zero coordinate for the X-Y grid located at the lower right corner (passenger side) of the windshield, record the following positions:

- (1) The area that the "Protected Zone" template was penetrated more than .25 inches by a vehicle component other than one which is normally in contact with the windshield.

None

- (2) The area beneath the "Protected Zone" that the inner surface of the windshield was penetrated by a vehicle component.

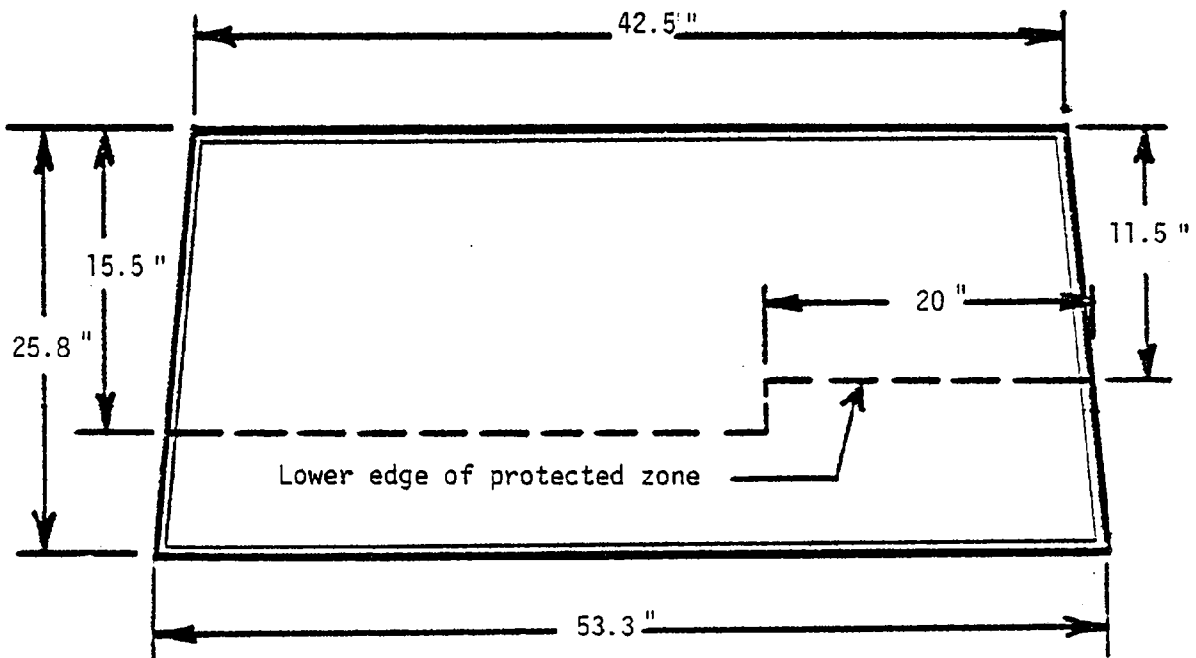
FIGURE 2: PROTECTED ZONE

Provide all dimensions necessary to reproduce the protected zone.

Method of adhering styrofoam to the windshield:

RTV adhesive applied to windshield surface and to back-side of  
styrofoam which was then clamped in place until dry.

Details of windshield mounting (method of retention, type of trim, etc.):

Windshield is bonded in place and has a three-quarter inch chrome piece  
around the perimeter of the window.

Windshield Periphery		Retention %
	Pre-Test	Post-Test	
Right Side	73.7	73.7	100
Left Side	73.7	73.7	100
TOTAL	147.4	147.4	100

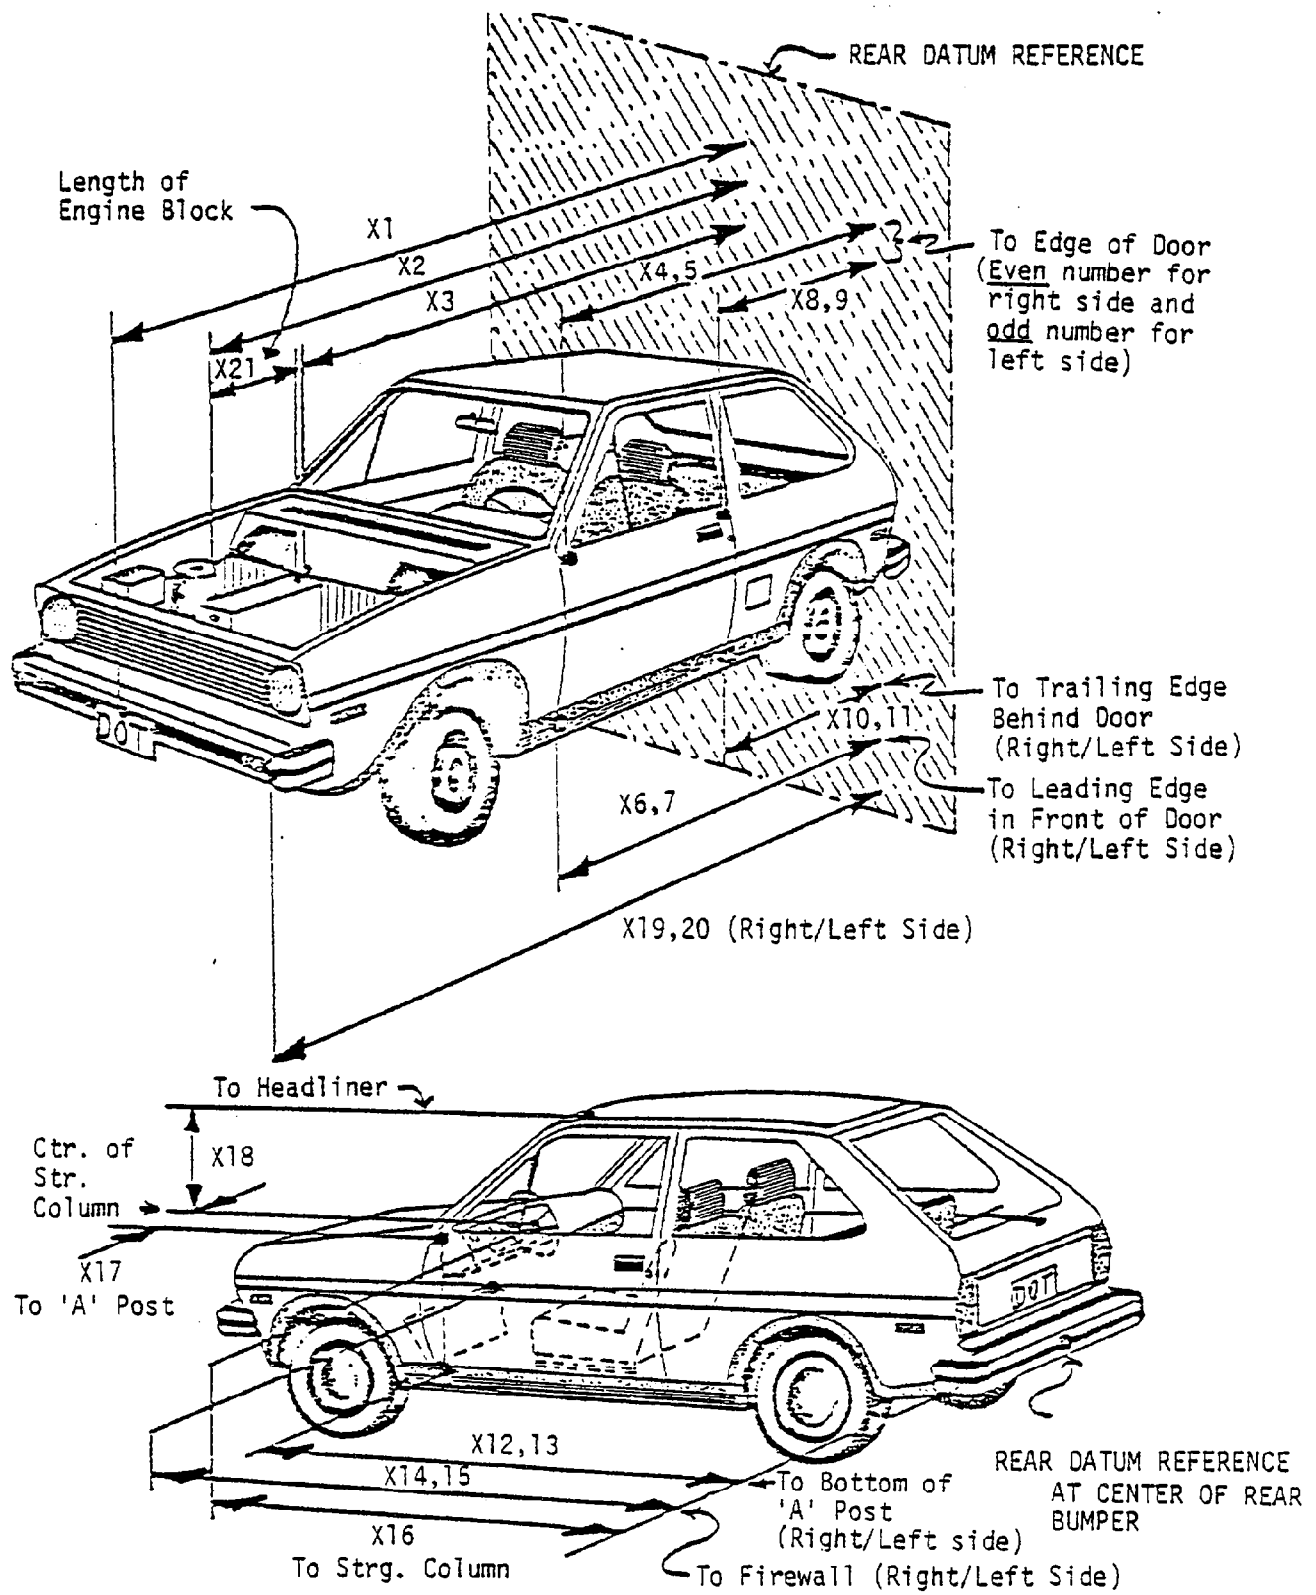
FIGURE 4 PRE-TEST AND POST-TEST MEASUREMENT POINTS

1981 Ford Escort

NO.	TYPE OF MEASUREMENT	ALL DIMENSIONS IN INCHES		Dif
		PRE-TEST	POST TEST	
X1	Total Length of Vehicle at Centerline	165.7	142.8	22
X2	Rear Surface of Vehicle to Front of Engine	143.6	134.7	8
X3	Rear Surface of Vehicle to Firewall	124.9	120.4	4
X4	Rear Surface of Vehicle to Upper Leading Edge of Right Door	111.	110.3	1
X5	Rear Surface of Vehicle to Upper Leading Edge of Left Door	111.6	109.1	2
X6	Rear Surface of Vehicle to Lower Leading Edge of Right Door	110.7	109.4	1
X7	Rear Surface of Vehicle to Lower Leading Edge of Left Door	110.8	108.5	2
X8	Rear Surface of Vehicle to Upper Trailing Edge of Right Door	64.3	63.1	1
X9	Rear Surface of Vehicle to Upper Trailing Edge of Left Door	64.3	62.8	1
X10	Rear Surface of Vehicle to Lower Trailing Edge of Right Door	64.2	63.1	1
X11	Rear Surface of Vehicle to Lower Trailing Edge of Left Door	64.2	62.8	1
X12	Rear Surface of Vehicle to Bottom of "A" Post of Right Side	108.1	106.0	2

X13	Rear Surface of Vehicle to Bottom of "A" Post of Left Side	108.0	104.3	3
X14	Rear Surface of Vehicle to Firewall - Right Side	122.5	114.8	7
X15	Rear Surface of Vehicle to Firewall - Left Side	123.2	116.8	6
X16	Rear Surface of Vehicle to Steering Column	94.8	920	2
X17	Center of Steering Column to "A" Post	14.6	15.1	-
X18	Center of Steering Column to Headliner	17.0	16.6	
X19	Rear Surface of Vehicle to Right Side of Front Bumper	162.4	142.2	20
X20	Rear Surface of Vehicle to Left Side of Front Bumper	162.4	141.0	21
X21	Length of Engine Block	12.3	12.3	
X22	Dash to Rear Deck	90.4	88.6	1

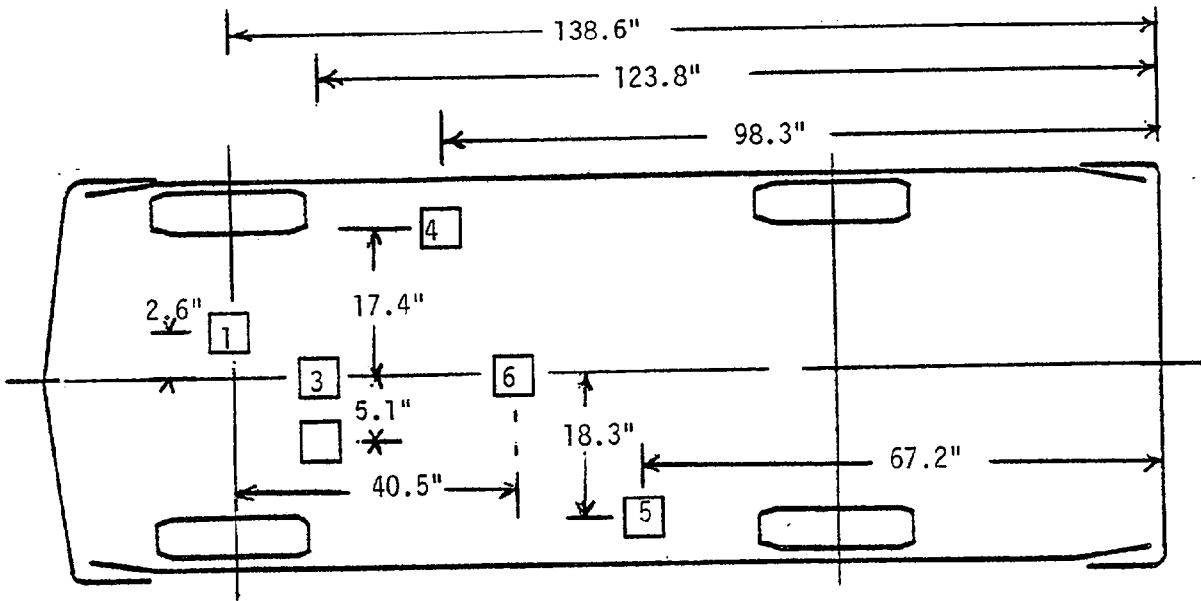
FIGURE 5 VEHICLE ACCELEROMETER LOCATIONS

ACCELEROMETER NUMBER *	ACCELEROMETER LOCATION	DIRECTION		
		X	Y	Z
1	Engine	X		X
2	Firewall Above Steering Column	X		X
3	Firewall at Vehicle Centerline	X		X
4	Front Seat Crossmember	X		X
5	Rear Seat Crossmember	X		X
6	Center of Gravity	X	X	X

\*The accelerometer pack number can be correlated with the vehicle response data traces found in Appendix B.

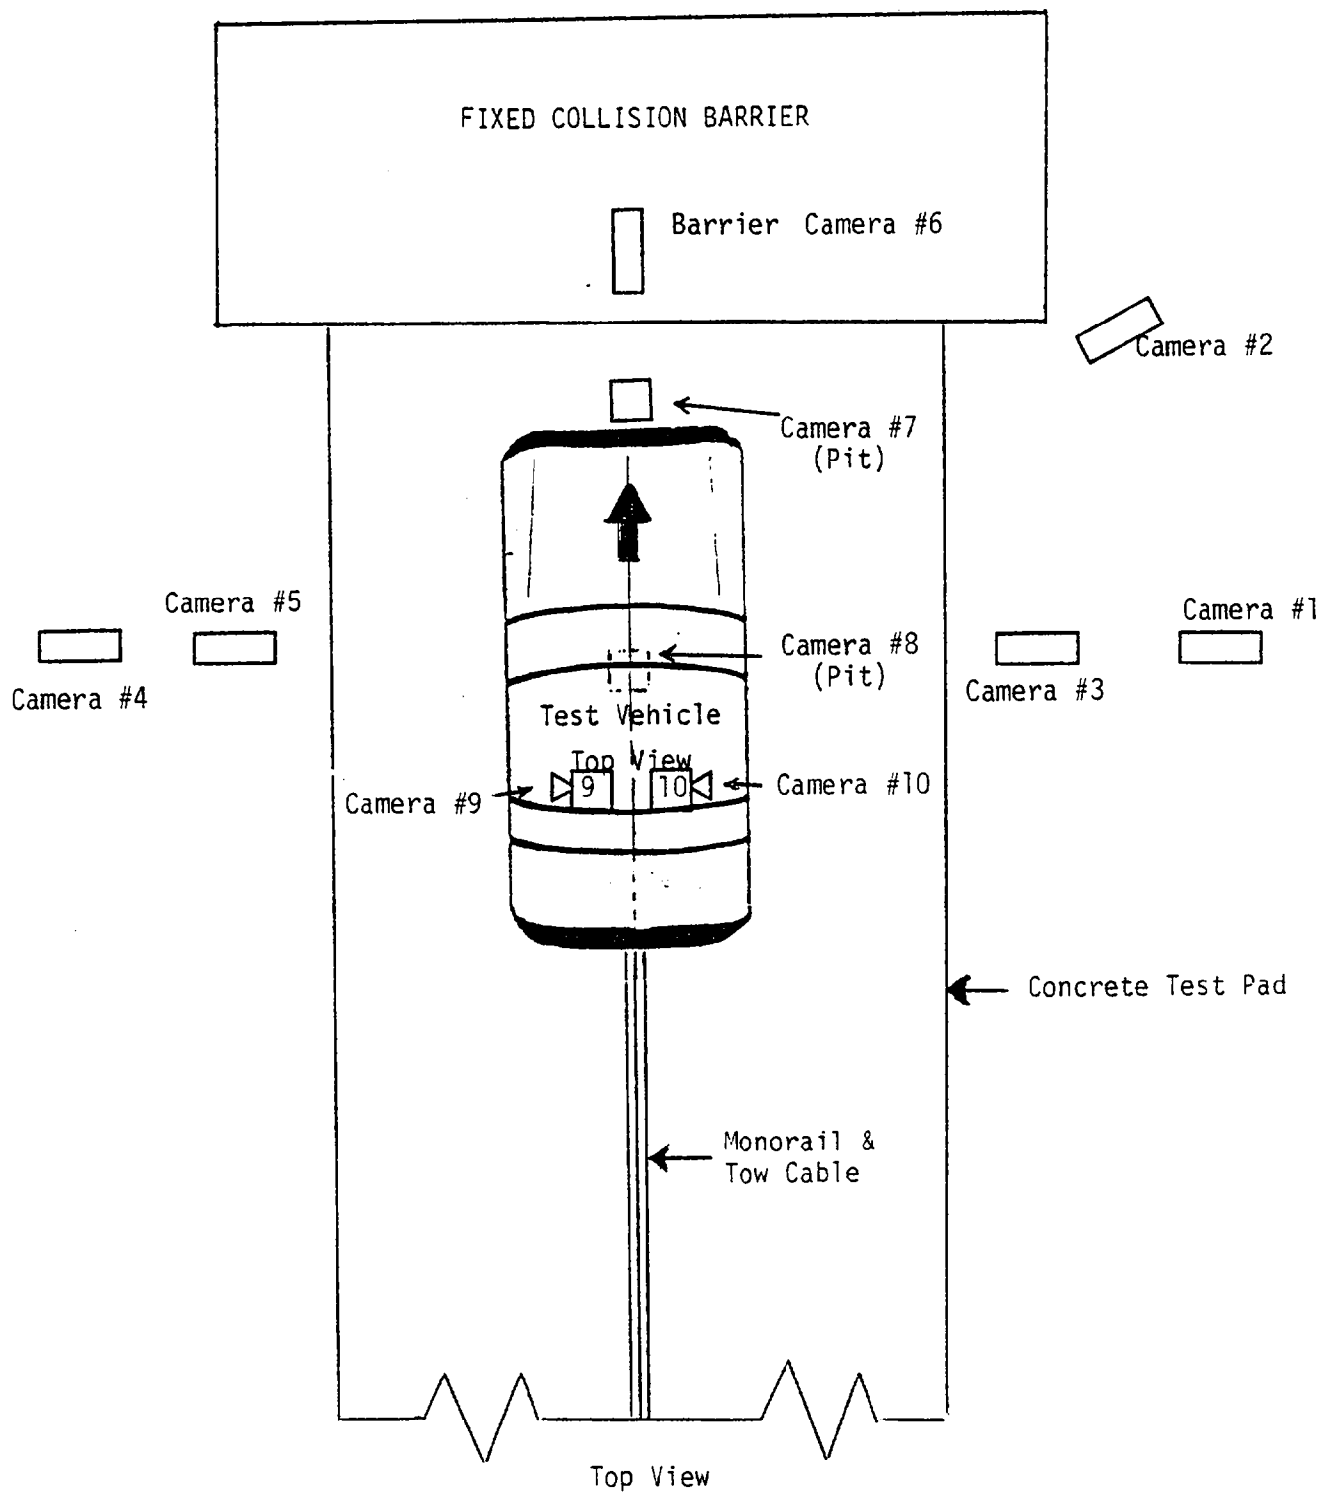
FIGURE 6 CAMERA POSITION FOR FRONTAL IMPACTS

NOTE: Camera Information Shown on Tables 7 and 8.
