NEW VEHICLE ASSESSMENT  
AND  
STANDARDS ENFORCEMENT INDICANT TESTING

FMVSS 301-75

FUJI HEAVY INDUSTRIES LTD.  
1980 SUBARU GL - 4 DOOR SEDAN  
NHTSA 800530

FINAL REPORT

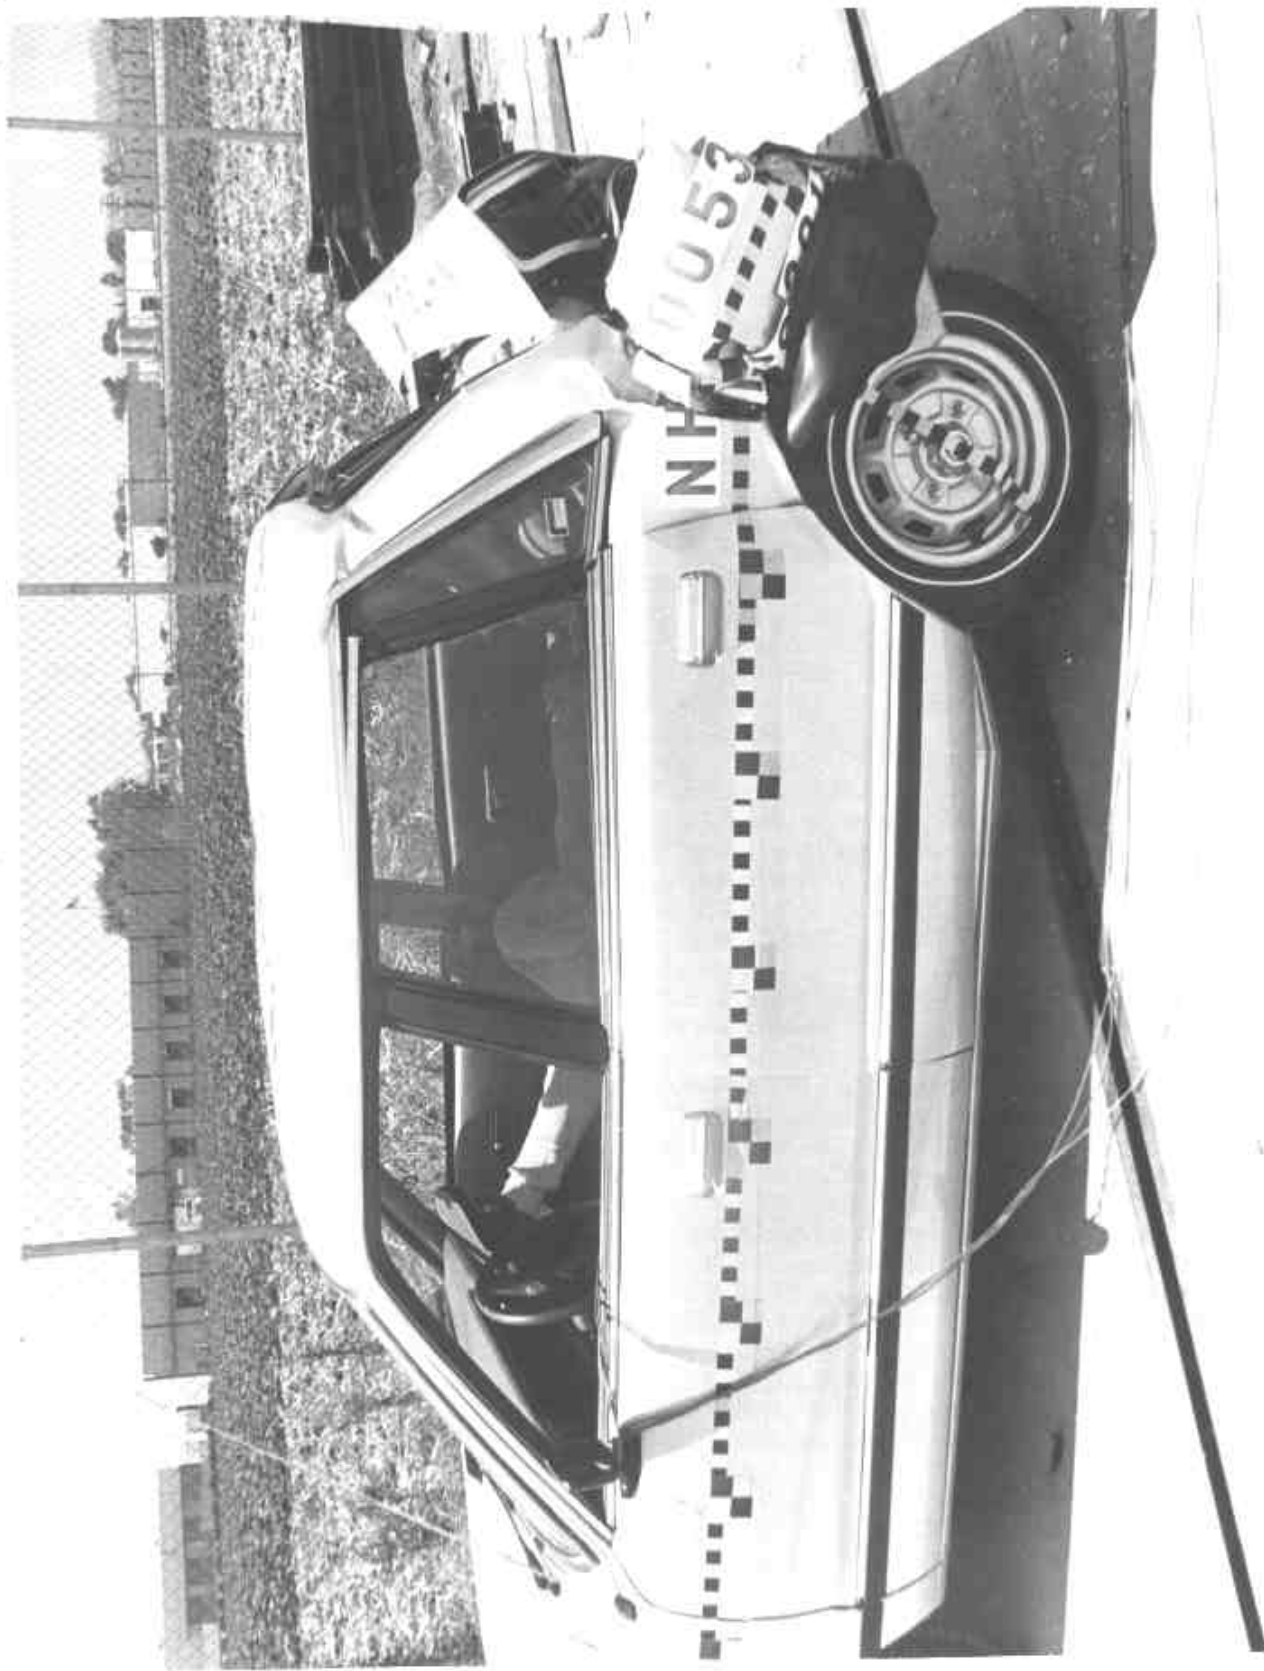
Figure 3-4  
1980 Subaru GL - 4 Door Sedan  
NHTSA 800530  
Post-Impact, Left Side View

Post-impact inspection of the test vehicle revealed almost all crush occurred rearward of the front doors. The left and right frame rails buckled under the rear doors and both rear wheels were jammed. The rear window shattered and the roof buckled over both left and right "B" and "C" posts. The rear seat floor pan buckled and all four doors were jammed. Both front seat backs bent backward unto the rear seat cushion and the rear seat assembly was deformed. Both the driver and passenger dummy head made contact with the rear seat back cushion.

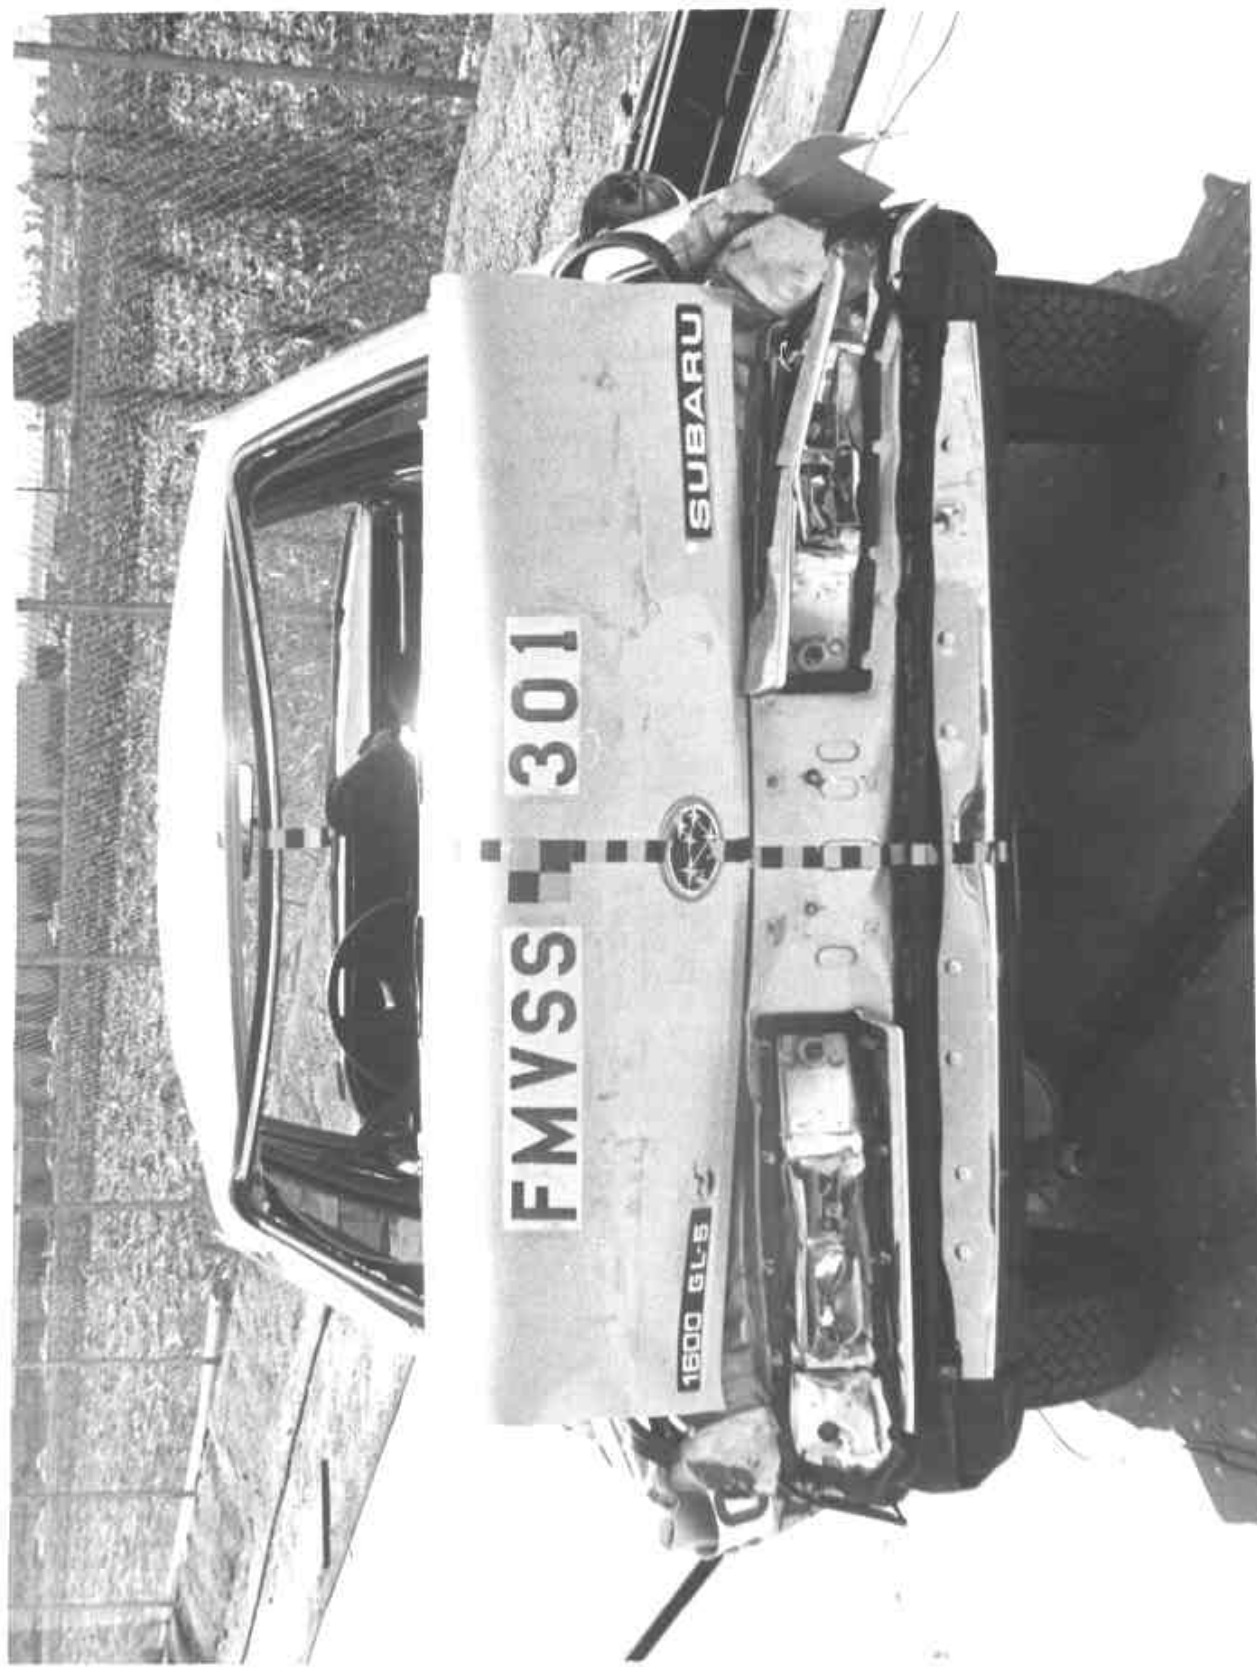
Figure 3-5  
1980 Subaru GL - 4 Door Sedan  
NHTSA 800530  
Post-Impact, Full Rear View

Crush Details: Frame buckled under rear doors, rear window shattered,  
roof buckled over both "B" and "C" posts, both dummies made contact  
with rear seat back cushion.
