OCCUPANT RESPONSE  
AND  
VEHICLE ACCELERATION  
IN A  
30 MPH FRONTAL BARRIER IMPACT TEST

MITSUBISHI MOTORS CORPORATION  
1979 DODGE D50 - PICK UP  
NHTSA 790605

CONTRACT NUMBER DOT-HS-6-01477

FINAL REPORT

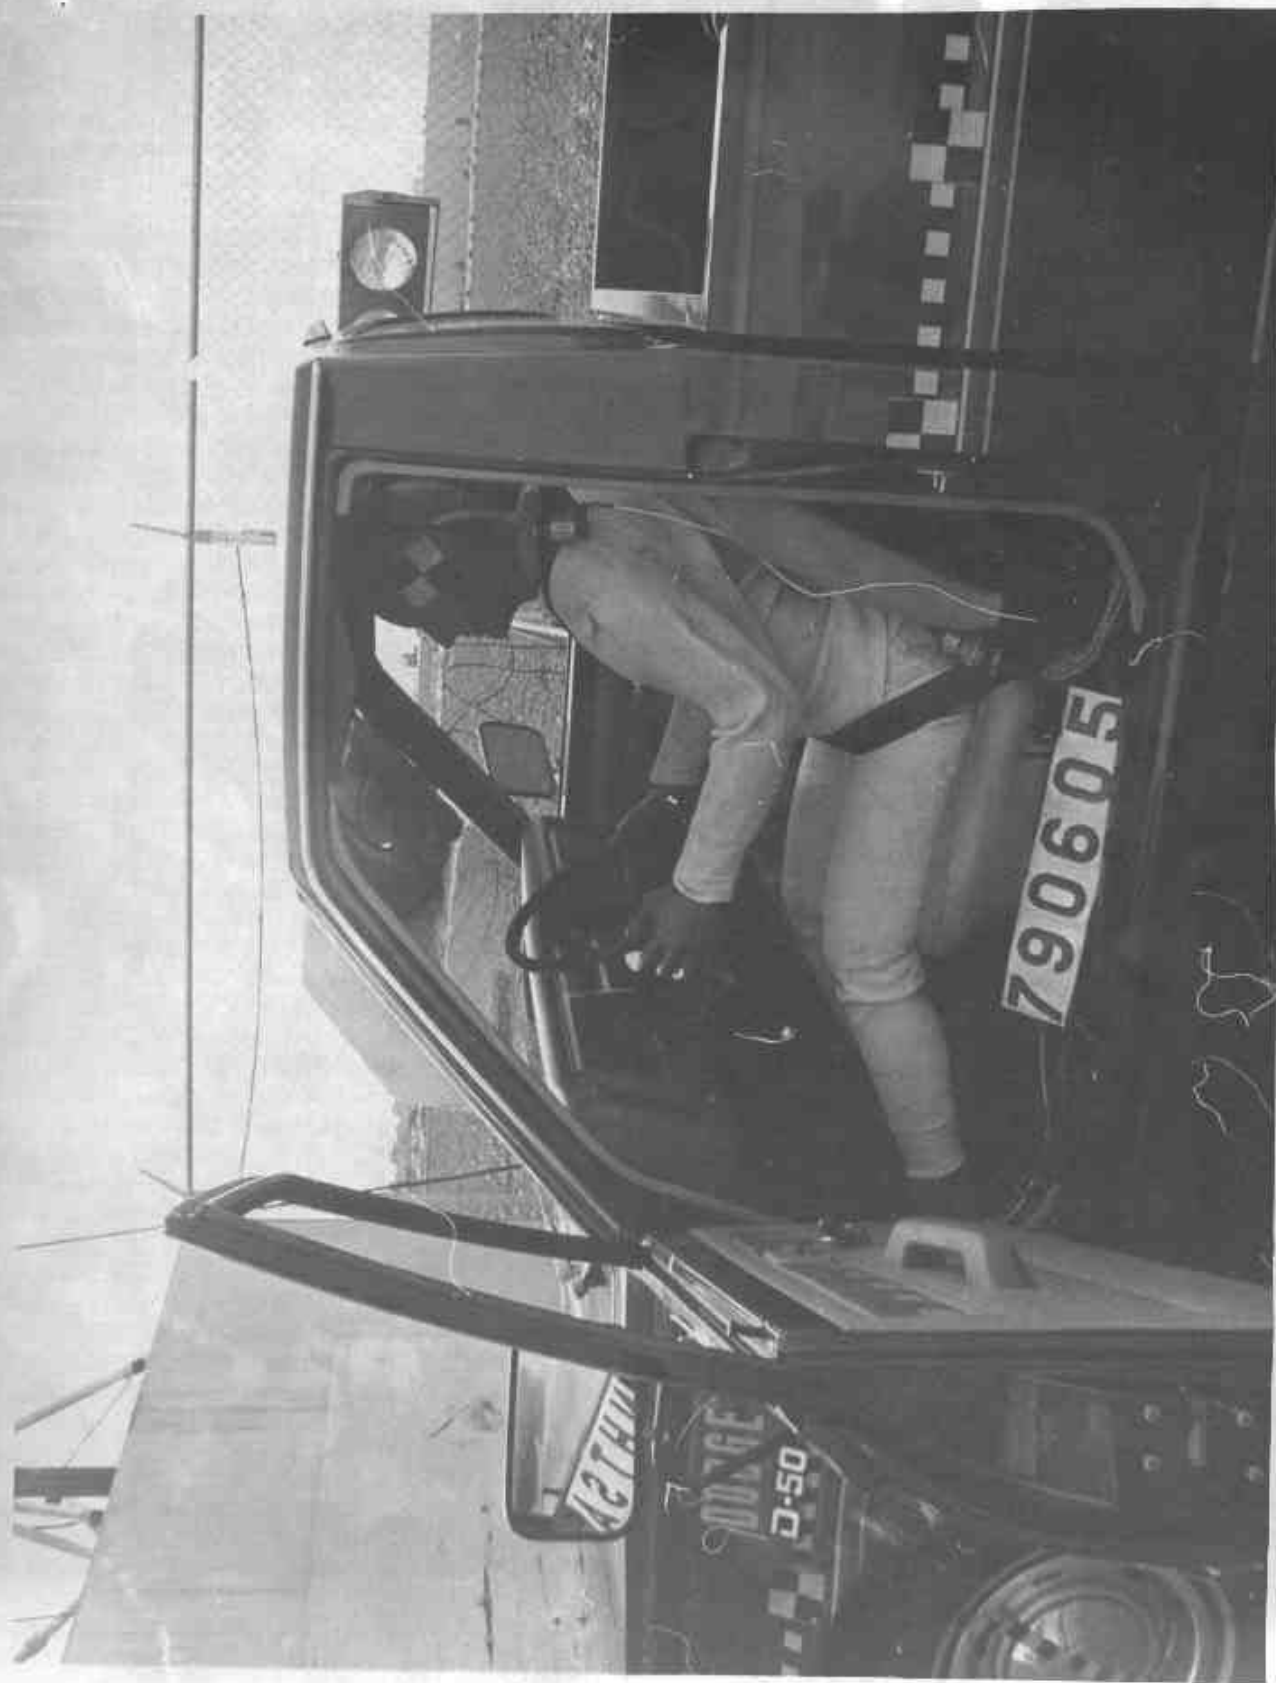
Figure 3-1  
1979 Dodge D50 - Pick Up  
NHTSA 790605  
Pre-Test, Driver Dummy View

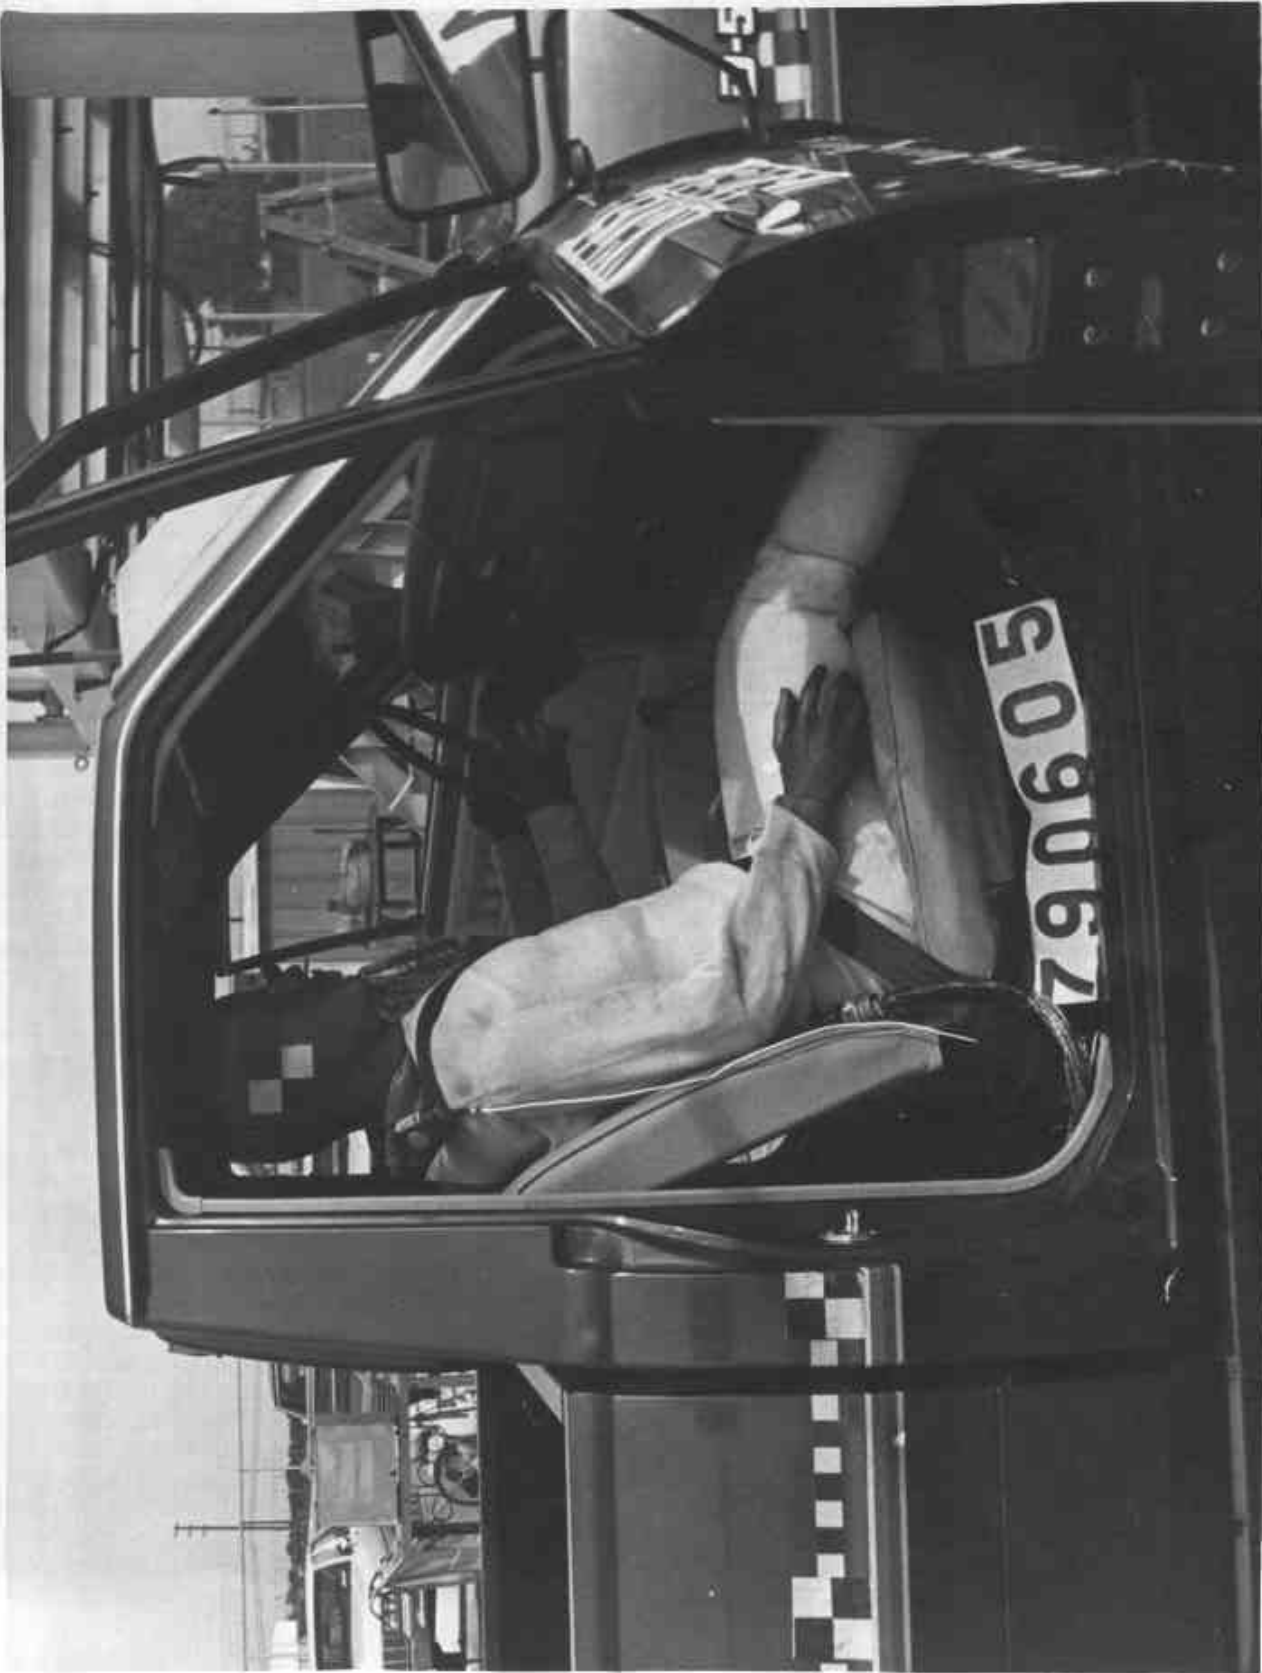
Pre-Test, Passenger Dummy View

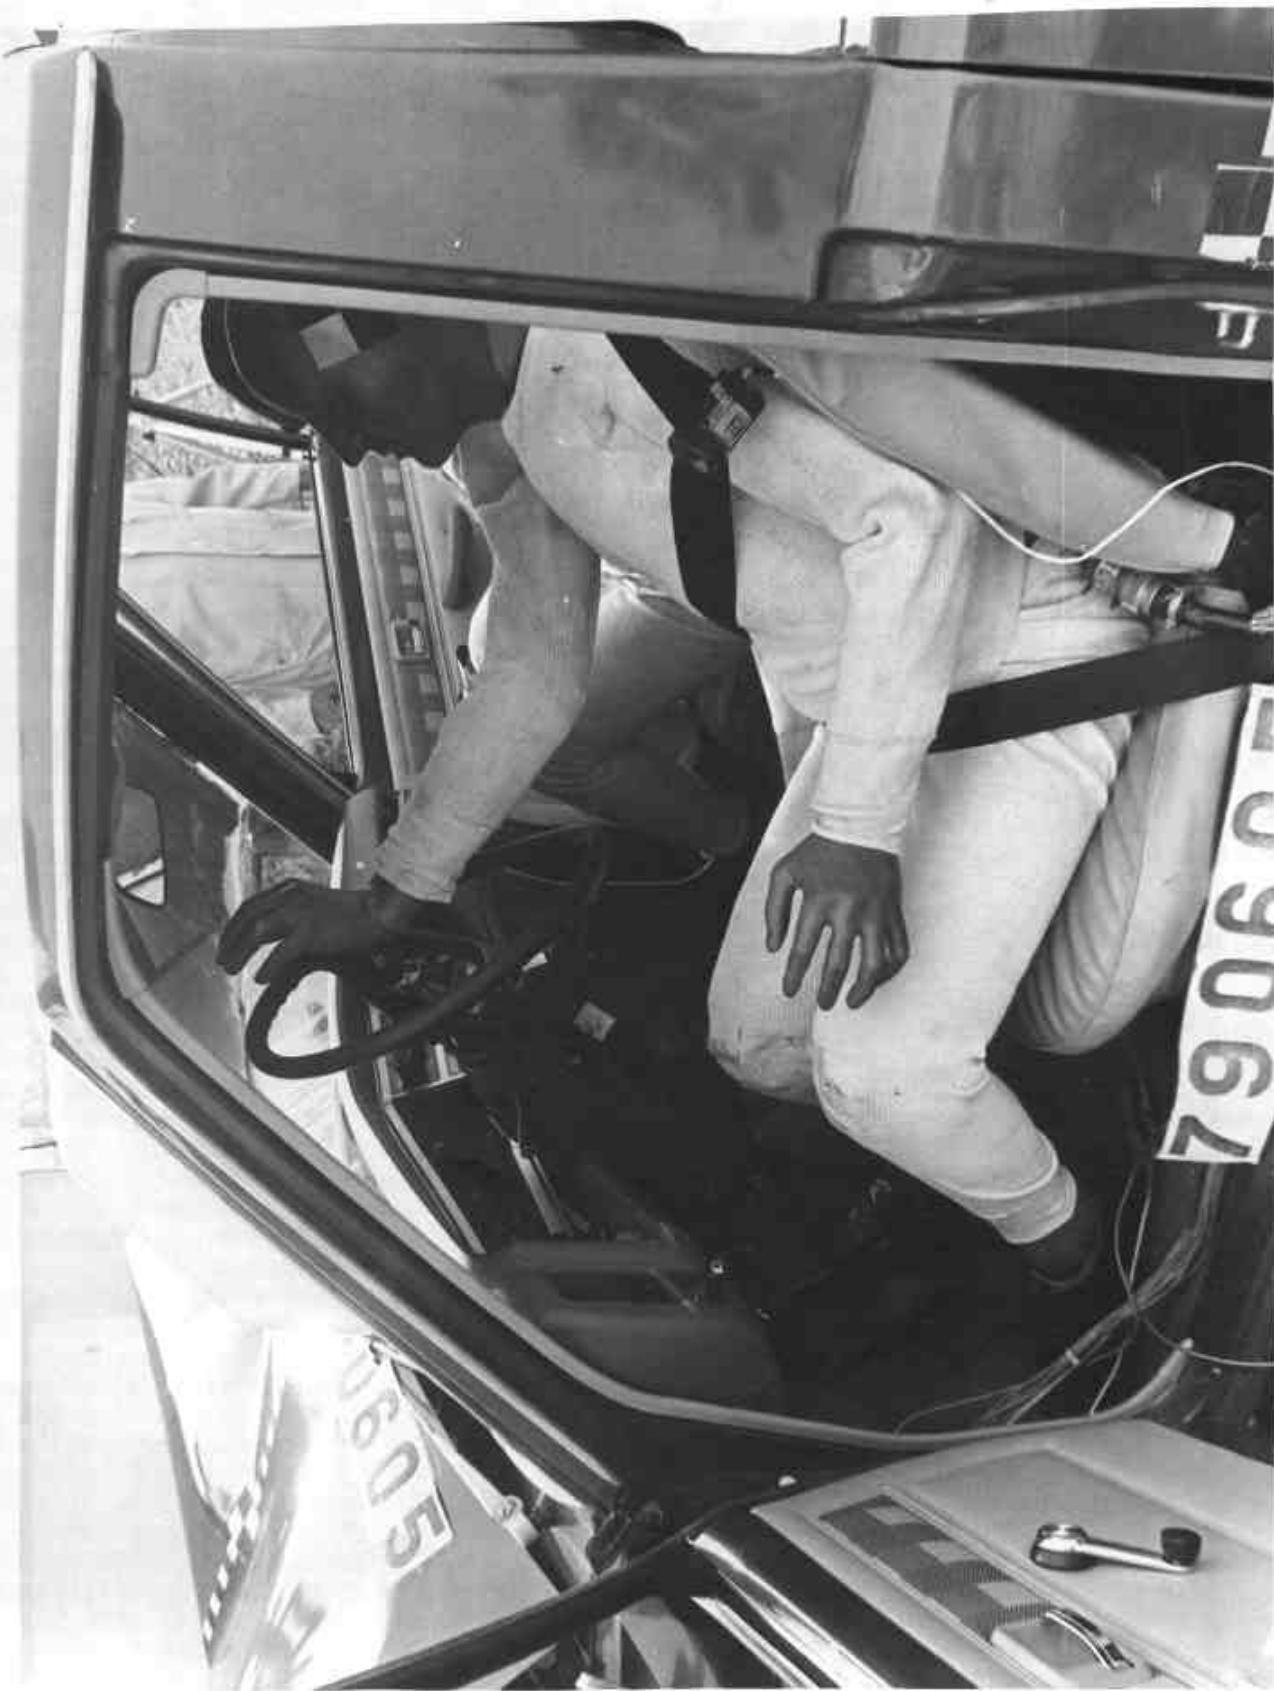
Figure 3-3  
1979 Dodge D50 - Pick Up  
NHTSA 790605  
Post-Impact, Driver Dummy View

Post-impact inspection of the vehicle revealed almost all crush occurred forward of the vehicle cab "B" posts. The left and right frame rails buckled at the "A" post and the cargo box impacted the cab. The driver dummy impacted the steering wheel and dash assembly. The passenger dummy also impacted the dash assembly. The cab floor pan buckled and the dash assembly deformed from apparent cowl deformation/or dummy contact. The windshield had numerous cracks, in front of the driver position, developed by the apparent cowl, dummy/or body deformation.

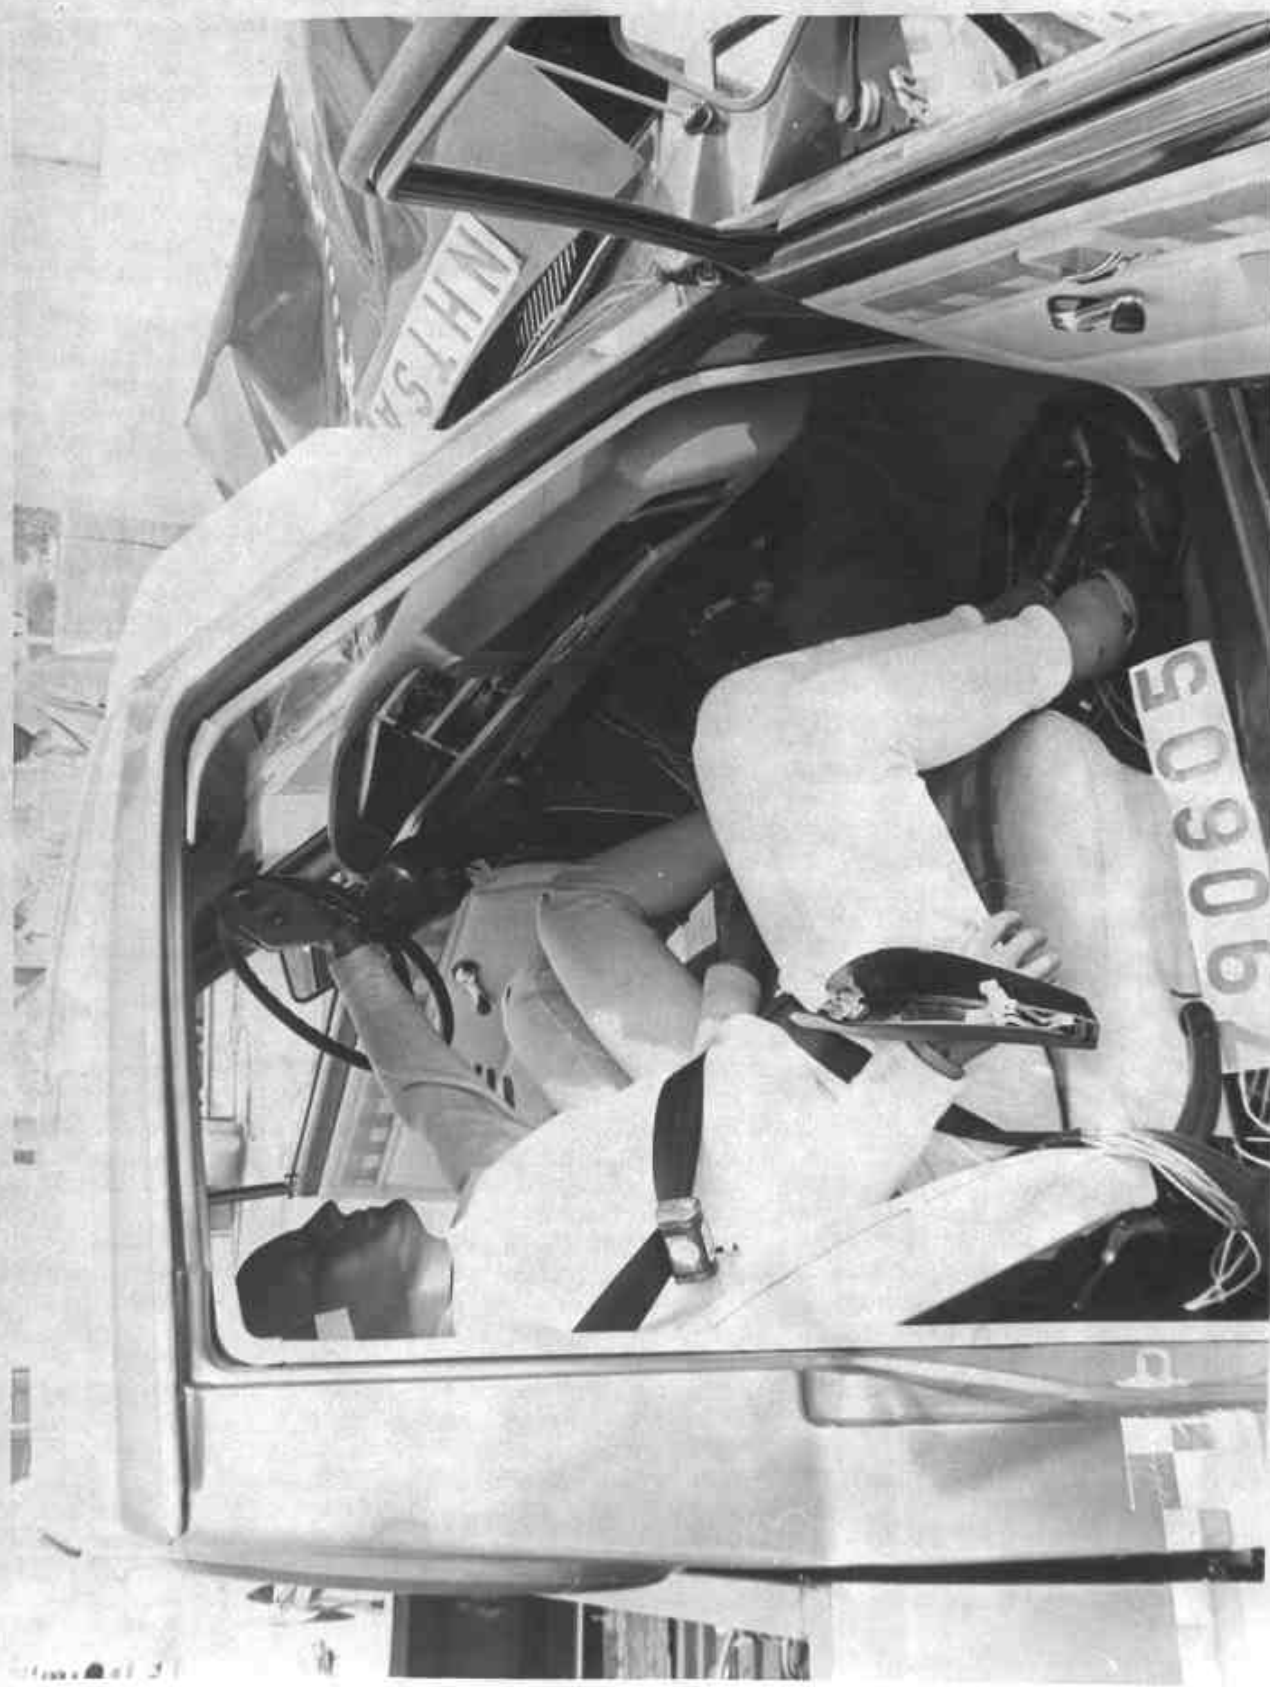
Figure 3-4  
1979 Dodge D50 - Pick Up  
NHTSA 790605  
Post-Impact, Passenger Dummy View
