TEST  
REPORT

CONTRACT NAME: DUMMY RESPONSE IN SIDE IMPACT

TEST DESCRIPTION: MALIBU INTO VOLKSWAGEN; TEST #1  
OF A THREE TEST SERIES

TEST NUMBER: 1950

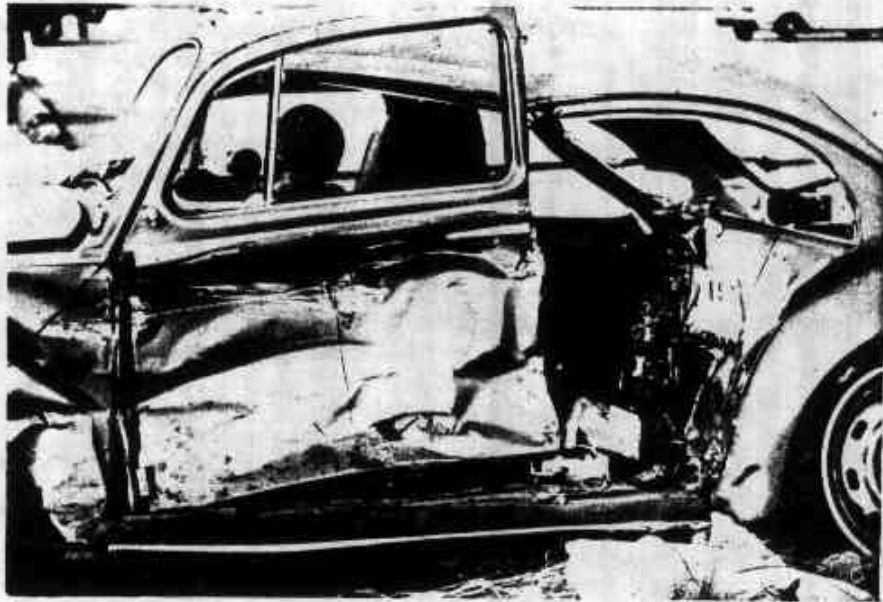
FIGURE 9. POST-TEST VOLKSWAGEN LEFT SIDE

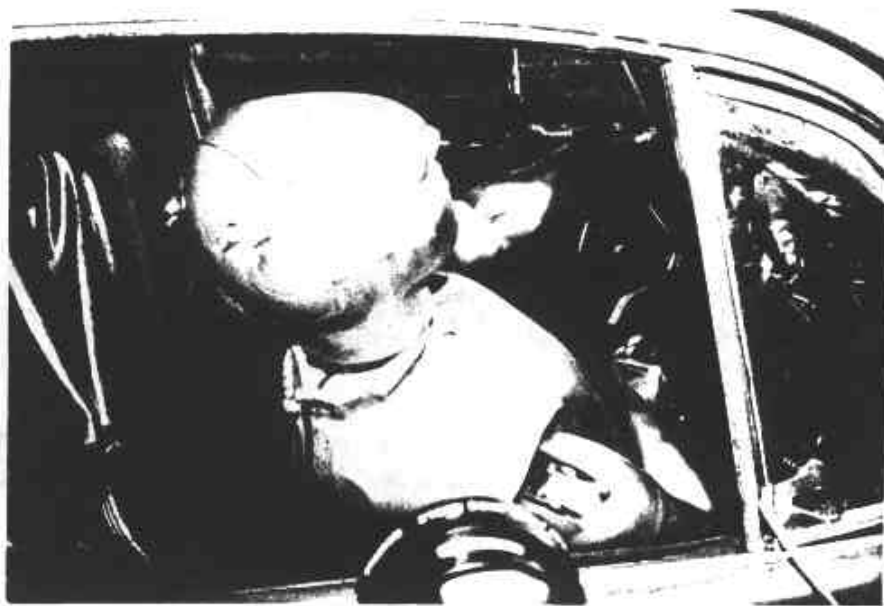
FIGURE 15. POST-TEST VOLKSWAGEN DUMMY POSITION
