NEW VEHICLE  
ASSESSMENT TESTING

FUJI HEAVY INDUSTRIES, LTD.  
1980 SUBARU GLF  
NHTSA 800569

FINAL REPORT

| 4. Title and Subtitle<br>NEW VEHICLE ASSESSMENT TESTING - 1980 SUBARU GLF -<br>NHTSA 800569 | | | | 5. Report Date<br>November 1980 | |

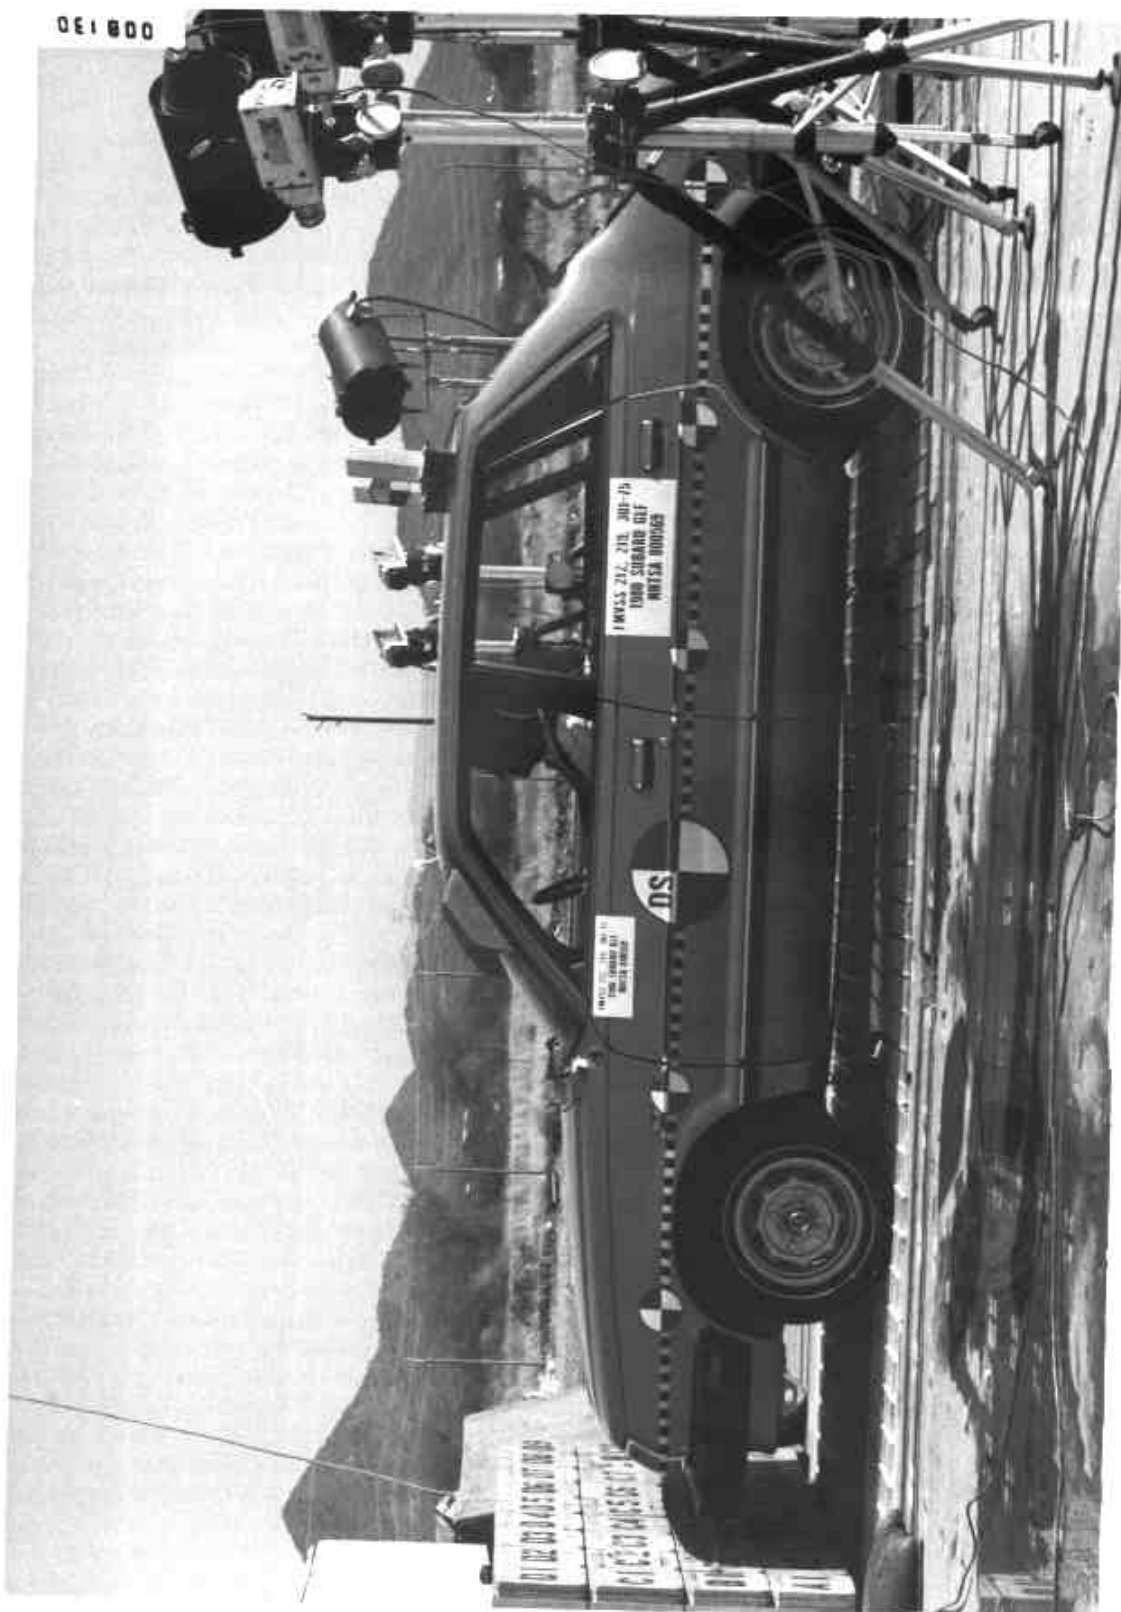
FIGURE A-3. PRE-TEST SIDE VIEW - 1980 SUBARU GLF - NHTSA 800 569.

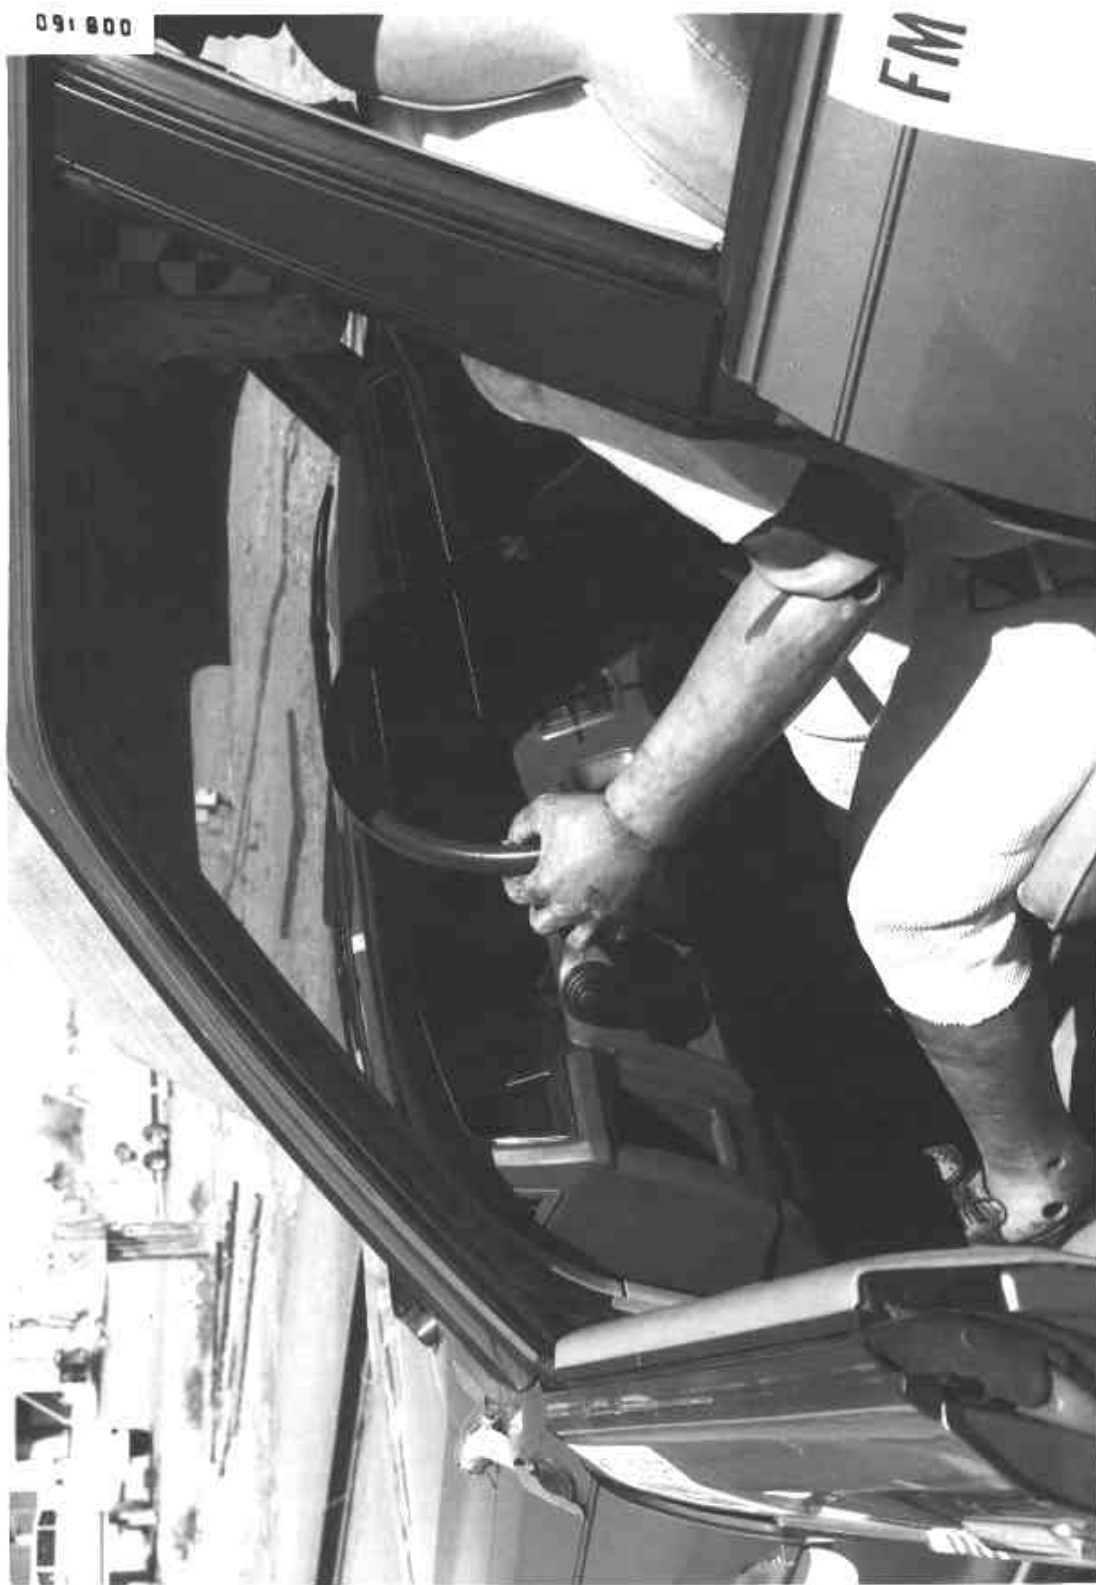
FIGURE A-6. PRE-TEST DRIVER DUMMY POSITION - 1980 SUBARU GLF - NHTSA 800569.

| <u>Measurement</u> | <u>Driver<br/>(in.)</u> | <u>Passenger<br/>(in.)</u> |
|---|---|---|
| Dummy Centerline to<br>Vehicle Centerline | <u>14.0</u> | <u>13.0</u> |
| Nose to Upper Rim<br>Steering Wheel | <u>14.3</u> | <u>N/A</u> |
| Nose to Windshield<br>(Horizontal Distance) | <u>18.3</u> | <u>17.3</u> |

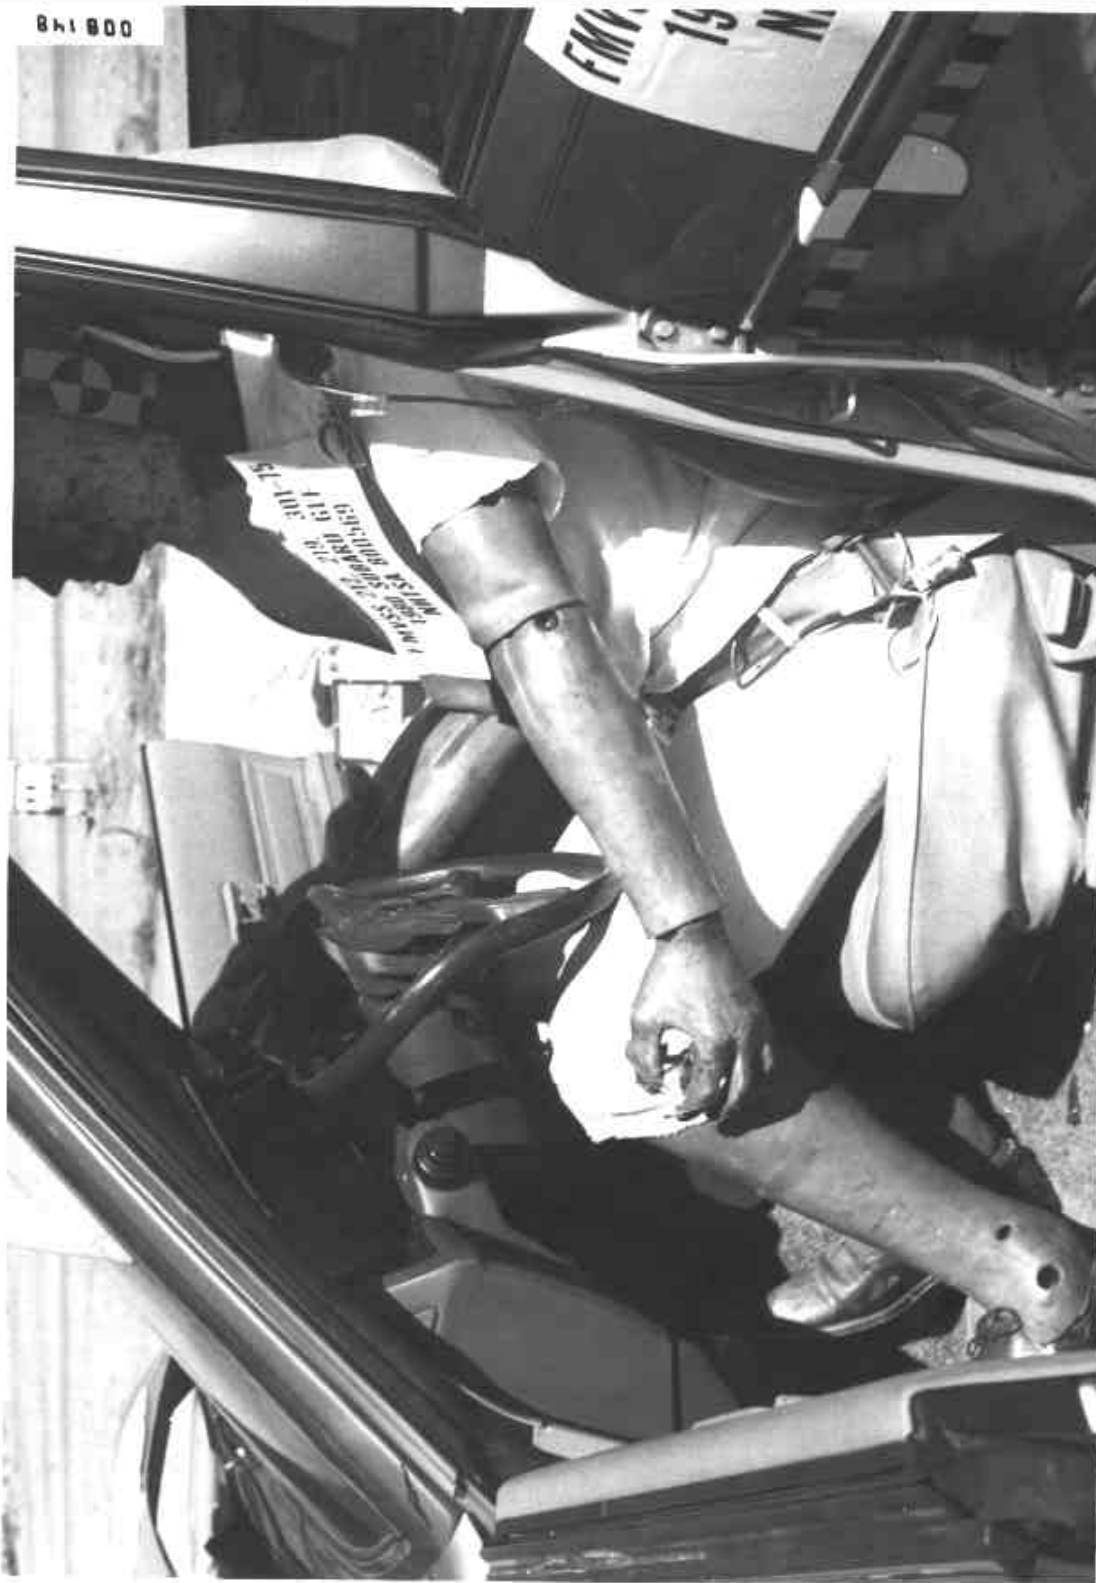
FIGURE A-7. POST-TEST DRIVER DUMMY POSITION - 1980 SUBARU GLF - NHTSA 800569.

| | <u>Driver</u> | | <u>Passenger</u> | |
|---|---|---|---|---|
| Head | <u>Forehead: Top of steering wheel rim</u> | | <u>Top of glovebox</u> | |
| | <u>Chin: Top of steering wheel hub</u> | | | |
| Chest | <u>Steering wheel hub &amp; bottom of rim</u> | | <u>None</u> | |
| Left Knee | <u>Dash</u> | | <u>Lower dash</u> | |
| Right Knee | <u>Dash and steering column</u> | | <u>Lower dash</u> | |

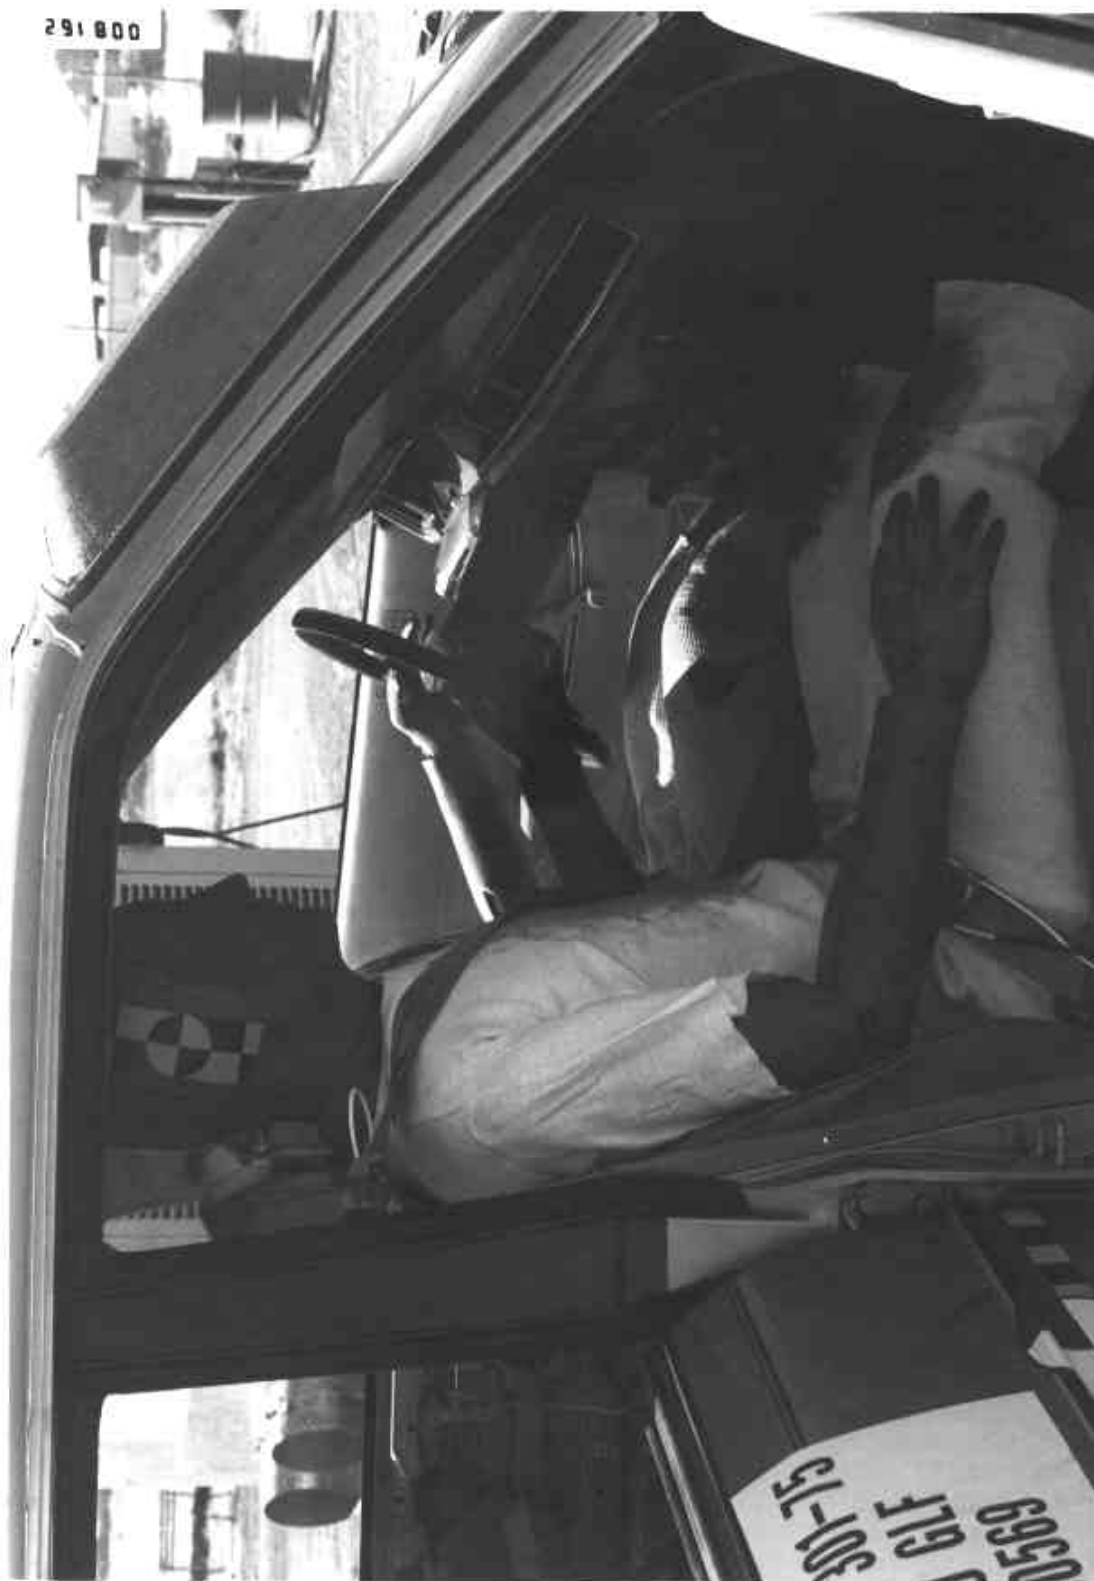
FIGURE A-8. PRE-TEST PASSENGER DUMMY POSITION - 1980 SUBARU GLF - NHTSA 800569.

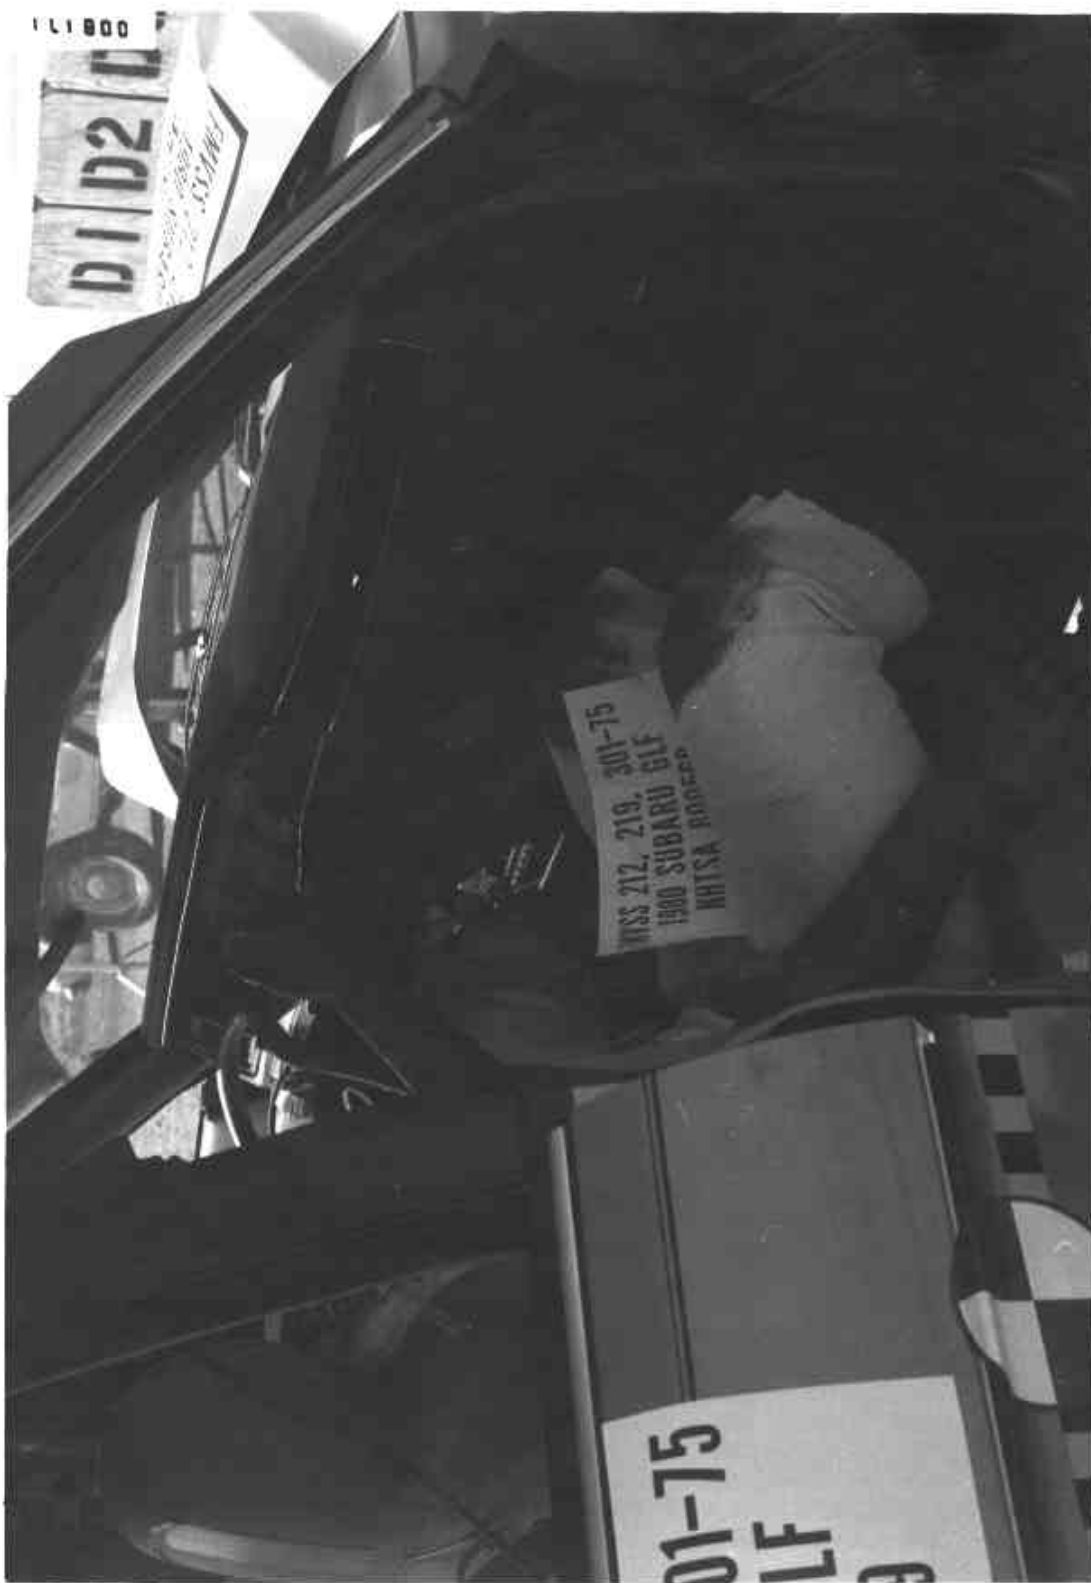
FIGURE A-9. POST-TEST PASSENGER DUMMY POSITION - 1980 SUBARU GLF - NHTSA 800569.

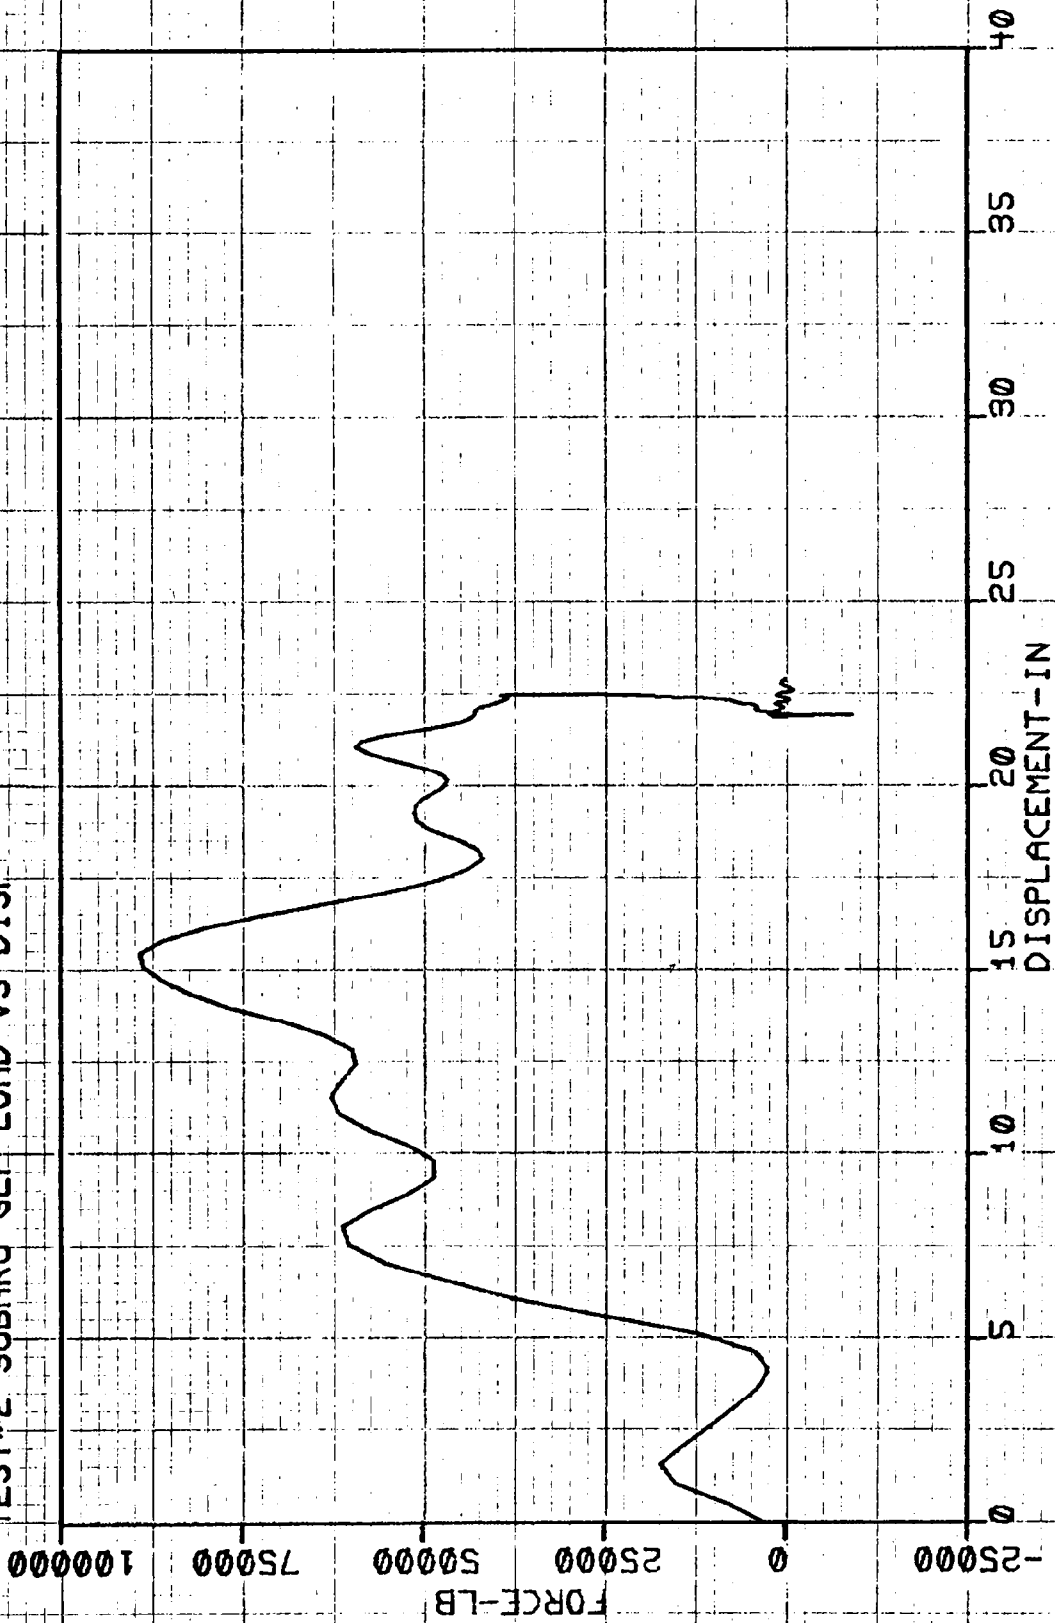
TEST#2 SUBARU GLF LOAD VS DISP
