NEW VEHICLE ASSESSMENT  
AND  
STANDARDS ENFORCEMENT INDICANT TESTING

FMVSS NOS. 212, 219, AND 301-75

FORD MOTOR COMPANY  
1980 FORD THUNDERBIRD II - 2 DOOR HARDTOP  
NHTSA 800206

FINAL REPORT

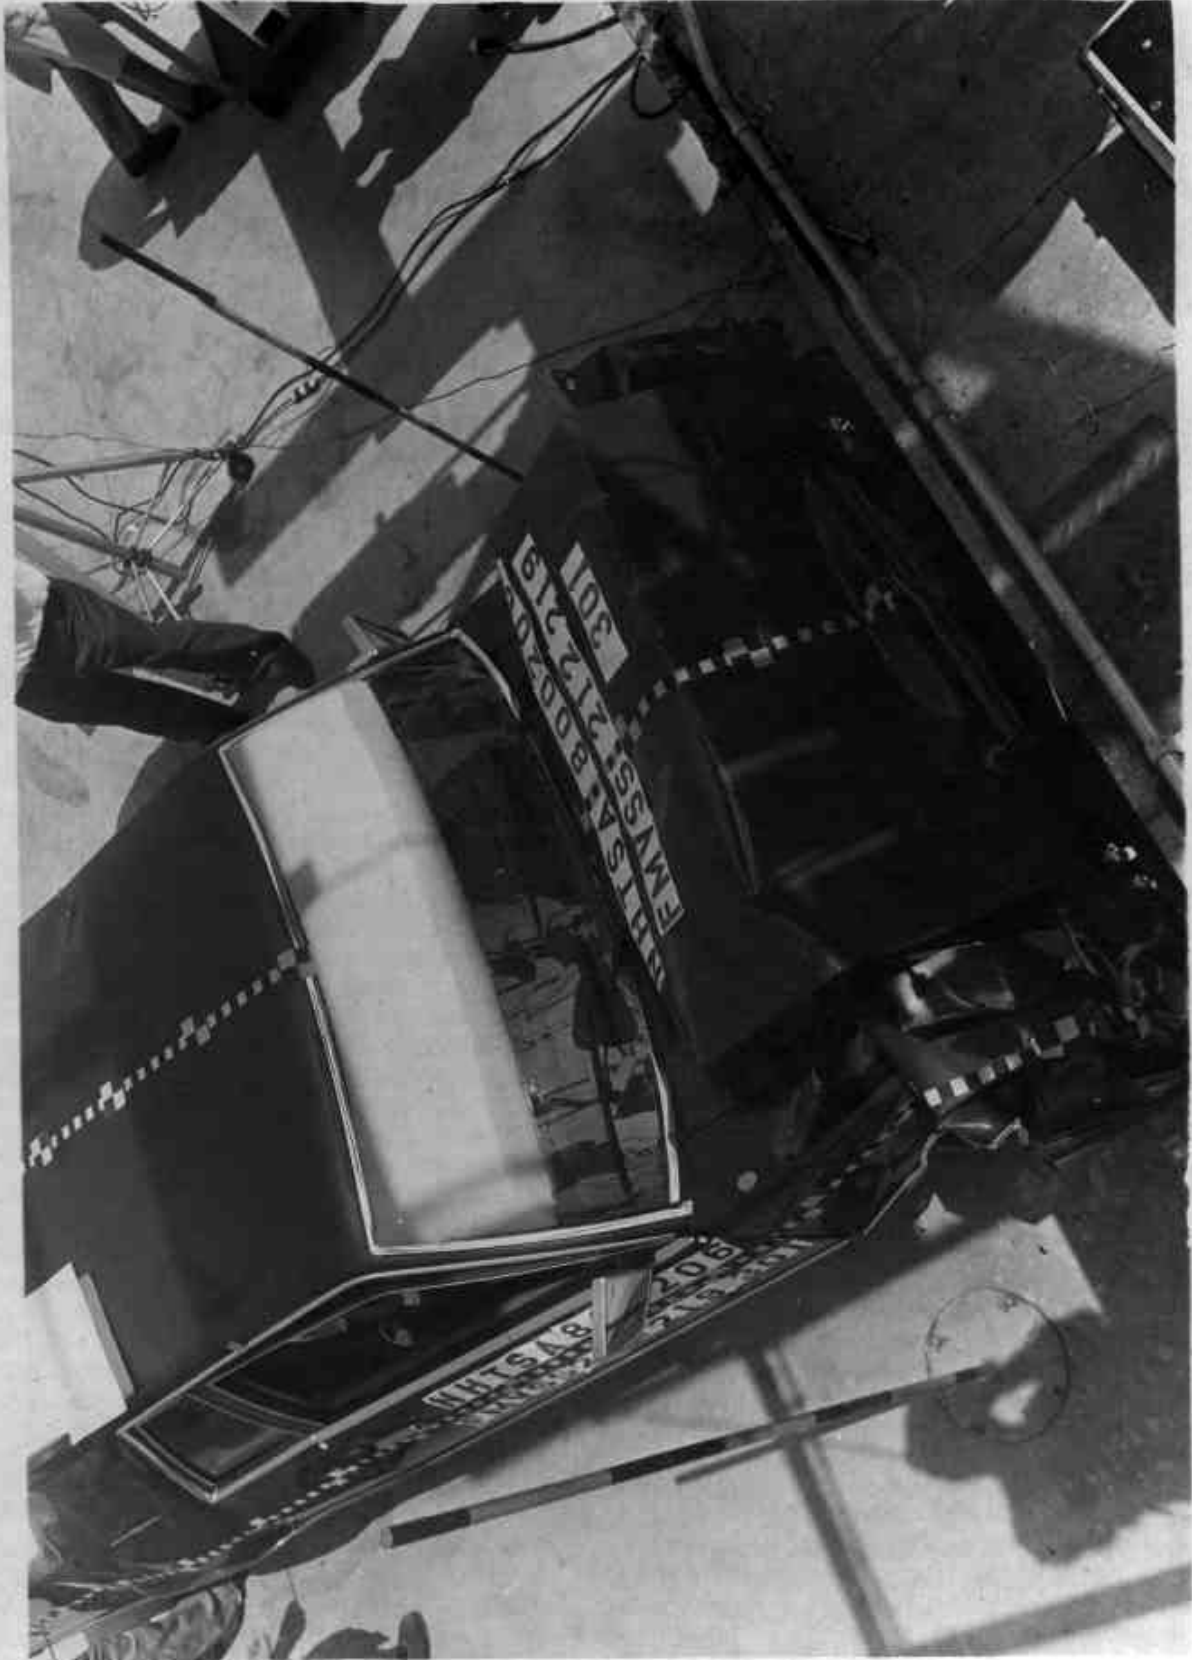
Figure 3-6  
1980 Ford Thunderbird II - 2 Door Hardtop  
NHTSA 800206  
Post-Impact, Right Front View

Crush Details: Windshield had numerous cracks, roof buckled over both "B" posts, driver dummy impacted steering wheel and right knee impacted dash assembly, passenger dummy head impacted the dash and his legs and both knees impacted dash assembly.
