Dynamic Science Report No. 301-DYS-81-004

NEW VEHICLE ASSESSMENT AND  
STANDARDS ENFORCEMENT INDICANT  
TESTING

FMVSS 301-75

MITSUBISHI MOTOR COMPANY/CHRYSLER CORPORATION  
1981 PLYMOUTH SAPPORO 2-DOOR HARDTOP

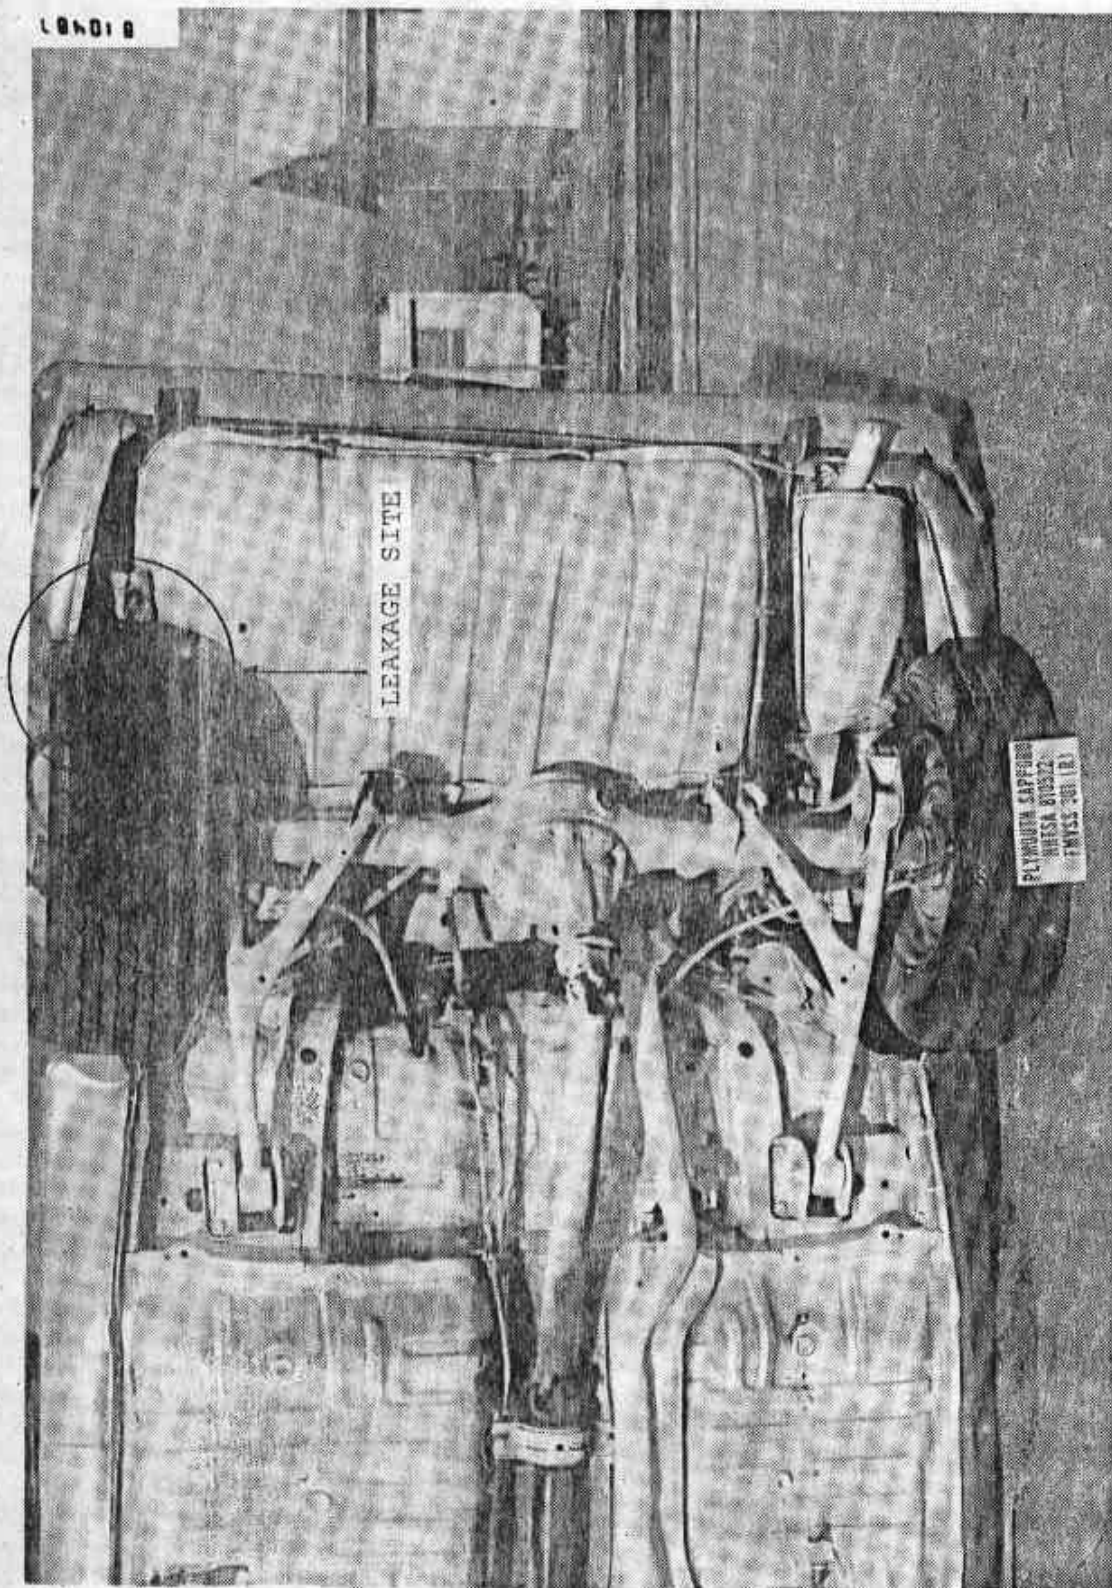
FIGURE 3-2. POST-TEST FUEL TANK - 1981 PLYMOUTH SAPPORO -  
NHSA 810522.

SOLVENT SPILLAGE DETAILS: Point of leakage was from left side tank mounting bolt. Source of leakage undetectable.

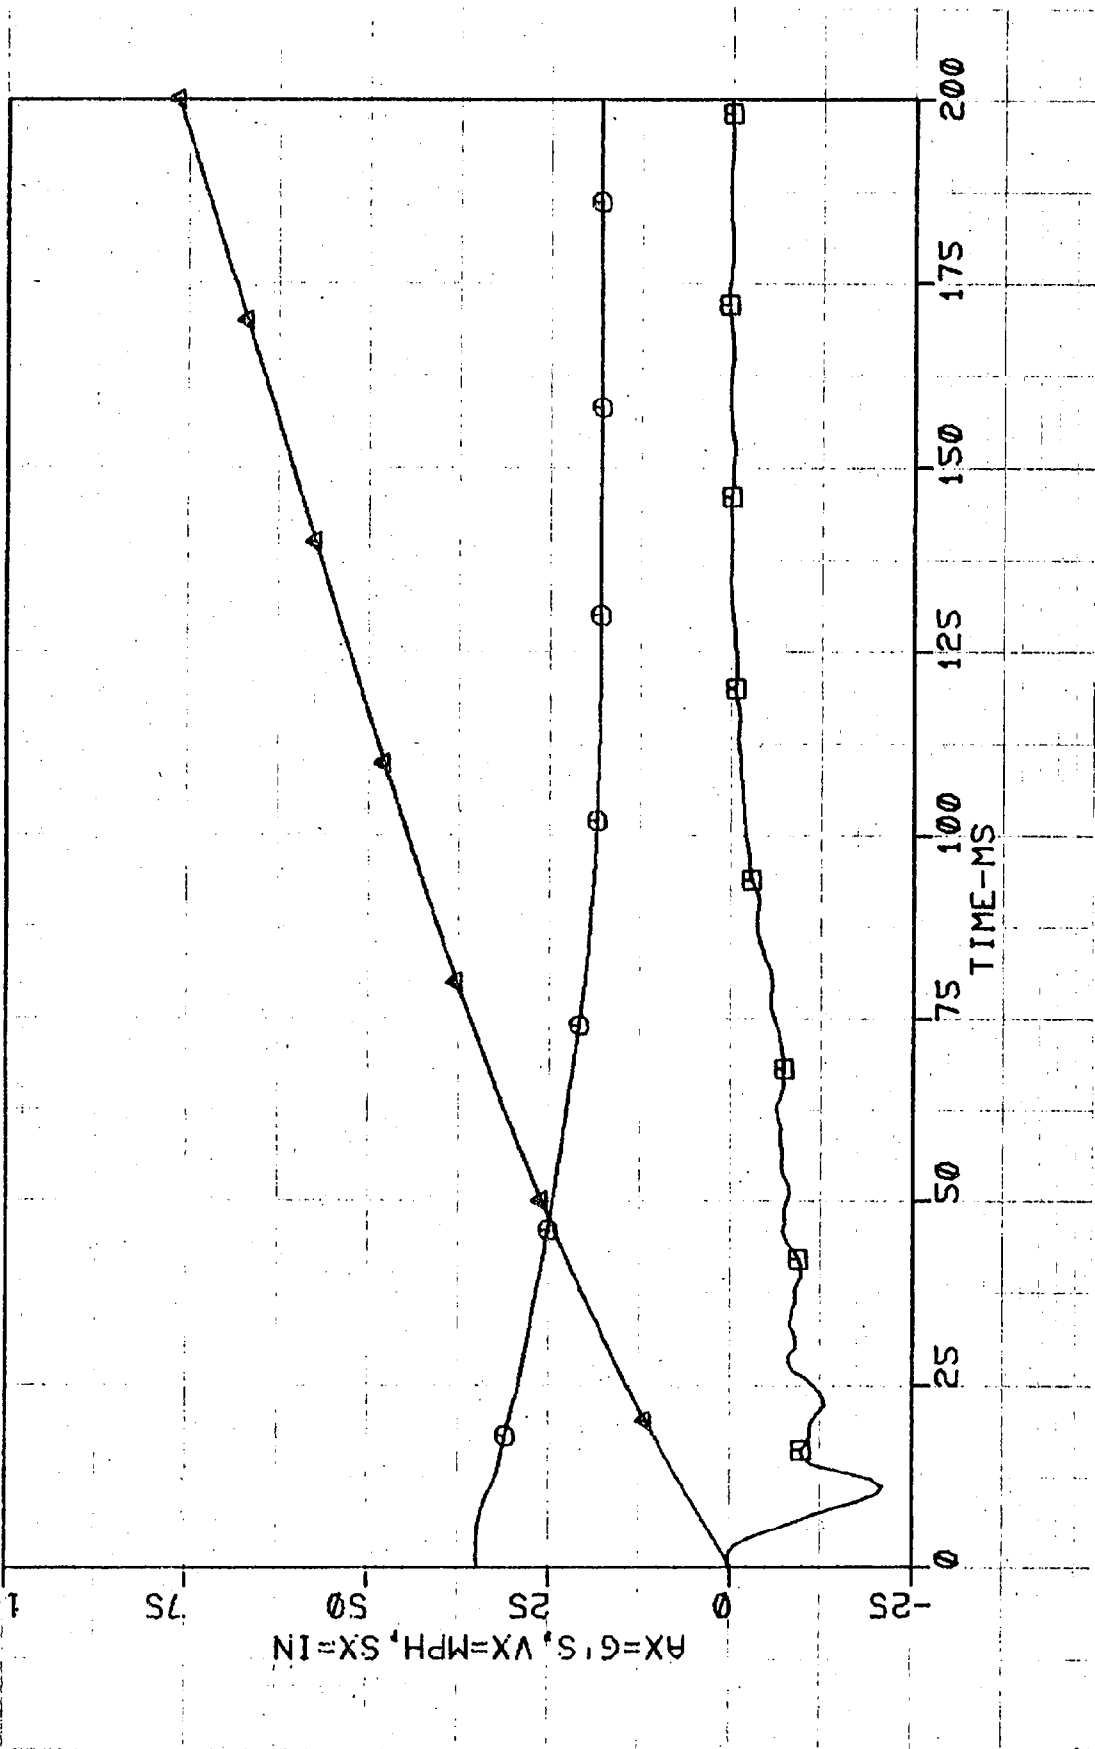
PLY SAPPORO LOC 8

| <u>Vehicle Data*</u> | <u>Location</u> |
|---|---|
| LOC 8 | Moving Barrier C.G. Acceleration (G) |
