FMVSS 212/219/301  
TESTING OF ELECTRIC VEHICLE

1980 EVA Ford Fairmont 4-Door Station Wagon

DYNAMIC SCIENCE, INC.  
A Talley Industries Company  
1850 West Pinnacle Peak Road  
Phoenix, Arizona 85027

FINAL REPORT

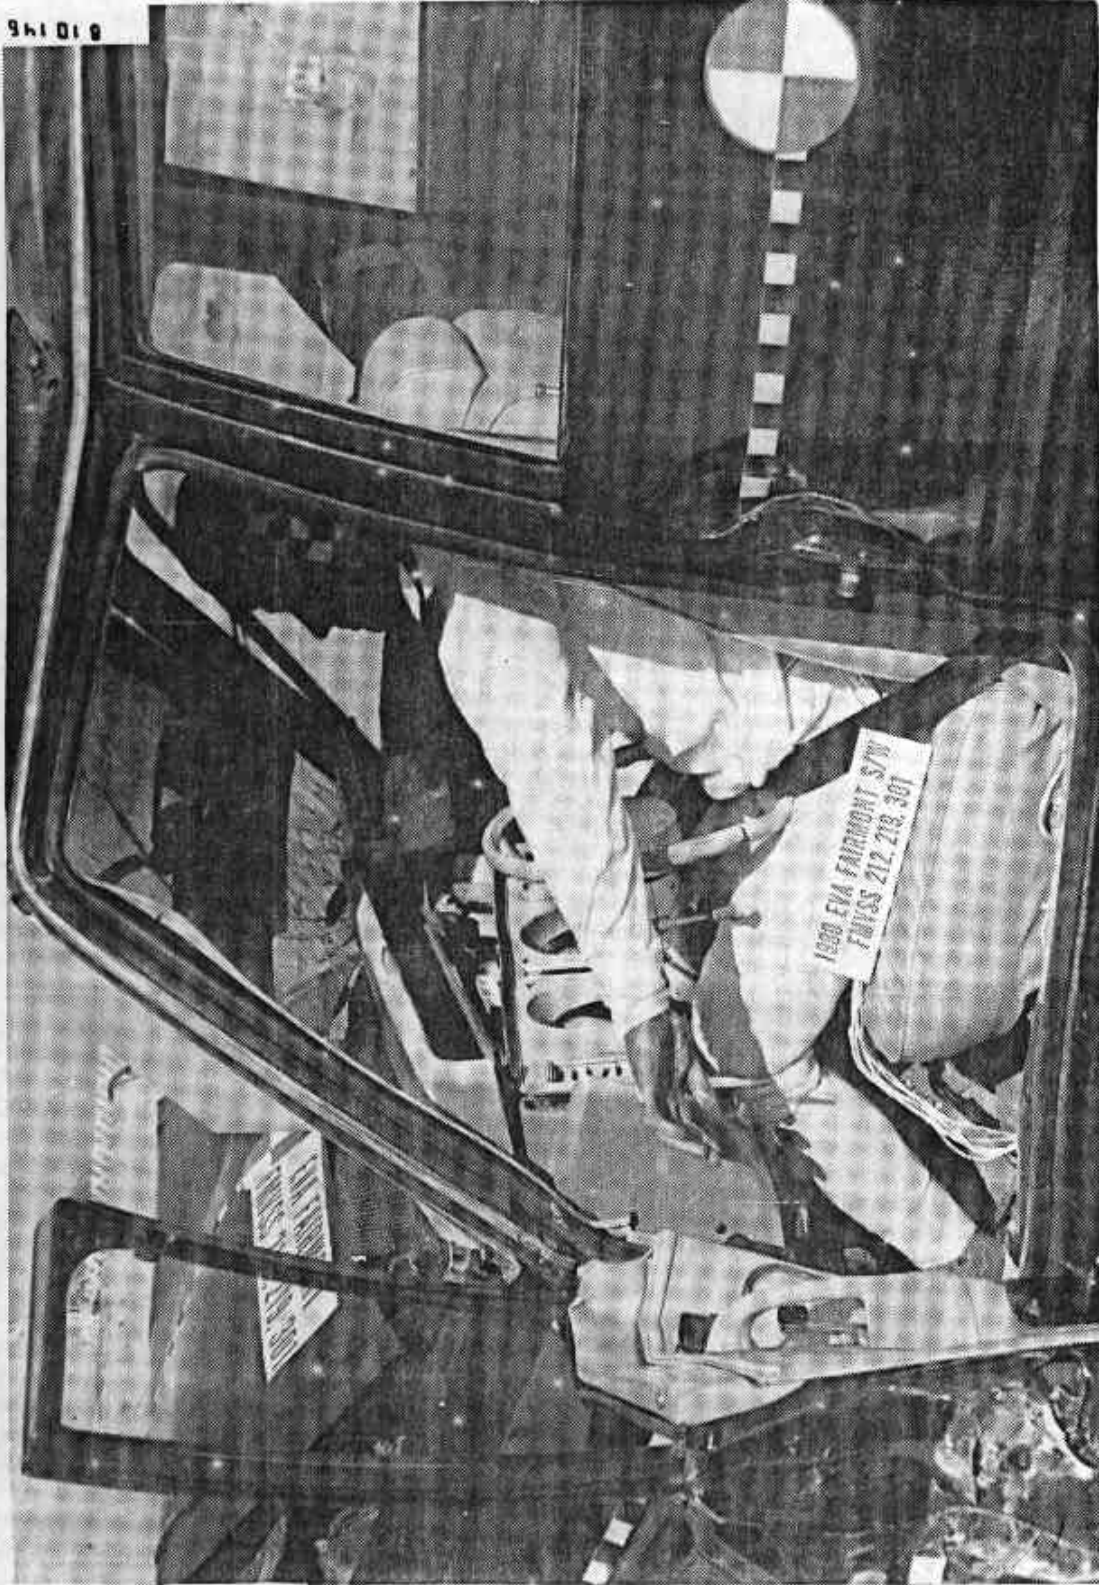
FIGURE 4-12. POST-TEST DRIVER DUMMY POSITION - 1980 EVA FAIRMONT.

OTHER COMMENTS: Steering column moved downward and 4.4 inches rearward prior to initial dummy chest contact. Steering wheel rim was cracked at spoke junctions due to dummy thorax contact. Both dummies experienced severe knee impacts with dash panel.
