REPORT NO. 301-AETL-81-029-971-3882-29

NEW VEHICLE ASSESSMENT  
AND  
STANDARDS ENFORCEMENT INDICANT TESTING

FMVSS 301-75

CHRYSLER CANADA LTD.  
1981 CHRYSLER IMPERIAL SPECIALTY - 2 DOOR HARDTOP  
NHTSA 810301

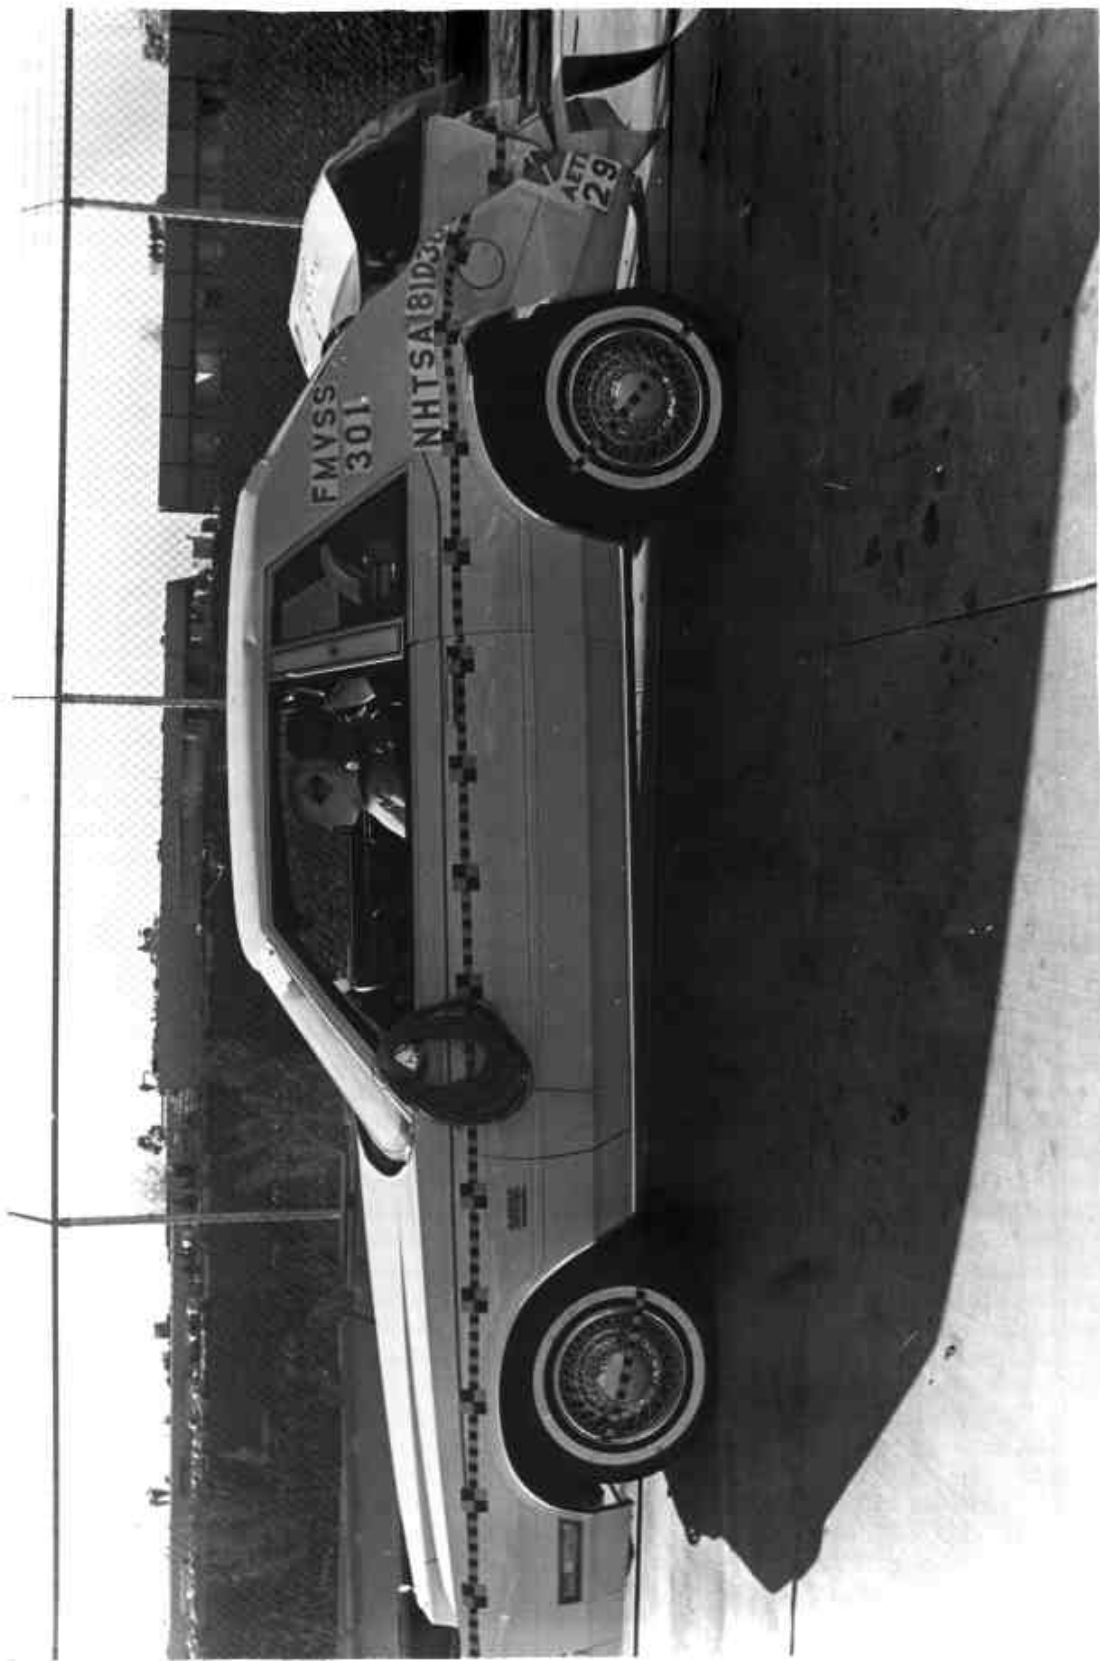
Figure 3-4  
1981 Chrysler Imperial Specialty - 2 Door Hardtop  
NHTSA 810301  
Post-Impact, Left Side View

Post-impact inspection of the test vehicle revealed almost all crush occurred rearward of the doors. The left and right frame rail buckled over the rear axle and both rear wheels were jammed. The roof buckled over both left and right "C" post and no window glass was broken. Both front seat backs bent backward unto the rear seat cushion. Both the driver and passenger dummy head made contact with the rear seat back.

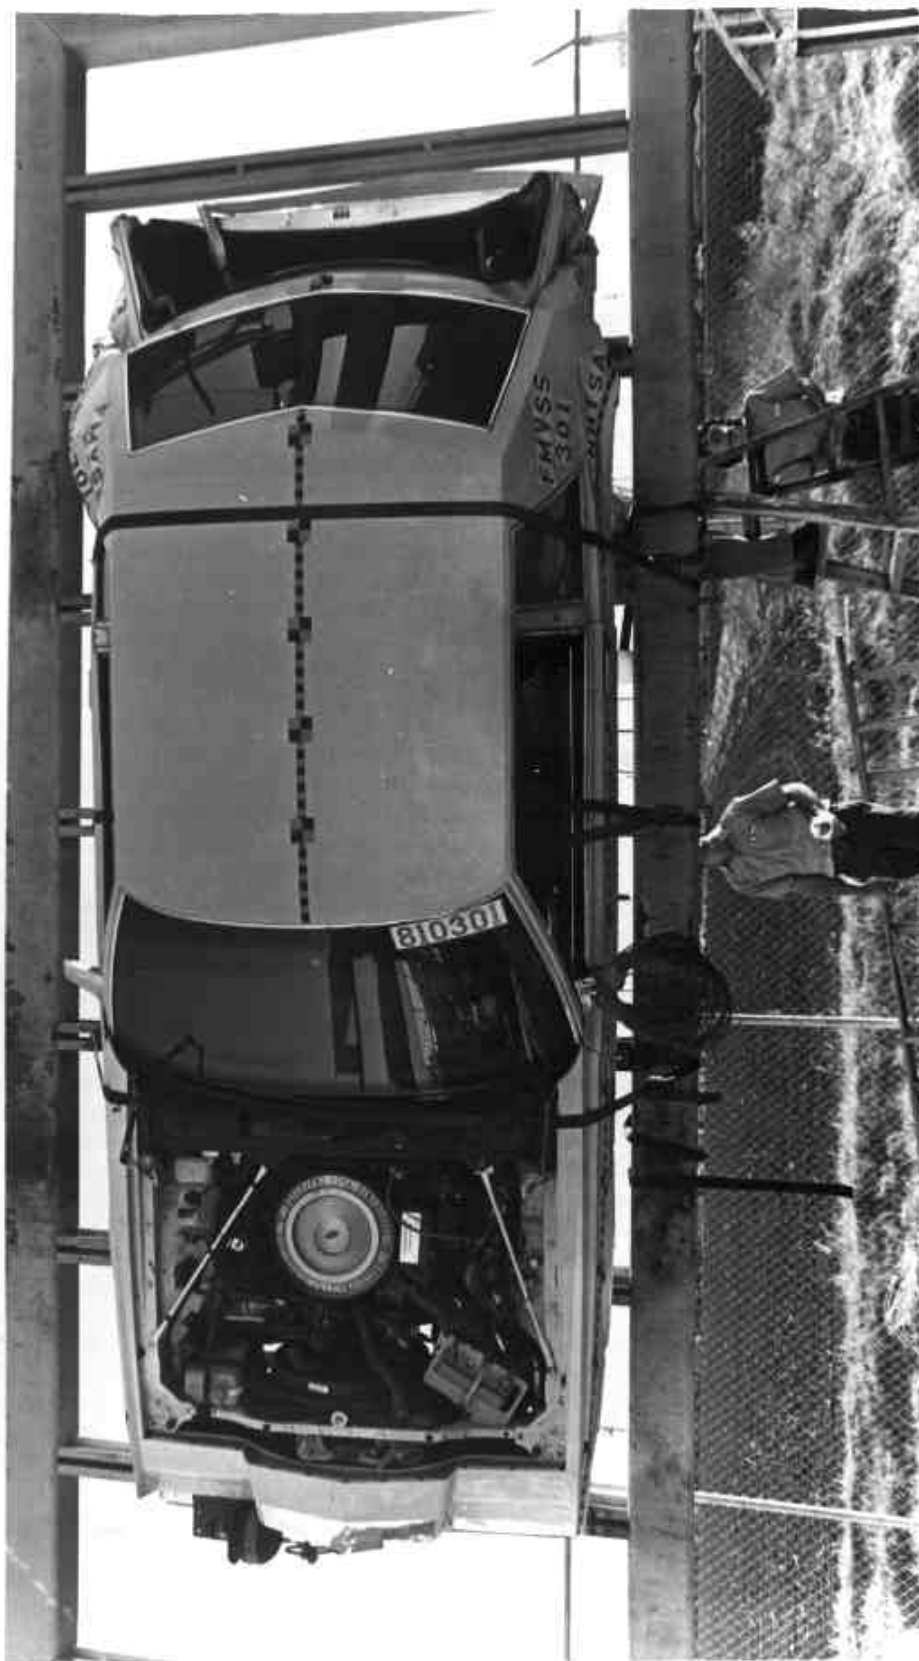
Post-Impact, Rollover Test, 90° Increment

Fuel spillage was noted immediately following cessation of vehicle motion after impact, however the fuel spillage was considered un-measureable. The fuel spillage was intermittent during the rollover test increment time periods. The fuel spillage was due to a partially severed fuel tank vent line connection, located in front of the fuel tank, which appeared to have been contacted by the differential during the impact event.
