NEW VEHICLE ASSESSMENT  
AND  
STANDARDS ENFORCEMENT INDICANT TESTING

FMVSS 301-75

HONDA MOTOR COMPANY, LTD.  
1981 HONDA CIVIC - 4 DOOR SEDAN  
NHTSA 810502

FINAL REPORT

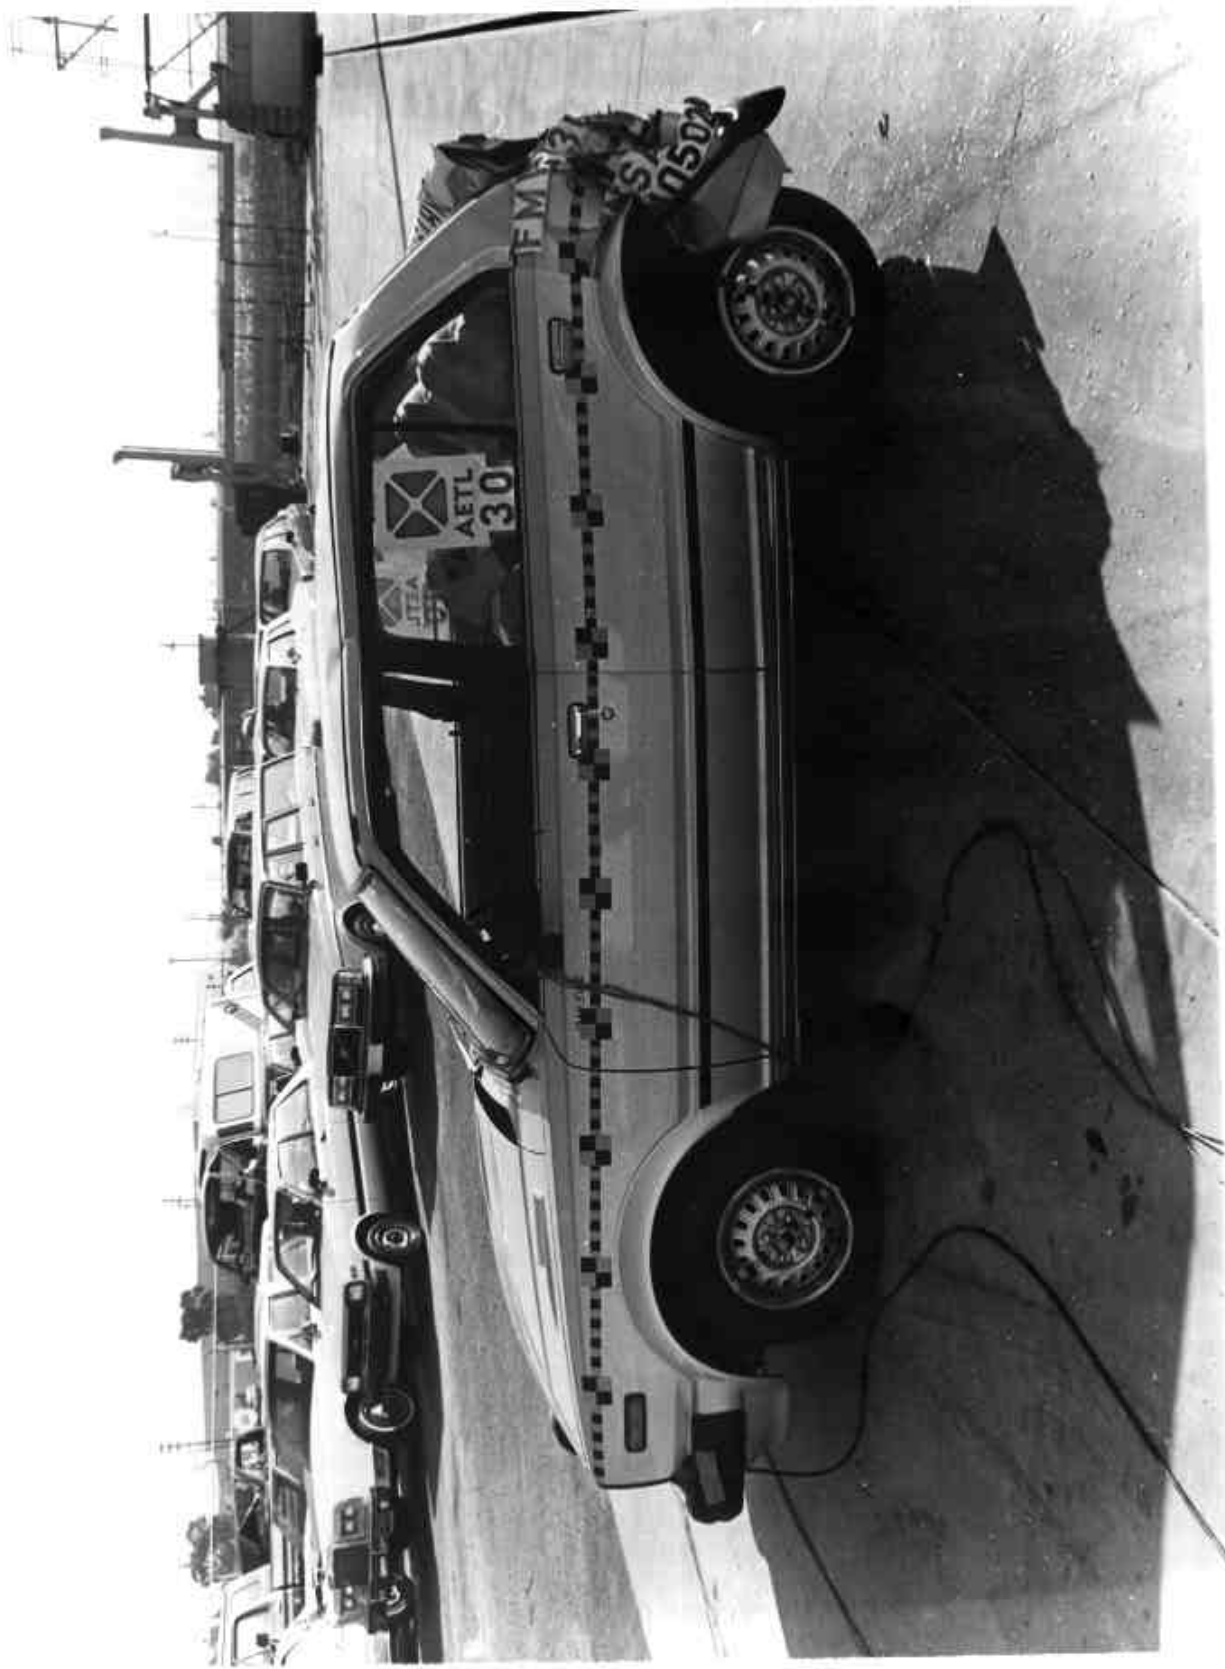
Figure 3-4  
1981 Honda Civic - 4 Door Sedan  
NHTSA 810502  
Post-Impact, Left Side View

Post-impact inspection of the test vehicle revealed almost all crush occurred rearward of the front doors. The left and right frame rails buckled over the rear suspension and both rear wheel were jammed. The rear window shattered and the roof buckled over both left and right "B" post. Both front seat backs bent backward unto the rear seat cushion and both the driver and passenger dummy head made contact with the rear seat back.

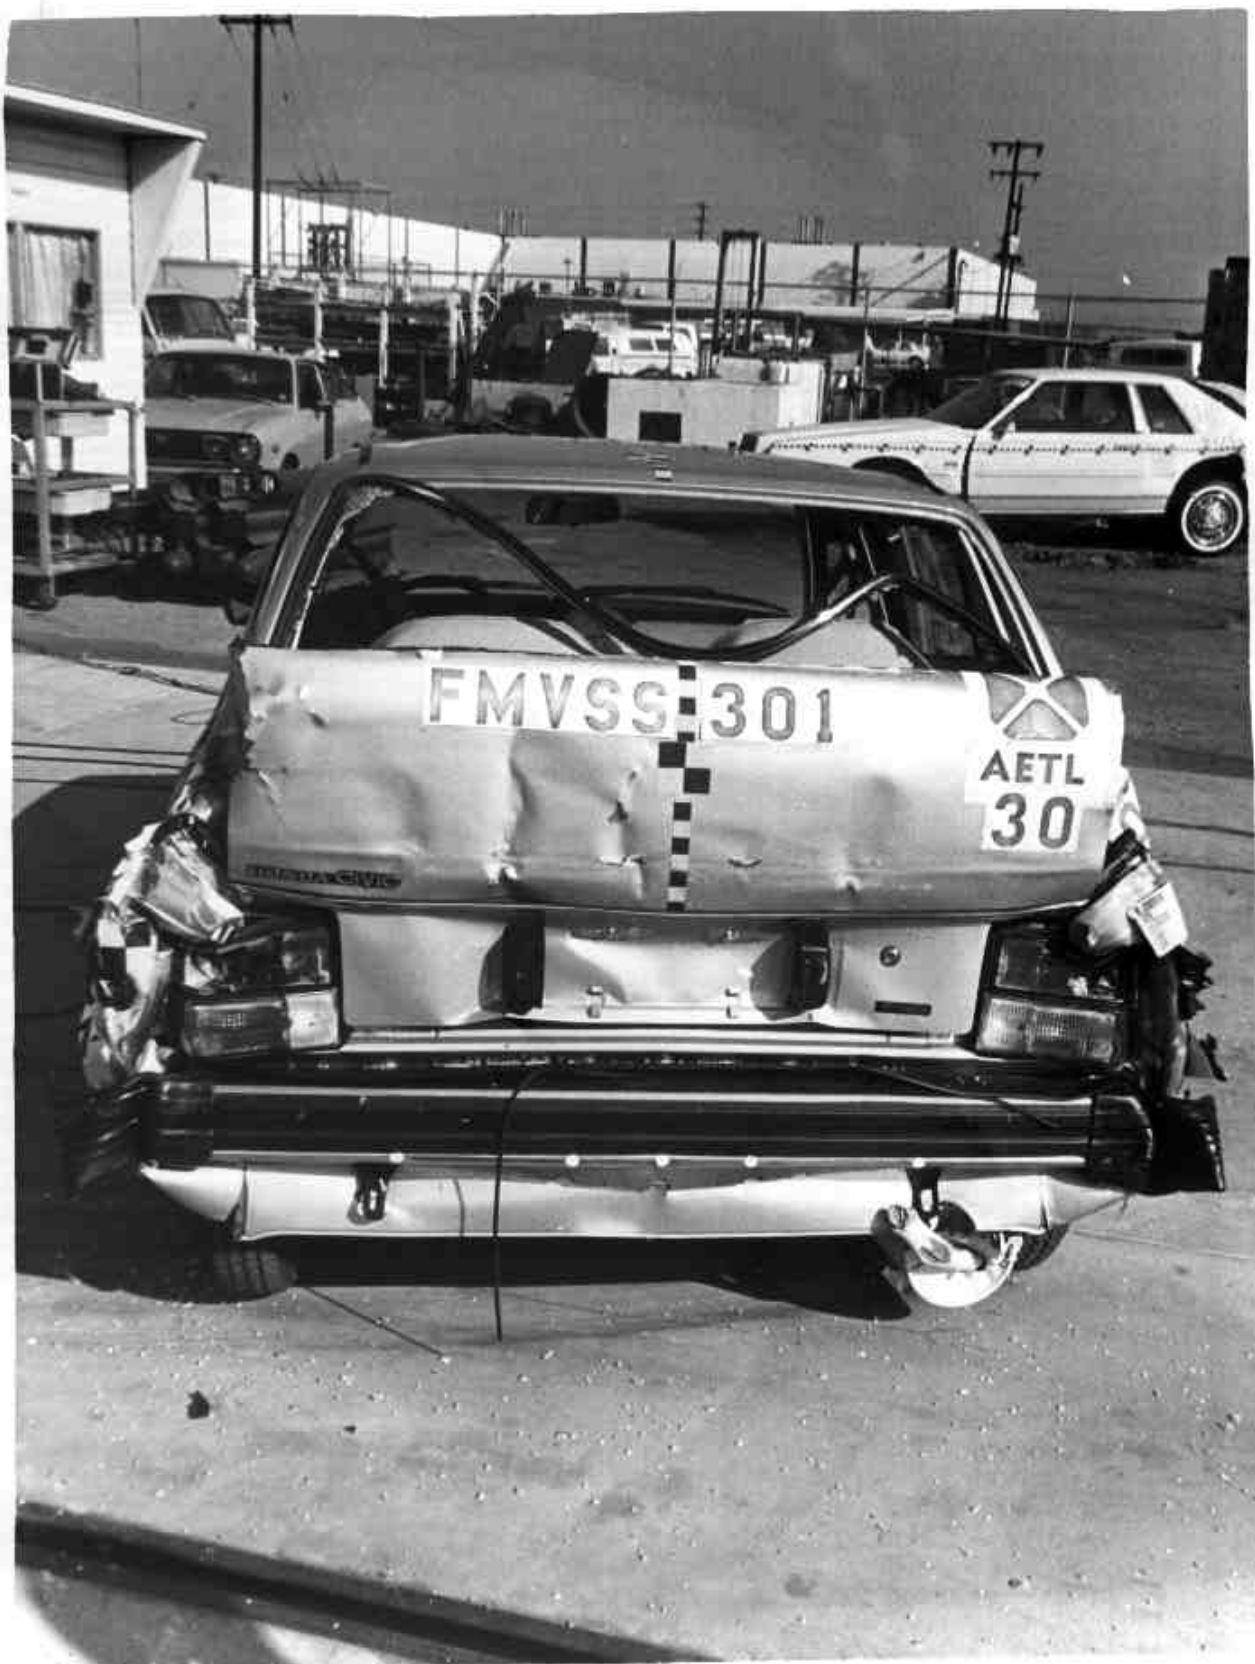
Figure 3-5  
1981 Honda Civic - 4 Door Sedan  
NHTSA 810502  
Post-Impact, Full Rear View

Crush Details: Both frame rails buckled over rear suspension, roof buckled  
over both "B" post, rear window shattered, both dummies made contact with  
rear seat back.
